Visual Site Inspection Report

Project Name	H-600 Pipeline Spread H	AFE	124300138	Spread	H-600 Pipeline Spread H
Contractor	Precision			Report #	34344
Inspector	Pat Davis			Date/Time	2/14/2022 4:00 PM
Permit #	TBD	Inspection Type	VA SWPP	Station Begin	+0
State	VA	Inspection Area	Partial	Station End	+0
County	Montgomery	Ground	Frozen	Temperature (°F)	23.00
Municipality	N/A	Weather	Cloudy	Rain Gauge (in)	0.00
				Rain Accumulation Time (days)	0.00

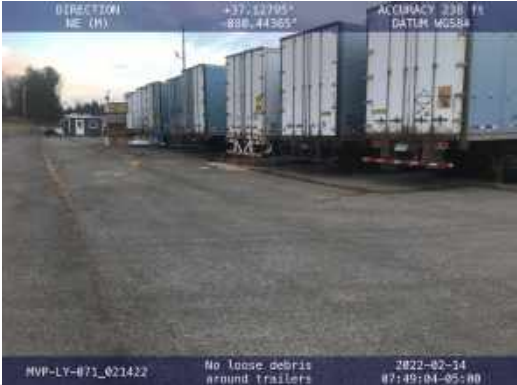
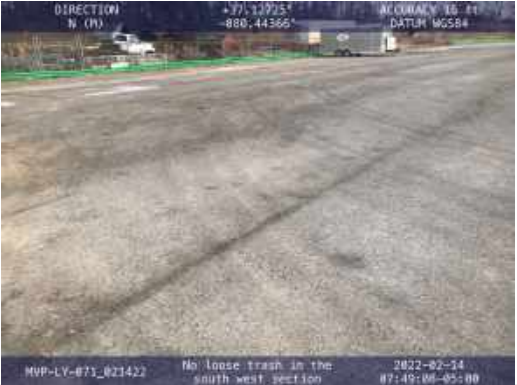
GPS Location	MVP-LY-071 See photo for gps data		GPS Location	MVP-LY-071 See photo for gps data	
Field Station#	+0		Field Station#	+0	
Pic 15 Desc.	No debris around straw trailers. Looking NE.		Pic 16 Desc.	No loose trash around the south west section of the yard. Looking N.

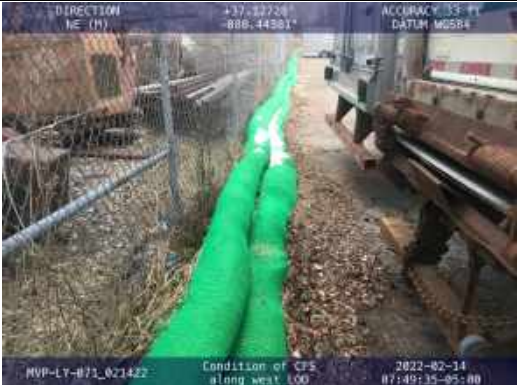
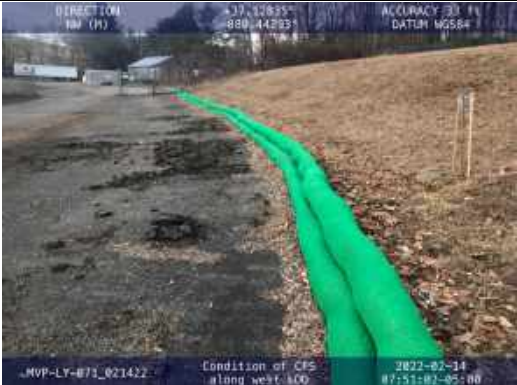
GPS Location	MVP-LY-071 See photo for gps data		GPS Location	MVP-LY-071 See photo for gps data	
Field Station#	+0		Field Station#	+0	
Pic 17 Desc.	Condition of triple stack compost filter sock along west LOD. Looking NE.		Pic 18 Desc.	Condition of triple stack compost filter sock along west LOD. Looking SW.

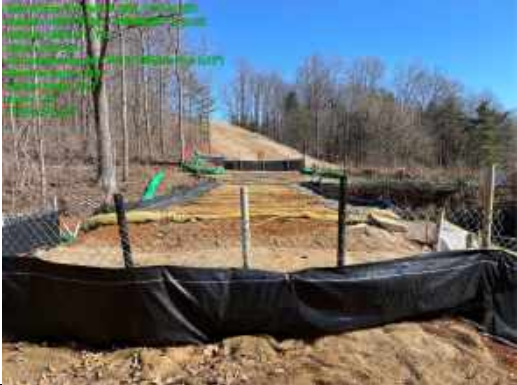
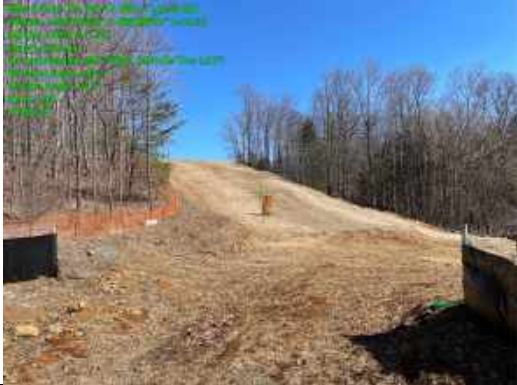
GPS Location	0	GPS Location	0		
Field Station#	13157+22	Field Station#	13158+00		
Pic 7 Desc.	MVP-S-D11 and corresponding buffer zone in good condition	Pic 8 Desc.	ROW and ECDs in good condition and stable

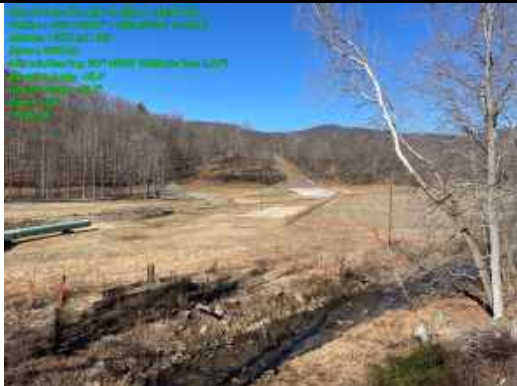
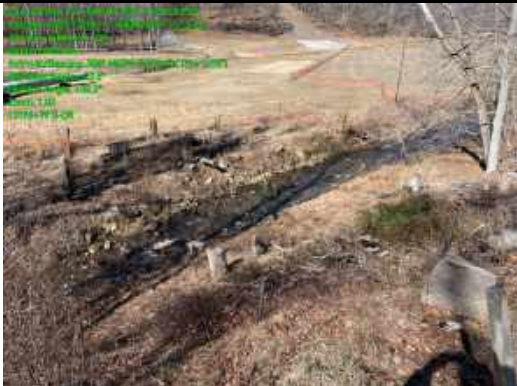
GPS Location	0	GPS Location	0		
Field Station#	13196+00	Field Station#	13196+79		
Pic 9 Desc.	ROW and ECDs in good condition and stable	Pic 10 Desc.	MVP-S-D8 and corresponding buffer zone in good condition

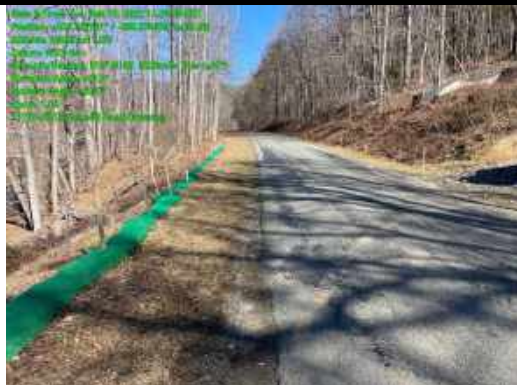
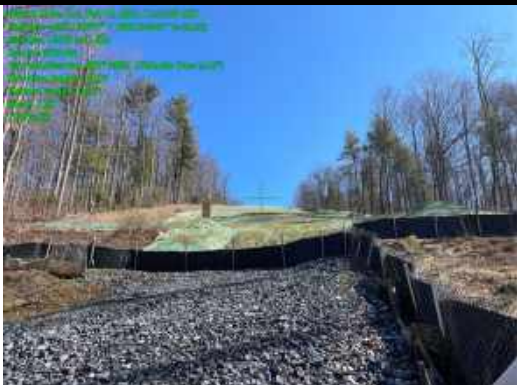
GPS Location	0	GPS Location	0		
Field Station#	13197+55	Field Station#	13198+00		
Pic 11 Desc.	Dillion Mill Road Crossing in good condition	Pic 12 Desc.	ROW and ECDs in good condition and stable

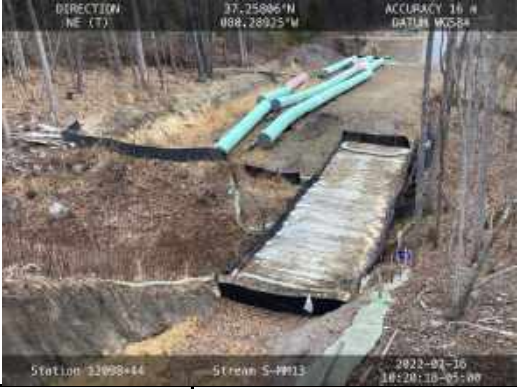
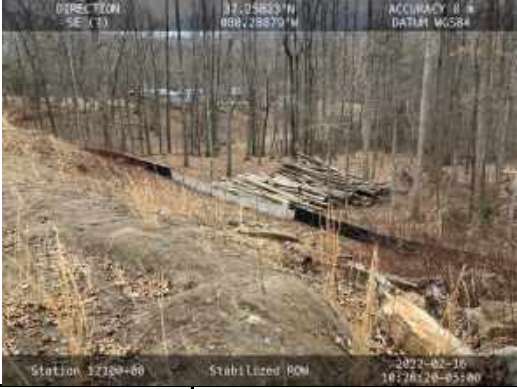
GPS Location	Please see photo for details.		GPS Location	Please see photo for details.	
Field Station#	12098+44		Field Station#	12100+00	
Pic 7 Desc.	Photo shows the stabilized ROW conditions with water bars and that all ECDs are installed and are functioning as designed.		Pic 8 Desc.	Photo shows stabilized edge of ROW with ECDs installed and functioning as designed.

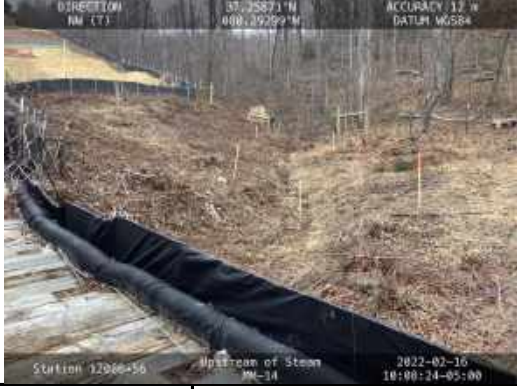
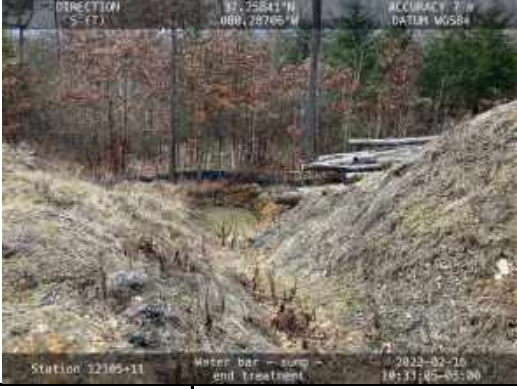
GPS Location	Please see photo for details.		GPS Location	Please see photo for details.	
Field Station#	12086+56		Field Station#	12105+11	
Pic 9 Desc.	Photo shows upstream view of Stream S-MM14 from equipment bridge.		Pic 10 Desc.	Photo shows water bar, sump and end treatment functioning as designed.

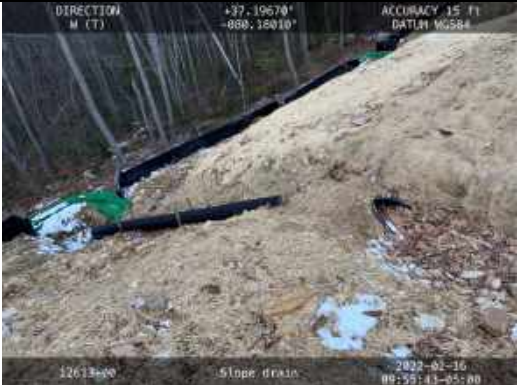
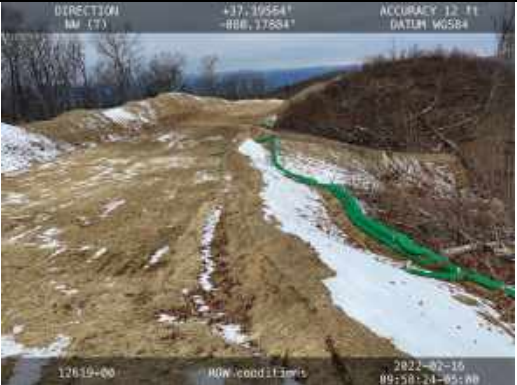
GPS Location	See photo for gps location data.		GPS Location	See photo for gps location data.	
Field Station#	12613+00		Field Station#	12619+00	
Pic 13 Desc.	Photo shows the slope drain		Pic 14 Desc.	Photo shows the ROW condition. ECDs are installed and functioning as designed.

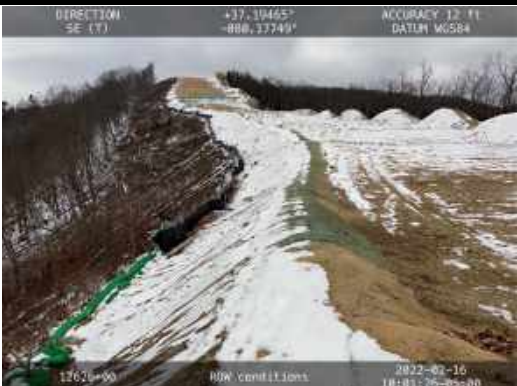
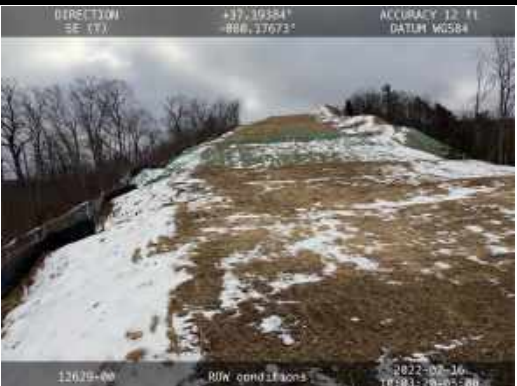
GPS Location	See photo for gps location data.		GPS Location	See photo for gps location data.	
Field Station#	12626+00		Field Station#	12629+00	
Pic 15 Desc.	Photo shows the ROW condition. ECDs are installed and functioning as designed.		Pic 16 Desc.	Photo shows the ROW condition. ECDs are installed and functioning as designed.

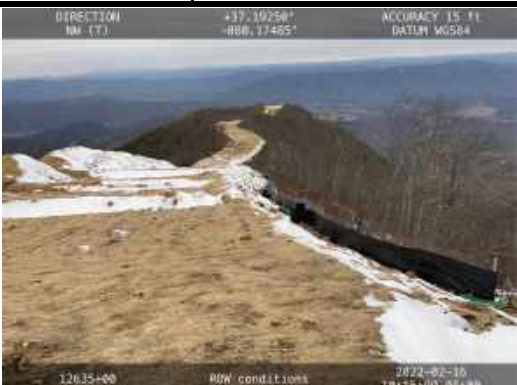
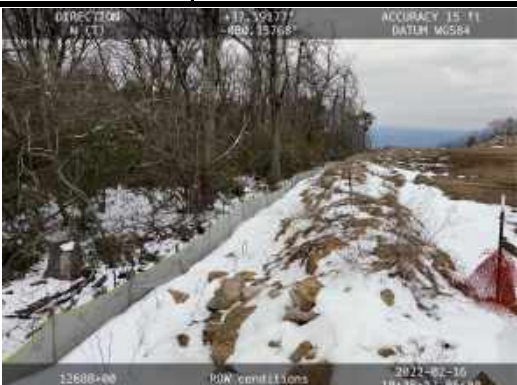
GPS Location	See photo for gps location data.		GPS Location	See photo for gps location data.	
Field Station#	12635+00		Field Station#	12688+00	
Pic 17 Desc.	Photo shows the ROW condition. ECDs are installed and functioning as designed.		Pic 18 Desc.	Photo shows the ROW condition. ECDs are installed and functioning as designed.

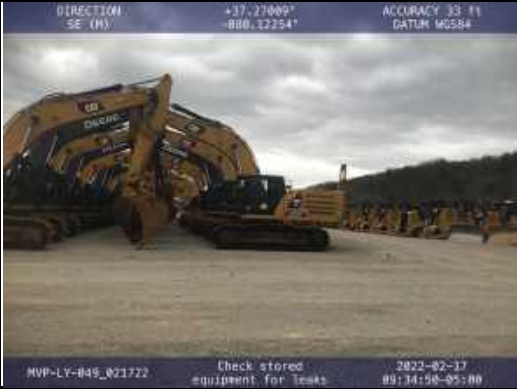
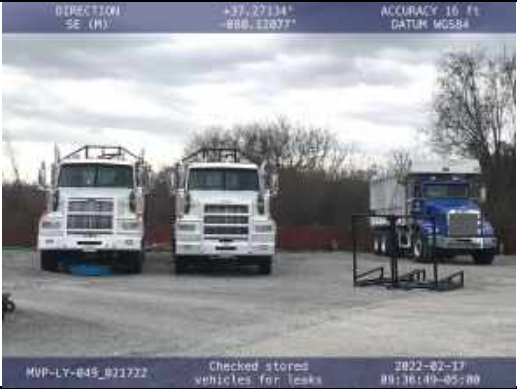
GPS Location	MVP-LY-049 See photo for gps data		GPS Location	MVP-LY-049 See photo for gps data	
Field Station#	+0		Field Station#	+0	
Pic 13 Desc.	Check stored equipment for new leaks. No new drips located. Looking SE.		Pic 14 Desc.	Check stored vehicles for new leaks. No new drips found. Looking SE.

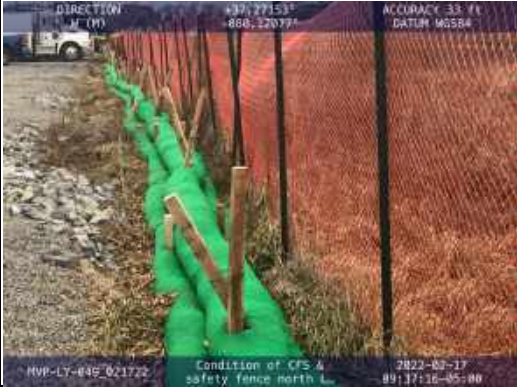
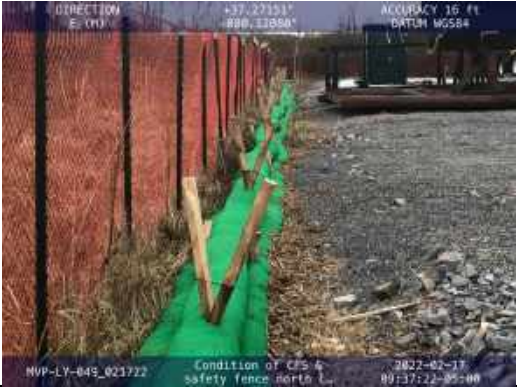
GPS Location	MVP-LY-049 See photo for gps data		GPS Location	MVP-LY-049 See photo for gps data	
Field Station#	+0		Field Station#	+0	
Pic 15 Desc.	Condition of triple stack compost filter sock and safety fence along north LOD. Looking W.		Pic 16 Desc.	Condition of triple stack compost filter sock and safety fence along north LOD. Looking E.

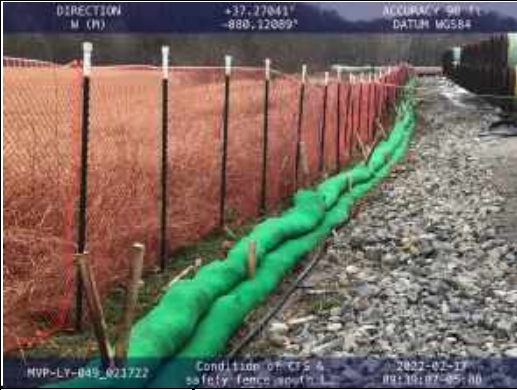
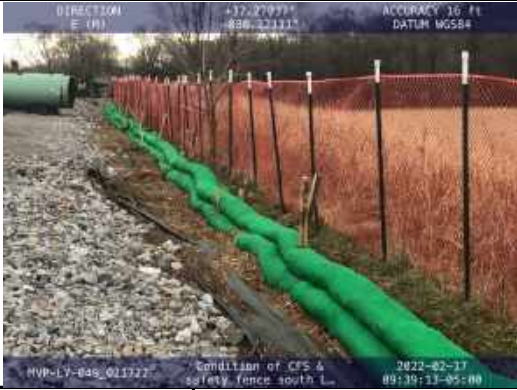
GPS Location	MVP-LY-049 See photo for gps data		GPS Location	MVP-LY-049 See photo for gps data	
Field Station#	+0		Field Station#	+0	
Pic 17 Desc.	Condition of triple stack compost filter sock and safety fence along south LOD. Looking W.		Pic 18 Desc.	Condition of triple stack compost filter sock and safety fence along south LOD. Looking E.

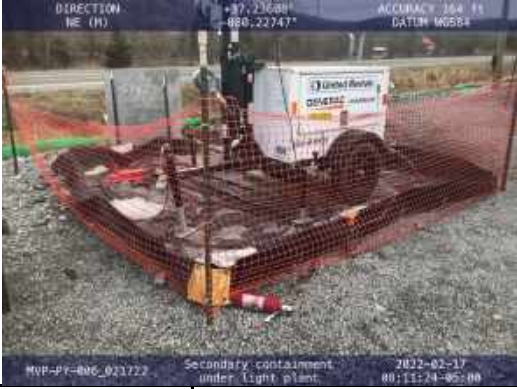
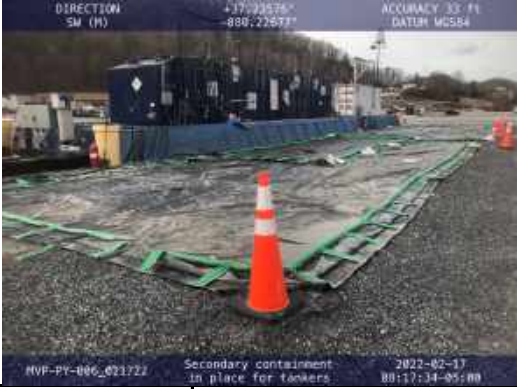
GPS Location	MVP-PY-006 See photo for gps data	GPS Location	MVP-PY-006 See photo for gps data		
Field Station#	+0	Field Station#	+0		
Pic 7 Desc.	Secondary containment under light plants. Free of fluids. Looking NE.	Pic 8 Desc.	Blue Bulk Fuel tanks secondary containment in place for tankers offloading fuel. Looking SW.

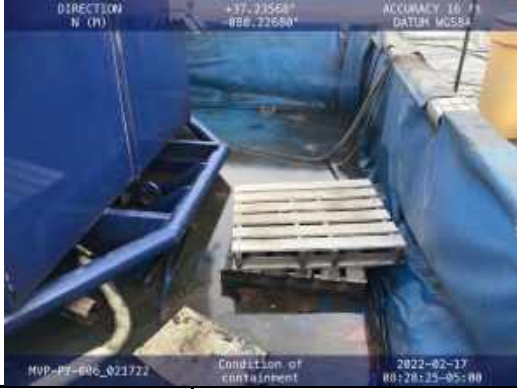
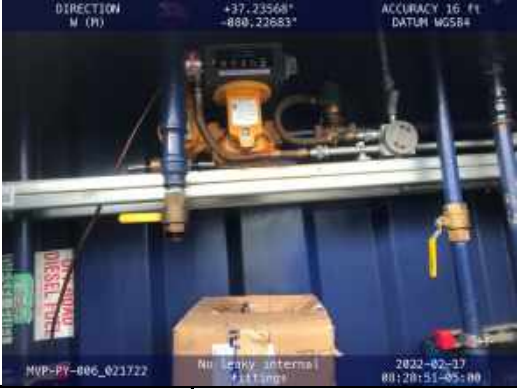
GPS Location	MVP-PY-006 See photo for gps data	GPS Location	MVP-PY-006 See photo for gps data		
Field Station#	+0	Field Station#	+0		
Pic 9 Desc.	Blue Bulk Fuel tanks containment holding stormwater. Looking N.	Pic 10 Desc.	Blue Bulk Fuel tanks no leaky internal fittings. Looking W.

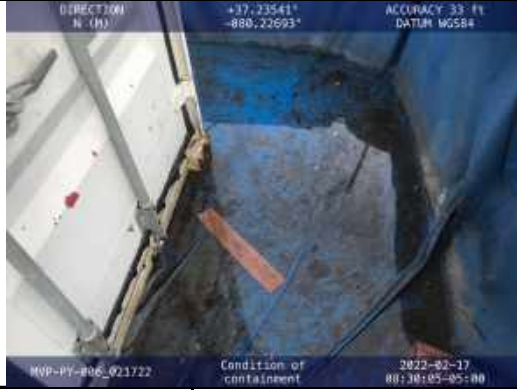
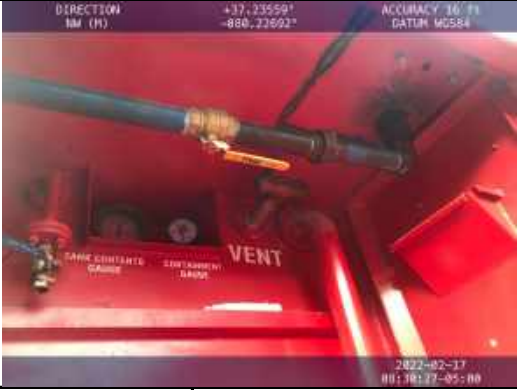
GPS Location	MVP-PY-006 See photo for gps data	GPS Location	MVP-PY-006 See photo for gps data		
Field Station#	+0	Field Station#	+0		
Pic 11 Desc.	Off Road Fuel unit containment holding stormwater. Looking N.	Pic 12 Desc.	Off Road Fuel unit no leaky internal fittings. Looking NW.

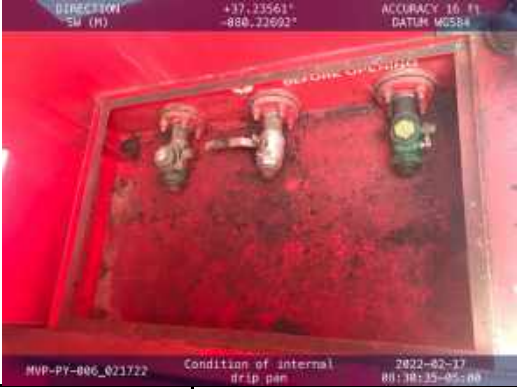
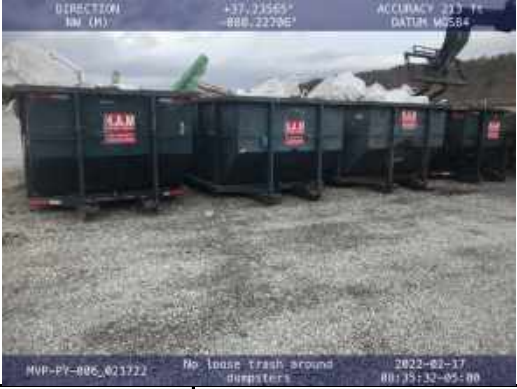
GPS Location	MVP-PY-006 See photo for gps data	GPS Location	MVP-PY-006 See photo for gps data		
Field Station#	+0	Field Station#	+0		
Pic 13 Desc.	Off Road Fuel unit condition of internal drip pan. Free of fluids. Looking SW.	Pic 14 Desc.	No loose trash around dumpsters or in the yard. Looking NW.

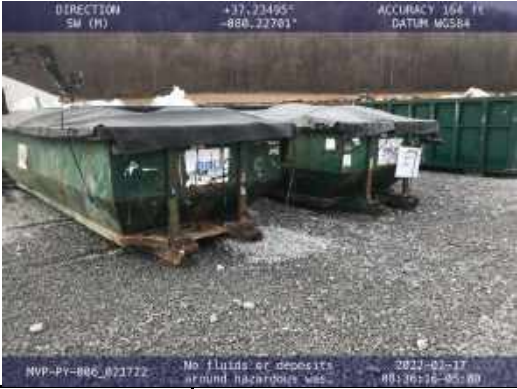
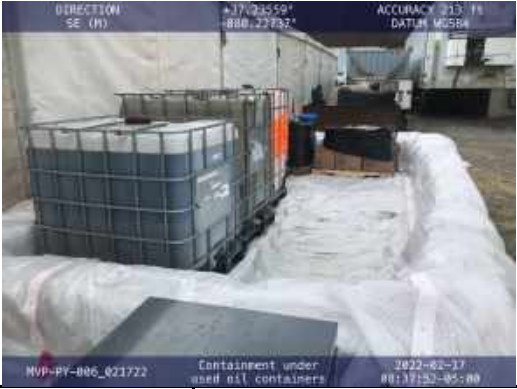
GPS Location	MVP-PY-006 See photo for gps data	GPS Location	MVP-PY-006 See photo for gps data		
Field Station#	+0	Field Station#	+0		
Pic 15 Desc.	No fluids or deposits around hazardous waste dumpsters. Looking SW.	Pic 16 Desc.	Secondary containment under used oil containers free of fluids. Looking SE.

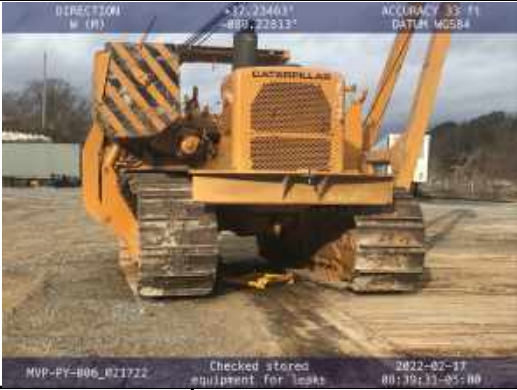
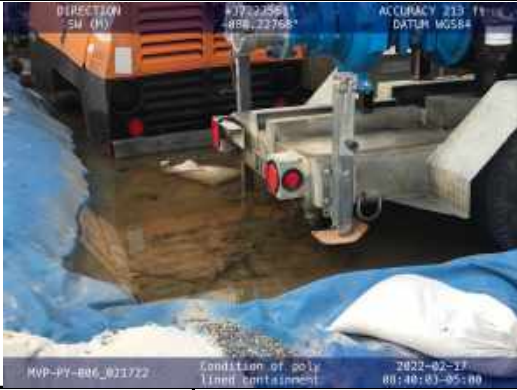
GPS Location	MVP-PY-006 See photo for gps data	GPS Location	MVP-PY-006 See photo for gps data		
Field Station#	+0	Field Station#	+0		
Pic 17 Desc.	Check stored equipment for new leaks. No new leaks found. Looking W.	Pic 18 Desc.	Condition of poly lined containments. Holding stormwater. Looking SW.

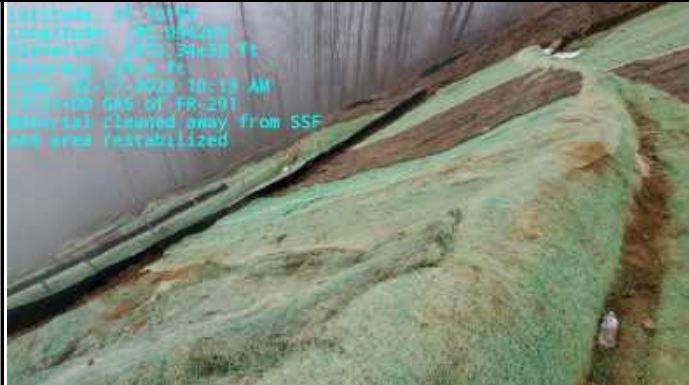
GPS Location	See pic for GPS location.		GPS Location	See pic for GPS location.	
Field Station#	13119+00		Field Station#	13121+00	
Pic 7 Desc.	Current ROW conditions between FR-291 and FR-292.		Pic 8 Desc.	SSF cleaned out and area stabilized with ECB.

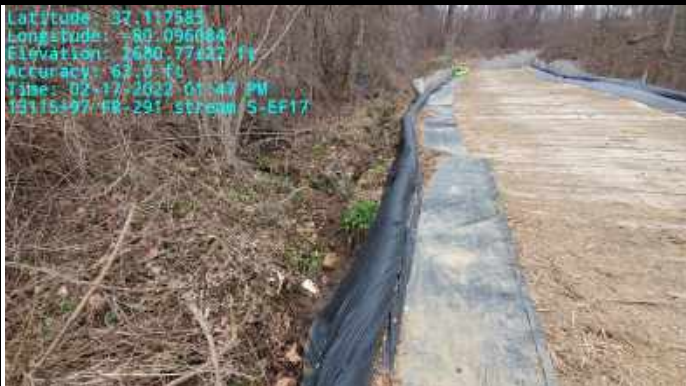
GPS Location	See pic for GPS location.		GPS Location	See pic for GPS location.	
Field Station#	13115+97		Field Station#	13124+50	
Pic 9 Desc.	No issues or impacts observed near stream S-EF17.		Pic 10 Desc.	Slope drains, waterbars and end treatments remain functional.

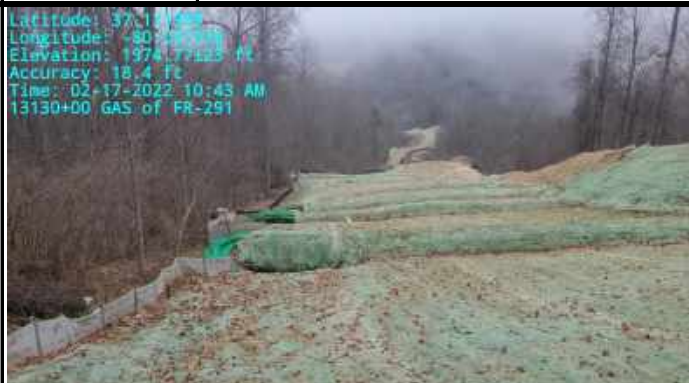
GPS Location	See pic for GPS location.		GPS Location	See pic for GPS location.	
Field Station#	13130+00		Field Station#	13130+00	
Pic 11 Desc.	Current ROW conditions between FR-291 and FR-292.		Pic 12 Desc.	Waterbars, sumps and end treatments remain functional.

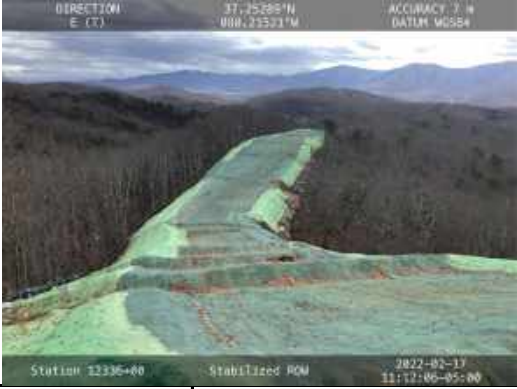
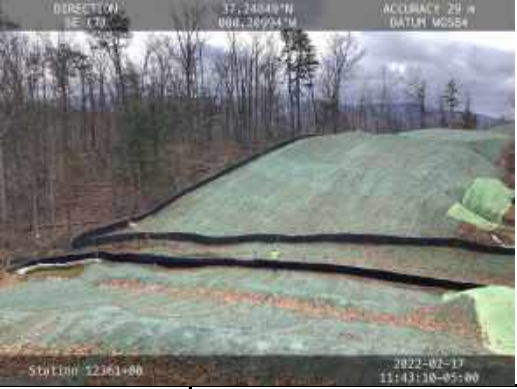
GPS Location	Please see photo for details.		GPS Location	Please see photo for details.	
Field Station#	12336+00		Field Station#	12361+00	
Pic 7 Desc.	Photo shows the stabilized ROW conditions with water bars and that all ECDs are installed and are functioning as designed.		Pic 8 Desc.	Photo shows the stabilized ROW conditions with water bars and that all ECDs are installed and are functioning as designed.

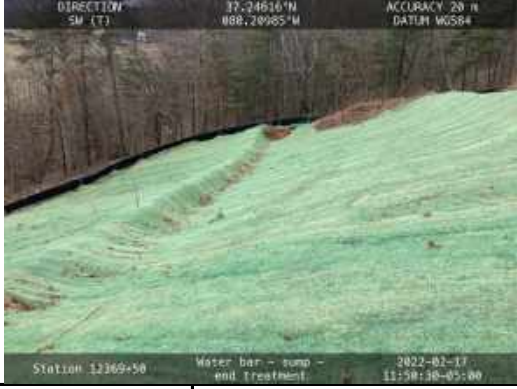
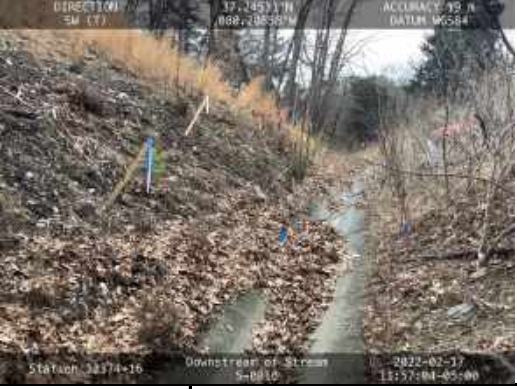
GPS Location	Please see photo for details.		GPS Location	Please see photo for details.	
Field Station#	12369+50		Field Station#	12374+16	
Pic 9 Desc.	Photo shows the stabilized ROW conditions with water bars and that all ECDs are installed and are functioning as designed.		Pic 10 Desc.	Photo shows channel of Stream S-0016.

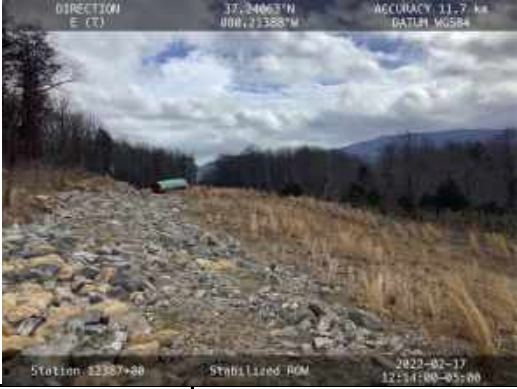
GPS Location	Please see photo for details.		GPS Location	Please see photo for details.	
Field Station#	12387+00		Field Station#	12408+50	
Pic 13 Desc.	Photo shows the stabilized ROW conditions with water bars and that all ECDs are installed and are functioning as designed.		Pic 14 Desc.	Photo shows clean water diversion inlet.

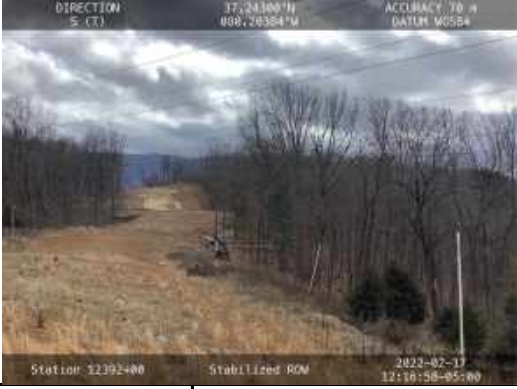
GPS Location	Please see photo for details.		GPS Location	Please see photo for details.	
Field Station#	12392+00		Field Station#	12412+00	
Pic 15 Desc.	Photo shows the stabilized ROW conditions with water bars and that all ECDs are installed and are functioning as designed.		Pic 16 Desc.	Photo shows environmental crew performing maintenance on P1 silt fence.

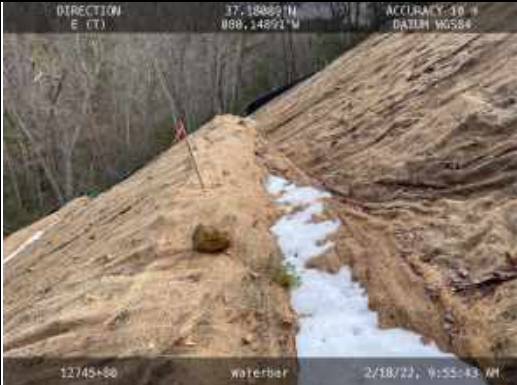
GPS Location	See photo		GPS Location	See photo	
Field Station#	12745+80		Field Station#	12746+75	
Pic 7 Desc.	Waterbar is functional.		Pic 8 Desc.	Sump and end treatment are functional

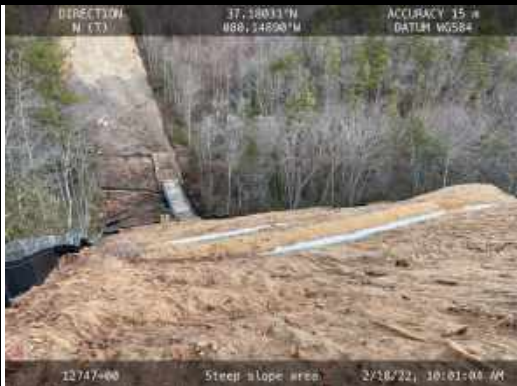
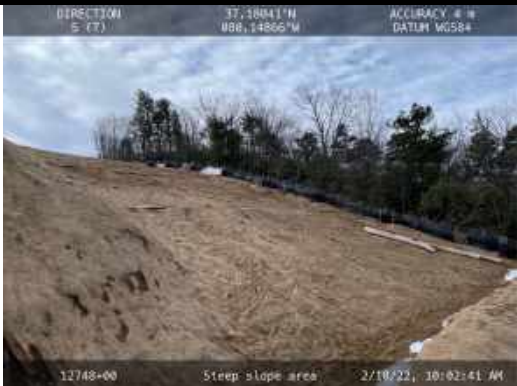
GPS Location	See photo		GPS Location	See photo	
Field Station#	12747+00		Field Station#	12748+00	
Pic 9 Desc.	Current ROW conditions. ROW is stable. ECDs are functional.		Pic 10 Desc.	Current ROW conditions. ROW is stable. ECDs are functional.

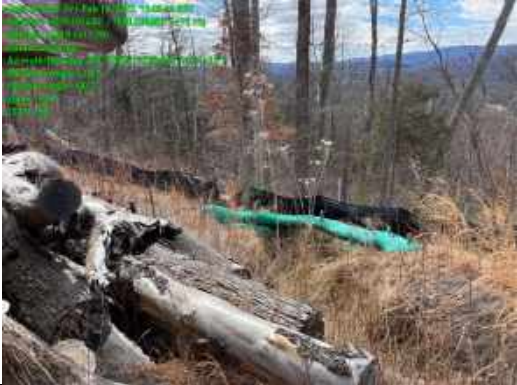
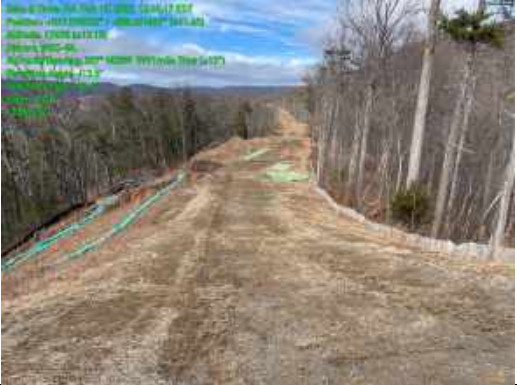
GPS Location	0	GPS Location	0		
Field Station#	13371+50	Field Station#	13398+50		
Pic 13 Desc.	Repair fence fabric - 72 hour maintenance item	Pic 14 Desc.	ROW and ECDs In good condition and stable

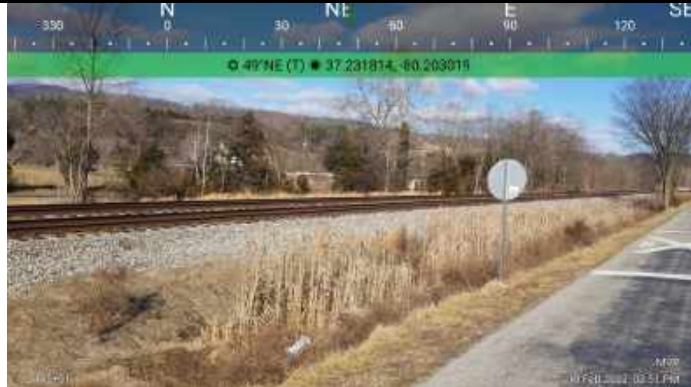
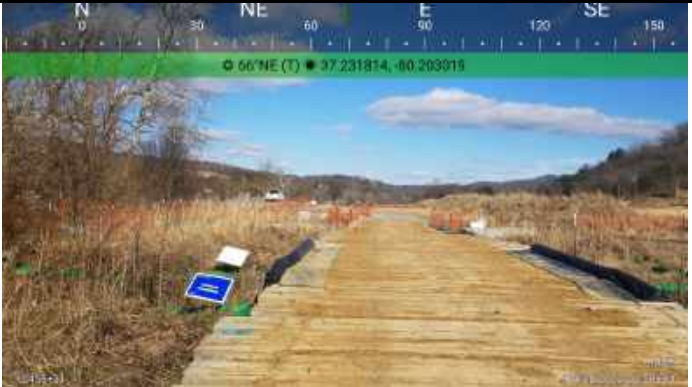
GPS Location	See Above	GPS Location	See Above		
Field Station#	12445+01	Field Station#	12455+21		
Pic 1 Desc.	Overview of Waterbody S-I1. ROW is stable. No erosion or sedimentation concerns noted.	Pic 2 Desc.	Overview of Waterbody S-CD12b. ECDs are functional and ROW is stable.

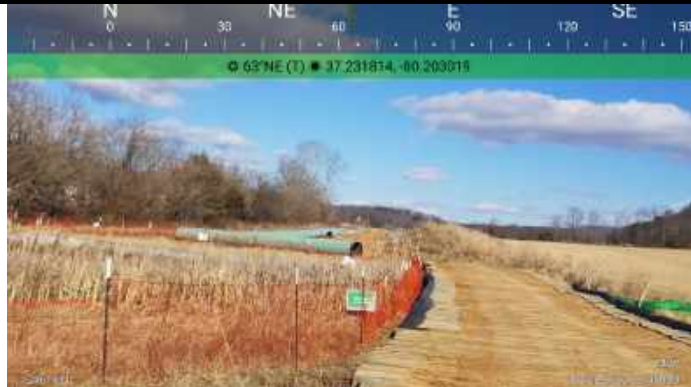
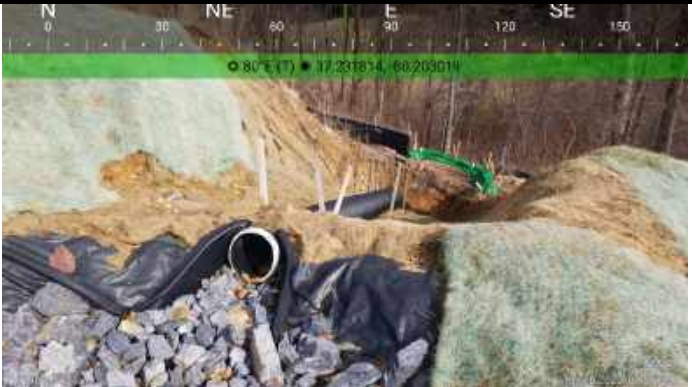
GPS Location	See Above	GPS Location	See Above		
Field Station#	12461+81	Field Station#	121481+00		
Pic 3 Desc.	Overview of Wetland W-KL58. ECDs are functional and ROW is stable.	Pic 4 Desc.	ROW Overview (temporary stabilization). ECDs are functional and ROW is stable.
