Visual Site Inspection Report

| Project Name | H-600 Pipeline Spread H | AFE | 124300138 | Spread | H-600 Pipeline Spread H |
| Contractor | Precision | | | Report # | 34937 |
| Inspector | Jordan Davis | | | Date/Time | 2/28/2022 3:34 PM |

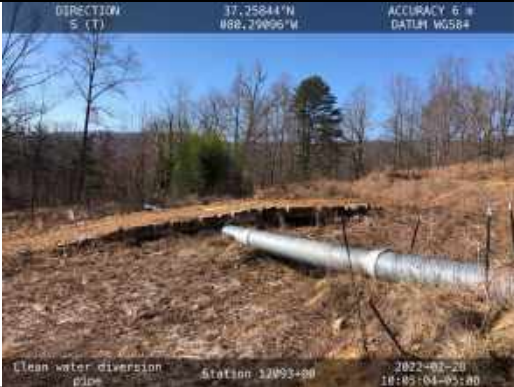
| Field Station# | 12093+00 | | Field Station# | 12086+56 | |

| Pic 1 Desc. | Photo shows the stabilized ROW conditions with water bars and that all ECDs are installed and are functioning as designed. | | Pic 2 Desc. | Photo shows the stabilized ROW conditions with water bars and that all ECDs are installed and are functioning as designed. | |

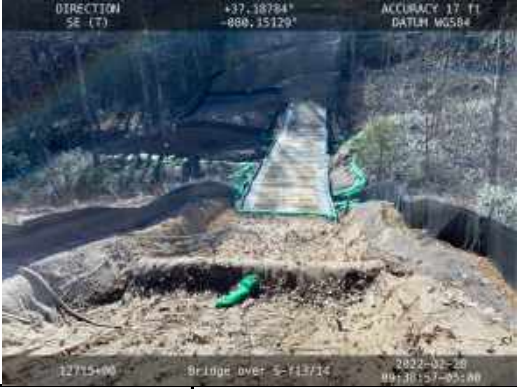
| Field Station# | 12715+00 | | Field Station# | 12715+80 | |

| Pic 5 Desc. | Photo shows the ROW condition. ECDs are installed and functioning as designed. | | Pic 6 Desc. | Photo shows the ROW condition. ECDs are installed and functioning as designed. | |

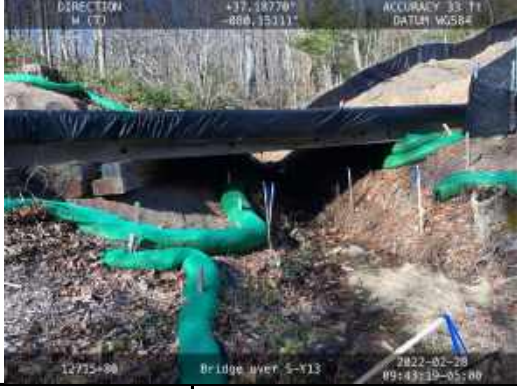
| Field Station# | 12715+80 | | Field Station# | 12716+20 | |

| Pic 7 Desc. | Photo shows the bridge over streams S-Y13 and S-Y14. | | Pic 8 Desc. | Photo shows S-Y13 downstream from the bridge. | |

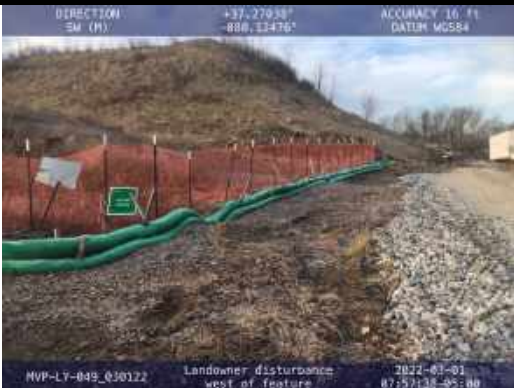
| Pic 3 Desc. | Landowner soil disturbance along triple stack compost filter sock. No new damage to installed ECD's. Looking S. | | Pic 4 Desc. | Landowner soil disturbance along edge of feature W-CV21A. Looking NW. | |

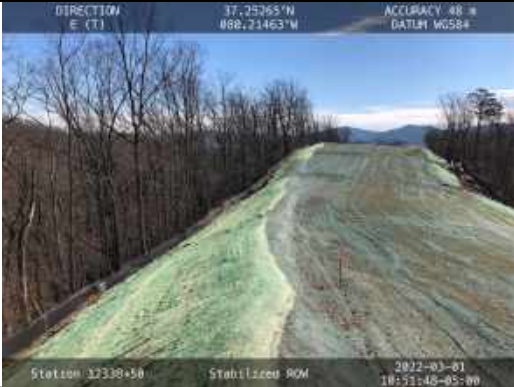
| Field Station# | 12338+50 | | Field Station# | 12354+75 | |

| Pic 1 Desc. | Photo shows the stabilized ROW conditions with water bars and that all ECDs are installed and are functioning as designed. | | Pic 2 Desc. | Photo shows the stabilized ROW conditions with water bars and that all ECDs are installed and are functioning as designed. | |

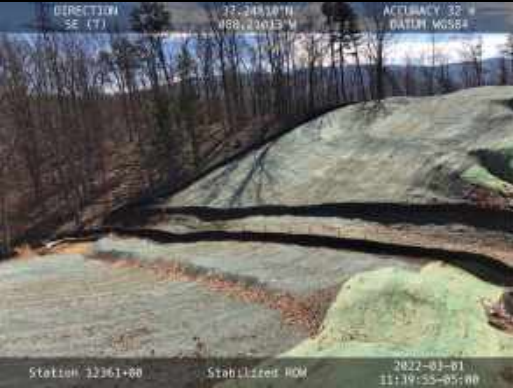
| Field Station# | 12346+25 | | Field Station# | 12361+00 | |

| Pic 3 Desc. | Photo shows the stabilized ROW conditions with water bars and that all ECDs are installed and are functioning as designed. | | Pic 4 Desc. | Photo shows stabilized ROW, timber pile and super silt fence. | |

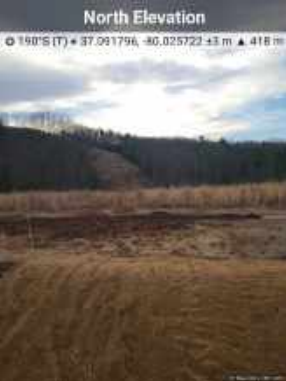
| Field Station# | 13421+30 | Field Station# | 13421+00 | | |

| Pic 1 Desc. | P1 at anode bed location requires maintenance due to being weathered, documented and added to the punch list. | | Pic 2 Desc. | Row photo in work space area showing stabilization and materials stock piled , no environmental issues observed at the time of inspection. | |

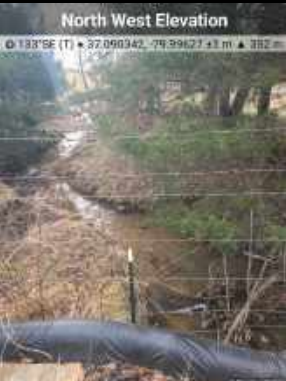
| Field Station# | 13525+10 | Field Station# | 13525+10 | | |

| Pic 3 Desc. | Erosion control blanket in place on water bar, vegetation observation on row, no environmental issues observed at the time of inspection. | | Pic 4 Desc. | Photo showing open ditch , fence around area in place, no environmental issues observed at the time of inspection. | |

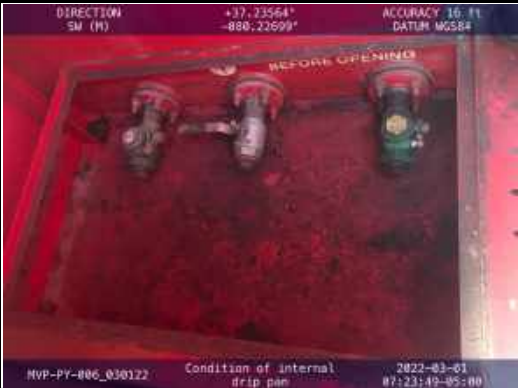
| Pic 13 Desc. | Blue Bulk Fuel tanks no leaky fittings or nozzles. Catch pans on site. Looking S. | | Pic 14 Desc. | Off Road Fuel unit no leaky internal fittings. Looking W. | |

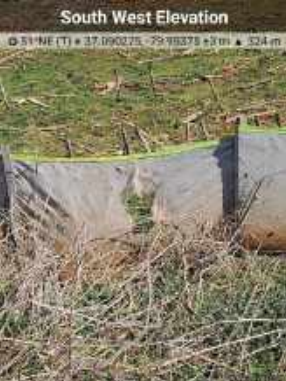
| Pic 1 Desc. | P1 requires maintenance, added to the punch list for repair. | Pic 2 Desc. | P1 requires maintenance, added to the punch list for repair. | | |

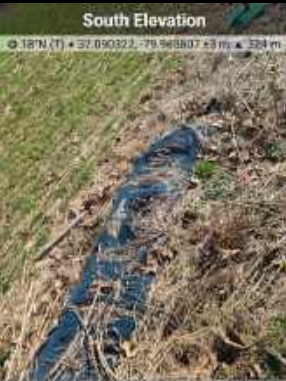
| Pic 3 Desc. | P1 requires maintenance, added to the punch list for repair. | Pic 4 Desc. | CFS requires maintenance due to being weathered, added to the punch list | | |

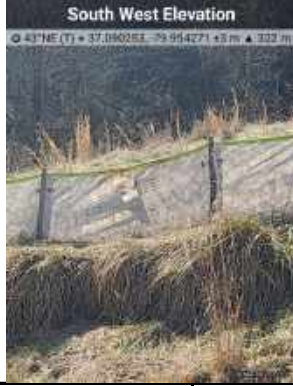
| Field Station# | 13660+50 | Field Station# | | | |

| Pic 9 Desc. | P1 requires maintenance, added to the punch list for repair. | | Pic 10 Desc. | CFS requires maintenance due to being weathered, added to the punch list | |

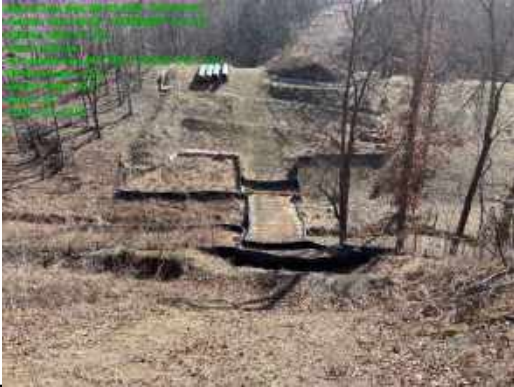
| Pic 1 Desc. | Wades Gap Road Crossing in good condition | Pic 2 Desc. | Private Driveway in good condition | | |

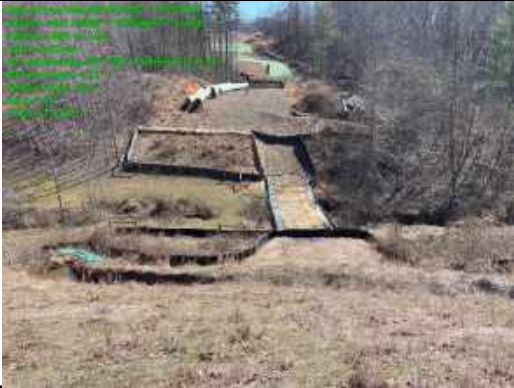
| Pic 3 Desc. | MVP-S-GH15 and corresponding buffer zone in good condition | Pic 4 Desc. | Repair fence fabric - 72 hour maintenance item, repair was completed and in good condition | | |

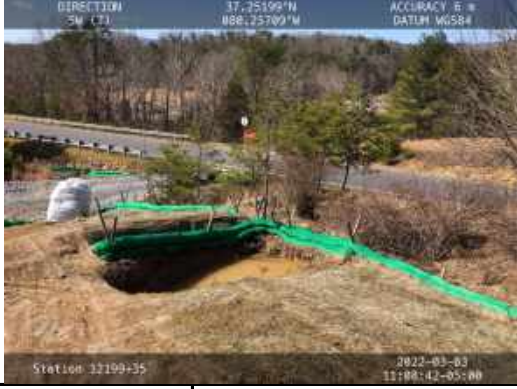
| Pic 7 Desc. | Photo shows permanent stabilization with permanent water bars with level spreaders. | | Pic 8 Desc. | Photo shows punch list item found today of torn erosion control blanket. | |

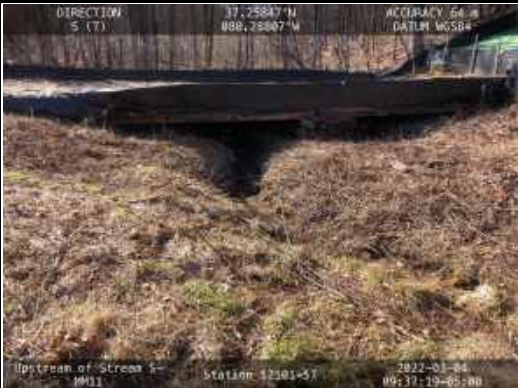
| Pic 13 Desc. | Photo shows sunken ditch line holding water. | | Pic 14 Desc. | Photo shows the stabilized ROW conditions with water bars and that all ECDs are installed and are functioning as designed. | |
