# Visual Site Inspection Report

<b>Project Name</b>	H-600 Pipeline Spread H	<b>AFE</b>	124300138	<b>Spread</b>	H-600 Pipeline Spread H
<b>Contractor</b>	Precision			<b>Report #</b>	34101
<b>Inspector</b>	Pat Davis			<b>Date/Time</b>	2/7/2022 4:00 PM
<b>Permit #</b>	TBD	<b>Inspection Type</b>	VA SWPP	<b>Station Begin</b>	+0
<b>State</b>	VA	<b>Inspection Area</b>	Partial	<b>Station End</b>	+0
<b>County</b>	Montgomery	<b>Ground</b>	Frozen	<b>Temperature (°F)</b>	18.00
<b>Municipality</b>	N/A	<b>Weather</b>	Cloudy	<b>Rain Gauge (in)</b>	0.00
				<b>Rain Accumulation Time (days)</b>	0.00

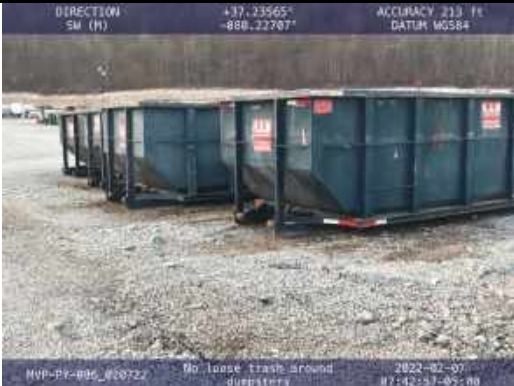
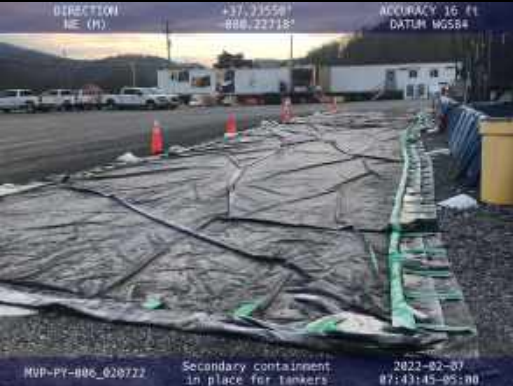
<b>Field Station#</b>	+0	<b>Field Station#</b>	+0		
<b>Pic 5 Desc.</b>	No loose trash around dumpsters or in the yard. Looking SW.	<b>Pic 6 Desc.</b>	Blue Bulk Fuel tanks Secondary containment in place for tankers offloading fuel. Looking NE.

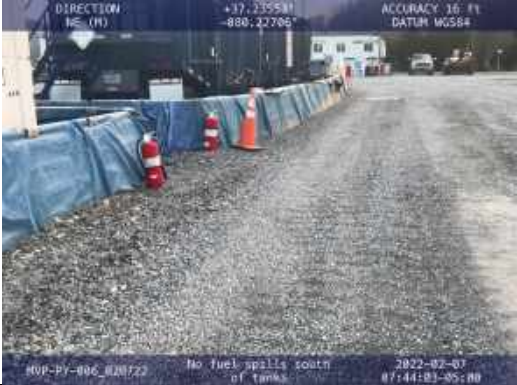
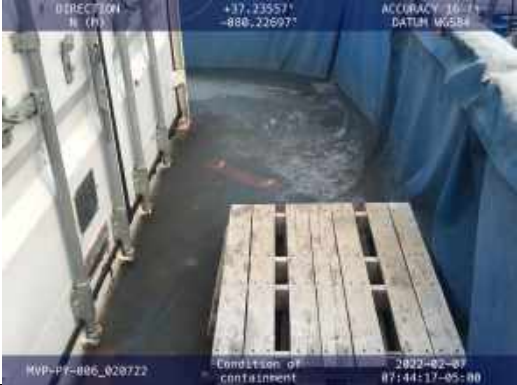
<b>GPS Location</b>	MVP-PY-006 See photo for gps data	<b>GPS Location</b>	MVP-PY-006 See photo for gps data		
<b>Field Station#</b>	+0	<b>Field Station#</b>	+0		
<b>Pic 7 Desc.</b>	Blue Bulk Fuel tanks no fuel spills south of tanks. Looking NE.	<b>Pic 8 Desc.</b>	Off Road Fuel unit containment holding ice and stormwater. Looking N.

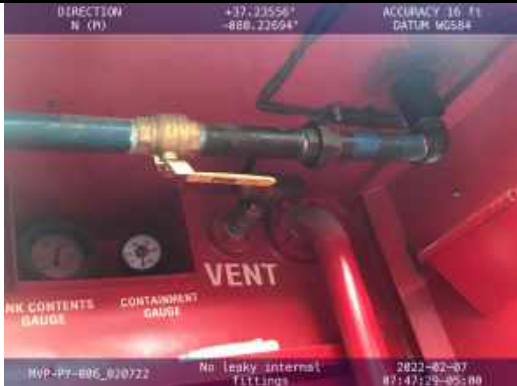
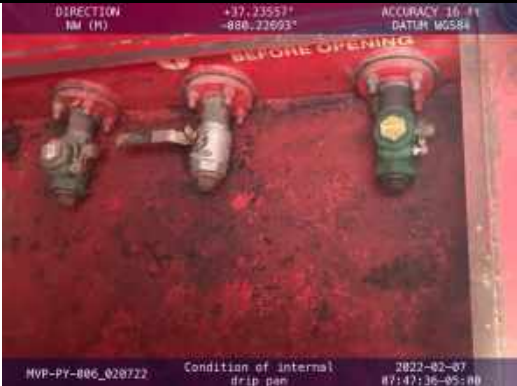
<b>GPS Location</b>	MVP-PY-006 See photo for gps data	<b>GPS Location</b>	MVP-PY-006 See photo for gps data		
<b>Field Station#</b>	+0	<b>Field Station#</b>	+0		
<b>Pic 9 Desc.</b>	Off Road Fuel unit no leaky internal fittings. Looking N.	<b>Pic 10 Desc.</b>	Off Road Fuel unit condition of internal drip pan. Free of fluids. Looking NW.

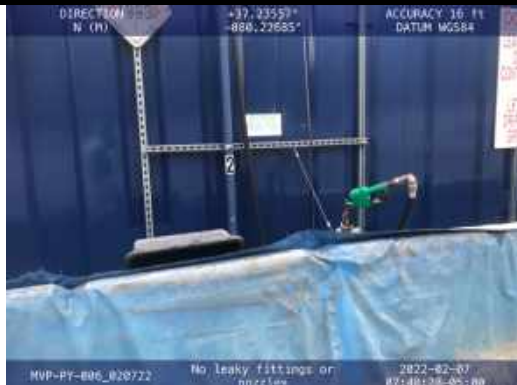
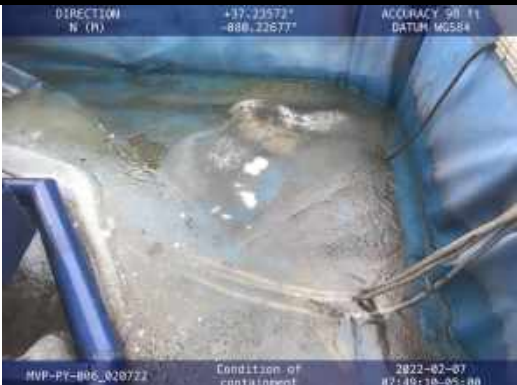
<b>Field Station#</b>	+0	<b>Field Station#</b>	+0		
<b>Pic 11 Desc.</b>	Blue Bulk Fuel tanks no leaky fittings or nozzles. Catch pans on site. Looking N.	<b>Pic 12 Desc.</b>	Blue Bulk Fuel tanks containment holding stormwater and ice. Looking N.

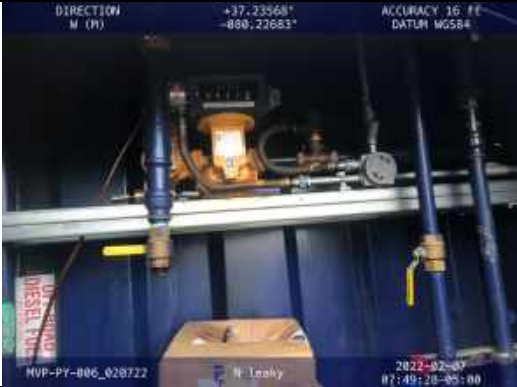
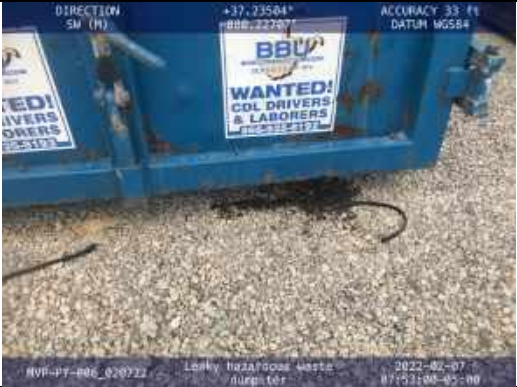
<b>GPS Location</b>	MVP-PY-006 See photo for gps data		<b>GPS Location</b>	MVP-PY-006 See photo for gps data	
<b>Field Station#</b>	+0		<b>Field Station#</b>	+0	
<b>Pic 13 Desc.</b>	Blue Bulk Fuel tanks no leaky internal fittings. Looking W.		<b>Pic 14 Desc.</b>	Oil spill from hazardous waste dumpster. Looking SW.

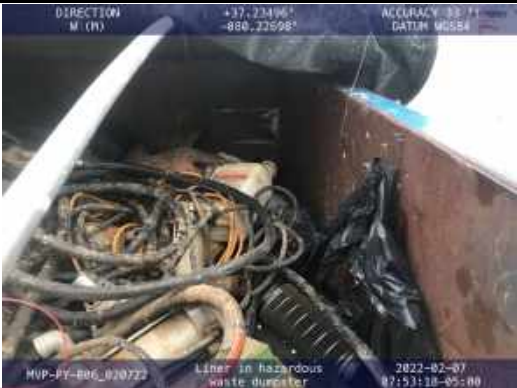
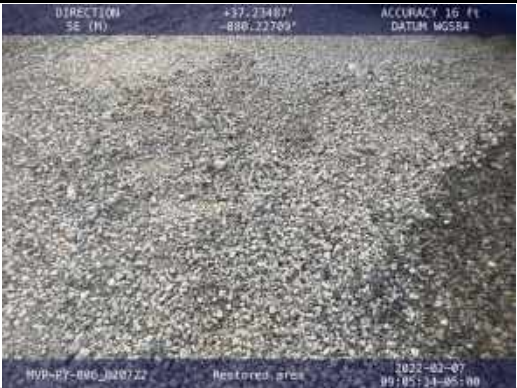
<b>GPS Location</b>	MVP-PY-006 See photo for gps data		<b>GPS Location</b>	MVP-PY-006 See photo for gps data	
<b>Field Station#</b>	+0		<b>Field Station#</b>	+0	
<b>Pic 15 Desc.</b>	Hazardous waste dumpster liner came loose allowing leak. See Spill Report #1550. Spill cleaned up. Looking W.		<b>Pic 16 Desc.</b>	Area of hazardous waste dumpster spill cleaned up. See Spill report #1550. Looking SE.

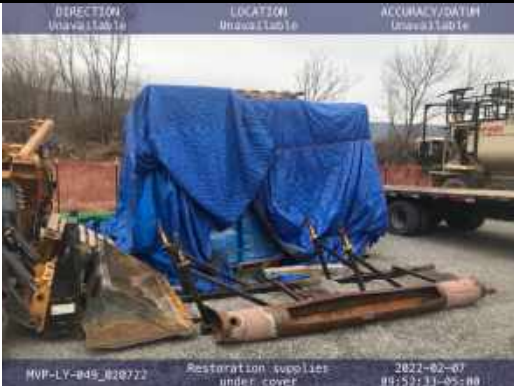
<b>Field Station#</b>	+0	<b>Field Station#</b>	+0		
<b>Pic 5 Desc.</b>	Restoration supplies under cover. Looking NE.	<b>Pic 6 Desc.</b>	Checked stored vehicles for new leaks. No new leaks found. Looking E.

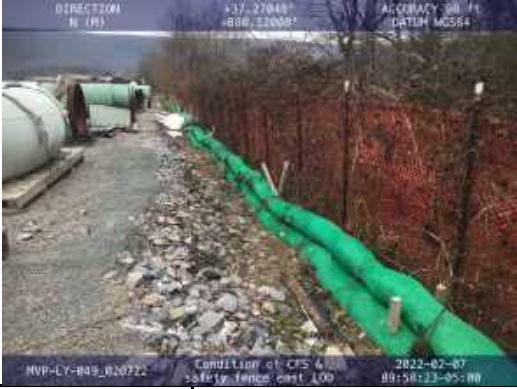
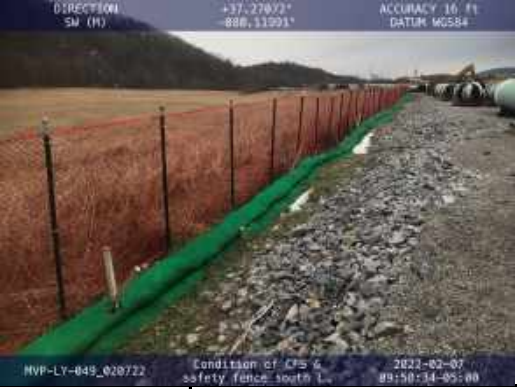
<b>GPS Location</b>	MVP-LY-049 See photo for gps data	<b>GPS Location</b>	MVP-LY-049 See photo for gps data		
<b>Field Station#</b>	+0	<b>Field Station#</b>	+0		
<b>Pic 7 Desc.</b>	Condition of triple stack compost filter sock and safety fence along east LOD. Looking N.	<b>Pic 8 Desc.</b>	Condition of triple stack compost filter sock and safety fence along south LOD. Looking SW.

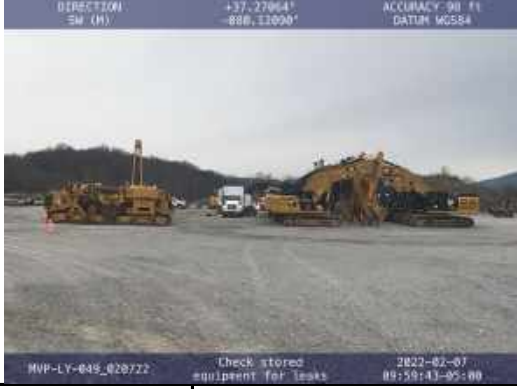
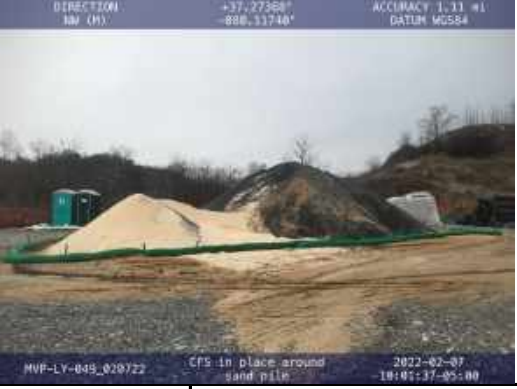
<b>GPS Location</b>	MVP-LY-049 See photo for gps data	<b>GPS Location</b>	MVP-LY-049 See photo for gps data		
<b>Field Station#</b>	+0	<b>Field Station#</b>	+0		
<b>Pic 9 Desc.</b>	Check stored equipment for new leaks. No new leaks located. Looking SW.	<b>Pic 10 Desc.</b>	Compost filter sock in place and functioning around sand pile. Looking NW.

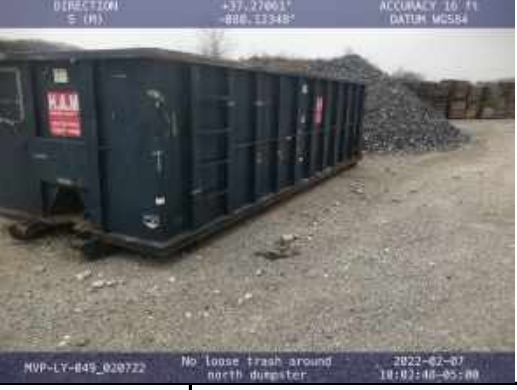
<b>Field Station#</b>	+0	<b>Field Station#</b>	+0		
<b>Pic 11 Desc.</b>	Condition of temporary trash transfer pit. Pit is empty of debris. Looking NW.	<b>Pic 12 Desc.</b>	No loose trash around north dumpster or in the yard. Looking S.

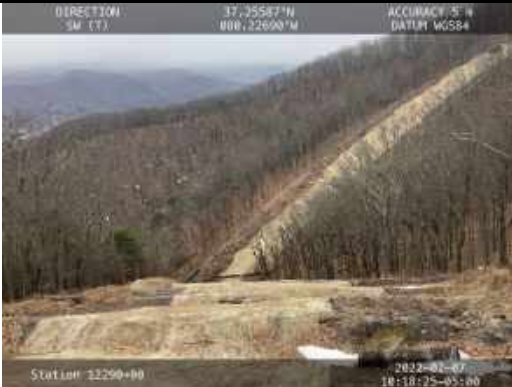
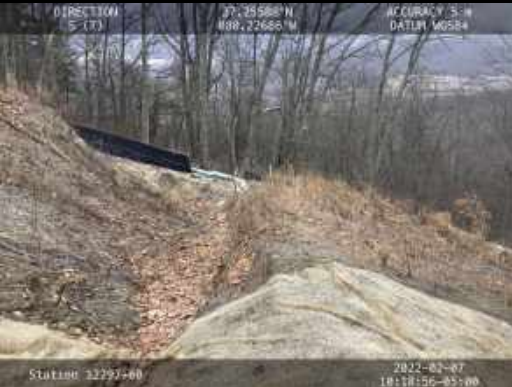
<b>GPS Location</b>	See photo		<b>GPS Location</b>	See photo	
<b>Field Station#</b>	12297+00		<b>Field Station#</b>	12297+00	
<b>Pic 1 Desc.</b>	Current ROW conditions. ROW is stable. ECDs are functional.		<b>Pic 2 Desc.</b>	Waterbar, sump and End Treatment are functional

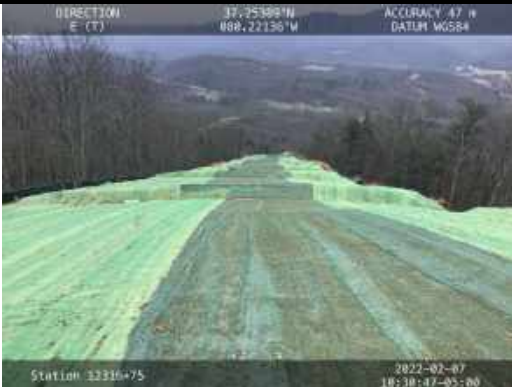
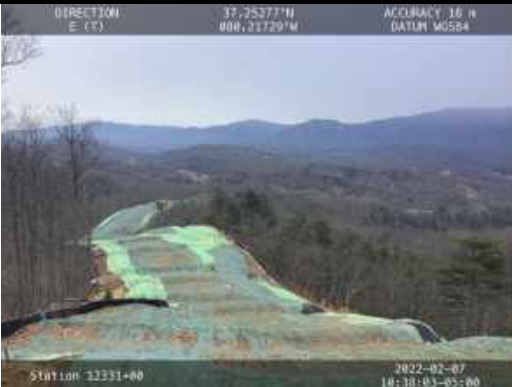
<b>GPS Location</b>	See photo		<b>GPS Location</b>	See photo	
<b>Field Station#</b>	12316+75		<b>Field Station#</b>	12331+00	
<b>Pic 3 Desc.</b>	Current ROW conditions. ROW is stable. ECDs are functional.		<b>Pic 4 Desc.</b>	Current ROW conditions. ROW is stable. ECDs are functional.

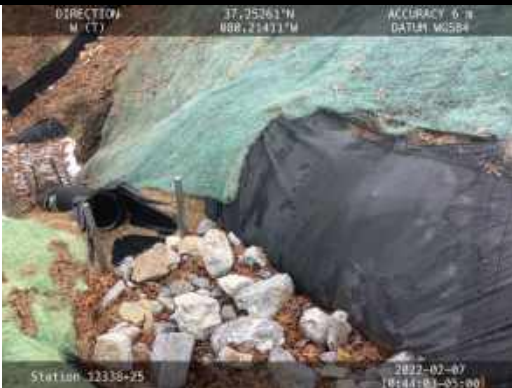
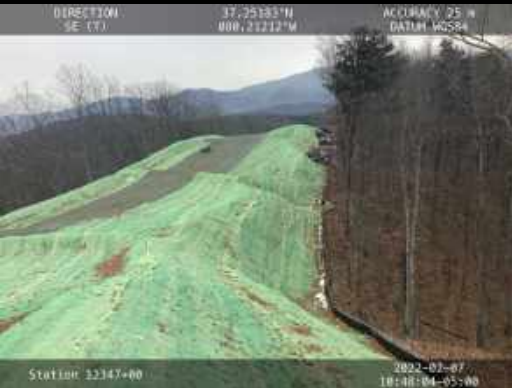
<b>GPS Location</b>	See photo		<b>GPS Location</b>	See photo	
<b>Field Station#</b>	12338+25		<b>Field Station#</b>	12347+00	
<b>Pic 5 Desc.</b>	Slope drain is functional and stone inlet protection is maintained		<b>Pic 6 Desc.</b>	Current ROW conditions. ROW is stable. ECDs are functional.

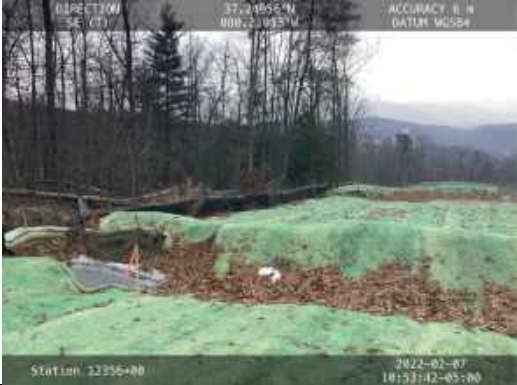
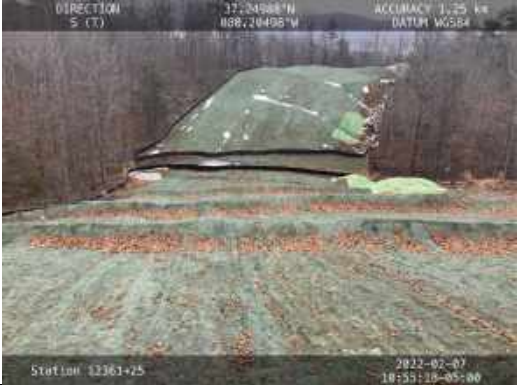
<b>GPS Location</b>	See photo		<b>GPS Location</b>	See photo	
<b>Field Station#</b>	12356+00		<b>Field Station#</b>	12361+25	
<b>Pic 7 Desc.</b>	Waterbar, sump and End treatment are functional. Perimeter Controls are functional		<b>Pic 8 Desc.</b>	Current ROW conditions. ROW is stable. ECDs are functional.

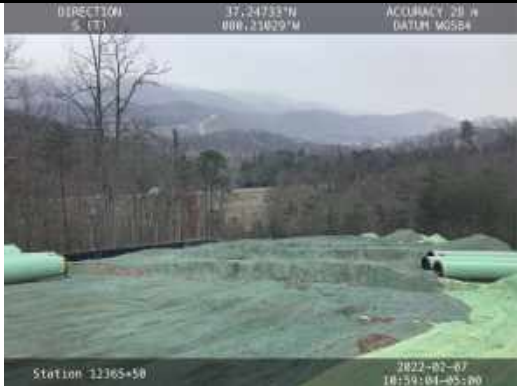
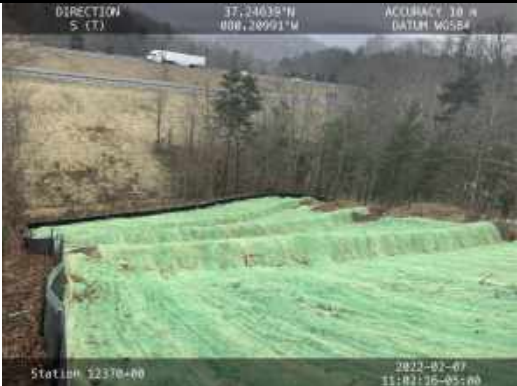
<b>GPS Location</b>	See photo		<b>GPS Location</b>	See photo	
<b>Field Station#</b>	12365+50		<b>Field Station#</b>	12370+00	
<b>Pic 9 Desc.</b>	Current ROW conditions. ROW is stable. ECDs are functional.		<b>Pic 10 Desc.</b>	Current ROW conditions. ROW is stable. ECDs are functional.

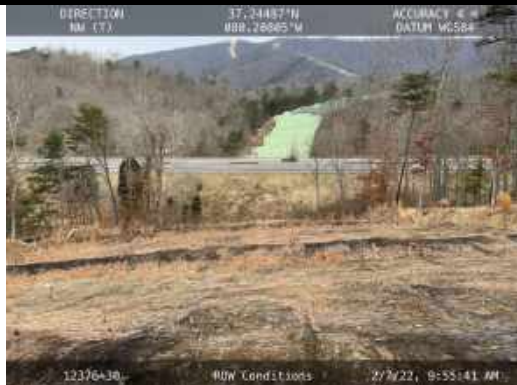
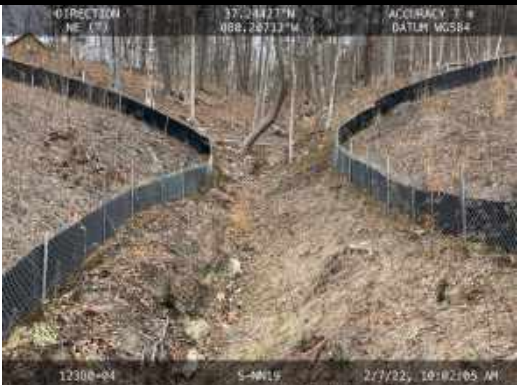
<b>GPS Location</b>	See photo		<b>GPS Location</b>	See photo	
<b>Field Station#</b>	12376+30		<b>Field Station#</b>	12380+04	
<b>Pic 11 Desc.</b>	Current ROW conditions. ROW is stable. ECDs are functional.		<b>Pic 12 Desc.</b>	Upstream of crossing at Stream S-NN19

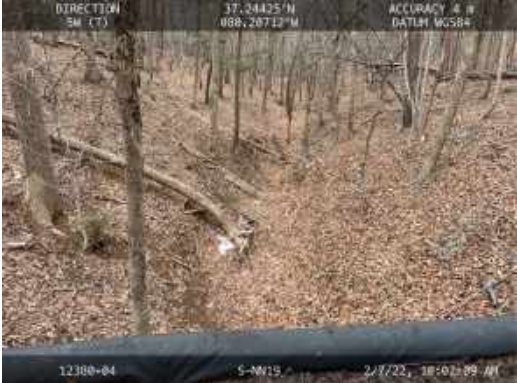
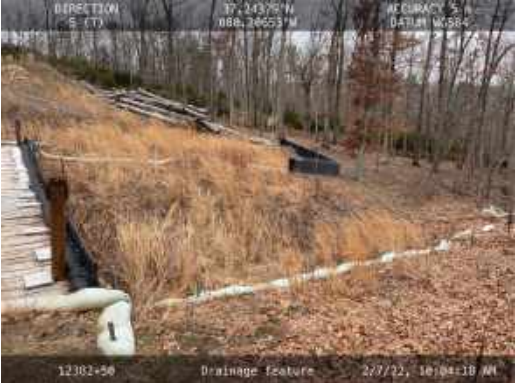
<b>GPS Location</b>	See photo		<b>GPS Location</b>	See photo	
<b>Field Station#</b>	12380+04		<b>Field Station#</b>	12383+50	
<b>Pic 13 Desc.</b>	Downstream of crossing at Stream S-NN19		<b>Pic 14 Desc.</b>	Drainage feature is functional

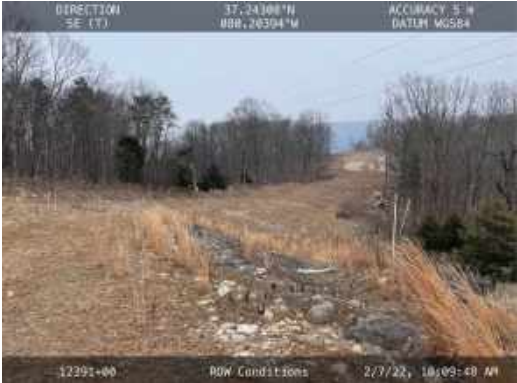
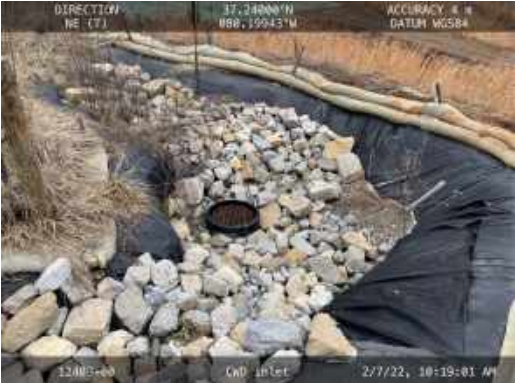
<b>GPS Location</b>	See photo		<b>GPS Location</b>	See photo	
<b>Field Station#</b>	12391+00		<b>Field Station#</b>	12409+00	
<b>Pic 15 Desc.</b>	Current ROW conditions. ROW is stable. ECDs are functional.		<b>Pic 16 Desc.</b>	CWD Pipe inlet is functional

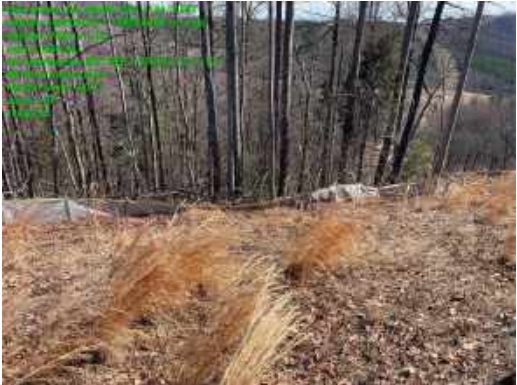
<b>GPS Location</b>	0	<b>GPS Location</b>	0		
<b>Field Station#</b>	13398+35	<b>Field Station#</b>	13402+50		
<b>Pic 15 Desc.</b>	SSF fabric needs repaired and reattached - 72hr maintenance item	<b>Pic 16 Desc.</b>	P1 needs repaired/replaced - 72hr maintenance item

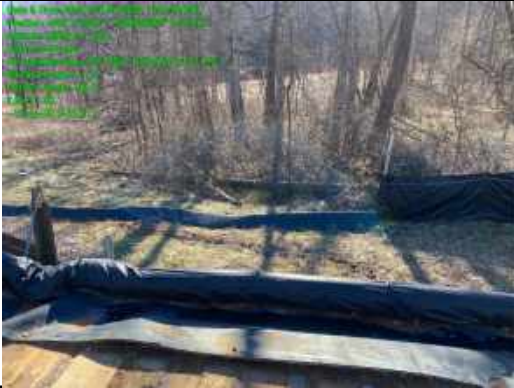
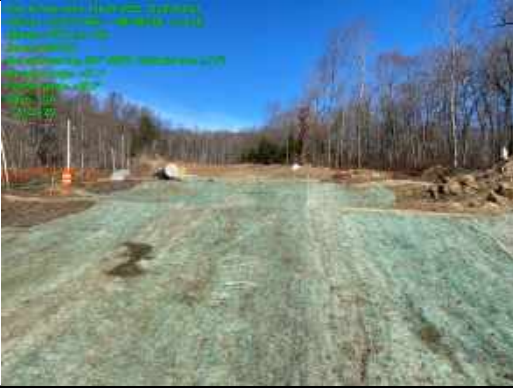
<b>GPS Location</b>	See photo for coordinates.		<b>GPS Location</b>	See photo for coordinates.	
<b>Field Station#</b>	13146+50		<b>Field Station#</b>	13147+25	
<b>Pic 5 Desc.</b>	Downstream side of equipment bridge, culvert functioning.		<b>Pic 6 Desc.</b>	ROW stabilized.

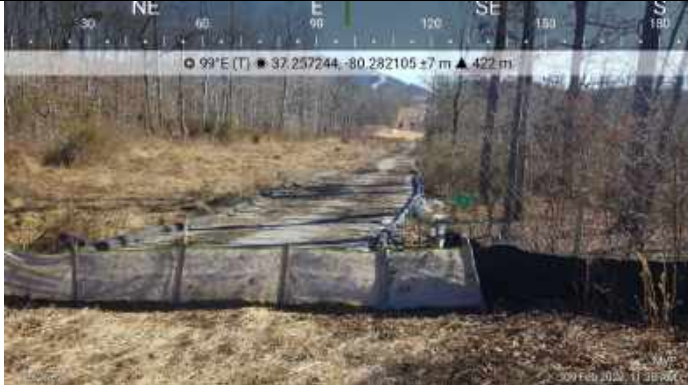
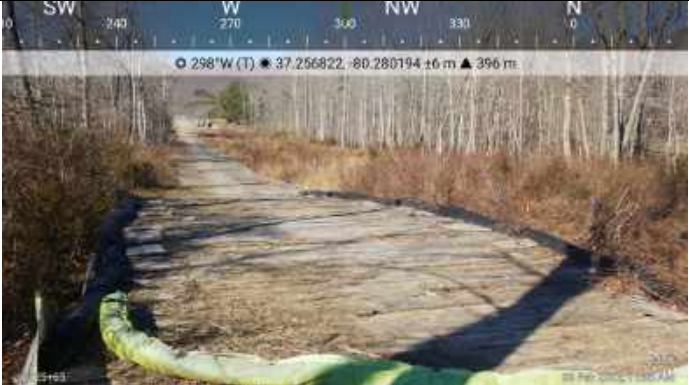
<b>GPS Location</b>	See Above	<b>GPS Location</b>	See Above		
<b>Field Station#</b>	12121+00	<b>Field Station#</b>	12125+65		
<b>Pic 1 Desc.</b>	Overview of Waterbody S-C36. ECDs functional and in good condition.	<b>Pic 2 Desc.</b>	Overview of Waterbody S-MM31. ECDs functional and in good condition.

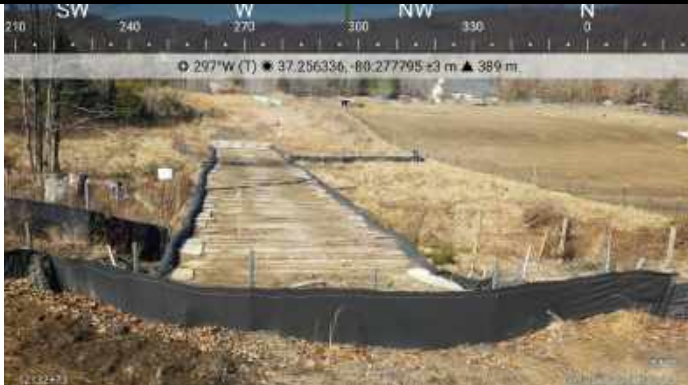
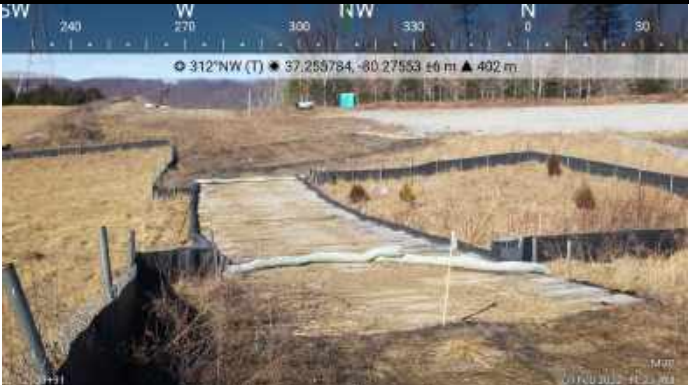
<b>GPS Location</b>	See Above	<b>GPS Location</b>	See Above		
<b>Field Station#</b>	12132+73	<b>Field Station#</b>	12139+91		
<b>Pic 3 Desc.</b>	Overview of Waterbody S-C29. ECDs functional and in good condition.	<b>Pic 4 Desc.</b>	Overview of Wetland W-C6. ECDs functional and in good condition.

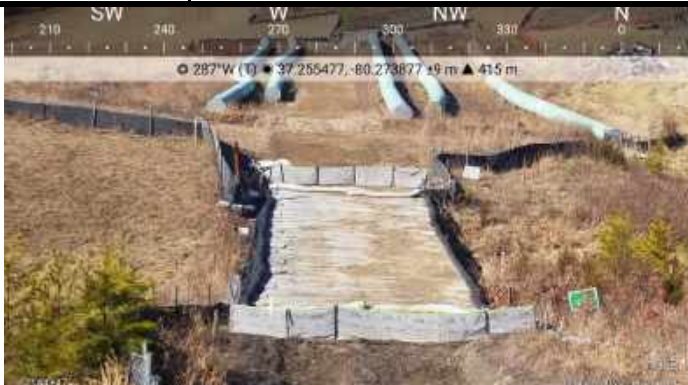
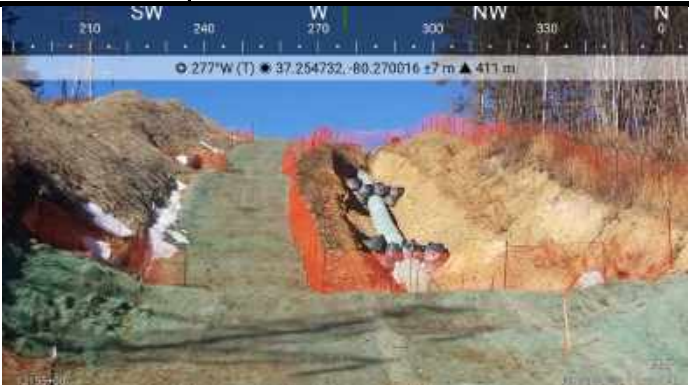
<b>GPS Location</b>	See Above	<b>GPS Location</b>	See Above		
<b>Field Station#</b>	12144+47	<b>Field Station#</b>	12155+00		
<b>Pic 5 Desc.</b>	Overview of Wetland W-C5. ECDs functional and in good condition.	<b>Pic 6 Desc.</b>	ROW Overview. ECDs functional and in good condition and ROW is stable.

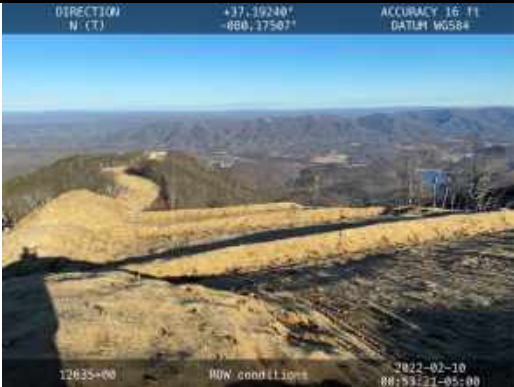
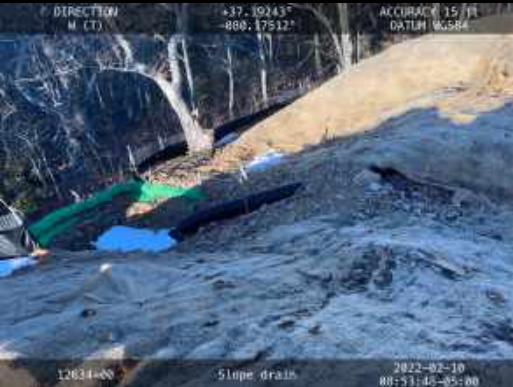
<b>GPS Location</b>	See photo for gps location data.		<b>GPS Location</b>	See photo for gps location data.	
<b>Field Station#</b>	12635+00		<b>Field Station#</b>	12634+00	
<b>Pic 1 Desc.</b>	Photo shows the ROW condition. ECDs are installed and functioning as designed.		<b>Pic 2 Desc.</b>	Photo shows the slope drain.

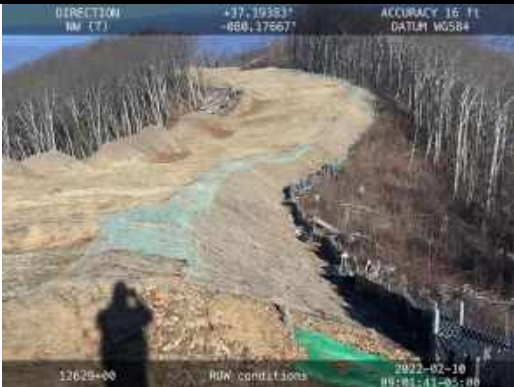
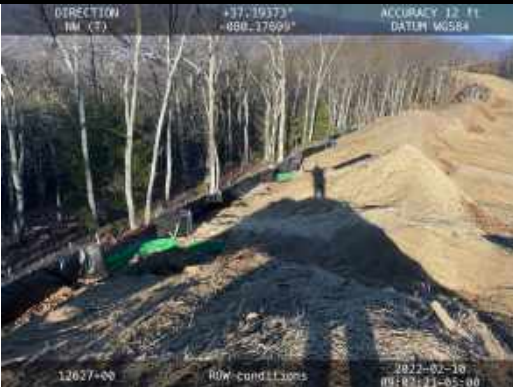
<b>GPS Location</b>	See photo for gps location data.		<b>GPS Location</b>	See photo for gps location data.	
<b>Field Station#</b>	12629+00		<b>Field Station#</b>	12627+00	
<b>Pic 3 Desc.</b>	Photo shows the ROW condition. ECDs are installed and functioning as designed.		<b>Pic 4 Desc.</b>	Photo shows the ROW condition. ECDs are installed and functioning as designed.

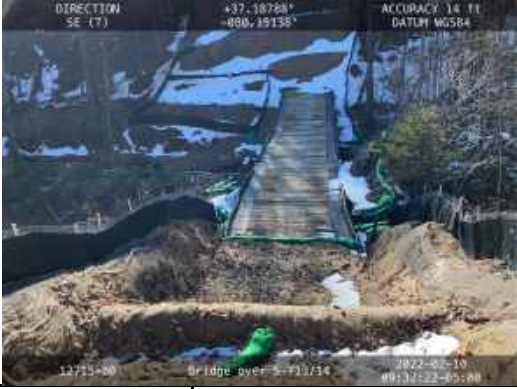
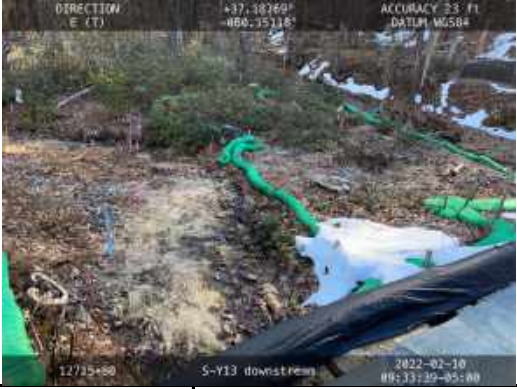
<b>GPS Location</b>	See photo for gps location data.		<b>GPS Location</b>	See photo for gps location data.	
<b>Field Station#</b>	12715+00		<b>Field Station#</b>	12715+80	
<b>Pic 13 Desc.</b>	Photo shows the bridge over streams S-Y13 and S-Y14. ECDs are installed and functioning as designed.		<b>Pic 14 Desc.</b>	Photo shows S-Y13 downstream from the bridge.

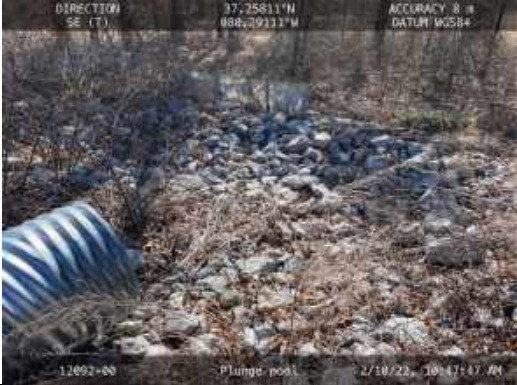
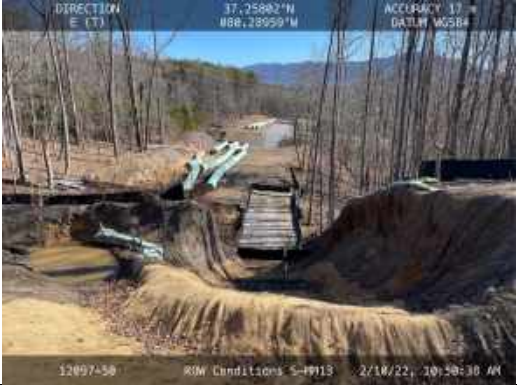
<b>GPS Location</b>	See photo		<b>GPS Location</b>	See photo	
<b>Field Station#</b>	12092+00		<b>Field Station#</b>	12097+50	
<b>Pic 13 Desc.</b>	Plunge pool is functional.		<b>Pic 14 Desc.</b>	Current ROW conditions. ROW is stable. ECDs are functional.

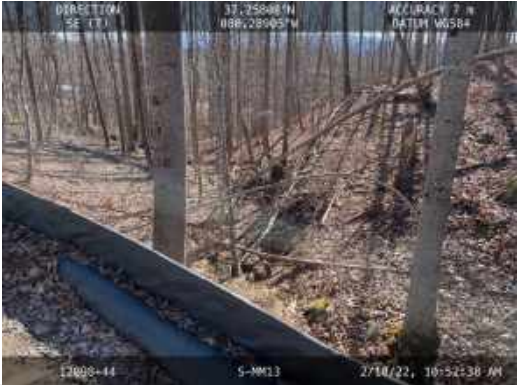
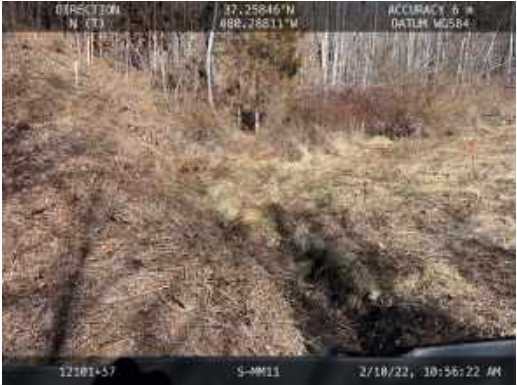
<b>GPS Location</b>	See photo		<b>GPS Location</b>	See photo	
<b>Field Station#</b>	12098+44		<b>Field Station#</b>	12101+57	
<b>Pic 15 Desc.</b>	Downstream of crossing at Stream S-MM13		<b>Pic 16 Desc.</b>	Upstream of crossing at Stream S-MM11

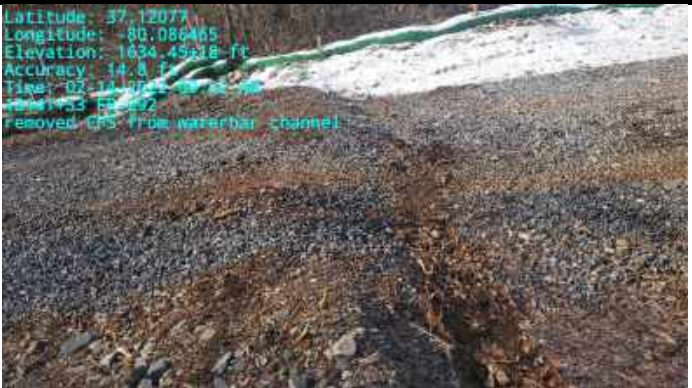
<b>GPS Location</b>	See Pic for GPS location.		<b>GPS Location</b>	See Pic for GPS location.	
<b>Field Station#</b>	13035+00		<b>Field Station#</b>	13141+53	
<b>Pic 5 Desc.</b>	Current ROW conditions on the GAS of FR-289.		<b>Pic 6 Desc.</b>	CFS blocking the flow of the waterbar channel and needs removed. Add to the Punch List. CFS removed 2/14/22

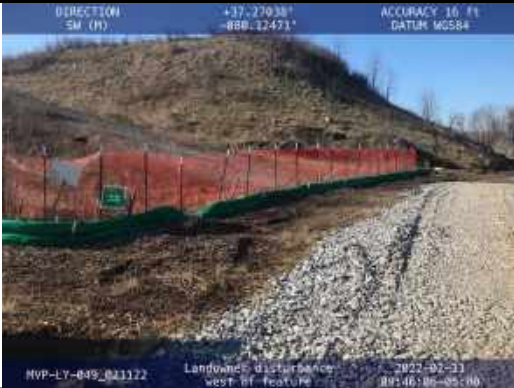
<b>GPS Location</b>	MVP-LY-049 See photo for gps data		<b>GPS Location</b>	MVP-LY-049 See photo for gps data	
<b>Field Station#</b>	+0		<b>Field Station#</b>	+0	
<b>Pic 5 Desc.</b>	Landowner soil disturbance west of feature W-CV21B. Areas not stabilized. Looking SW.		<b>Pic 6 Desc.</b>	Landowner soil disturbance and debris piled along triple stack compost filter sock and east of feature W-CV21B. Looking S.

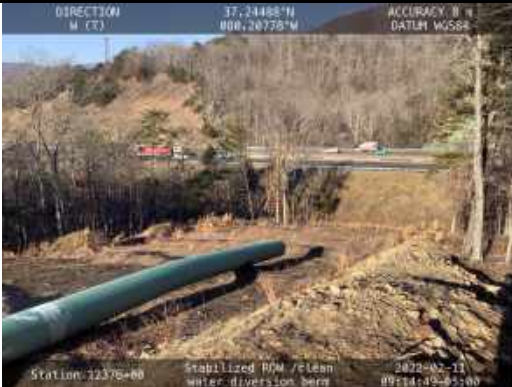
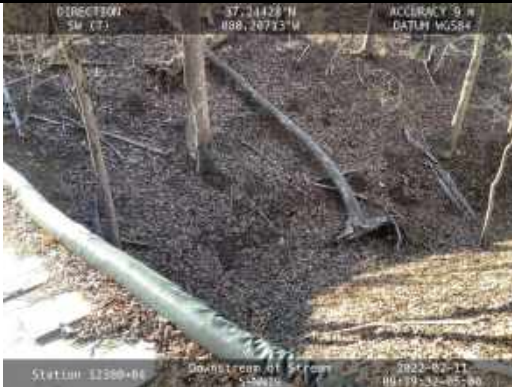
<b>GPS Location</b>	See photo		<b>GPS Location</b>	See photo	
<b>Field Station#</b>	12376+00		<b>Field Station#</b>	12380+04	
<b>Pic 1 Desc.</b>	Current ROW conditions. ROW is stable. ECDs are functional.		<b>Pic 2 Desc.</b>	Downstream of crossing at Stream S-NN19

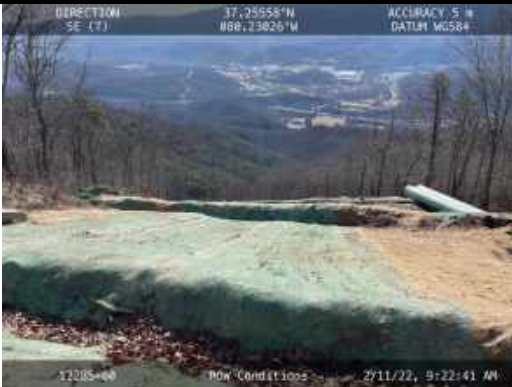
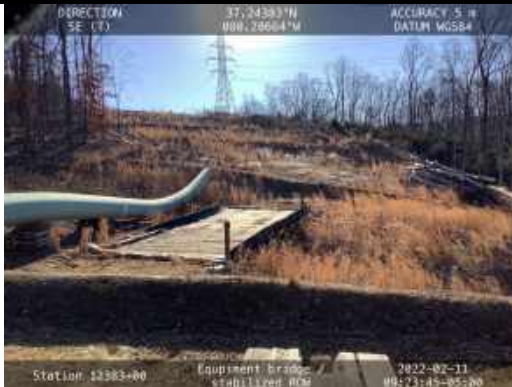
<b>GPS Location</b>	See photo		<b>GPS Location</b>	See photo	
<b>Field Station#</b>	12285+00		<b>Field Station#</b>	12303+00	
<b>Pic 3 Desc.</b>	Current ROW conditions. ROW is stable. ECDs are functional.		<b>Pic 4 Desc.</b>	Current ROW conditions. ROW is stable. ECDs are functional.

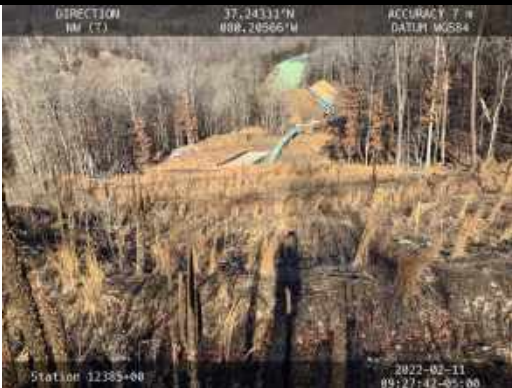
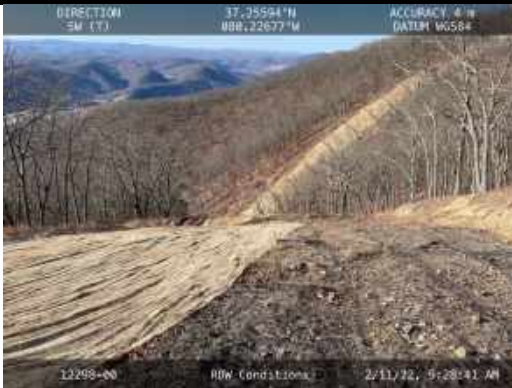
<b>GPS Location</b>	See photo		<b>GPS Location</b>	See photo	
<b>Field Station#</b>	12385+00		<b>Field Station#</b>	12298+00	
<b>Pic 5 Desc.</b>	Current ROW conditions. ROW is stable. ECDs are functional.		<b>Pic 6 Desc.</b>	Current ROW conditions. ROW is stable. ECDs are functional.

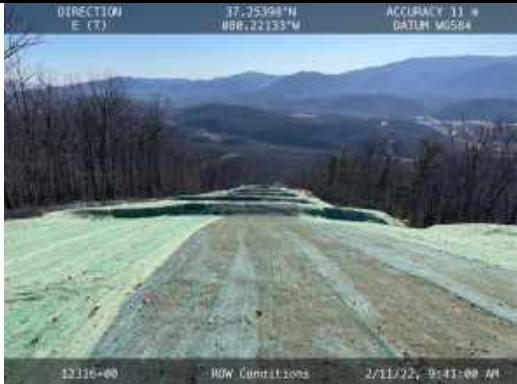
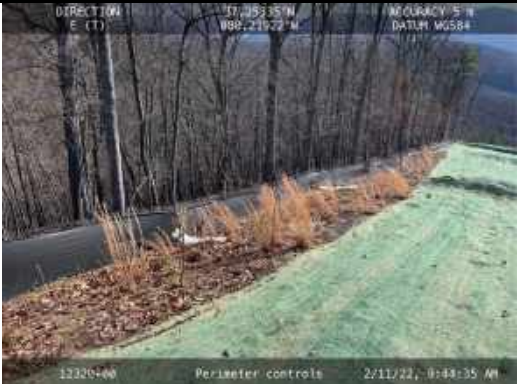
<b>GPS Location</b>	See photo		<b>GPS Location</b>	See photo	
<b>Field Station#</b>	12316+00		<b>Field Station#</b>	12320+00	
<b>Pic 9 Desc.</b>	Current ROW conditions. ROW is stable. ECDs are functional.		<b>Pic 10 Desc.</b>	Perimeter controls are functional
