Visual Site Inspection Report

Project Name	H-600 Pipeline Spread I	AFE	124300139	Spread	H-600 Pipeline Spread I
Contractor	Precision			Report #	33331
Inspector	Charles Head			Date/Time	1/18/2022 10:11 AM
Permit #	TBD	Inspection Type	VA SWPP	Station Begin	14454+22
State	VA	Inspection Area	Full	Station End	14546+75
County	Franklin	Ground	Frozen	Temperature (°F)	36.00
Municipality	N/A	Weather	Sunny	Rain Gauge (in)	0.00
				Rain Accumulation Time (days)	1.00

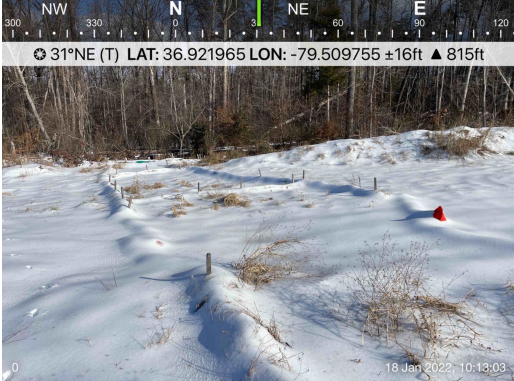
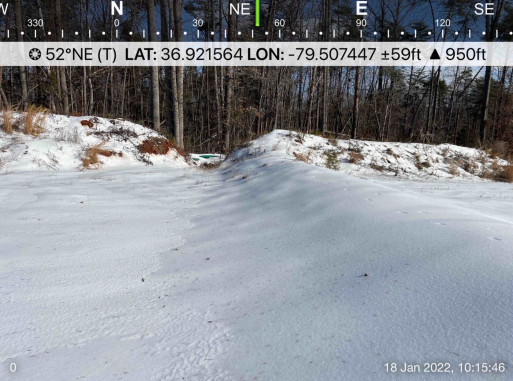
GPS Location	See photo		GPS Location	See photo	
Field Station#	15375+00		Field Station#	15380+00	
Pic 1 Desc.	Drainage feature ECDs are in good condition.		Pic 2 Desc.	Waterbars are in good condition.

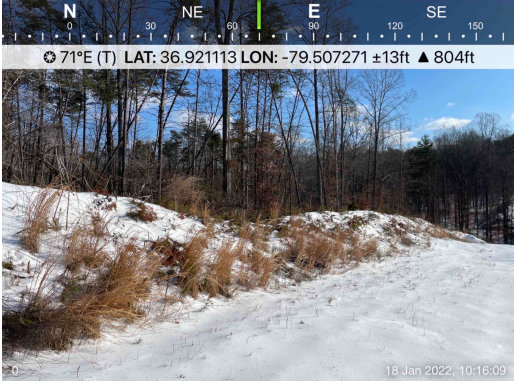
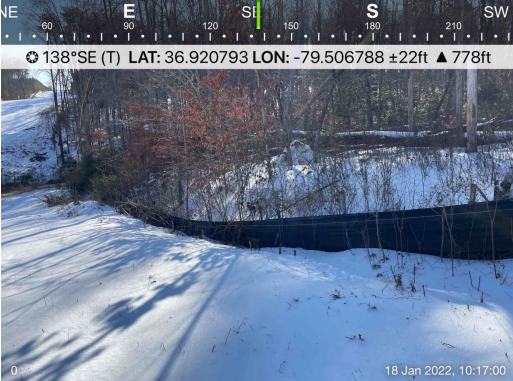
GPS Location	See photo		GPS Location	See photo	
Field Station#	15381+00		Field Station#	15383+00	
Pic 3 Desc.	Stockpiles remain stabilized.		Pic 4 Desc.	Perimeter SSF is in good condition.

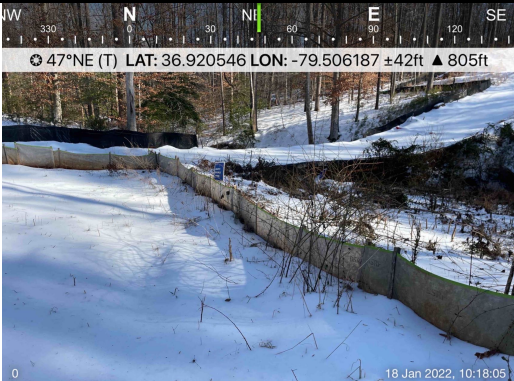
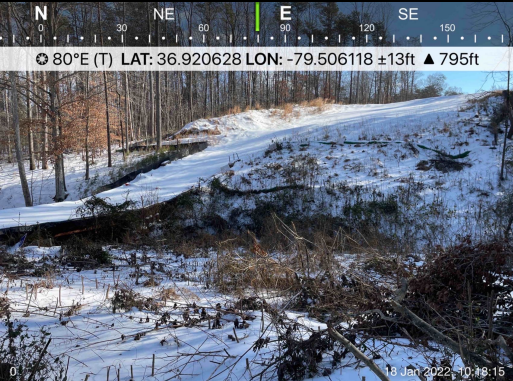
GPS Location	See photo		GPS Location	See photo	
Field Station#	15384+00		Field Station#	15384+74	
Pic 5 Desc.	P1 is in good condition at stream and wetland buffers.		Pic 6 Desc.	Resource buffers remain in good condition.

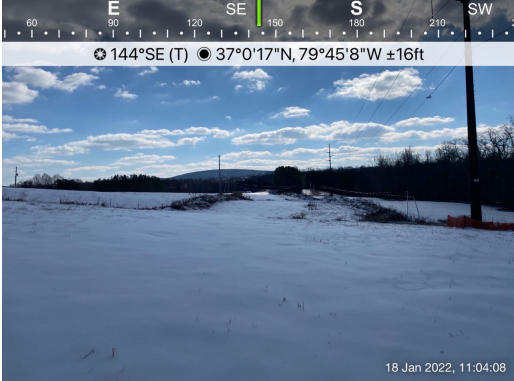
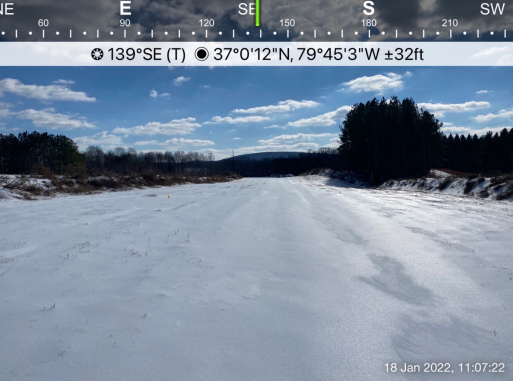
GPS Location	0	GPS Location	0		
Field Station#	14550+00	Field Station#	14557+00		
Pic 1 Desc.	Approximately 14550+00. Overview of ROW.		Pic 2 Desc.	Approximately 14557+00. Overview of ROW.

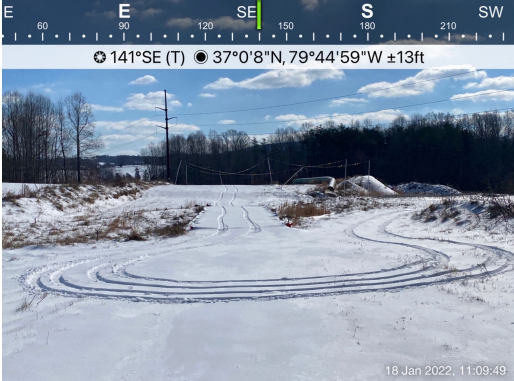
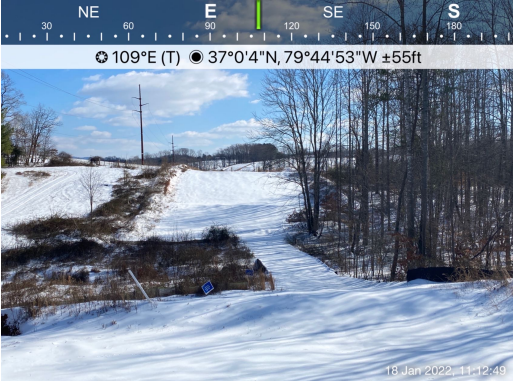
GPS Location	0	GPS Location	0		
Field Station#	14563+00	Field Station#	14568+10		
Pic 3 Desc.	Approximately 14563+00. Overview of ROW. Third party vehicles tracks observed crossing and traveling on ROW.		Pic 4 Desc.	Approximately 14568+10. Overview of stream crossing, equipment bridge and ECDs at stream S-E18.

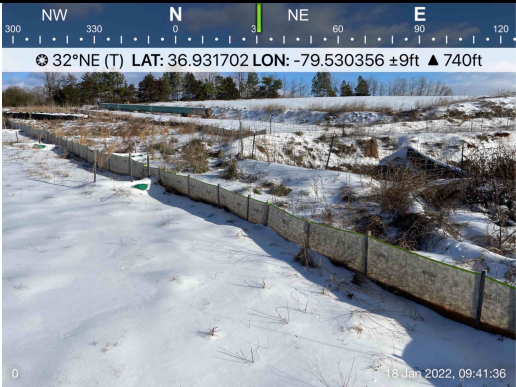
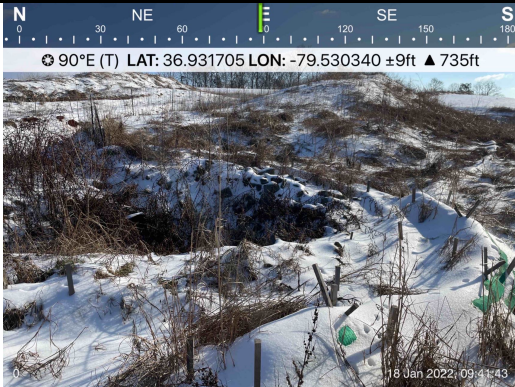
GPS Location	See photo		GPS Location	See photo	
Field Station#	15299+00		Field Station#	15299+00	
Pic 1 Desc.	P1 is in good condition along this drainage feature.		Pic 2 Desc.	CWD remains in good condition.

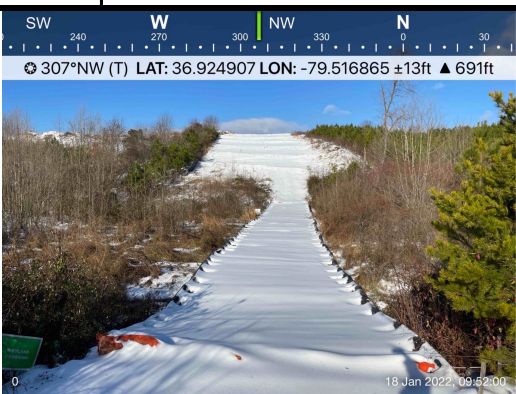
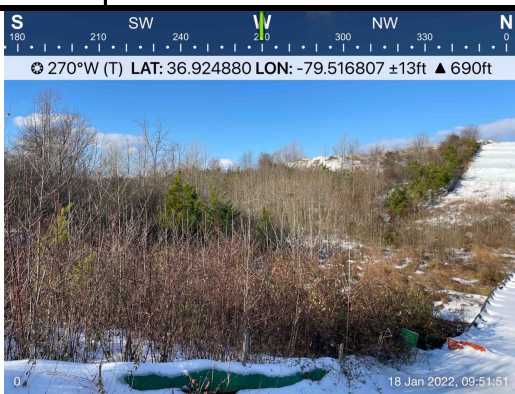
GPS Location	See photo		GPS Location	See photo	
Field Station#	15347+00		Field Station#	15347+00	
Pic 3 Desc.	Equipment bridge ECDs are in place and functioning.		Pic 4 Desc.	Resource buffers remain in good condition.

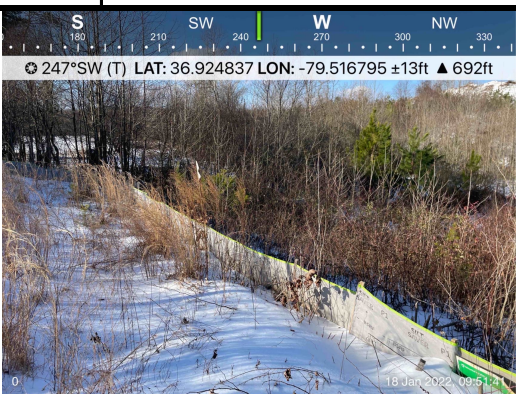
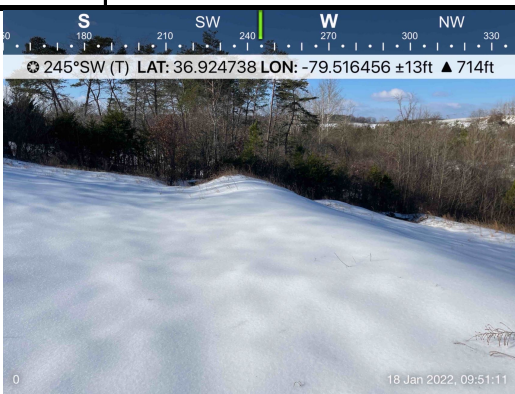
GPS Location	See photo		GPS Location	See photo	
Field Station#	15349+00		Field Station#	15349+50	
Pic 5 Desc.	P1 is in good condition at all stream and wetland buffers.		Pic 6 Desc.	Waterbars are in good condition.

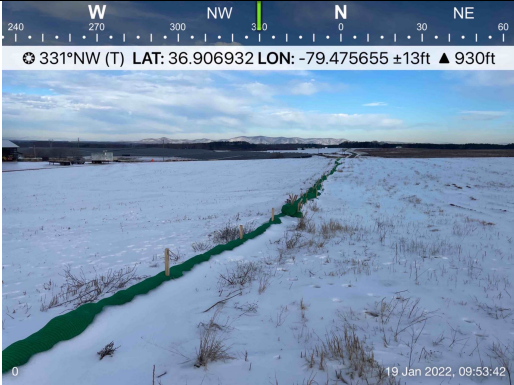
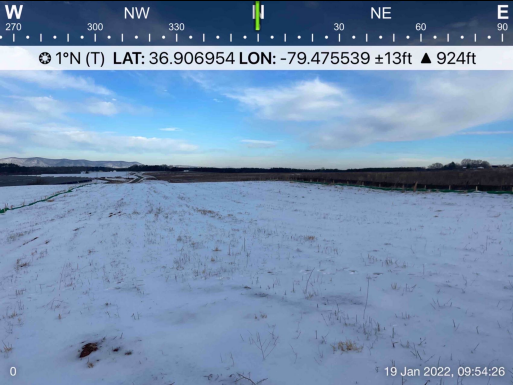
GPS Location	See photo		GPS Location	See photo	
Field Station#	15490+00		Field Station#	15494+00	
Pic 1 Desc.	Perimeter CFS is in good condition.		Pic 2 Desc.	ROW remains stabilized.

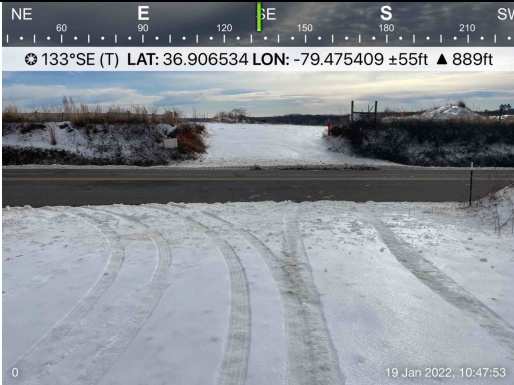
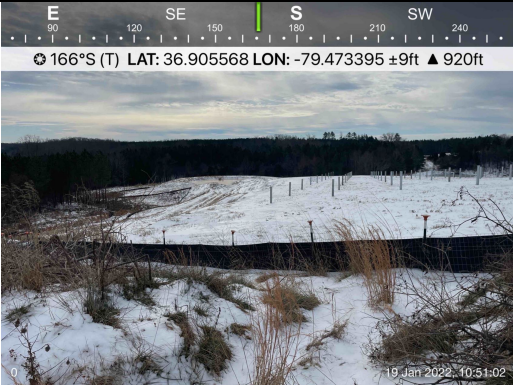
GPS Location	See photo		GPS Location	See photo	
Field Station#	15496+70		Field Station#	15501+00	
Pic 3 Desc.	RCEs are in good condition at all road crossings.		Pic 4 Desc.	No evidence of sedimentation from 3rd party disturbance.

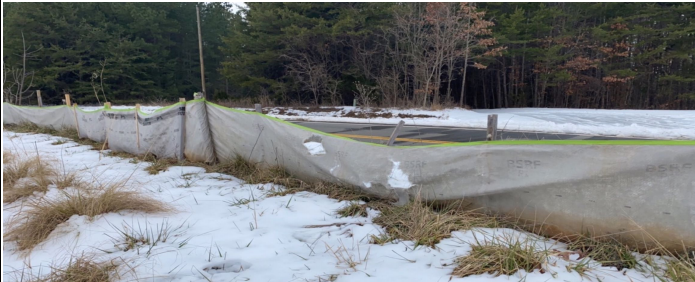
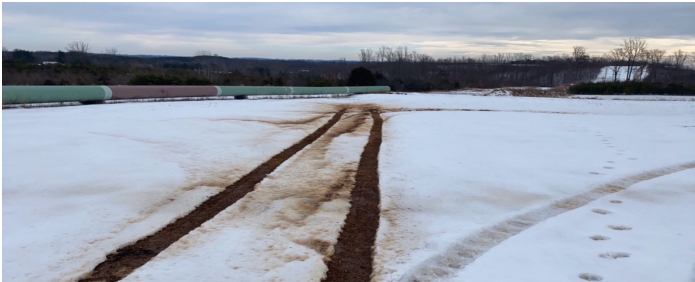
36°57'17" N 79°34'59" W 273°W COURSE 335° GPS 8850-8968 Museville Rd, Sandy Level, VA 24161, United States 01.19.2022 12:51:10 Accur +/-30.7 Ft ALT 930 Ft			36°57'19" N 79°34'55" W 152°SE COURSE -1° GPS 8850-8968 Museville Rd, Sandy Level, VA 24161, United States 01.19.2022 12:49:16 Accur +/-15.5 Ft ALT 914 Ft		
GPS Location	1		GPS Location	2	
Field Station#	15113+25		Field Station#	15113+50	
Pic 1 Desc.	Routine maintenance. Replace damaged panels of P1 silt fence in extra workspace. Cattle damage.		Pic 2 Desc.	Made note of area where vehicle left RCE. Will monitor area.

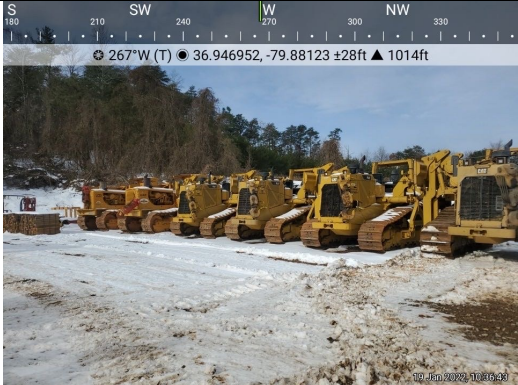
GPS Location	0	GPS Location	0		
Field Station#	0+00	Field Station#	0+00		
Pic 1 Desc.	LY-032 Damaged CFS of secondary containment		Pic 2 Desc.	LY-032 Equipment staging

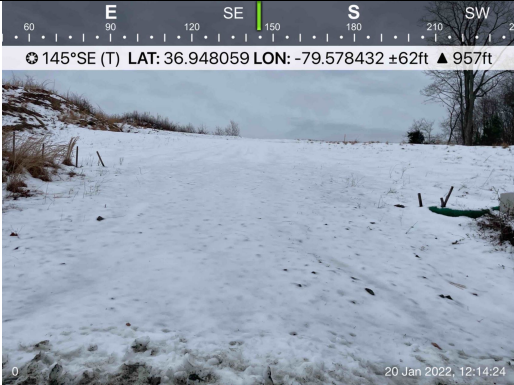
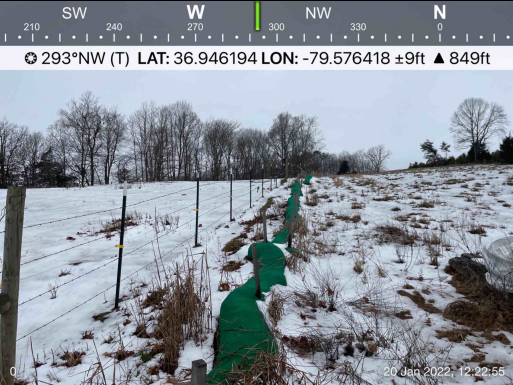
GPS Location	See photo		GPS Location	See photo	
Field Station#	15142+66		Field Station#	15150+00	
Pic 1 Desc.	RCEs is in good condition at Rockcreek.		Pic 2 Desc.	Perimeter CFS is in good condition.

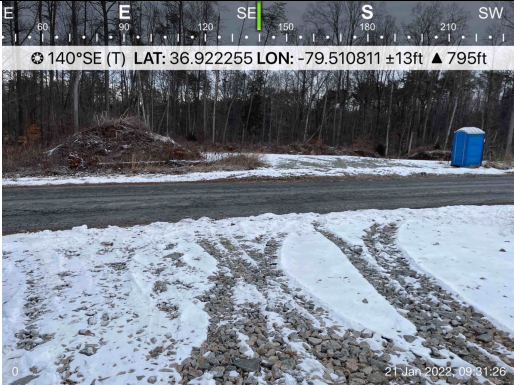
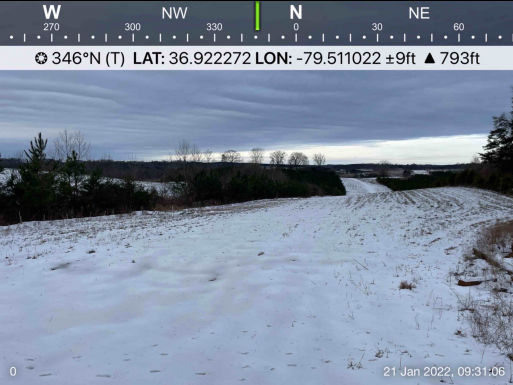
GPS Location	See photo	GPS Location	See photo		
Field Station#	15370+62	Field Station#	15370+00		
Pic 1 Desc.	RCEs are in good condition at all road crossings.	Pic 2 Desc.	ROW remains stabilized.
