# Visual Site Inspection Report

<b>Project Name</b>	H-600 Pipeline Spread H	<b>AFE</b>	124300138	<b>Spread</b>	H-600 Pipeline Spread H
<b>Contractor</b>	Precision			<b>Report #</b>	35418
<b>Inspector</b>	Pat Davis			<b>Date/Time</b>	3/14/2022 4:00 PM
<b>Permit #</b>	TBD	<b>Inspection Type</b>	VA SWPP	<b>Station Begin</b>	+0
<b>State</b>	VA	<b>Inspection Area</b>	Partial	<b>Station End</b>	+0
<b>County</b>	Montgomery	<b>Ground</b>	Wet	<b>Temperature (°F)</b>	44.00
<b>Municipality</b>	N/A	<b>Weather</b>	Sunny	<b>Rain Gauge (in)</b>	0.50
				<b>Rain Accumulation Time (days)</b>	0.00

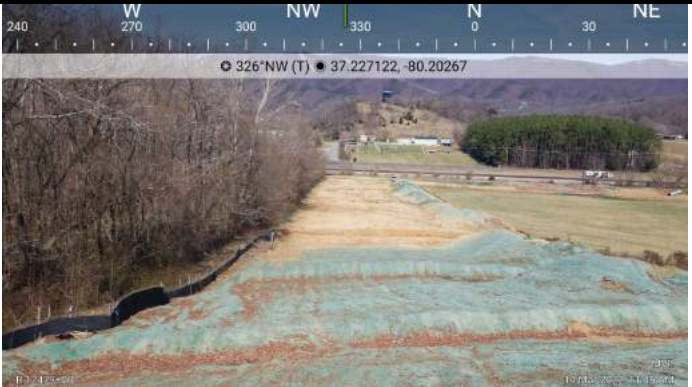
<b>GPS Location</b>	See Above	<b>GPS Location</b>	See Above		
<b>Field Station#</b>	12445+01	<b>Field Station#</b>	12455+21		
<b>Pic 1 Desc.</b>	Overview of Waterbody S-I1. ROW is stable. No erosion or sedimentation concerns noted.	<b>Pic 2 Desc.</b>	Overview of Waterbody S-CD12b. ECDs are functional and ROW is stable.

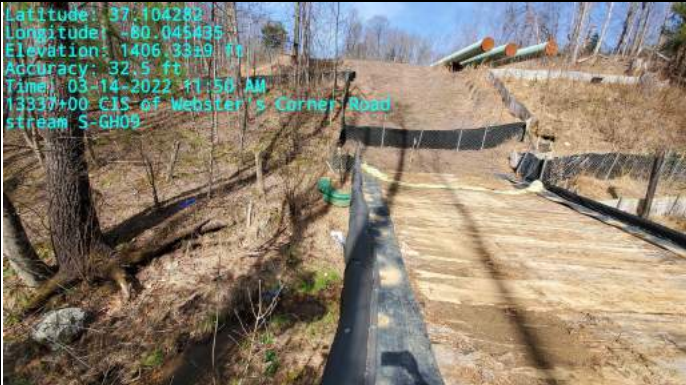
A/E	124300138	Date/Time	3/14/2022 7:54 PM	Report #	
Pictures					
<div>Latitude: 37.104282 Longitude: -80.045435 Elevation: 1406.33±9 ft Accuracy: 32.5 ft Time: 03-14-2022 11:50 AM 13337+00 CIS of Webster's Corner Road stream S-GH09</div>

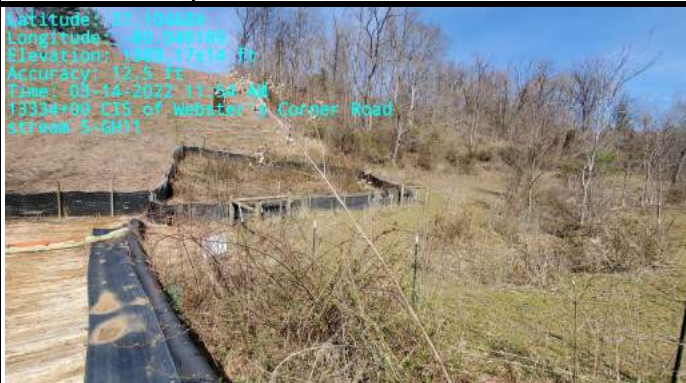
<div>Latitude: 37.10459 Longitude: -80.045993 Elevation: 1409.84±10 ft Accuracy: 19.7 ft Time: 03-14-2022 11:53 AM 13335+00 CIS of Webster's Corner Road stream S-GH11</div>  		
GPS Location	See photo for coordinates.		GPS Location	See photo for coordinates.	
Field Station#	13337+00		Field Station#	13335+00	
Pic 7 Desc.	S-GH09, downstream, perimeter controls in acceptable condition.		Pic 8 Desc.	S-GH11, ROW stabilized, perimeter controls in acceptable condition.	
<div>Latitude: 37.104448 Longitude: -80.045116 Elevation: 1406.17±10 ft Accuracy: 12.5 ft Time: 03-14-2022 11:54 AM 13334+00 CIS of Webster's Corner Road stream S-GH11</div>

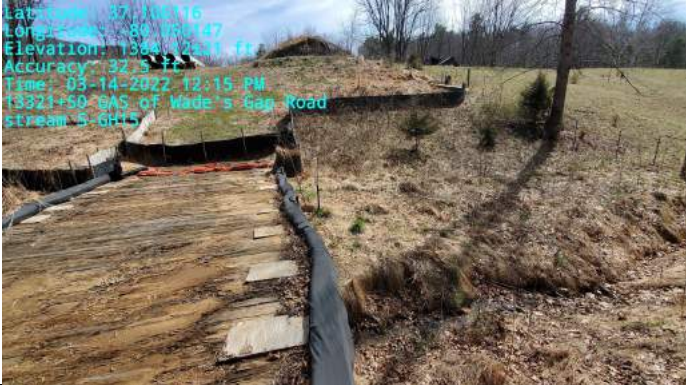
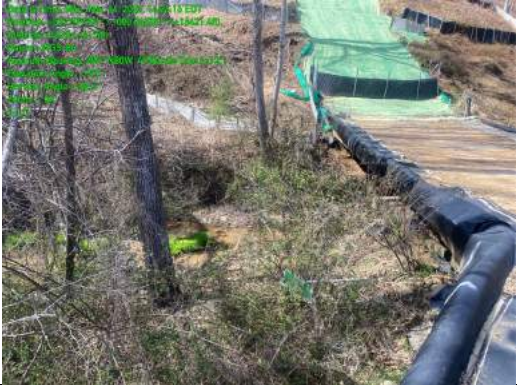
<b>GPS Location</b>	See photo for coordinates.		<b>GPS Location</b>	See photo for coordinates.	
<b>Field Station#</b>	13321+50		<b>Field Station#</b>	13413+13	
<b>Pic 13 Desc.</b>	S-GH15, downstream, perimeter controls in acceptable condition.		<b>Pic 14 Desc.</b>	S-IJ1, downstream, perimeter controls in acceptable condition.

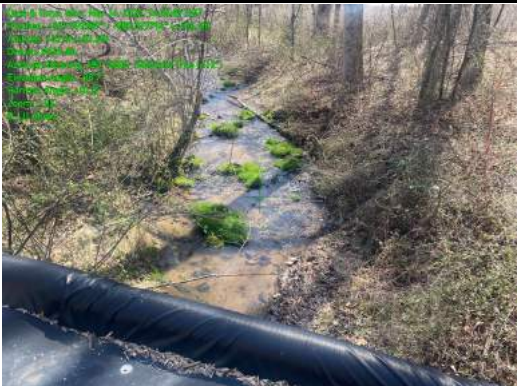
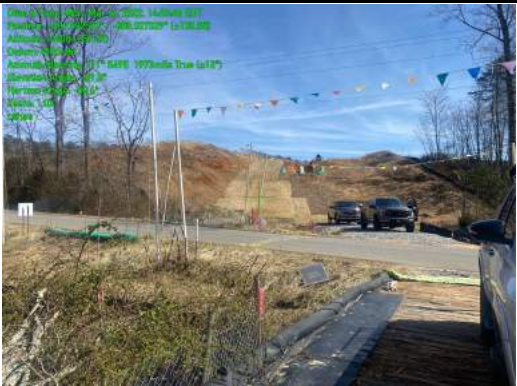
<b>GPS Location</b>	See photo for coordinates.		<b>GPS Location</b>	See photo for coordinates.	
<b>Field Station#</b>	13413+13		<b>Field Station#</b>	13415+00	
<b>Pic 15 Desc.</b>	S-IJ1, downstream, perimeter controls in acceptable condition.		<b>Pic 16 Desc.</b>	Cahas Mountain road crossing.

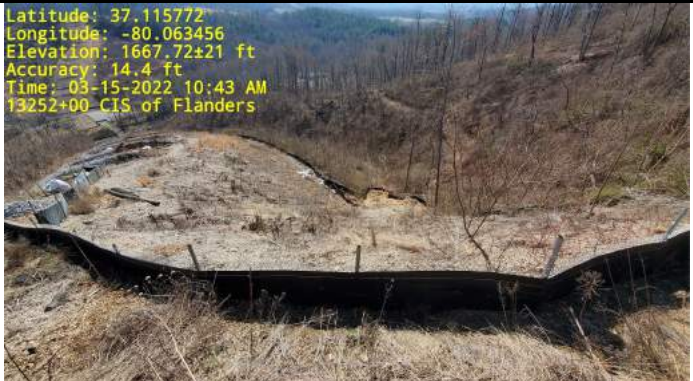
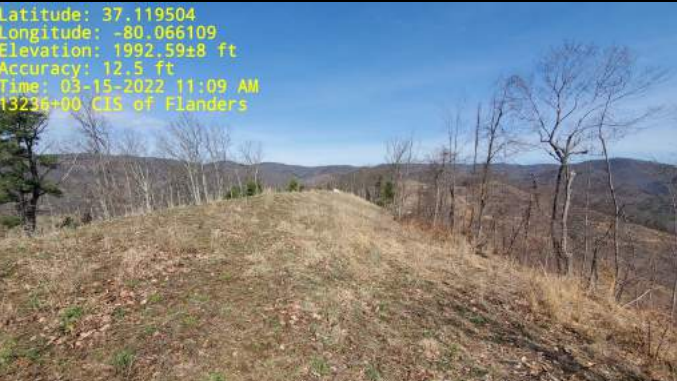
<b>GPS Location</b>	See photo for coordinates.		<b>GPS Location</b>	See photo for coordinates.	
<b>Field Station#</b>	13252+00		<b>Field Station#</b>	13236+00	
<b>Pic 5 Desc.</b>	No movement noted at slip.		<b>Pic 6 Desc.</b>	ROW restored, good vegetative cover noted.

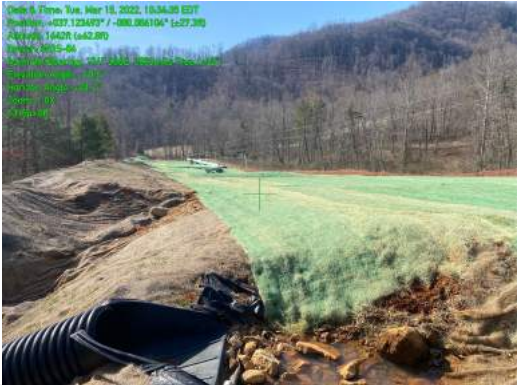
<b>GPS Location</b>	See photo for coordinates.		<b>GPS Location</b>	See photo for coordinates.	
<b>Field Station#</b>	13157+13		<b>Field Station#</b>	13157+13	
<b>Pic 13 Desc.</b>	S-D11, looking toward the going away side, perimeter controls in acceptable condition.		<b>Pic 14 Desc.</b>	S-D11, downstream, no turbidity noted; stream banks appeared stable.

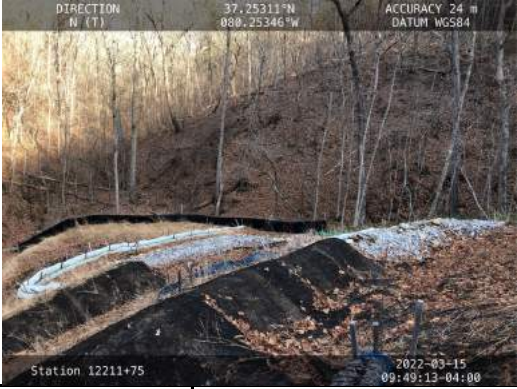
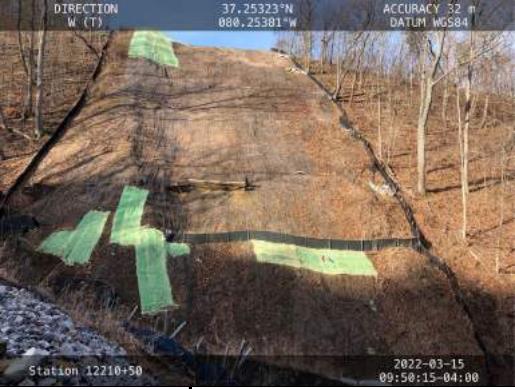
<b>GPS Location</b>	Please see photo for details.		<b>GPS Location</b>	Please see photo for details.	
<b>Field Station#</b>	12211+75		<b>Field Station#</b>	12210+50	
<b>Pic 7 Desc.</b>	Photo shows stabilized ROW with permanent water bars equipped with level spreaders.		<b>Pic 8 Desc.</b>	Photo shows the stabilized ROW conditions with water bars and that all ECDs are installed and are functioning as designed.

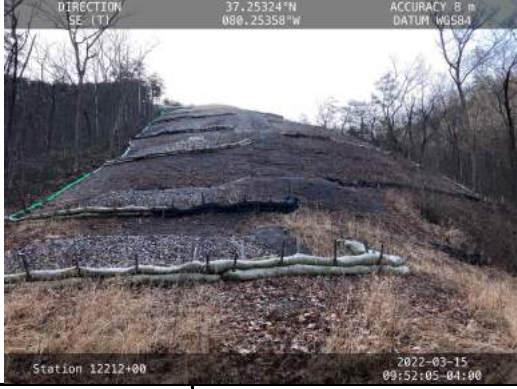
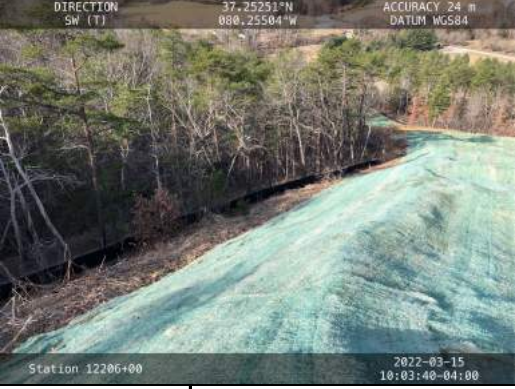
<b>GPS Location</b>	Please see photo for details.		<b>GPS Location</b>	Please see photo for details.	
<b>Field Station#</b>	12212+00		<b>Field Station#</b>	12206+00	
<b>Pic 9 Desc.</b>	Photo shows stabilized ROW with permanent water bars equipped with level spreaders.		<b>Pic 10 Desc.</b>	Photo shows stabilized side slope and super silt fence functioning as designed.

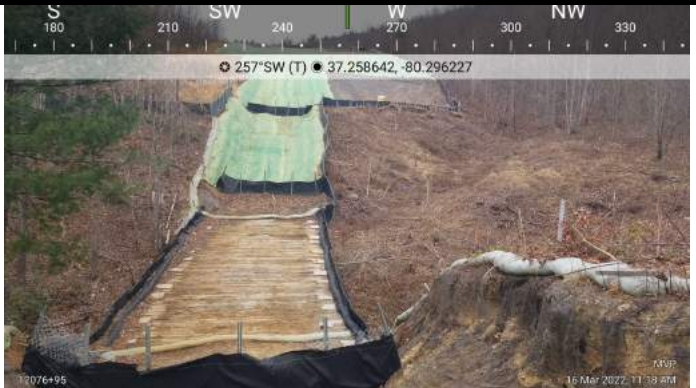
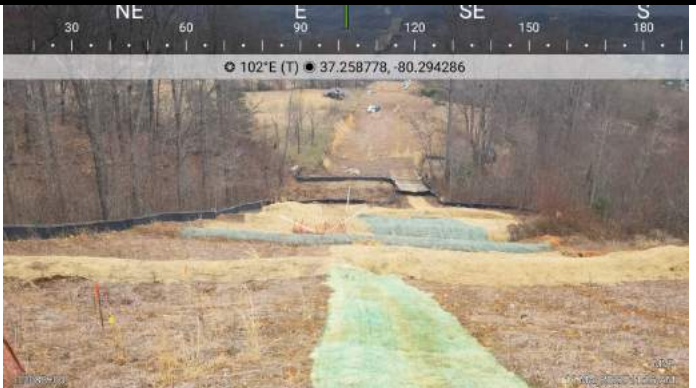
<b>GPS Location</b>	See Above	<b>GPS Location</b>	See Above		
<b>Field Station#</b>	12062+00	<b>Field Station#</b>	12070+00		
<b>Pic 7 Desc.</b>	DEQ (MBP) punchlist item: Replace Erosion Control Blanket/Re-Stabilize ROW.	<b>Pic 8 Desc.</b>	DEQ (MBP) punchlist item: Replace Erosion Control Blanket/Re-Stabilize ROW.

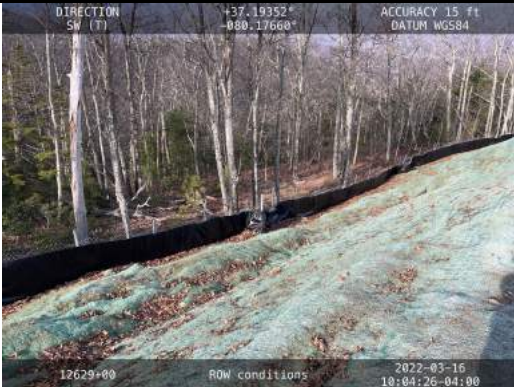
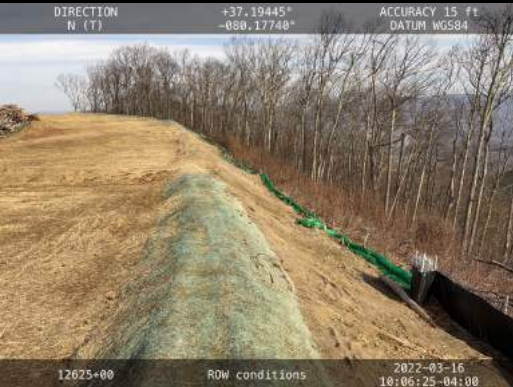
<b>GPS Location</b>	See photo for gps location data.		<b>GPS Location</b>	See photo for gps location data.	
<b>Field Station#</b>	12629+00		<b>Field Station#</b>	12625+00	
<b>Pic 1 Desc.</b>	Photo shows the ROW condition. ECDs are installed and functioning as designed.		<b>Pic 2 Desc.</b>	Photo shows the ROW condition. ECDs are installed and functioning as designed.

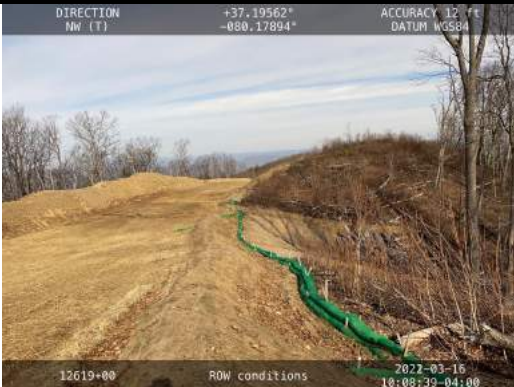
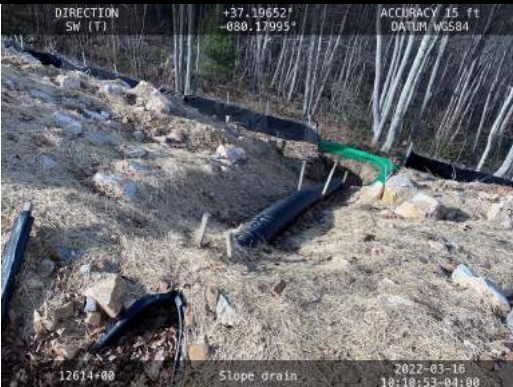
<b>GPS Location</b>	See photo for gps location data.		<b>GPS Location</b>	See photo for gps location data.	
<b>Field Station#</b>	12619+00		<b>Field Station#</b>	12614+00	
<b>Pic 3 Desc.</b>	Photo shows the ROW condition. ECDs are installed and functioning as designed.		<b>Pic 4 Desc.</b>	Photo shows the slope drain.

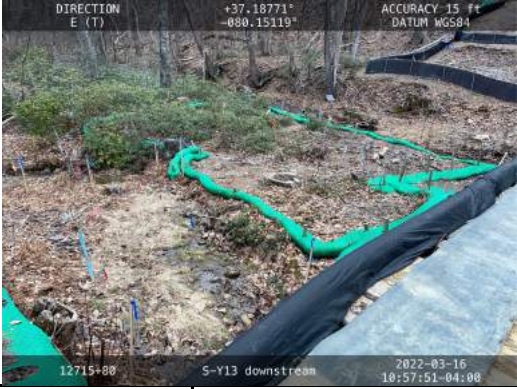
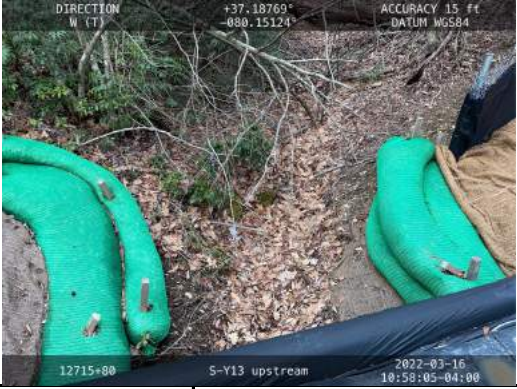
<b>GPS Location</b>	See photo for gps location data.		<b>GPS Location</b>	See photo for gps location data.	
<b>Field Station#</b>	12715+80		<b>Field Station#</b>	12715+80	
<b>Pic 13 Desc.</b>	Photo shows stream S-Y13 downstream from the bridge.		<b>Pic 14 Desc.</b>	Photo shows stream S-Y13 upstream from the bridge.

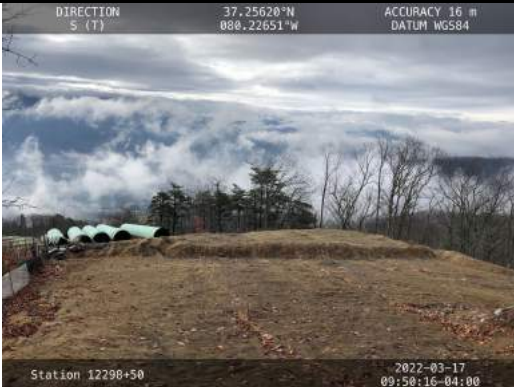
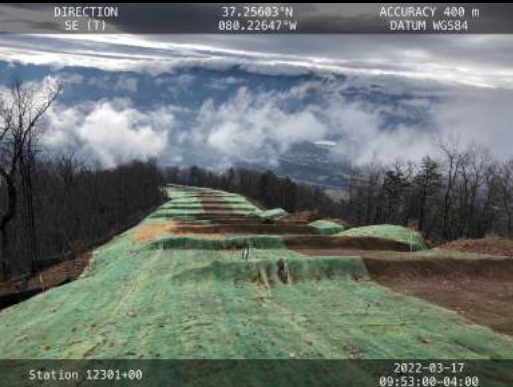
<b>GPS Location</b>	Please see photo for details.		<b>GPS Location</b>	Please see photo for details.	
<b>Field Station#</b>	12998+50		<b>Field Station#</b>	12301+00	
<b>Pic 1 Desc.</b>	Photo shows the stabilized ROW conditions with water bars and that all ECDs are installed and are functioning as designed.		<b>Pic 2 Desc.</b>	Photo shows the stabilized ROW conditions with water bars and that all ECDs are installed and are functioning as designed.

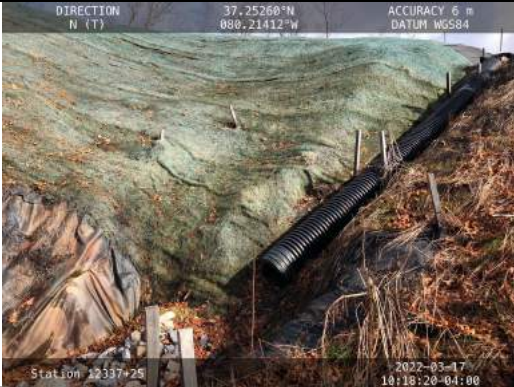
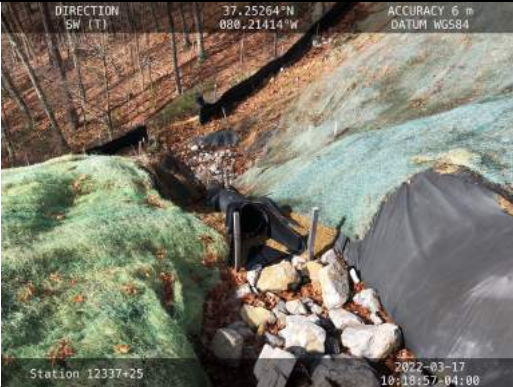
<b>GPS Location</b>	Please see photo for details.		<b>GPS Location</b>	Please see photo for details.	
<b>Field Station#</b>	12337+25		<b>Field Station#</b>	12337+25	
<b>Pic 3 Desc.</b>	Photo shows slop drain pipe and plunge pool.		<b>Pic 4 Desc.</b>	Photo shows slope drain inlet with stone inlet protection.

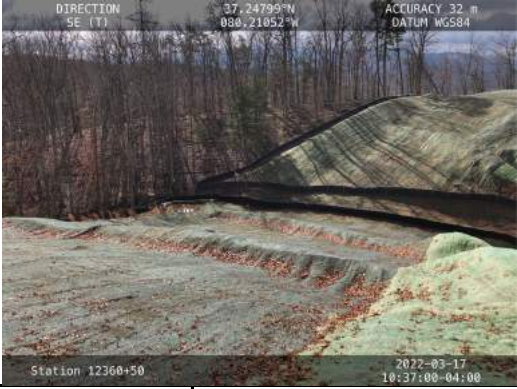
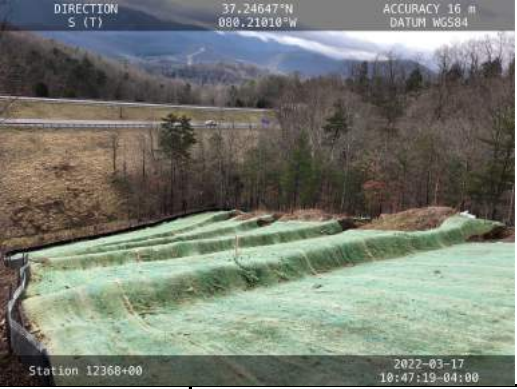
<b>GPS Location</b>	Please see photo for details.		<b>GPS Location</b>	Please see photo for details.	
<b>Field Station#</b>	12360+50		<b>Field Station#</b>	12368+00	
<b>Pic 7 Desc.</b>	Photo shows the stabilized ROW conditions with water bars and that all ECDs are installed and are functioning as designed.		<b>Pic 8 Desc.</b>	Photo shows the stabilized ROW conditions with water bars and that all ECDs are installed and are functioning as designed.

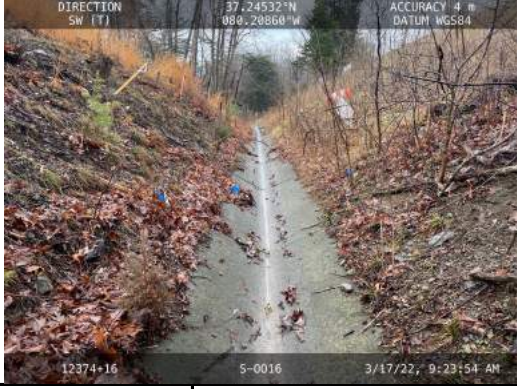
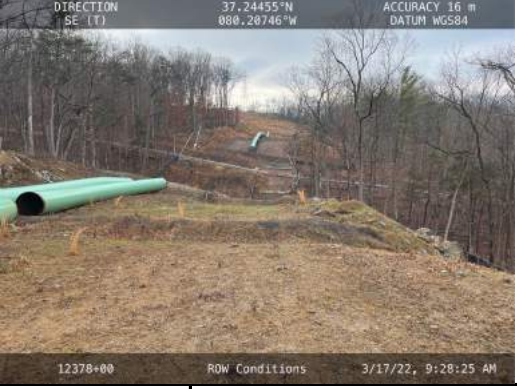
<b>GPS Location</b>	Please see photo for details.		<b>GPS Location</b>	Please see photo for details.	
<b>Field Station#</b>	12374+16		<b>Field Station#</b>	12378+00	
<b>Pic 9 Desc.</b>	Photo shows upstream view of Stream S-0016.		<b>Pic 10 Desc.</b>	Photo shows the stabilized ROW conditions with water bars and that all ECDs are installed and are functioning as designed.

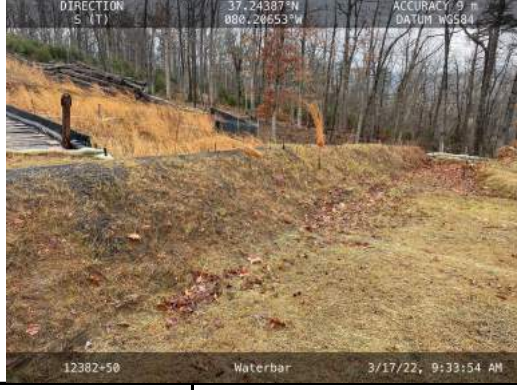
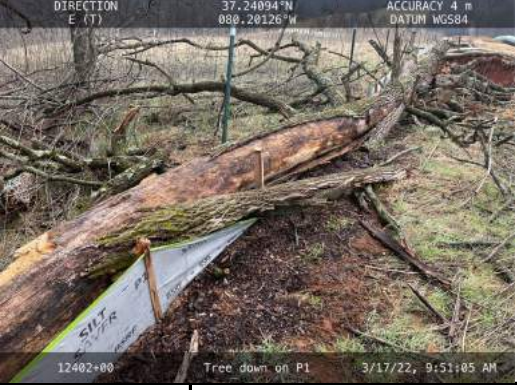
<b>GPS Location</b>	Please see photo for details.		<b>GPS Location</b>	Please see photo for details.	
<b>Field Station#</b>	12382+50		<b>Field Station#</b>	12402+00	
<b>Pic 11 Desc.</b>	Photo shows stabilized ROW with water bar, sump and end treatment functioning as designed.		<b>Pic 12 Desc.</b>	Photo shows today's punch list item. Downed tree damaged P1 silt fence.

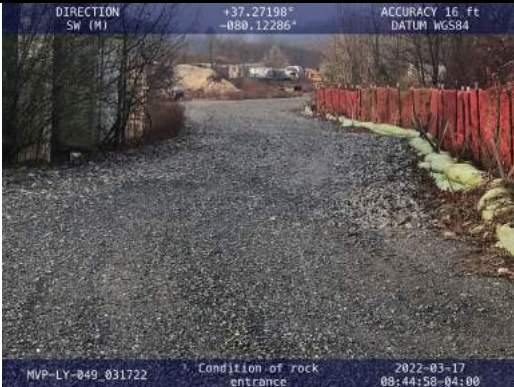
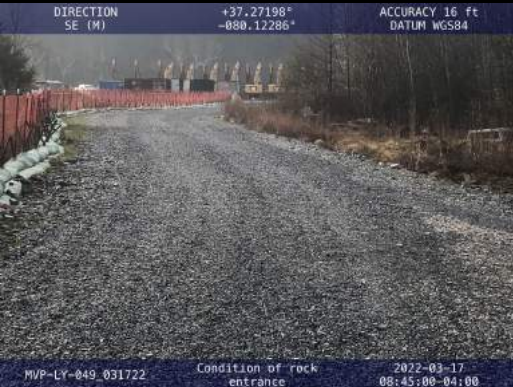
<b>GPS Location</b>	MVP-LY-049 See photo for gps data		<b>GPS Location</b>	MVP-LY-049 See photo for gps data	
<b>Field Station#</b>	+0		<b>Field Station#</b>	+0	
<b>Pic 1 Desc.</b>	Condition of rock entrance on north drive. No sediment or debris on stone. Looking SW.		<b>Pic 2 Desc.</b>	Condition of rock entrance. Small stone applied over larger stone. Looking SE.

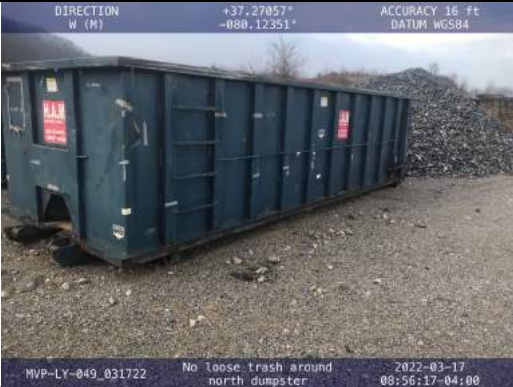
<b>GPS Location</b>	MVP-LY-049 See photo for gps data		<b>GPS Location</b>	MVP-LY-049 See photo for gps data	
<b>Field Station#</b>	+0		<b>Field Station#</b>	+0	
<b>Pic 3 Desc.</b>	Temporary trash transfer pit empty of debris. Looking NW.		<b>Pic 4 Desc.</b>	No loose trash around north dumpster or in the yard. Looking W.

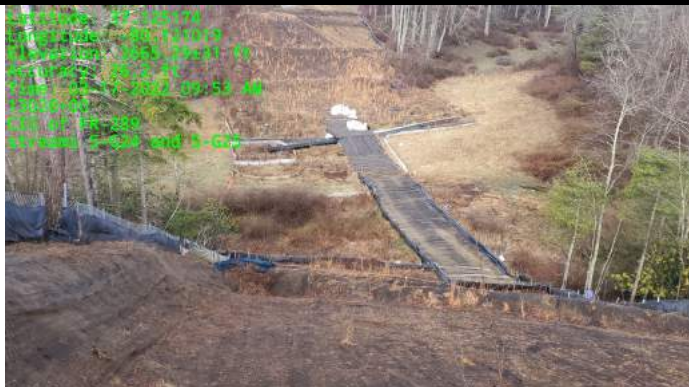
GPS Location	See pic for GPS location.		GPS Location	See pic for GPS location.	
Field Station#	13033+59		Field Station#	13026+00	
Pic 1 Desc.	0.2" rainfall accumulation total for Callaway Road.		Pic 2 Desc.	Stream crossings S-G24 and S-G25 from the GAS.

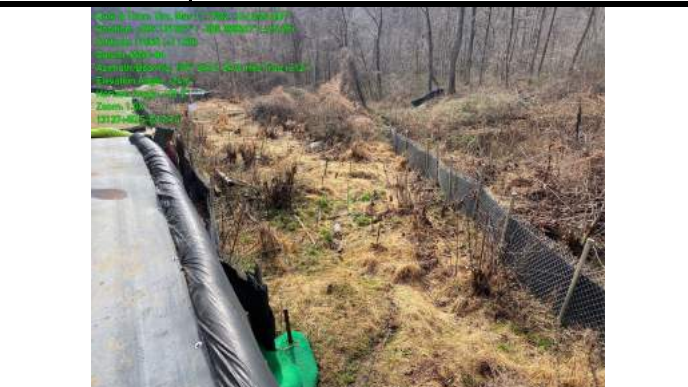
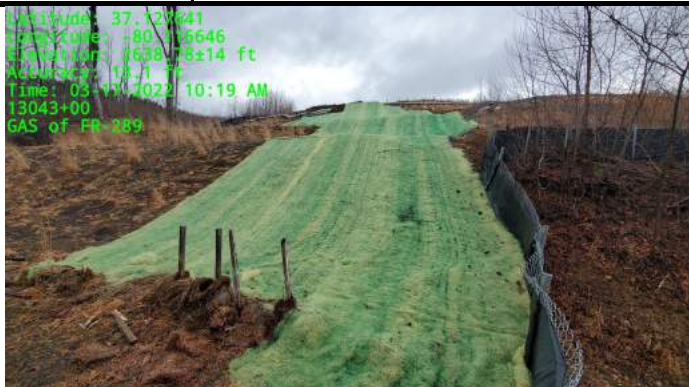
GPS Location	See pic for GPS location.		GPS Location	See pic for GPS location.	
Field Station#	13137+50		Field Station#	13043+00	
Pic 5 Desc.	Downstream side of stream S-D17/14.		Pic 6 Desc.	Current ROW conditions on the GAS of FR-289.

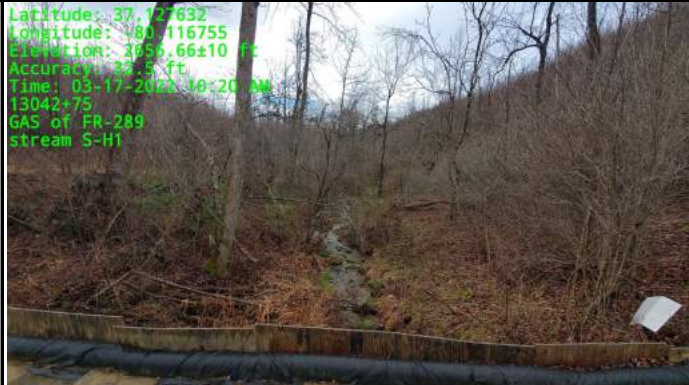
<b>GPS Location</b>			See pic for GPS location.		
<b>Field Station#</b>			13043+00		
<b>Pic 7 Desc.</b>			Stream crossing S-H1 from the GAS.

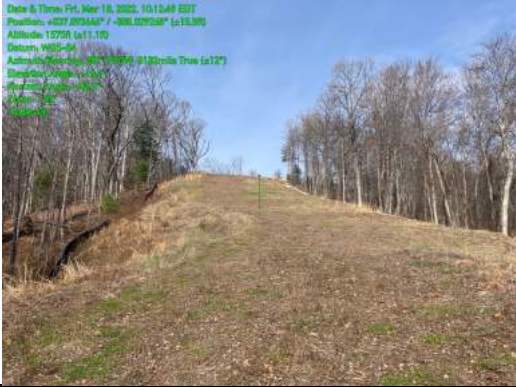
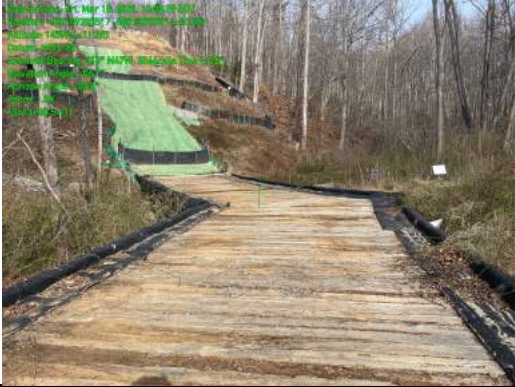
<b>GPS Location</b>	0	<b>GPS Location</b>	0		
<b>Field Station#</b>	13408+00	<b>Field Station#</b>	13413+05		
<b>Pic 13 Desc.</b>	ROW and ECDs In good condition and stable	<b>Pic 14 Desc.</b>	MVP-S-IJ1 and corresponding buffer zone in good condition

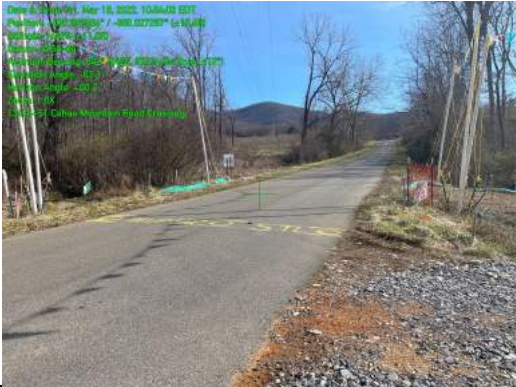
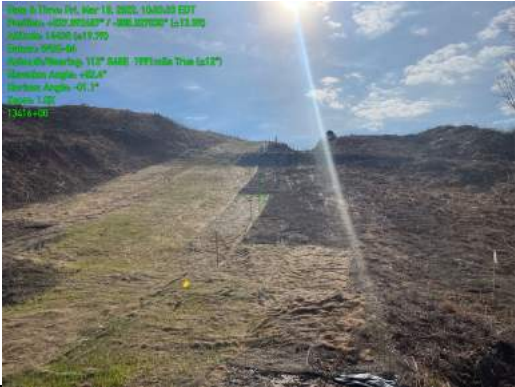
<b>GPS Location</b>	0	<b>GPS Location</b>	0		
<b>Field Station#</b>	13415+51	<b>Field Station#</b>	13416+00		
<b>Pic 15 Desc.</b>	Cahas Mountain Road Crossing in good condition	<b>Pic 16 Desc.</b>	ROW and ECDs In good condition and stable

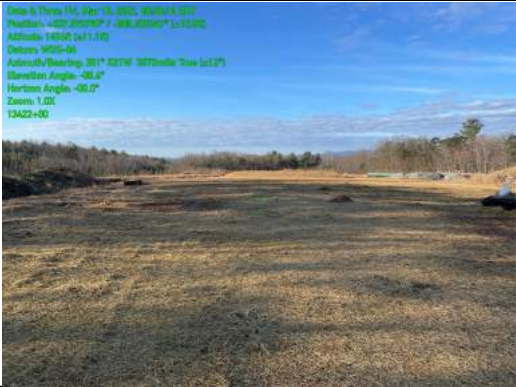
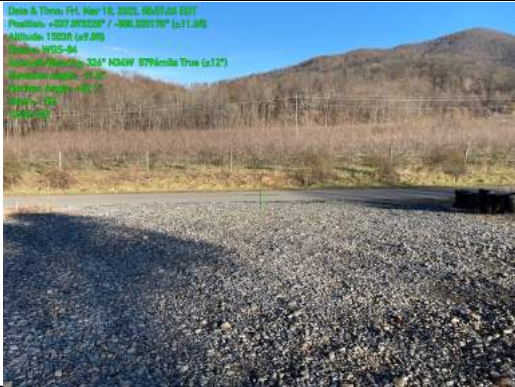
<b>GPS Location</b>	0	<b>GPS Location</b>	0		
<b>Field Station#</b>	13422+00	<b>Field Station#</b>	13422+00		
<b>Pic 17 Desc.</b>	ROW and ECDs In good condition and stable	<b>Pic 18 Desc.</b>	RCE in good condition and functioning properly

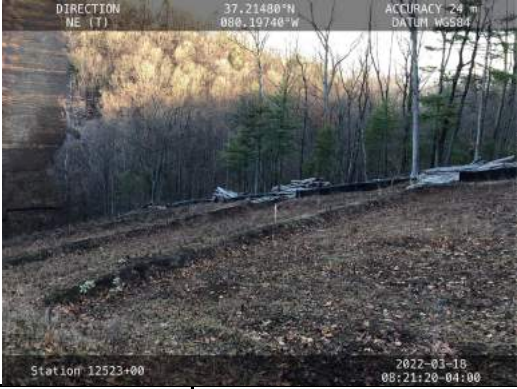
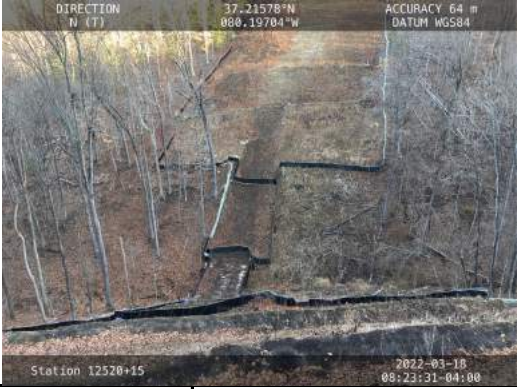
<b>GPS Location</b>	Please see photo for details.		<b>GPS Location</b>	Please see photo for details.	
<b>Field Station#</b>	12523+00		<b>Field Station#</b>	12520+15	
<b>Pic 7 Desc.</b>	Photo shows the stabilized ROW conditions with water bars and that all ECDs are installed and are functioning as designed.		<b>Pic 8 Desc.</b>	Photo shows the stabilized ROW conditions with water bars and that all ECDs are installed and are functioning as designed.

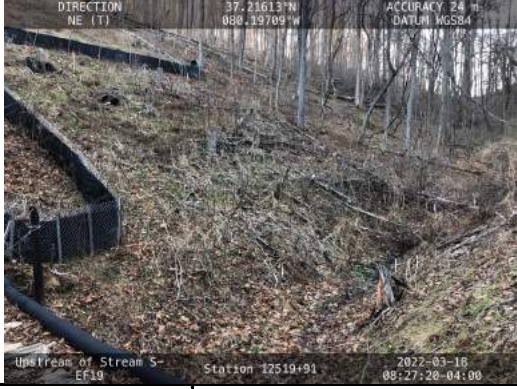
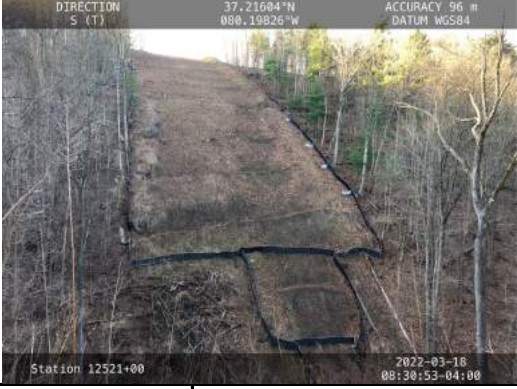
<b>GPS Location</b>	Please see photo for details.		<b>GPS Location</b>	Please see photo for details.	
<b>Field Station#</b>	12519+91		<b>Field Station#</b>	12521+00	
<b>Pic 9 Desc.</b>	Photo shows up stream of Stream S-EF19		<b>Pic 10 Desc.</b>	Photo shows the stabilized ROW conditions with water bars and that all ECDs are installed and are functioning as designed.

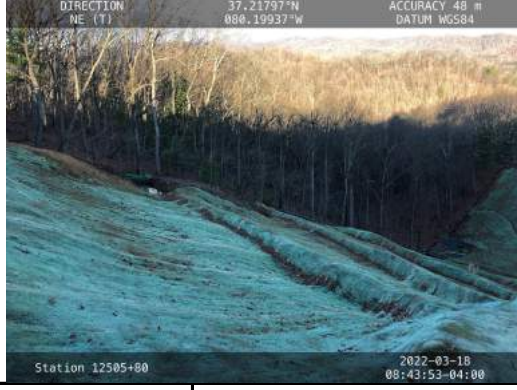
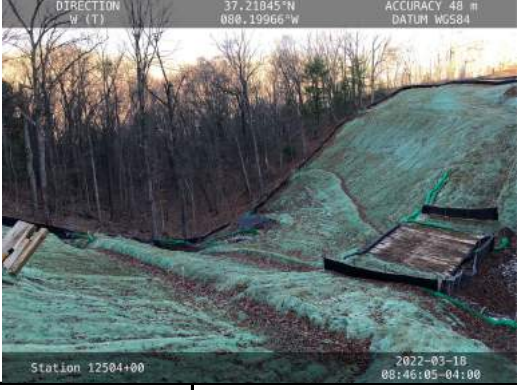
<b>GPS Location</b>	Please see photo for details.		<b>GPS Location</b>	Please see photo for details.	
<b>Field Station#</b>	12505+80		<b>Field Station#</b>	12504+00	
<b>Pic 11 Desc.</b>	Photo shows the stabilized ROW conditions with water bars and that all ECDs are installed and are functioning as designed.		<b>Pic 12 Desc.</b>	Photo shows the stabilized ROW conditions with water bars and that all ECDs are installed and are functioning as designed.

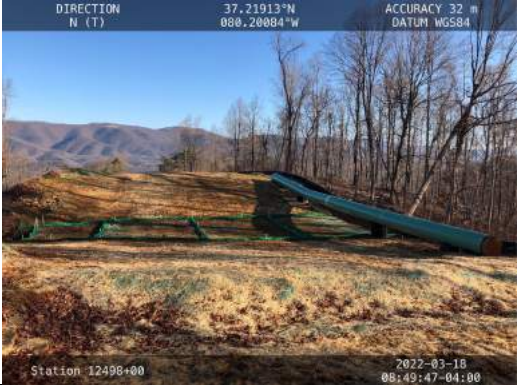
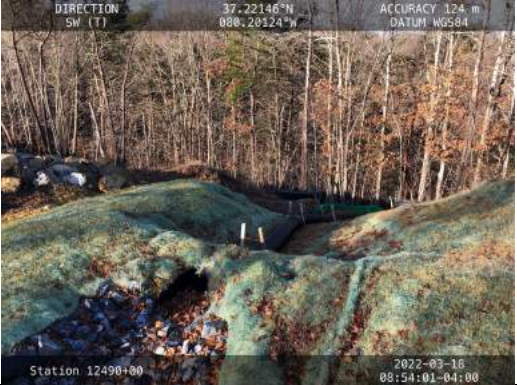
<b>GPS Location</b>	Please see photo for details.		<b>GPS Location</b>	Please see photo for details.	
<b>Field Station#</b>	12498+00		<b>Field Station#</b>	12490+00	
<b>Pic 13 Desc.</b>	Photo shows the stabilized ROW conditions with water bars and that all ECDs are installed and are functioning as designed.		<b>Pic 14 Desc.</b>	Photo shows slope drain and stone inlet protection.

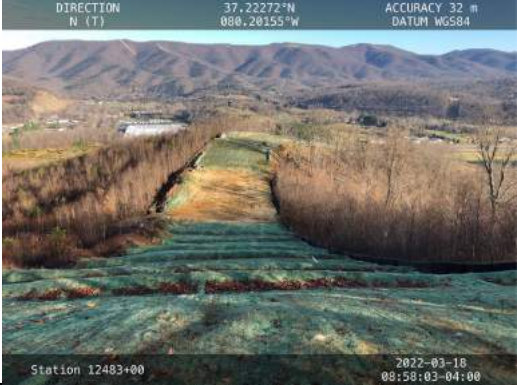
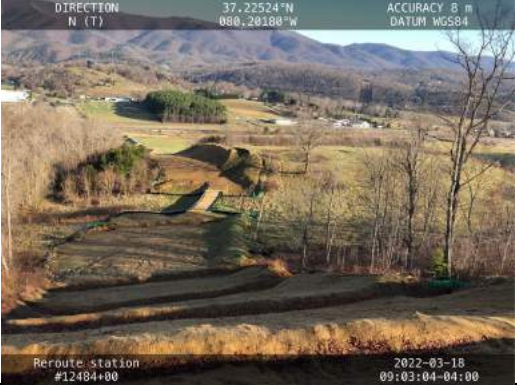
<b>GPS Location</b>	Please see photo for details.		<b>GPS Location</b>	Please see photo for details.	
<b>Field Station#</b>	12483+00		<b>Field Station#</b>	12484+00	
<b>Pic 15 Desc.</b>	Photo shows the stabilized ROW conditions with water bars and that all ECDs are installed and are functioning as designed.		<b>Pic 16 Desc.</b>	Photo shows the stabilized ROW conditions with water bars and that all ECDs are installed and are functioning as designed.

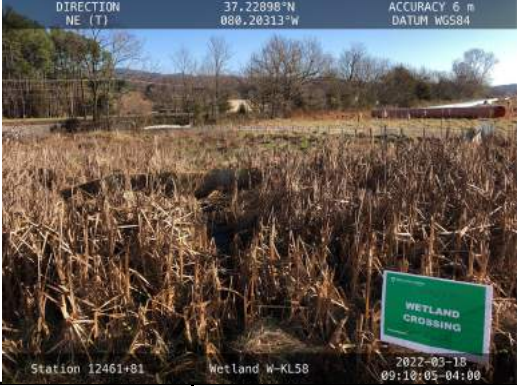
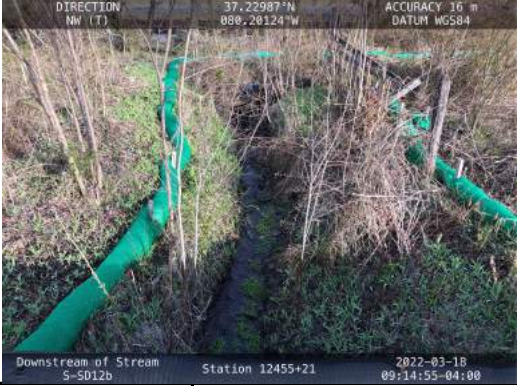
<b>GPS Location</b>	Please see photo for details.		<b>GPS Location</b>	Please see photo for details.	
<b>Field Station#</b>	12461+81		<b>Field Station#</b>	12455+21	
<b>Pic 17 Desc.</b>	Photo shows Wetland W-KL58.		<b>Pic 18 Desc.</b>	Photo shows downstream of Stream S-SD12b.

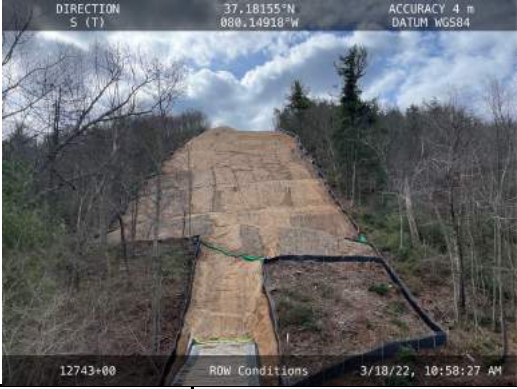
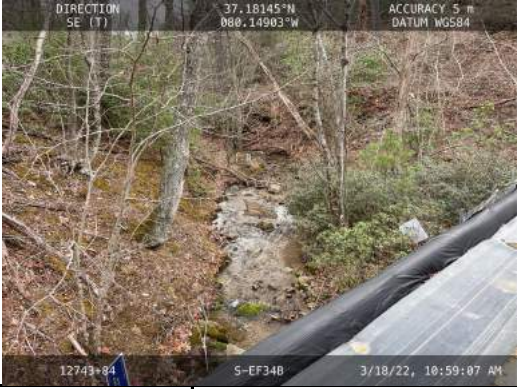
<b>GPS Location</b>	See photo		<b>GPS Location</b>	See photo	
<b>Field Station#</b>	12743+00		<b>Field Station#</b>	12743+84	
<b>Pic 7 Desc.</b>	Current ROW conditions. ROW is stable. ECDs are functional.		<b>Pic 8 Desc.</b>	Downstream of crossing at Stream S-EF34B

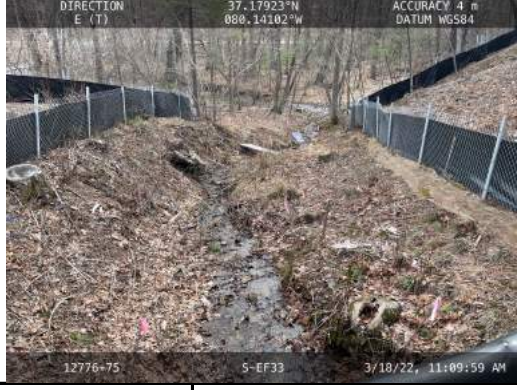
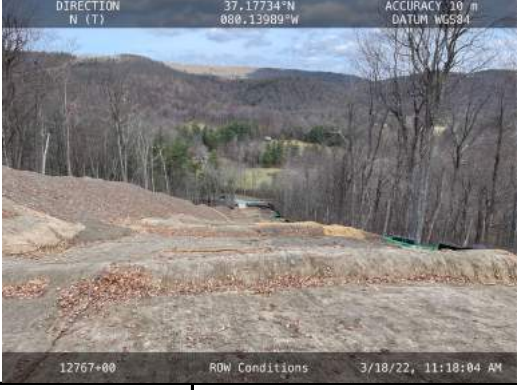
<b>GPS Location</b>	See photo		<b>GPS Location</b>	See photo	
<b>Field Station#</b>	12776+75		<b>Field Station#</b>	12767+00	
<b>Pic 11 Desc.</b>	Downstream of crossing at stream S-EF33		<b>Pic 12 Desc.</b>	Current ROW conditions. ROW is stable. ECDs are functional.
