Visual Site Inspection Report

Project Name	H-600 Pipeline Spread H	AFE	124300138	Spread	H-600 Pipeline Spread H
Contractor	Precision			Report #	35203
Inspector	Jordan Davis			Date/Time	3/7/2022 7:55 PM
Permit #	TBD	Inspection Type	VA SWPP	Station Begin	12284+75
State	VA	Inspection Area	Partial	Station End	12443+75
County	Montgomery	Ground	Dry	Temperature (°F)	76.00
Municipality	N/A	Weather	Sunny	Rain Gauge (in)	0.00
				Rain Accumulation Time (days)	0.00

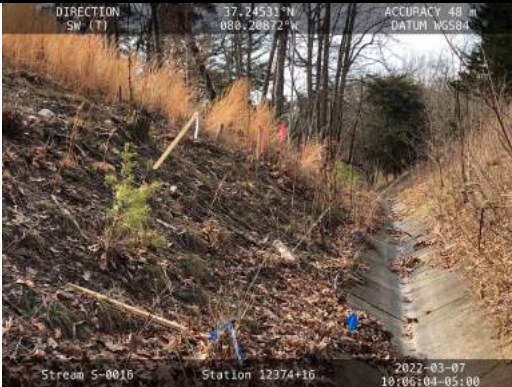
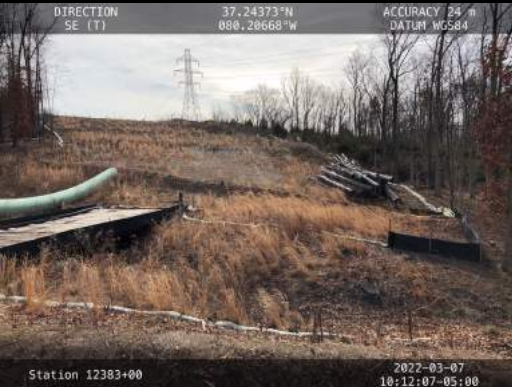
GPS Location	Please see photo for details.		GPS Location	Please see photo for details.	
Field Station#	12374+16		Field Station#	12383+00	
Pic 1 Desc.	Photo shows Stream S-0016.		Pic 2 Desc.	Photo shows the stabilized ROW conditions with water bars and that all ECDs are installed and are functioning as designed.

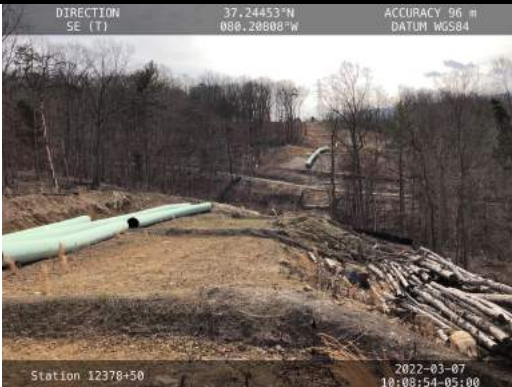
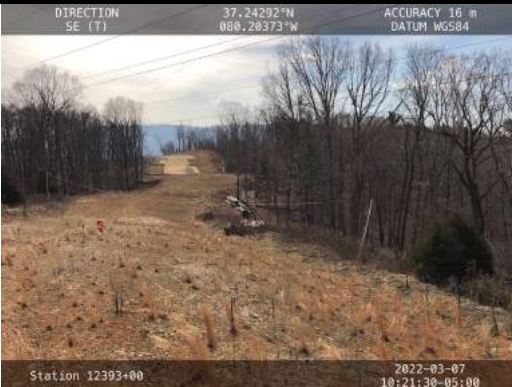
GPS Location	Please see photo for details.		GPS Location	Please see photo for details.	
Field Station#	12378+50		Field Station#	12393+00	
Pic 3 Desc.	Photo shows the stabilized ROW conditions with water bars and that all ECDs are installed and are functioning as designed.		Pic 4 Desc.	Photo shows the stabilized ROW conditions with water bars and that all ECDs are installed and are functioning as designed.

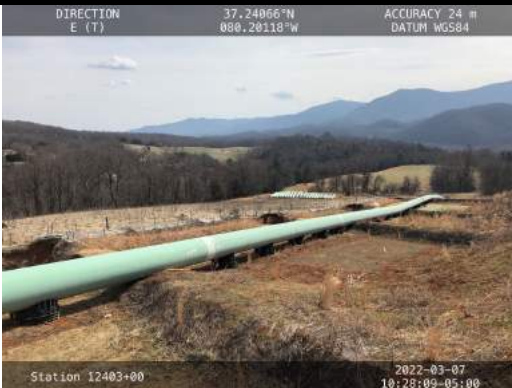
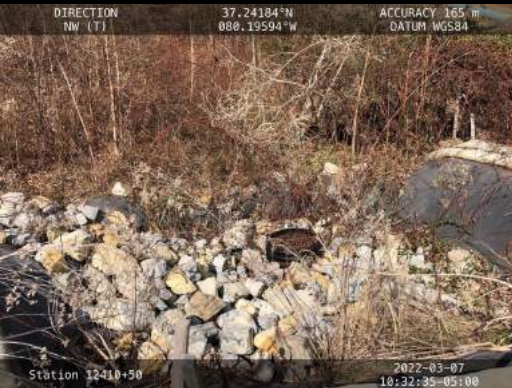
Field Station#	12403+00		Field Station#	12410+50	
Pic 5 Desc.	Photo shows the stabilized ROW conditions with water bars and that all ECDs are installed and are functioning as designed.		Pic 6 Desc.	Photo shows clean water diversion inlet with stone inlet protection.

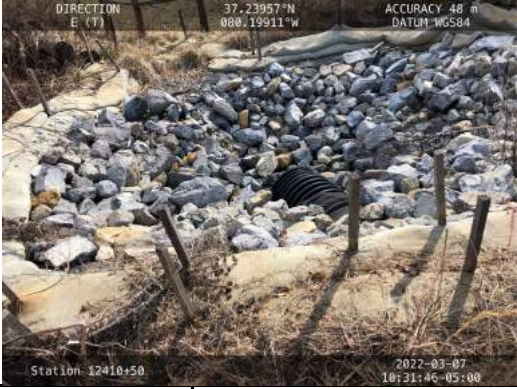
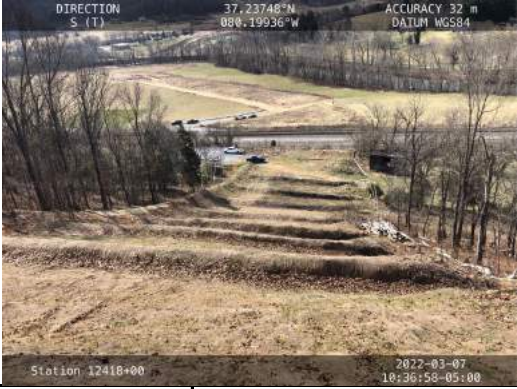
GPS Location	Please see photo for details.		GPS Location	Please see photo for details.	
Field Station#	12410+50		Field Station#	12418+00	
Pic 7 Desc.	Photo shows clean water diversion pipe and plunge pool.		Pic 8 Desc.	Photo shows the stabilized ROW conditions with water bars and that all ECDs are installed and are functioning as designed.

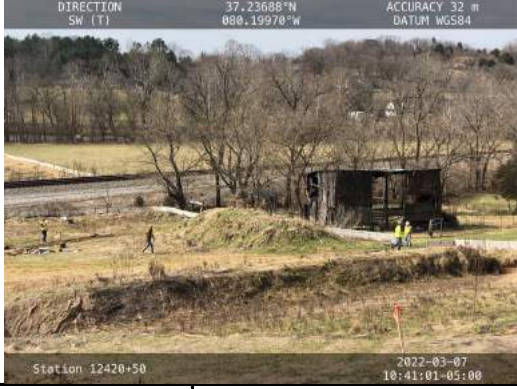
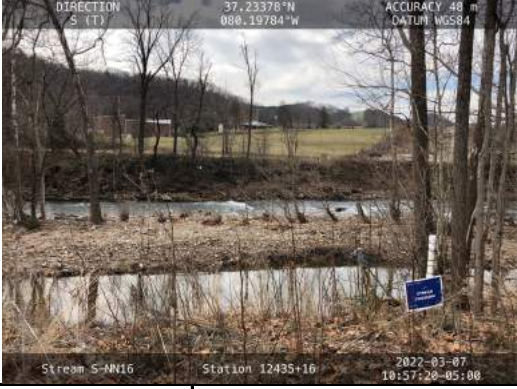
GPS Location	Please see photo for details.		GPS Location	Please see photo for details.	
Field Station#	12420+50		Field Station#	12432+16	
Pic 9 Desc.	Photo shows stabilized ROW and environmental crew maintaining ECDs.		Pic 10 Desc.	Photo shows coming in side of Stream S-NN16.

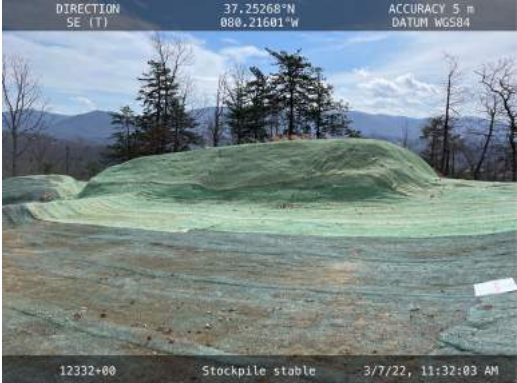
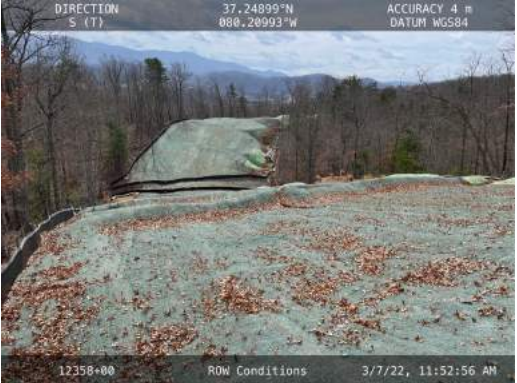
GPS Location	Please see photo for details.		GPS Location	Please see photo for details.	
Field Station#	12332+00		Field Station#	12358+00	
Pic 13 Desc.	Photo shows stabilized stock pile.		Pic 14 Desc.	Photo shows the stabilized ROW conditions with water bars and that all ECDs are installed and are functioning as designed.

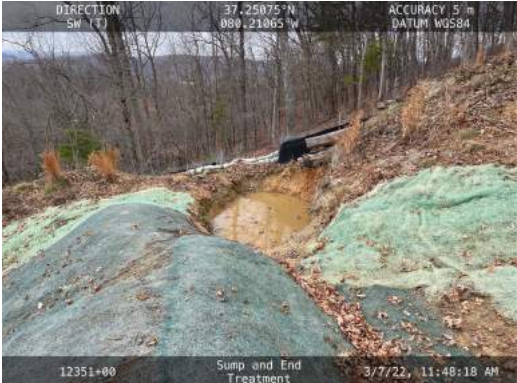
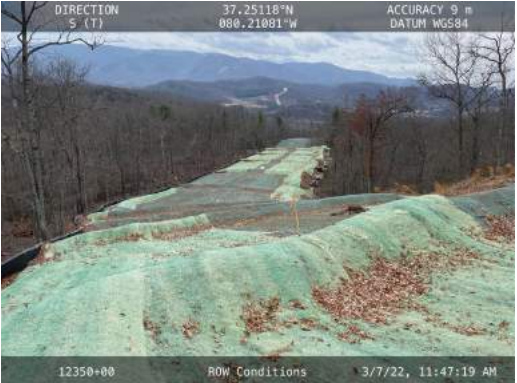
GPS Location	Please see photo for details.		GPS Location	Please see photo for details.	
Field Station#	12351+00		Field Station#	12350+00	
Pic 15 Desc.	Photo shows water bar, sump and end treatment functioning as designed.		Pic 16 Desc.	Photo shows the stabilized ROW conditions with water bars and that all ECDs are installed and are functioning as designed.

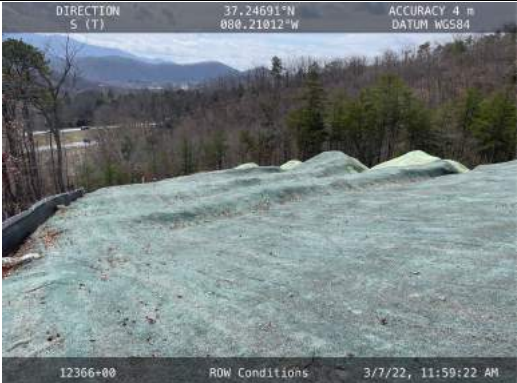
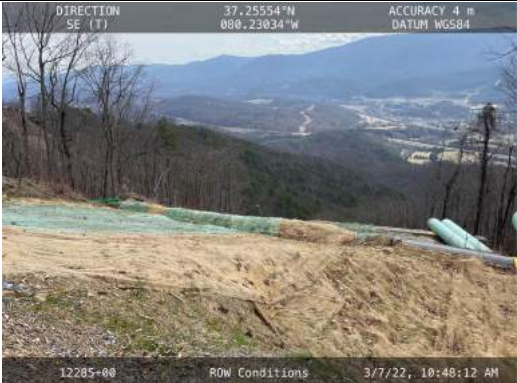
Pic 17 Desc.	Photo shows the stabilized ROW conditions with water bars and that all ECDs are installed and are functioning as designed.		Pic 18 Desc.	Photo shows the stabilized ROW conditions with water bars and that all ECDs are installed and are functioning as designed.

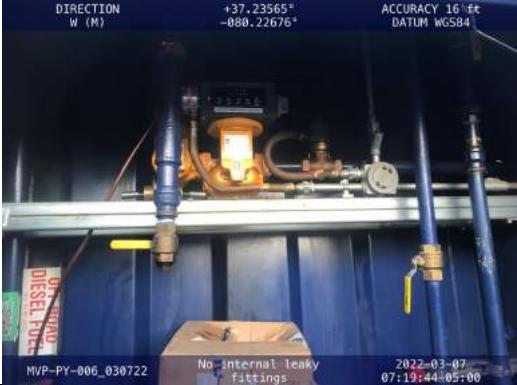
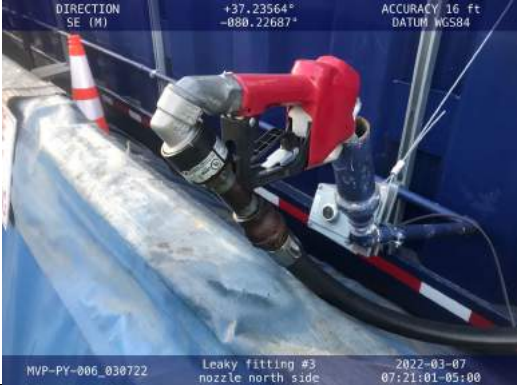
GPS Location	MVP-PY-006 See photo for gps data		GPS Location	MVP-PY-006 See photo for gps data	
Field Station#	+0		Field Station#	+0	
Pic 7 Desc.	Blue Bulk Fuel tanks no leaky internal fittings. Looking W.		Pic 8 Desc.	Blue Bulk Fuel tanks one leaky fitting. Contractor advised and nozzle taken out of service until it can be repaired. Looking SE.

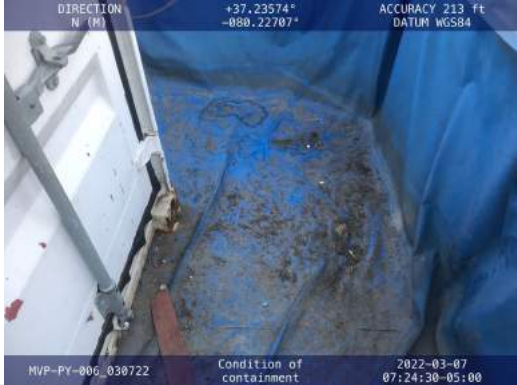
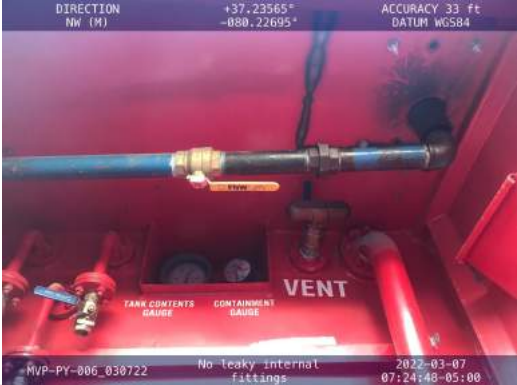
GPS Location	MVP-PY-006 See photo for gps data		GPS Location	MVP-PY-006 See photo for gps data	
Field Station#	+0		Field Station#	+0	
Pic 9 Desc.	Off Road Fuel unit containment free of stormwater. Looking N.		Pic 10 Desc.	Off Road Fuel unit no leaky internal fittings. Looking NW.

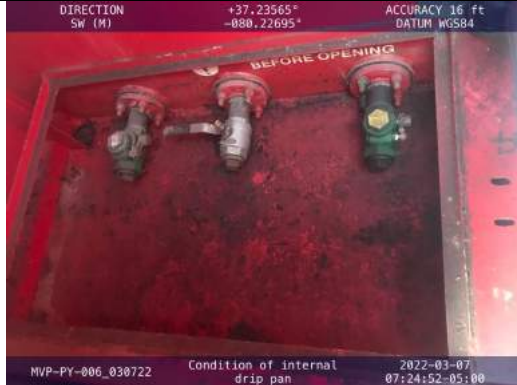
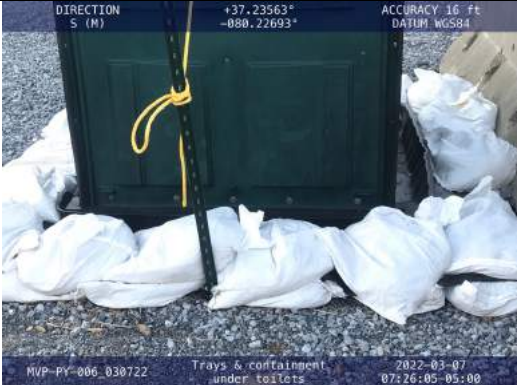
GPS Location	MVP-PY-006 See photo for gps data		GPS Location	MVP-PY-006 See photo for gps data	
Field Station#	+0		Field Station#	+0	
Pic 11 Desc.	Off Road Fuel unit condition of internal drip pan. Free of fluids. Looking SW.		Pic 12 Desc.	Tray and containment under toilet. Tray free of fluids. Looking S.

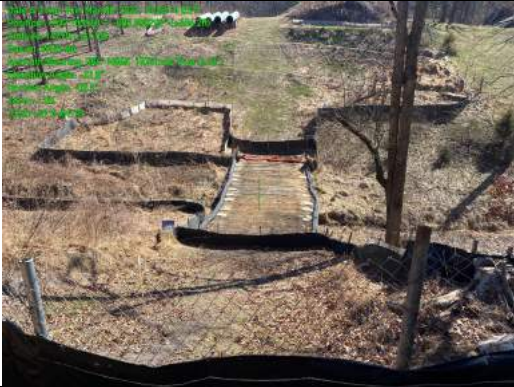
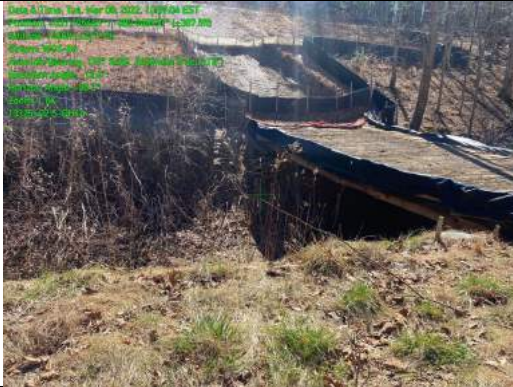
GPS Location	0	GPS Location	0		
Field Station#	13321+47	Field Station#	13325+02		
Pic 1 Desc.	MVP-S-GH15 and corresponding buffer zone in good condition	Pic 2 Desc.	MVP-S-GH14 and corresponding buffer zone in good condition

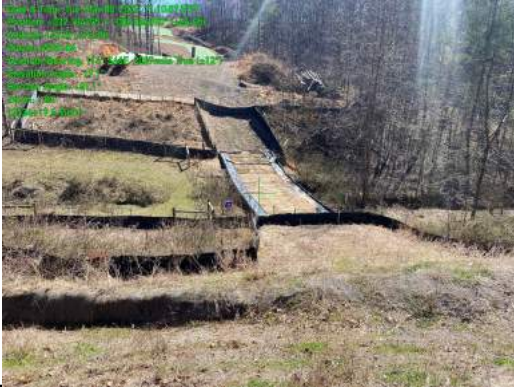
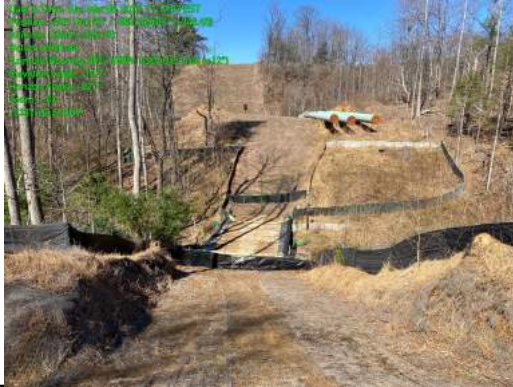
GPS Location	0	GPS Location	0		
Field Station#	13334+17	Field Station#	13337+83		
Pic 3 Desc.	MVP-S-GH11 and corresponding buffer zone in good condition	Pic 4 Desc.	MVP-S-GH9 and corresponding buffer zone in good condition

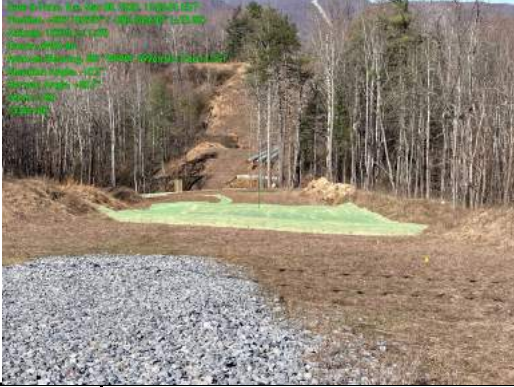
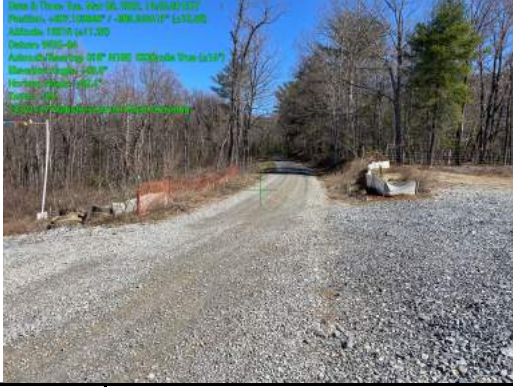
GPS Location	0	GPS Location	0		
Field Station#	13342+00	Field Station#	13342+67		
Pic 5 Desc.	ROW and ECDs In good condition and stable	Pic 6 Desc.	Websters Corner Road Crossing in good condition

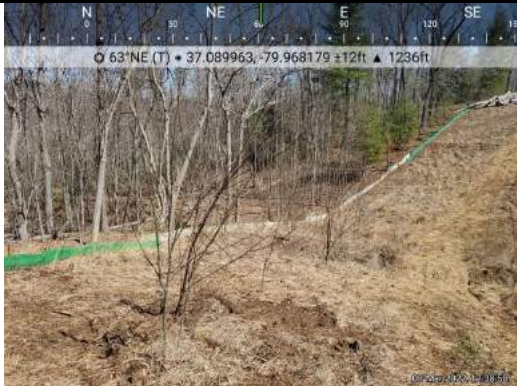
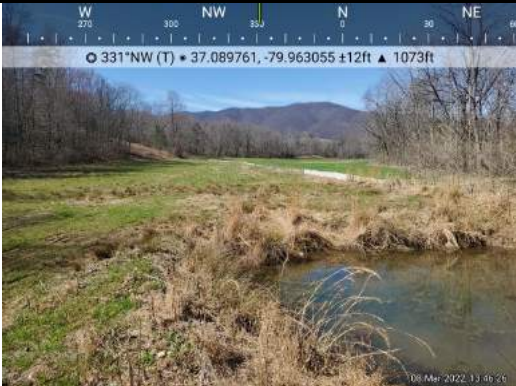
GPS Location	0	GPS Location	0		
Field Station#	13607+00	Field Station#	13637+00		
Pic 9 Desc.	Perimeter ECDs and Sideslope vegetation	Pic 10 Desc.	Sump and Temporary vegetation

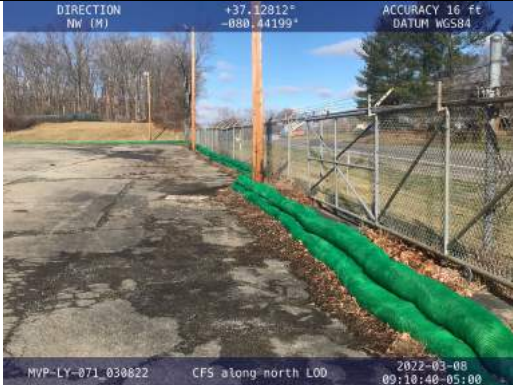
GPS Location	MVP-LY-071 See photo for gps data	GPS Location	MVP-LY-071 See photo for gps data		
Field Station#	+0	Field Station#	+0		
Pic 1 Desc.	Condition of asphalt entrance. No sediment or debris on public roadway. Looking NE.	Pic 2 Desc.	Con of triple stack compost filter sock along north LOD. Looking NW.

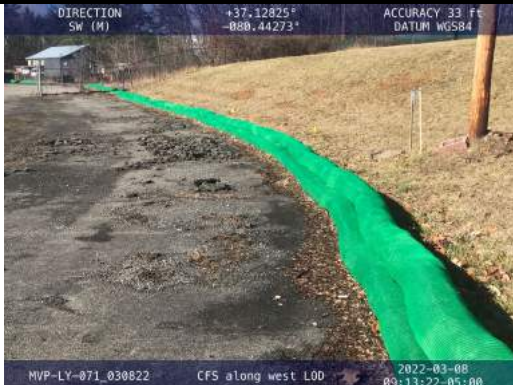
GPS Location	MVP-LY-071 See photo for gps data	GPS Location	MVP-LY-071 See photo for gps data		
Field Station#	+0	Field Station#	+0		
Pic 3 Desc.	No loose trash or debris in north section of the yard. Looking NW.	Pic 4 Desc.	Condition of triple stack compost filter sock along west LOD. Looking SW.

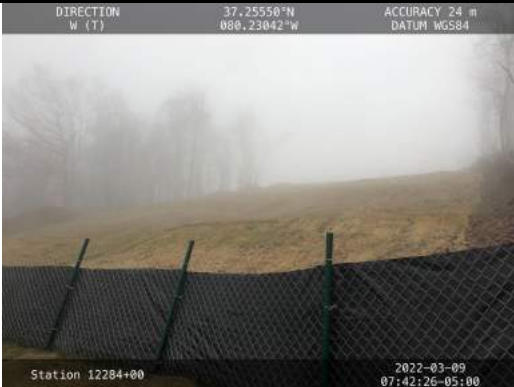
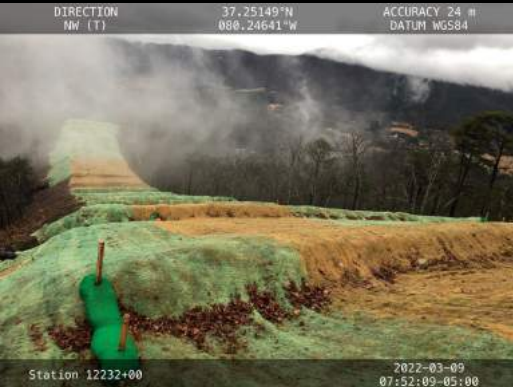
GPS Location	Please see photo for details.		GPS Location	Please see photo for details.	
Field Station#	12284+00		Field Station#	12232+00	
Pic 1 Desc.	Photo shows the stabilized ROW conditions with water bars and that all ECDs are installed and are functioning as designed.		Pic 2 Desc.	Photo shows the stabilized ROW conditions with water bars and that all ECDs are installed and are functioning as designed.

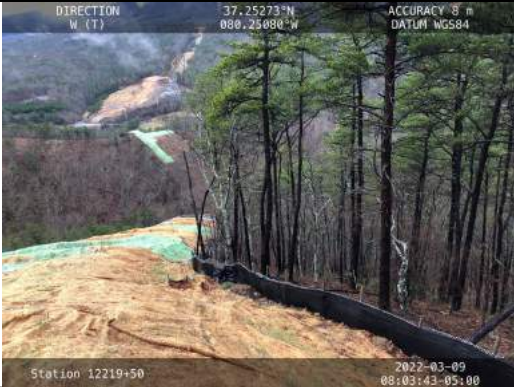
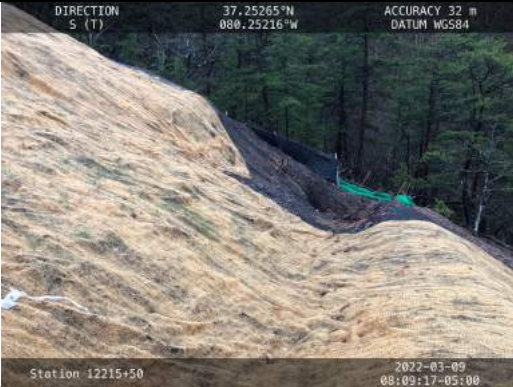
GPS Location	Please see photo for details.		GPS Location	Please see photo for details.	
Field Station#	12219+50		Field Station#	12215+50	
Pic 3 Desc.	Photo shows the stabilized ROW conditions with water bars and that all ECDs are installed and are functioning as designed.		Pic 4 Desc.	Photo shows water bar, sump and end treatment installed and functioning as designed.

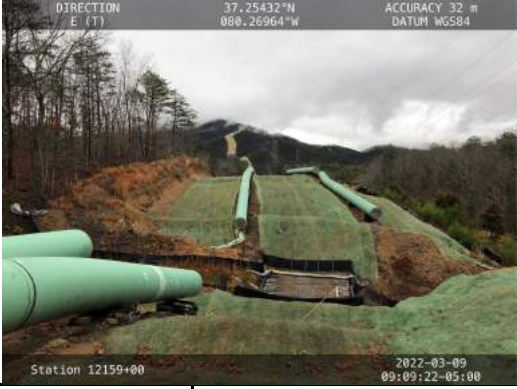
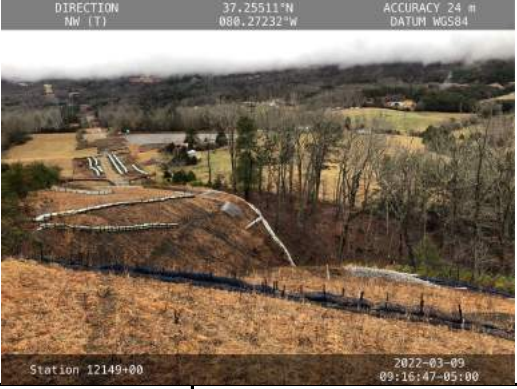
GPS Location	Please see photo for details.		GPS Location	Please see photo for details.	
Field Station#	12159+00		Field Station#	12149+00	
Pic 15 Desc.	Photo shows the stabilized ROW conditions with water bars and that all ECDs are installed and are functioning as designed.		Pic 16 Desc.	Photo shows stabilized ROW with permanent water bars and level spreaders installed and functioning as designed.

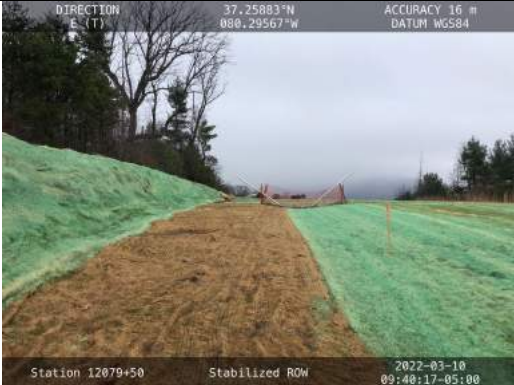
GPS Location	Please see photo for details.		GPS Location	Please see photo for details.	
Field Station#	12079+50		Field Station#	12076+95	
Pic 1 Desc.	Photo shows stabilized ROW with erosion control blanket.		Pic 2 Desc.	Photo shows upstream of Stream S-MM15.

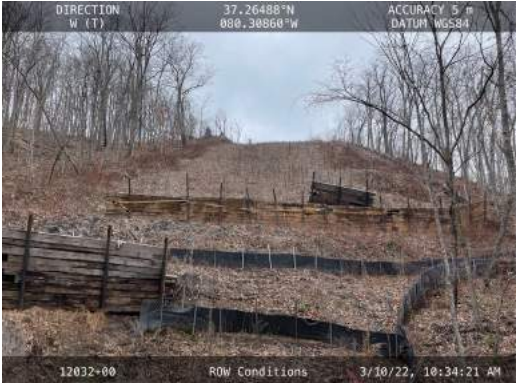
GPS Location	Please see photo for details.		GPS Location	Please see photo for details.	
Field Station#	12016+00		Field Station#	12032+00	
Pic 15 Desc.	Photo shows stabilized ROW conditions with installed ECDs functioning as designed.		Pic 16 Desc.	Photo shows stabilized ROW conditions with installed ECDs functioning as designed.

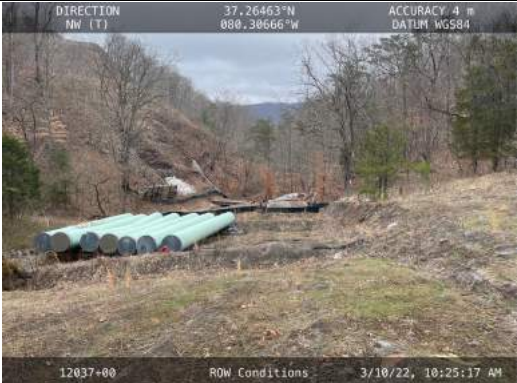
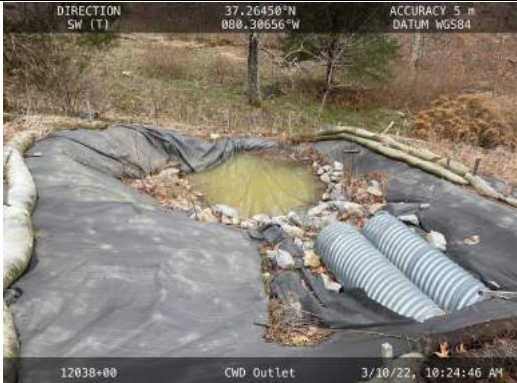
GPS Location	Please see photo for details.		GPS Location	Please see photo for details.	
Field Station#	12037+00		Field Station#	12038+00	
Pic 17 Desc.	Photo shows stabilized ROW conditions with installed ECDs functioning as designed.		Pic 18 Desc.	Photo shows clean water diversion pipes where they enter the plunge pool.

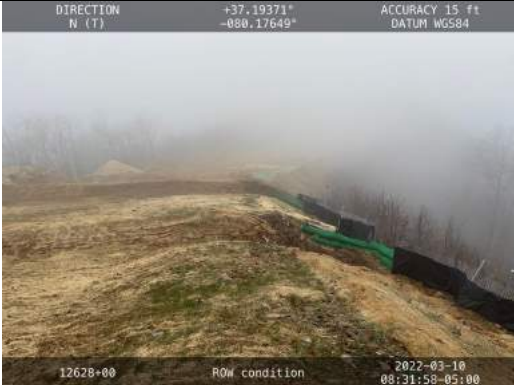
GPS Location	See photo for gps location data.		GPS Location	See photo for gps location data.	
Field Station#	12628+00		Field Station#	12627+00	
Pic 1 Desc.	Photo shows the ROW condition. ECDs are installed and functioning as designed.		Pic 2 Desc.	Photo shows the ROW condition. ECDs are installed and functioning as designed.

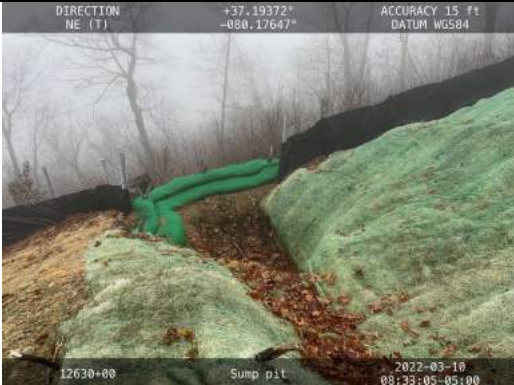
GPS Location	See photo for gps location data.		GPS Location	See photo for gps location data.	
Field Station#	12630+00		Field Station#	12639+00	
Pic 3 Desc.	Photo shows the sump pit and end treatment. ECDs are installed and functioning as designed.		Pic 4 Desc.	Photo shows the ROW condition. ECDs are installed and functioning as designed.

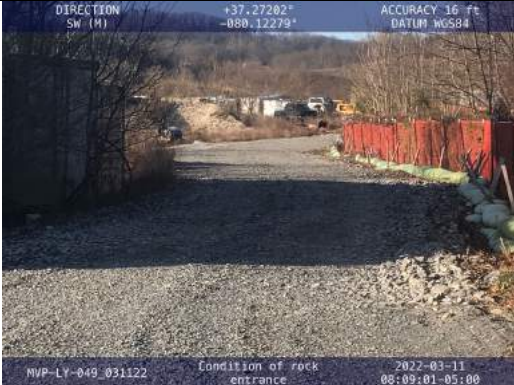
GPS Location	MVP-LY-049 See photo for gps data	GPS Location	MVP-LY-049 See photo for gps data		
Field Station#	+0	Field Station#	+0		
Pic 1 Desc.	Condition of rock entrance. No sediment or debris on stone. Looking SW.	Pic 2 Desc.	Condition of rock entrance. Small stone applied over larger stone. Looking S.

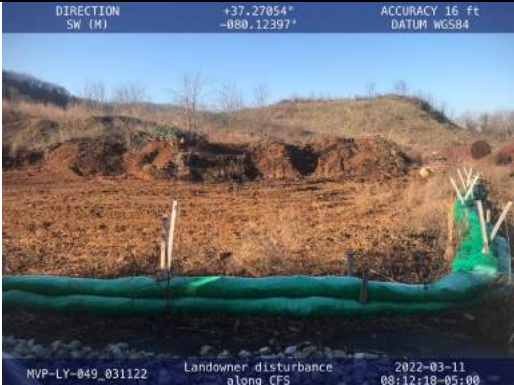
GPS Location	MVP-LY-049 See photo for gps data	GPS Location	MVP-LY-049 See photo for gps data		
Field Station#	+0	Field Station#	+0		
Pic 3 Desc.	Landowner soil disturbance along triple stack compost filter sock. No new damage to installed ECD's. Looking SW.	Pic 4 Desc.	Landowner soil disturbance along feature W-CV21A. Areas not stabilized. Looking W.

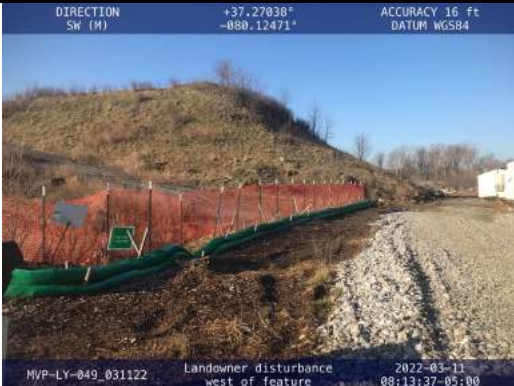
GPS Location	MVP-LY-049 See photo for gps data	GPS Location	MVP-LY-049 See photo for gps data		
Field Station#	+0	Field Station#	+0		
Pic 5 Desc.	Landowner soil disturbance west of feature W-CV21B. Areas not stabilized. Looking SW.	Pic 6 Desc.	Landowner soil disturbance and debris piled along triple stack compost filter sock and east of feature W-CV21B. Looking S.

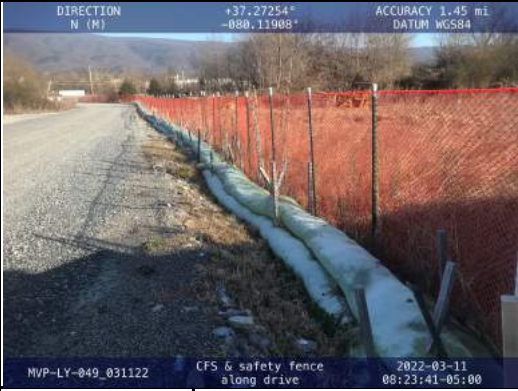
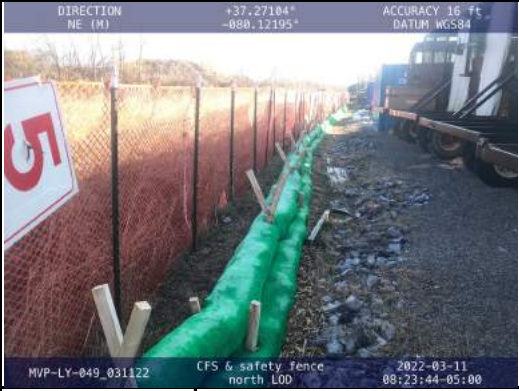
GPS Location	MVP-LY-049 See photo for gps data	GPS Location	MVP-LY-049 See photo for gps data		
Field Station#	+0	Field Station#	+0		
Pic 13 Desc.	Condition of triple stack compost filter sock and safety fence along east edge of center drive. Looking N.	Pic 14 Desc.	Condition of triple stack compost filter sock and safety fence along north LOD. Looking NE.

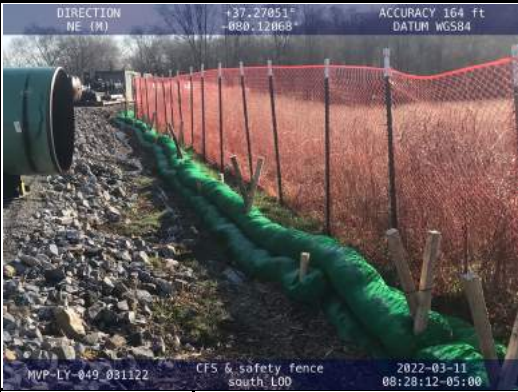
GPS Location	MVP-LY-049 See photo for gps data	GPS Location	MVP-LY-049 See photo for gps data		
Field Station#	+0	Field Station#	+0		
Pic 15 Desc.	Condition of triple stack compost filter sock and safety fence along south LOD. Looking E.	Pic 16 Desc.	Condition of triple stack compost filter sock and safety fence along south LOD. Looking SW.

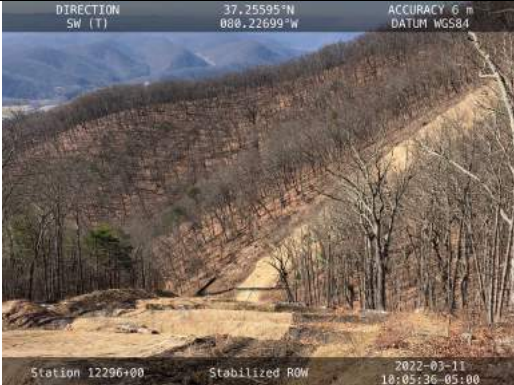
GPS Location	Please see photo for details.		GPS Location	Please see photo for details.	
Field Station#	12296+00		Field Station#	12317+00	
Pic 1 Desc.	Photo shows the stabilized ROW conditions with water bars and that all ECDs are installed and are functioning as designed.		Pic 2 Desc.	Photo shows the stabilized ROW conditions with water bars and that all ECDs are installed and are functioning as designed.

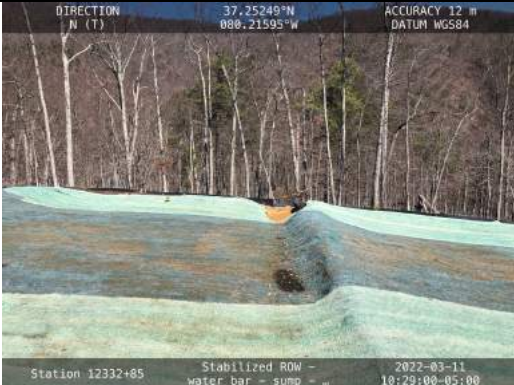
GPS Location	Please see photo for details.		GPS Location	Please see photo for details.	
Field Station#	12332+85		Field Station#	12338+00	
Pic 3 Desc.	Photo shows stabilized ROW with water bar, sump, and end treatment functioning as designed.		Pic 4 Desc.	Photo shows stabilized side slope with slope drains and plunge pool functioning as designed.

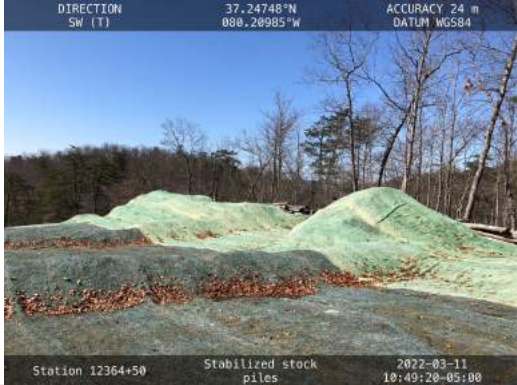
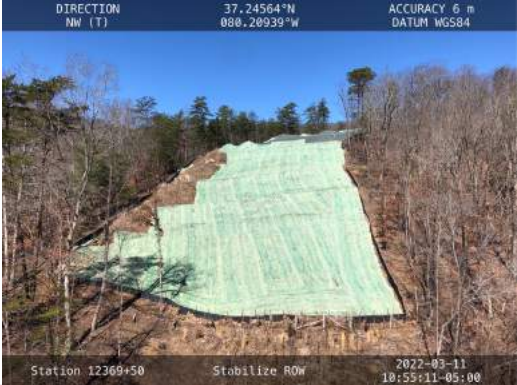
GPS Location	Please see photo for details.		GPS Location	Please see photo for details.	
Field Station#	12364+50		Field Station#	12369+50	
Pic 9 Desc.	Photo shows stabilized ROW and stabilized stock piles.		Pic 10 Desc.	Photo shows the stabilized ROW conditions with water bars and that all ECDs are installed and are functioning as designed.

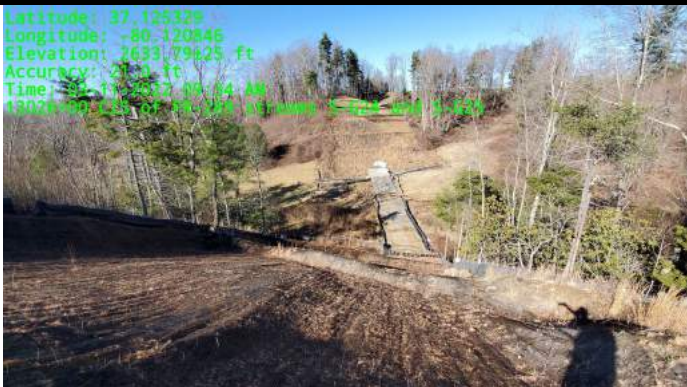
GPS Location	See pic for GPS location.		GPS Location	See pic for GPS location.	
Field Station#	13024+00		Field Station#	13026+00	
Pic 1 Desc.	Downstream side of streams S-G24 and S-G25.		Pic 2 Desc.	Streams S-G24 and S-G25 from the GAS.

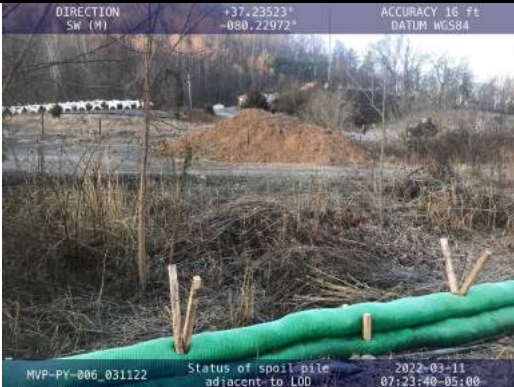
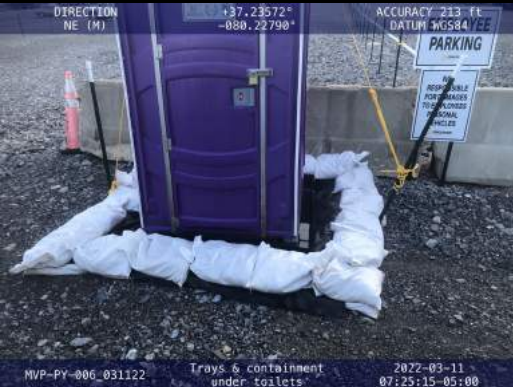
GPS Location	MVP-PY-006 See photo for gps data		GPS Location	MVP-PY-006 See photo for gps data	
Field Station#	+0		Field Station#	+0	
Pic 1 Desc.	Status of spoil pile adjacent to LOD. Soil pile not stabilized. Looking SW.		Pic 2 Desc.	Trays and containment under toilets. Trays holding stormwater. Looking NE.

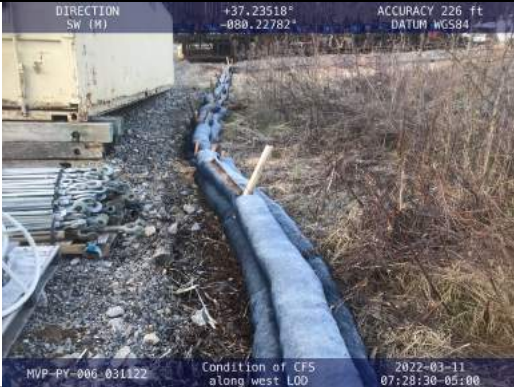
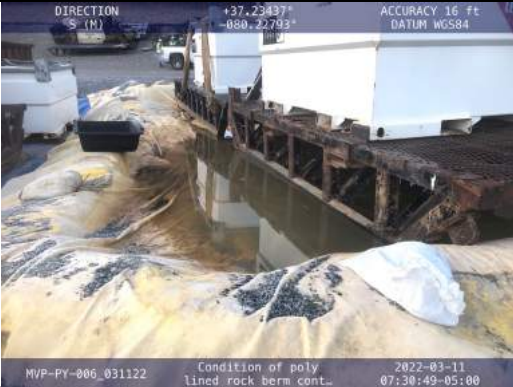
GPS Location	MVP-PY-006 See photo for gps data		GPS Location	MVP-PY-006 See photo for gps data	
Field Station#	+0		Field Station#	+0	
Pic 3 Desc.	Condition of triple stack compost filter sock along west LOD. Looking SW.		Pic 4 Desc.	Condition of poly lined rock berm containments. Holding stormwater. Looking S.

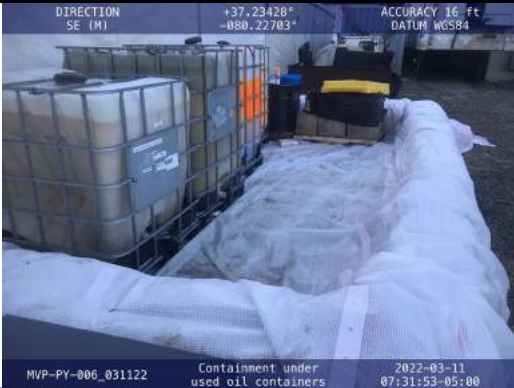
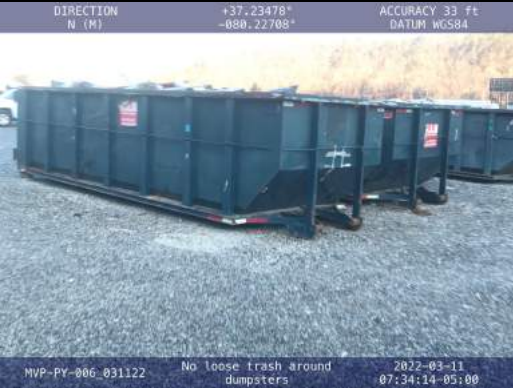
GPS Location	MVP-PY-006 See photo for gps data		GPS Location	MVP-PY-006 See photo for gps data	
Field Station#	+0		Field Station#	+0	
Pic 5 Desc.	Secondary containment under used oil containers. Holding some stormwater. Looking SE.		Pic 6 Desc.	No loose trash around dumpsters or in the yard. Looking N.
