# Visual Site Inspection Report

| <b>Project Name</b> | H-600 Pipeline Spread H | <b>AFE</b> | 124300138 | <b>Spread</b> | H-600 Pipeline Spread H |
| <b>Inspector</b> | Norm Kitchen | | | <b>Date/Time</b> | 4/11/2022 3:00 PM |

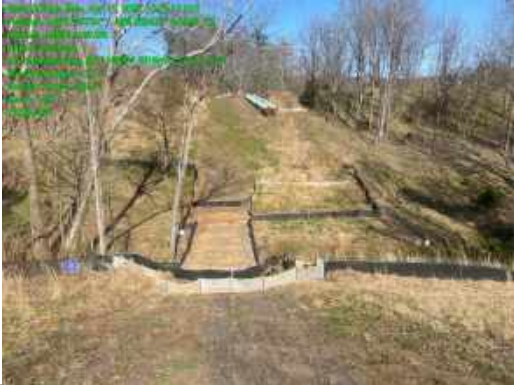
| <b>Pic 1 Desc.</b> | Private drive in good condition | <b>Pic 2 Desc.</b> | MVP-S-GH15 and Corresponding buffer zone in good condition | | |

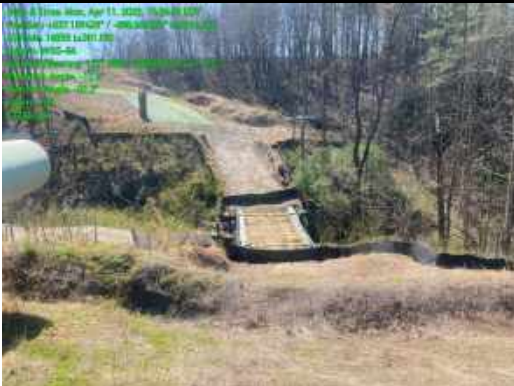
| <b>Pic 3 Desc.</b> | MVP-S-GH14 and corresponding buffer zone in good condition | <b>Pic 4 Desc.</b> | MVP-S-GH11 and Corresponding buffer zone in good condition | | |

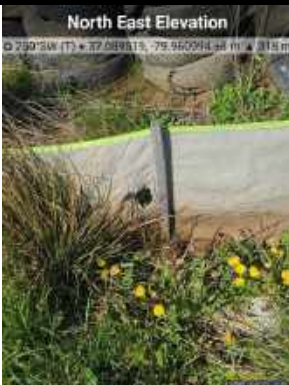
| <b>Pic 3 Desc.</b> | Vegetation observation photo showing stabilization. No environmental issues observed at the time of inspection. | | <b>Pic 4 Desc.</b> | Additional photo showing P1 that requires maintenance. | |

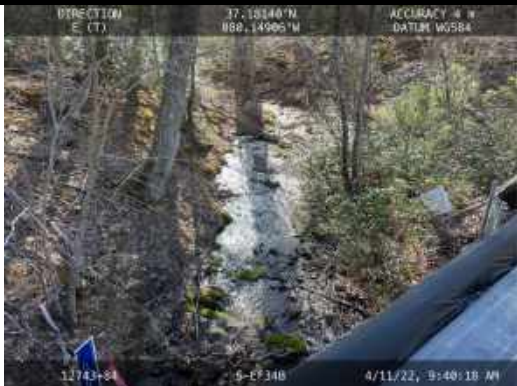
| <b>Pic 7 Desc.</b> | Current ROW Conditions. ROW is stable. ECDs are functional. | | <b>Pic 8 Desc.</b> | Equipment Bridge over Stream S-EF34B | |

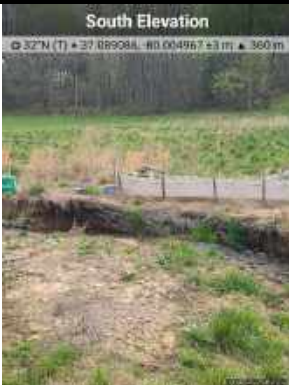
| <b>Pic 1 Desc.</b> | Stream observation facing downstream of S-IJ10. No environmental issues observed at the time of inspection. | | <b>Pic 2 Desc.</b> | S-IJ10 stream bank requires additional erosion control blanket, documented and added to the punch list. | |

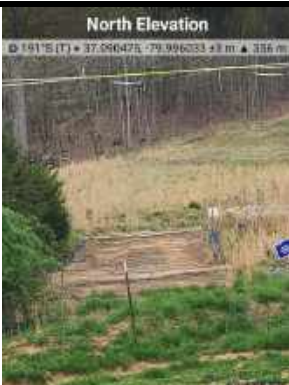
| <b>Pic 3 Desc.</b> | S-IJ10 stream bank requires additional erosion control blanket, documented and added to the punch list. | | <b>Pic 4 Desc.</b> | Monitored ECDs at stream crossing, no environmental issues were observed at the time of inspection. | |

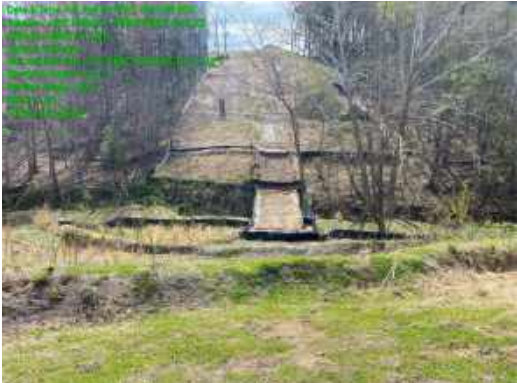
| <b>Pic 13 Desc.</b> | S-GH14, no notable changes observed of stakes and curlex on bank. | | <b>Pic 14 Desc.</b> | S-GH14, sediment accumulation noted upstream side of equipment bridge. | |

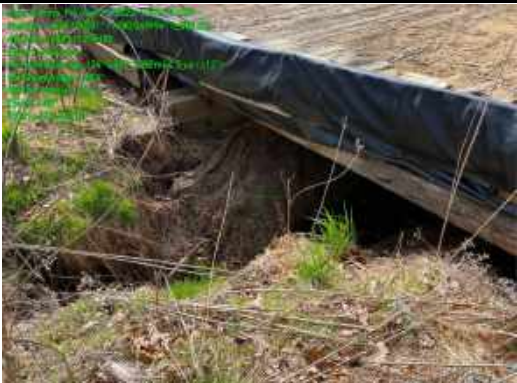
| <b>Pic 15 Desc.</b> | ROW stabilized, ECDs in acceptable condition. | | <b>Pic 16 Desc.</b> | S-GH15, downstream, no ROW impacts observed; evidence of cattle in stream. | |
