Visual Site Inspection Report

Project Name	H-600 Pipeline Spread H	AFE	124300138	Spread	H-600 Pipeline Spread H
Contractor	Precision			Report #	36973
Inspector	Norm Kitchen			Date/Time	4/25/2022 3:00 PM
Permit #	TBD	Inspection Type	VA SWPP	Station Begin	12005+00
State	VA	Inspection Area	Partial	Station End	12119+17
County	Montgomery	Ground	Dry	Temperature (°F)	75.00
Municipality	N/A	Weather	Sunny	Rain Gauge (in)	0.00
				Rain Accumulation Time (days)	1.00

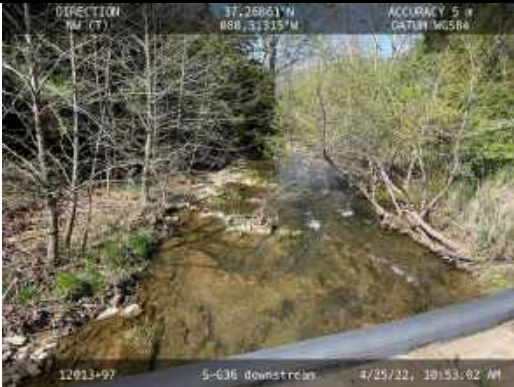
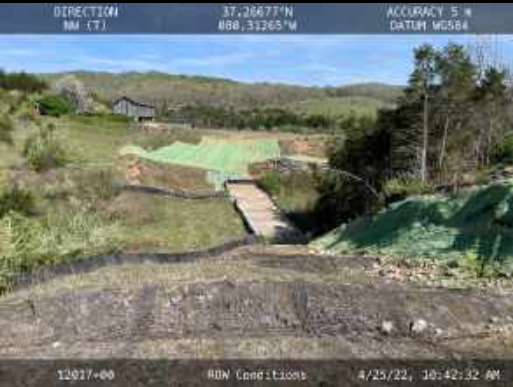
GPS Location	See Above		GPS Location	See Above	
Field Station#	12013+97		Field Station#	12017+00	
Pic 1 Desc.	Overview (downstream) of Waterbody S-G36 (Acc Rd 268). ECDs are functional and ROW is stable.		Pic 2 Desc.	ROW Overview. ECDs are functional and ROW is stable.

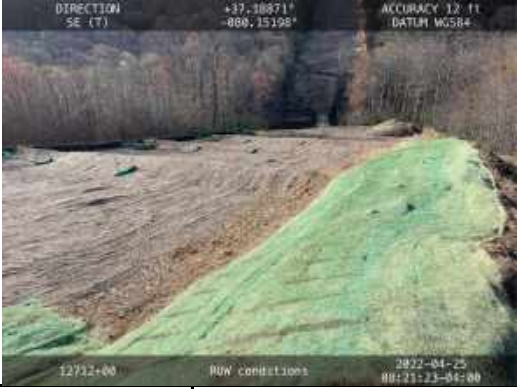
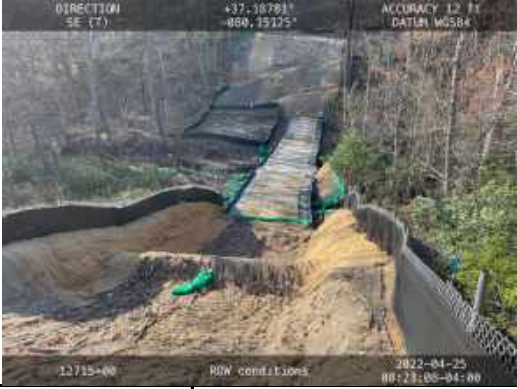
GPS Location	See photo for gps location data.		GPS Location	See photo for gps location data.	
Field Station#	12712+00		Field Station#	12715+00	
Pic 7 Desc.	Photo shows the ROW condition. ECDs are installed and functioning as designed.		Pic 8 Desc.	Photo shows the bridge over streams S-Y13 and S-Y14.

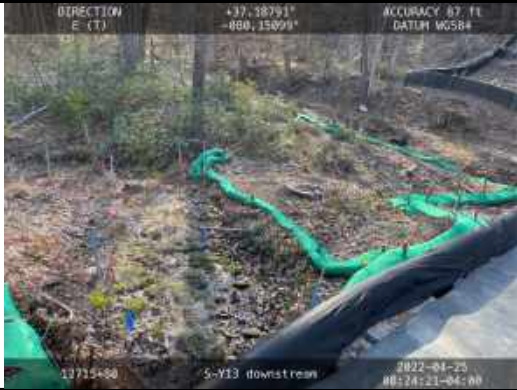
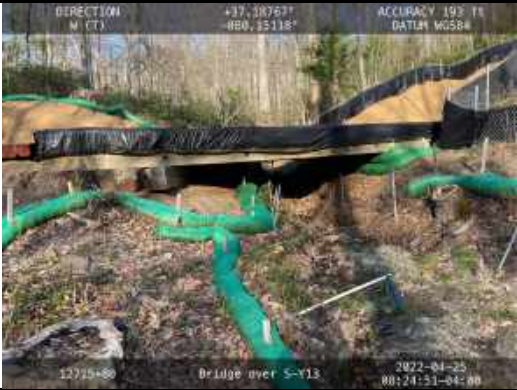
GPS Location	See photo for gps location data.		GPS Location	See photo for gps location data.	
Field Station#	12715+80		Field Station#	12715+80	
Pic 9 Desc.	Photo shows stream S-Y13 downstream from the bridge.		Pic 10 Desc.	Photo shows the bridge over stream S-Y13.

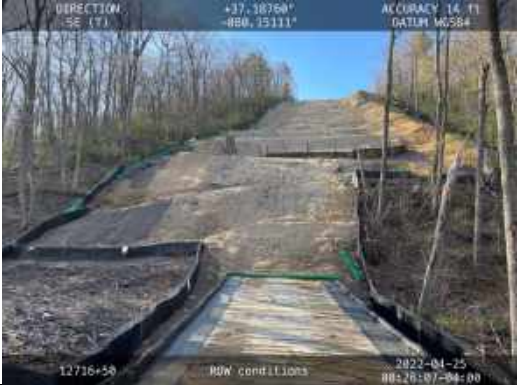
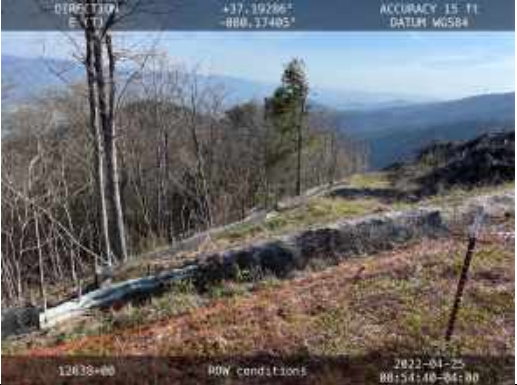
GPS Location	See photo for gps location data.		GPS Location	See photo for gps location data.	
Field Station#	12716+50		Field Station#	12638+00	
Pic 13 Desc.	Photo shows the ROW condition. ECDs are installed and functioning as designed.		Pic 14 Desc.	Photo shows the ROW condition. ECDs are installed and functioning as designed.

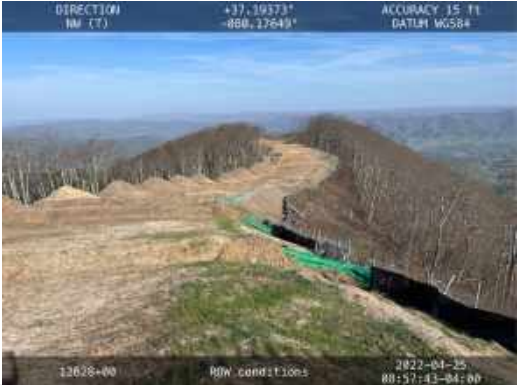
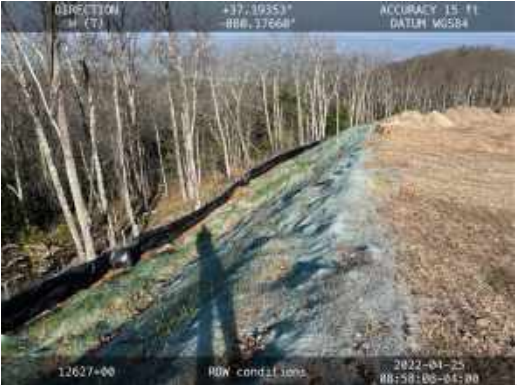
GPS Location	See photo for gps location data.		GPS Location	See photo for gps location data.	
Field Station#	12628+00		Field Station#	12627+00	
Pic 15 Desc.	Photo shows the ROW condition. ECDs are installed and functioning as designed.		Pic 16 Desc.	Photo shows the ROW condition. ECDs are installed and functioning as designed.

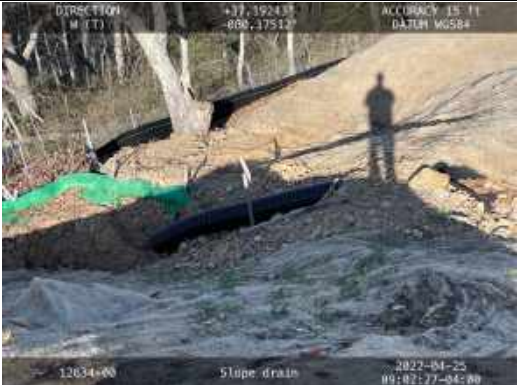
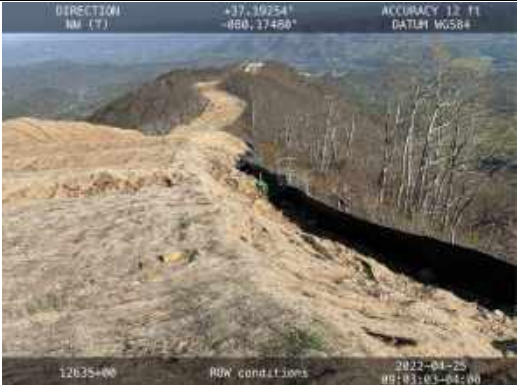
GPS Location	See photo for gps location data.		GPS Location	See photo for gps location data.	
Field Station#	12634+00		Field Station#	12735+00	
Pic 17 Desc.	Photo shows the slope drain.		Pic 18 Desc.	Photo shows the ROW condition. ECDs are installed and functioning as designed.

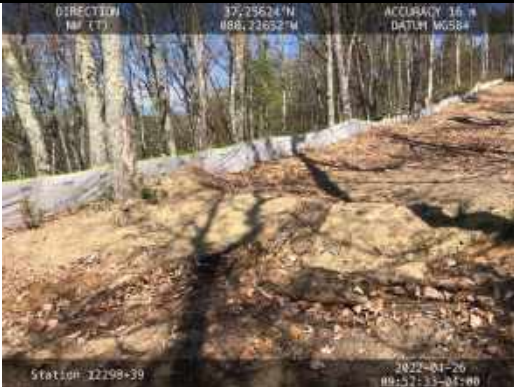
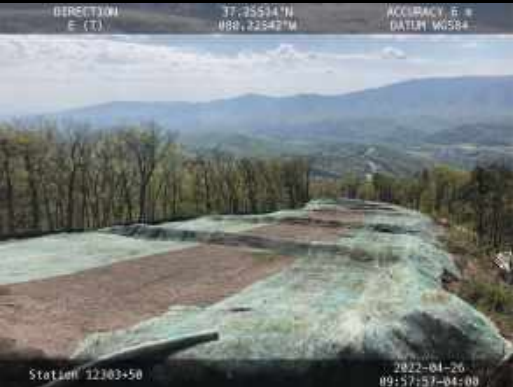
GPS Location	Please see photo for details.		GPS Location	Please see photo for details.	
Field Station#	12299+24		Field Station#	12303+50	
Pic 1 Desc.	Today's punch list item on MVP-MN-276.03. Replace torn Erosion Control Blanket on water bar. (Item resolved 4/26/2022).		Pic 2 Desc.	Photo shows the stabilized ROW conditions with water bars and that all ECDs are installed and are functioning as designed.

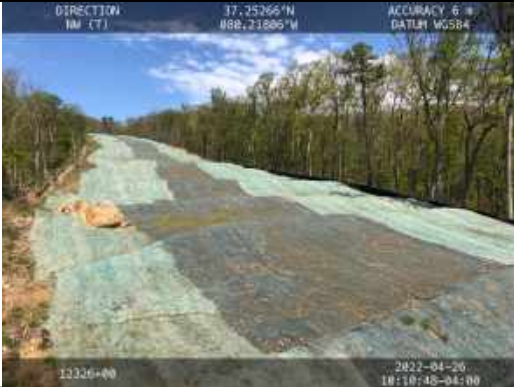
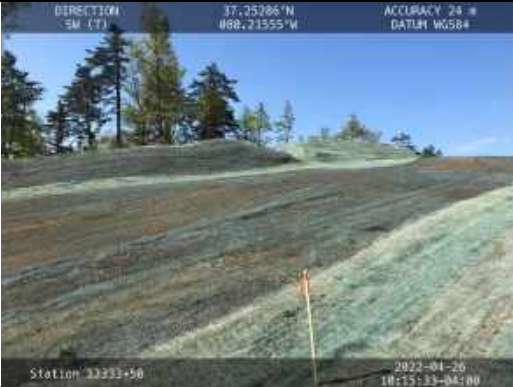
GPS Location	Please see photo for details.		GPS Location	Please see photo for details.	
Field Station#	12326+00		Field Station#	12333+50	
Pic 3 Desc.	Photo shows the stabilized ROW conditions with water bars and that all ECDs are installed and are functioning as designed.		Pic 4 Desc.	Photo shows stabilized ROW along with stabilized stock piles.

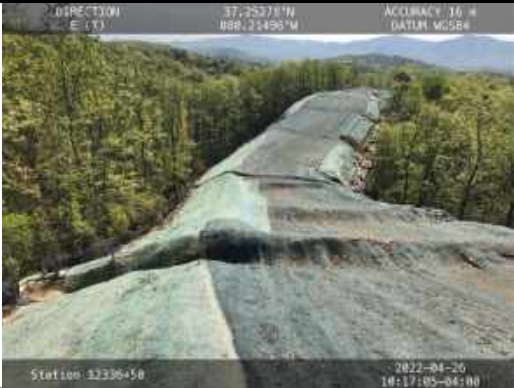
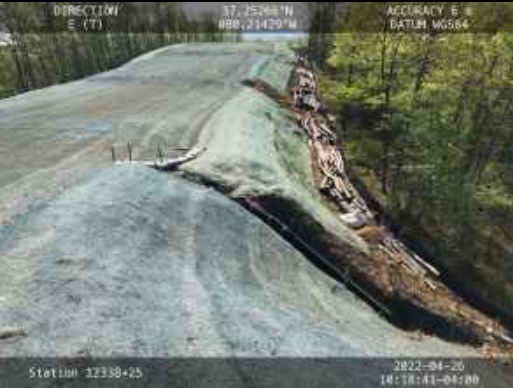
Field Station#	12336+50		Field Station#	12338+25	
Pic 5 Desc.	Photo shows the stabilized ROW conditions with water bars and that all ECDs are installed and are functioning as designed.		Pic 6 Desc.	Photo shows slope drain pipe and stabilized side slope.

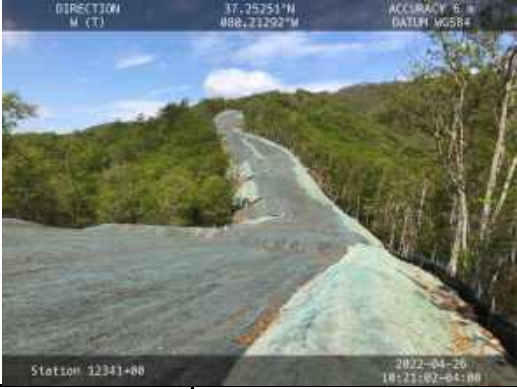
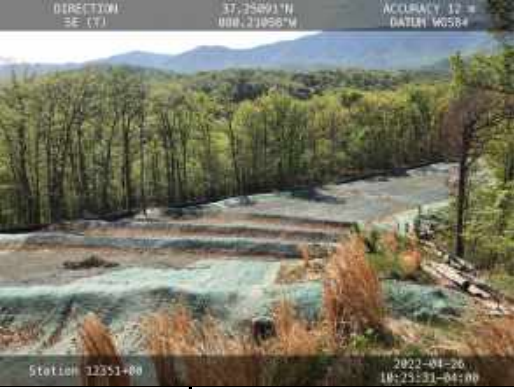
GPS Location	Please see photo for details.		GPS Location	Please see photo for details.	
Field Station#	12341+00		Field Station#	12351+00	
Pic 7 Desc.	Photo shows the stabilized ROW conditions with water bars and that all ECDs are installed and are functioning as designed.		Pic 8 Desc.	Photo shows the stabilized ROW conditions with water bars and that all ECDs are installed and are functioning as designed.

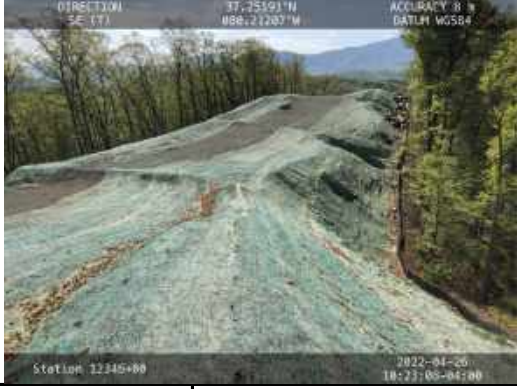
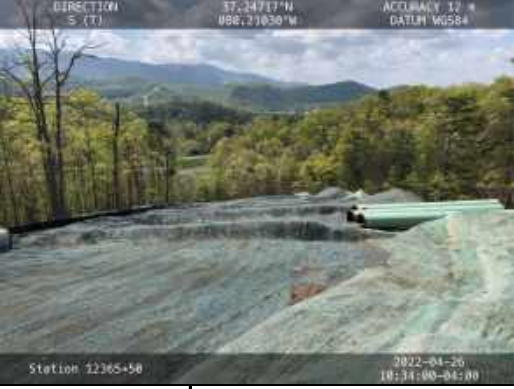
GPS Location	Please see photo for details.		GPS Location	Please see photo for details.	
Field Station#	12346+00		Field Station#	12365+50	
Pic 9 Desc.	Photo shows the stabilized ROW conditions with water bars and that all ECDs are installed and are functioning as designed.		Pic 10 Desc.	Photo shows the stabilized ROW conditions with water bars and that all ECDs are installed and are functioning as designed.

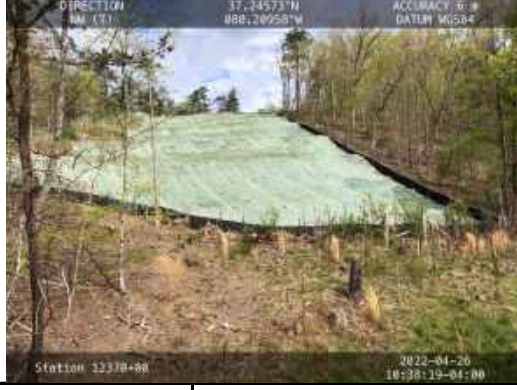
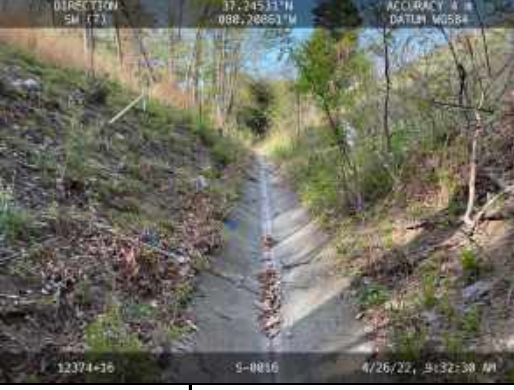
GPS Location	Please see photo for details.		GPS Location	Please see photo for details.	
Field Station#	12370+00		Field Station#	12374+16	
Pic 11 Desc.	Photo shows the stabilized ROW conditions with water bars and that all ECDs are installed and are functioning as designed.		Pic 12 Desc.	Photo shows downstream view of Stream S-0016.

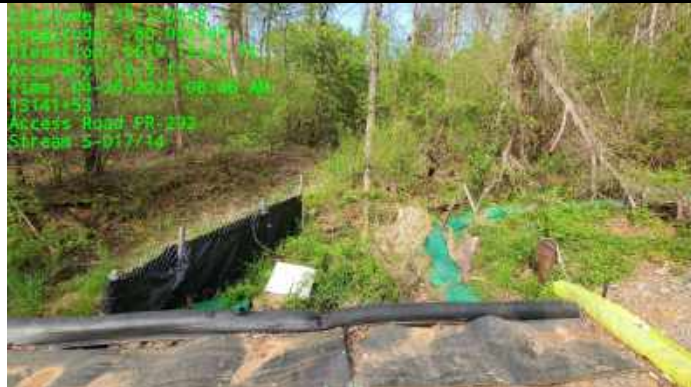
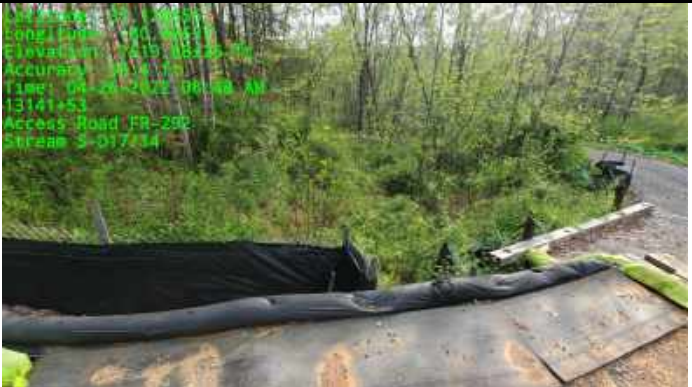
GPS Location	See pic for GPS location.		GPS Location	See pic for GPS location.	
Field Station#	13141+53		Field Station#	13141+53	
Pic 1 Desc.	Upstream side of stream S-D17/14 where it crosses access road FR-292.		Pic 2 Desc.	Downstream side of stream S-D17/14 where it crosses access road FR-292.

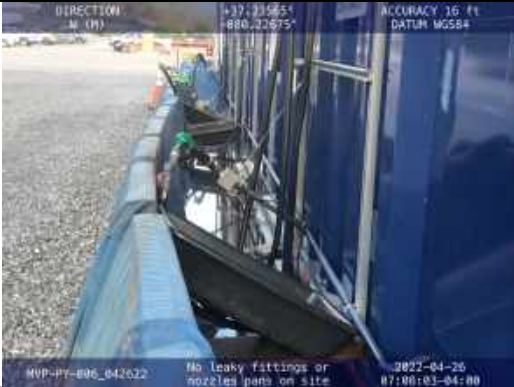
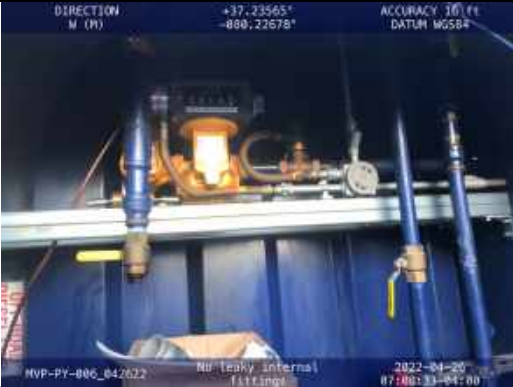
GPS Location	MVP-PY-006 See photo for gps data	GPS Location	MVP-PY-006 See photo for gps data		
Field Station#	+0	Field Station#	+0		
Pic 3 Desc.	Blue Bulk Fuel tanks no leaky fittings or nozzles. Catch pans on site. Looking W.	Pic 4 Desc.	Blue Bulk Fuel tanks no leaky internal fittings. Looking W.

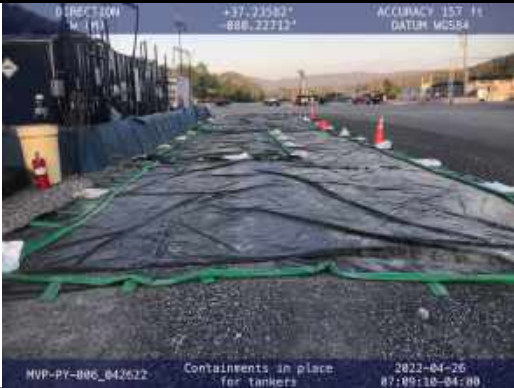
GPS Location	MVP-PY-006 See photo for gps data	GPS Location	MVP-PY-006 See photo for gps data		
Field Station#	+0	Field Station#	+0		
Pic 5 Desc.	Secondary containments in place for tankers offloading fuel. Containment showing wear. Looking W.	Pic 6 Desc.	Off Road Fuel unit holding stormwater. Looking N.

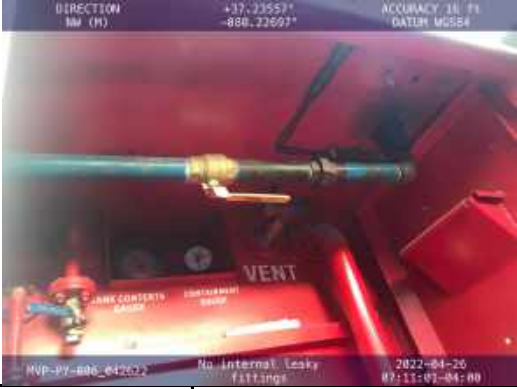
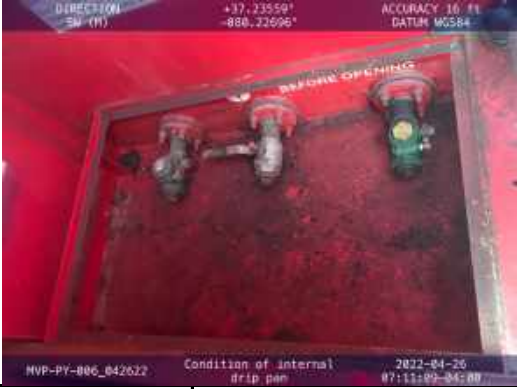
GPS Location	MVP-PY-006 See photo for gps data	GPS Location	MVP-PY-006 See photo for gps data		
Field Station#	+0	Field Station#	+0		
Pic 7 Desc.	Off Road Fuel unit no leaky internal fittings. Looking NW.	Pic 8 Desc.	Off Road Fuel unit condition of internal drip pan. Free of fluids. Looking SW.

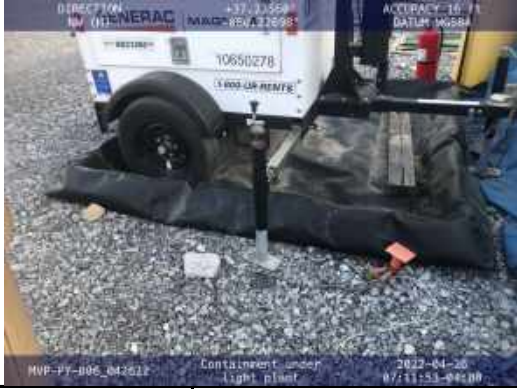
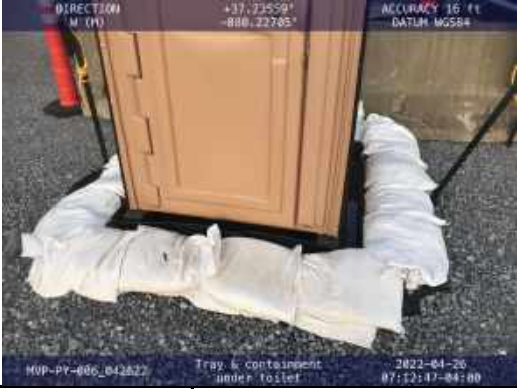
GPS Location	MVP-PY-006 See photo for gps data	GPS Location	MVP-PY-006 See photo for gps data		
Field Station#	+0	Field Station#	+0		
Pic 9 Desc.	Secondary containment under light plant free of fluids. Looking NW.	Pic 10 Desc.	Tray and containment under toilet. Tray holding fluids. Looking W.

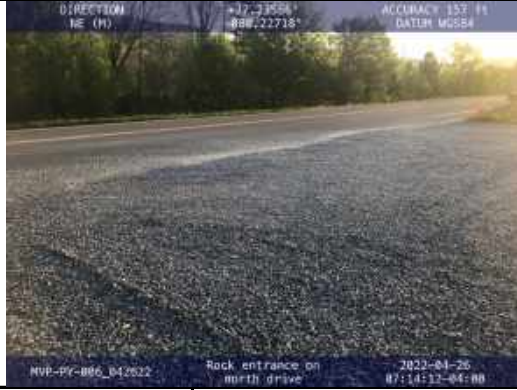
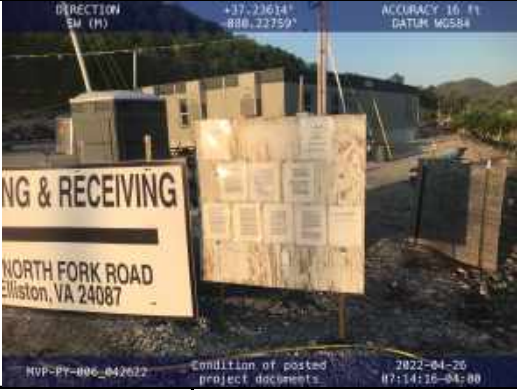
GPS Location	MVP-PY-006 See photo for gps data	GPS Location	MVP-PY-006 See photo for gps data		
Field Station#	+0	Field Station#	+0		
Pic 11 Desc.	Condition of rock entrance on north drive. No stone on public roadway. Looking NE.	Pic 12 Desc.	Condition of posted project documents at north main entrance. Looking SW.

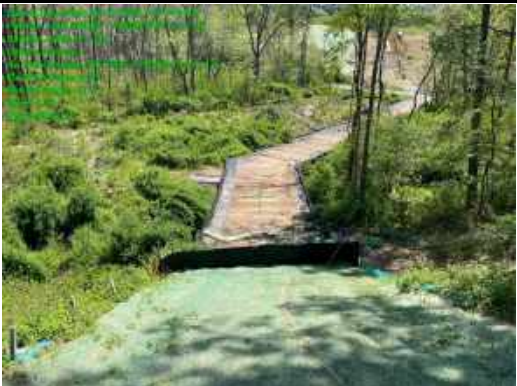
GPS Location	0	GPS Location	0		
Field Station#	13403+00	Field Station#	13413+05		
Pic 15 Desc.	ROW and ECDs In good condition and stable	Pic 16 Desc.	MVP-S-IJ1 and corresponding buffer zone in good condition

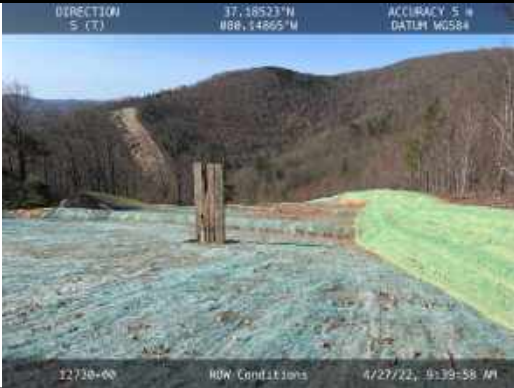
GPS Location	See photo		GPS Location	See photo	
Field Station#	12730+00		Field Station#	12728+74	
Pic 5 Desc.	Current ROW conditions. ROW is stable. ECDs are functional.		Pic 6 Desc.	ATWS-1226 is stable and ECDs are functional.

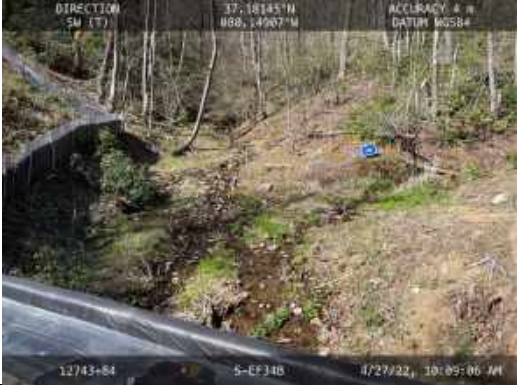
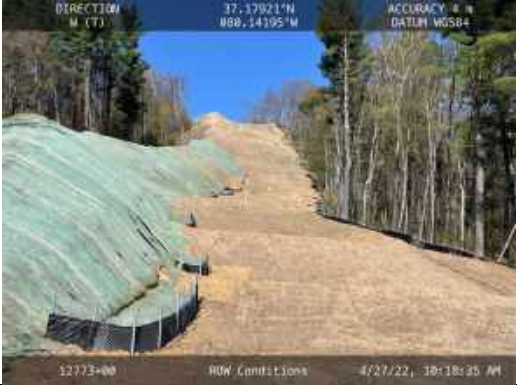
GPS Location	See photo		GPS Location	See photo	
Field Station#	12743+84		Field Station#	12773+00	
Pic 13 Desc.	Upstream of crossing at Stream S-EF34B		Pic 14 Desc.	Current ROW conditions. ROW is stable. ECDs are functional.

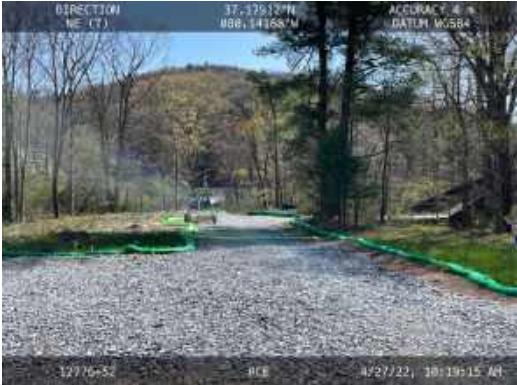
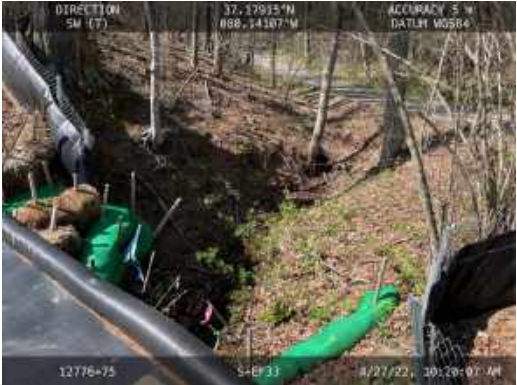
GPS Location	See photo		GPS Location	See photo	
Field Station#	12776+52		Field Station#	12776+75	
Pic 15 Desc.	RCE is functional on RO-282		Pic 16 Desc.	Upstream of crossing at Stream S-EF33

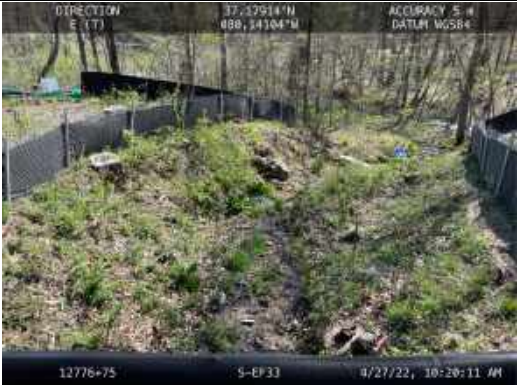
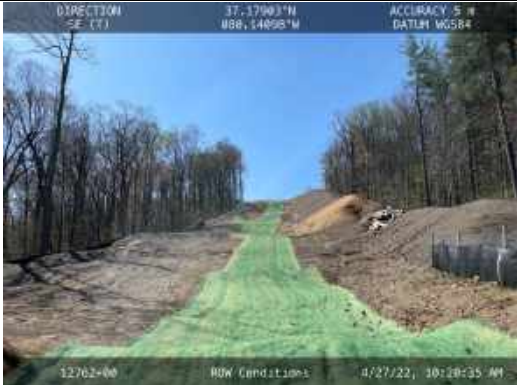
GPS Location	See photo		GPS Location	See photo	
Field Station#	12776+75		Field Station#	12762+00	
Pic 17 Desc.	Downstream of crossing at Stream S-EF33		Pic 18 Desc.	Current ROW conditions. ROW is stable. ECDs are functional.

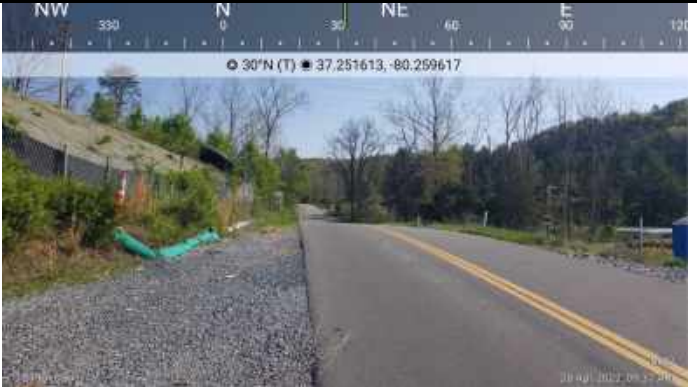
GPS Location	Please see photo for details.		GPS Location	Please see photo for details.	
Field Station#	12192+36		Field Station#	12190+85	
Pic 11 Desc.	Photo shows downstream view of Stream S-C21 from equipment bridge spanning the stream channel.		Pic 12 Desc.	Photo shows ST RTE 626 BRADSHAW ROAD.

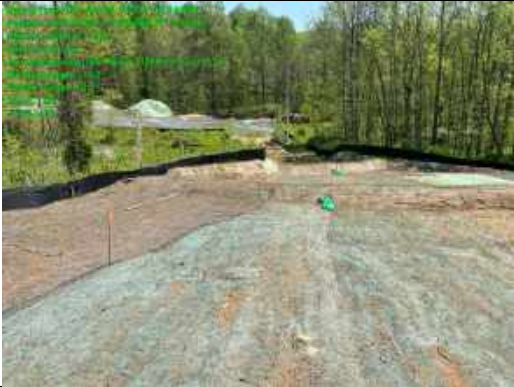
GPS Location	See photo for coordinates.		GPS Location	See photo for coordinates.	
Field Station#	13143+50		Field Station#	13146+50	
Pic 1 Desc.	ROW stabilized.		Pic 2 Desc.	S-D12 and S-D13 upstream of equipment bridge.

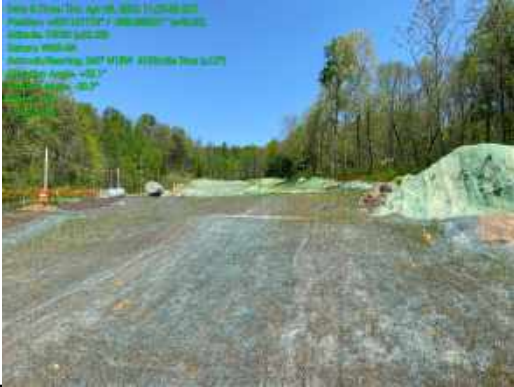
GPS Location	See photo for coordinates.		GPS Location	See photo for coordinates.	
Field Station#	13147+25		Field Station#	13157+13	
Pic 3 Desc.	ROW stabilized.		Pic 4 Desc.	S-D11, downstream, no ROW impacts observed.

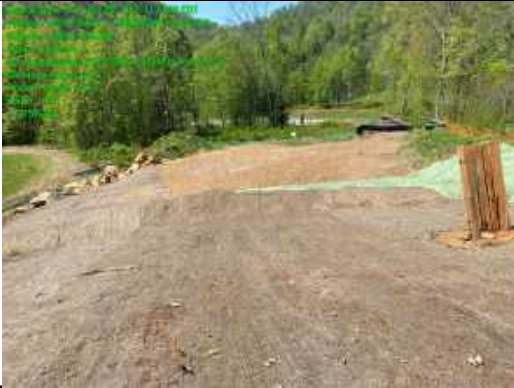
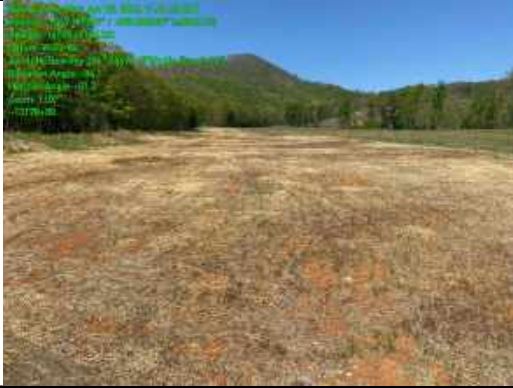
GPS Location	See photo for coordinates.		GPS Location	See photo for coordinates.	
Field Station#	13159+00		Field Station#	13178+00	
Pic 5 Desc.	ROW stabilized.		Pic 6 Desc.	ROW stabilized.

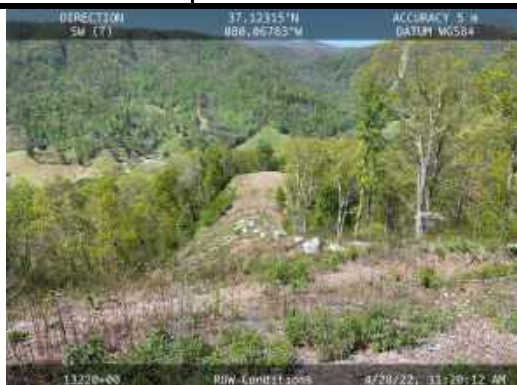
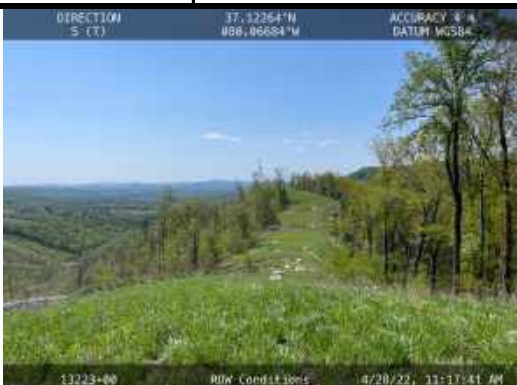
GPS Location	See photo for coordinates.		GPS Location	See photo for coordinates.	
Field Station#	13220+00		Field Station#	13223+00	
Pic 11 Desc.	ROW stable, vegetation establishing in restored areas.		Pic 12 Desc.	Good vegetative cover noted.

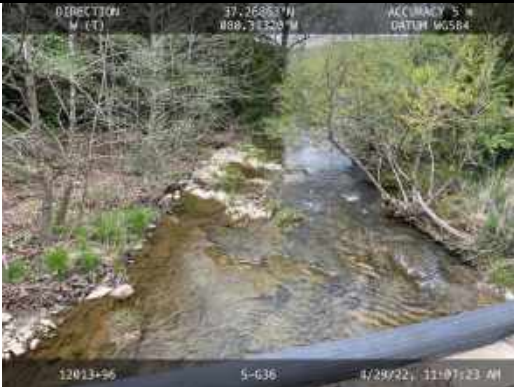
GPS Location	Please see photo for details.		GPS Location	Please see photo for details.	
Field Station#	12013+96		Field Station#	12031+00	
Pic 1 Desc.	Photo shows downstream view of Stream S-G36 from equipment bridge spanning the stream channel.		Pic 2 Desc.	Photo shows the stabilized ROW conditions with water bars and that all ECDs are installed and are functioning as designed.

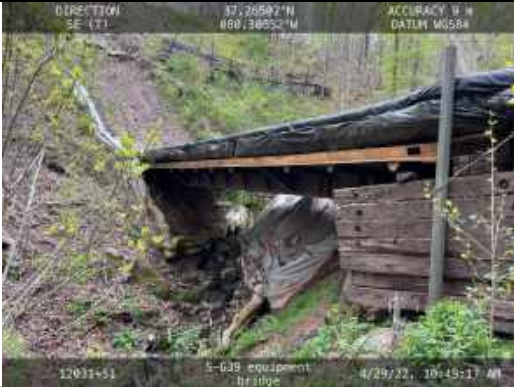
GPS Location	Please see photo for details.		GPS Location	Please see photo for details.	
Field Station#	12031+51		Field Station#	12035+75	
Pic 3 Desc.	Photo shows downstream view of Stream S-G39.		Pic 4 Desc.	Photo shows downstream view of Stream S-PP23 from equipment bridge spanning the stream channel.

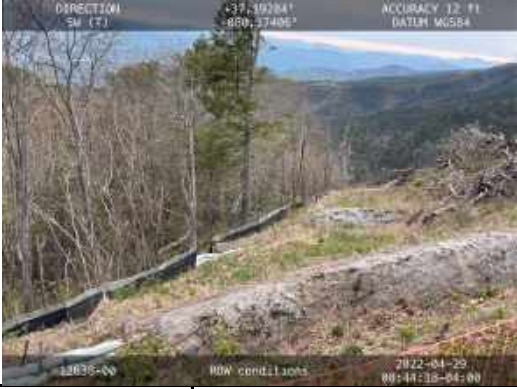
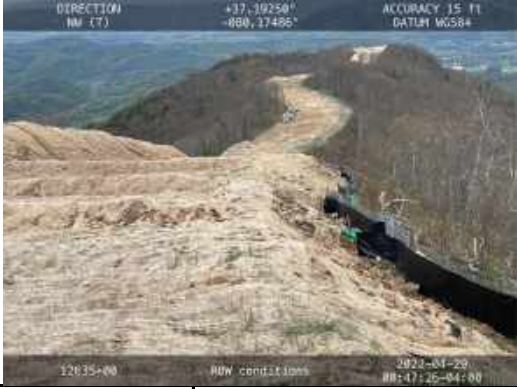
GPS Location	See photo for gps location data.		GPS Location	See photo for gps location data.	
Field Station#	12638+00		Field Station#	12635+00	
Pic 7 Desc.	Photo shows the ROW condition. ECDs are installed and functioning as designed.		Pic 8 Desc.	Photo shows the ROW condition. ECDs are installed and functioning as designed.

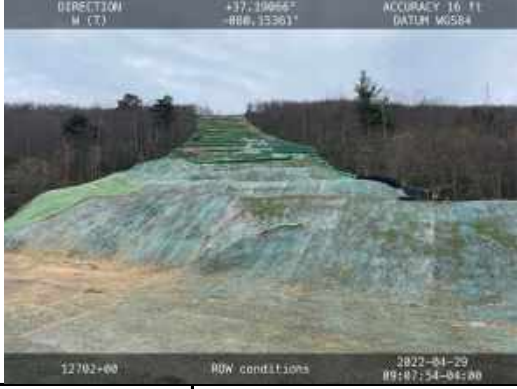
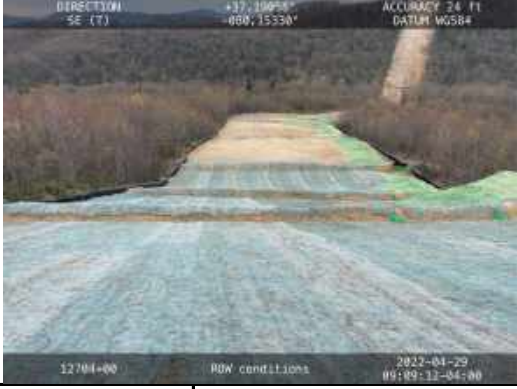
GPS Location	See photo for gps location data.		GPS Location	See photo for gps location data.	
Field Station#	12702+00		Field Station#	12704+00	
Pic 9 Desc.	Photo shows the ROW condition. ECDs are installed and functioning as designed.		Pic 10 Desc.	Photo shows the ROW condition. ECDs are installed and functioning as designed.

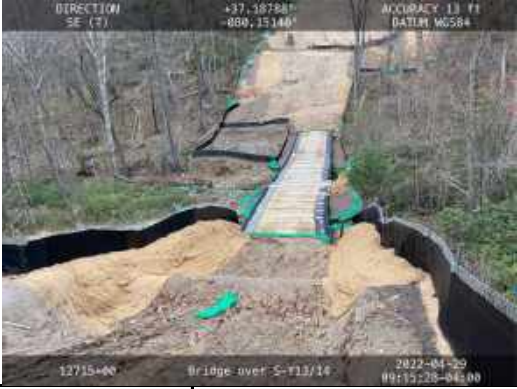
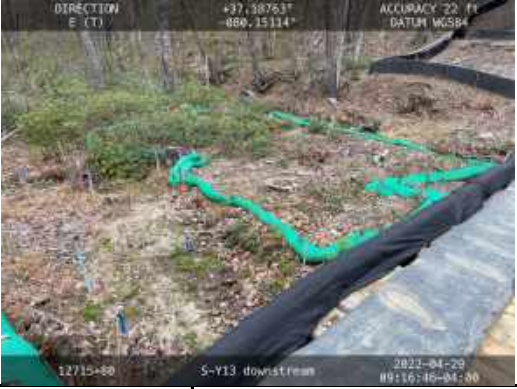
GPS Location	See photo for gps location data.		GPS Location	See photo for gps location data.	
Field Station#	12715+00		Field Station#	12715+80	
Pic 13 Desc.	Photo shows the bridge over stream S-Y13 and S-Y14.		Pic 14 Desc.	Photo shows S-Y13 downstream from the bridge.

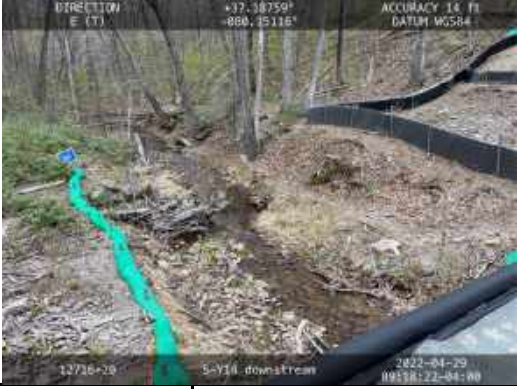
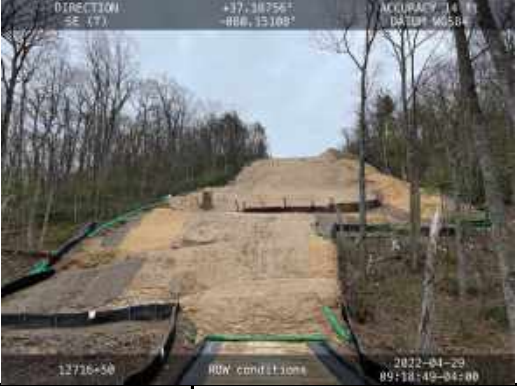
GPS Location	See photo for gps location data.		GPS Location	See photo for gps location data.	
Field Station#	12716+20		Field Station#	12716+50	
Pic 15 Desc.	Photo shows S-Y14 downstream from the bridge.		Pic 16 Desc.	Photo shows the ROW condition. ECDs are installed and functioning as designed.

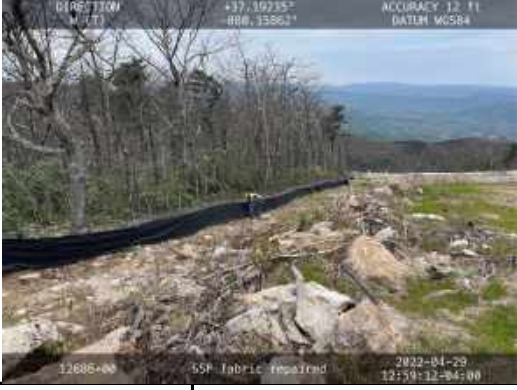
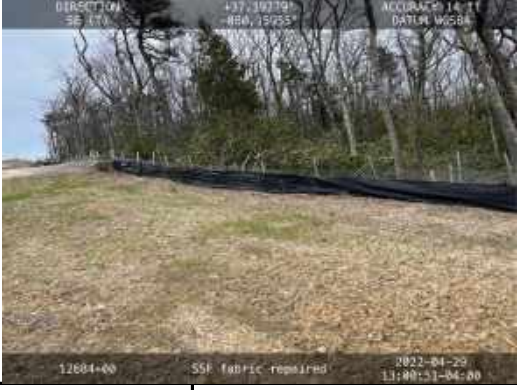
GPS Location	See photo for gps location data.		GPS Location	See photo for gps location data.	
Field Station#	12686+00		Field Station#	12684+00	
Pic 17 Desc.	Photo shows the repaired SSF fabric.		Pic 18 Desc.	Photo shows the repaired SSF fabric.
