# Visual Site Inspection Report

| <b>Project Name</b> | H-600 Pipeline Spread H | <b>AFE</b> | 124300138 | <b>Spread</b> | H-600 Pipeline Spread H |
| <b>Contractor</b> | Precision | | | <b>Report #</b> | 36201 |
| <b>Inspector</b> | Joe Scott | | | <b>Date/Time</b> | 4/4/2022 5:41 PM |

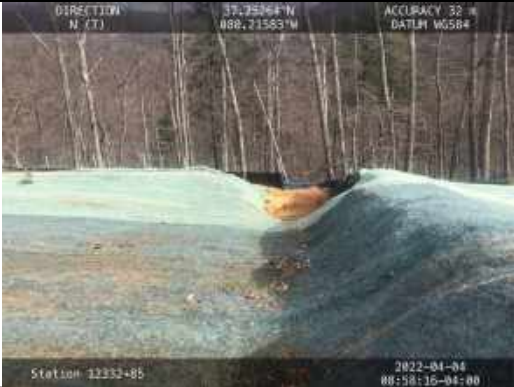
| <b>Pic 1 Desc.</b> | Photo shows the stabilized ROW conditions with water bars and that all ECDs are installed and are functioning as designed. | | <b>Pic 2 Desc.</b> | Photo shows the stabilized ROW conditions with water bars and that all ECDs are installed and are functioning as designed. | |

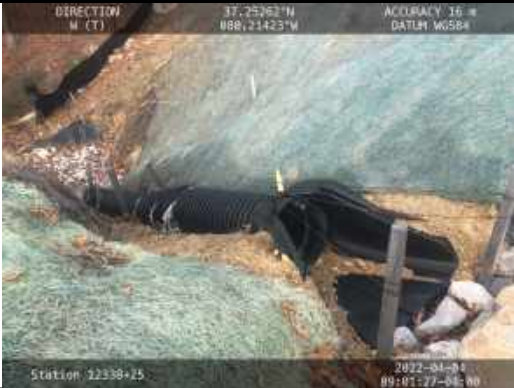
| <b>Pic 3 Desc.</b> | Photo shows stabilized ROW with water bar, sump and end treatment functioning as designed. | | <b>Pic 4 Desc.</b> | Photo shows the stabilized ROW conditions with water bars and that all ECDs are installed and are functioning as designed. | |

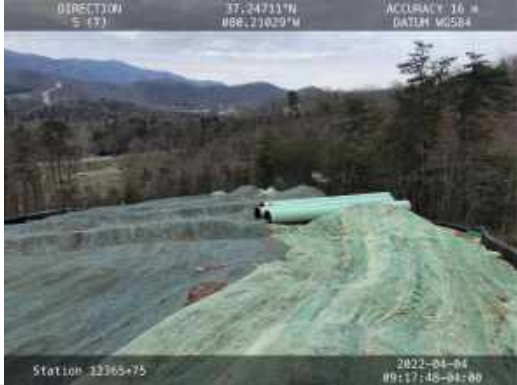
| <b>Pic 7 Desc.</b> | Photo shows the stabilized ROW conditions with water bars and that all ECDs are installed and are functioning as designed. | | <b>Pic 8 Desc.</b> | Photo shows the stabilized ROW conditions with water bars and that all ECDs are installed and are functioning as designed. | |

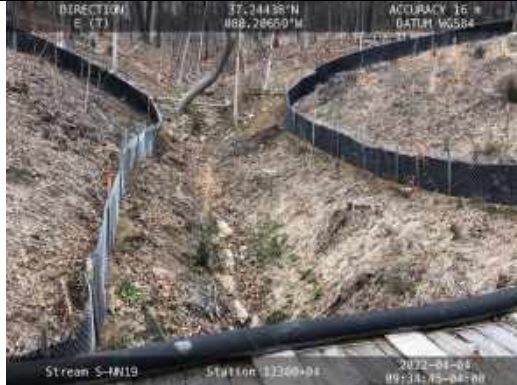
| <b>Pic 9 Desc.</b> | Photo shows the stabilized ROW conditions with water bars and that all ECDs are installed and are functioning as designed. | | <b>Pic 10 Desc.</b> | Photo shows upstream view of Stream S-0016. | |

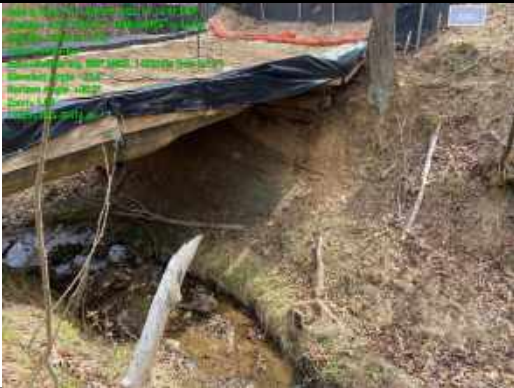
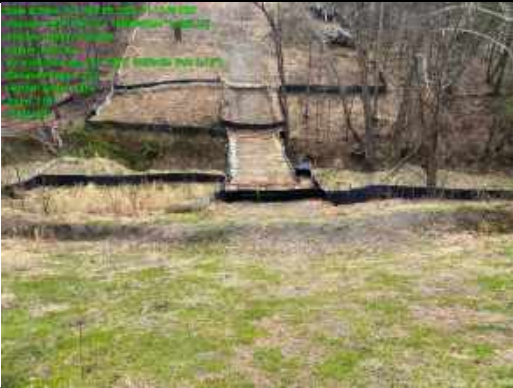
| <b>Pic 3 Desc.</b> | S-GH15, ROW stabilized. | | <b>Pic 4 Desc.</b> | S-GH15, downstream, no ROW impacts observed in stream crossing. | |

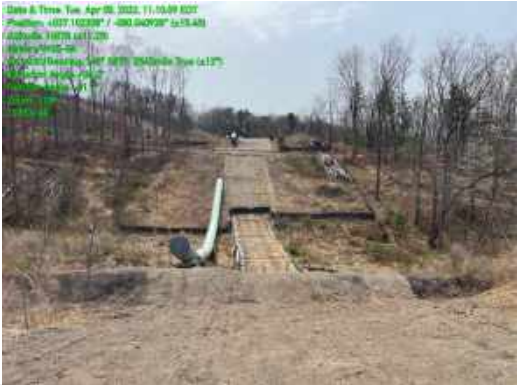
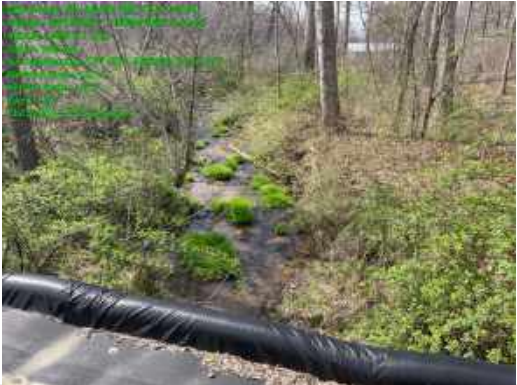
| <b>Pic 13 Desc.</b> | S-RR08, downstream, no ROW impacts observed. | | <b>Pic 14 Desc.</b> | S-RR09, downstream, no ROW impacts observed. | |

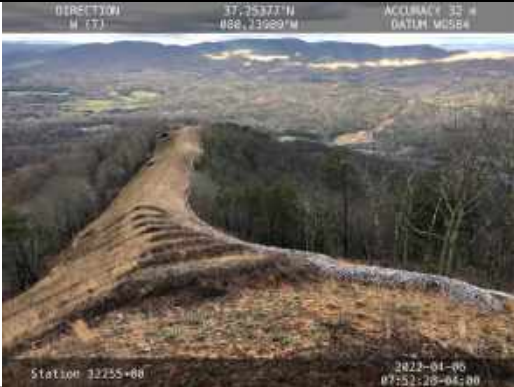
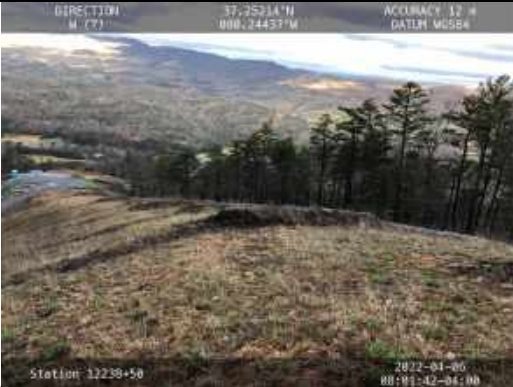
| <b>Pic 1 Desc.</b> | Photo shows the stabilized ROW conditions with water bars and that all ECDs are installed and are functioning as designed. | | <b>Pic 2 Desc.</b> | Photo shows punch list item today of stock pile needing erosion control blanket for stabilization. (Item resolved). | |

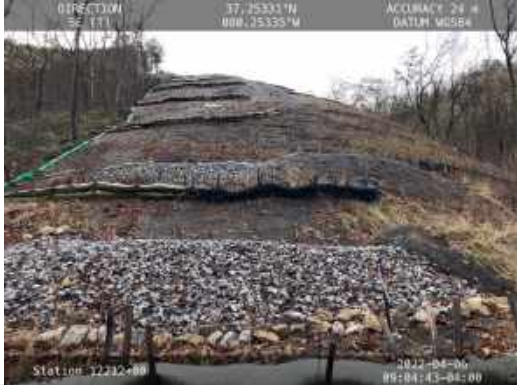
| <b>Pic 7 Desc.</b> | Photo shows punch list item for today of replacing damaged erosion control blanket. | | <b>Pic 8 Desc.</b> | Photo shows the stabilized ROW conditions with water bars and that all ECDs are installed and are functioning as designed. | |

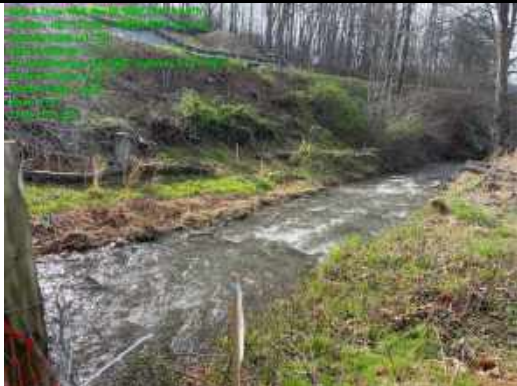
| <b>Pic 7 Desc.</b> | Continuing to monitor logging activity adjacent to row | <b>Pic 8 Desc.</b> | ROW and ECDs In good condition and stable | | |

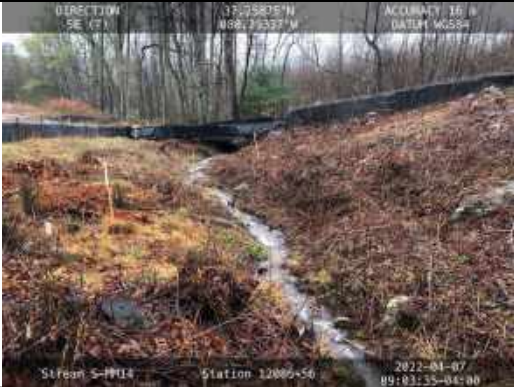
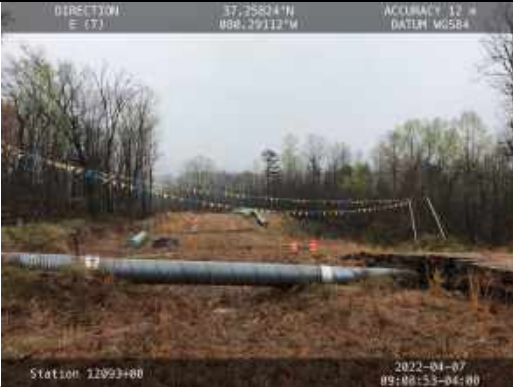
| <b>Pic 1 Desc.</b> | Photo shows the stabilized ROW conditions with water bars and that all ECDs are installed and are functioning as designed. | | <b>Pic 2 Desc.</b> | Photo shows punch list item today of water bar needing erosion control blanket added for stabilization. | |
