## Visual Site Inspection Report

| <b>Project Name</b> | H-600 Pipeline Spread H | <b>AFE</b> | 124300138 | <b>Spread</b> | H-600 Pipeline Spread H |

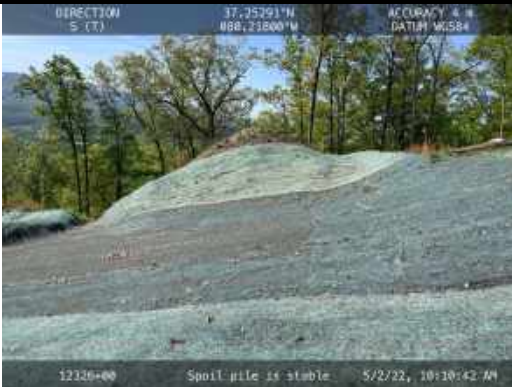
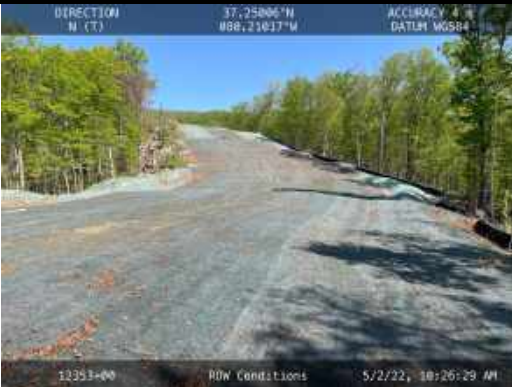
| <b>Pic 1 Desc.</b> | Photo shows the stabilized ROW conditions with water bars and that all ECDs are installed and are functioning as designed. | | <b>Pic 2 Desc.</b> | Photo shows the stabilized ROW conditions with water bars and that all ECDs are installed and are functioning as designed. | |

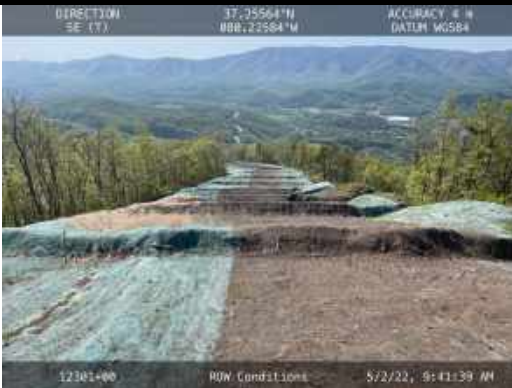
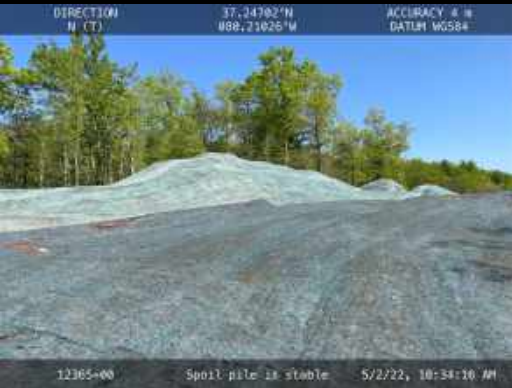
| <b>Pic 3 Desc.</b> | Photo shows the stabilized ROW conditions with water bars and that all ECDs are installed and are functioning as designed. | | <b>Pic 4 Desc.</b> | Photo shows the stabilized ROW conditions with water bars and that all ECDs are installed and are functioning as designed. | |

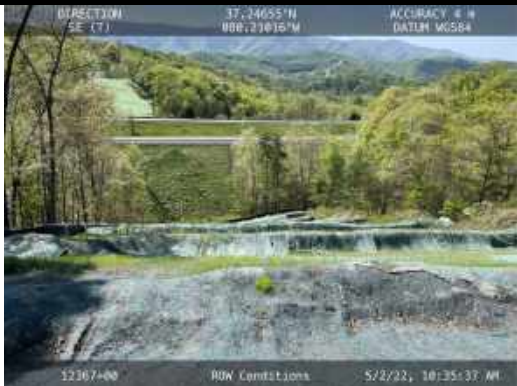
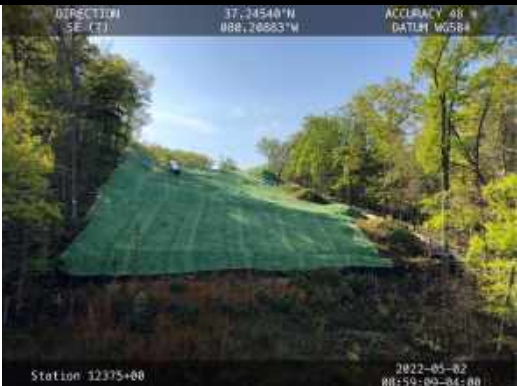
| <b>Pic 7 Desc.</b> | Photo shows the stabilized ROW conditions with water bars and that all ECDs are installed and are functioning as designed. | | <b>Pic 8 Desc.</b> | Photo shows the stabilized side slope and all ECDs are installed and functioning as designed. | |

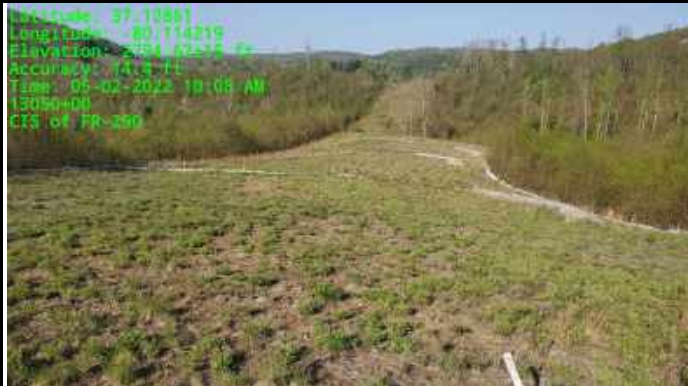
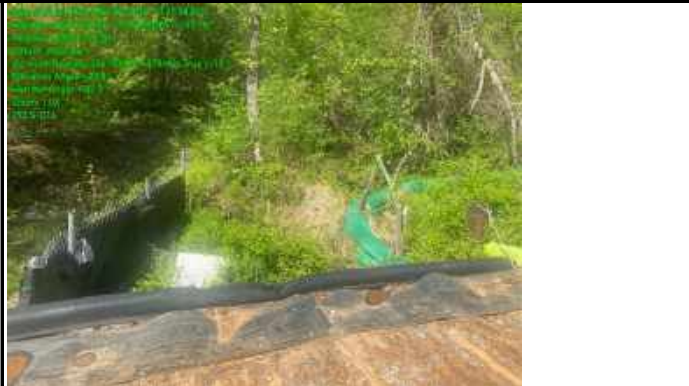
| <b>Pic 7 Desc.</b> | Current ROW conditions. | | <b>Pic 8 Desc.</b> | Current ROW conditions. | |

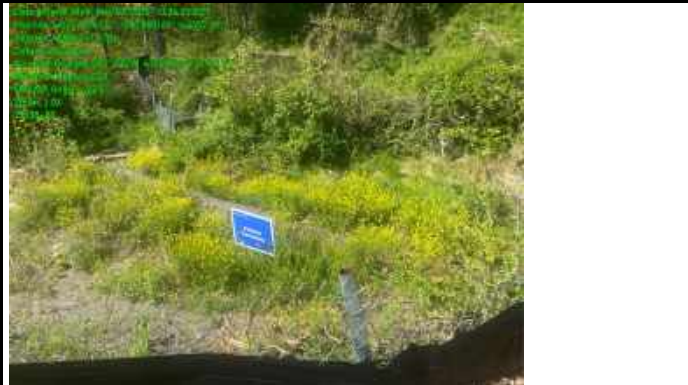
| <b>Pic 9 Desc.</b> | Current ROW conditions. | | <b>Pic 10 Desc.</b> | Upstream side of stream S-D17/14 at access road FR-292. | |

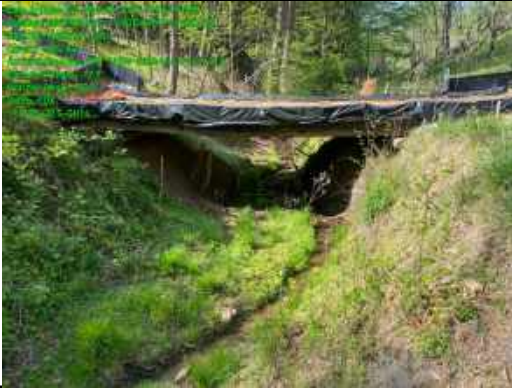
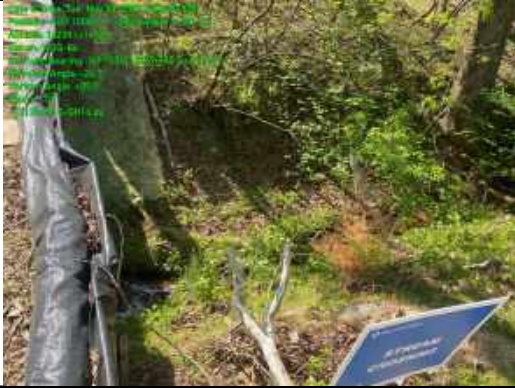
| <b>Pic 3 Desc.</b> | S-GH15, ROW stabilized. | | <b>Pic 4 Desc.</b> | S-GH15, upstream, no changes noted to stream banks. | |

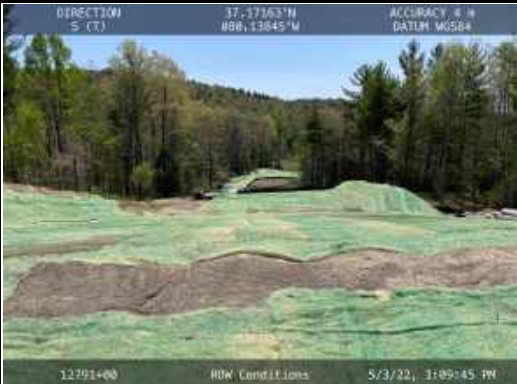
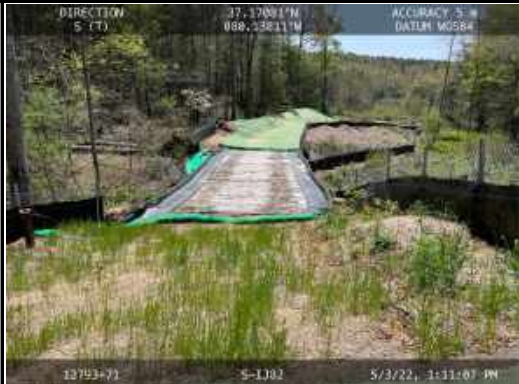
| Pic 13 Desc. | Current ROW conditions. ROW is stable. ECDs are functional. | | Pic 14 Desc. | Level spreader is functional | |

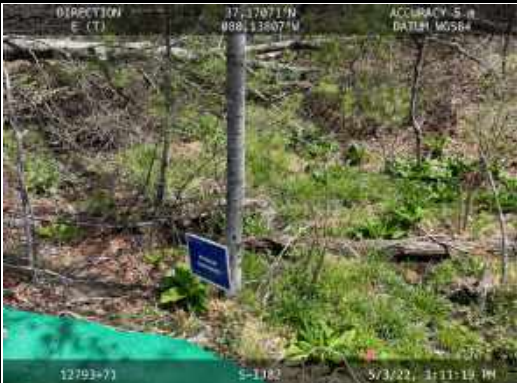
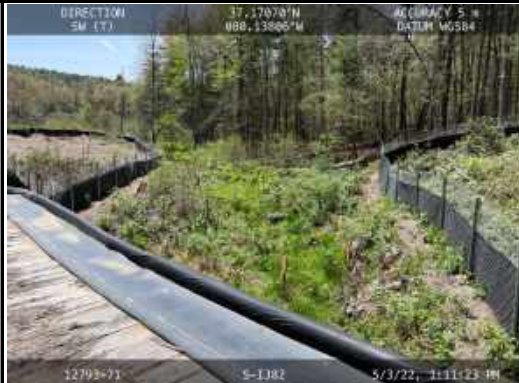
| Pic 15 Desc. | Current ROW conditions. ROW is stable. ECDs are functional. | | Pic 16 Desc. | Equipment bridge over Stream S-IJ82 | |

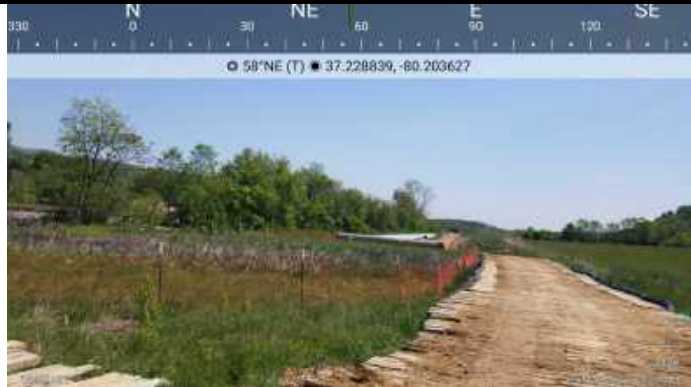
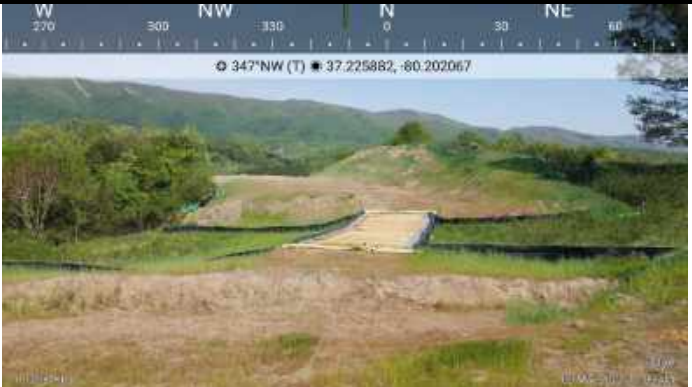
| <b>Pic 1 Desc.</b> | Overview of Waterbody S-I1. ROW is stable. No erosion or sedimentation concerns noted. | <b>Pic 2 Desc.</b> | Overview of Waterbody S-CD12b. ECDs are functional and ROW is stable. | | |

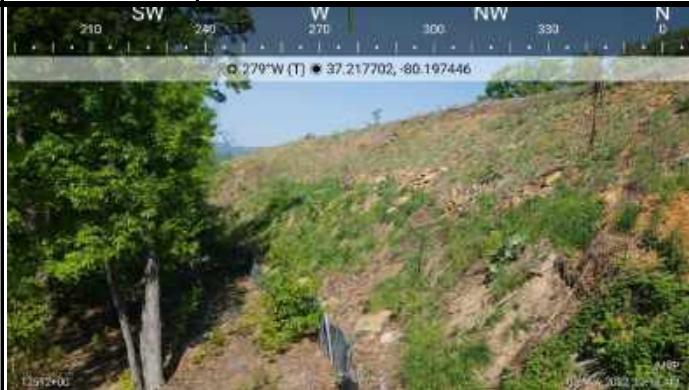
| Pic 7 Desc. | ROW Overview (temporary stabilization). ECDs are functional and ROW is stable. | | Pic 8 Desc. | ROW Overview (temporary stabilization). ECDs are functional and ROW is stable. | |

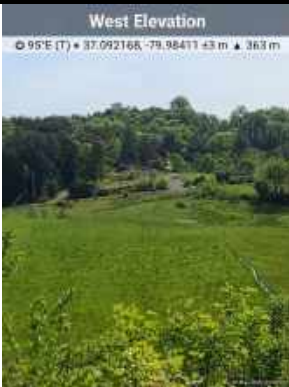
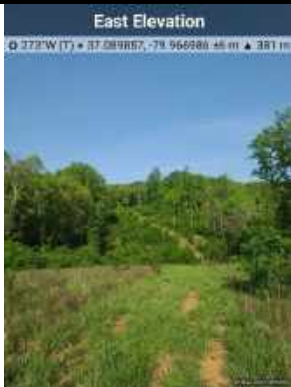
| <b>Pic 1 Desc.</b> | Observed equipment bridge and protection during routine inspection of stream crossings, no environmental issues observed at the time of inspection. | | <b>Pic 2 Desc.</b> | Monitored ECDs and stabilization on stream banks during routine inspection of stream crossings. No environmental issues observed at the time of inspection. | |

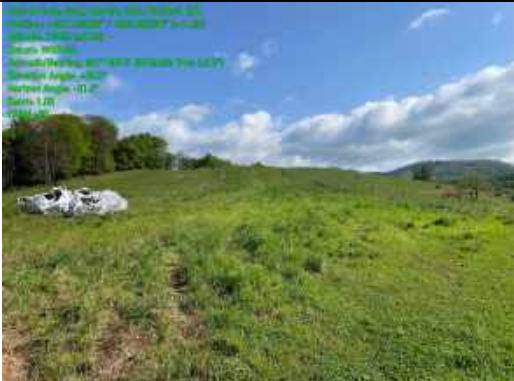
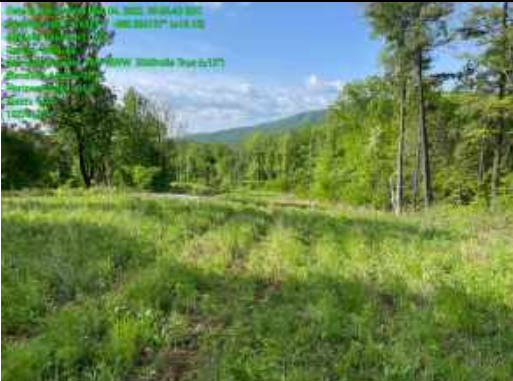
| <b>Pic 1 Desc.</b> | Wades Gap Road Crossing in good condition | <b>Pic 2 Desc.</b> | MVP-S-GH7 and corresponding buffer zone in good condition | | |

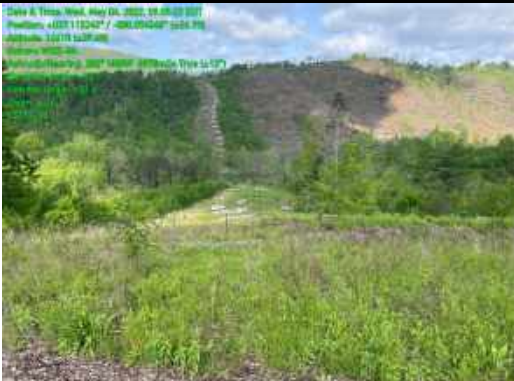
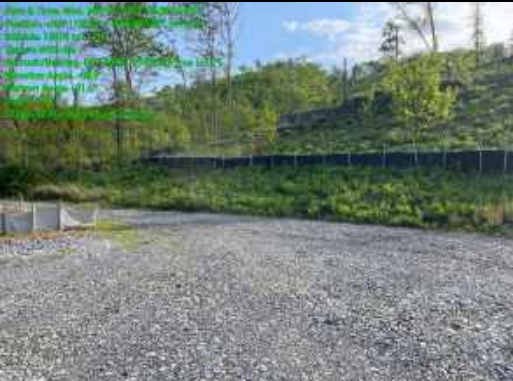
| <b>Pic 3 Desc.</b> | ROW and ECDs In good condition and stable | <b>Pic 4 Desc.</b> | ROW and ECDs In good condition and stable | | |

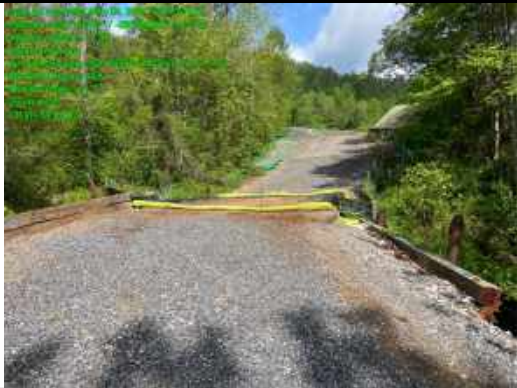
| <b>Pic 7 Desc.</b> | MVP-S-II4 and corresponding buffer zone in good condition | <b>Pic 8 Desc.</b> | ROW and ECDs In good condition and stable | | |

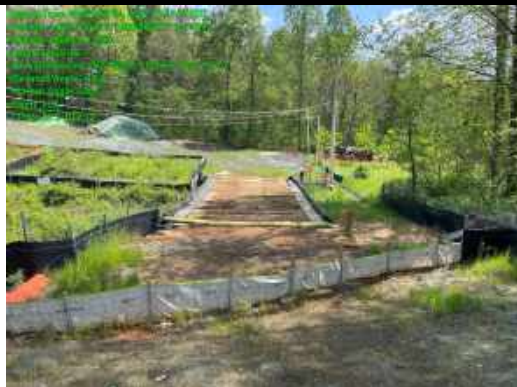
| <b>Pic 9 Desc.</b> | MVP-S-D14 and corresponding buffer zone in good condition | <b>Pic 10 Desc.</b> | ROW and ECDs In good condition and stable | | |

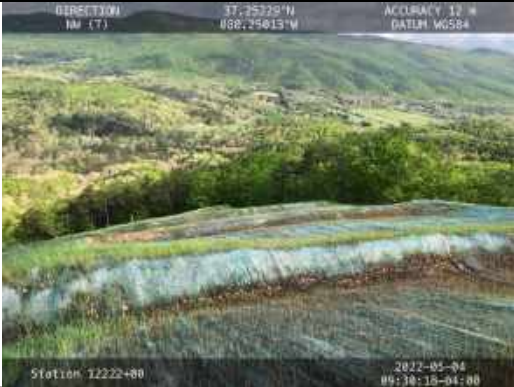
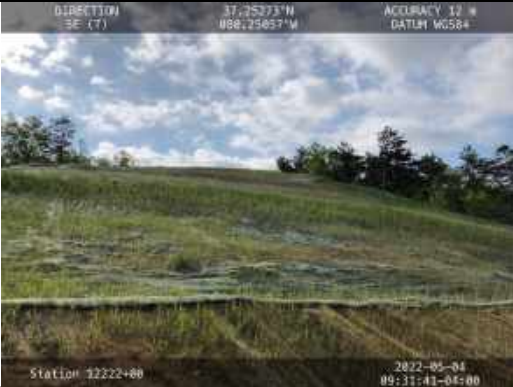
| <b>Pic 1 Desc.</b> | Photo shows the stabilized ROW conditions with water bars and that all ECDs are installed and are functioning as designed. | | <b>Pic 2 Desc.</b> | Photo shows vegetation on side slope and super silt fence installed and functioning as designed. | |

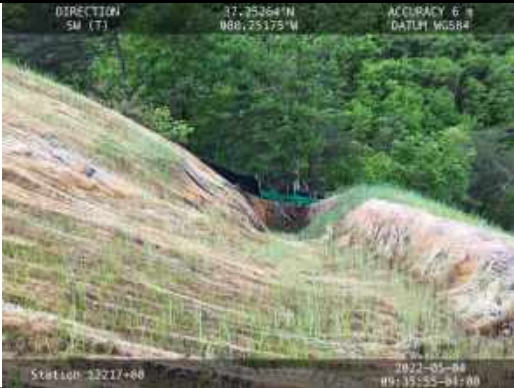
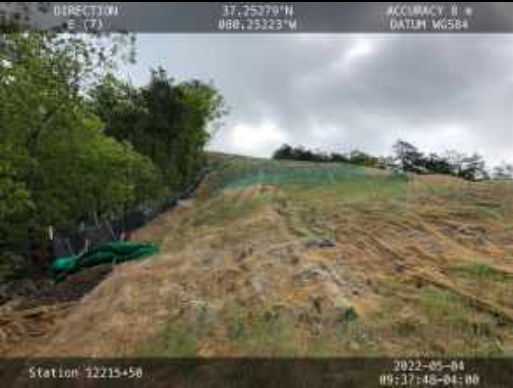
| <b>Pic 3 Desc.</b> | Photo shows the stabilized ROW conditions with water bars and that all ECDs are installed and are functioning as designed. | | <b>Pic 4 Desc.</b> | Photo shows the stabilized ROW conditions with water bars and that all ECDs are installed and are functioning as designed. | |

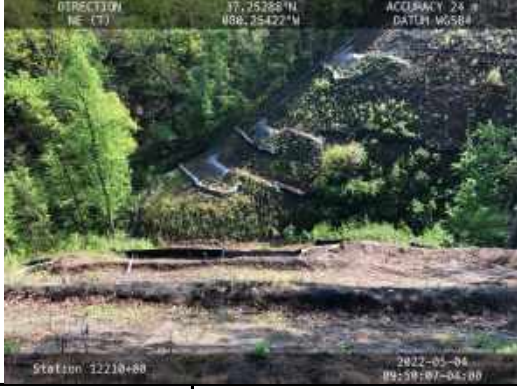
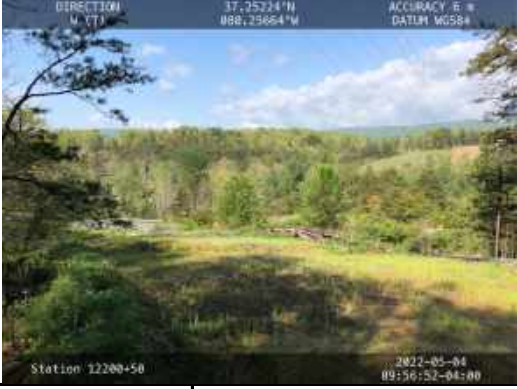
| <b>Pic 7 Desc.</b> | Photo shows permanent restoration section of ROW with permanent water bars installed equipped with level spreaders. | | <b>Pic 8 Desc.</b> | Photo shows the stabilized ROW conditions with water bars and that all ECDs are installed and are functioning as designed. | |

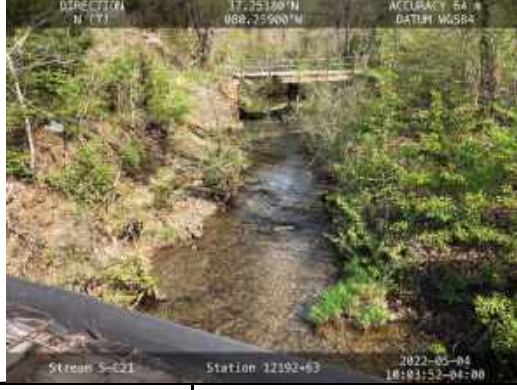
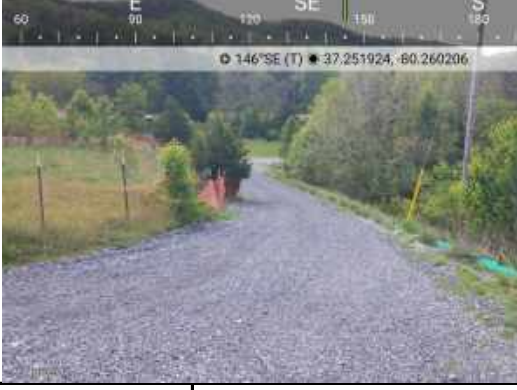
| <b>Pic 9 Desc.</b> | Photo shows the stabilized ROW conditions with water bars and that all ECDs are installed and are functioning as designed. | | <b>Pic 10 Desc.</b> | Photo shows the stabilized ROW conditions with water bars and that all ECDs are installed and are functioning as designed. | |

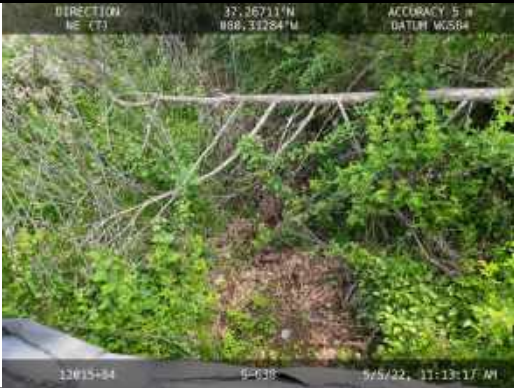
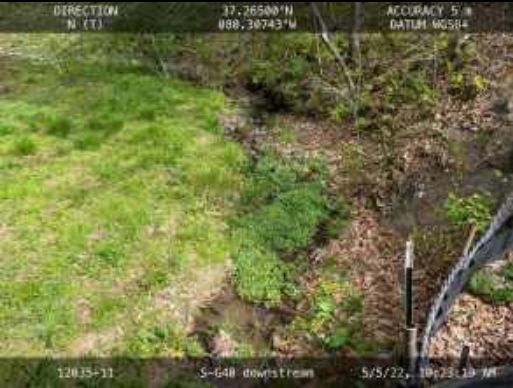
| <b>Pic 3 Desc.</b> | Photo shows the stabilized ROW conditions with water bars and that all ECDs are installed and are functioning as designed. | | <b>Pic 4 Desc.</b> | Photo shows the stabilized ROW conditions with water bars and that all ECDs are installed and are functioning as designed. | |

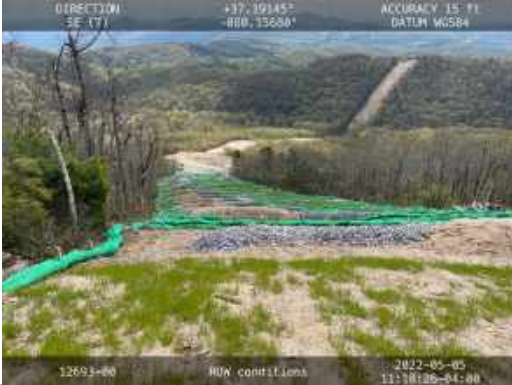
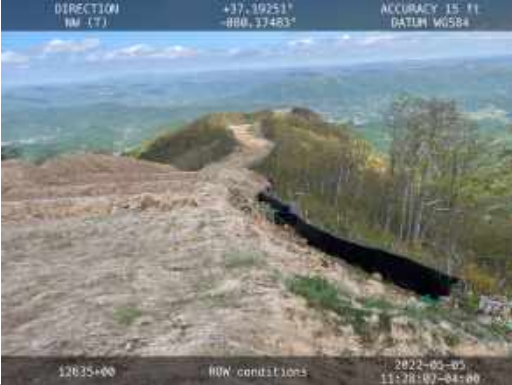
| <b>Pic 1 Desc.</b> | Photo shows the ROW condition. ECDs are installed and functioning as designed. | | <b>Pic 2 Desc.</b> | Photo shows the level spreader. | |

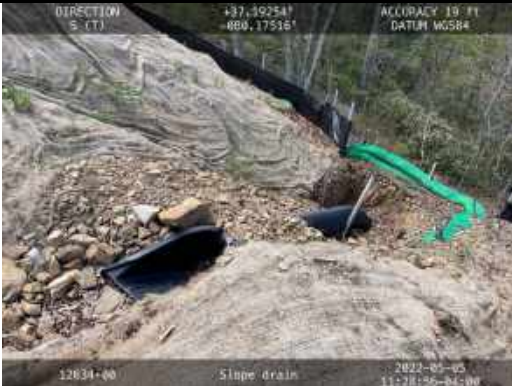
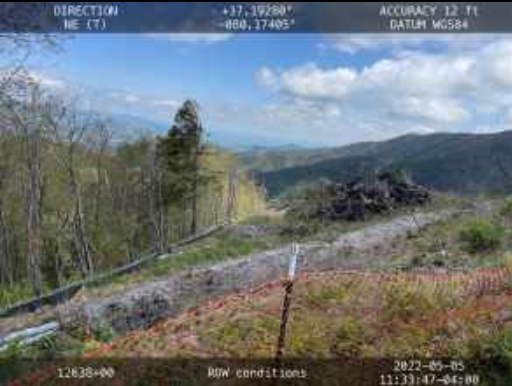
| <b>Pic 3 Desc.</b> | Photo shows the ROW condition. ECDs are installed and functioning as designed. | | <b>Pic 4 Desc.</b> | Photo shows the ROW condition. ECDs are installed and functioning as designed. | |

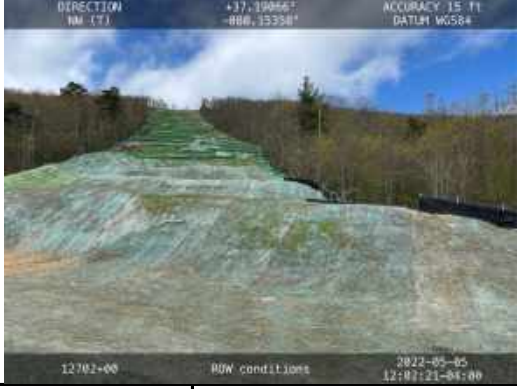
| <b>Pic 7 Desc.</b> | Photo shows the ROW condition. ECDs are installed and functioning as designed. | | <b>Pic 8 Desc.</b> | Photo shows the ROW condition. ECDs are installed and functioning as designed. | |

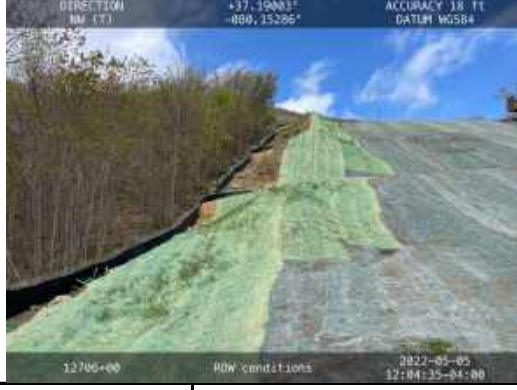
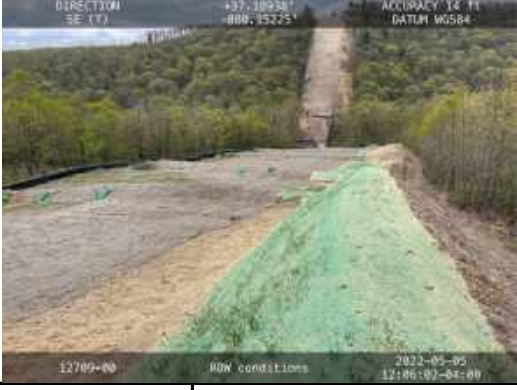
| <b>Pic 9 Desc.</b> | Photo shows the ROW condition. ECDs are installed and functioning as designed. | | <b>Pic 10 Desc.</b> | Photo shows the ROW condition. ECDs are installed and functioning as designed. | |

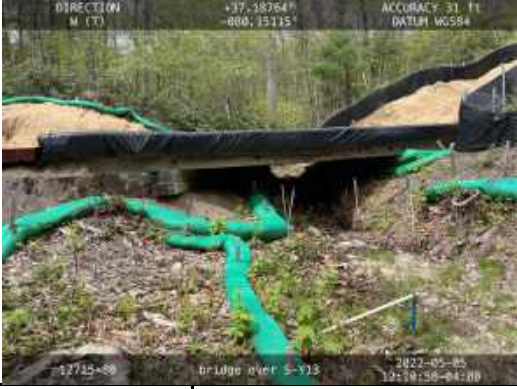
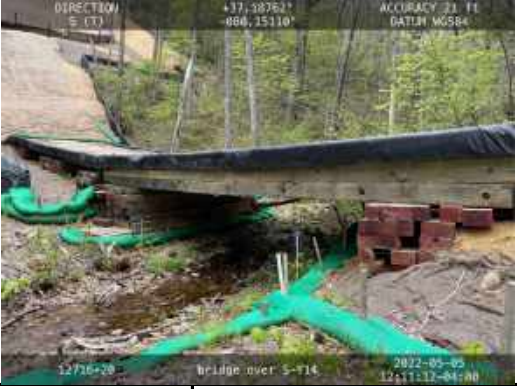
| <b>Pic 13 Desc.</b> | Photo shows the ROW condition. ECDs are installed and functioning as designed. | | <b>Pic 14 Desc.</b> | Photo shows S-Y13 downstream from the bridge. | |

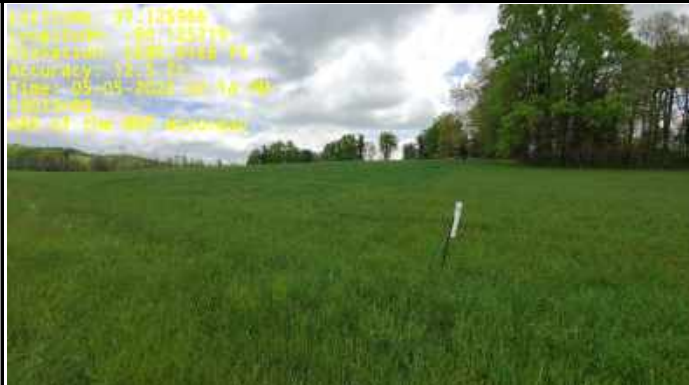
| <b>Pic 15 Desc.</b> | Current ROW conditions. | | <b>Pic 16 Desc.</b> | Current ROW conditions. | |

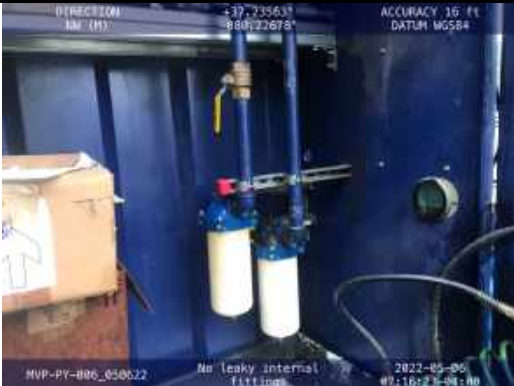
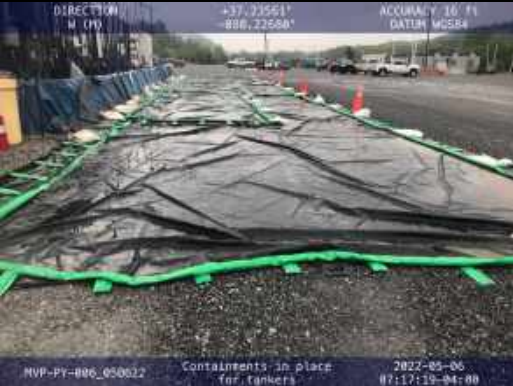
| <b>Pic 3 Desc.</b> | Blue Bulk Fuel tanks no leaky fittings or nozzles. Catch pans on site. Looking W. | <b>Pic 4 Desc.</b> | Blue Bulk Fuel tanks containment holding stormwater with sheen. Looking N. | | |
