Visual Site Inspection Report

Project Name	H-600 Pipeline Spread I	AFE	124300139	Spread	H-600 Pipeline Spread I
Contractor	Precision			Report #	36182
Inspector	Justin Burch			Date/Time	4/4/2022 10:28 AM
Permit #	TBD	Inspection Type	VA SWPP	Station Begin	15142+66
State	VA	Inspection Area	Full	Station End	15260+00
County	Pittsylvania	Ground	Damp	Temperature (°F)	67.00
Municipality	Chatham	Weather	Cloudy	Rain Gauge (in)	0.30
				Rain Accumulation Time (days)	6.00

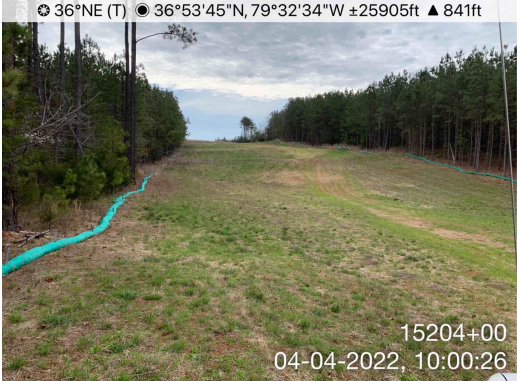
<p>15231+00 04-04-2022, 10:41:17</p>			
GPS Location	0	GPS Location	0		
Field Station#	15204+00	Field Station#	15231+00		
Pic 7 Desc.	Permanent vegetative stabilization and perimeter CFS in acceptable conditions		Pic 8 Desc.	Waterbar in acceptable condition

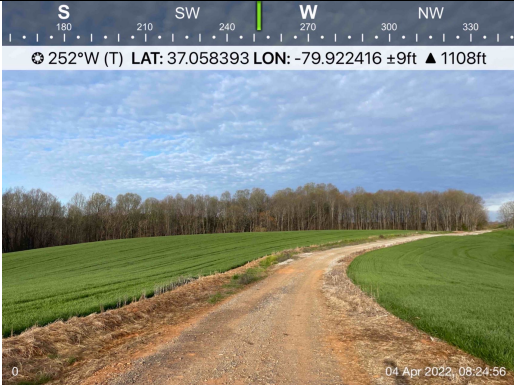
GPS Location	See photo		GPS Location	See photo	
Field Station#	13852+46		Field Station#	13857+00	
Pic 1 Desc.	MVP-FR-303.1 is in good condition		Pic 2 Desc.	Waterbar end treatments are functioning as intended

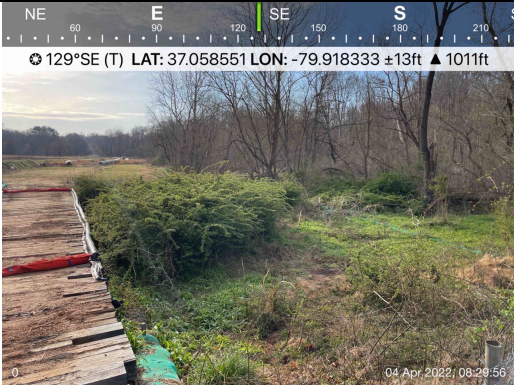
GPS Location	See photo		GPS Location	See photo	
Field Station#	13863+00		Field Station#	13863+01	
Pic 3 Desc.	Resource buffers remain well vegetated		Pic 4 Desc.	Equipment bridge ECDs are in good condition and functioning

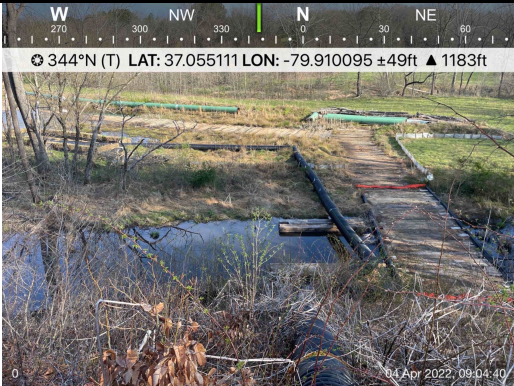
GPS Location	See photo		GPS Location	See photo	
Field Station#	13888+27		Field Station#	13892+45	
Pic 5 Desc.	Slope drain is functioning as intended		Pic 6 Desc.	RCEs are in good condition at all road crossings

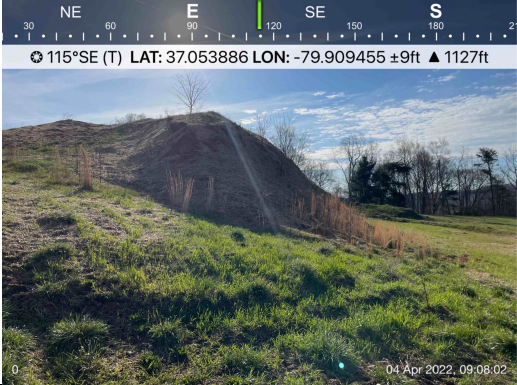
GPS Location	See photo	GPS Location	See photo		
Field Station#	13897+00	Field Station#	13897+00		
Pic 7 Desc.	Stockpiles remain stabilized	Pic 8 Desc.	Sediment trap is in good condition and functioning as intended

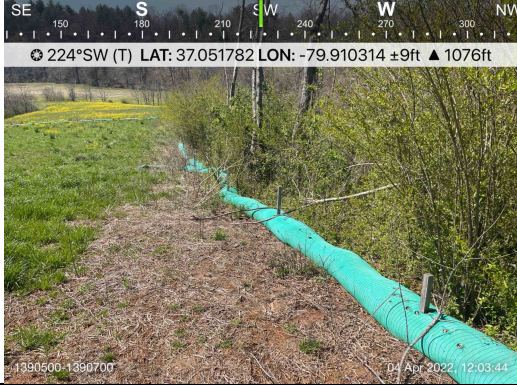
GPS Location	See photo	GPS Location	See photo		
Field Station#	13905+00	Field Station#	13943+00		
Pic 9 Desc.	Perimeter CFS is degraded and needs to be replaced	Pic 10 Desc.	CWDs are functioning as intended

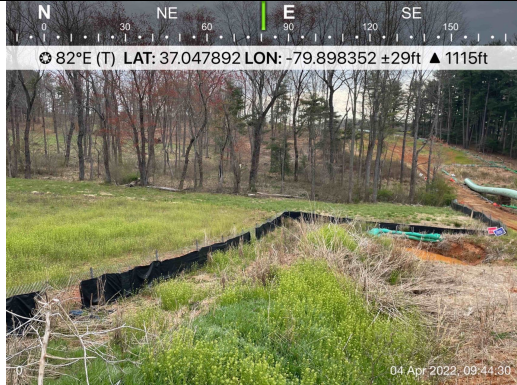
GPS Location	See photo	GPS Location	See photo		
Field Station#	13949+00	Field Station#	13955+00		
Pic 11 Desc.	SSF is in good condition	Pic 12 Desc.	Slope drain is in good condition and functioning.

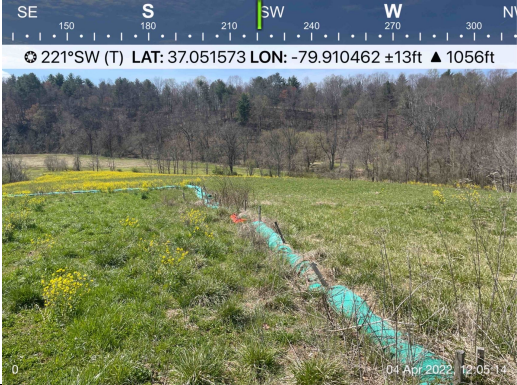
GPS Location	See photo	GPS Location			
Field Station#	13905+00	Field Station#			
Pic 13 Desc.	CFS is degraded and needs to be replaced.	Pic 14 Desc.			
Insert image here		Insert image here			
GPS Location		GPS Location			
Field Station#		Field Station#			
Pic 15 Desc.		Pic 16 Desc.			
Insert image here		Insert image here			
GPS Location		GPS Location			
Field Station#		Field Station#			
Pic 17 Desc.		Pic 18 Desc.

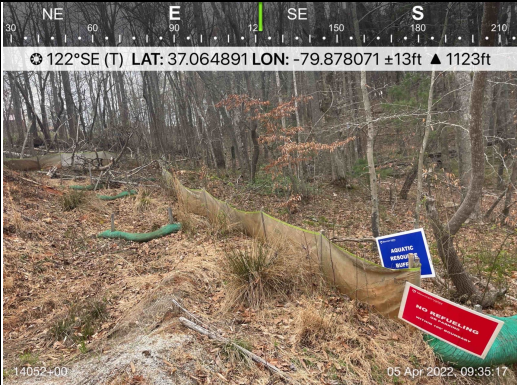
GPS Location	See photo		GPS Location	See photo	
Field Station#	14052+00		Field Station#	14052+00	
Pic 13 Desc.	P1 is degraded and needs to be replaced		Pic 14 Desc.	CFS end treatment needs to be replaced

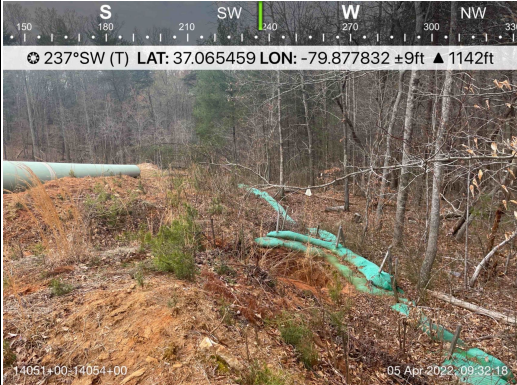
GPS Location	See photo		GPS Location	See photo	
Field Station#	14051+00		Field Station#	14055+00	
Pic 15 Desc.	Perimeter CFS needs to be replaced		Pic 16 Desc.	SSF fabric needs to be reattached

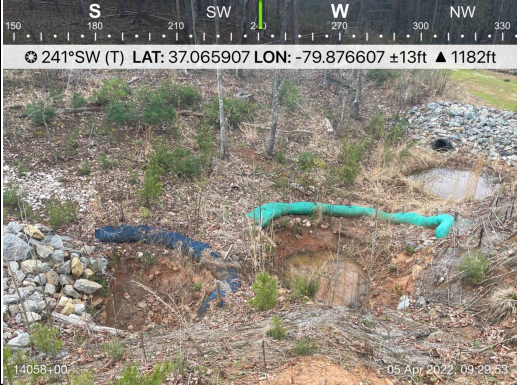
GPS Location	See photo		GPS Location	See photo	
Field Station#	14958+00		Field Station#	14061+00	
Pic 17 Desc.	CFS checks need to be replaced		Pic 18 Desc.	CFS end treatment needs to be replaced.

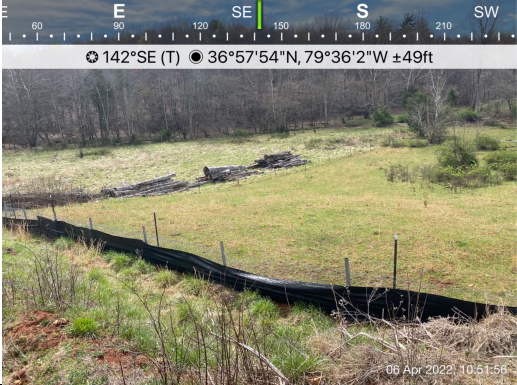
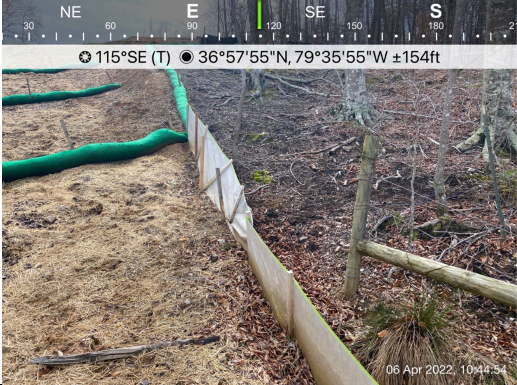
GPS Location	0	GPS Location	0		
Field Station#	14041+00	Field Station#	15047+00		
Pic 7 Desc.	Approximately 14040+00-15041+30. SSF requires maintenance. Reattach fabric to chain link.		Pic 8 Desc.	Approximately 14047+00. P-1 requires maintenance. Damaged by livestock.	
Insert image here		Insert image here			
GPS Location		GPS Location			
Field Station#		Field Station#			
Pic 9 Desc.		Pic 10 Desc.			
Insert image here		Insert image here			
GPS Location		GPS Location			
Field Station#		Field Station#			
Pic 11 Desc.		Pic 12 Desc.

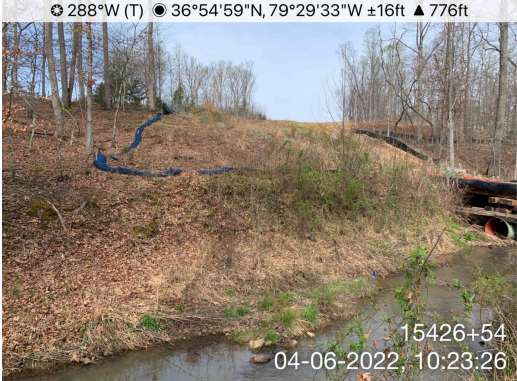
GPS Location	0	GPS Location	0		
Field Station#	15426+54	Field Station#	15426+54		
Pic 7 Desc.	Sensitive resource buffer in acceptable condition		Pic 8 Desc.	Equipment bridge in acceptable condition

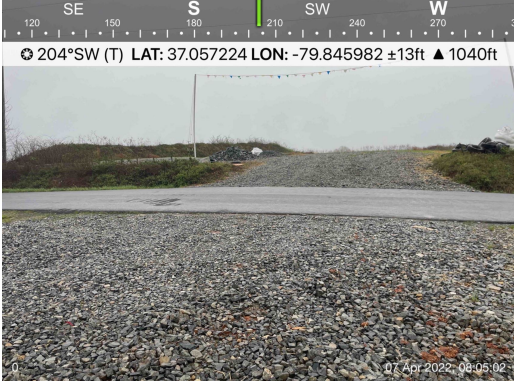
GPS Location	See photo	GPS Location	See photo		
Field Station#	14171+36	Field Station#	14176+09		
Pic 1 Desc.	RCEs are in good condition at all road crossings	Pic 2 Desc.	Equipment bridge ECDs are in good condition and functioning

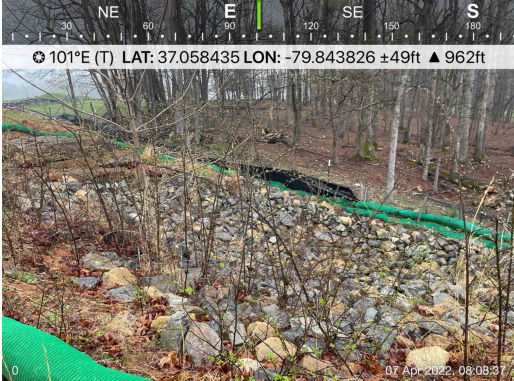
GPS Location	See photo	GPS Location	See photo		
Field Station#	14180+00	Field Station#	14183+00		
Pic 3 Desc.	CWDs are functioning as intended	Pic 4 Desc.	SSF is in good condition

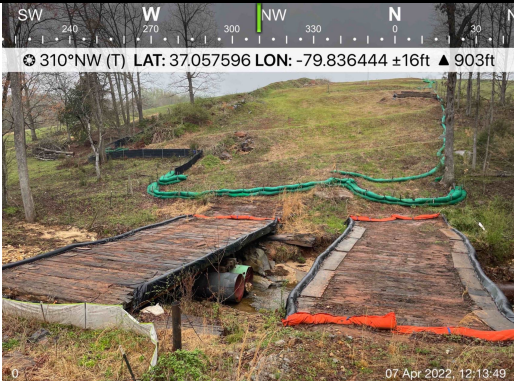
GPS Location	See photo	GPS Location	See photo		
Field Station#	14208+69	Field Station#	14231+00		
Pic 5 Desc.	Equipment bridge ECDs are in good condition and functioning	Pic 6 Desc.	Slope drain is functioning as intended

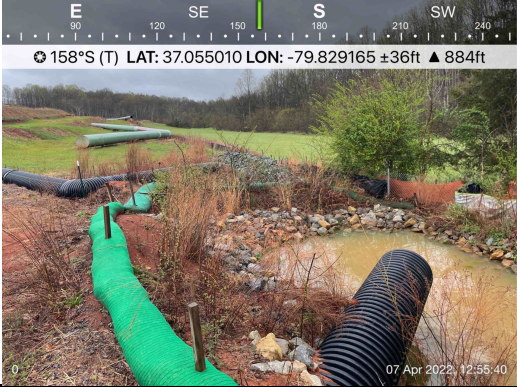
GPS Location	See photo		GPS Location	See photo	
Field Station#	14236+00		Field Station#	14250+00	
Pic 7 Desc.	CWDs are in good condition and functioning		Pic 8 Desc.	This slope remains stabilized with controls in place

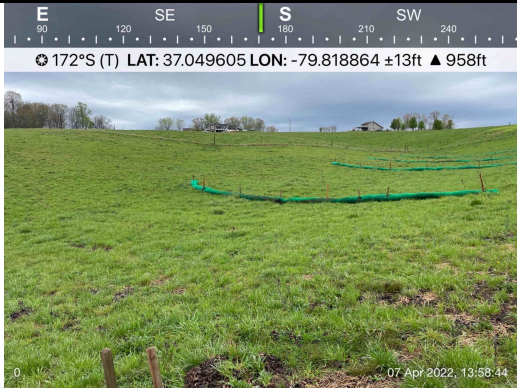
GPS Location	See photo		GPS Location	See photo	
Field Station#	14274+00		Field Station#	14276+00	
Pic 9 Desc.	CFS is in good condition condition along drainage feature		Pic 10 Desc.	Waterbars are functioning as intended

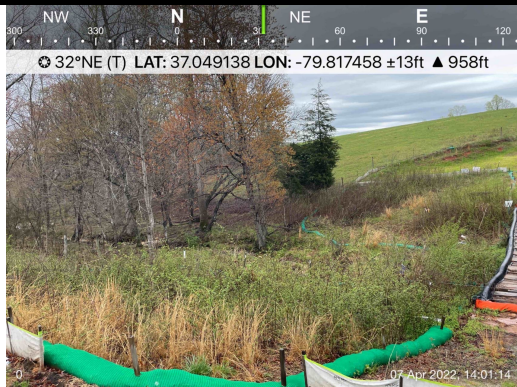
GPS Location	See photo		GPS Location	See photo	
Field Station#	14278+93		Field Station#	14278+93	
Pic 11 Desc.	Resource buffers remain well vegetated		Pic 12 Desc.	P1 is in good condition at all stream and wetland buffers.

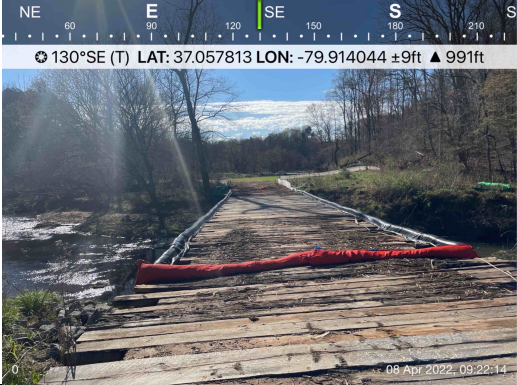
GPS Location	See photo		GPS Location	See photo	
Field Station#	13875+16		Field Station#	13889+00	
Pic 7 Desc.	Equipment bridge ECDs are in good condition and functioning		Pic 8 Desc.	Slope drain is in good condition and functioning

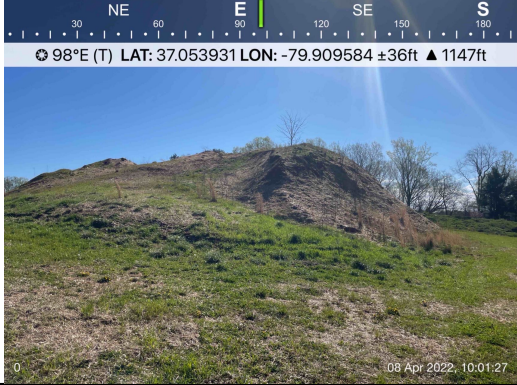
GPS Location	See photo		GPS Location	See photo	
Field Station#	13897+00		Field Station#	13897+00	
Pic 9 Desc.	Topsoil berms remain stabilized		Pic 10 Desc.	Sediment trap is functioning as intended

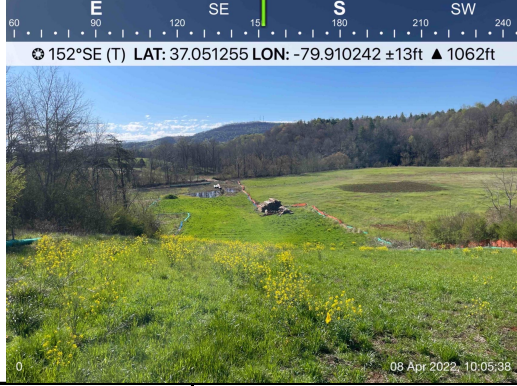
GPS Location	See photo		GPS Location	See photo	
Field Station#	13908+00		Field Station#	13925+00	
Pic 11 Desc.	Vegetation continues to fill in throughout this section		Pic 12 Desc.	CFS is in good condition
