Visual Site Inspection Report

Project Name	H-600 Pipeline Spread I	AFE	124300139	Spread	H-600 Pipeline Spread I
Contractor	Precision			Report #	37459
Inspector	Charles Head			Date/Time	5/9/2022 9:10 AM
Permit #	TBD	Inspection Type	VA SWPP	Station Begin	14802+19
State	VA	Inspection Area	Full	Station End	14928+52
County	Franklin	Ground	Wet	Temperature (°F)	66.00
Municipality	N/A	Weather	Sunny	Rain Gauge (in)	1.00
				Rain Accumulation Time (days)	2.00

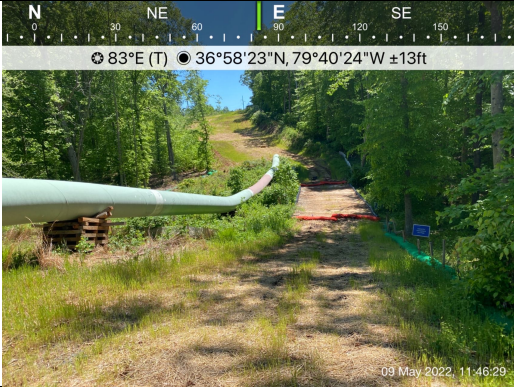
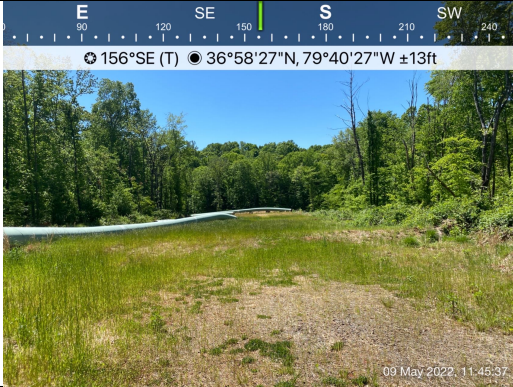
GPS Location	0	GPS Location	0		
Field Station#	15823+54	Field Station#	14818+00		
Pic 1 Desc.	Approximately 14823+54. Overview of stream crossing, equipment bridge and ECDs at stream S-A13.		Pic 2 Desc.	Approximately 14818+00. Overview of ROW.

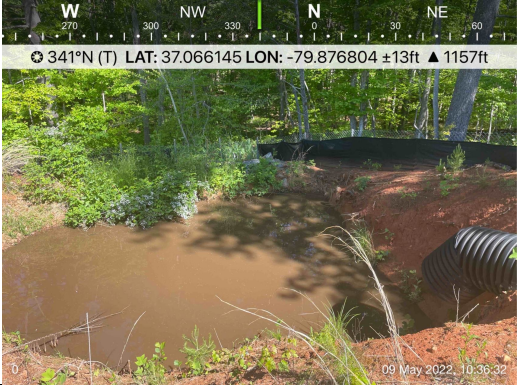
GPS Location	See photo	GPS Location			
Field Station#	14058+00	Field Station#			
Pic 13 Desc.	Slope drain is in good condition and functioning.	Pic 14 Desc.			
Insert image here		Insert image here			
GPS Location		GPS Location			
Field Station#		Field Station#			
Pic 15 Desc.		Pic 16 Desc.			
Insert image here		Insert image here			
GPS Location		GPS Location			
Field Station#		Field Station#			
Pic 17 Desc.		Pic 18 Desc.

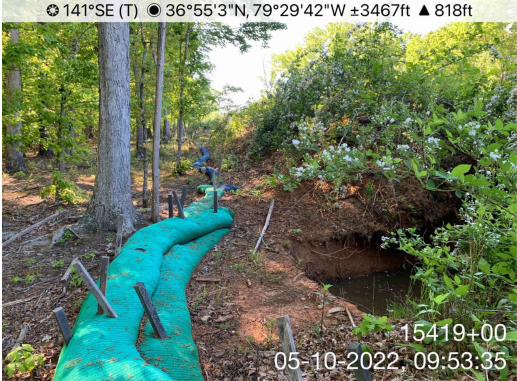
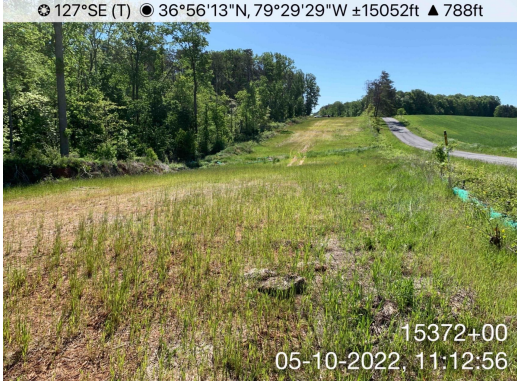
GPS Location	0	GPS Location	0		
Field Station#	15419+00	Field Station#	15372+00		
Pic 7 Desc.	Waterbar end treatment and perimeter CFS in acceptable conditions		Pic 8 Desc.	Temporary vegetative stabilization in acceptable condition

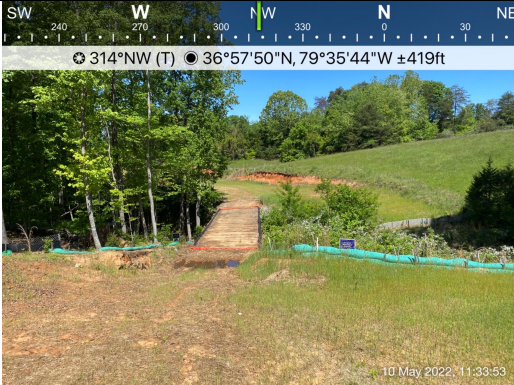
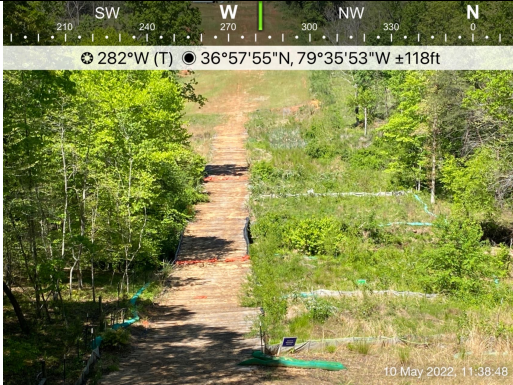
GPS Location	0	GPS Location	0		
Field Station#	15055+80	Field Station#	15044+90		
Pic 1 Desc.	Approximately 15055+80. Overview of stream crossing, equipment bridge and ECDs at stream S-D1.		Pic 2 Desc.	Approximately 15044+90. Overview of stream crossing, equipment bridge and ECDs at stream S-D2.

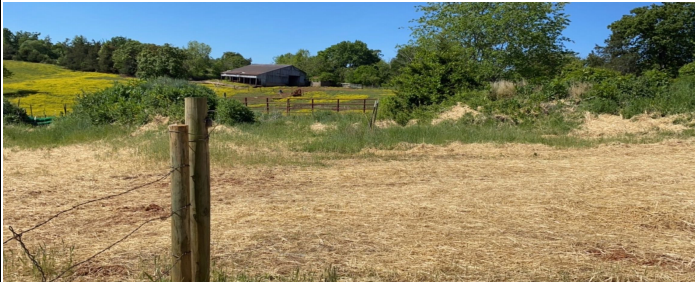
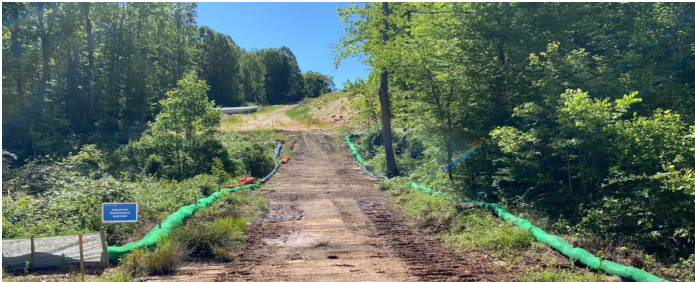
36°59'51" N 79°44'17" W 265°W COURSE 39° GPS 753 Simmons Creek Rd, Union Hall, VA 24176, United States 05.10.2022 10:12:41 Accur +/-35.8 Ft ALT 937 Ft			36°59'44" N 79°44'7" W 161°S COURSE 152° GPS Union Hall, VA 24176, United States 05.10.2022 10:08:13 Accur +/-23.1 Ft ALT 867 Ft		
GPS Location	1	GPS Location	2		
Field Station#	14601+00	Field Station#	14611+17		
Pic 1 Desc.	Routine maintenance. All fence gaps need closed GAS Simmons Creek Rd.		Pic 2 Desc.	Routine maintenance. Bridge wattles need placed at stream crossing of S-E14.

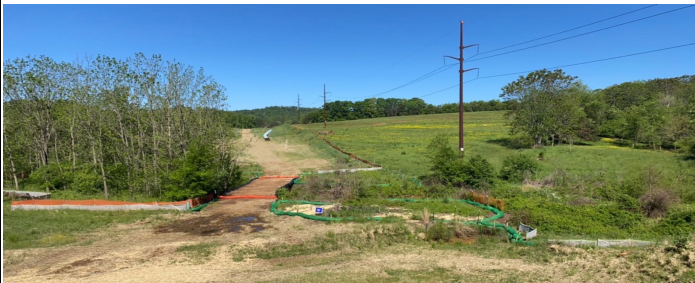
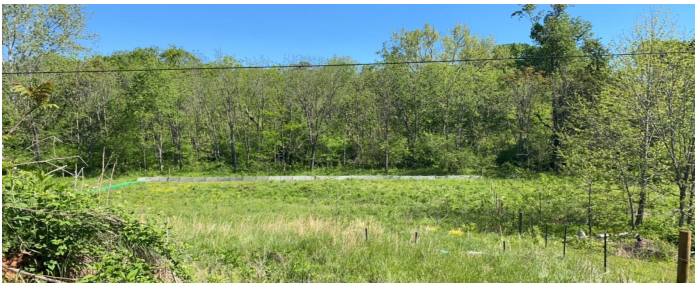
GPS Location	3	GPS Location	4		
Field Station#	14582+85	Field Station#	14584+75		
Pic 3 Desc.	Equipment bridge and surrounding ECDs replaced and in place and functional at stream crossing and resource buffer.		Pic 4 Desc.	Perimeter P1 silt fence replaced in extra workspace.

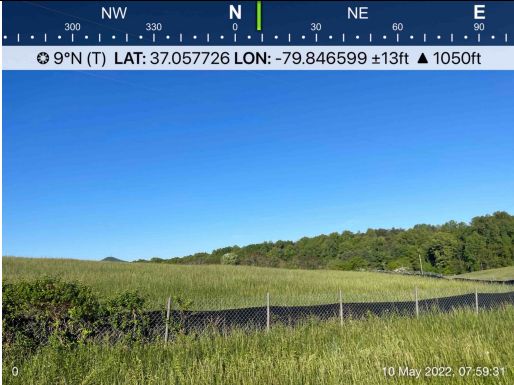
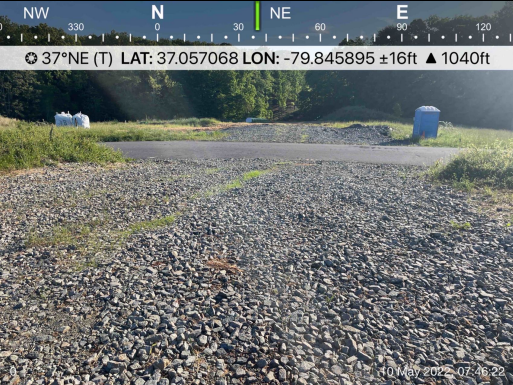
GPS Location	See photo		GPS Location	See photo	
Field Station#	14171+36		Field Station#	14171+36	
Pic 1 Desc.	SSF is in good condition		Pic 2 Desc.	RCEs are in good condition and functioning

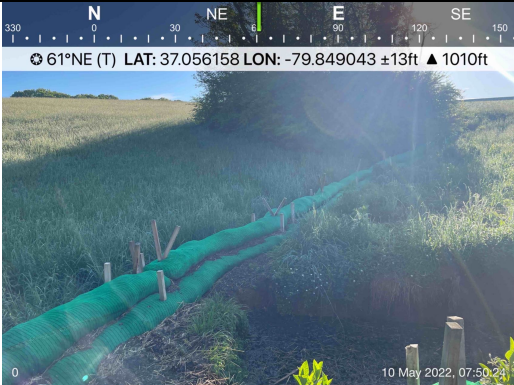
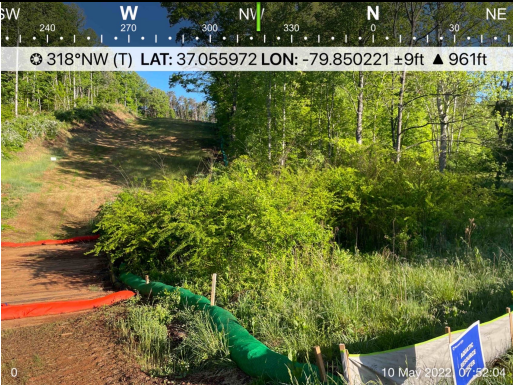
GPS Location	See photo		GPS Location	See photo	
Field Station#	14161+00		Field Station#	14157+55	
Pic 3 Desc.	CFS is in good condition throughout this section		Pic 4 Desc.	Resource buffers remain well vegetated

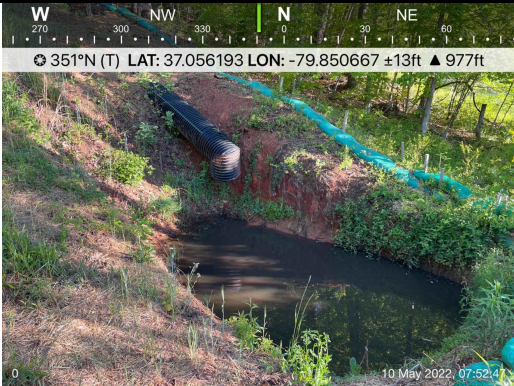
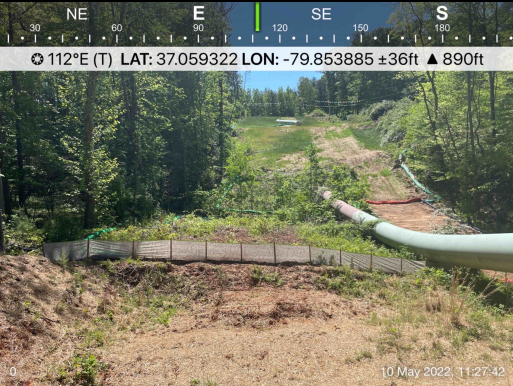
GPS Location	See photo		GPS Location	See photo	
Field Station#	14157+00		Field Station#	14141+62	
Pic 5 Desc.	Slope drain is in good condition		Pic 6 Desc.	P1 is in good condition at all stream and wetland buffers

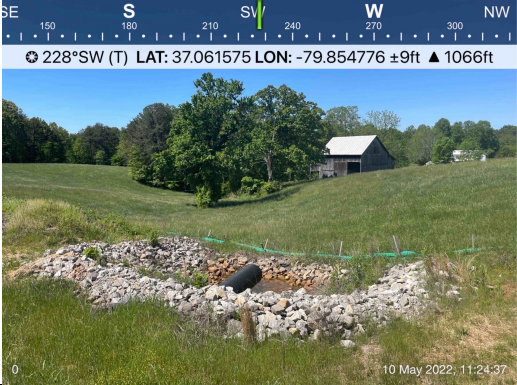
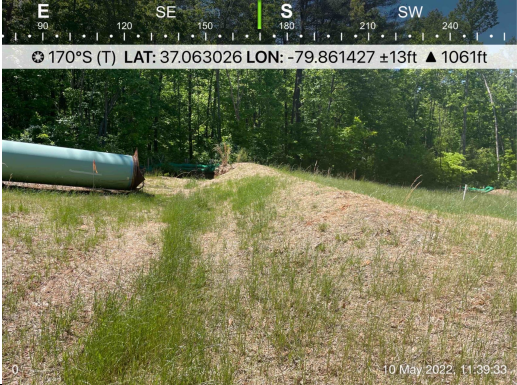
GPS Location	See photo		GPS Location	See photo	
Field Station#	14132+00		Field Station#	14109+00	
Pic 7 Desc.	CWDs are functioning as intended		Pic 8 Desc.	Waterbars are in good condition

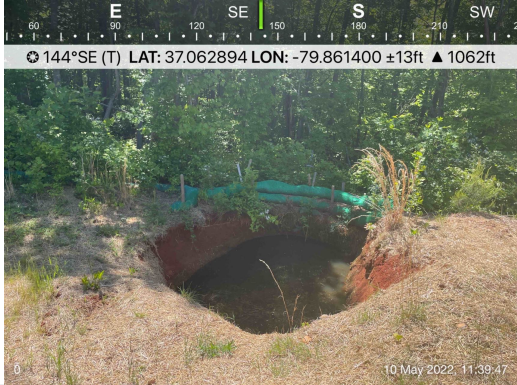
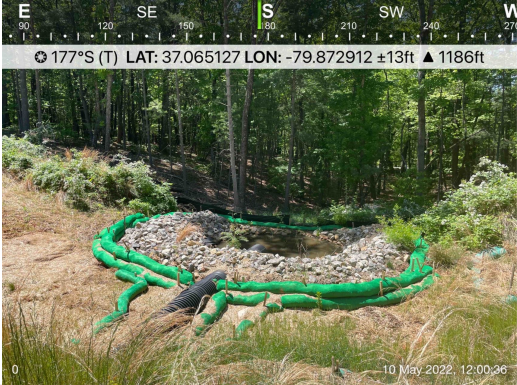
GPS Location	See photo		GPS Location	See photo	
Field Station#	14109+00		Field Station#	14070+00	
Pic 9 Desc.	End treatments are functioning as intended		Pic 10 Desc.	CWDs are functioning as intended

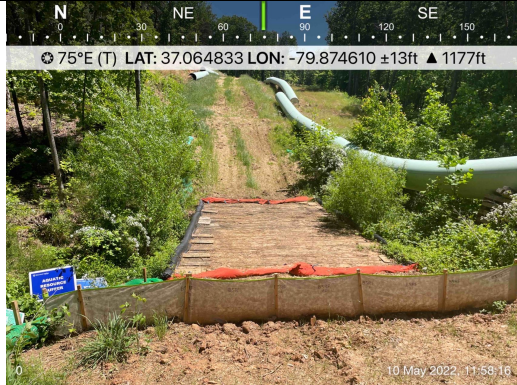
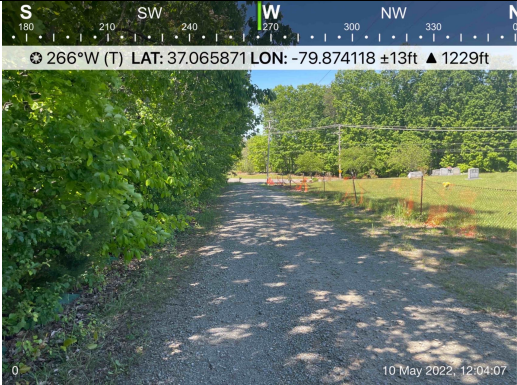
GPS Location	See photo		GPS Location	See photo	
Field Station#	14066+77		Field Station#	14072+91	
Pic 11 Desc.	Equipment bridge ECDs are in good condition		Pic 12 Desc.	FR-309.95 is in good condition with controls in place

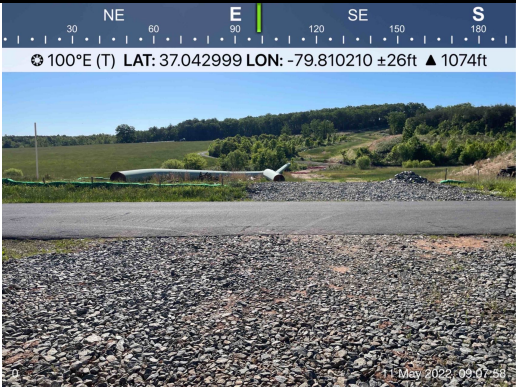
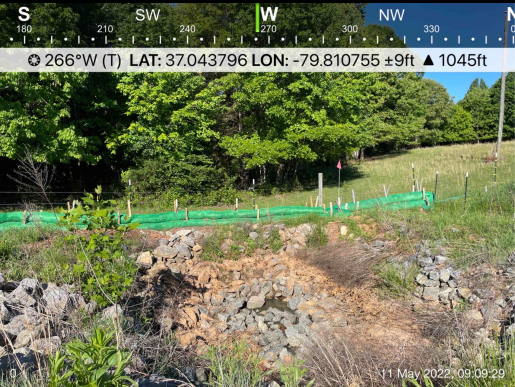
GPS Location	See photo		GPS Location	See photo	
Field Station#	14311+57		Field Station#	14305+00	
Pic 1 Desc.	RCEs are in good condition at all road crossings		Pic 2 Desc.	CWDs are functioning as intended

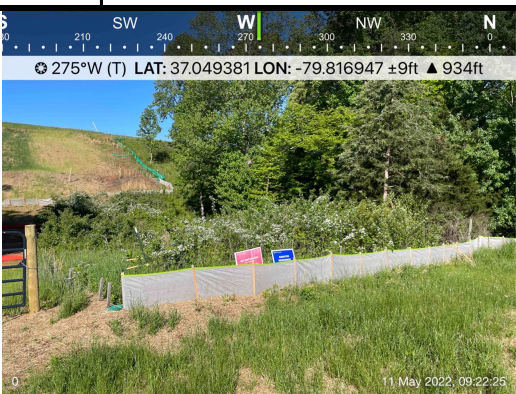
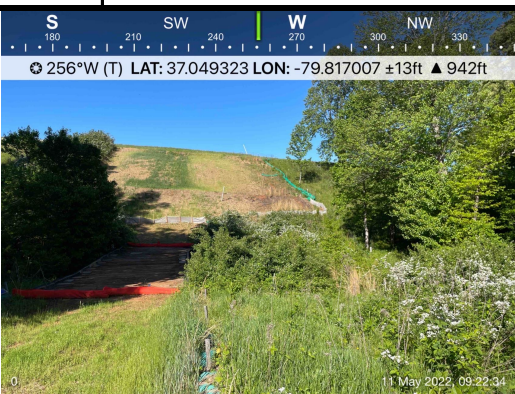
GPS Location	See photo		GPS Location	See photo	
Field Station#	14280+00		Field Station#	14279+08	
Pic 3 Desc.	P1 is in good condition at all stream and wetland buffers		Pic 4 Desc.	Resource buffers remain well vegetated

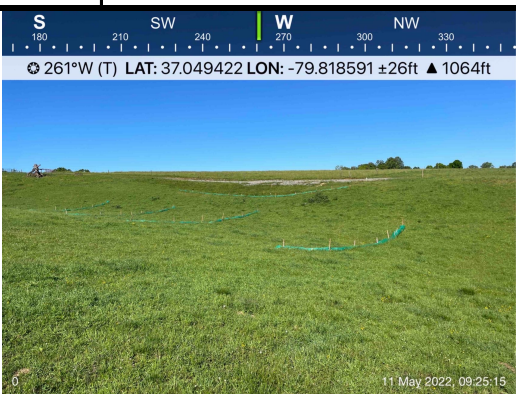
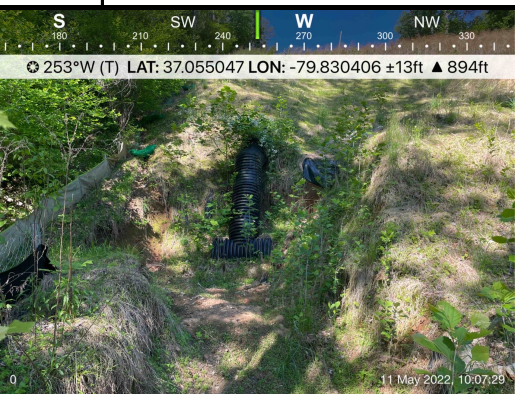
GPS Location	See photo		GPS Location	See photo	
Field Station#	14274+00		Field Station#	14232+00	
Pic 5 Desc.	CFS is in good condition		Pic 6 Desc.	Slope drain is in good condition and functioning

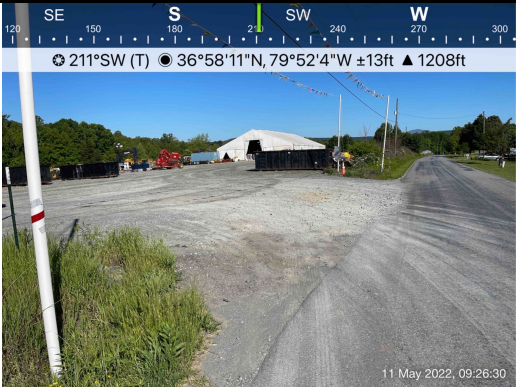
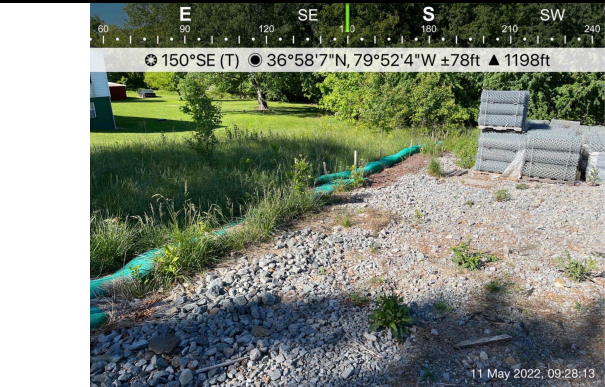
GPS Location	See picture		GPS Location	See picture	
Field Station#	0000+00		Field Station#	0000+00	
Pic 1 Desc.	RCE for LY-045 in good condition.		Pic 2 Desc.	Perimeter ECD's on southwest corner of LY-045 in good condition.

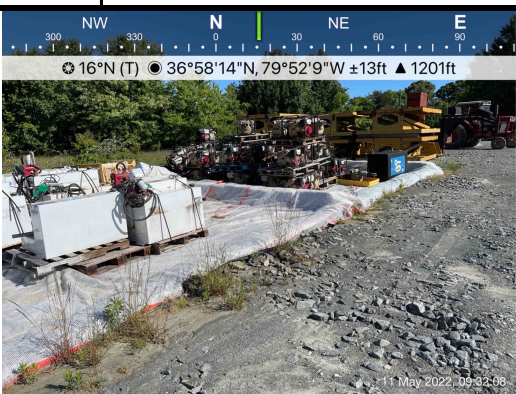
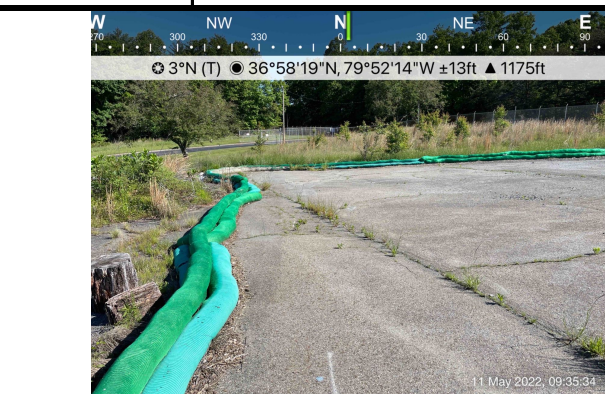
GPS Location	See picture		GPS Location	See picture	
Field Station#	0000+00		Field Station#	0000+00	
Pic 3 Desc.	Secondary containment structure at north end of LY-045 in good condition.		Pic 4 Desc.	Perimeter ECD's on northwest corner of LY-046 in good condition.

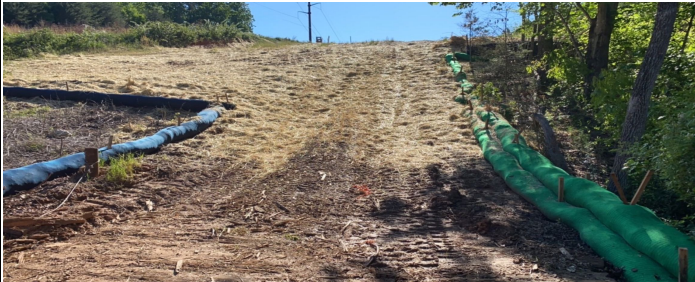
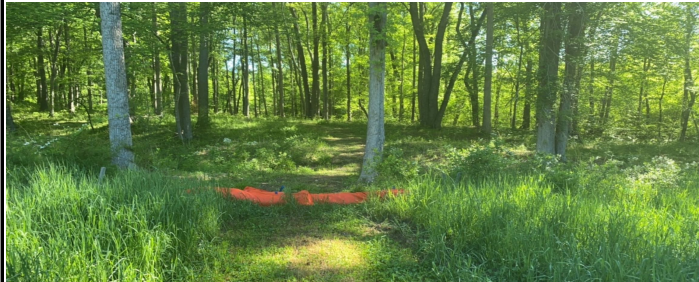
36°59'16" N 79°42'52" W 95°E COURSE -1' GPS Union Hall, VA 24176, United States 05.11.2022 09:04:30 Accur +/-266.6 Ft ALT 919 Ft			36°59'23" N 79°43'21" W 116°SE COURSE 322' GPS Union Hall, VA 24176, United States 05.11.2022 09:23:13 Accur +/-15.7 Ft ALT 941 Ft		
GPS Location	1	GPS Location	2		
Field Station#	14680+75	Field Station#	14654+00		
Pic 1 Desc.	Routine maintenance. Seed and stabilize ~30' denuded area GAS H-36.		Pic 2 Desc.	Contractor replaced torn perimeter CFS with wattles where landowner crosses.

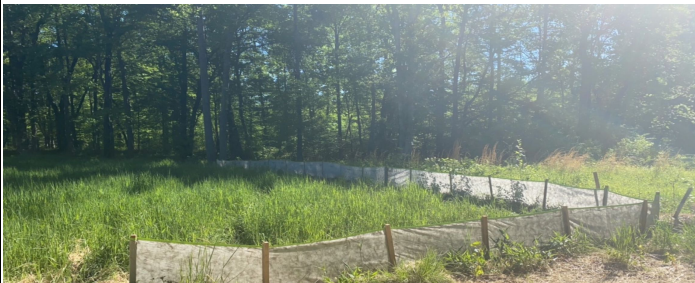
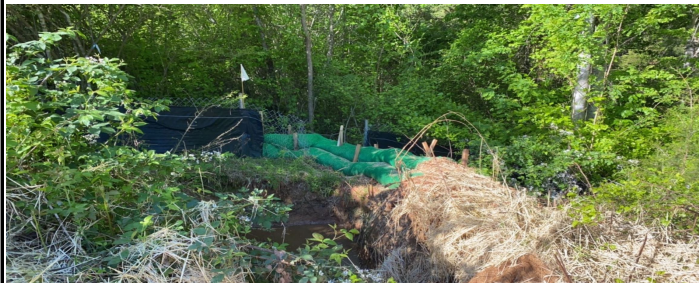
Field Station#	14656+37	Field Station#	14674+00		
Pic 3 Desc.	P1 silt fence in good condition.		Pic 4 Desc.	Sump pit and CFS end treatment performing intended functions.

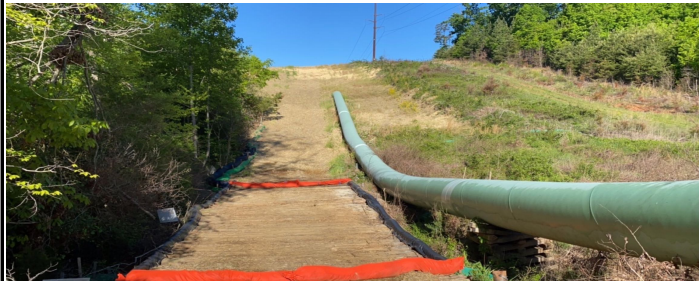
36°59'17" N 79°42'47" W 173°S COURSE 59' GPS Union Hall, VA 24176, United States 05.11.2022 09:08:31 Accur +/-70.4 Ft ALT 914 Ft			36°59'16" N 79°42'40" W 311°NW COURSE 319' GPS 1559-2499 Jacks Creek Rd, Union Hall, VA 24176, United States 05.11.2022 08:58:56 Accur +/-303.7 Ft ALT 938 Ft		
GPS Location	5	GPS Location	6		
Field Station#	14685+00	Field Station#	14689+36		
Pic 5 Desc.	ROW stabilized and vegetated in temporary area; water bars performing intended functions.		Pic 6 Desc.	Equipment bridge and surrounding ECDs in place and functional at stream crossing and resource buffer.

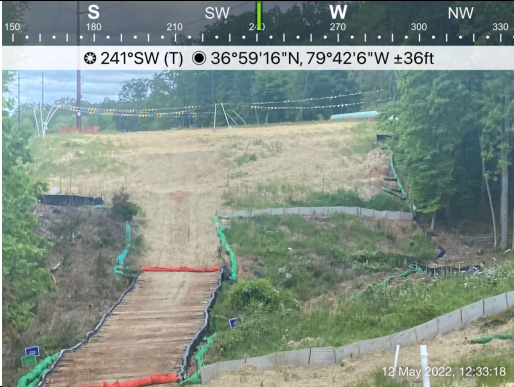
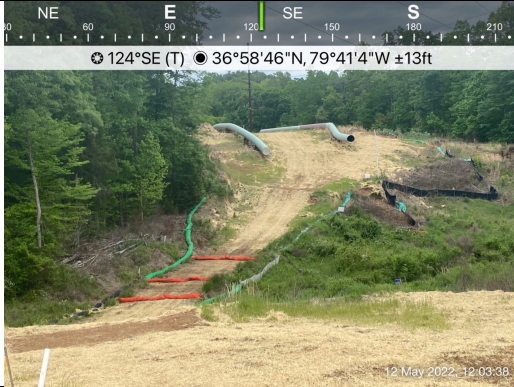
GPS Location	0	GPS Location	0		
Field Station#	14716+50	Field Station#	14782+25		
Pic 1 Desc.	Approximately 14716+50. Overview of wetland crossing, equipment bridge and ECDs at wetland W-H11. Area north and uphill of wetland has been disturbed by third party.		Pic 2 Desc.	Approximately 14782+25. Overview of ROW.

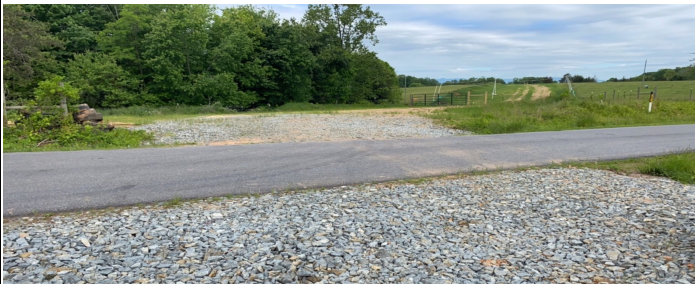
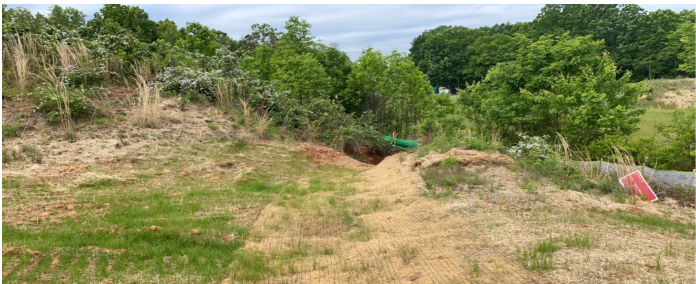
37°2'34" N 79°48'35" W 315°NW COURSE 156° GPS 530 Farm View Rd, Glade Hill, VA 24092, United States 05.12.2022 09:59:31 Accur +/-28.6 Ft ALT 1068 Ft			37°2'34" N 79°48'35" W 243°SW COURSE -1° GPS 530 Farm View Rd, Glade Hill, VA 24092, United States 05.12.2022 10:02:15 Accur +/-277.0 Ft ALT 1068 Ft		
GPS Location	1		GPS Location	2	
Field Station#	14311+57		Field Station#	14316+00	
Pic 1 Desc.	RCE at Farm View Rd in good condition.		Pic 2 Desc.	Erosion control blanket in throat of water bar performing intended function.

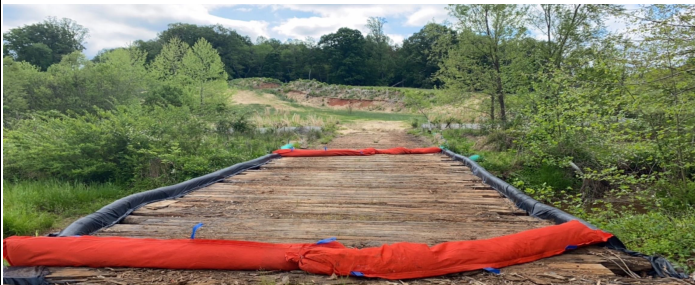
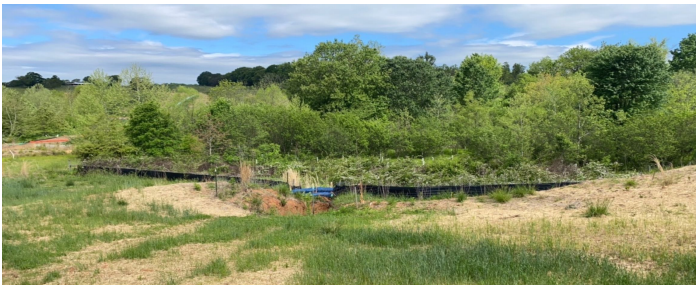
Field Station#	14391+47		Field Station#	14395+00	
Pic 3 Desc.	Equipment bridge and surrounding ECDs in place and functional at stream crossing and resource buffer.		Pic 4 Desc.	Sump pit and CFS end treatment performing intended functions; perimeter SSF in good condition.

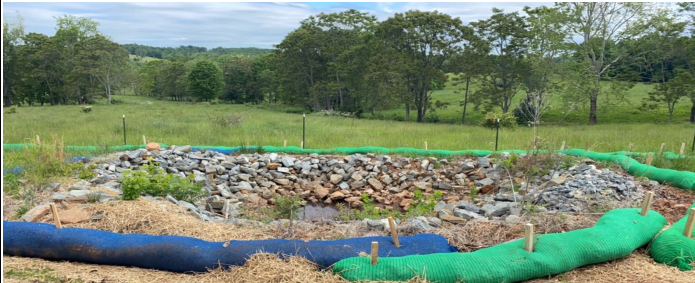
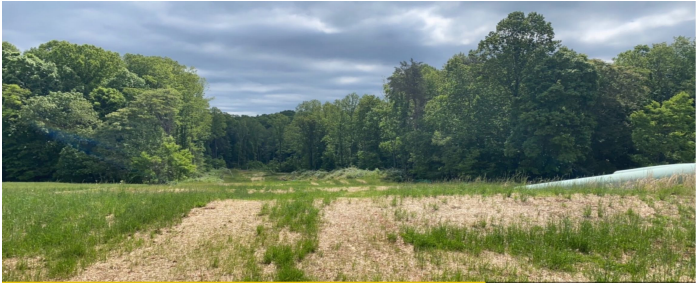
37°1'52" N 79°47'11" W 356°N COURSE 336° GPS Glade Hill, VA 24092, United States 05.12.2022 10:13:22 Accur +/-29.7 Ft ALT 1068 Ft			37°1'51" N 79°46'53" W 116°SE COURSE 104° GPS Glade Hill, VA 24092, United States 05.12.2022 10:27:54 Accur +/-32.9 Ft ALT 1082 Ft		
GPS Location	5		GPS Location	6	
Field Station#	14404+00		Field Station#	14416+00	
Pic 5 Desc.	Plunge pool performing intended function.		Pic 6 Desc.	ROW stabilized and vegetated in temporary area.

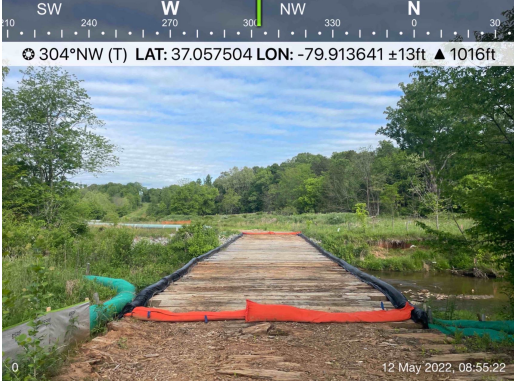
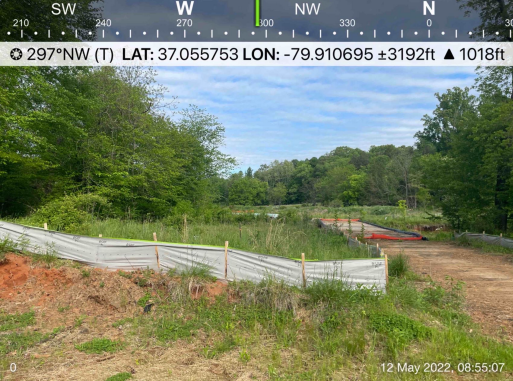
GPS Location	See photo		GPS Location	See photo	
Field Station#	13875+50		Field Station#	13876+00	
Pic 1 Desc.	Equipment bridge ECDs are in good condition		Pic 2 Desc.	P1 is in good condition at all stream and wetland buffers

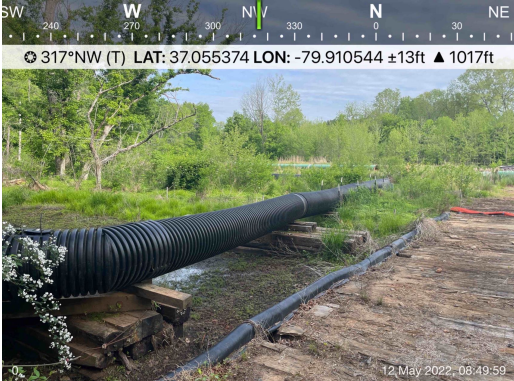
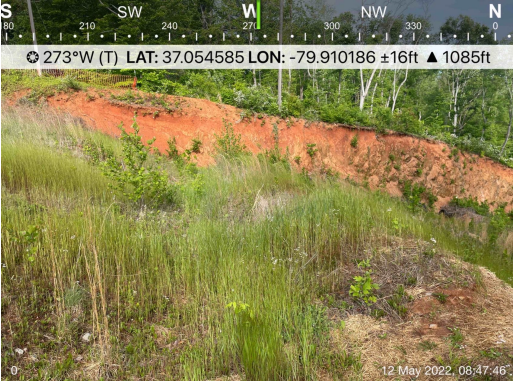
GPS Location	See photo		GPS Location	See photo	
Field Station#	13888+50		Field Station#	13891+00	
Pic 3 Desc.	Slope drain is in good condition and functioning		Pic 4 Desc.	Waterbars are in good condition

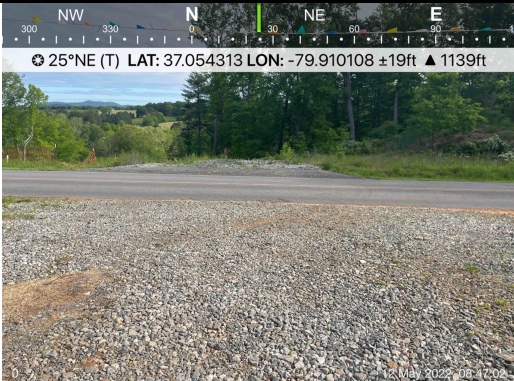
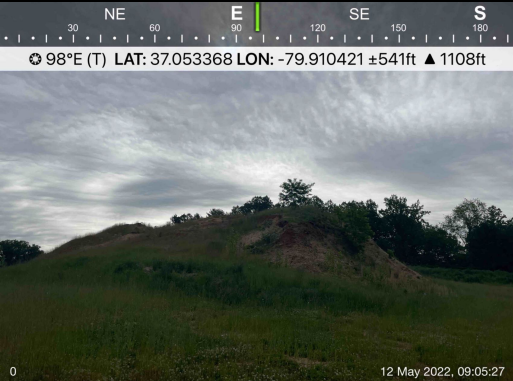
GPS Location	See photo		GPS Location	See photo	
Field Station#	13892+45		Field Station#	13897+00	
Pic 5 Desc.	RCEs are in good condition at all road crossings.		Pic 6 Desc.	Topsoil pile remains stabilized

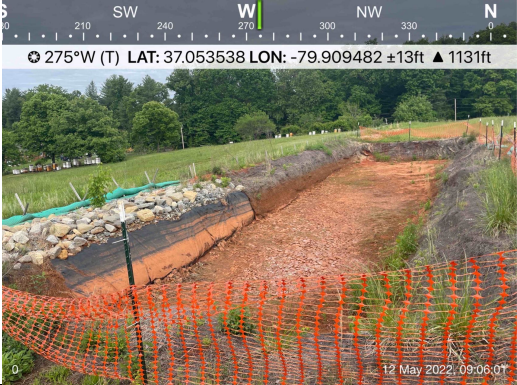
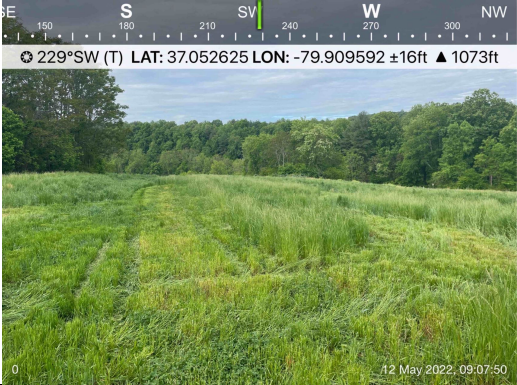
GPS Location	See photo		GPS Location	See photo	
Field Station#	13897+00		Field Station#	13905+00	
Pic 7 Desc.	Sediment trap is functioning as intended		Pic 8 Desc.	3rd party has mowed ROW. (Unauthorized)

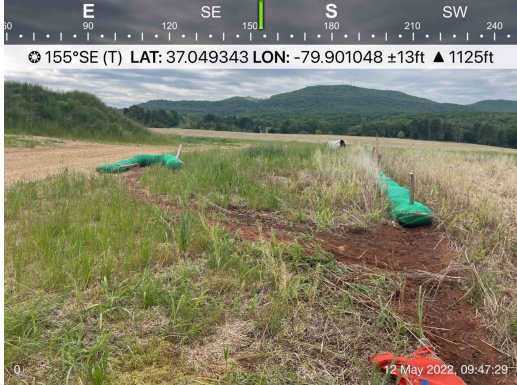
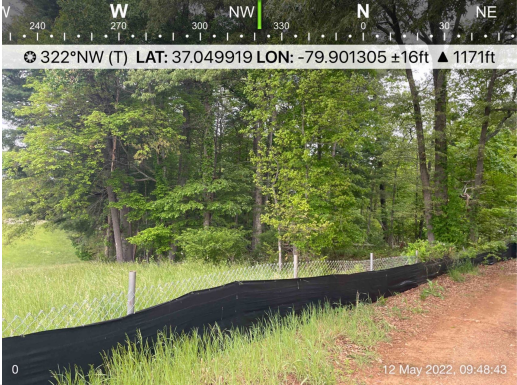
GPS Location	See photo		GPS Location	See photo	
Field Station#	13939+50		Field Station#	13939+50	
Pic 9 Desc.	CFS has been damaged/displaced by 3rd party		Pic 10 Desc.	SSF is in good condition

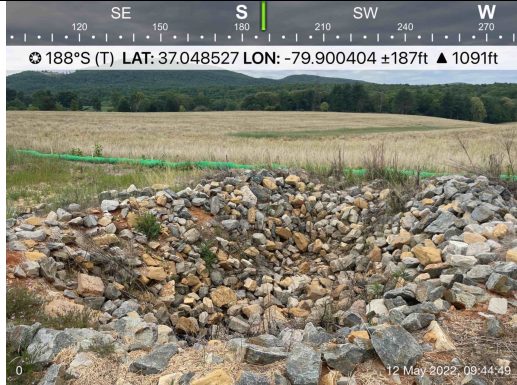
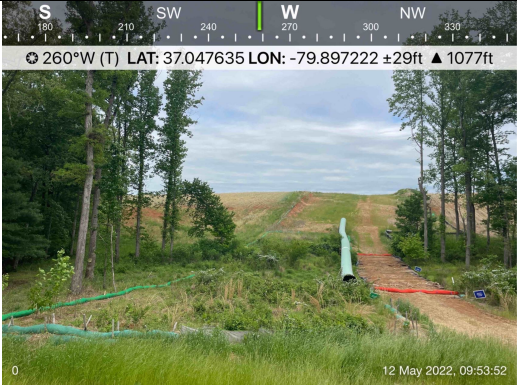
GPS Location	See photo		GPS Location	See photo	
Field Station#	13941+00		Field Station#	13950+00	
Pic 11 Desc.	CWDs are functioning as intended		Pic 12 Desc.	Resource buffers remain well vegetated

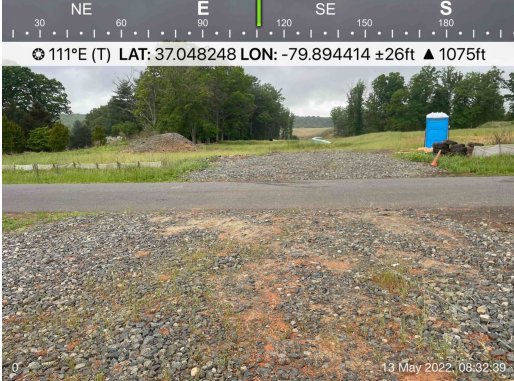
GPS Location	See photo		GPS Location	See photo	
Field Station#	13958+31		Field Station#	13960+00	
Pic 1 Desc.	RCEs are in good condition at all road crossings		Pic 2 Desc.	CWDs are functioning as intended

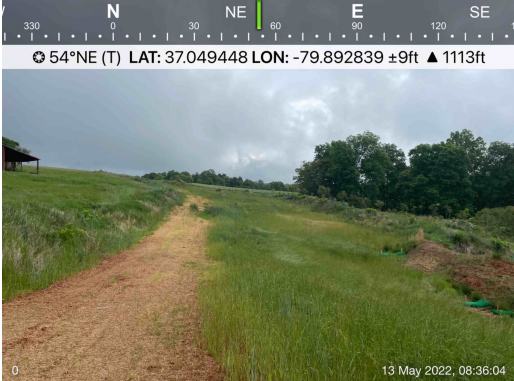
GPS Location	See photo		GPS Location	See photo	
Field Station#	13970+00		Field Station#	13998+00	
Pic 3 Desc.	Vegetation continues to fill in throughout this section		Pic 4 Desc.	P1 is in good condition at all stream and wetland buffers

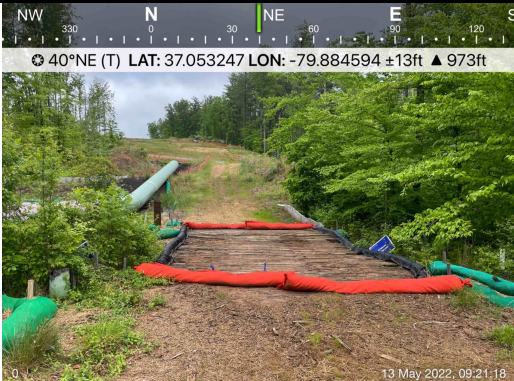
GPS Location	See photo		GPS Location	See photo	
Field Station#	13998+15		Field Station#	14000+00	
Pic 5 Desc.	Equipment bridge ECDs are in good condition and functioning		Pic 6 Desc.	No evidence of 3rd party pond discharging onto ROW

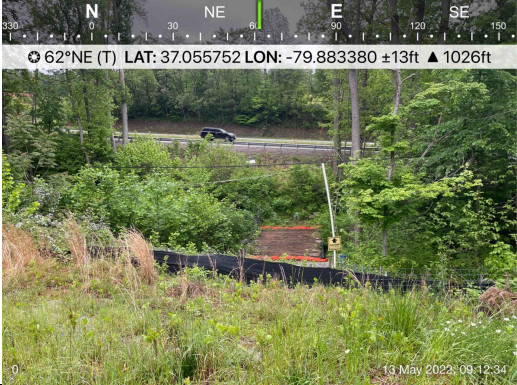
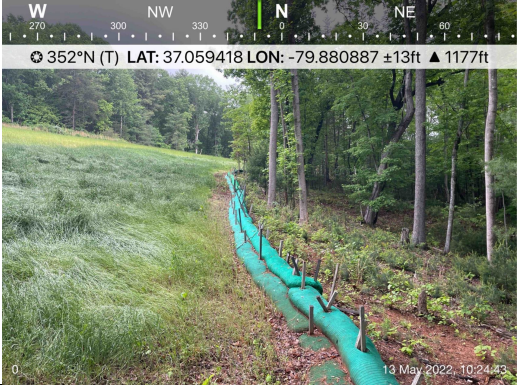
GPS Location	See photo		GPS Location	See photo	
Field Station#	14009+20		Field Station#	14027+00	
Pic 7 Desc.	SSF is in good condition		Pic 8 Desc.	CFS is in good condition throughout this section

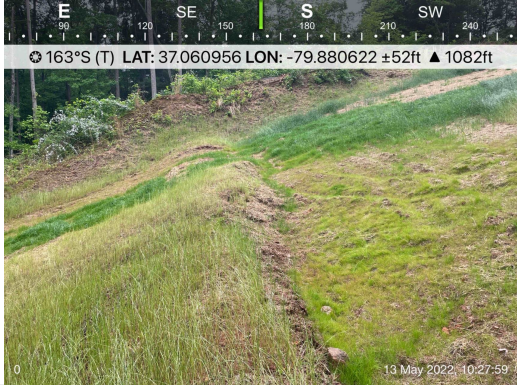
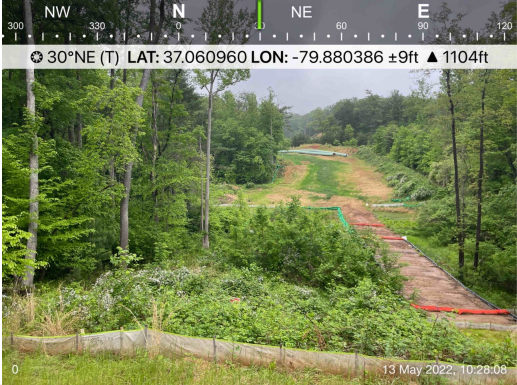
GPS Location	See photo		GPS Location	See photo	
Field Station#	14033+00		Field Station#	14035+00	
Pic 9 Desc.	Waterbars are functioning as intended		Pic 10 Desc.	Resource buffers remain well vegetated

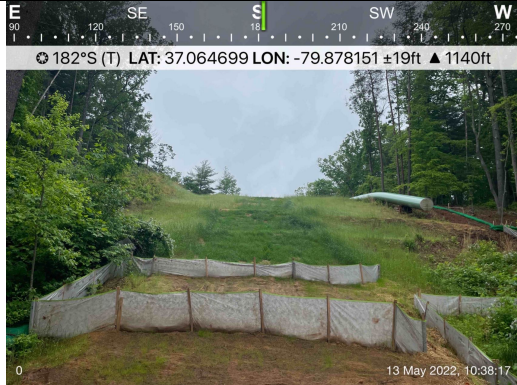
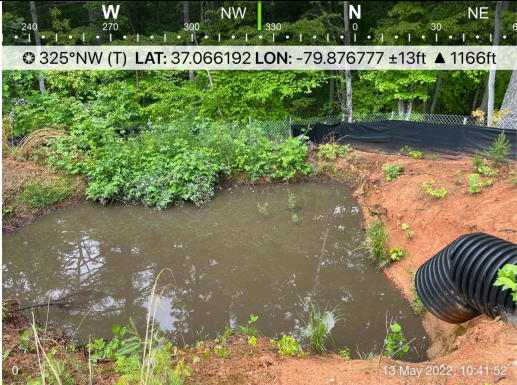
GPS Location	See photo		GPS Location	See photo	
Field Station#	14050+00		Field Station#	14058+00	
Pic 11 Desc.	Slope remains stabilized with controls in place		Pic 12 Desc.	Slope drain is in good condition and functioning

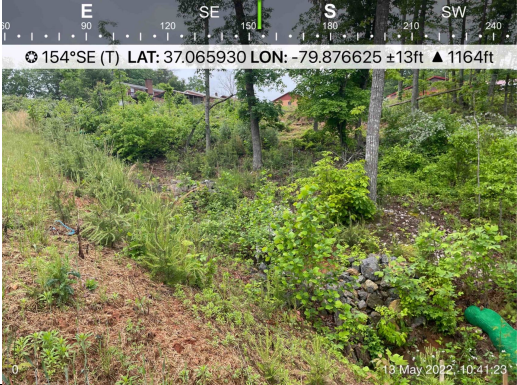
GPS Location	See photo	GPS Location			
Field Station#	14060+00	Field Station#			
Pic 13 Desc.	Rock check dams are functioning as intended.	Pic 14 Desc.			
Insert image here		Insert image here			
GPS Location		GPS Location			
Field Station#		Field Station#			
Pic 15 Desc.		Pic 16 Desc.			
Insert image here		Insert image here			
GPS Location		GPS Location			
Field Station#		Field Station#			
Pic 17 Desc.		Pic 18 Desc.

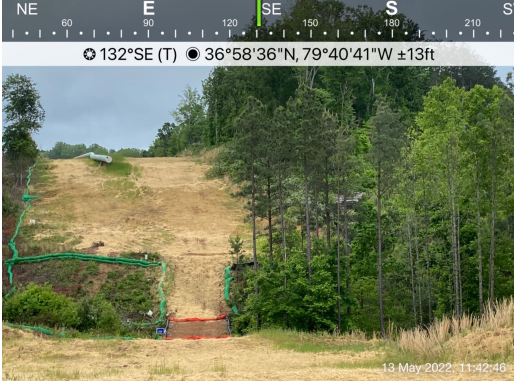
GPS Location	0	GPS Location	0		
Field Station#	14806+00	Field Station#	14851+00		
Pic 1 Desc.	Approximately 14806+00. Overview of ROW.	Pic 2 Desc.	Approximately 14851+00. Overview of ROW.
