Visual Site Inspection Report

Project Name	H-600 Pipeline Spread G	AFE	124300137	Spread	H-600 Pipeline Spread G
Contractor	Precision			Report #	37689
Inspector	Eric Hanlon			Date/Time	5/16/2022 7:26 AM
Permit #	TBD	Inspection Type	VA SWPP	Station Begin	11524+16
State	VA	Inspection Area	Full	Station End	11600+01
County	Giles	Ground	Wet	Temperature (°F)	67.00
Municipality	N/A	Weather	Cloudy	Rain Gauge (in)	0.00
				Rain Accumulation Time (days)	1.00

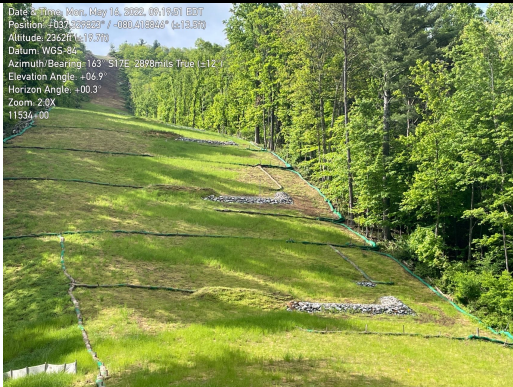
GPS Location		See photo						GPS Location		See photo	
Field Station#		11534+00						Field Station#		11530+00	
Pic 1 Desc.		Permanent water bars and level spreader in place						Pic 2 Desc.		CFS perimeter controls functional

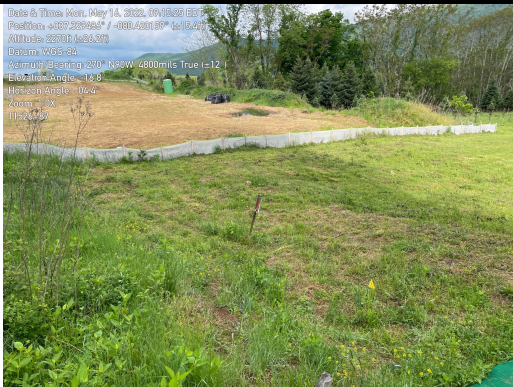
GPS Location		See photo						GPS Location		See photo	
Field Station#		11526+87						Field Station#		11524+16	
Pic 3 Desc.		Clean water drainage feature in place						Pic 4 Desc.		Access road in good condition

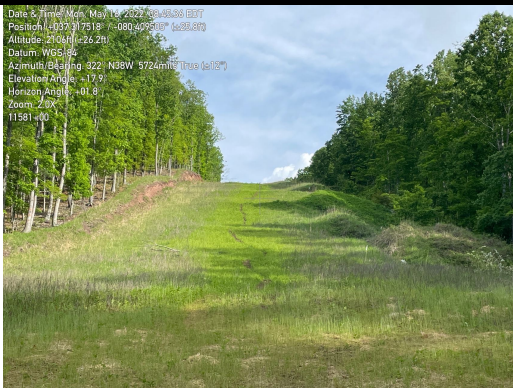
GPS Location		See photo						GPS Location		See photo	
Field Station#		11581+00						Field Station#		11585+00	
Pic 5 Desc.		Water bars in place						Pic 6 Desc.		Resource buffers in place

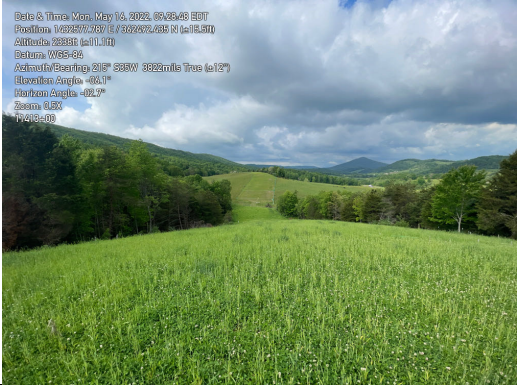
GPS Location	7	GPS Location	8		
Field Station#	11413+00	Field Station#	11396+75		
Pic 7 Desc.	Section of restored RoW showing conditions and controls.		Pic 8 Desc.	Representative photo of permanent waterbar and level spreaders installed.

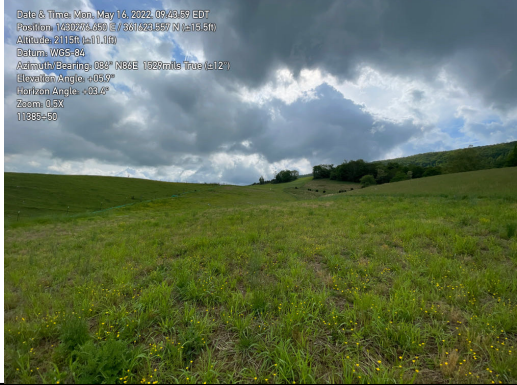
GPS Location	9	GPS Location	10		
Field Station#	11385+50	Field Station#	11367+00		
Pic 9 Desc.	Section of restored RoW showing conditions and controls.		Pic 10 Desc.	Section of restored RoW showing conditions and controls.

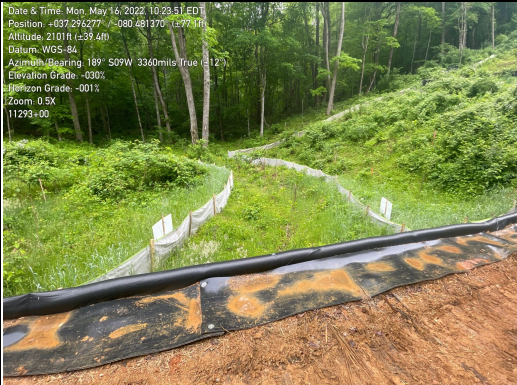
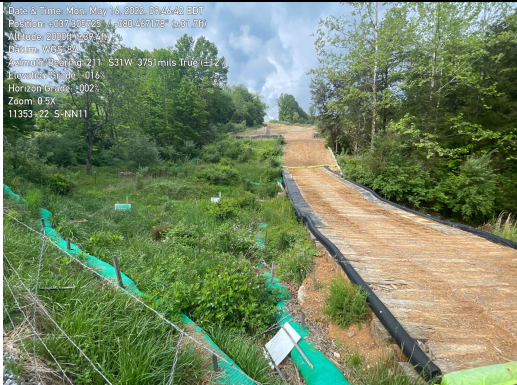
GPS Location	See Photo	GPS Location	See Photo		
Field Station#	11293+00	Field Station#	11353+22		
Pic 7 Desc.	S-MM18 vegetated stream bed.	Pic 8 Desc.	S-NN11 Resource area. Equipment bridge condition, and heavily vegetated buffer zones.		
<div><div><div><div><div><div></div><div></div></div></div><div><div><div></div><div></div></div></div><div><div><div></div></div></div></div></div><div><div>Date & Time: Mon, May 16, 2022, 05:41:00 EDT Position: +037.294927° / -080.455556° (-87° 30' Altitude: 2190ft (+66.7m) Datum: WGS-84 Azimuth Bearing: 301° N35W 5551mils True (+13°) Elevation Grade: +063° Horizon Grade: +003° Zoom: 0.5X 11351+00</div></div></div> <div>

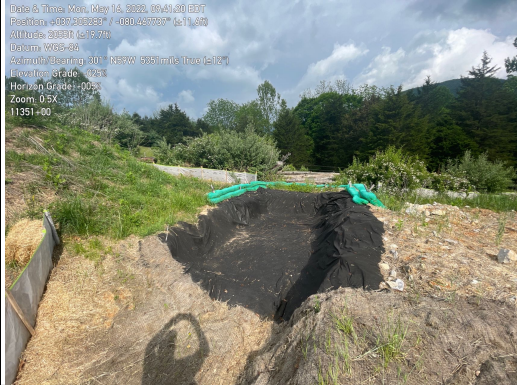
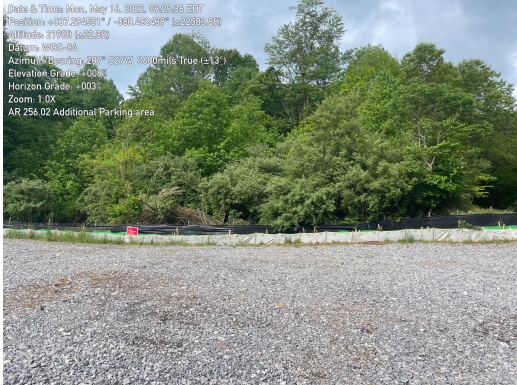
GPS Location	See Photo	GPS Location	See		
Field Station#	11351+00	Field Station#	11353+47		
Pic 9 Desc.	Geo-textile fabric lined sump pit, and water bar end treatment conditions.	Pic 10 Desc.	RCE at the AR 256.02 additional parking area		
<div><div><div><div><div><div></div><div></div></div></div><div><div><div></div><div></div></div></div><div><div><div></div></div></div></div></div><div><div>Date & Time: Mon, May 16, 2022, 09:11:49 EDT Position: +037.295553° / -080.455556° (-87° 30' Altitude: 2124ft (+64.7m) Datum: WGS-84 Azimuth Bearing: 240° NW0E 1001mils True (+13°) Elevation Grade: +002° Horizon Grade: +002° Zoom: 0.5X 11327+50 S-NN12</div></div></div> <div>

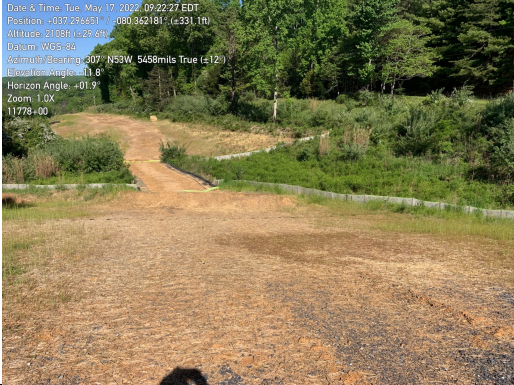
GPS Location	See photo		GPS Location	See photo	
Field Station#	11778+00		Field Station#	11767+44	
Pic 1 Desc.	Section of Row showing conditions and controls		Pic 2 Desc.	S-IJ52 looking upstream

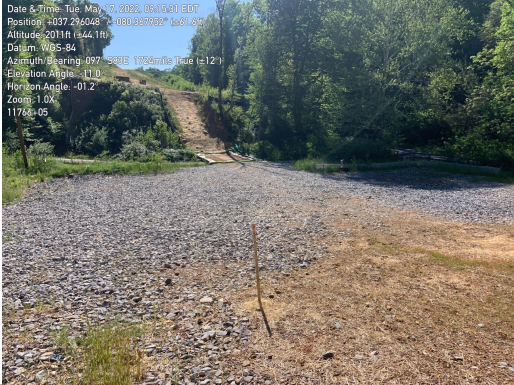
GPS Location	See photo		GPS Location	See photo	
Field Station#	11766+05		Field Station#	11763+00	
Pic 3 Desc.	RCE is maintained and in acceptable condition		Pic 4 Desc.	Section of Row showing conditions and controls

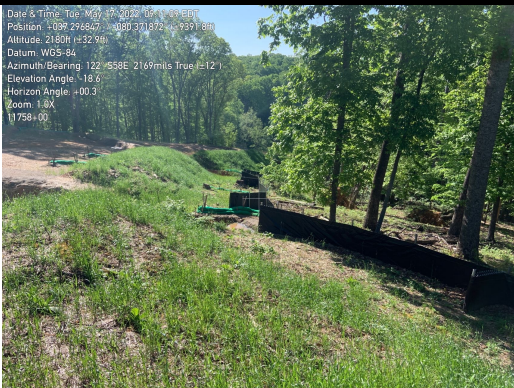
GPS Location	See photo		GPS Location	See photo	
Field Station#	11758+00		Field Station#	11751+00	
Pic 5 Desc.	Section of Row showing conditions and controls		Pic 6 Desc.	Section of Row showing conditions and controls

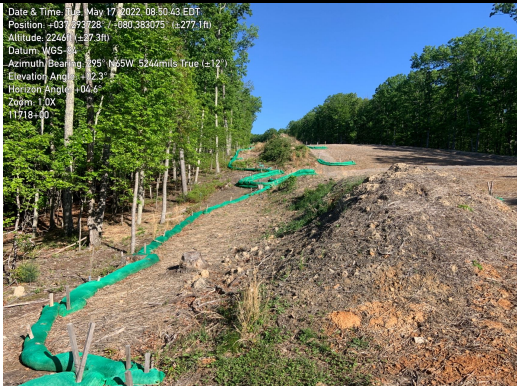
GPS Location	See photo	GPS Location	See photo		
Field Station#	11735+00	Field Station#	11718+00		
Pic 9 Desc.	Section of Row showing conditions and controls	Pic 10 Desc.	CFS is in place and in acceptable condition

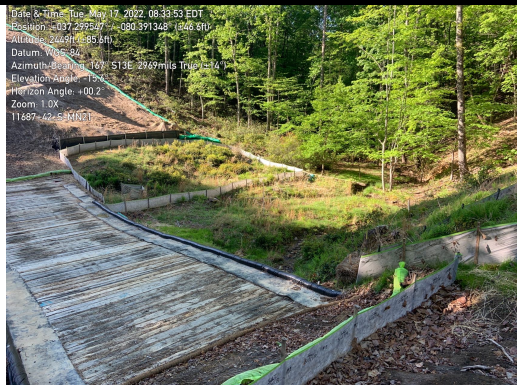
GPS Location	See photo	GPS Location	See photo		
Field Station#	11687+42	Field Station#	11676+75		
Pic 11 Desc.	Section of Row showing conditions and controls at S-MN21	Pic 12 Desc.	Section of Row showing conditions and controls

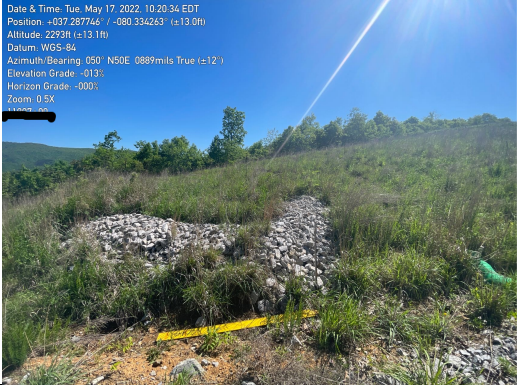
GPS Location	See Photo	GPS Location	See Photo		
Field Station#	11923+00	Field Station#	11900+81		
Pic 7 Desc.	Permanent water bar and level spreader conditions. Final Restoration Area.	Pic 8 Desc.	Heavily vegetated row and level spreader conditions.		
Insert image here		Insert image here			
GPS Location		GPS Location

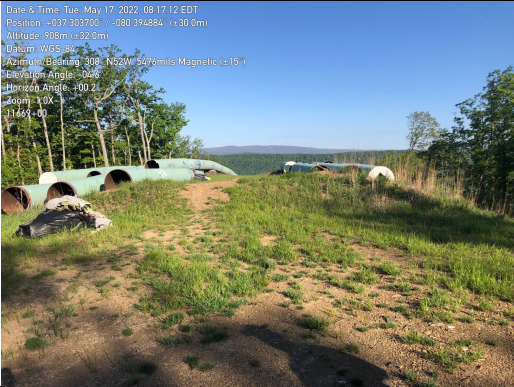
<p>Date & Time: Tue, May 17, 2022 08:17:12 EDT Position: +037.393703, -080.374684 (+30.0m) Altitude: 808m (+32.0m) Datum: WGS-84 Azimuth/Bearing: 308.120W, 540mils Magnetic (+15.1) Elevation Angle: -0.0 Horizon Angle: -0.0 Zoom: 1.0x 11669+00</p>			
GPS Location	On photo	GPS Location	On photo		
Field Station#	11662+50	Field Station#	11669+00		
Pic 1 Desc.	Communication; repair P1 silt fence.	Pic 2 Desc.	ROW stable.

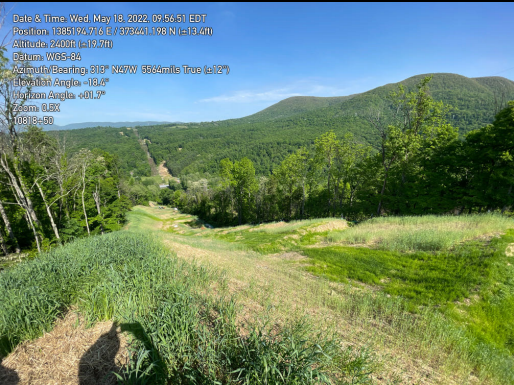
GPS Location	7	GPS Location	8		
Field Station#	10818+50	Field Station#	10809+04		
Pic 7 Desc.	Section of RoW showing conditions and controls.		Pic 8 Desc.	S-Z14.

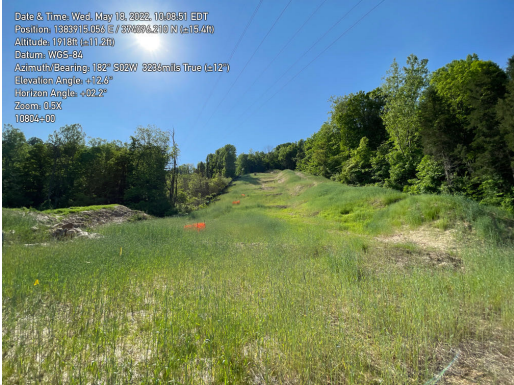
GPS Location	9	GPS Location	10		
Field Station#	10804+00	Field Station#	10801+52		
Pic 9 Desc.	Section of RoW showing conditions and controls.		Pic 10 Desc.	Overview S-Z11/S-Z12/S-Z13.

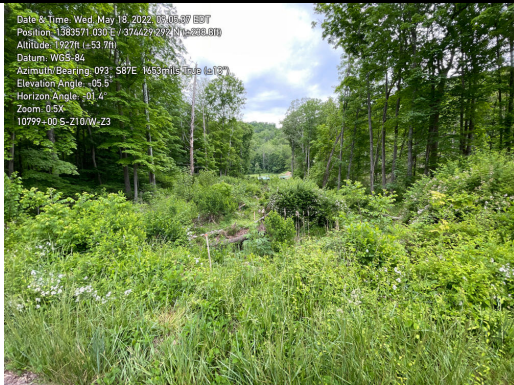
<div>Insert image here</div>			
GPS Location	11	GPS Location			
Field Station#	10799+00	Field Station#			
Pic 11 Desc.	Overview S-Z10/W-Z3		Pic 12 Desc.

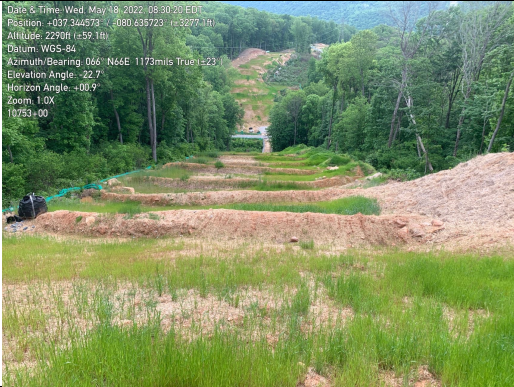
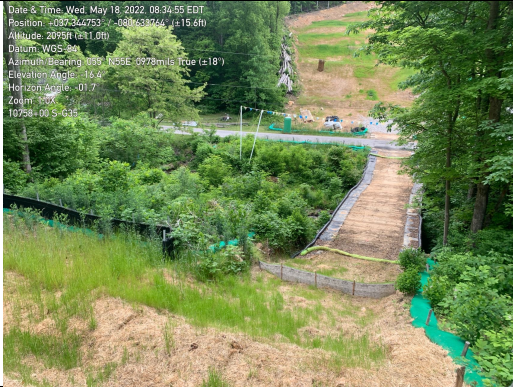
GPS Location	See photo for GPS location.		GPS Location	See photo for GPS location.	
Field Station#	10753+00		Field Station#	10758+00	
Pic 1 Desc.	Waterbars in place. ROW temporarily stabilized with seed, mulch and vegetation growth.		Pic 2 Desc.	Sensitive resource buffer in place at stream S-G35.

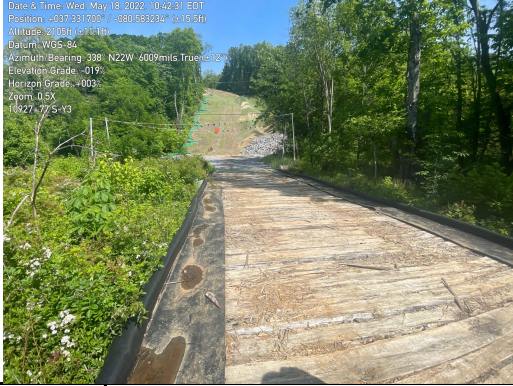
<p>Date & Time: Wed May 18 2022 10:42:31 EDT Position: -697.331382, -680.593007, 10927.77 Altitude: 2100ft (±11.1ft) Datum: WGS-84 Azimuth/Bearing: 338° N22W 4009mils True (±1°) Elevation Grade: -019° Horizon Grade: -003° Zoom: 0.5X 10927+77</p>			
GPS Location	See Photo	GPS Location	See Photo		
Field Station#	10929+70	Field Station#	10927+77		
Pic 1 Desc.	S-Y2 stream bed condition. No Issues at this time.	Pic 2 Desc.	S-Y3 equipment bridge condition.

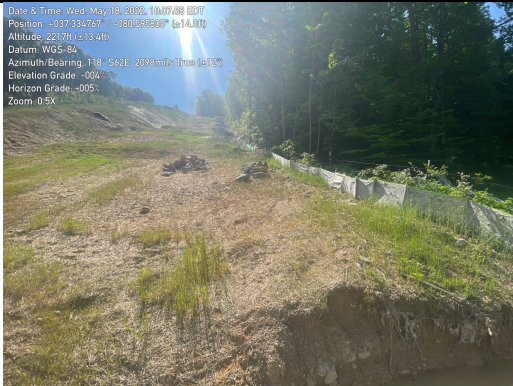
<p>Date & Time: Wed May 18 2022 10:07:08 EDT Position: -697.334767, -680.593668, 10886.00 Altitude: 2217ft (±13.4ft) Datum: WGS-84 Azimuth/Bearing: 118° S62E 2098mils True (±1°) Elevation Grade: -004° Horizon Grade: -005° Zoom: 0.5X</p>			
GPS Location	See Photo	GPS Location	See Photo		
Field Station#	10894+00	Field Station#	10886+00		
Pic 5 Desc.	Stone inlet protection condition. Visible vegetation in the water bar throat.	Pic 6 Desc.	Perimeter P1 silt fencing condition. No Issues at this time.

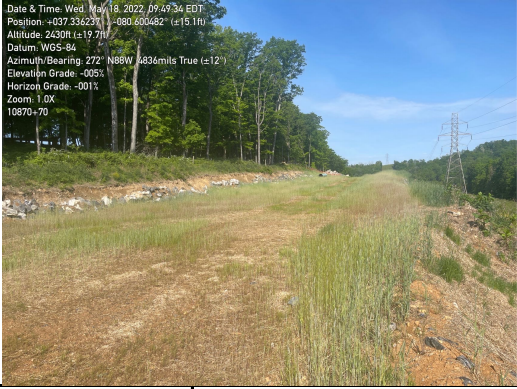
Insert image here	
GPS Location	See Photo	GPS Location			
Field Station#	10870+70	Field Station#			
Pic 13 Desc.	Vegetated earthen berm adjacent to the travel lane.	Pic 14 Desc.			
Insert image here		Insert image here			
GPS Location		GPS Location			
Field Station#		Field Station#			
Pic 15 Desc.		Pic 16 Desc.			
Insert image here		Insert image here			
GPS Location		GPS Location			
Field Station#		Field Station#			
Pic 17 Desc.		Pic 18 Desc.

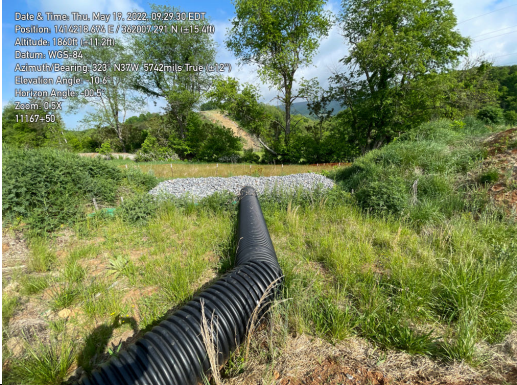
GPS Location	7	GPS Location	8		
Field Station#	11167+50	Field Station#	11176+00		
Pic 7 Desc.	CWDP outlet protection functional.	Pic 8 Desc.	Section of restored RoW showing conditions and controls.

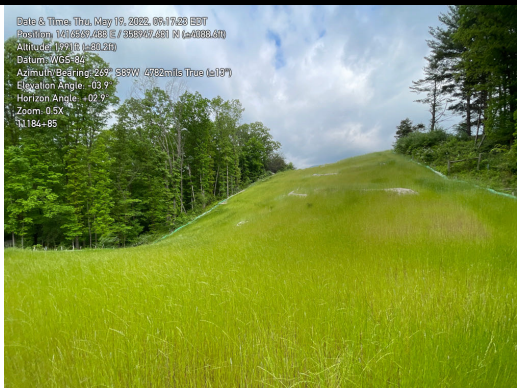
<div style="text-align: center;">Insert image here</div>			
GPS Location	9	GPS Location			
Field Station#	11184+85	Field Station#			
Pic 9 Desc.	Section of restored RoW showing conditions and controls.	Pic 10 Desc.			
<div style="text-align: center;">Insert image here</div>		<div style="text-align: center;">Insert image here</div>			
GPS Location		GPS Location			
Field Station#		Field Station#			
Pic 11 Desc.		Pic 12 Desc.

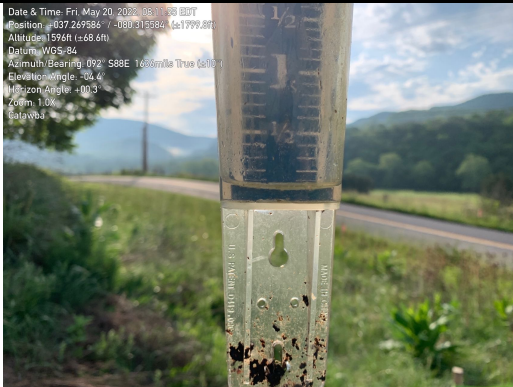
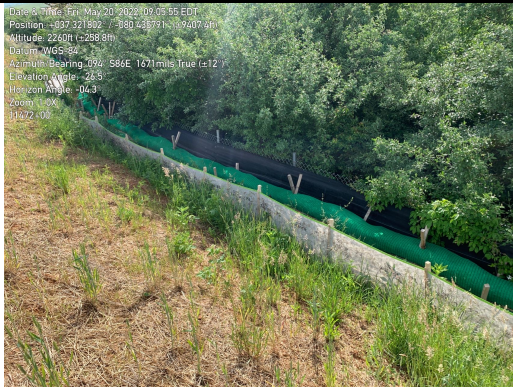
<p>Date & Time: Fri, May 20, 2022 09:51:30 EDT Position: +037.239584 / -080.315584 / 461799.80ft Altitude: 594ft (+68.6m) Datum: WGS 84 Azimuth/Bearing: 092° S88E 163mils True (+10°) Elevation Angle: -35.4° Horizon Angle: +10.3° Zoom: 1.0X 11476+00</p>				<p>Date & Time: Fri, May 20, 2022 09:02:55 EDT Position: +037.214292 / -080.437714 / 19400.56ft Altitude: 2260ft (+288.9m) Datum: WGS 84 Azimuth/Bearing: 076° S86E 167mils True (+12°) Elevation Angle: -26.5° Horizon Angle: -05.3° Zoom: 1.0X 11472+00</p>											
GPS Location				See photo for GPS location.				GPS Location				See photo for GPS location.			
Field Station#				11990+00				Field Station#				11472+00			
Pic 1 Desc.				Rain gauge at Catawba Road reads 0.1 inches.				Pic 2 Desc.				Triple barrier ECDs in place.

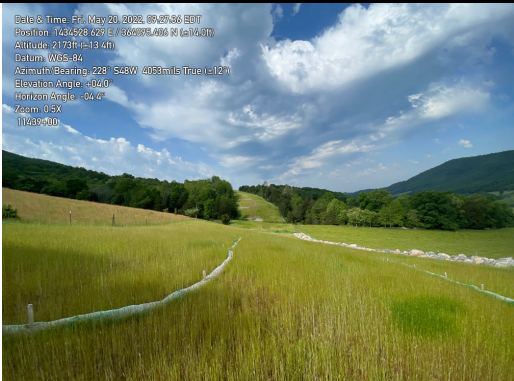
GPS Location	5	GPS Location	6		
Field Station#	11439+00	Field Station#	11342+00		
Pic 5 Desc.	Section of restored RoW showing conditions and controls.	Pic 6 Desc.	Representative photo of permanent waterbar and level spreaders installed.

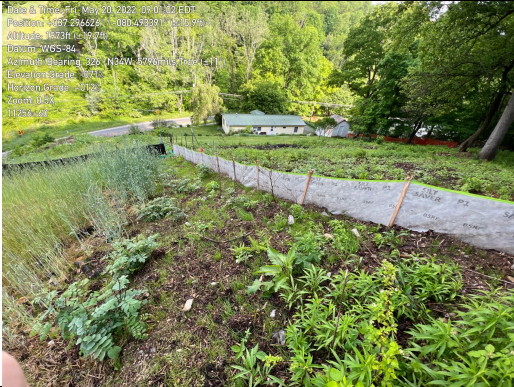
GPS Location	See Photo	GPS Location	See Photo		
Field Station#	11256+60	Field Station#	11314+00		
Pic 1 Desc.	Perimeter ECDs on steep slope. Downslope super silt fence in view. No issues at this time.	Pic 2 Desc.	Perimeter controls to protect off site Karst feature. No Issues.
