Visual Site Inspection Report

Project Name	H-600 Pipeline Spread H	AFE	124300138	Spread	H-600 Pipeline Spread H
Contractor	Precision			Report #	37956
Inspector	Jonathan Altizer			Date/Time	5/23/2022 3:47 PM
Permit #	TBD	Inspection Type	VA SWPP	Station Begin	12865+00
State	VA	Inspection Area	Partial	Station End	13024+00
County	Roanoke	Ground	Wet	Temperature (°F)	65.00
Municipality	N/A	Weather	Light Rain	Rain Gauge (in)	0.60
				Rain Accumulation Time (days)	1.00

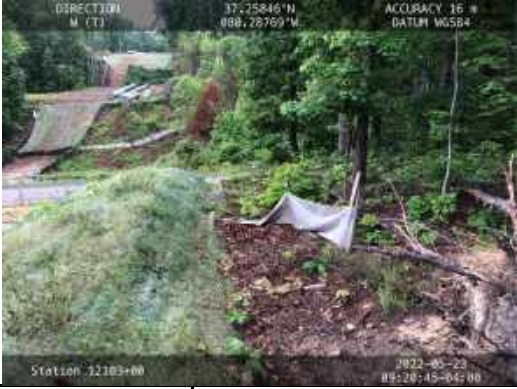
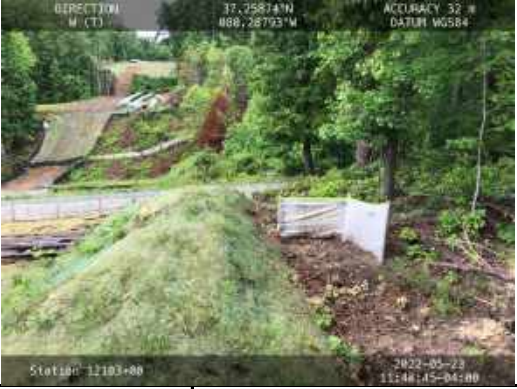
GPS Location	Please see photo for details.		GPS Location	Please see photo for details.	
Field Station#	12103+00		Field Station#	12103+00	
Pic 13 Desc.	Photo shows todays punch list item of damaged P1 silt fence J-hook.		Pic 14 Desc.	Photo shows todays punch list item of damaged P1 silt fence J-hook fixed and back to being in compliance.

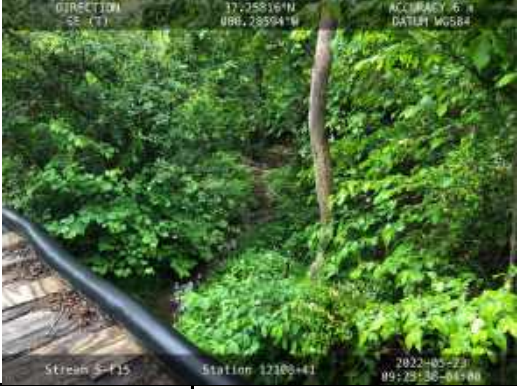
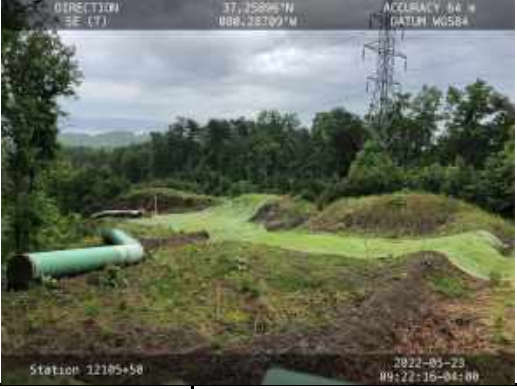
GPS Location	Please see photo for details.		GPS Location	Please see photo for details.	
Field Station#	12108+41		Field Station#	12105+50	
Pic 15 Desc.	Photo shows downstream view of Stream S-F15 from equipment bridge spanning the stream channel.		Pic 16 Desc.	Photo shows the stabilized ROW conditions with water bars and that all ECDs are installed and are functioning as designed.

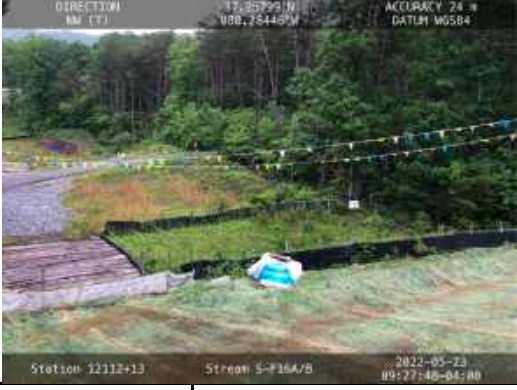
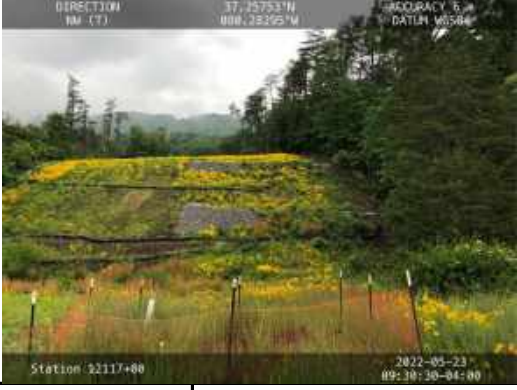
Field Station#	12112+13		Field Station#	12117+00	
Pic 17 Desc.	Photo shows overview of Stream S-F16A/B and its buffer zone from the going away side.		Pic 18 Desc.	Stabilized ROW conditions in permanent restoration area with permanent water bars installed equipped with level spreaders.

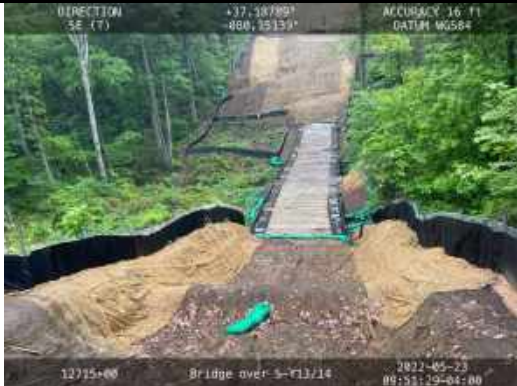
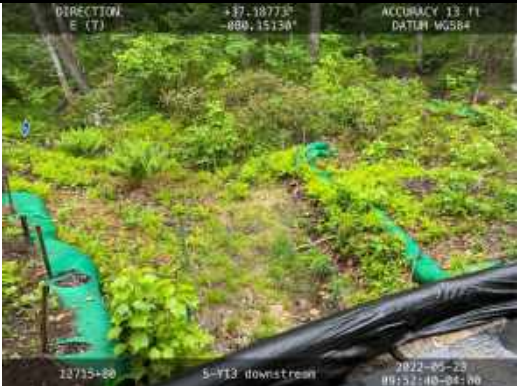
GPS Location	See photo for gps location data.		GPS Location	See photo for gps location data.	
Field Station#	12715+00		Field Station#	12715+80	
Pic 9 Desc.	Photo shows the bridge over streams S-Y13 and S-Y14.		Pic 10 Desc.	Photo shows S-Y13 downstream from the bridge.

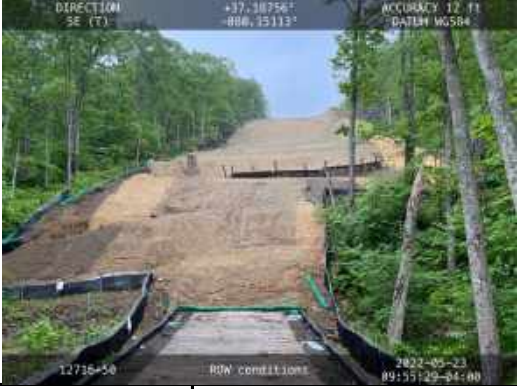
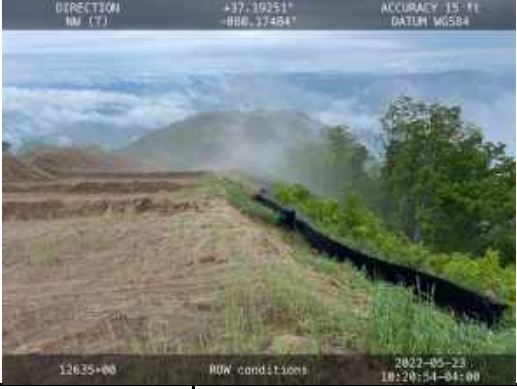
GPS Location	See photo for gps location data.		GPS Location	See photo for gps location data.	
Field Station#	12716+50		Field Station#	12635+00	
Pic 15 Desc.	Photo shows the ROW condition. ECDs are installed and functioning as designed.		Pic 16 Desc.	Photo shows the ROW condition. ECDs are installed and functioning as designed.

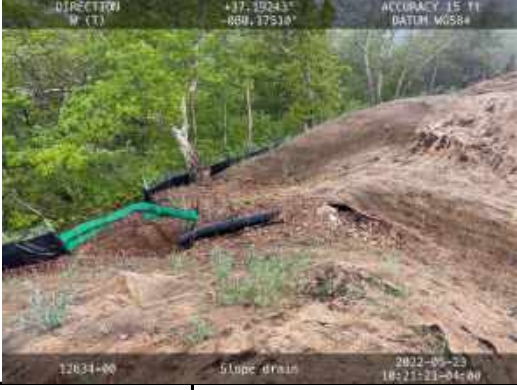
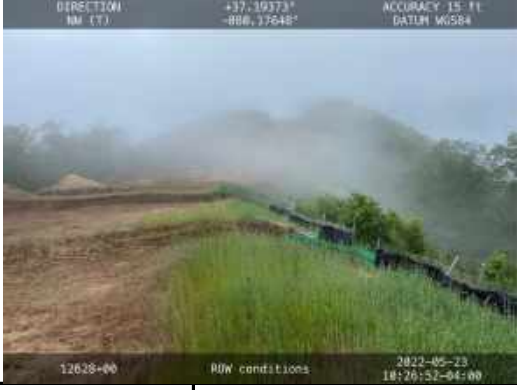
GPS Location	See photo for gps location data.		GPS Location	See photo for gps location data.	
Field Station#	12634+00		Field Station#	12628+00	
Pic 17 Desc.	Photo shows the slope drain.		Pic 18 Desc.	Photo shows the ROW condition. ECDs are installed and functioning as designed.

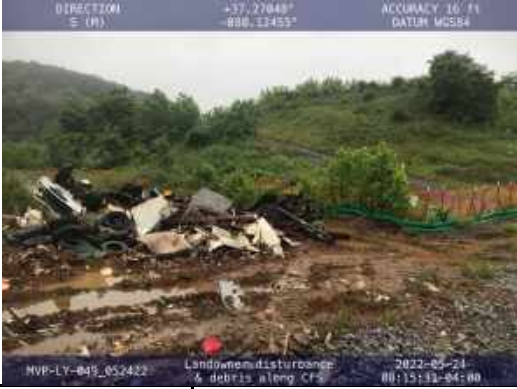
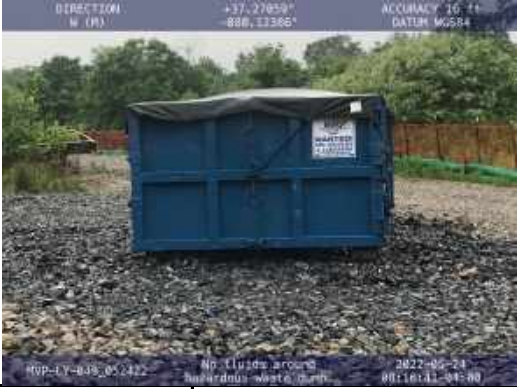
GPS Location	MVP-LY-049 See photo for gps data	GPS Location	MVP-LY-049 See photo for gps data		
Field Station#	+0	Field Station#	+0		
Pic 7 Desc.	Landowner soil disturbance and debris along triple stack compost filter sock and east of feature W-CV21B. Looking S.	Pic 8 Desc.	No fluids or deposits around hazardous waste dumpsters. Looking W.

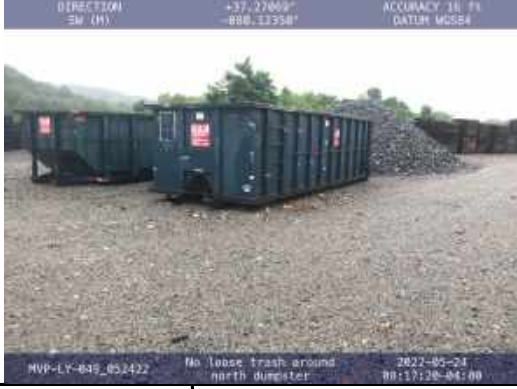
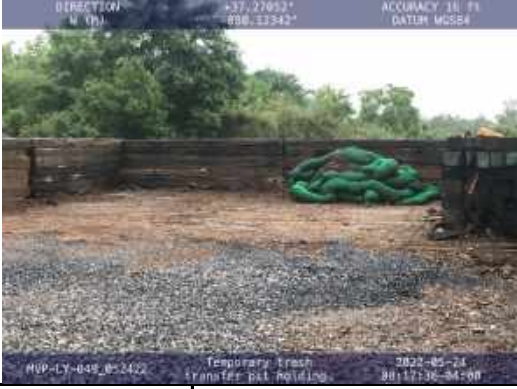
GPS Location	MVP-LY-049 See photo for gps data	GPS Location	MVP-LY-049 See photo for gps data		
Field Station#	+0	Field Station#	+0		
Pic 9 Desc.	No loose trash around north dumpster or in the yard. Looking SW.	Pic 10 Desc.	Temporary trash transfer pit holding debris. Looking W.

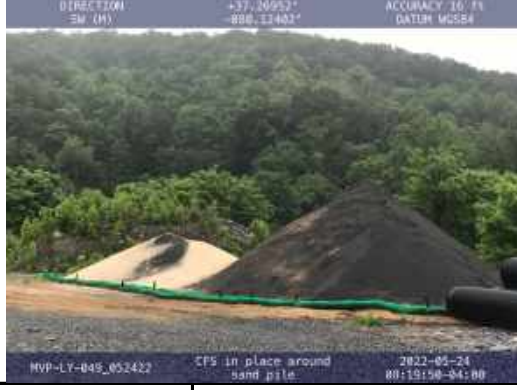
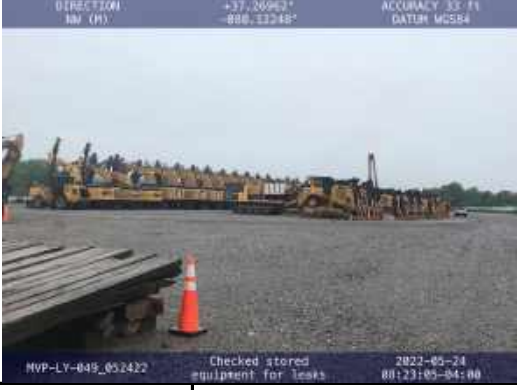
GPS Location	MVP-LY-049 See photo for gps data	GPS Location	MVP-LY-049 See photo for gps data		
Field Station#	+0	Field Station#	+0		
Pic 11 Desc.	Compost filter sock in place and functioning around sand pile. Looking SW.	Pic 12 Desc.	Checked stored equipment for new leaks. No new leaks found. Looking NE.

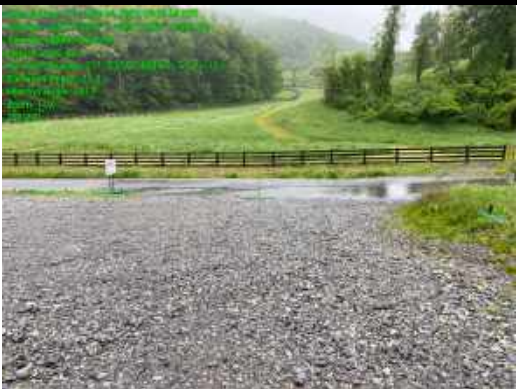
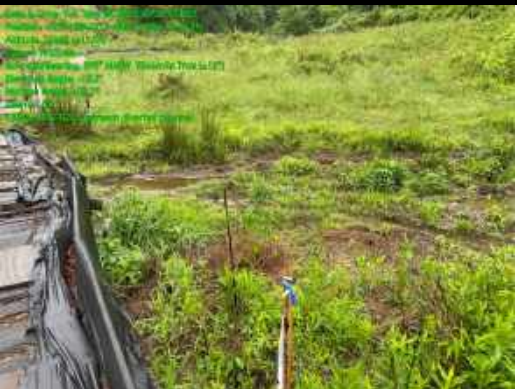
GPS Location	See photo for coordinates.		GPS Location	See photo for coordinates.	
Field Station#	13033+59		Field Station#	13024+08	
Pic 1 Desc.	Entrance to MVP-FR-289 and MVP-FR-290 in acceptable condition.		Pic 2 Desc.	Upstream of equipment bridge, S-G24 outside original banks; continued landowner disturbance noted.

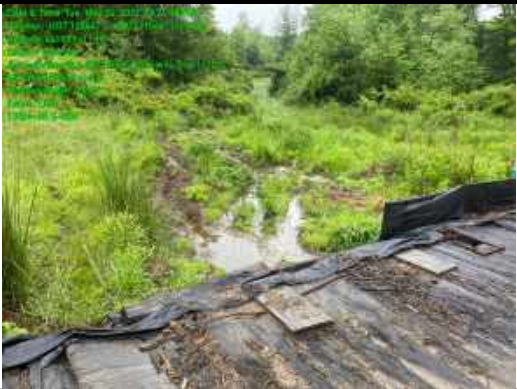
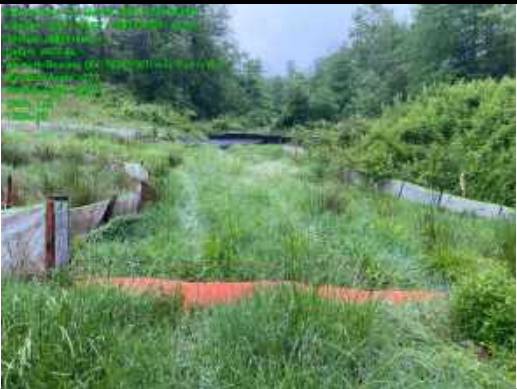
GPS Location	See photo for coordinates.		GPS Location	See photo for coordinates.	
Field Station#	13024+08		Field Station#	13024+08	
Pic 3 Desc.	Upstream of equipment bridge, S-G24 outside original banks; ruts noted from continued landowner disturbance (UTV).		Pic 4 Desc.	Off road vehicle route across right of way, ECDs in acceptable condition.

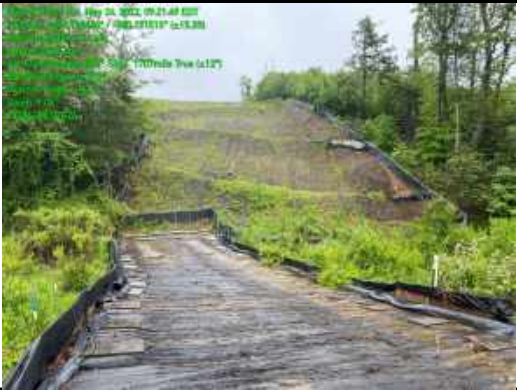
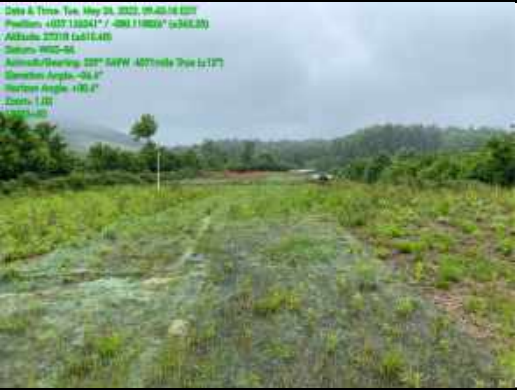
GPS Location	See photo for coordinates.		GPS Location	See photo for coordinates.	
Field Station#	13024+08		Field Station#	13033+00	
Pic 5 Desc.	Bridge over S-G24 and S-G25, right of way stabilized.		Pic 6 Desc.	Right of way stabilized.

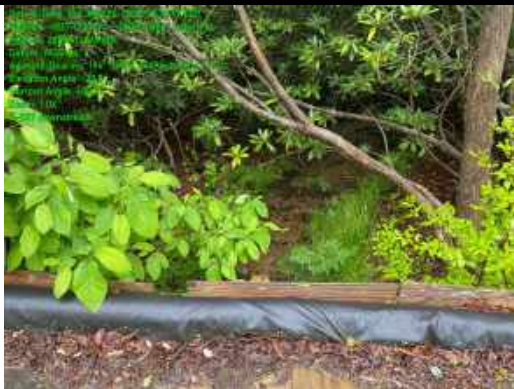
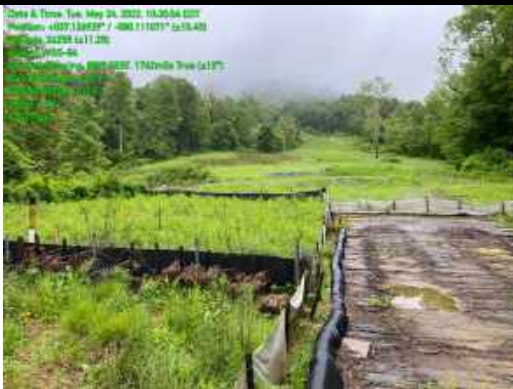
GPS Location		See photo for coordinates.			GPS Location		See photo for coordinates.		
Field Station#		13062+96			Field Station#		13062+96		
Pic 11 Desc.		S-G27, downstream, no turbidity noted.			Pic 12 Desc.		Right of way stabilized.

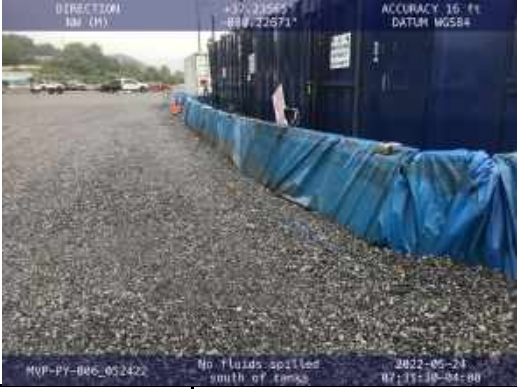
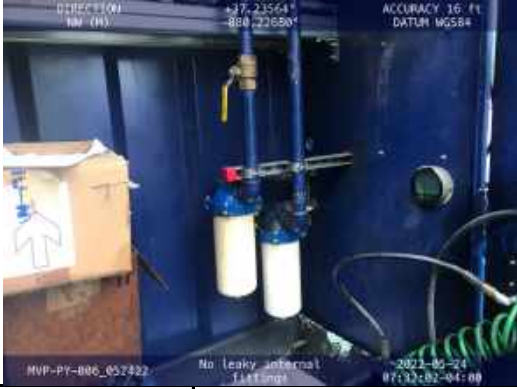
GPS Location	MVP-PY-006 See photo for gps data	GPS Location	MVP-PY-006 See photo for gps data		
Field Station#	+0	Field Station#	+0		
Pic 7 Desc.	Blue Bulk Fuel tanks no fuel spills south of tanks. Looking NW.	Pic 8 Desc.	Blue Bulk Fuel tanks no leaky internal fittings. Looking NW.

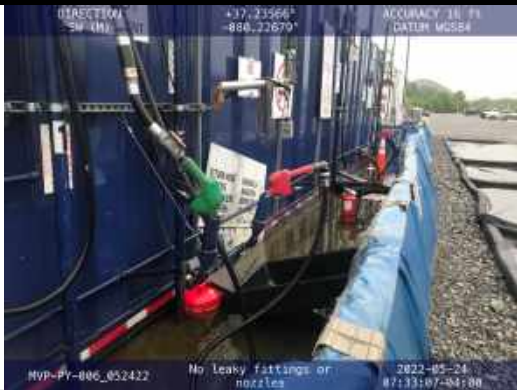
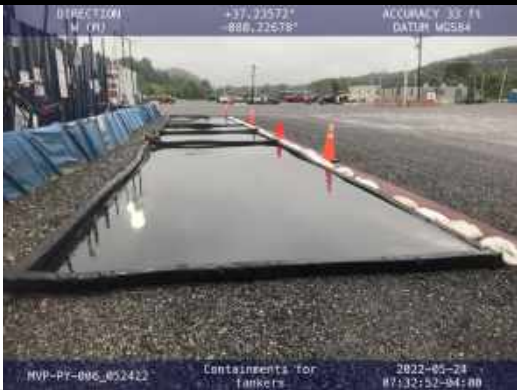
GPS Location	MVP-PY-006 See photo for gps data	GPS Location	MVP-PY-006 See photo for gps data		
Field Station#	+0	Field Station#	+0		
Pic 9 Desc.	Blue Bulk Fuel tanks. No leaky fittings or nozzles. Looking SW.	Pic 10 Desc.	Secondary containments for tankers offloading fuel in place, holding stormwater. Looking W.

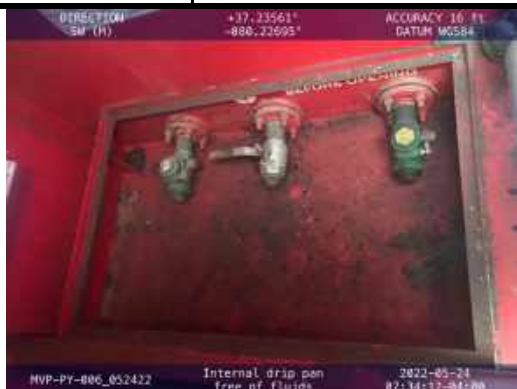
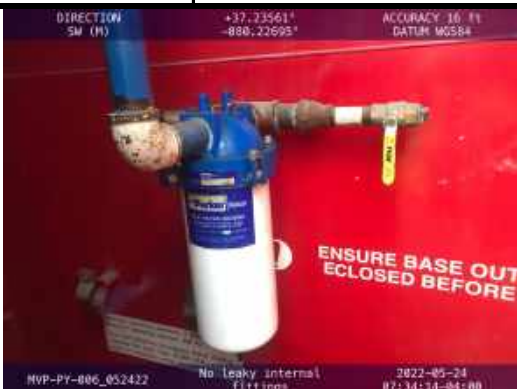
GPS Location	MVP-PY-006 See photo for gps data	GPS Location	MVP-PY-006 See photo for gps data		
Field Station#	+0	Field Station#	+0		
Pic 11 Desc.	Off Road Fuel unit internal drip pan free of fluids. Looking SW.	Pic 12 Desc.	Off Road Fuel unit no leaky internal fittings. Looking SW.

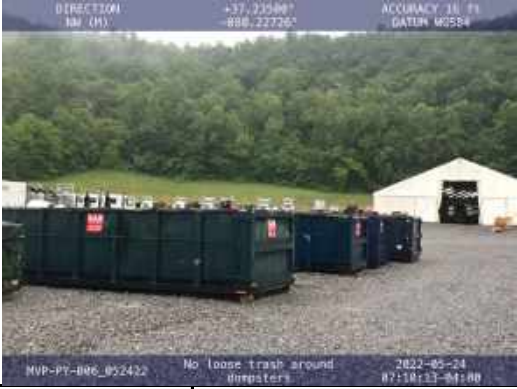
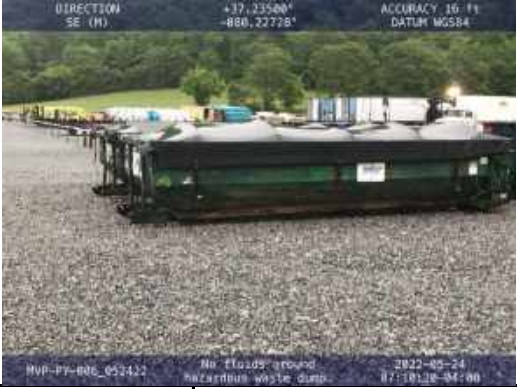
GPS Location	MVP-PY-006 See photo for gps data	GPS Location	MVP-PY-006 See photo for gps data		
Field Station#	+0	Field Station#	+0		
Pic 13 Desc.	No loose trash around dumpsters or in the yard. Looking NW.	Pic 14 Desc.	No fluids or deposits around hazardous waste dumpsters. Looking SE.

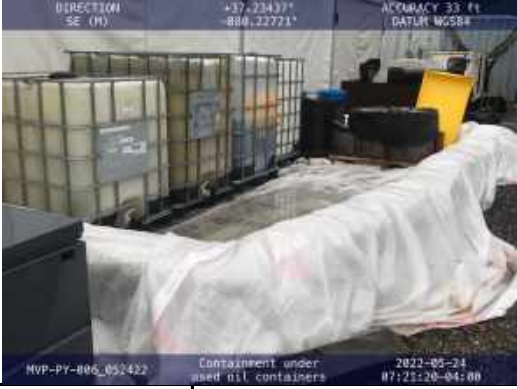
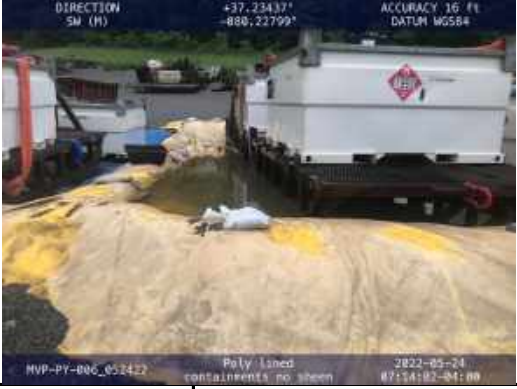
GPS Location	MVP-PY-006 See photo for gps data	GPS Location	MVP-PY-006 See photo for gps data		
Field Station#	+0	Field Station#	+0		
Pic 15 Desc.	Secondary containment under used oil containers, holding stormwater. Looking SE.	Pic 16 Desc.	Poly lined rock berm containments, holding stormwater. Looking SW.

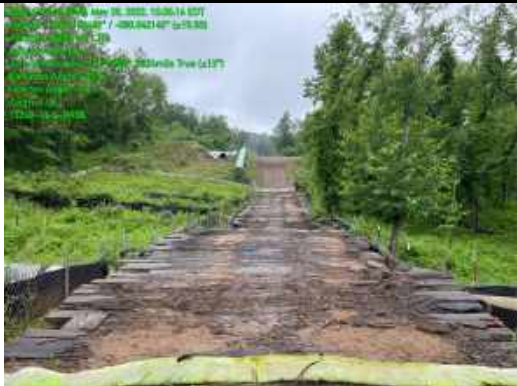
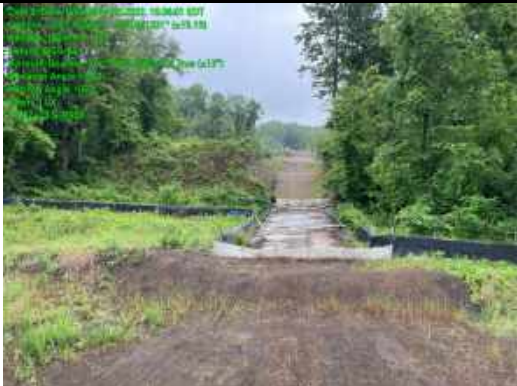
GPS Location	0	GPS Location	0		
Field Station#	13348+46	Field Station#	13352+23		
Pic 9 Desc.	MVP-S-RR08 and corresponding buffer zone in good condition	Pic 10 Desc.	MVP-S-RR09 and corresponding buffer zone in good condition

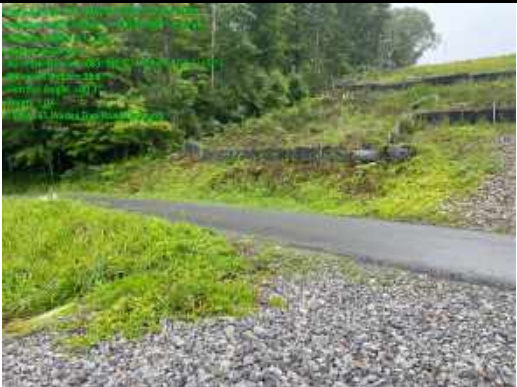
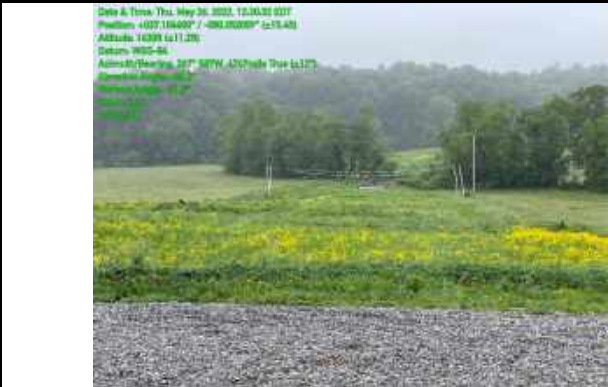
GPS Location	0		GPS Location	0	
Field Station#	13316+21		Field Station#	13314+00	
Pic 1 Desc.	Wades Gap Road Crossing in good condition		Pic 2 Desc.	ROW and ECDs In good condition and stable

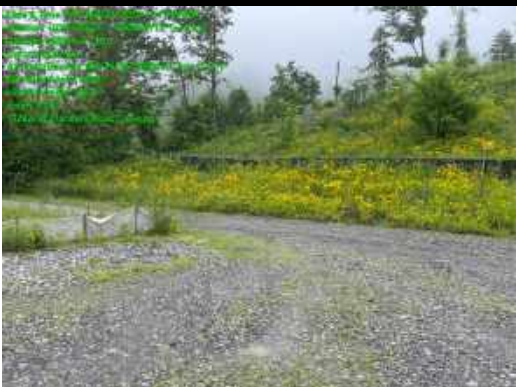
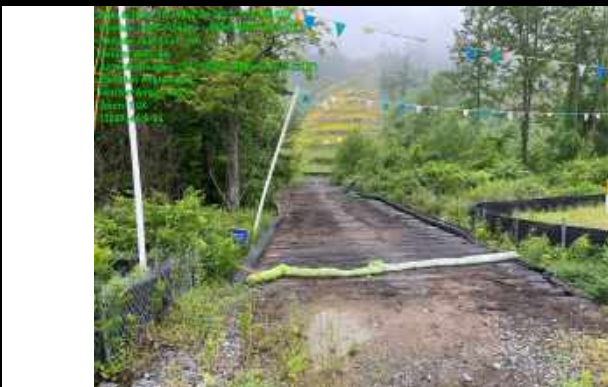
GPS Location	0		GPS Location	0	
Field Station#	13262+62		Field Station#	13260+66	
Pic 3 Desc.	Flanders Road Crossing in good condition		Pic 4 Desc.	MVP-S-II4 and corresponding buffer zone in good condition

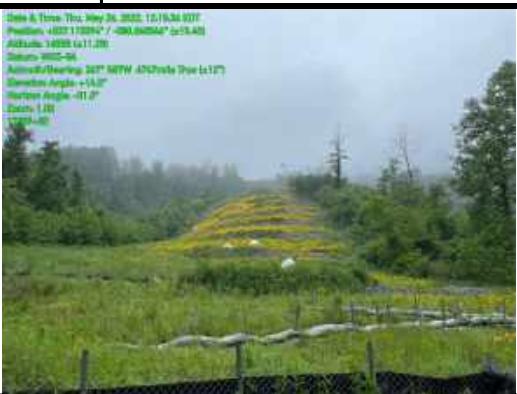
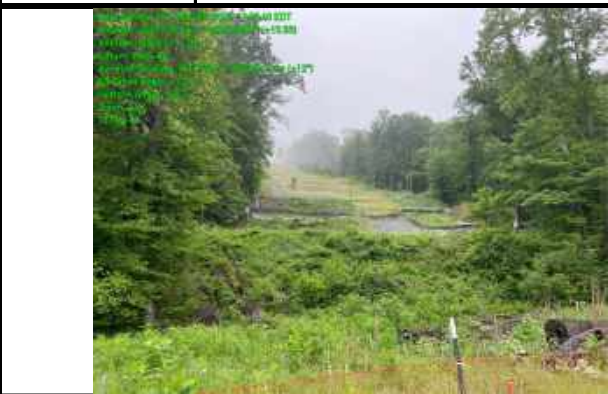
GPS Location	0		GPS Location	0	
Field Station#	13259+00		Field Station#	13196+00	
Pic 5 Desc.	ROW and ECDs In good condition and stable		Pic 6 Desc.	ROW and ECDs In good condition and stable

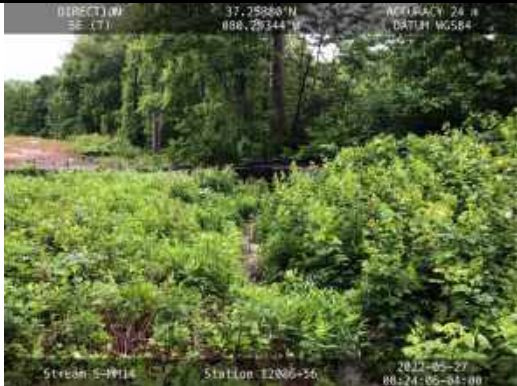
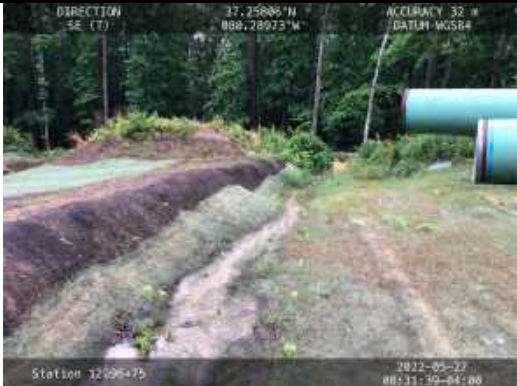
GPS Location	Please see photo for details.	GPS Location	Please see photo for details.		
Field Station#	12086+56	Field Station#	12096+75		
Pic 9 Desc.	Photo shows upstream view of Stream S-MM14.	Pic 10 Desc.	Photo shows stabilized ROW conditions with waterbar, sump and end treatment functioning as designed.

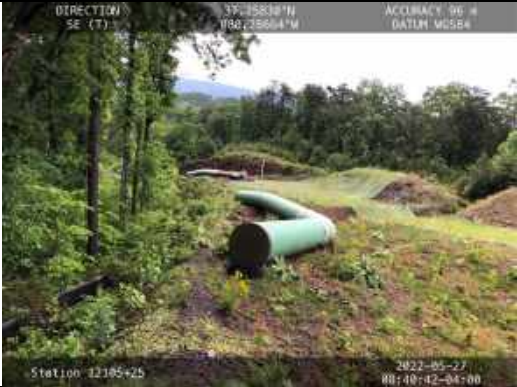
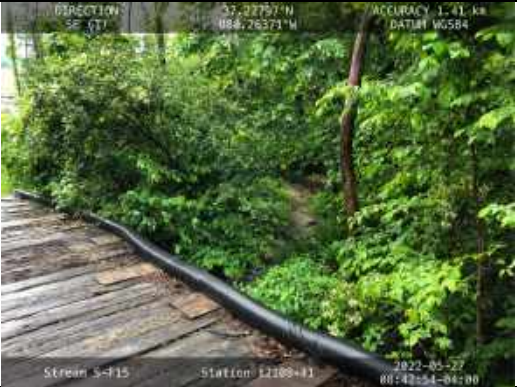
GPS Location	Please see photo for details.		GPS Location	Please see photo for details.	
Field Station#	12105+25		Field Station#	12108+41	
Pic 13 Desc.	Photo shows stabilized ROW conditions and installed ECDs are functioning as designed.		Pic 14 Desc.	Photo shows downstream view of Stream S-F15 from equipment bridge spanning the stream channel.

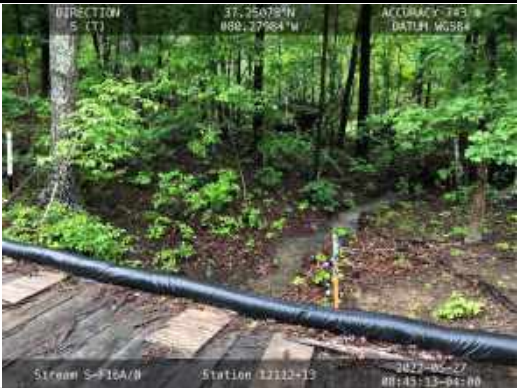
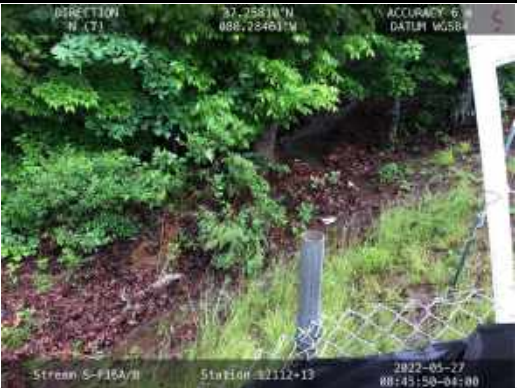
GPS Location	Please see photo for details.		GPS Location	Please see photo for details.	
Field Station#	12112+13		Field Station#	12112+13	
Pic 15 Desc.	Photo shows downstream view of Stream S-F16A/B from equipment bridge spanning the stream channel.		Pic 16 Desc.	Photo shows upstream view of Stream S-F16A/B where it enters the ROW.

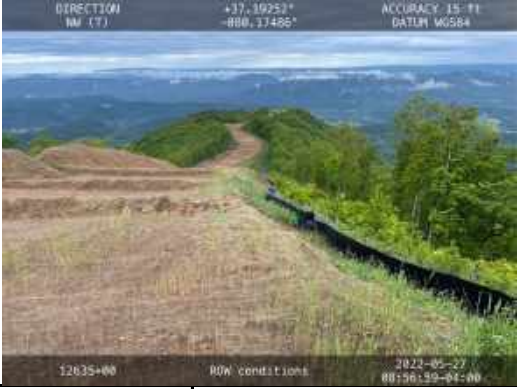
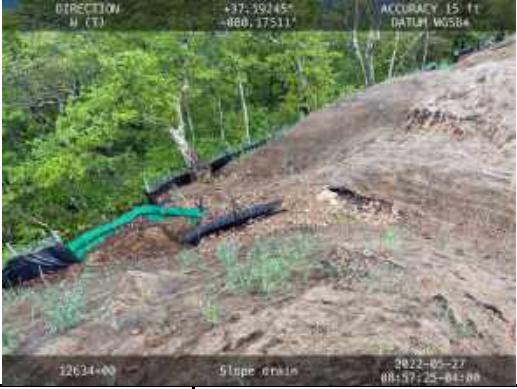
GPS Location	See photo for gps location data.		GPS Location	See photo for gps location data.	
Field Station#	12635+00		Field Station#	12634+00	
Pic 13 Desc.	Photo shows the ROW condition. ECDs are installed and functioning as designed.		Pic 14 Desc.	Photo shows the slope drain.

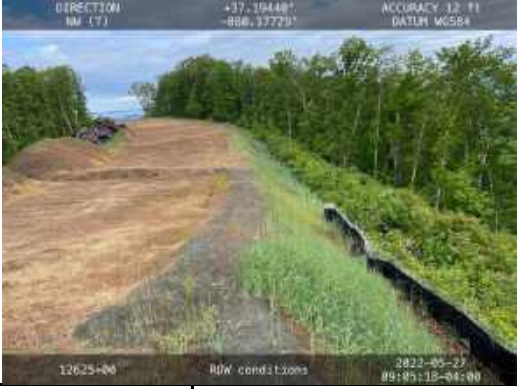
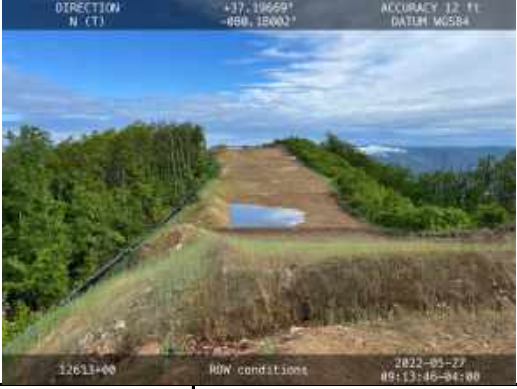
GPS Location	See photo for gps location data.		GPS Location	See photo for gps location data.	
Field Station#	12625+00		Field Station#	12613+00	
Pic 15 Desc.	Photo shows the ROW condition. ECDs are installed and functioning as designed.		Pic 16 Desc.	Photo shows the ROW condition. ECDs are installed and functioning as designed.

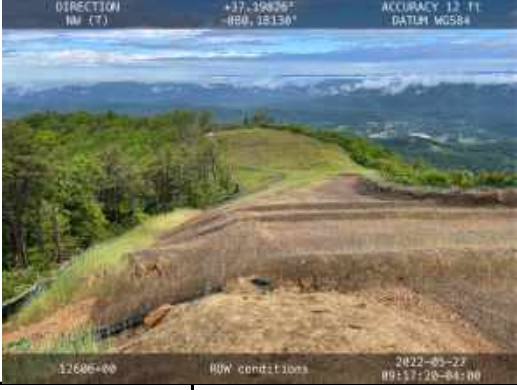
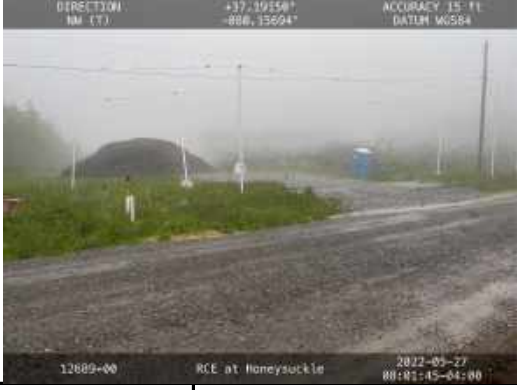
GPS Location	See photo for gps location data.		GPS Location	See photo for gps location data.	
Field Station#	12606+00		Field Station#	12689+00	
Pic 17 Desc.	Photo shows the ROW condition. ECDs are installed and functioning as designed.		Pic 18 Desc.	Photo shows the RCE at Honeysuckle Road.
