Visual Site Inspection Report

Project Name	H-600 Pipeline Spread H	AFE	124300138	Spread	H-600 Pipeline Spread H
Contractor	Precision			Report #	38179
Inspector	Logan Box			Date/Time	5/30/2022 4:48 PM
Permit #	TBD	Inspection Type	VA SWPP	Station Begin	13415+51
State	VA	Inspection Area	Partial	Station End	13525+99
County	Franklin	Ground	Damp	Temperature (°F)	81.00
Municipality	N/A	Weather	Sunny	Rain Gauge (in)	0.00
				Rain Accumulation Time (days)	0.00

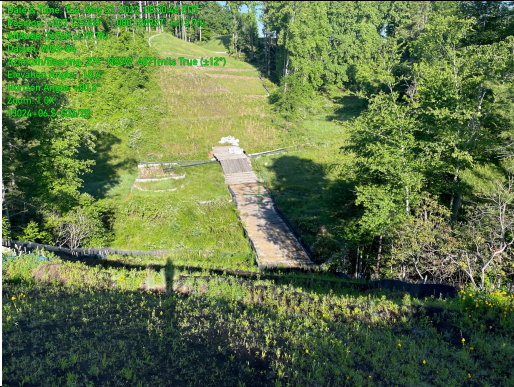
GPS Location	See photo for coordinates.		GPS Location	See photo for coordinates.	
Field Station#	13024+06		Field Station#	13045+00	
Pic 1 Desc.	S-G24 and S-G25; S-G24 flowing in UTV disturbance upstream of bridge.		Pic 2 Desc.	S-H1, ROW stable with vegetation establishing across the ROW.

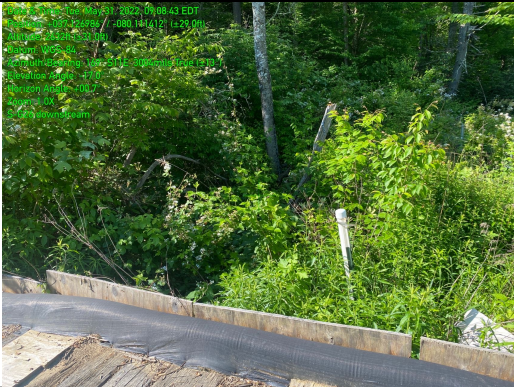
GPS Location	See photo for coordinates.		GPS Location	See photo for coordinates.	
Field Station#	13061+89		Field Station#	13062+96	
Pic 3 Desc.	S-G26, downstream, no turbidity noted in stream, banks well vegetated.		Pic 4 Desc.	S-G27, downstream, no turbidity noted.

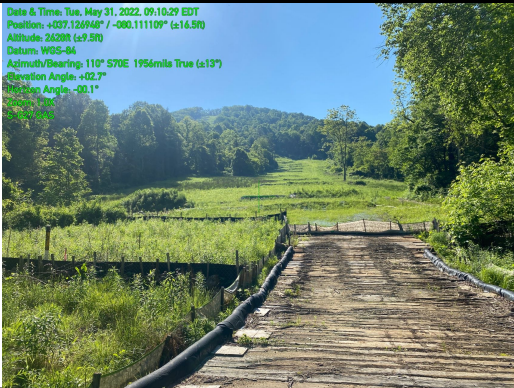
GPS Location	See photo for coordinates.		GPS Location	See photo for coordinates.	
Field Station#	13062+96		Field Station#	13116+00	
Pic 5 Desc.	GAS of S-G27, ROW stable, vegetative cover noted across LOD.		Pic 6 Desc.	ROW stabilized.

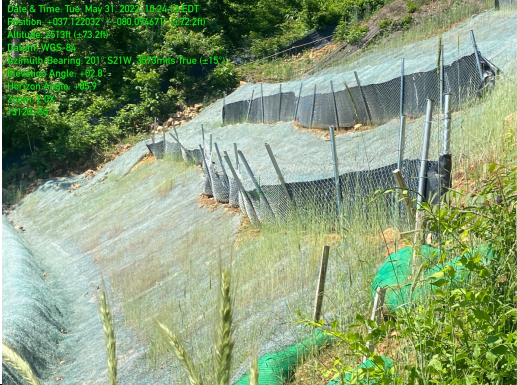
GPS Location	See photo for coordinates.		GPS Location	See photo for coordinates.	
Field Station#	13120+50		Field Station#	13121+00	
Pic 7 Desc.	ROW stabilized, some substrate accumulation noted in SSF across ROW.		Pic 8 Desc.	ROW stabilized, some substrate accumulation noted in SSF across ROW.

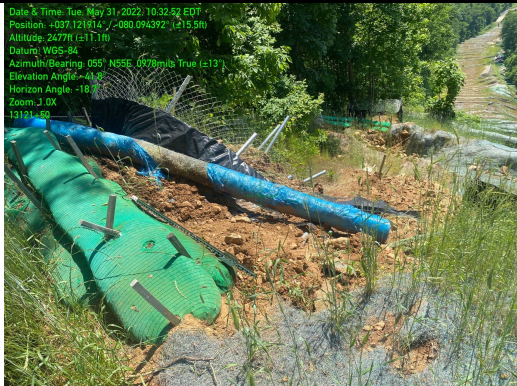
GPS Location	See photo for coordinates.		GPS Location	See photo for coordinates.	
Field Station#	13121+50		Field Station#	13122+00	
Pic 9 Desc.	SSF failure, denuded soil, CFS checks filled with fallen material; added to daily Punch List as maintenance items.		Pic 10 Desc.	Sump filled with material from SSF failure upslope; added to daily Punch List as maintenance item.

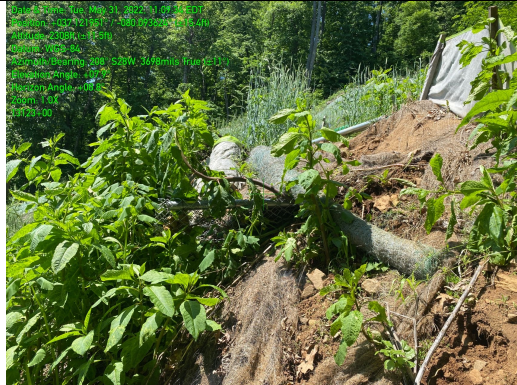
GPS Location	See photo for coordinates.		GPS Location	See photo for coordinates.	
Field Station#	13123+00		Field Station#	13123+50	
Pic 11 Desc.	Super silt fence failed downslope of sump, denuded soil present erosion; added to daily Punch List as maintenance item.		Pic 12 Desc.	Sediment and rock accumulated in waterbar throat from cut bank; added to daily Punch List as maintenance item.

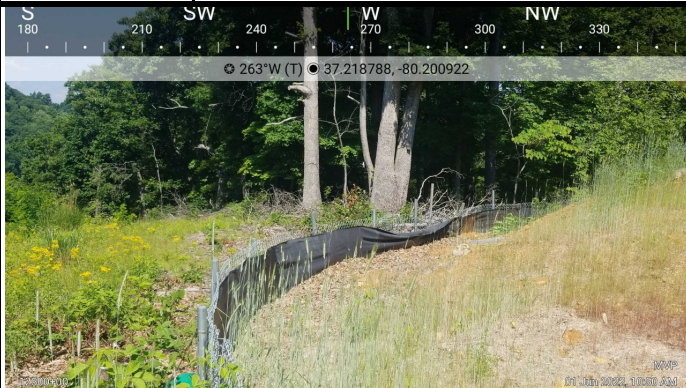
GPS Location	See Above		GPS Location	See Above	
Field Station#	12500+00		Field Station#	12500+00	
Pic 9 Desc.	Punchlist Item: Repair Super Silt Fence.		Pic 10 Desc.	Punchlist Item: Repair Super Silt Fence Completed.

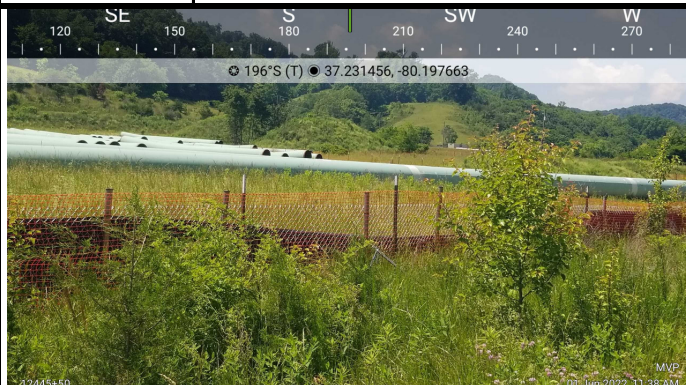
GPS Location	See Above		GPS Location	See Above	
Field Station#	12445+50		Field Station#	12445+50	
Pic 11 Desc.	Punchlist Item: Repair Super Silt Fence.		Pic 12 Desc.	Punchlist Item: Repair Super Silt Fence Completed.

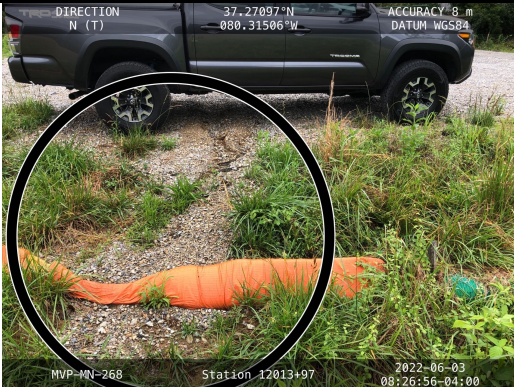
GPS Location	Please see photo for details.		GPS Location	Please see photo for details.	
Field Station#	12013+97		Field Station#	12013+97	
Pic 1 Desc.	Photo shows todays punch list item. Replace flattened triangle diversion and fix rills above.		Pic 2 Desc.	Photo shows resolved punch list item.

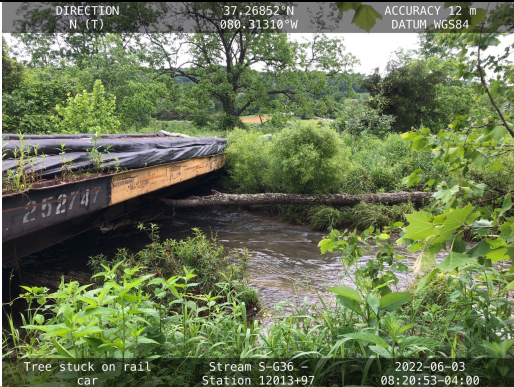
GPS Location	Please see photo for details.		GPS Location	Please see photo for details.	
Field Station#	12013+97		Field Station#	12031+51	
Pic 3 Desc.	Photo shows tree stuck under equipment bridge spanning the stream channel of Stream S-G36.		Pic 4 Desc.	Photo shows downstream view of Stream S-S-G39.
