# Visual Site Inspection Report

<b>Project Name</b>	H-600 Pipeline Spread H	<b>AFE</b>	124300138	<b>Spread</b>	H-600 Pipeline Spread H
<b>Contractor</b>	Precision			<b>Report #</b>	38706
<b>Inspector</b>	Jonathan Altizer			<b>Date/Time</b>	6/13/2022 3:48 PM
<b>Permit #</b>	TBD	<b>Inspection Type</b>	VA SWPP	<b>Station Begin</b>	12725+00
<b>State</b>	VA	<b>Inspection Area</b>	Partial	<b>Station End</b>	12865+00
<b>County</b>	Roanoke	<b>Ground</b>	Dry	<b>Temperature (°F)</b>	82.00
<b>Municipality</b>	N/A	<b>Weather</b>	Sunny	<b>Rain Gauge (in)</b>	0.00
				<b>Rain Accumulation Time (days)</b>	3.00

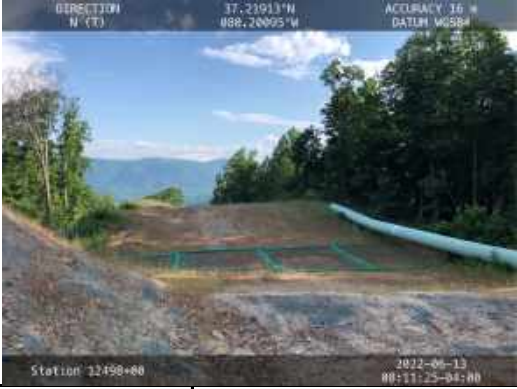
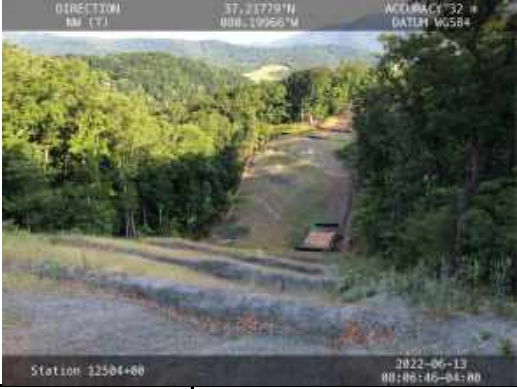
<b>GPS Location</b>	Please see photo for details.		<b>GPS Location</b>	Please see photo for details.	
<b>Field Station#</b>	12498+00		<b>Field Station#</b>	12504+00	
<b>Pic 7 Desc.</b>	Photo shows the stabilized ROW conditions with water bars and that all ECDs are installed and are functioning as designed.		<b>Pic 8 Desc.</b>	Photo shows the stabilized ROW conditions with water bars and that all ECDs are installed and are functioning as designed.

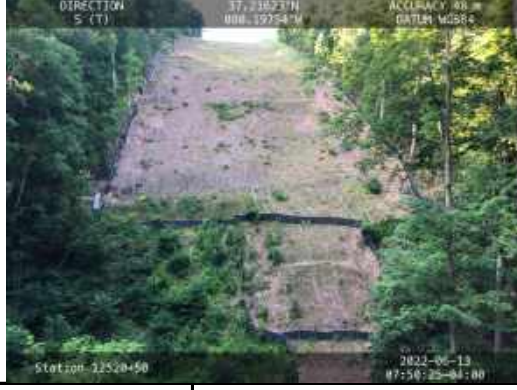
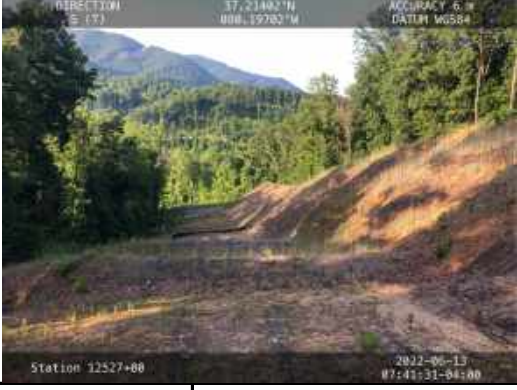
<b>GPS Location</b>	Please see photo for details.		<b>GPS Location</b>	Please see photo for details.	
<b>Field Station#</b>	12520+50		<b>Field Station#</b>	12527+00	
<b>Pic 11 Desc.</b>	Photo shows the stabilized ROW conditions with water bars and that all ECDs are installed and are functioning as designed.		<b>Pic 12 Desc.</b>	Photo shows the stabilized ROW conditions with water bars and that all ECDs are installed and are functioning as designed.

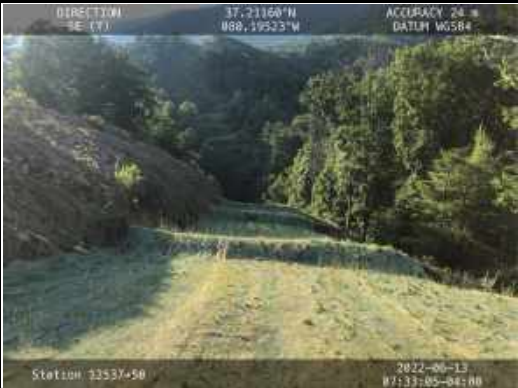
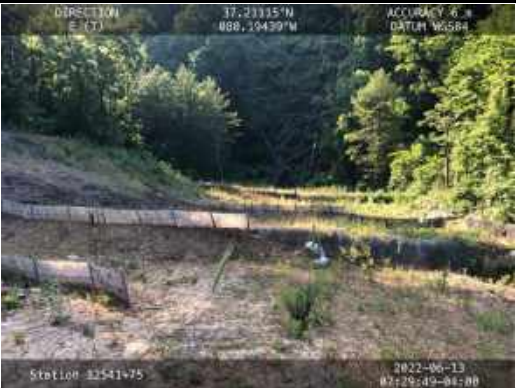
<b>GPS Location</b>	Please see photo for details.		<b>GPS Location</b>	Please see photo for details.	
<b>Field Station#</b>	12337+50		<b>Field Station#</b>	12541+75	
<b>Pic 15 Desc.</b>	Photo shows the stabilized ROW conditions with water bars and that all ECDs are installed and are functioning as designed.		<b>Pic 16 Desc.</b>	Photo shows the stabilized ROW conditions with water bars and that all ECDs are installed and are functioning as designed.

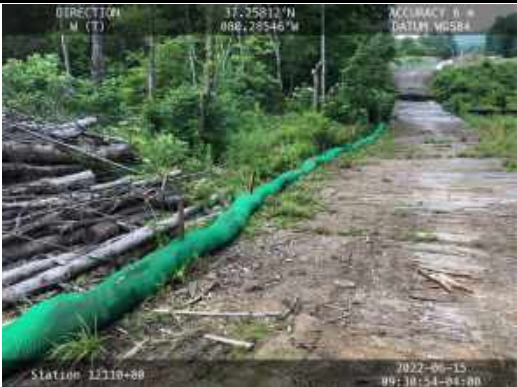
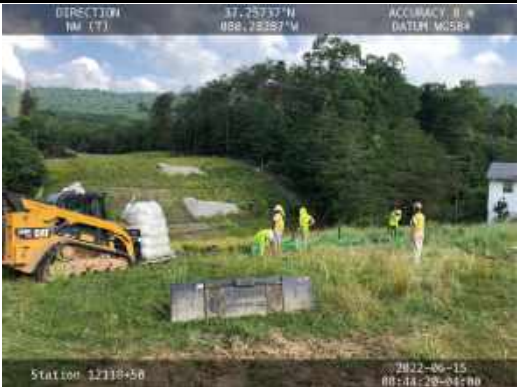
<b>GPS Location</b>	Please see photo for details.		<b>GPS Location</b>	Please see photo for details.	
<b>Field Station#</b>	12110+00		<b>Field Station#</b>	12118+50	
<b>Pic 17 Desc.</b>	Photo shows punch list item resolved. Item consisted of replacing flat CFS.		<b>Pic 18 Desc.</b>	Photo shows environmental crew resolving punch list item. Item consisted of replacing deteriorated CFS.

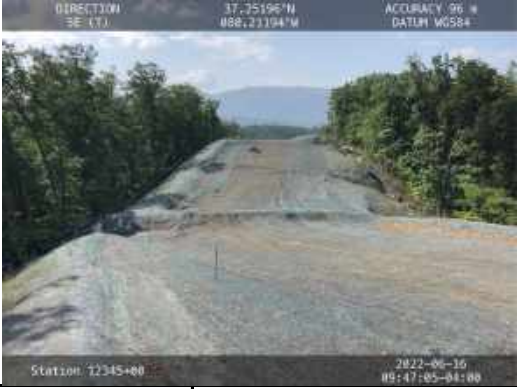
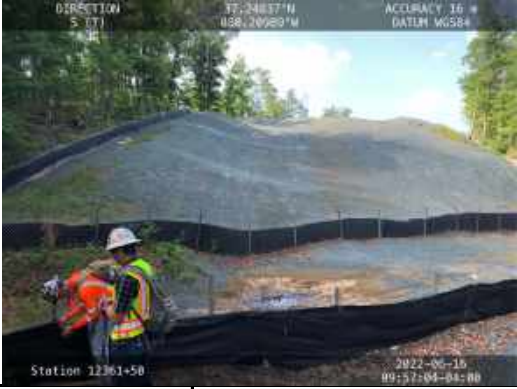
<b>GPS Location</b>	Please see photo for details.		<b>GPS Location</b>	Please see photo for details.	
<b>Field Station#</b>	12345+00		<b>Field Station#</b>	12361+50	
<b>Pic 7 Desc.</b>	Photo shows the stabilized ROW conditions with water bars and that all ECDs are installed and are functioning as designed.		<b>Pic 8 Desc.</b>	Photo shows stabilized ROW conditions and environmental employees tightening SSF fabric on chain link.

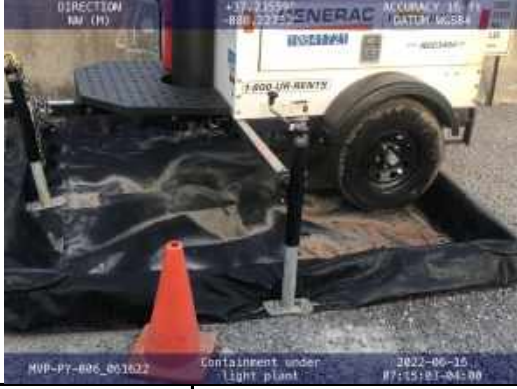
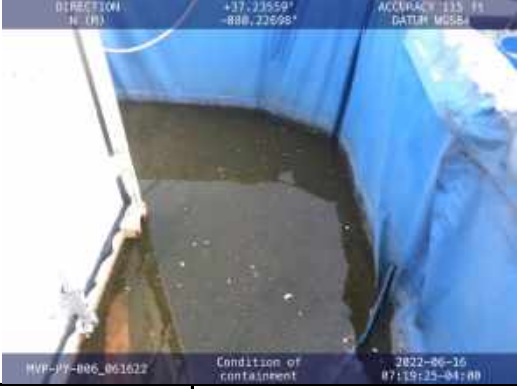
<b>GPS Location</b>	MVP-PY-006 See photo for gps data	<b>GPS Location</b>	MVP-PY-006 See photo for gps data		
<b>Field Station#</b>	+0	<b>Field Station#</b>	+0		
<b>Pic 9 Desc.</b>	Secondary containment under light plant. Free of fluids. Looking NW.	<b>Pic 10 Desc.</b>	Off Road Fuel unit containment holding stormwater. Looking N.

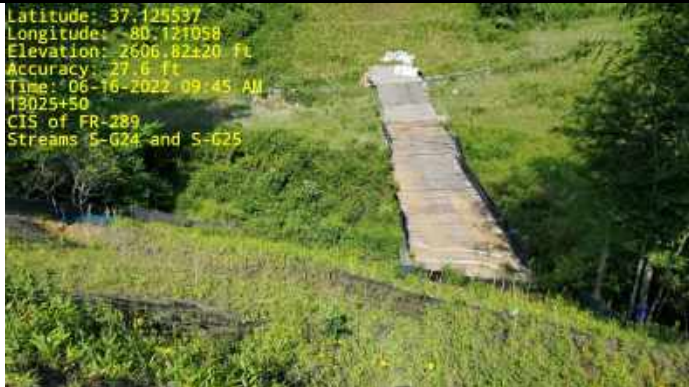
GPS Location	See pic		GPS Location	See pic	
Field Station#	13024+00		Field Station#	13025+50	
Pic 1 Desc.	GAS of streams S-G24 and S-G25.		Pic 2 Desc.	Streams S-G24 and S-G25 from the GAS.	
<div>Latitude: 37.127407 Longitude: -80.117996 Elevation: 2752.23±15 ft Accuracy: 12.5 ft Time: 06-16-2022 09:56 AM 13039+00 GAS of FR-289 replace damaged P1</div>

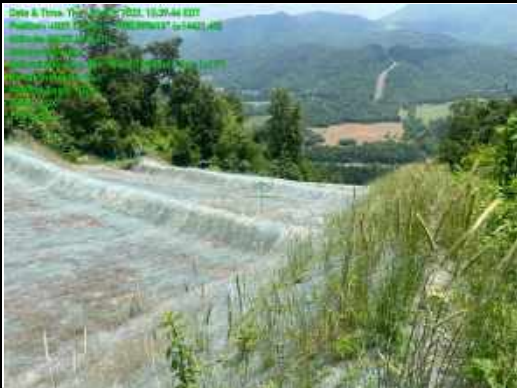
<b>GPS Location</b>	See pic	<b>GPS Location</b>	See pic		
<b>Field Station#</b>	13090+00	<b>Field Station#</b>	13116+50		
<b>Pic 15 Desc.</b>	Landowner UTV activities inside the ROW. No signs of sedimentation or erosion at this time. Significant vegetation in throughout the area.	<b>Pic 16 Desc.</b>	Current ROW conditions.

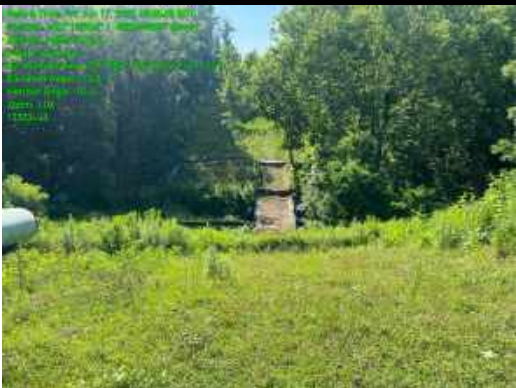
GPS Location	See photo for coordinates.		GPS Location	See photo for coordinates.	
Field Station#	13323+43		Field Station#	13325+30	
Pic 5 Desc.	S-GH14, silt fence perimeter controls were in acceptable condition.		Pic 6 Desc.	S-GH14, upstream looking downstream, long term bank erosion along right descending bank present.
