Visual Site Inspection Report

Project Name	H-600 Pipeline Spread H	AFE	124300138	Spread	H-600 Pipeline Spread H
Contractor	Precision			Report #	38947
Inspector	Jordan Davis			Date/Time	6/20/2022 3:00 PM
Permit #	TBD	Inspection Type	VA SWPP	Station Begin	12119+17
State	VA	Inspection Area	Partial	Station End	12284+75
County	Montgomery	Ground	Dry	Temperature (°F)	75.00
Municipality	N/A	Weather	Cloudy	Rain Gauge (in)	0.00
				Rain Accumulation Time (days)	0.00

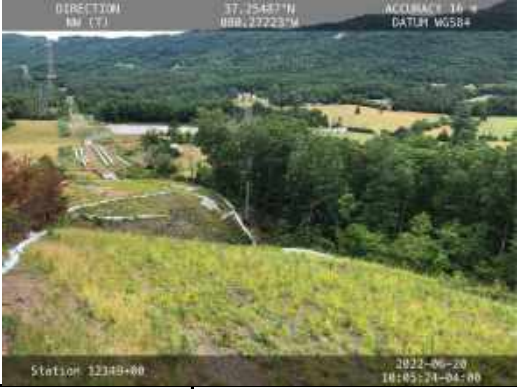
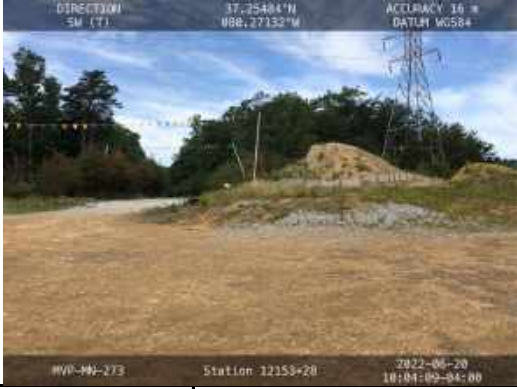
GPS Location	Please see photo for details.		GPS Location	Please see photo for details.	
Field Station#	12149+00		Field Station#	12153+28	
Pic 7 Desc.	Photo shows stabilized permanent restoration section of ROW with permanent slope breakers and level spreaders.		Pic 8 Desc.	Photo shows stabilized ROW conditions along with MVP-MN-273 where it intersects the ROW.

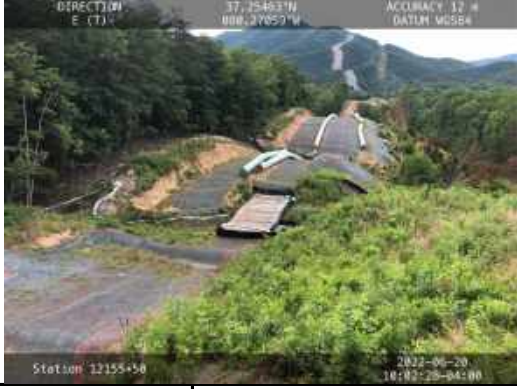
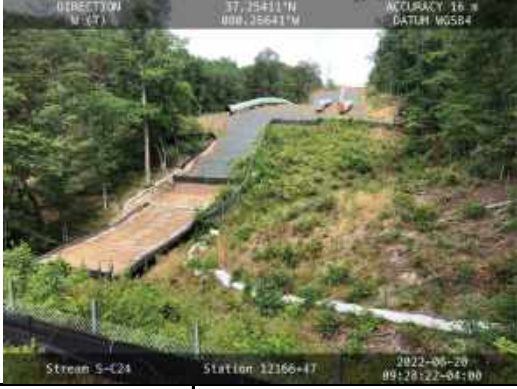
GPS Location	Please see photo for details.		GPS Location	Please see photo for details.	
Field Station#	12155+50		Field Station#	12166+47	
Pic 9 Desc.	Photo shows the stabilized ROW conditions with water bars and that all ECDs are installed and are functioning as designed.		Pic 10 Desc.	Photo shows overview of Stream S-C24 and its buffer zone from the going away side.

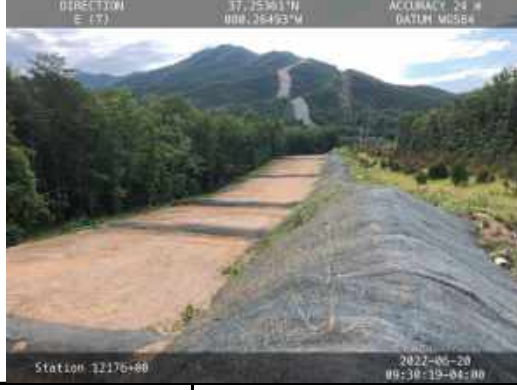
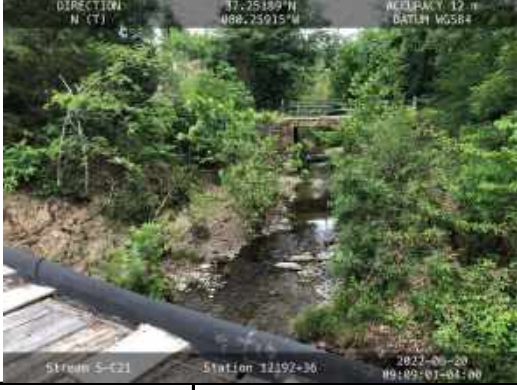
Field Station#	12176+00		Field Station#	12192+36	
Pic 11 Desc.	Photo shows the stabilized ROW conditions with water bars and that all ECDs are installed and are functioning as designed.		Pic 12 Desc.	Photo shows upstream view of Stream S-C21 from the equipment bridge spanning the stream channel.

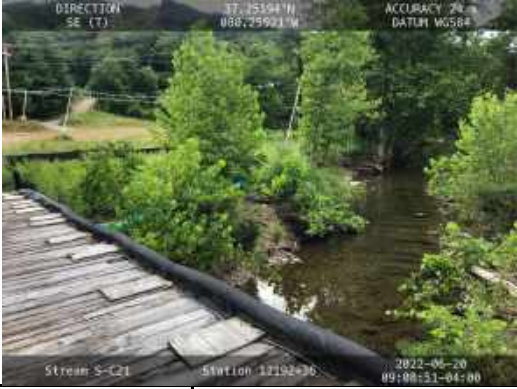
<p>Stream S-C21 Station 12192+36 2022-06-20 09:08:31-04:00</p>

<p>MVP-MN-275 Station 12198+90 2022-06-20 09:11:37-04:00</p>			
GPS Location	Please see photo for details.		GPS Location	Please see photo for details.	
Field Station#	12192+36		Field Station#	12198+90	
Pic 13 Desc.	Photo shows downstream view of Stream S-C21 from the equipment bridge spanning the stream channel.		Pic 14 Desc.	Photo shows current condition of MVP-MN-275.

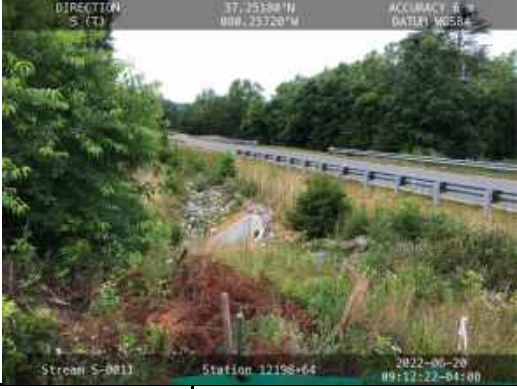
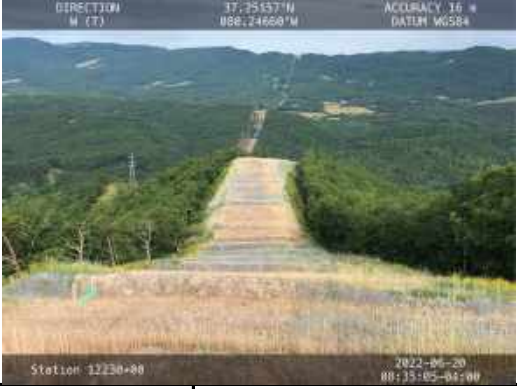
<p>Stream S-0011 Station 12198+64 2022-06-20 09:12:22-04:00</p>

<p>Station 12230+00 2022-06-20 09:15:05-04:00</p>			
GPS Location	Please see photo for details.		GPS Location	Please see photo for details.	
Field Station#	12198+64		Field Station#	12230+00	
Pic 15 Desc.	Photo shows overview of Stream S-0011.		Pic 16 Desc.	Photo shows the stabilized ROW conditions with water bars and that all ECDs are installed and are functioning as designed.

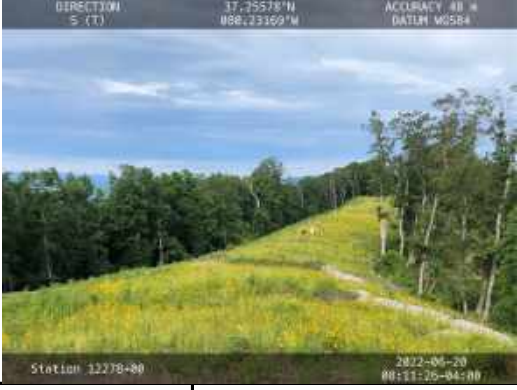
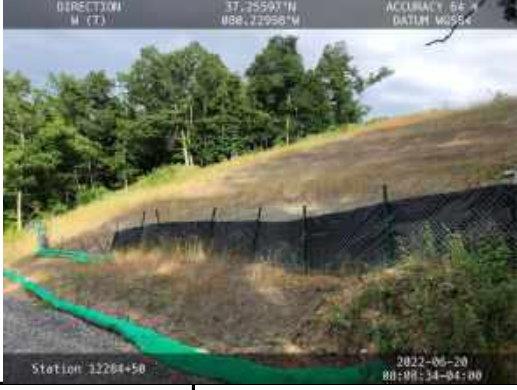
<p>Station 12278+80 2022-06-20 08:11:26-04:00</p>

<p>Station 12284+75 2022-06-20 08:08:14-04:00</p>			
GPS Location	Please see photo for details.		GPS Location	Please see photo for details.	
Field Station#	12278+00		Field Station#	12284+75	
Pic 17 Desc.	Photo shows final restoration with permanent water bars equipped with level spreads along with environmental crew walking ROW.		Pic 18 Desc.	Photo shows the stabilized ROW conditions with water bars and that all ECDs are installed and are functioning as designed.

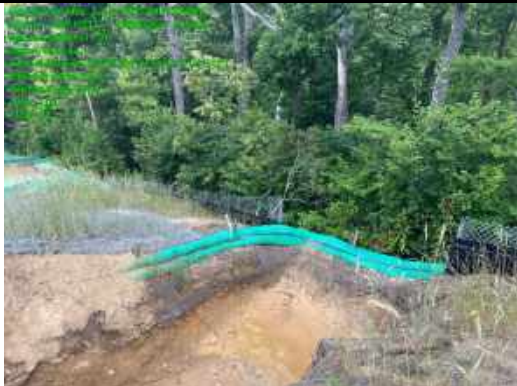
GPS Location	0	GPS Location	0		
Field Station#	13209+50	Field Station#	13209+50		
Pic 9 Desc.	Repair SSF fabric - 72hr maintenance item	Pic 10 Desc.	Repair rilling and stabilize sump and waterbar - 72hr maintenance item

7. Identify all remedial measures that have been taken since the previous inspection was conducted.					
Comments (Reference above questions as appropriate.)					
<p>A SWPPP inspection was performed from MVP-FR-292 to Wade's Gap Road Crossing, Station 13141+65 to 13316+21. Included in today's inspection were streams S-D17, S-D14, S-D13, S-D-11, S-D10, S-D8, S-II4, and S-GH7. There were no impacts or any other deficiencies at the streams or their corresponding buffer zones. ROW was stable throughout this inspection area. All other ECDs were in satisfactory condition and functioning properly. Rock Construction Entrances were in good condition. No movement or changes were observed at either slip, Station 13253+00 or 13222+00. Cattle disturbance noted along MVP-MLV-AR-29 and MVP-FR-292.01. No additional maintenance or environmental concerns were observed or noted during this SWPPP inspection.</p> <p>During the inspection 4 - 72hr maintenance items were observed and added to the punch list. Clean sumps along access 292.01, 13196+31. Clean and repair rills in sumps 13208+00 thru 13209+50, and repair rilling in waterbars at same locations. Repair SSF fabric station 13209+50.</p>

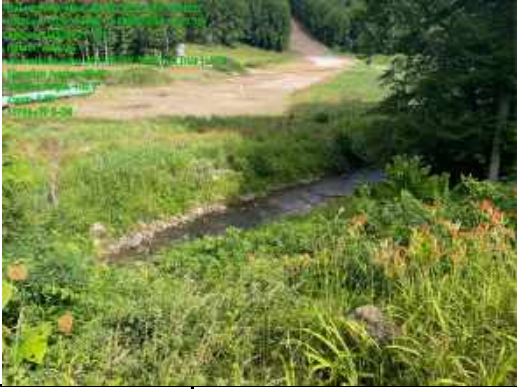
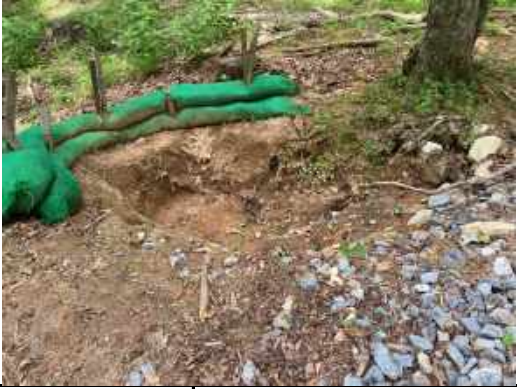
GPS Location	0	GPS Location	0		
Field Station#	13196+79	Field Station#	13196+31		
Pic 13 Desc.	MVP-S-II4 and corresponding buffer zone in good condition	Pic 14 Desc.	Clean out sump - 72hr maintenance item

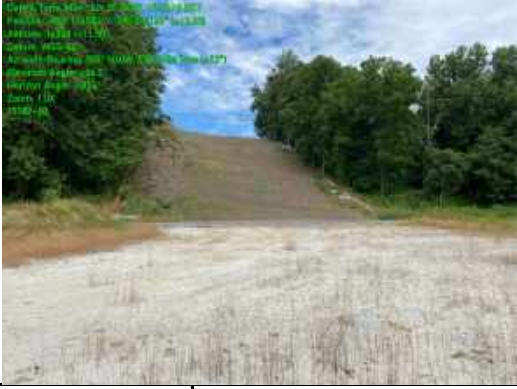
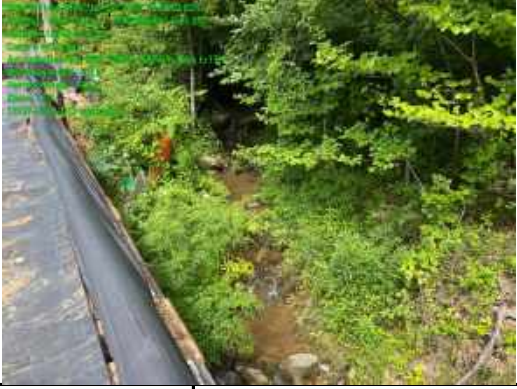
GPS Location	0	GPS Location	0		
Field Station#	13189+00	Field Station#	13157+50		
Pic 15 Desc.	ROW and ECDs In good condition and stable	Pic 16 Desc.	MVP-S-D11 and corresponding buffer zone in good condition

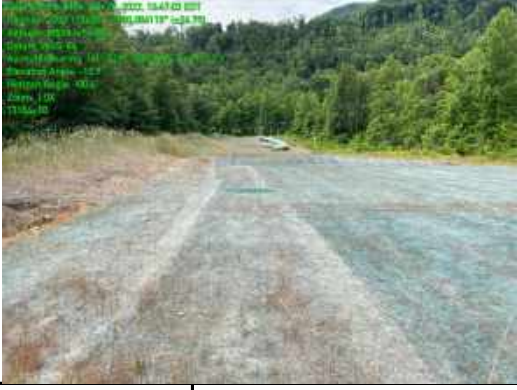
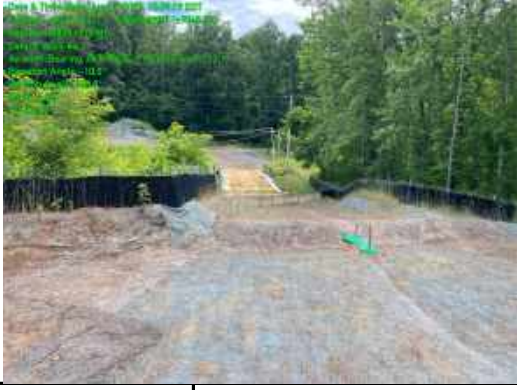
GPS Location	0	GPS Location	0		
Field Station#	13154+00	Field Station#	13146+56		
Pic 17 Desc.	ROW and ECDs In good condition and stable	Pic 18 Desc.	MVP-S-D12/13 and corresponding buffer zone in good condition

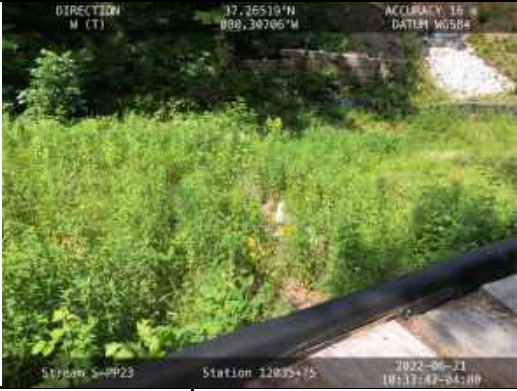
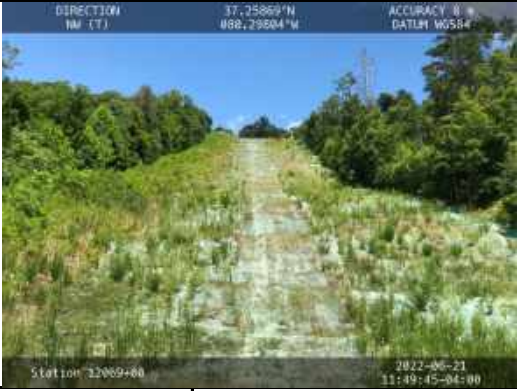
GPS Location	Please see photo for details.		GPS Location	Please see photo for details.	
Field Station#	12035+75		Field Station#	12069+00	
Pic 7 Desc.	Photo shows downstream view of Stream S-PP23 from the equipment bridge spanning the stream Channel.		Pic 8 Desc.	Photo shows the stabilized ROW conditions with water bars and that all ECDs are installed and are functioning as designed.

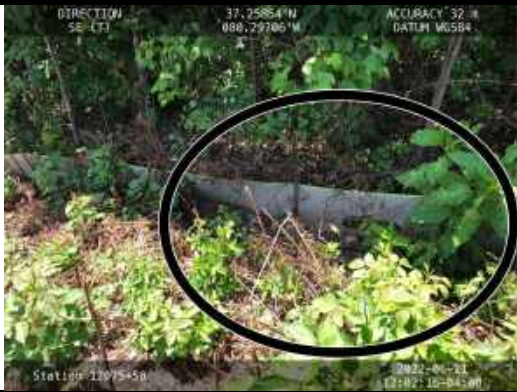
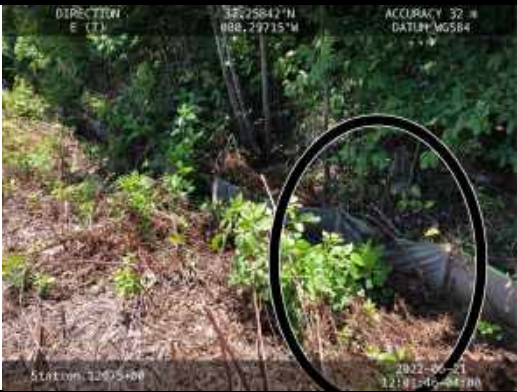
GPS Location	Please see photo for details.		GPS Location	Please see photo for details.	
Field Station#	12075+50		Field Station#	12075+00	
Pic 9 Desc.	Photo shows one of three punch list items today. Replace or repair damaged P1.		Pic 10 Desc.	Photo shows one of three punch list items today. Replace or repair damaged P1.

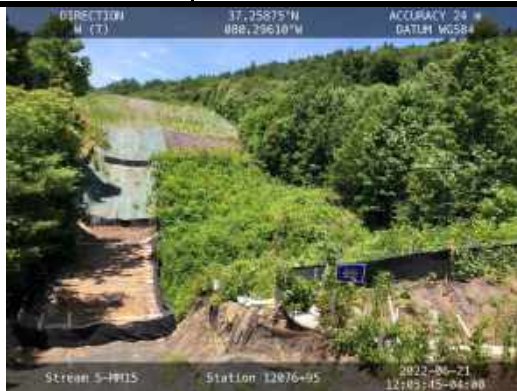
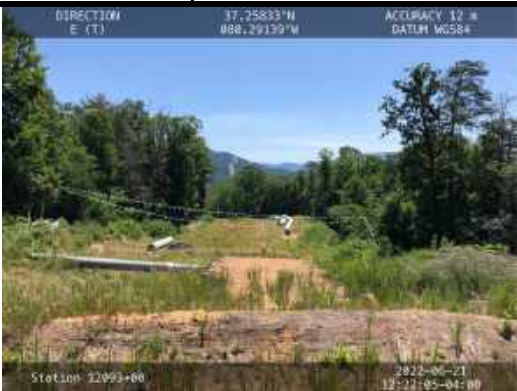
Pic 11 Desc.	Photo shows overview of Stream S-MM15 and its buffer zone from the going away side.		Pic 12 Desc.	Photo shows stabilized ROW conditions with clean water diversion pipe running around the ROW to a plunge pool.

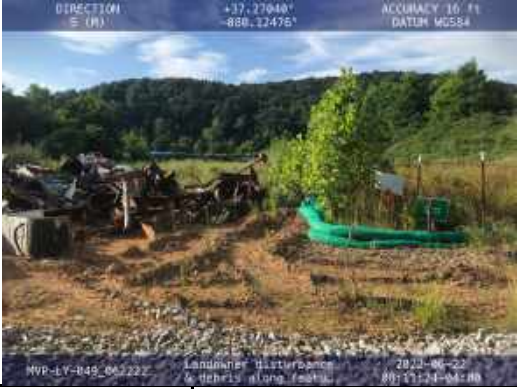
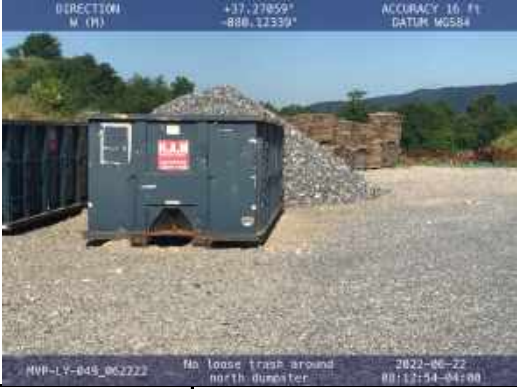
GPS Location	MVP-LY-049 See photo for gps data	GPS Location	MVP-LY-049 See photo for gps data		
Field Station#	+0	Field Station#	+0		
Pic 7 Desc.	Landowner soil disturbance along triple stack compost filter sock and east of feature W-CV21B. Area not stabilized. Looking S.	Pic 8 Desc.	No loose trash around north dumpster or in the yard. Looking W.

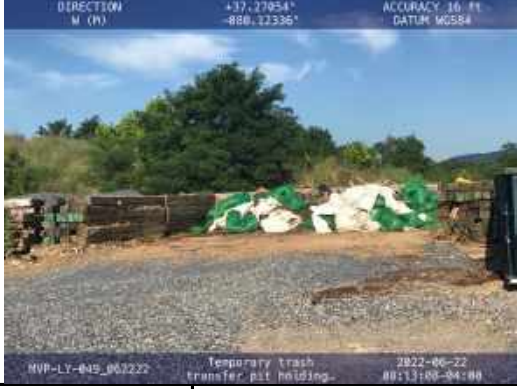
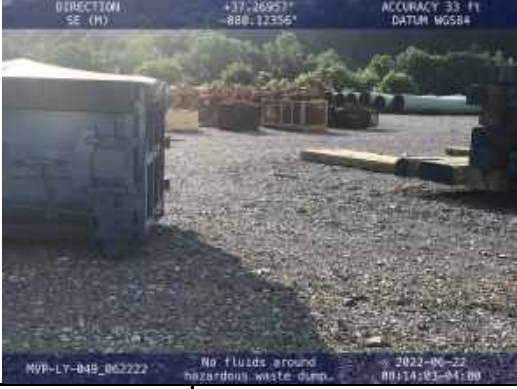
GPS Location	MVP-LY-049 See photo for gps data	GPS Location	MVP-LY-049 See photo for gps data		
Field Station#	+0	Field Station#	+0		
Pic 9 Desc.	Temporary trash transfer pit holding debris. Looking W.	Pic 10 Desc.	No fluids or deposits around hazardous waste dumpster. Looking SE.

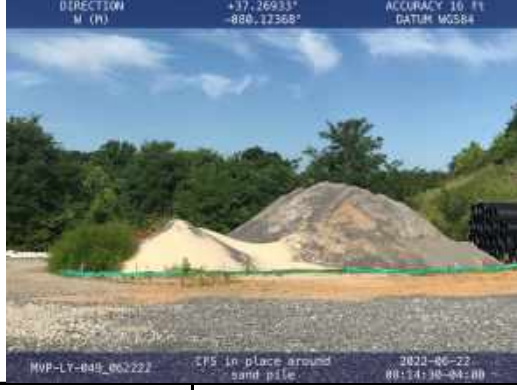
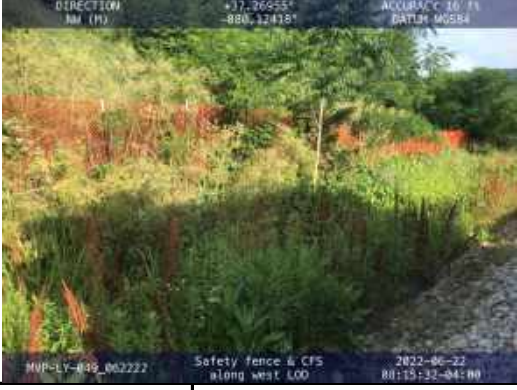
GPS Location	MVP-LY-049 See photo for gps data	GPS Location	MVP-LY-049 See photo for gps data		
Field Station#	+0	Field Station#	+0		
Pic 11 Desc.	Compost filter sock in place and functioning around sand pile. Looking W.	Pic 12 Desc.	Safety fence and triple stack compost filter sock along west LOD. Looking NW.

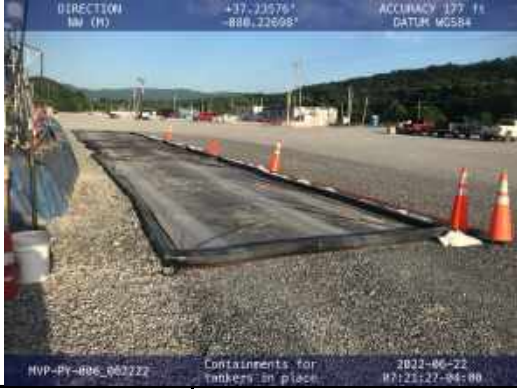
GPS Location	MVP-PY-006 See photo for gps data	GPS Location	MVP-PY-006 See photo for gps data		
Field Station#	+0	Field Station#	+0		
Pic 9 Desc.	Secondary containments in place for tankers offloading fuel. Looking NW.	Pic 10 Desc.	Blue Bulk Fuel tanks no leaky fittings or nozzles. Catch pans on site. Looking S.

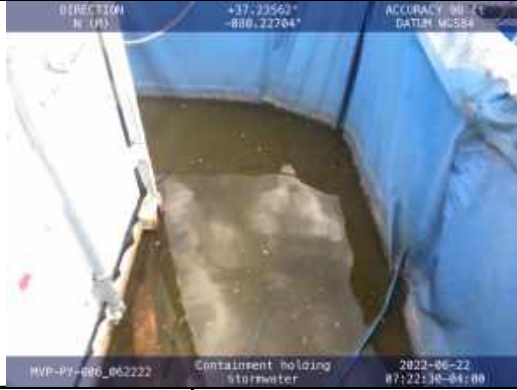
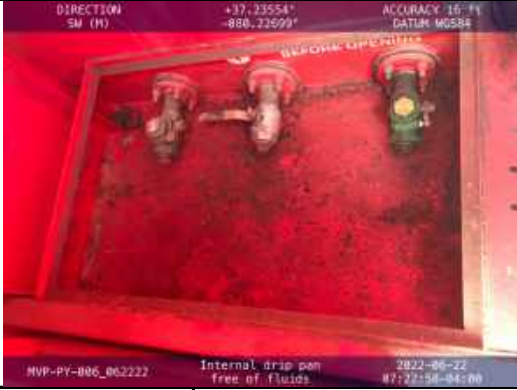
GPS Location	MVP-PY-006 See photo for gps data	GPS Location	MVP-PY-006 See photo for gps data		
Field Station#	+0	Field Station#	+0		
Pic 11 Desc.	Off Road Fuel unit containment holding stormwater. Looking N.	Pic 12 Desc.	Off Road fuel unit internal drip pan free of fluids. Looking SW.

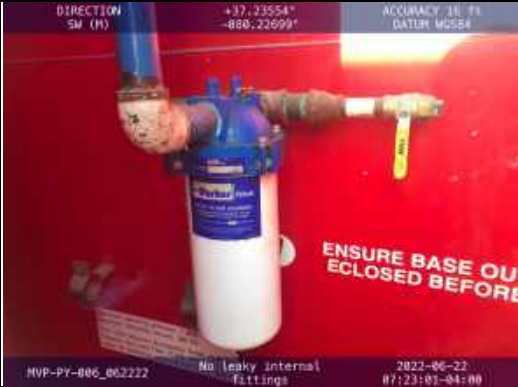
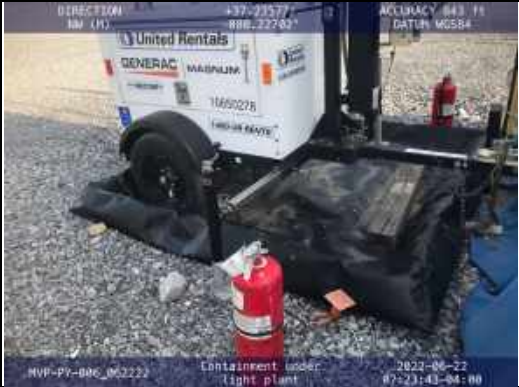
GPS Location	MVP-PY-006 See photo for gps data	GPS Location	MVP-PY-006 See photo for gps data		
Field Station#	+0	Field Station#	+0		
Pic 13 Desc.	Off Road Fuel unit no leaky internal fittings. Looking SW.	Pic 14 Desc.	Secondary containment under light plant free of fluids. Looking NW.

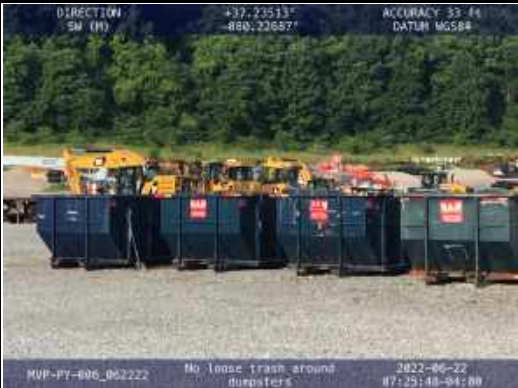
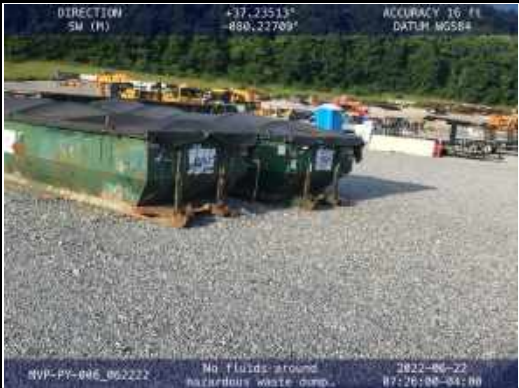
GPS Location	MVP-PY-006 See photo for gps data	GPS Location	MVP-PY-006 See photo for gps data		
Field Station#	+0	Field Station#	+0		
Pic 15 Desc.	No loose trash around dumpsters or in the yard. Looking SW.	Pic 16 Desc.	No fluids or deposits around hazardous waste dumpsters. Looking SW.

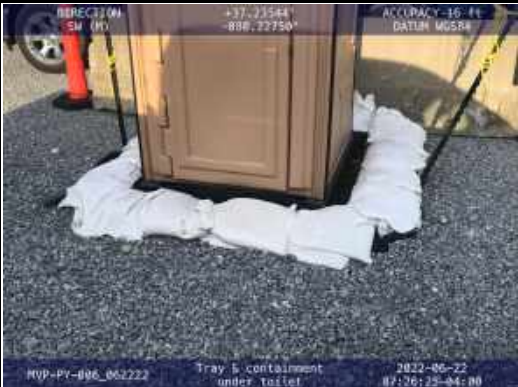
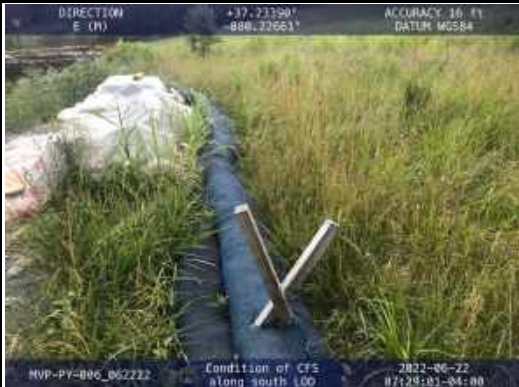
GPS Location	MVP-PY-006 See photo for gps data	GPS Location	MVP-PY-006 See photo for gps data		
Field Station#	+0	Field Station#	+0		
Pic 17 Desc.	Tray and containment under toilet. Tray holding fluids. Looking SW.	Pic 18 Desc.	Triple stack compost filter sock along south LOD. Becoming overgrown with vegetation. Looking E.
