Visual Site Inspection Report

Project Name	H-600 Pipeline Spread H	AFE	124300138	Spread	H-600 Pipeline Spread H
Contractor	Precision			Report #	39213
Inspector	Jordan Davis			Date/Time	6/27/2022 3:52 PM
Permit #	TBD	Inspection Type	VA SWPP	Station Begin	12005+00
State	VA	Inspection Area	Partial	Station End	12119+17
County	Montgomery	Ground	Dry	Temperature (°F)	83.00
Municipality	N/A	Weather	Cloudy	Rain Gauge (in)	0.00
				Rain Accumulation Time (days)	0.00

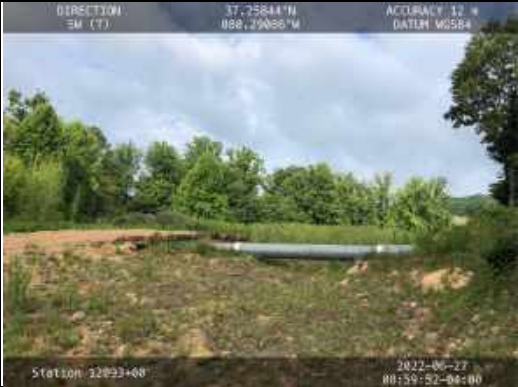
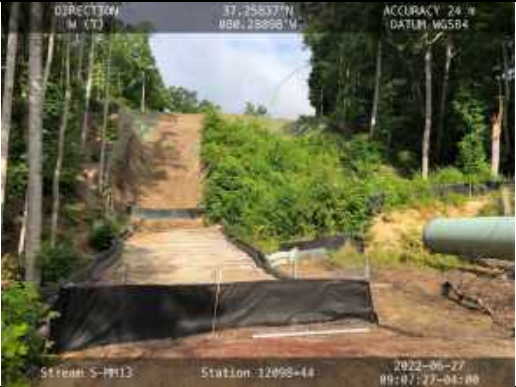
GPS Location	Please see photo for details.		GPS Location	Please see photo for details.	
Field Station#	12093+00		Field Station#	12098+44	
Pic 13 Desc.	Photo shows stabilized ROW conditions and clean water diversion pipe running around the ROW to a plunge pool.		Pic 14 Desc.	Photo shows overview of Stream S-MM13 and its buffer zone from the going away side.

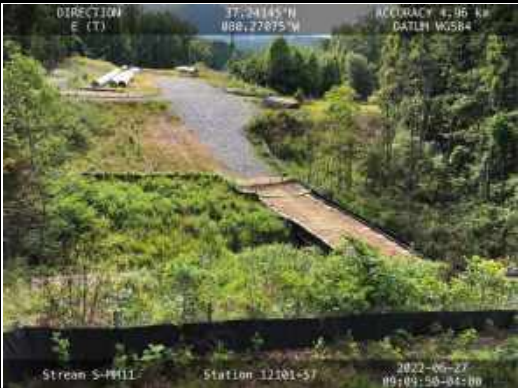
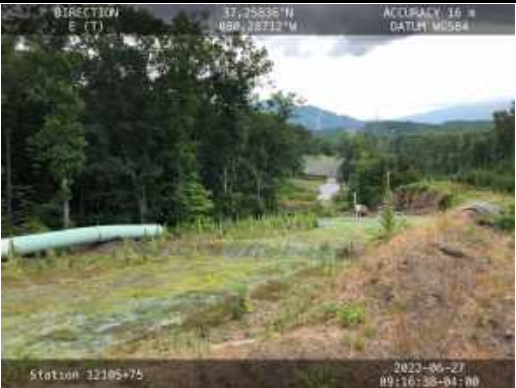
GPS Location	Please see photo for details		GPS Location	Please see photo for details	
Field Station#	12101+57		Field Station#	12105+75	
Pic 15 Desc.	Photo shows overview of Stream S-MM11 and its buffer zone from the coming in side.		Pic 16 Desc.	Photo shows the stabilized ROW conditions with water bars and that all ECDs are installed and are functioning as designed.

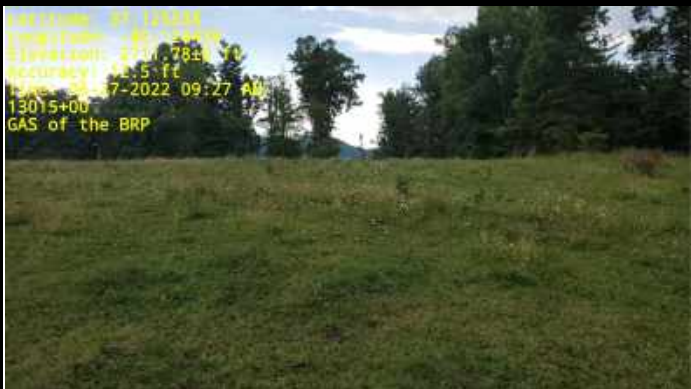
AFE	124300138	Date/Time	6/27/2022 3:29 PM	Report #	
Pictures					
<div>Latitude: 37.128222 Longitude: -80.128451 Elevation: 2711.78±10 ft Accuracy: 12.5 ft Time: 06-27-2022 09:27 AM 13015+00 GAS of the BRP</div>

GPS Location	See pic.		GPS Location	See pic.	
Field Station#	13015+00		Field Station#	13000+00	
Pic 7 Desc.	Current ROW conditions.		Pic 8 Desc.	Current ROW conditions.	
<div>Latitude: 37.128333 Longitude: -80.128811 Elevation: 2711.06±25 ft Accuracy: 13.8 ft Time: 06-27-2022 09:54 AM 13000+00 GAS of US-221</div>

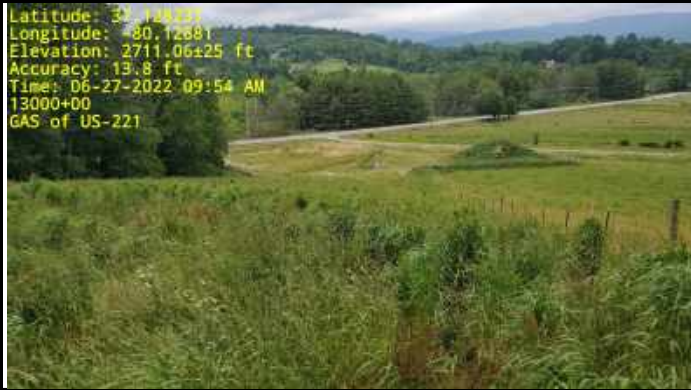
Pic 9 Desc.	Current ROW conditions.		Pic 10 Desc.	Current ROW conditions.	
<div>Latitude: 37.128444 Longitude: -80.128895 Elevation: 2037.43±10 ft Accuracy: 12.5 ft Time: 06-27-2022 09:58 AM 12993+50 GAS of US-221</div>

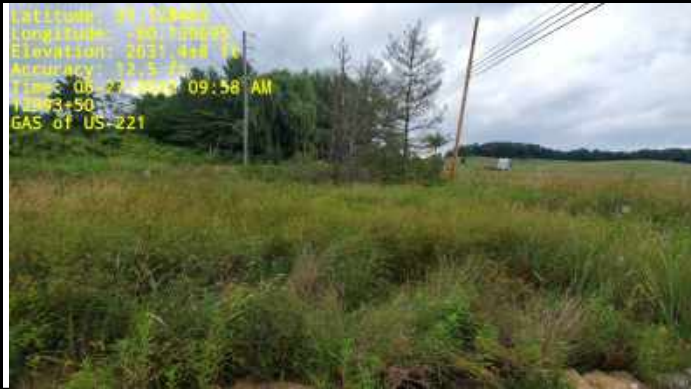
GPS Location	See pic.		GPS Location	See pic.	
Field Station#	12993+50		Field Station#	12975+00	
Pic 11 Desc.	Current ROW conditions.		Pic 12 Desc.	Current ROW conditions.

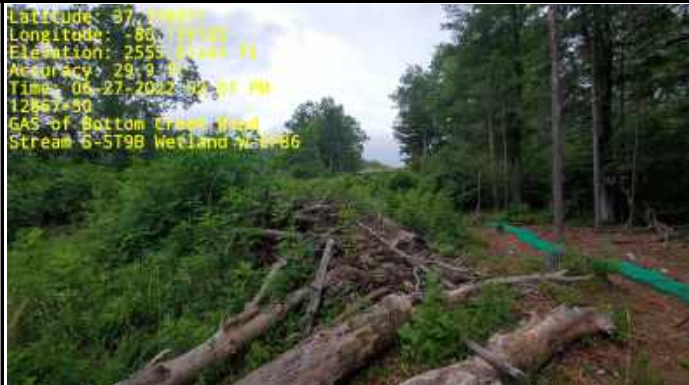
<div>Latitude: 37.144665 Longitude: -80.137246 Elevation: 2553.14±11 ft Accuracy: 29.9 ft Time: 06-27-2022 11:30 AM 12867+50 GAS of Bottom Creek Road Stream S-ST9B Wetland W-EF86</div>

GPS Location	See pic.		GPS Location	See pic.	
Field Station#	12916+00		Field Station#	12867+50	
Pic 17 Desc.	Current ROW conditions.		Pic 18 Desc.	Stream S-ST9B and wetland W-EF86 from the CIS.

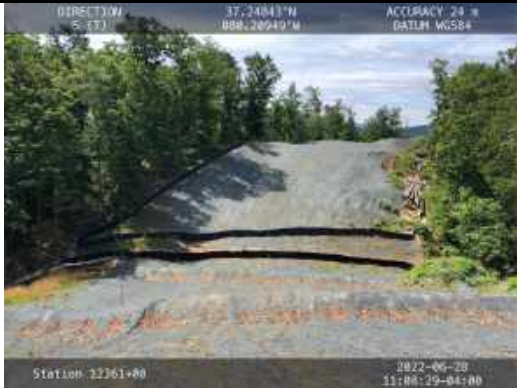
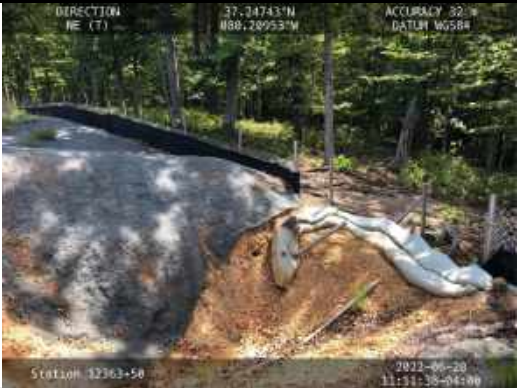
E&S BMPs	Compliance Level	Corrective Action	Corrective Time Frame	Date Repaired
Silt Fence (Reinforce Filter Fence)	Communication	Reattach SSF fabric to chain link		6/29/2022
Waterbar End Treatment	Communication	Secure back into water bar key		6/29/2022
Sensitive Resource Buffer	Acceptable			
Erosion Control Blanket	Acceptable			
Stone Inlet Protection	Acceptable			
Slope Drain Pipe	Acceptable			
Plunge Pool	Acceptable			
Waterbar	Acceptable			
Sump Pit	Acceptable

GPS Location	Please see photo for details.		GPS Location	Please see photo for details.	
Field Station#	12361+00		Field Station#	12363+50	
Pic 9 Desc.	Photo shows the stabilized ROW conditions with water bars and that all ECDs are installed and are functioning as designed.		Pic 10 Desc.	Photo shows punch list item of CFS end treatment needing to be Resecured back into water bar key.

7. Identify all remedial measures that have been taken since the previous inspection was conducted. A total of five 72hr maintenance punch list items were found during the 06/22/2022 VA DEQ SWPPP inspection. These consisted of reattaching SSF fabric to chain link at stations 12345+00, 12346+00, 12347+00, 12353+00 and 12354+00. During today's VA DEQ SWPPP inspection all these past items were observed and found to be completed.					
Comments (Reference above questions as appropriate.) Attended morning virtual conference call for inspection at 6:30am then traveled to MVP-MN-276.03. Here, the VA DEQ SWPPP inspection was performed on this date. From station 12284+75 to station 12443+75 the ROW was walked to evaluate that all ECDs are installed and functioning as designed along with the ROW that had been previously disturbed and is now inactive has been properly stabilized with either straw mulch, erosion control blanket or temporary or permanent vegetation. In which appeared to be adequate. - Final result of all areas observed and evaluated in today's inspection were found to be in compliance and have no environmental issues, no off ROW sediment as well as no stream or wetland impacts. - The ECDs observed today appeared to be installed and functioning as designed. Some of the ECDs are showing some wear but are still functioning. Located within today's SWPPP inspection area are the following resources and other access roads that were evaluated and observed. Stream S-0016 located at station 12374+16 - Stream S-NN19 located at 12380+04 - Stream S-NN16 located at station 12435+16. Wetland W-NN8 located from station 12434+55 to station 12435+46. MVP-MN-276.03 - MVP-MN-277.0 * A total of two 72hr maintenance punch list items were found today during today's VA DEQ SWPPP inspection. They are as follows: (1) Reattach SSF fabric to chain link at station 12310+00 (2) Resecure water bar end treatment bank into keyed portion of water bar at station 12363+50.

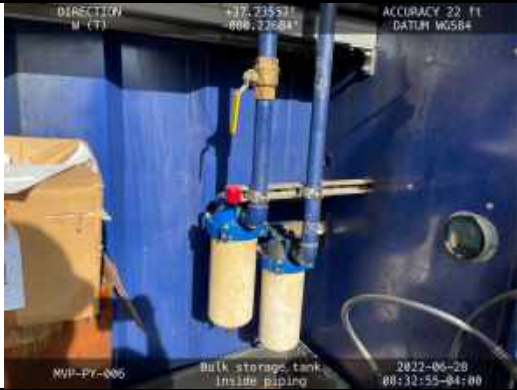
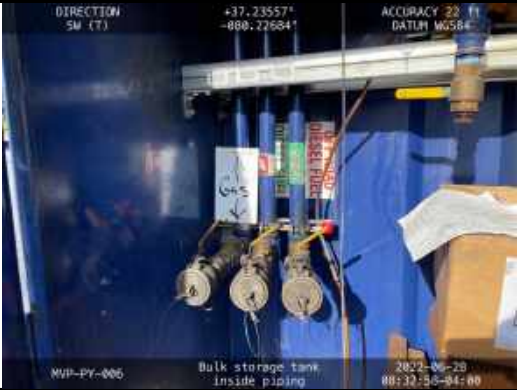
GPS Location	See photo for gps location data		GPS Location	See photo for gps location data	
Field Station#	+0		Field Station#	+0	
Pic 9 Desc.	Photo shows the internal piping for the bulk fuel tank. No leaks observed.		Pic 10 Desc.	Photo shows the internal piping for the bulk fuel tank. No leaks observed.

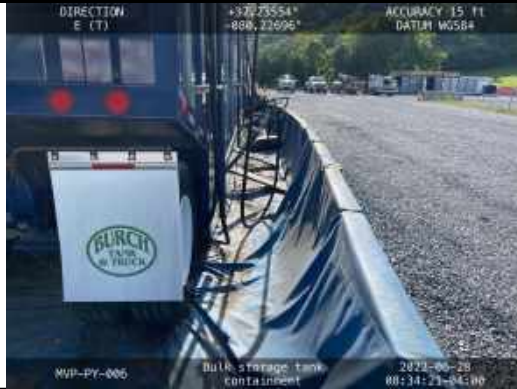
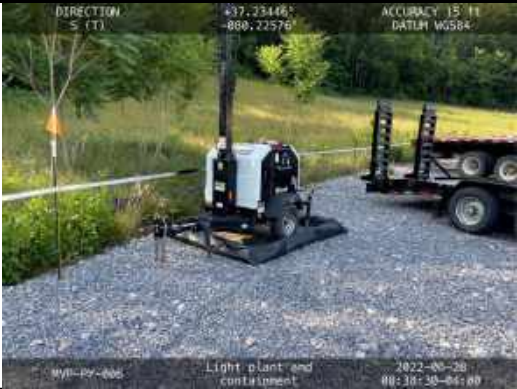
GPS Location	See photo for gps location data		GPS Location	See photo for gps location data	
Field Station#	+0		Field Station#	+0	
Pic 11 Desc.	Photo shows the containment for the bulk fuel tank.		Pic 12 Desc.	Photo shows a light plant and secondary containment.

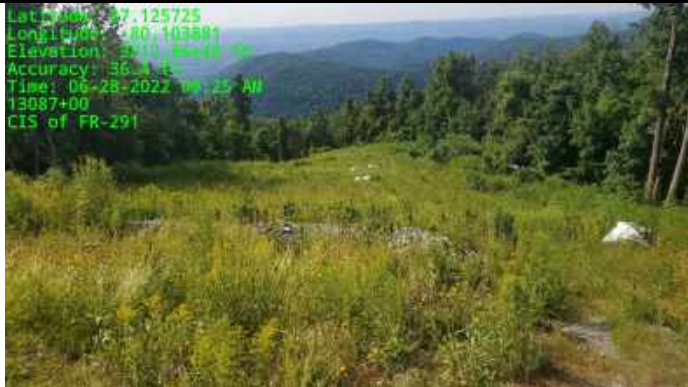
AFE	124300138	Date/Time	6/28/2022 3:31 PM	Report #	
Pictures					
<div>Latitude: 37.125725 Longitude: -80.103891 Elevation: 3023.75±8 ft Accuracy: 36.4 ft Time: 06-28-2022 09:25 AM 13087+00 CIS of FR-291</div>

GPS Location	See pic.		GPS Location	See pic.	
Field Station#	13087+00		Field Station#	13090+00	
Pic 1 Desc.	Current ROW conditions.		Pic 2 Desc.	Current ROW conditions.	
<div>Latitude: 37.125775 Longitude: -80.1006 Elevation: 3023.75±27 ft Accuracy: 18.9 ft Time: 06-28-2022 09:30 AM 13097+00 CIS of FR-291</div>

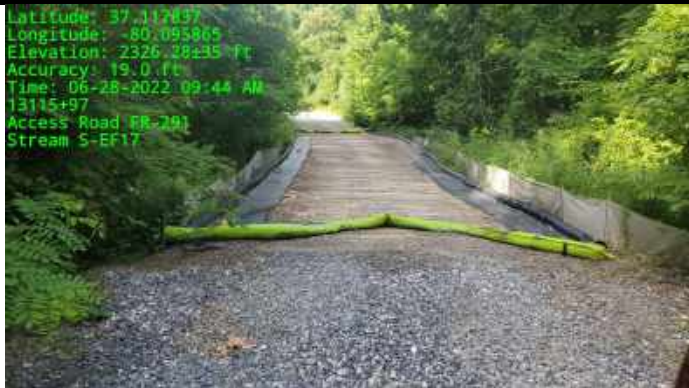
<div>Latitude: 37.117837 Longitude: -80.095865 Elevation: 2326.28±35 ft Accuracy: 19.0 ft Time: 06-28-2022 09:44 AM 13115+97 Access Road FR-291 Stream S-EF17</div>

GPS Location	See pic.		GPS Location	See pic.	
Field Station#	13108+00		Field Station#	13115+97	
Pic 5 Desc.	Current ROW conditions.		Pic 6 Desc.	Stream S-EF17 along access road FR-291.

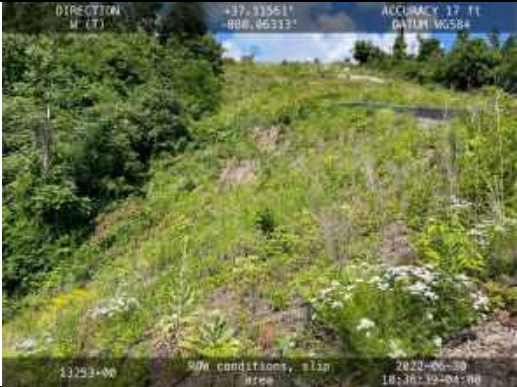
GPS Location	See photo for coordinates.		GPS Location	See photo for coordinates.	
Field Station#	13253+00		Field Station#	13260+50	
Pic 13 Desc.	Documented slip area appeared stable.		Pic 14 Desc.	ROW stable, good vegetative cover noted across LOD; remaining perimeter controls in acceptable condition.

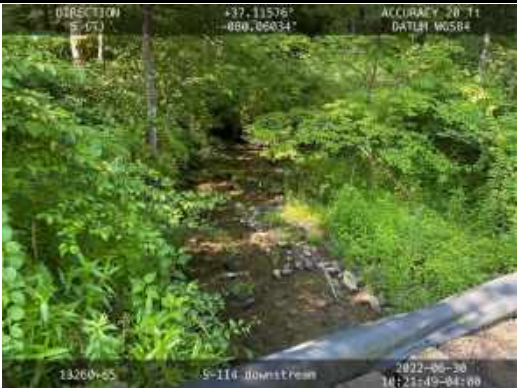
GPS Location	See photo for coordinates.		GPS Location	See photo for coordinates.	
Field Station#	13260+65		Field Station#	13197+00	
Pic 15 Desc.	S-114, downstream, no turbidity noted.		Pic 16 Desc.	S-D8, no ground disturbance at stream crossing; no ROW impacts noted.

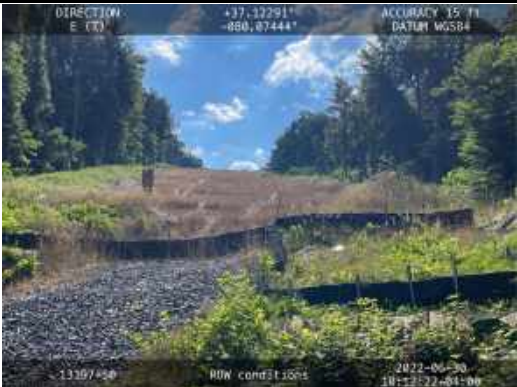
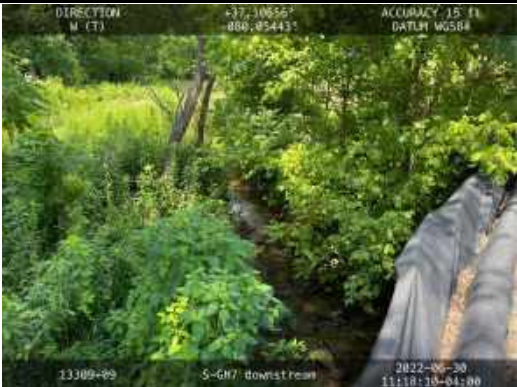
GPS Location	See photo for coordinates.		GPS Location	See photo for coordinates.	
Field Station#	13197+50		Field Station#	13309+09	
Pic 17 Desc.	ROW stabilized, perimeter controls in acceptable condition.		Pic 18 Desc.	S-GH7, downstream, no observable turbidity noted.
