Visual Site Inspection Report

Project Name	H-600 Pipeline Spread G	AFE	124300137	Spread	H-600 Pipeline Spread G
Contractor	Precision			Report #	39668
Inspector	Daniel Fortune			Date/Time	7/11/2022 1:29 PM
Permit #	TBD	Inspection Type	VA SWPP	Station Begin	11254+99
State	VA	Inspection Area	Partial	Station End	11353+67
County	Giles	Ground	Wet	Temperature (°F)	74.00
Municipality	N/A	Weather	Cloudy	Rain Gauge (in)	1.50
				Rain Accumulation Time (days)	1.00

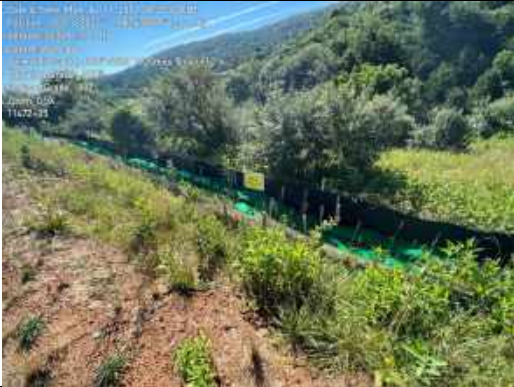
GPS Location	See photo		GPS Location	See photo	
Field Station#	11472+25		Field Station#	11476+75	
Pic 1 Desc.	Triple protection ECDs in place at karst feature		Pic 2 Desc.	Stone inlet protection in place

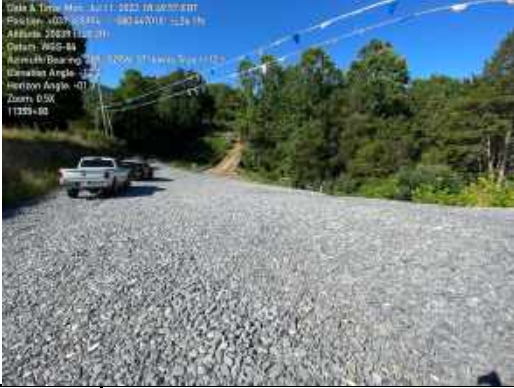
GPS Location	See photo	GPS Location	See photo		
Field Station#	11355+00	Field Station#	11361+00		
Pic 1 Desc.	RCE functional	Pic 2 Desc.	P1 damaged by live stock needs repaired

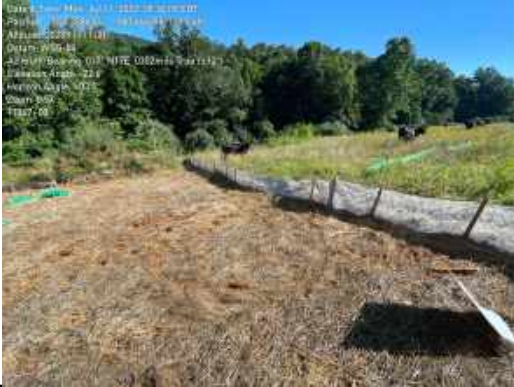
GPS Location	See photo	GPS Location	See photo		
Field Station#	11367+00	Field Station#	11366+50		
Pic 3 Desc.	P1 damaged by live stock needs repaired	Pic 4 Desc.	P1 damaged by live stock needs repaired

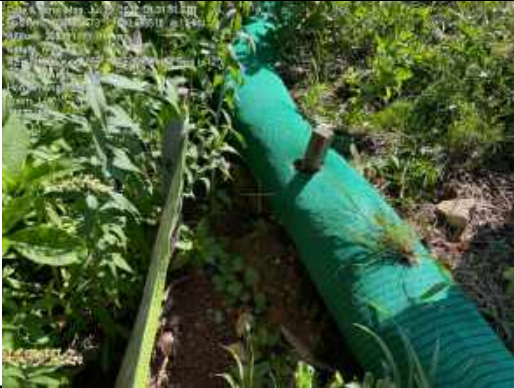
GPS Location	See photo	GPS Location	See photo		
Field Station#	11372+00	Field Station#	11412+00		
Pic 5 Desc.	CFS undermined & P1 needs extended	Pic 6 Desc.	Permanent stabilization in place

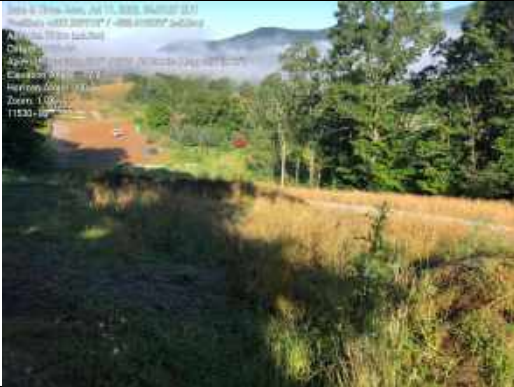
GPS Location	On photo		GPS Location	On photo	
Field Station#	11530+00		Field Station#	11538+00	
Pic 1 Desc.	ROW stable. No erosion occurring.		Pic 2 Desc.	ROW well vegetated. ECDs are in place.

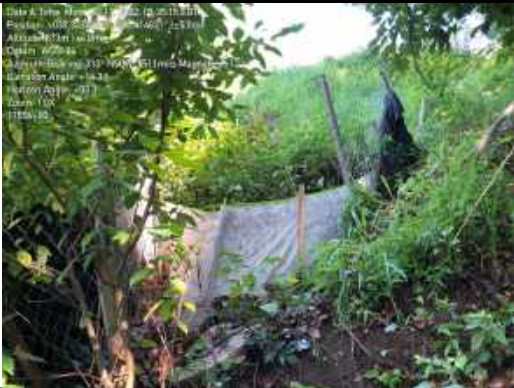
GPS Location	On photo		GPS Location	On photo	
Field Station#	11556+00		Field Station#	11567+42	
Pic 5 Desc.	No erosion caused by runoff discovered.		Pic 6 Desc.	The S-PP22 crossing is stable with ECDs in place.

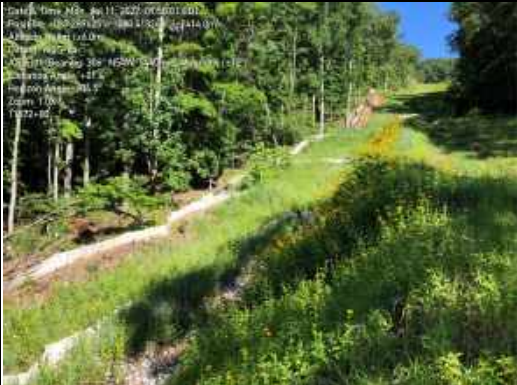
GPS Location	On photo		GPS Location	On photo	
Field Station#	11572+00		Field Station#	11585+48	
Pic 7 Desc.	ROW stable. Rock lined channel is functional.		Pic 8 Desc.	The S-PP21 crossing is currently stable with ECDs in place.

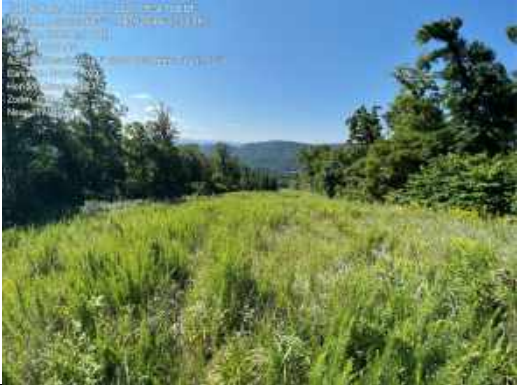
GPS Location	See photo		GPS Location	See photo	
Field Station#	11940+00		Field Station#	11972+50	
Pic 7 Desc.	Permanent vegetation in final restoration area		Pic 8 Desc.	Permanent water bars in final restoration area

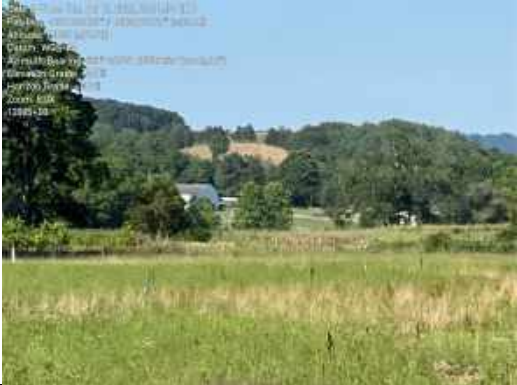
GPS Location	See photo	GPS Location	See photo		
Field Station#	12005+00	Field Station#	11932+00		
Pic 13 Desc.	Final Restoration at spread break.	Pic 14 Desc.	AR 266 and sump pit end treatment conditions.

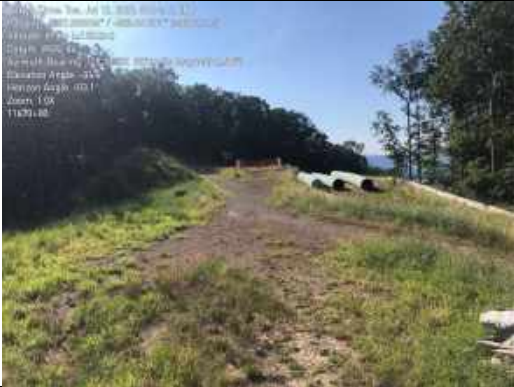
GPS Location	On photo		GPS Location	On photo	
Field Station#	11670+00		Field Station#	11665+00	
Pic 1 Desc.	Top of Brush Mountain is stable with no evidence of vandalism.		Pic 2 Desc.	ROW surface well vegetated. No erosion.

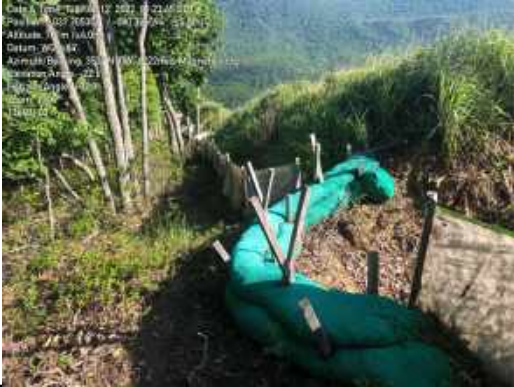
GPS Location	On photo		GPS Location	On photo	
Field Station#	11660+00		Field Station#	11655+50	
Pic 3 Desc.	There are no issues caused by runoff from slope breakers.		Pic 4 Desc.	ROW surface stable. No movement of soils. ECDs in place along perimeter.

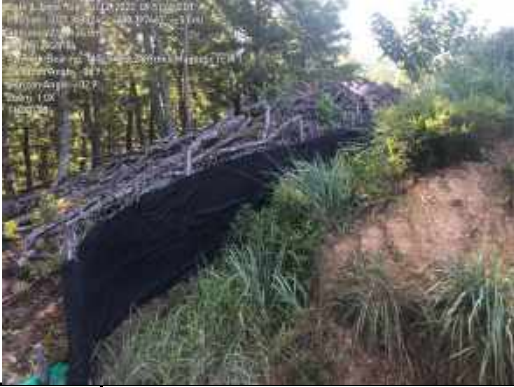
GPS Location	On photo		GPS Location	On photo	
Field Station#	11630+00		Field Station#	11626+04	
Pic 5 Desc.	ROW stable with ECDs in place.		Pic 6 Desc.	The S-HH18 crossing is stable.

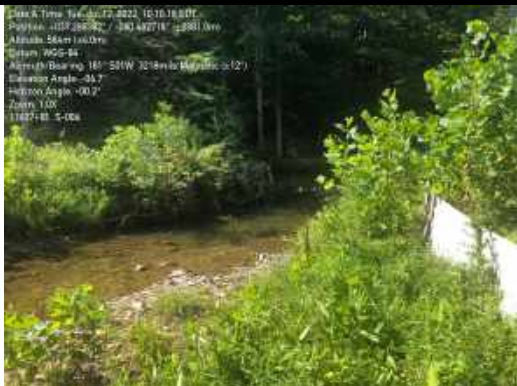
GPS Location	On photo	GPS Location	On photo		
Field Station#	11607+81	Field Station#	11601+00		
Pic 9 Desc.	The S-006 crossing is stable.	Pic 10 Desc.	The ROW is currently stable. Private lands will be re-stabilized as mulch deteriorates.		
<p>Insert image here</p>		<p>Insert image here</p>			
GPS Location		GPS Location			
Field Station#		Field Station#			
Pic 11 Desc.		Pic 12 Desc.

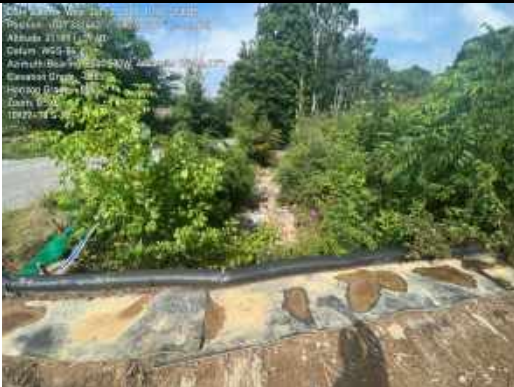
GPS Location	See photo	GPS Location	See photo		
Field Station#	10929+70	Field Station#	10927+77		
Pic 1 Desc.	S-Y2 stream resource area. No issues. Equipment bridge found functional	Pic 2 Desc.	S-Y3 vegetated stream resource area. No issues. Equipment bridge found functional

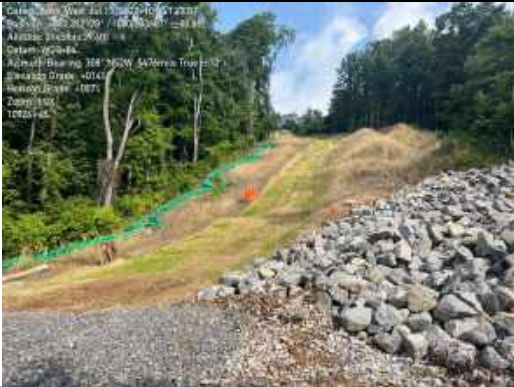
GPS Location	See photo	GPS Location	See photo		
Field Station#	10926+45	Field Station#	10926+45		
Pic 3 Desc.	Over view of steep slope stabilization.	Pic 4 Desc.	Over view of RCE

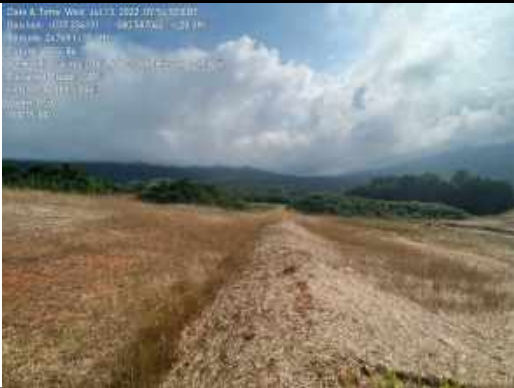
GPS Location	See photo	GPS Location	See photo		
Field Station#	10917+00	Field Station#	10888+50		
Pic 5 Desc.	Temporary water bar conditions, and temporary stabilization conditions. No Issues.	Pic 6 Desc.	Temporary stabilization of soil pile and recent row conditions.

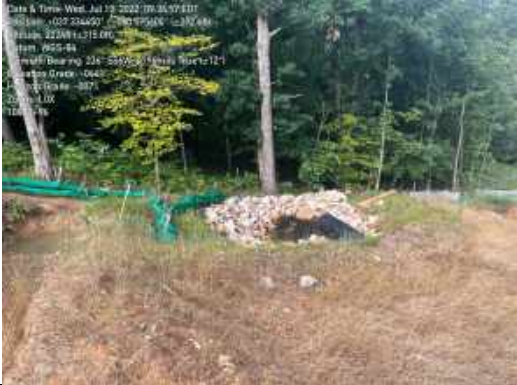
GPS Location	See photo	GPS Location	See photo		
Field Station#	10887+96	Field Station#	10885+50		
Pic 7 Desc.	Plunge Pool current conditions.	Pic 8 Desc.	Perimeter ECD's found functional.

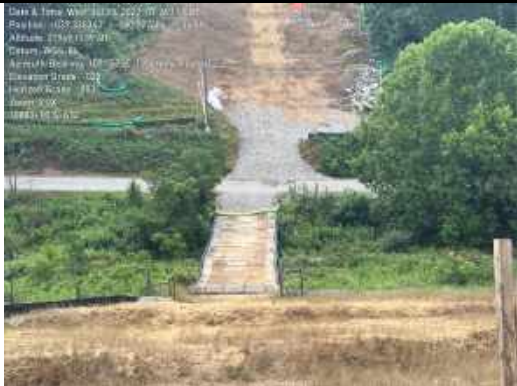
GPS Location	See photo	GPS Location	See photo		
Field Station#	10883+00	Field Station#	10881+20		
Pic 9 Desc.	S-A32 Stream resource conditions. Vegetated buffer zones adequately protected with functioning ECDs.	Pic 10 Desc.	Temporary water bar with CFS throat checks.

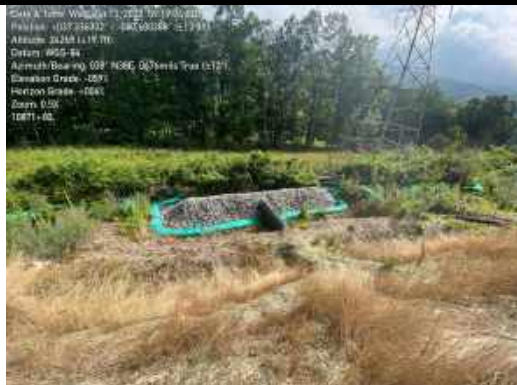
GPS Location	See photo	GPS Location	See photo		
Field Station#	10871+00	Field Station#	10870+68		
Pic 11 Desc.	TLS and temporary stabilization of side slope.	Pic 12 Desc.	Stone inlet protection.

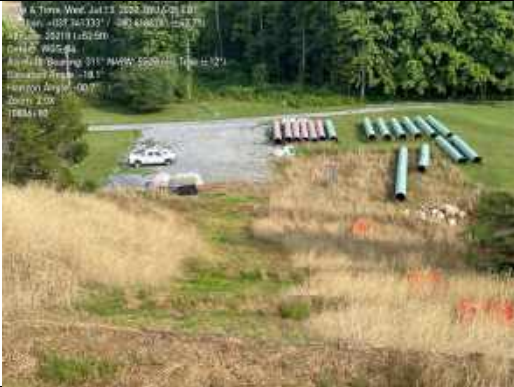
GPS Location	See photo		GPS Location	See photo	
Field Station#	10806+00		Field Station#	10809+04	
Pic 1 Desc.	Picture showing condition of row		Pic 2 Desc.	Equipment bridge functional

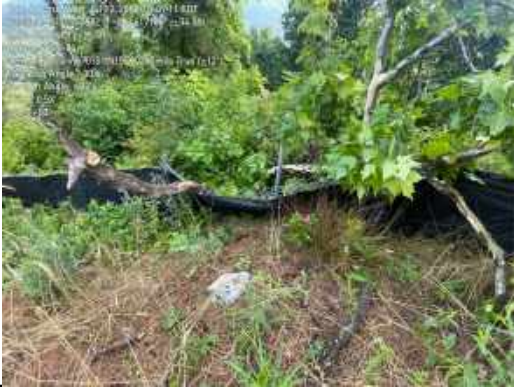
GPS Location	See photo		GPS Location	See photo	
Field Station#	10811+00		Field Station#	10812+00	
Pic 3 Desc.	SSF damaged needs repaired		Pic 4 Desc.	ET in place

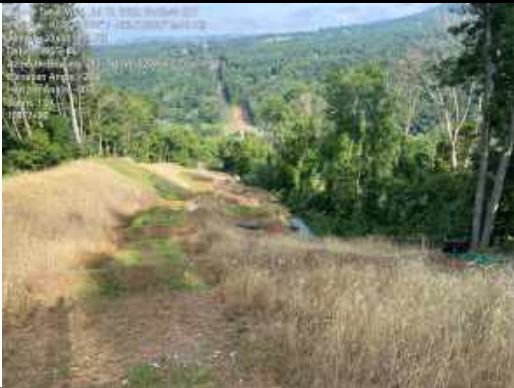
GPS Location	See photo		GPS Location	See photo	
Field Station#	10817+00		Field Station#	10818+41	
Pic 5 Desc.	Picture showing condition of row		Pic 6 Desc.	Access road 241.03 in good condition

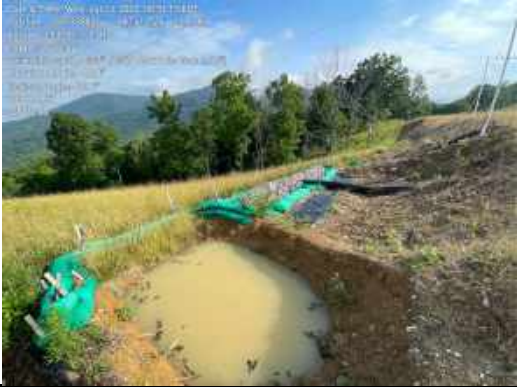
GPS Location	See photo	GPS Location	See photo		
Field Station#	10826+00	Field Station#	10835+00		
Pic 7 Desc.	Level spreader in place	Pic 8 Desc.	Stabilization functional

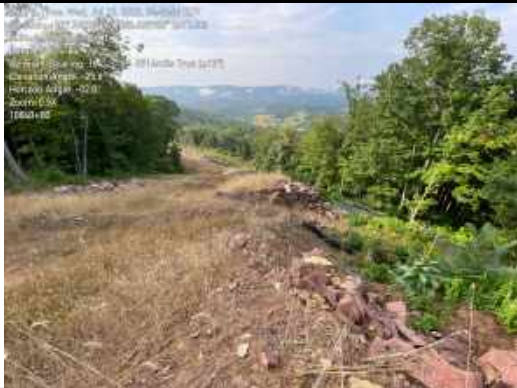
GPS Location	See photo	GPS Location	See photo		
Field Station#	10840+00	Field Station#	10847+50		
Pic 9 Desc.	Slope drain pipe in place	Pic 10 Desc.	Clean water drainage pipe in good condition

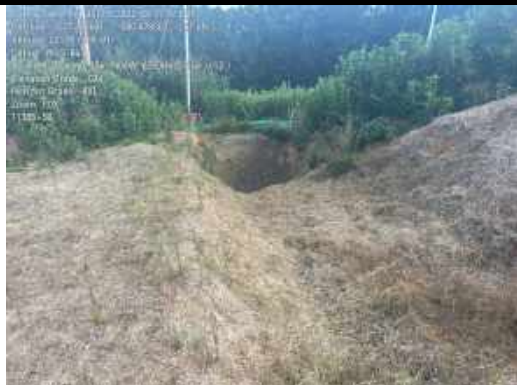
GPS Location	See photo	GPS Location	See photo		
Field Station#	11305+50	Field Station#	11293+66		
Pic 11 Desc.	Recently repaired erosion to the functional sump pit.	Pic 12 Desc.	S-MM18 vegetated stream resource area. Adequately protected with functional ECDs.

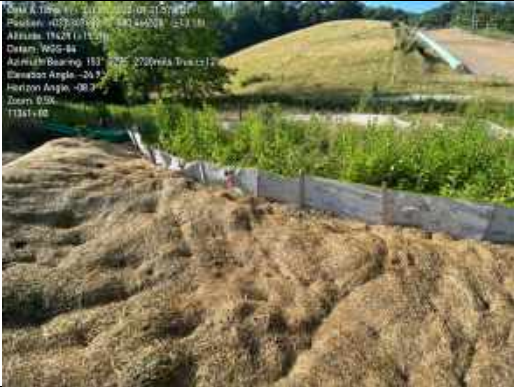
GPS Location	See photo		GPS Location	See photo	
Field Station#	11361+00		Field Station#	11362+00	
Pic 1 Desc.	11361+00 to 11360+00 P1 damaged do to live stock/ needs repaired		Pic 2 Desc.	Housekeeping trash needs removed

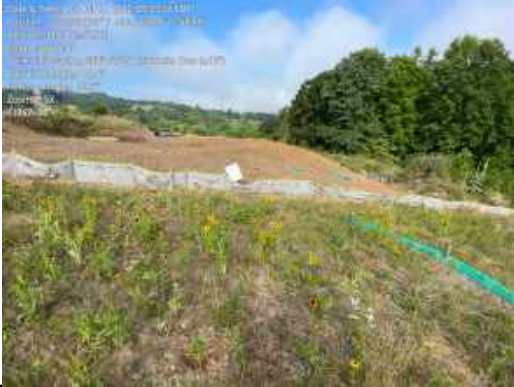
GPS Location	See photo		GPS Location	See photo	
Field Station#	11367+00		Field Station#	11398+00	
Pic 3 Desc.	P1 damaged by live stock needs repaired		Pic 4 Desc.	Permanent stabilization in place

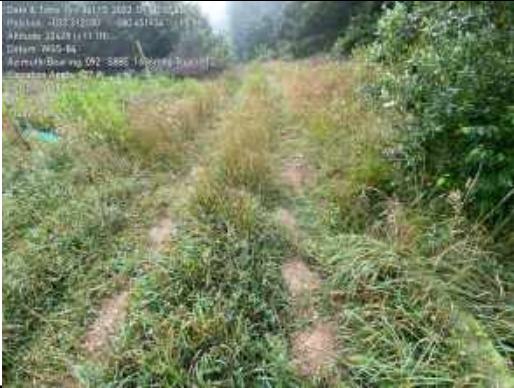
GPS Location	See photo		GPS Location	See photo	
Field Station#	11409+50		Field Station#	11412+00	
Pic 5 Desc.	Land owner access wattles need replaced		Pic 6 Desc.	Picture showing condition of row

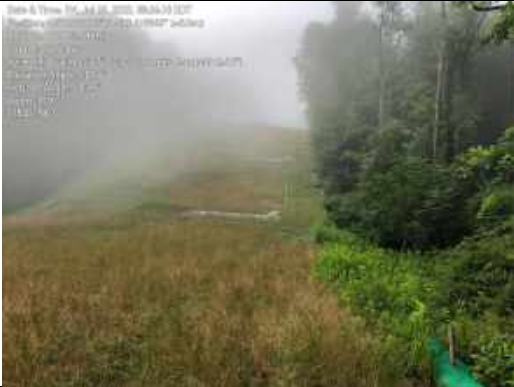
GPS Location	On photo		GPS Location	On photo	
Field Station#	11530+50		Field Station#	11541+00	
Pic 1 Desc.	ROW with good vegetation is currently stable.		Pic 2 Desc.	Stable ROW with ECDs in place along edge.
