Visual Site Inspection Report

Project Name	H-600 Pipeline Spread G	AFE	124300137	Spread	H-600 Pipeline Spread G
Contractor	Precision			Report #	39962
Inspector	Daniel Fortune			Date/Time	7/18/2022 3:10 PM
Permit #	TBD	Inspection Type	VA SWPP	Station Begin	12005+00
State	VA	Inspection Area	Partial	Station End	12005+00
County	Giles	Ground	Dry	Temperature (°F)	78.00
Municipality	N/A	Weather	Cloudy	Rain Gauge (in)	0.00
				Rain Accumulation Time (days)	0.00

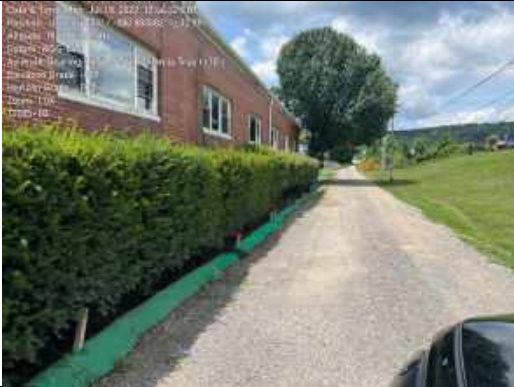
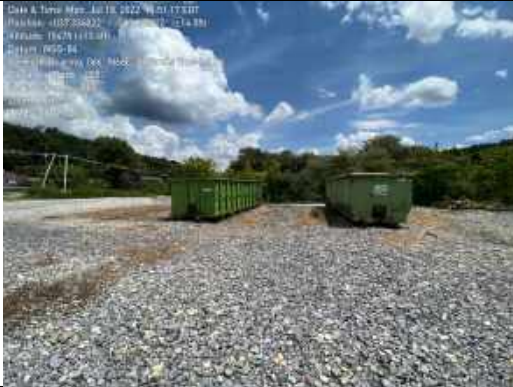
GPS Location	See photo LY 028		GPS Location	See photo LY 028	
Field Station#	12005+00		Field Station#	12005+00	
Pic 1 Desc.	LY 028 - RCE to LY28. Perimeter CFS found functional		Pic 2 Desc.	RCE and trash receptacle area.

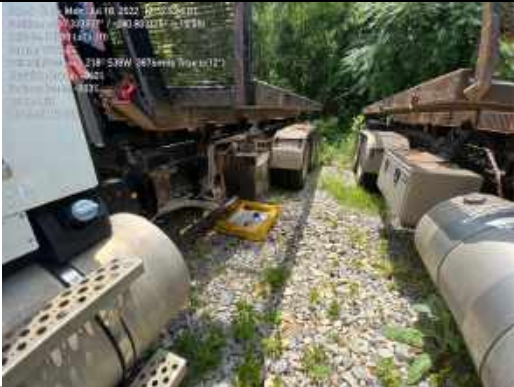
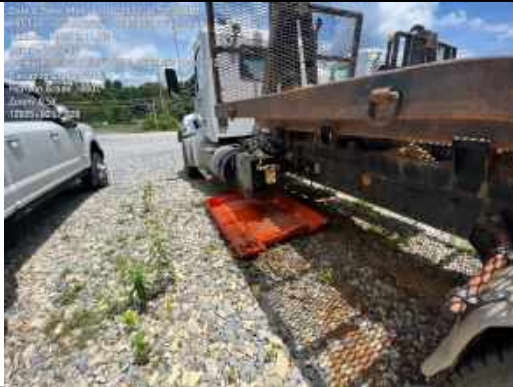
GPS Location	See photo LY 028		GPS Location	See photo LY 028	
Field Station#	12005+00		Field Station#	12005+00	
Pic 3 Desc.	Secondary containment under hydraulic box.		Pic 4 Desc.	Secondary containment under hydraulic box

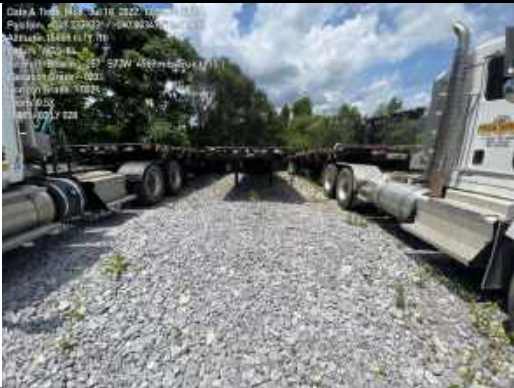
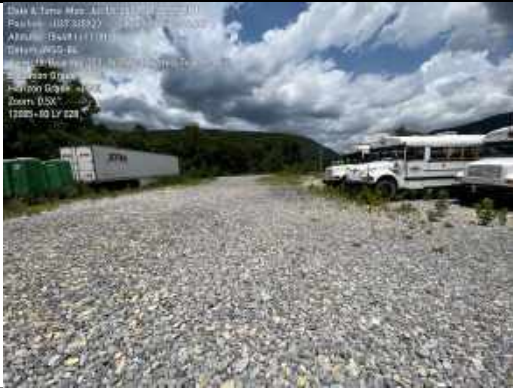
GPS Location	See photo LY 028		GPS Location	See photo LY 028	
Field Station#	12005+00		Field Station#	12005+00	
Pic 5 Desc.	RCE conditions at the float storage area.		Pic 6 Desc.	RCE at the transit bus storage area.

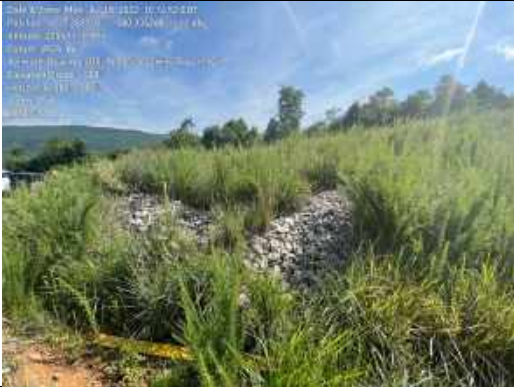
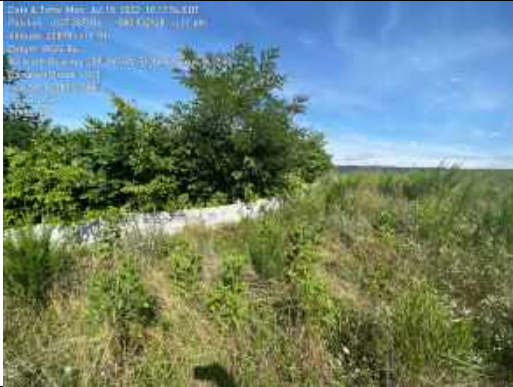
GPS Location	See photo		GPS Location	See photo	
Field Station#	11900+81		Field Station#	11906+00	
Pic 1 Desc.	Temporary level spreader condition in final restoration area		Pic 2 Desc.	Perimeter P1 silt fencing with heavy vegetation coverage.

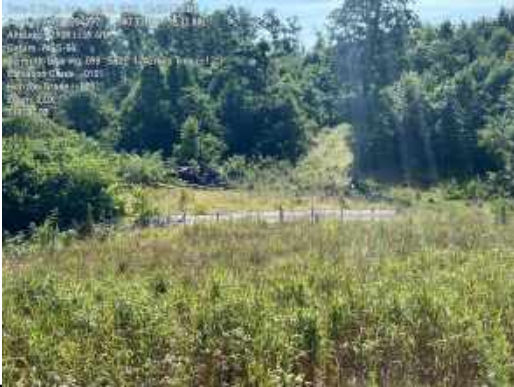
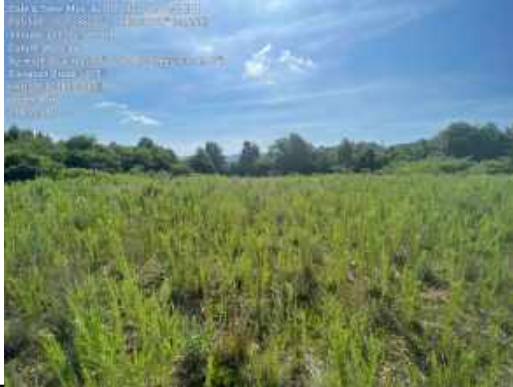
GPS Location	See photo		GPS Location	See photo	
Field Station#	11918+00		Field Station#	11912+40	
Pic 3 Desc.	Perimeter P1 silt fencing and heavy vegetation cover.		Pic 4 Desc.	Final restoration area.

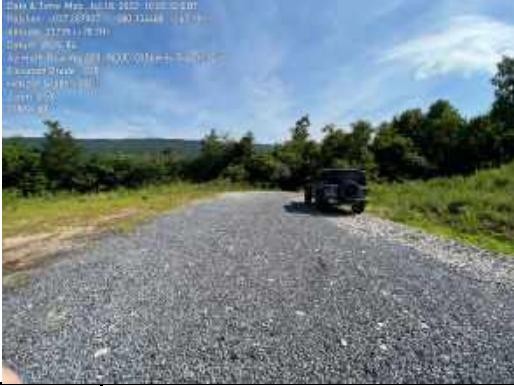
GPS Location	See photo	GPS Location	See photo		
Field Station#	11899+89	Field Station#	11854+00		
Pic 1 Desc.	RCE in place	Pic 2 Desc.	Permanent waterbar in place

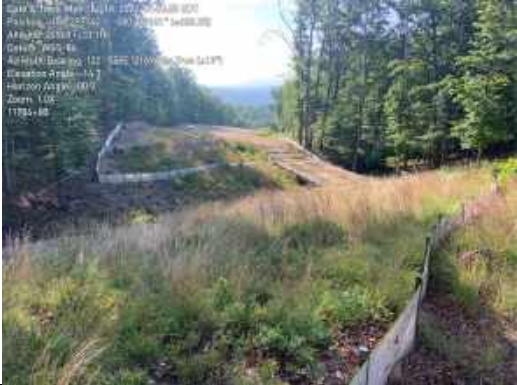
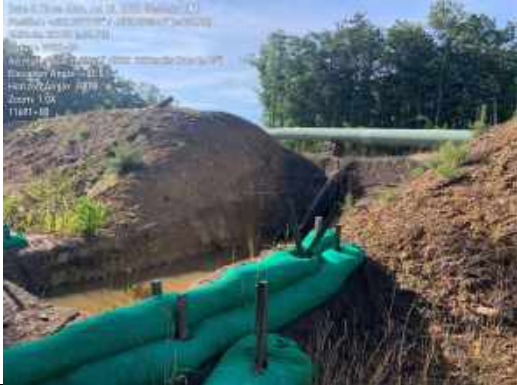
GPS Location	See photo		GPS Location	See photo	
Field Station#	11704+00		Field Station#	11691+00	
Pic 7 Desc.	Section of Row showing conditions and controls at S-MN22		Pic 8 Desc.	Section of Row showing conditions and controls

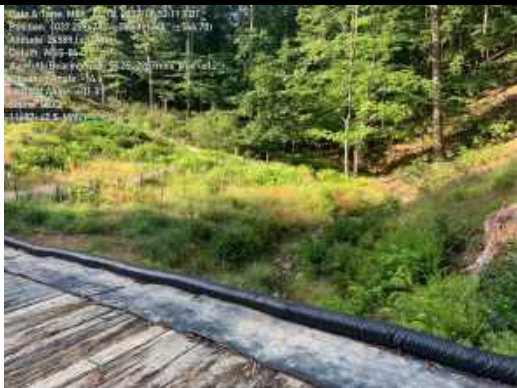
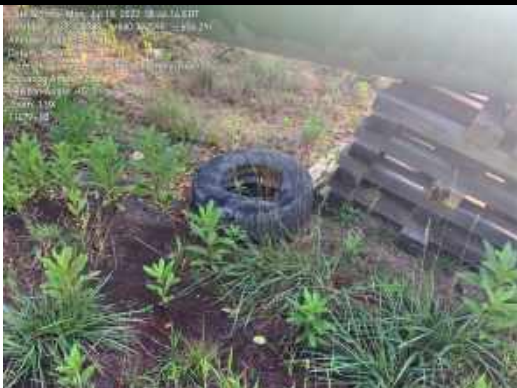
GPS Location	See photo		GPS Location	See photo	
Field Station#	11687+42		Field Station#	11679+00	
Pic 9 Desc.	Section of Row showing conditions and controls at S-MN21		Pic 10 Desc.	Tire added to punch list for removal

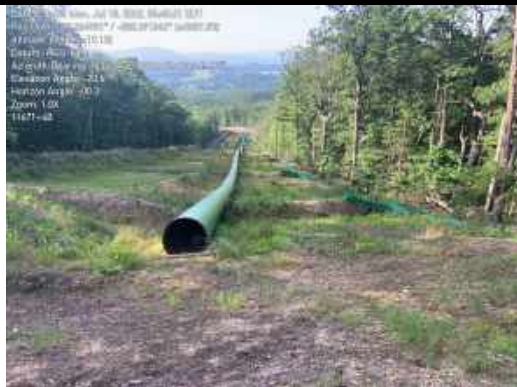
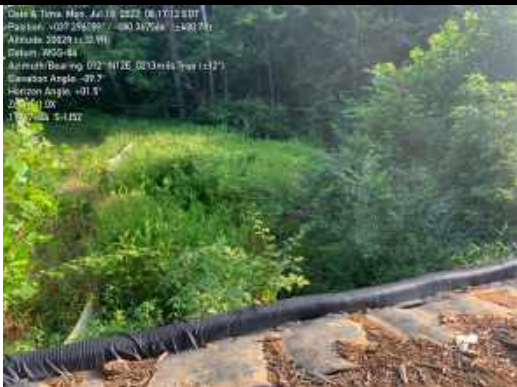
GPS Location	See photo		GPS Location	see photo	
Field Station#	11671+40		Field Station#	11767+44	
Pic 11 Desc.	Section of Row showing conditions and controls		Pic 12 Desc.	Looking upstream at S-IJ52

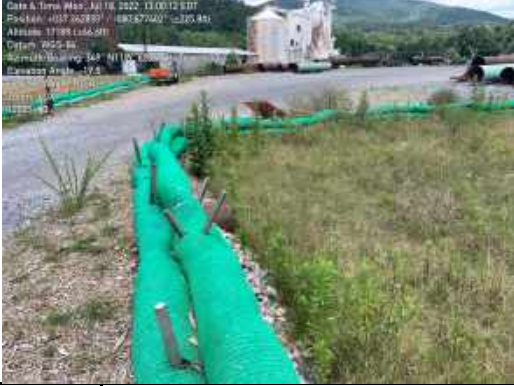
GPS Location	See photo	GPS Location	See photo		
Field Station#	12005+00	Field Station#	12005+00		
Pic 1 Desc.	Culvert is in place	Pic 2 Desc.	CFS perimeter controls are in place

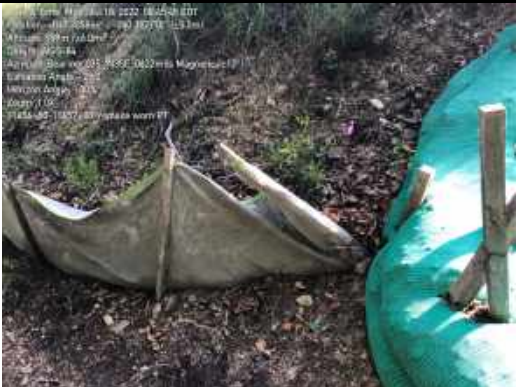
GPS Location	On photo		GPS Location	On photo	
Field Station#	11656+50		Field Station#	11669+00	
Pic 1 Desc.	COMMUNICATION; replace worn P1 silt fence along edge of LOD from 11656+50-11657+00.		Pic 2 Desc.	ECDs in place at top of Brush Mountain

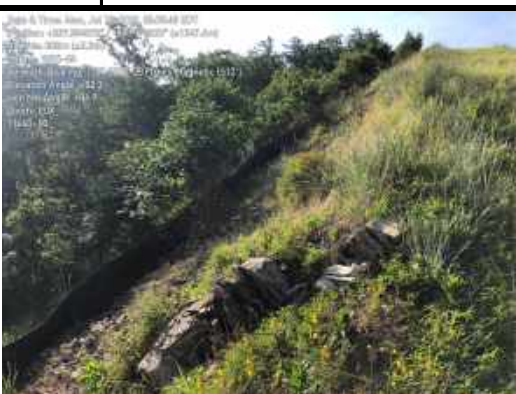
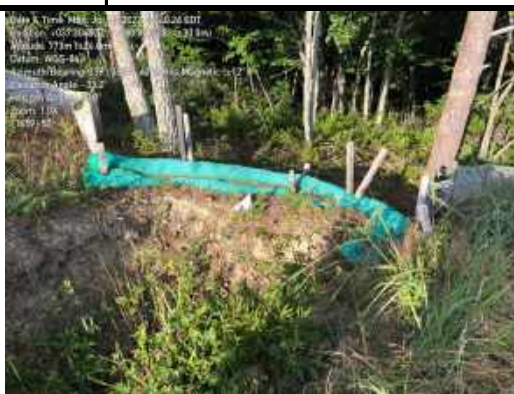
GPS Location	On photo		GPS Location	On photo	
Field Station#	11660+00		Field Station#	11659+50	
Pic 3 Desc.	ROW stable. ECDs in place.		Pic 4 Desc.	No issues from runoff. No sediment accumulation.

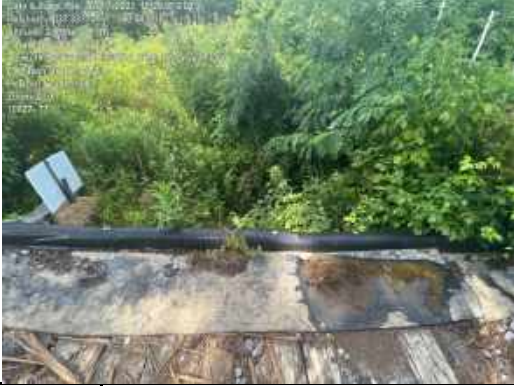
GPS Location	See photo	GPS Location	See photo		
Field Station#	10927+77	Field Station#	10924+50		
Pic 1 Desc.	S-Y3 vegetated stream bed conditions. Buffer zones heavily vegetated.	Pic 2 Desc.	Steep slope stabilization and new emerging temporary vegetation. Perimeter controls functional.

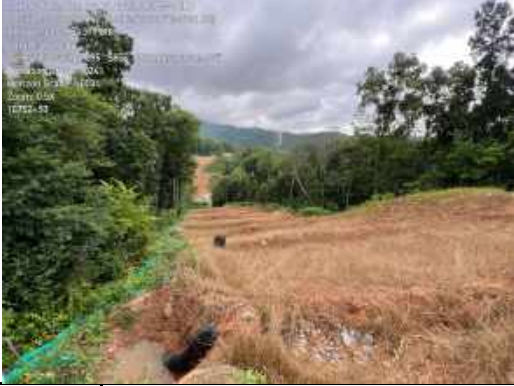
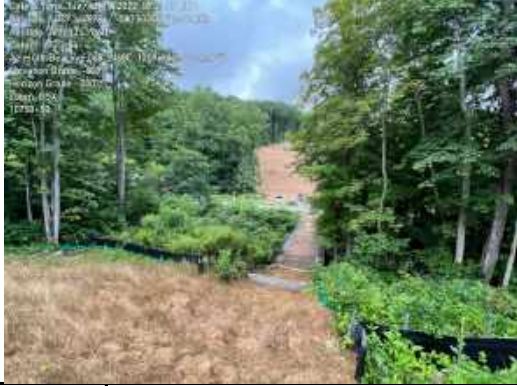
GPS Location	See photo		GPS Location	See photo	
Field Station#	10752+50		Field Station#	10758+50	
Pic 1 Desc.	Waterbars in place		Pic 2 Desc.	Stream buffer in place

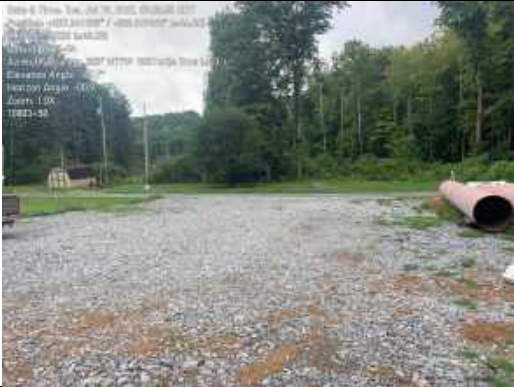
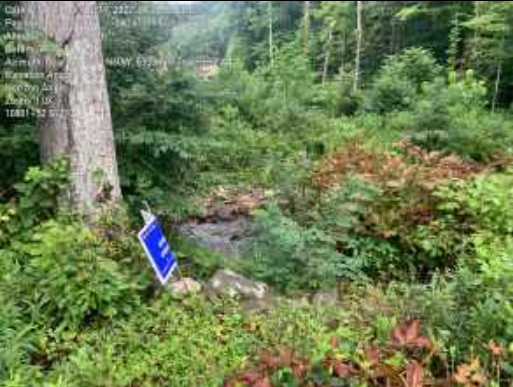
GPS Location	See photo		GPS Location	See photo	
Field Station#	10803+50		Field Station#	10801+52	
Pic 1 Desc.	RCE is maintained and in acceptable condition		Pic 2 Desc.	S-Z13

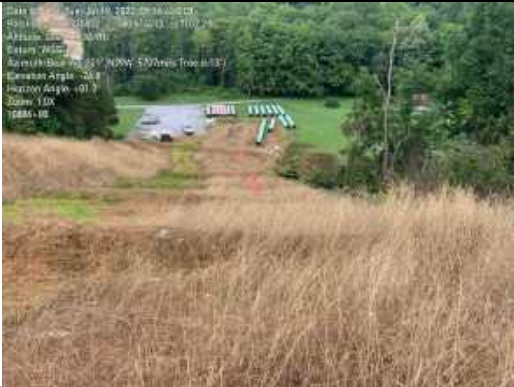
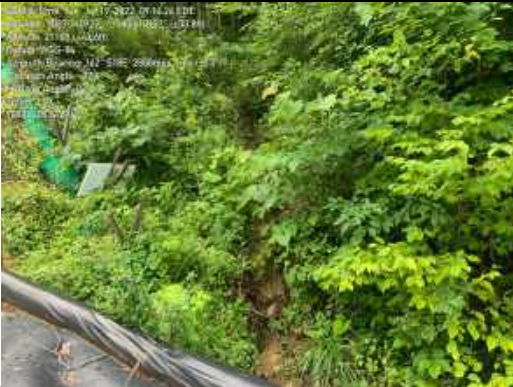
GPS Location	See photo		GPS Location	See photo	
Field Station#	10806+00		Field Station#	10809+04	
Pic 3 Desc.	Section of Row showing conditions and controls		Pic 4 Desc.	S-Z14 looking upstream

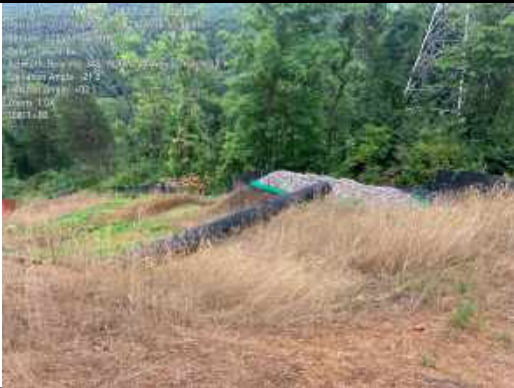
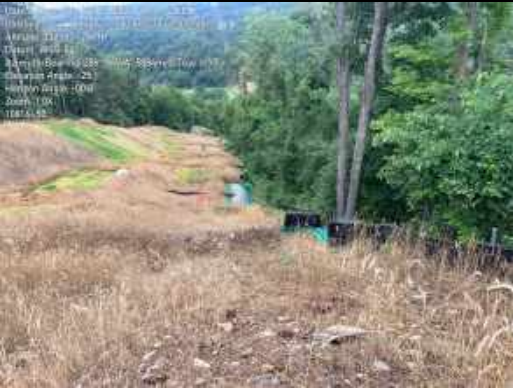
GPS Location	See photo		GPS Location	See photo	
Field Station#	10811+00		Field Station#	10816+50	
Pic 5 Desc.	Clean water diversion pipe and level spreader are in acceptable condition		Pic 6 Desc.	Section of Row showing conditions and controls

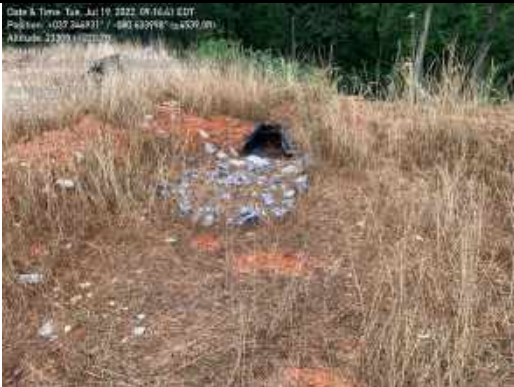
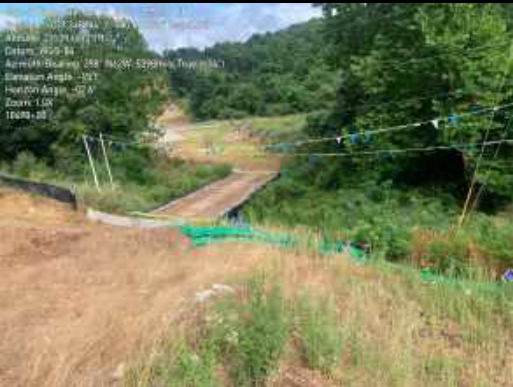
GPS Location	See photo for GPS location.		GPS Location	See photo for GPS location.	
Field Station#	10738+00		Field Station#	10698+00	
Pic 1 Desc.	Rock inlet in place at slope drain.		Pic 2 Desc.	Sensitive resource buffer in place at stream S-G32.

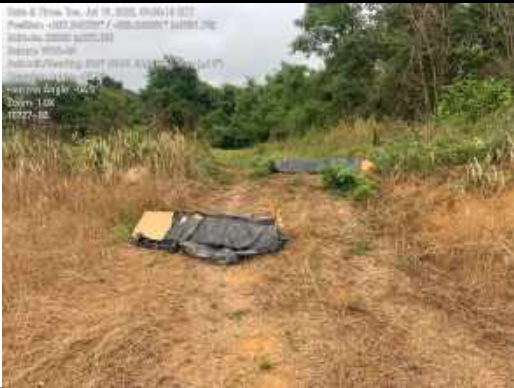
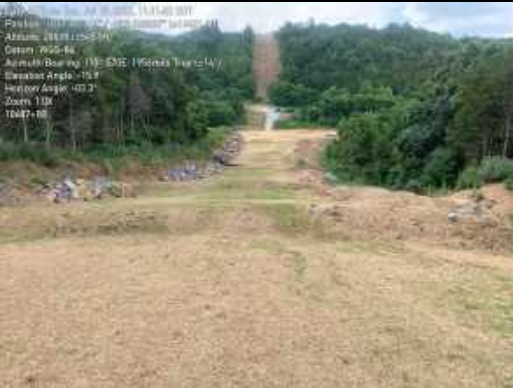
GPS Location	See photo for GPS location.		GPS Location	See photo for GPS location.	
Field Station#	10727+00		Field Station#	10687+00	
Pic 5 Desc.	Foam silt dike damaged at land owner access point. Item added to punchlist.		Pic 6 Desc.	ROW temporarily stabilized with seed and mulch.

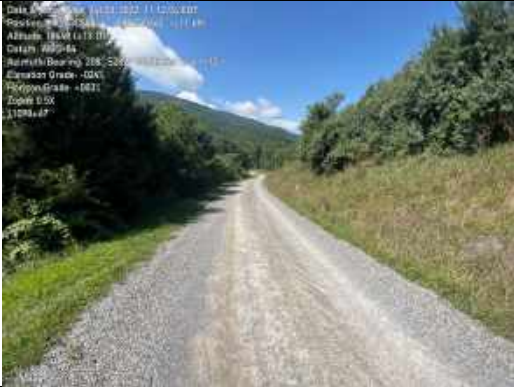
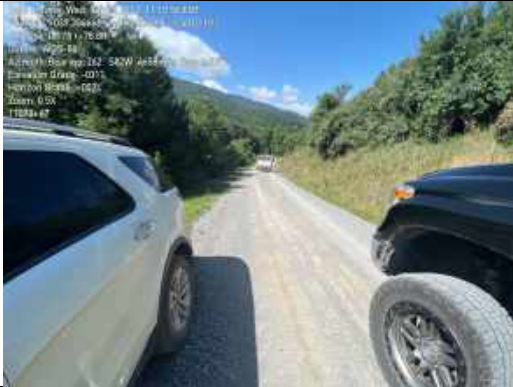
GPS Location	See photo	GPS Location	See photo		
Field Station#	11098+67	Field Station#	11098+67		
Pic 1 Desc.	View of AR 245.02	Pic 2 Desc.	View of 245.02 after a clean up of landowner hydraulic spill. Please see Clint Sears spill report.

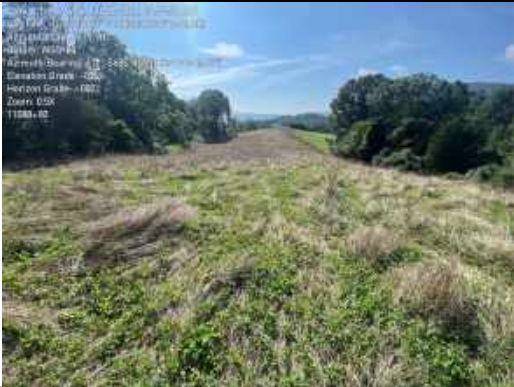
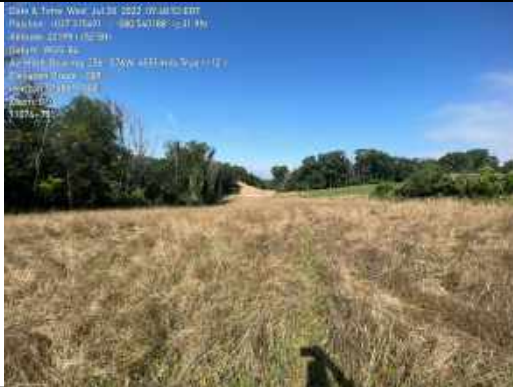
GPS Location	See photo	GPS Location	See photo		
Field Station#	11088+00	Field Station#	11074+75		
Pic 3 Desc.	View of permanent vegetation. Clover has overtaken the area.	Pic 4 Desc.	View of annual grasses that have died off due to summer heat conditions. (Final Restoration area).

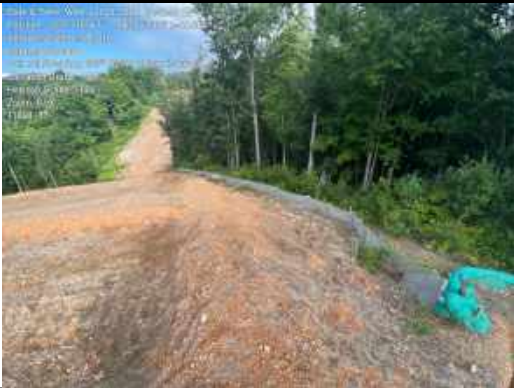
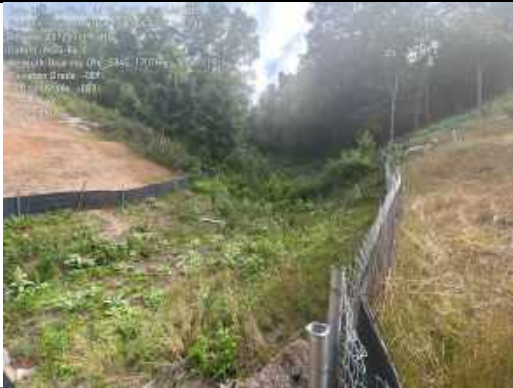
GPS Location	See photo	GPS Location	See photo		
Field Station#	11068+77	Field Station#	11064+85		
Pic 5 Desc.	View of perimeter P1 silt fencing conditions. Additional seeding has been recommended.	Pic 6 Desc.	Drainage feature area conditions.

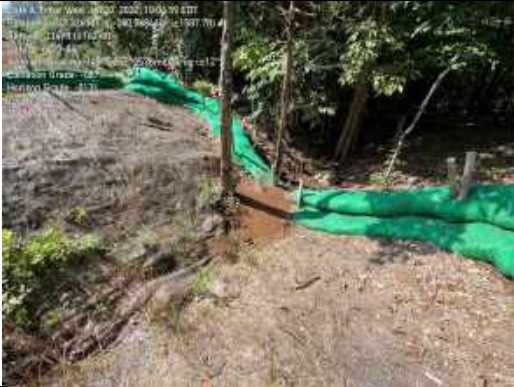
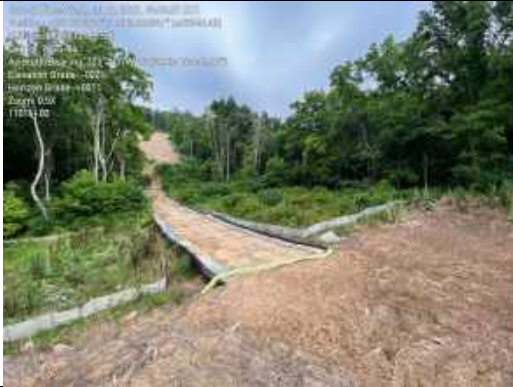
GPS Location	See photo		GPS Location	See photo	
Field Station#	10976+25		Field Station#	11016+00	
Pic 1 Desc.	Sediment needs cleaned off of CFS		Pic 2 Desc.	Stream buffer in place

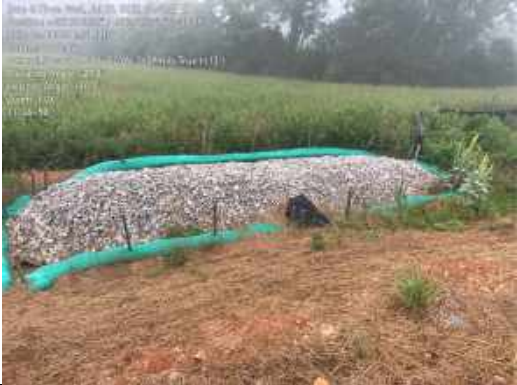
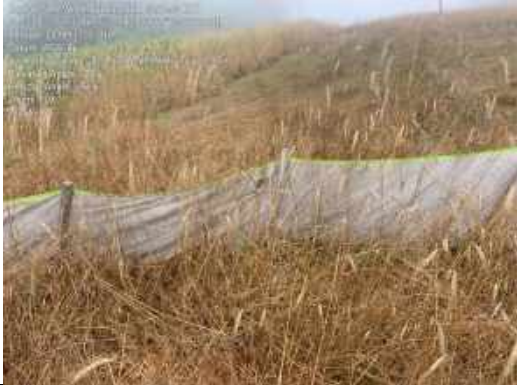
GPS Location	See photo		GPS Location	See photo	
Field Station#	11146+50		Field Station#	11146+00	
Pic 7 Desc.	Clean water diversion pipe and level spreader are in acceptable condition		Pic 8 Desc.	P1 silt fence is damaged

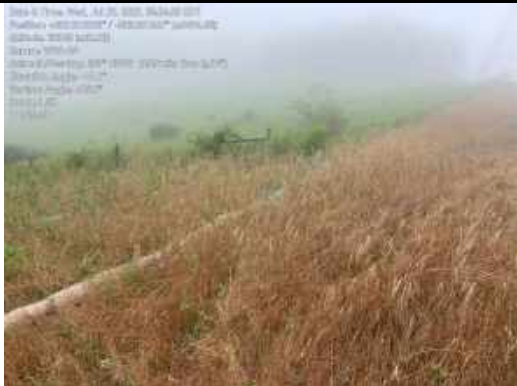
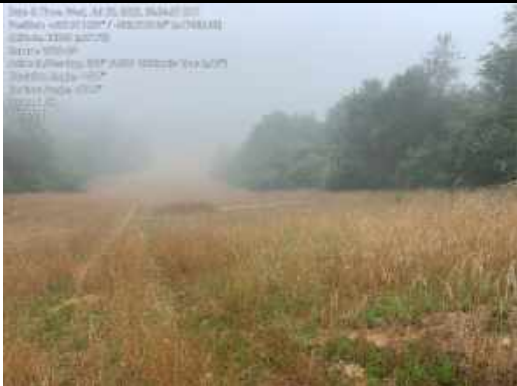
GPS Location	See photo		GPS Location	See photo	
Field Station#	11140+00		Field Station#	11137+00	
Pic 9 Desc.	Section of Row showing conditions and controls		Pic 10 Desc.	Section of Row showing conditions and controls

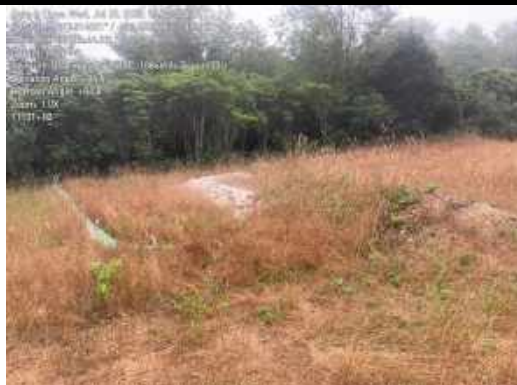
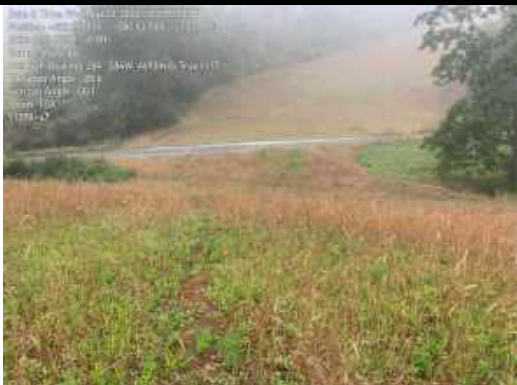
GPS Location	See photo		GPS Location	See photo	
Field Station#	11131+00		Field Station#	11098+47	
Pic 11 Desc.	Representational photo of water bar and level spreader		Pic 12 Desc.	Section of Row showing conditions and controls

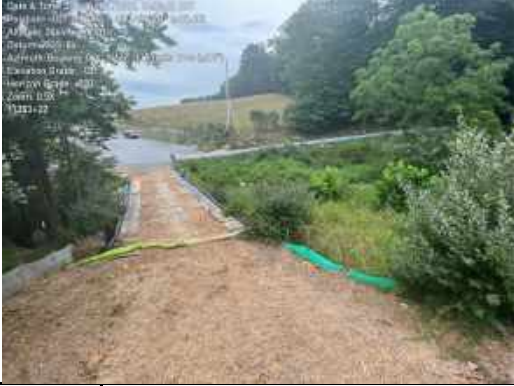
GPS Location	See photo		GPS Location	See photo	
Field Station#	11353+22		Field Station#	11328+00	
Pic 1 Desc.	S-NN11 Stream resource area and well vegetated undisturbed buffer zones		Pic 2 Desc.	S-NN 12 Stream resource area and well vegetated undisturbed buffer zones

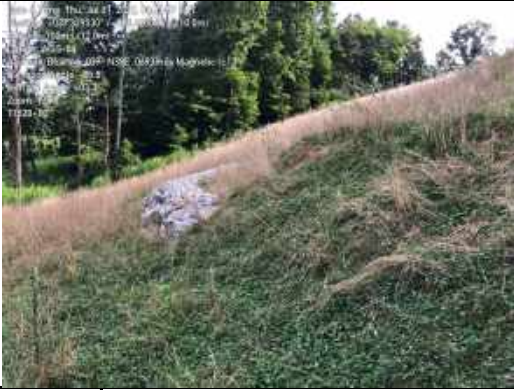
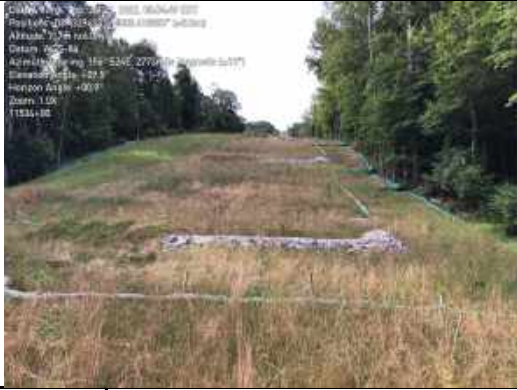
GPS Location	On photo	GPS Location	On photo		
Field Station#	11528+00	Field Station#	11534+00		
Pic 1 Desc.	All level spreaders and temporary slope breakers are in place.	Pic 2 Desc.	ROW vegetation good. Surface stable.

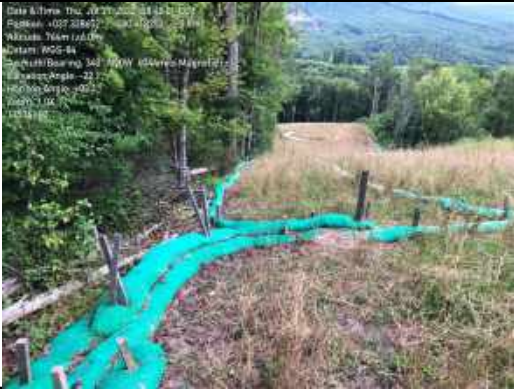
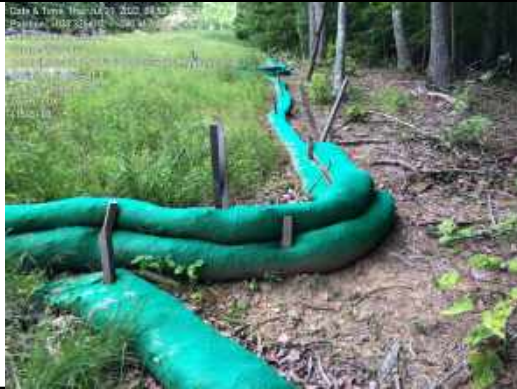
GPS Location	On photo	GPS Location	On photo		
Field Station#	11536+00	Field Station#	11545+00		
Pic 3 Desc.	ECDs are in acceptable condition.	Pic 4 Desc.	ECDs in place. No sediment migration occurring.

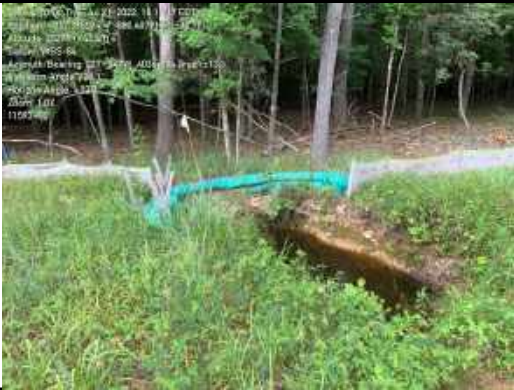
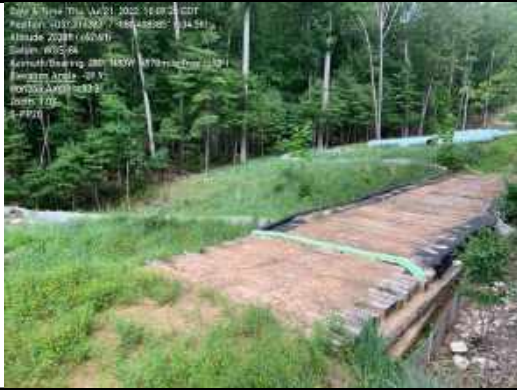
GPS Location	On photo	GPS Location	On photo		
Field Station#	11593+00	Field Station#	11588+41		
Pic 5 Desc.	Heavy vegetation exist and perimeter ECDs in place.	Pic 6 Desc.	The resource crossings are stable with good vegetation and ECDs in place.

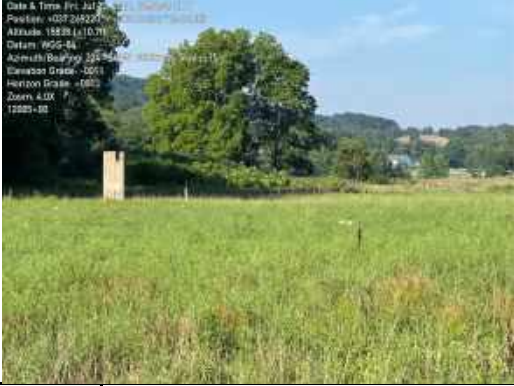
GPS Location	See photo	GPS Location	See photo		
Field Station#	12005+00	Field Station#	11994+50		
Pic 1 Desc.	Final Restoration at the spread break G/H	Pic 2 Desc.	Final Restoration near the spread break./

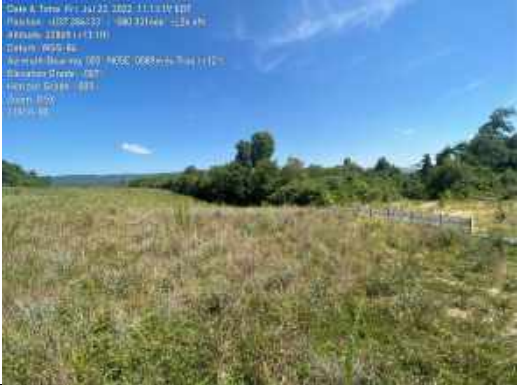
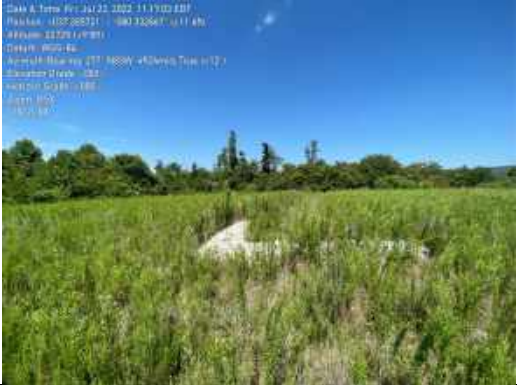
GPS Location	See photo	GPS Location	See photo		
Field Station#	11919+00	Field Station#	11912+00		
Pic 13 Desc.	Perimeter P1 silt fencing functional in the final restoration area.	Pic 14 Desc.	Permanent level spreader condition and well vegetated final restoration area.		
Insert image here		Insert image here			
GPS Location		GPS Location			
Field Station#		Field Station#			
Pic 15 Desc.		Pic 16 Desc.			
Insert image here		Insert image here			
GPS Location		GPS Location			
Field Station#		Field Station#			
Pic 17 Desc.		Pic 18 Desc.

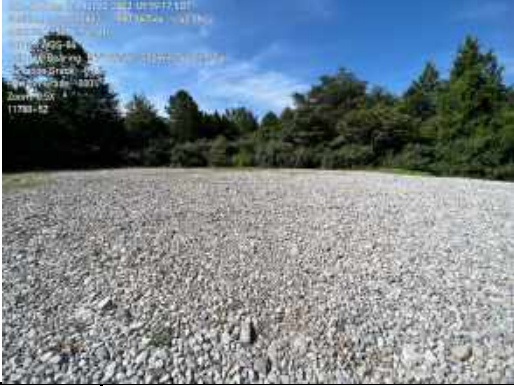
GPS Location	See photo	GPS Location	See photo		
Field Station#	11788+52	Field Station#	11811+00		
Pic 1 Desc.	RCE in place	Pic 2 Desc.	Permanent vegetation present

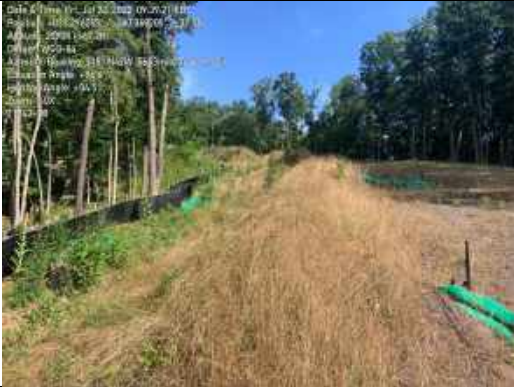
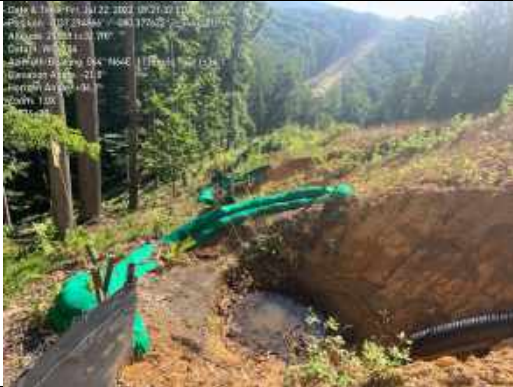
GPS Location	See photo	GPS Location	See photo		
Field Station#	11763+00	Field Station#	11734+30		
Pic 1 Desc.	Section of Row showing conditions and controls	Pic 2 Desc.	Section of Row showing conditions and controls

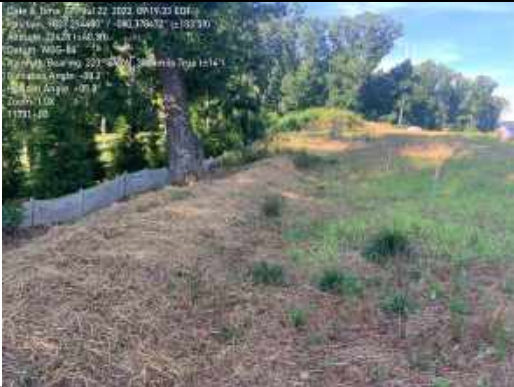
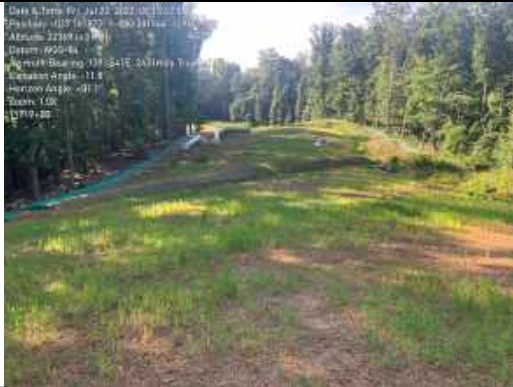
GPS Location	See photo	GPS Location	See photo		
Field Station#	11731+00	Field Station#	11719+00		
Pic 3 Desc.	P1 silt fence and temporary stabilization are in acceptable condition	Pic 4 Desc.	Section of Row showing conditions and controls

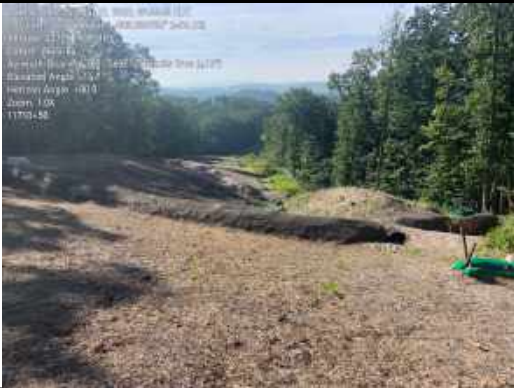
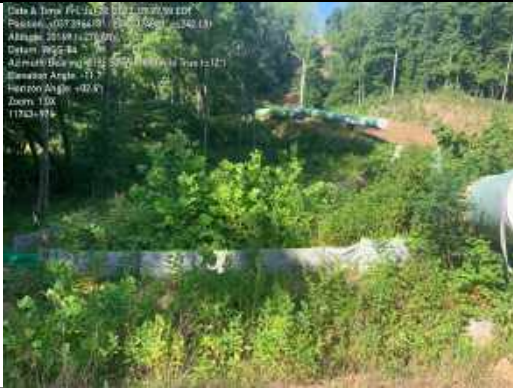
GPS Location	See photo	GPS Location	See photo		
Field Station#	11710+50	Field Station#	11743+97		
Pic 5 Desc.	Section of Row showing conditions and controls	Pic 6 Desc.	Section of Row showing conditions and controls at S-EF62

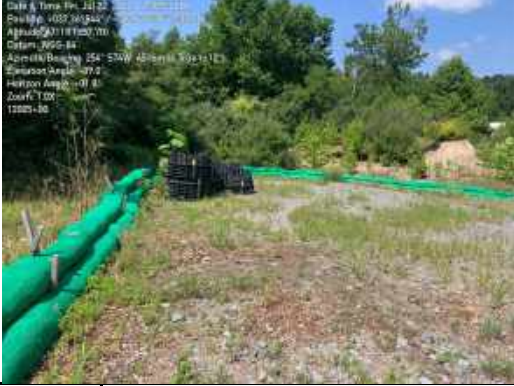
GPS Location	See photo	GPS Location	See photo		
Field Station#	12005+00	Field Station#	12005+00		
Pic 1 Desc.	CFS perimeter controls are in acceptable condition	Pic 2 Desc.	Culvert in place
