Visual Site Inspection Report

Project Name	H-600 Pipeline Spread H	AFE	124300138	Spread	H-600 Pipeline Spread H
Contractor	Precision			Report #	39667
Inspector	Jordan Davis			Date/Time	7/11/2022 3:00 PM
Permit #	TBD	Inspection Type	VA SWPP	Station Begin	12284+75
State	VA	Inspection Area	Partial	Station End	12443+75
County	Montgomery	Ground	Damp	Temperature (°F)	80.00
Municipality	N/A	Weather	Cloudy	Rain Gauge (in)	0.20
				Rain Accumulation Time (days)	1.00

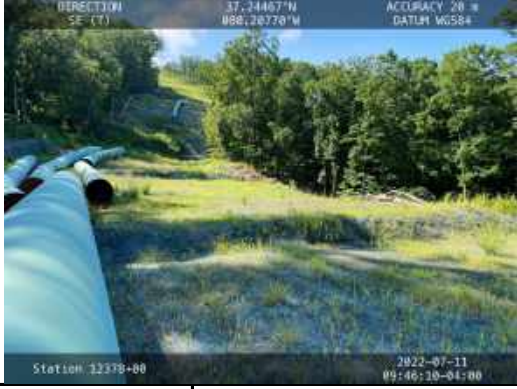
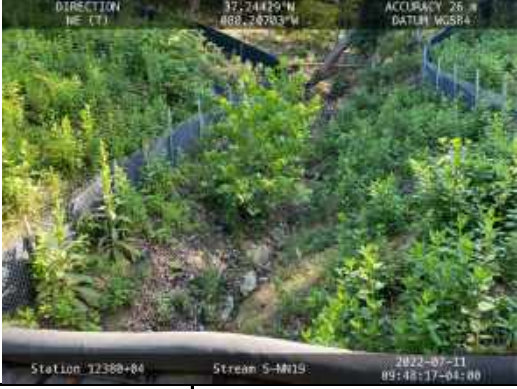
GPS Location	Please see photo for details.		GPS Location	Please see photo for details.	
Field Station#	12378+00		Field Station#	12380+04	
Pic 9 Desc.	Photo shows the stabilized ROW conditions with water bars and that all ECDs are installed and are functioning as designed.		Pic 10 Desc.	Photo shows upstream view of Stream S-NN19 from the equipment bridge spanning the stream channel.

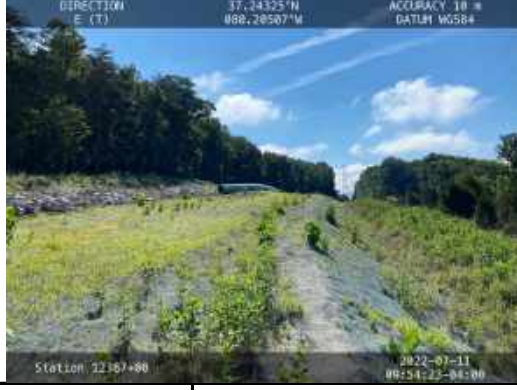
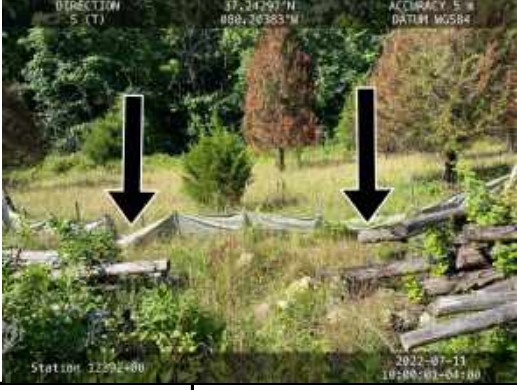
Pic 11 Desc.	Photo shows the stabilized ROW conditions with water bars and that all ECDs are installed and are functioning as designed.		Pic 12 Desc.	Photo shows punch list item of P1 silt fence that needs repair due to detached panel and sagging panel.

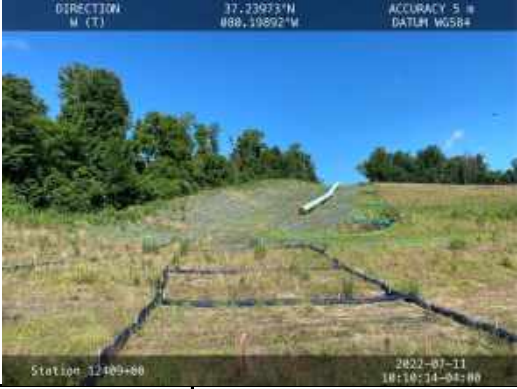
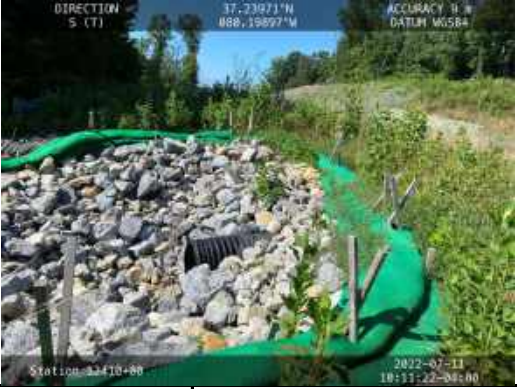
GPS Location	Please see photo for details.		GPS Location	Please see photo for details.	
Field Station#	12409+00		Field Station#	12410+00	
Pic 13 Desc.	Photo shows the stabilized ROW conditions with water bars and that all ECDs are installed and are functioning as designed.		Pic 14 Desc.	Photo shows plunge pool for clean water diversion pipe outlet.

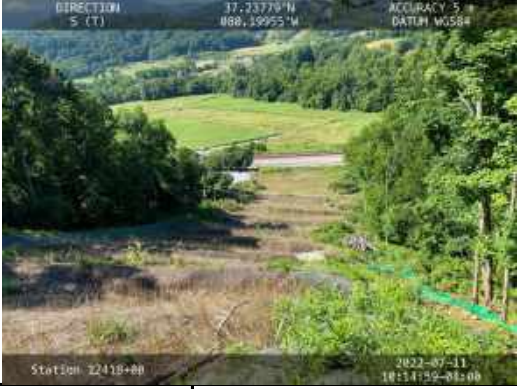
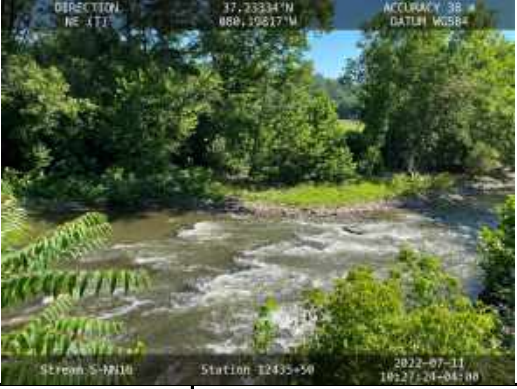
GPS Location	Please see photo for details.		GPS Location	Please see photo for details.	
Field Station#	12418+00		Field Station#	12435+50	
Pic 15 Desc.	Photo shows the stabilized ROW conditions with water bars and that all ECDs are installed and are functioning as designed.		Pic 16 Desc.	Photo shows overview of Stream S-NN16 from the going away side.

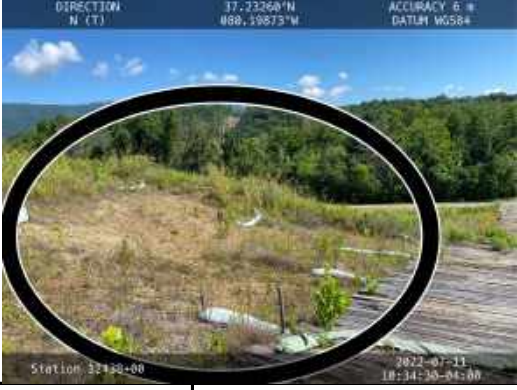
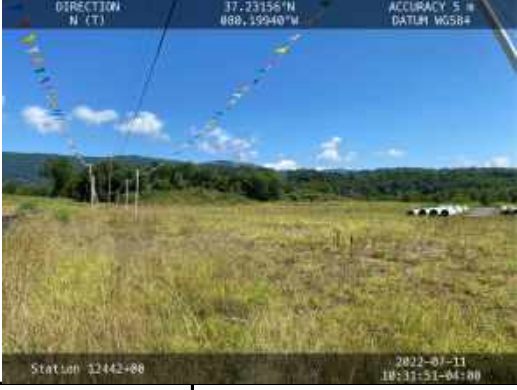
Pic 17 Desc.	Photo shows punch list item of bare area needing seed and straw mulch applied to be in compliance with temporary stabilization.		Pic 18 Desc.	Photo shows current stabilized ROW conditions.

7. Identify all remedial measures that have been taken since the previous inspection was conducted. No remedial measures since the last VA DEQ SWPPP Inspection on 07/05/2022.					
Comments (Reference above questions as appropriate.) Attended morning virtual conference call for inspection at 6:30am then traveled to MVP-MN-276.03. Here, the VA DEQ SWPPP inspection was performed on this date. From station 12284+75 to station 12443+75 the ROW was walked to evaluate that all ECDs are installed and functioning as designed along with the ROW that had been previously disturbed and is now inactive has been properly stabilized with either straw mulch, erosion control blanket or temporary or permanent vegetation. In which appeared to be adequate. - Final result of all areas observed and evaluated in todays inspection were found to be in compliance and have no environmental issues, no off ROW sediment as well as no stream or wetland impacts. - The ECDs observed today appeared to be installed and functioning as designed. Some of the ECDs are showing some wear but are still functioning. - Located within todays SWPPP inspection area are the following resources and other access roads that were evaluated and observed. Stream S-0016 located at station 12374+16 - Stream S-NN19 located at 12380+04 - Stream S-NN16 located at station 12435+16. Wetland W-NN8 located from station 12434+55 to station 12435+46. MVP-MN-276.03 - MVP-MN-277.0 * A total of (6) punch list items were found during todays VA DEQ SWPPP inspection. They are as listed along with their locations: (1) Repair CFS in MVP-MN-276.03 due to third party damage. (2) Refresh CFS on CFS water end treatment at station 12306+00. (3) Refresh CFS on CFS water end treatment at station 12329+00. (4) Reattach SSF to chain link at station 12343+00. (5) Reattach P1 fabric to stake that is no longer attached / tighten another sagging panel of P1 at 12392+00. (6) Apply seed and straw mulch on bare area of the ROW to be in compliance with temporary stabilization at station 12438+00 to station 12438+50.

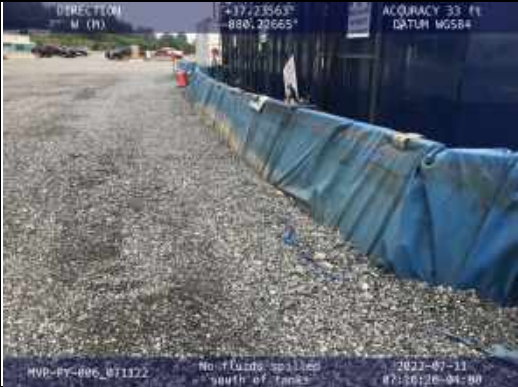
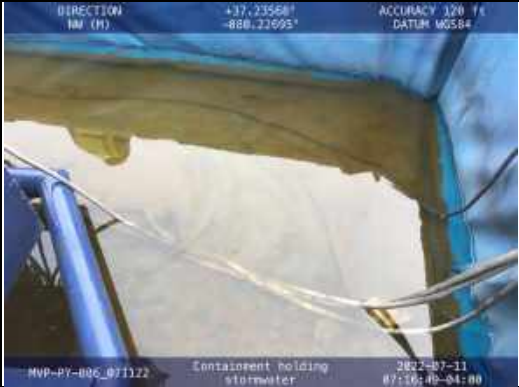
GPS Location	MVP-PY-006 See photo for gps data	GPS Location	MVP-PY-006 See photo for gps data		
Field Station#	+0	Field Station#	+0		
Pic 13 Desc.	Blue Bulk Fuel tanks no fluids spilled on the south side of tanks. Looking W.	Pic 14 Desc.	Blue Bulk Fuel tanks containment holding stormwater. Looking NW.

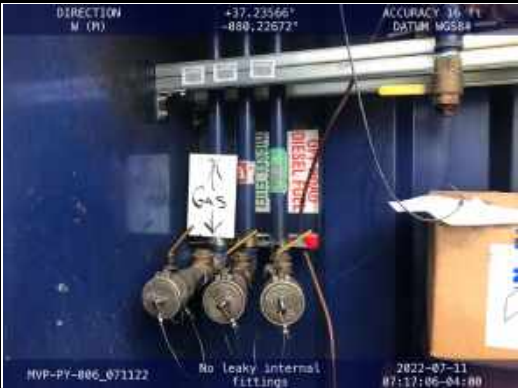
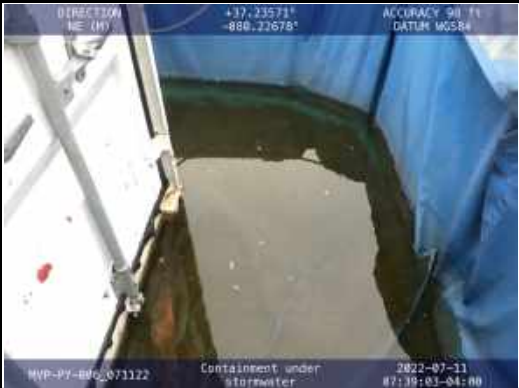
GPS Location	MVP-PY-006 See photo for gps data	GPS Location	MVP-PY-006 See photo for gps data		
Field Station#	+0	Field Station#	+0		
Pic 15 Desc.	Blue Bulk Fuel tanks no leaky internal fittings. Looking W.	Pic 16 Desc.	Off Road Fuel unit containment holding stormwater. Looking NE.

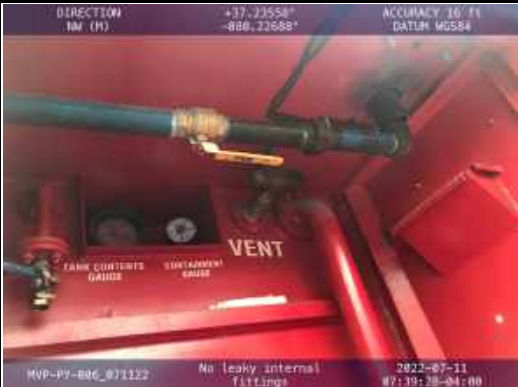
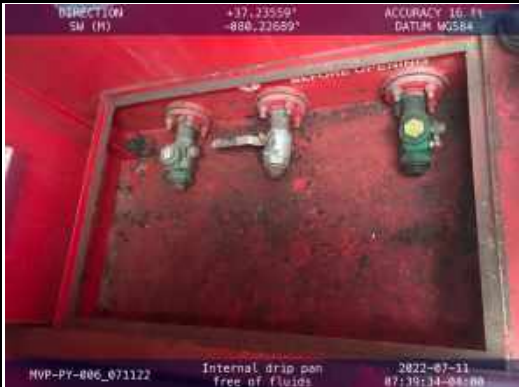
GPS Location	MVP-PY-006 See photo for gps data	GPS Location	MVP-PY-006 See photo for gps data		
Field Station#	+0	Field Station#	+0		
Pic 17 Desc.	Off Road Fuel unit no leaky internal fittings. Looking NW.	Pic 18 Desc.	Off Road Fuel unit internal drip pan free of fluids. Looking SW.

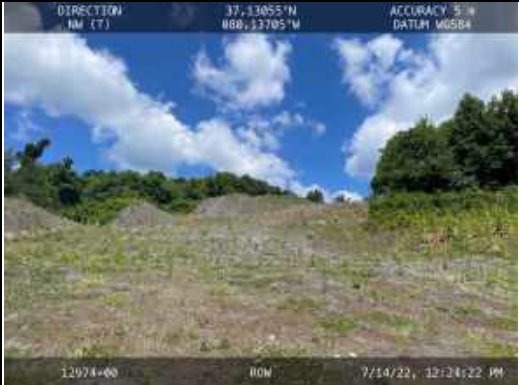
<p>12974+00 ROW 7/14/22, 12:34:22 PM</p>			
GPS Location	See photo		GPS Location	See photo	
Field Station#	12957+00		Field Station#	12974+00	
Pic 13 Desc.	Sediment trap is functional		Pic 14 Desc.	Current ROW conditions. ROW is stable and ECDs are functional.

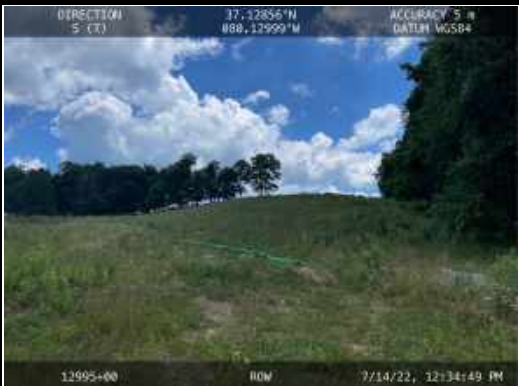
<p>12995+00 ROW 7/14/22, 12:34:49 PM</p>			
GPS Location	See photo		GPS Location	See photo	
Field Station#	12977+00		Field Station#	12995+00	
Pic 15 Desc.	Plunge pool is functional		Pic 16 Desc.	Current ROW conditions. ROW is stable and ECDs are functional.

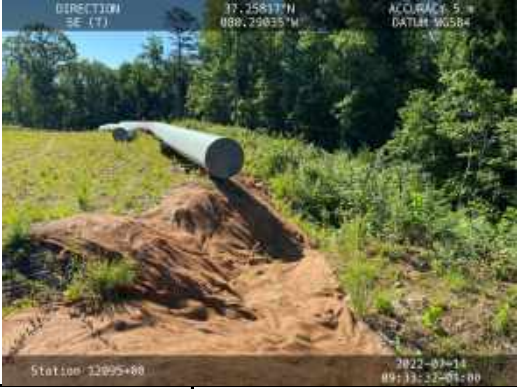
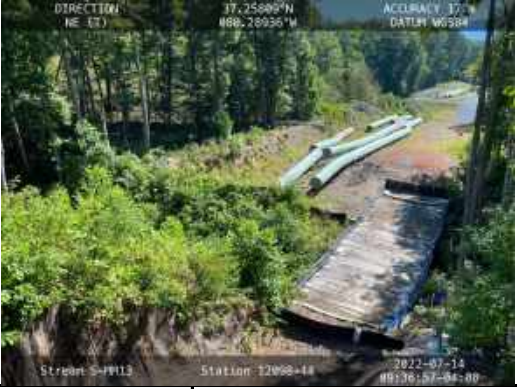
GPS Location	Please see photo for details.		GPS Location	Please see photo for details.	
Field Station#	12095+00		Field Station#	12098+44	
Pic 13 Desc.	Photo shows a remedial measure taken since the last VA DEW SWPPP inspection.		Pic 14 Desc.	Photo shows overview of Stream S-MM13 and its buffer zone from the coming in side.

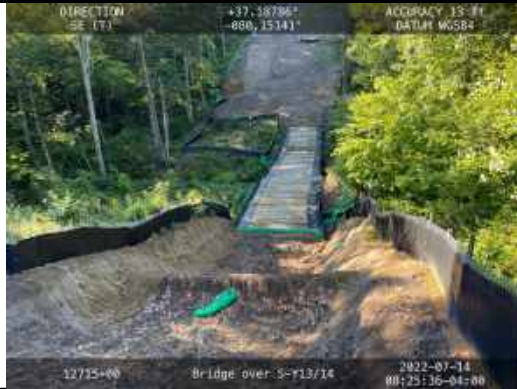
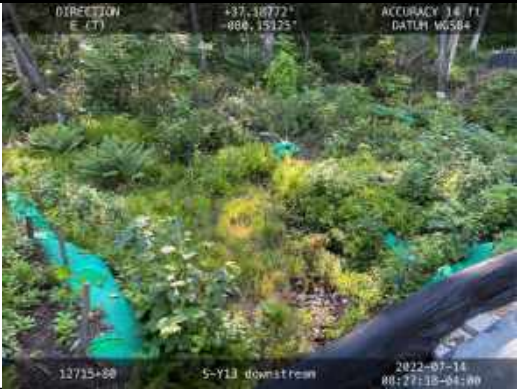
GPS Location	See photo for gps location data.		GPS Location	See photo for gps location data.	
Field Station#	12715+00		Field Station#	12715+80	
Pic 11 Desc.	Photo shows the bridge over streams S-Y13 and S-Y14.		Pic 12 Desc.	Photo shows S-Y13 downstream from the bridge.
