Visual Site Inspection Report

| Project Name | H-600 Pipeline Spread H | AFE | 124300138 | Spread | H-600 Pipeline Spread H |
| Inspector | Bryan Cole | | | Date/Time | 7/18/2022 1:42 PM |

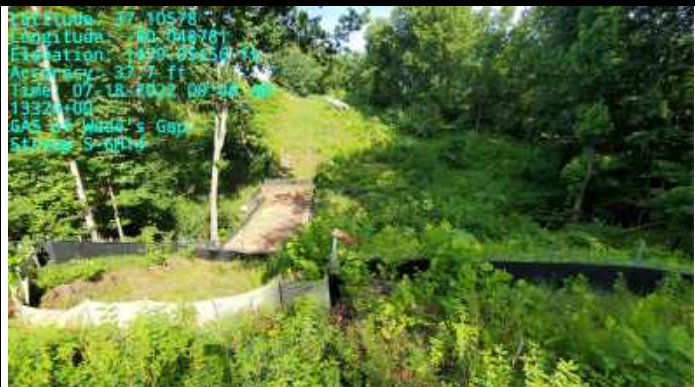
| Field Station# | 13326+00 | | Field Station# | 13333+00 | |

| Pic 1 Desc. | ROW and ECDs In good condition and stable | | Pic 2 Desc. | MVP-S-GH15 and corresponding buffer zone in good condition | |

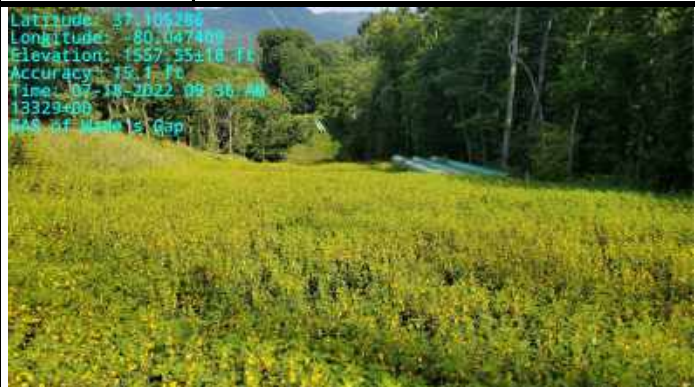
| Field Station# | 13329+00 | | Field Station# | 13335+00 | |

| Pic 3 Desc. | MVP-S-GH14 and corresponding buffer zone in good condition | | Pic 4 Desc. | MVP-S-GH11 and corresponding buffer zone in good condition | |

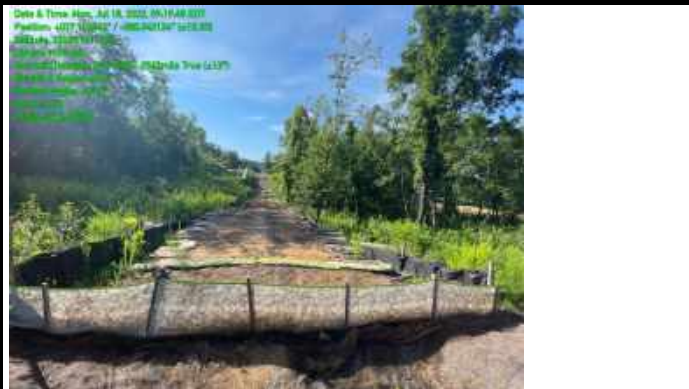
| Field Station# | 13348+46 | | Field Station# | 13352+23 | |

| Pic 9 Desc. | MVP-S-GH14 and corresponding buffer zone in good condition | | Pic 10 Desc. | ROW and ECDs In good condition and stable | |

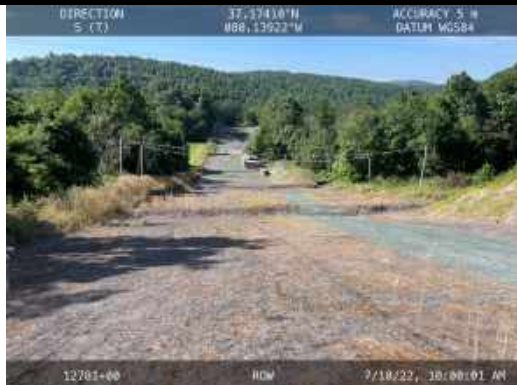
| Field Station# | 12781+00 | | Field Station# | 12791+00 | |

| Pic 9 Desc. | Current ROW conditions. ROW is stable and ECDs are functional. | | Pic 10 Desc. | Level spreader is functional. | |

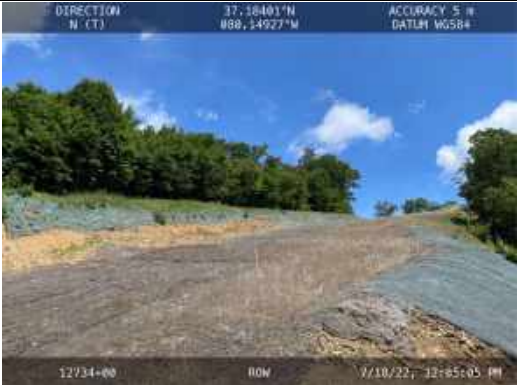
| Field Station# | 12734+00 | | Field Station# | 12728+00 | |

| Pic 15 Desc. | Downstream of crossing at Stream S-EF32 | | Pic 16 Desc. | Current ROW conditions. ROW is stable and ECDs are functional. | |

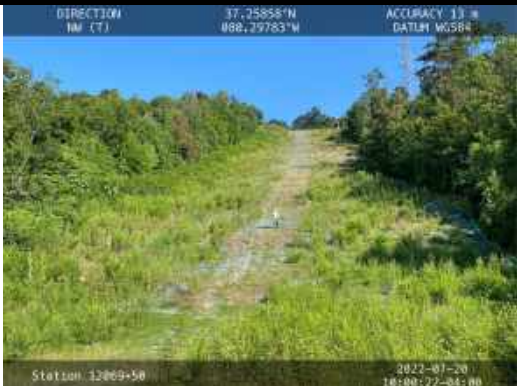
| E&S BMPs | Compliance Level | Corrective Action | Corrective Time Frame | Date Repaired |
|---|---|---|---|---|
| Silt Fence (Filter Fabric Fence) | Communication | Repair or replace down panel P1 | | 7/20/2022 |

| Pic 7 Desc. | Photo shows downstream view of Stream S-G40 from the equipment bridge spanning the stream channel. | | Pic 8 Desc. | Photo shows punch list item from today of repairing or replacing down P1. (Resolved 07/20/22). | |

| <p>Attended morning virtual conference call for inspection at 6:30am then traveled to MVP-MN-268.01. Here, the VA DEQ SWPPP inspection was performed on this date. From station 12005+00 to station 12119+17 the ROW was walked to evaluate that all ECDs are installed and functioning as designed along with the ROW that had been previously disturbed and is now inactive has been properly stabilized with either straw mulch, erosion control blanket or temporary or permanent vegetation. In which appeared to be adequate.</p> <p>- Final result of all areas observed and evaluated in todays inspection were found to be in compliance and have no environmental issues, no off ROW sediment as well as no stream or wetland impacts.</p> <p>- The ECDs observed today appeared to be installed and functioning as designed. Some of the ECDs are showing some wear but are still functioning.</p> <p>- Located within todays SWPPP inspection area are the following resources that were evaluated and observed. Stream S-SG36 located at station number 12008+53. Stream S-G38 located at station number 12015+84. Stream S-G39 located at station number 12031+51. Stream S-G40 located at station number 12035+11. Stream S-PP23 located at station number 12035+75. Stream S-MM15 located at station number 12076+95. Stream S-MM14 located at station number 12086+56. Stream S-MM13 located at station number 12098+44. Stream S-MM11 located at station number 12101+57. Stream S-F15 located at station number 12108+41. Stream S-F16A/B located at station number 12112+23. Wetland W-F9-PFO located from station number 12108+40 to station number 12109+05.</p> <p>* One punch list item during todays VA DEQ SWPPP inspection. Repair or replace panel of P1 at 12013+97. (MVP-MN-268.01).</p> | | | | | |

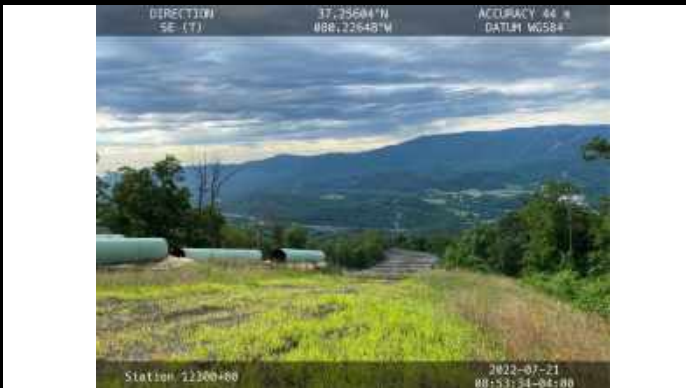
| Pic 3 Desc. | Photo shows before and after of punch list item consisting of reattaching SSF fabric to chain link. | | Pic 4 Desc. | Photo shows the stabilized ROW conditions with water bars and that all ECDs are installed and are functioning as designed. | |

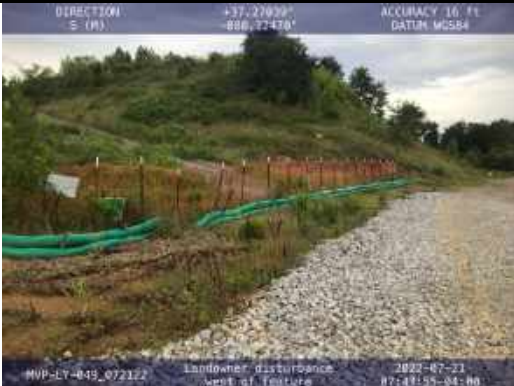
| Pic 3 Desc. | Landowner soil disturbance along triple stack compost filter sock. No new damage to installed ECD's. Area not stabilized. Looking S | | Pic 4 Desc. | Landowner soil disturbance along feature W-CV21A. Area not stabilized. Looking W. | |
