Visual Site Inspection Report

Project Name	H-600 Pipeline Spread H	AFE	124300138	Spread	H-600 Pipeline Spread H
Contractor	Precision			Report #	39499
Inspector	Jordan Davis			Date/Time	7/5/2022 3:00 PM
Permit #	TBD	Inspection Type	VA SWPP	Station Begin	12284+75
State	VA	Inspection Area	Partial	Station End	12443+75
County	Montgomery	Ground	Dry	Temperature (°F)	87.00
Municipality	N/A	Weather	Sunny	Rain Gauge (in)	0.00
				Rain Accumulation Time (days)	0.00

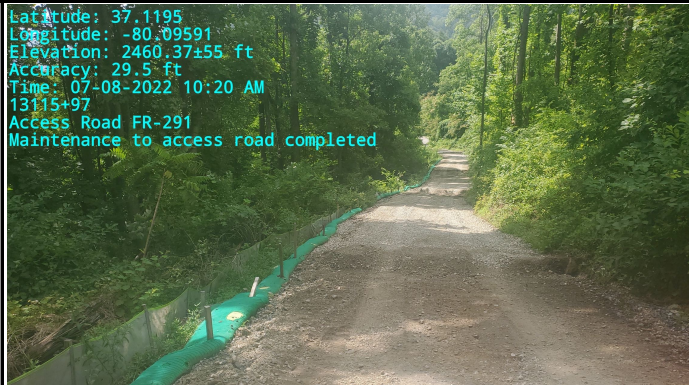
<div>Latitude: 37.1195 Longitude: -80.09591 Elevation: 2460.37±55 ft Accuracy: 29.5 ft Time: 07-08-2022 10:20 AM 13115+97 Access Road FR-291 Maintenance to access road completed</div>

GPS Location	See pic.		GPS Location	See pic.	
Field Station#	13109+00		Field Station#	13115+97	
Pic 17 Desc.	Current ROW conditions.		Pic 18 Desc.	Gravel on access road displaced by rainfall requires maintenance by the contractor. Added to PL to be addressed. Completed 7-8-22

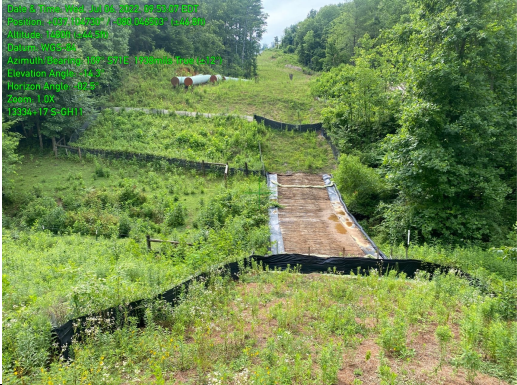
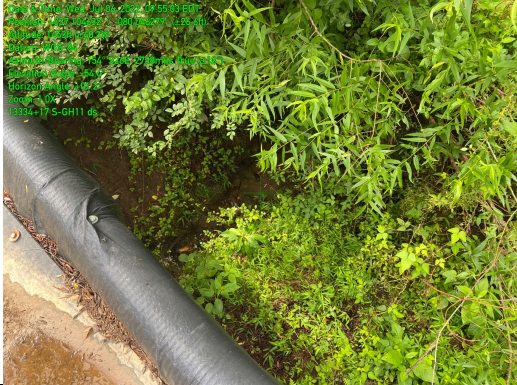
GPS Location	See photo for coordinates.		GPS Location	See photo for coordinates.	
Field Station#	13334+17		Field Station#	13334+17	
Pic 7 Desc.	S-GH11, ROW stabilized and perimeter controls were in acceptable condition along stream crossing perimeters.		Pic 8 Desc.	S-GH11, downstream, slight turbidity noted downstream of equipment bridge, culvert not visible on upstream side of equipment bridge.

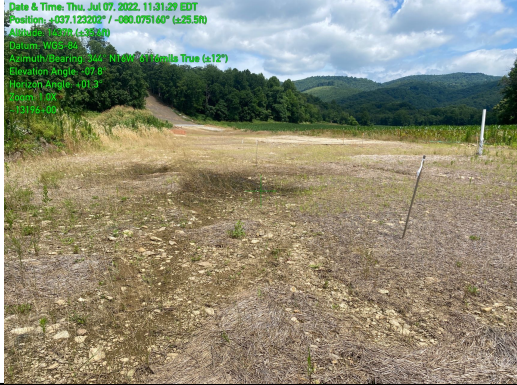
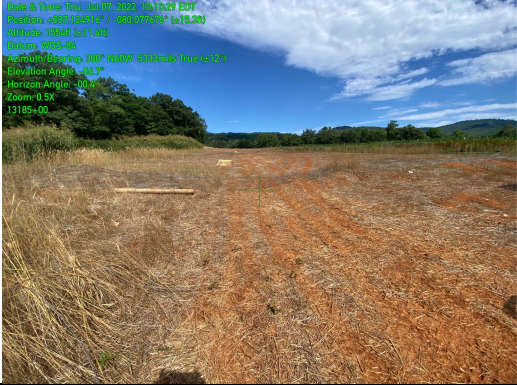
GPS Location	See photo for coordinates.		GPS Location	See photo for coordinates.	
Field Station#	13196+00		Field Station#	13185+00	
Pic 9 Desc.	ROW stabilized, minor erosion noted in field.		Pic 10 Desc.	ROW stabilized, sparse vegetation noted.

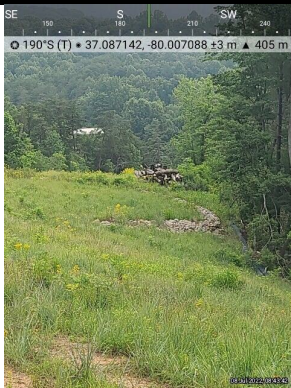
GPS Location	00000	GPS Location	00000		
Field Station#	13479+00	Field Station#	13490+00		
Pic 5 Desc.	Additional materials that needs removed from the row, added to the punch list.		Pic 6 Desc.	Additional photo showing water bars and level spreaders. No issues were observed at the time of inspection.
