## Baseline Assessment - Stream Attributes

**Reach S-E24 (Pipeline ROW)**

**Giles County, Virginia**

Profile and Cross-Sections Baseline Survey

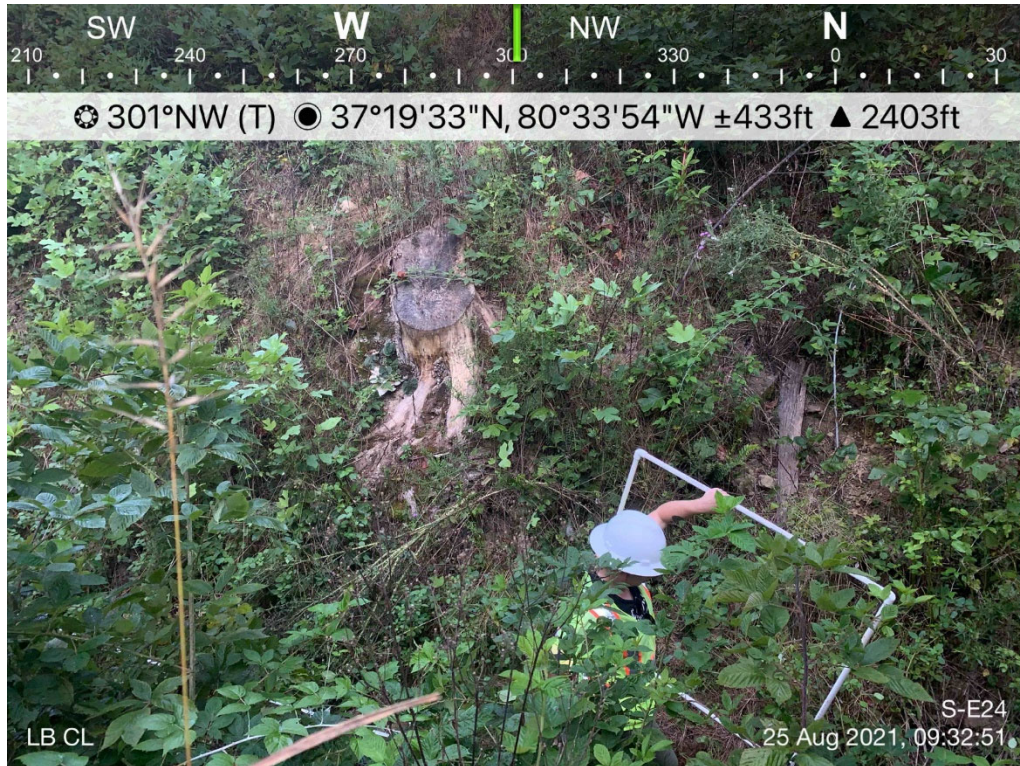
Photo Type: LB CL

Location, Orientation, Photographer Initials: On left bank at pipe centerline looking NW at right streambank, TC.

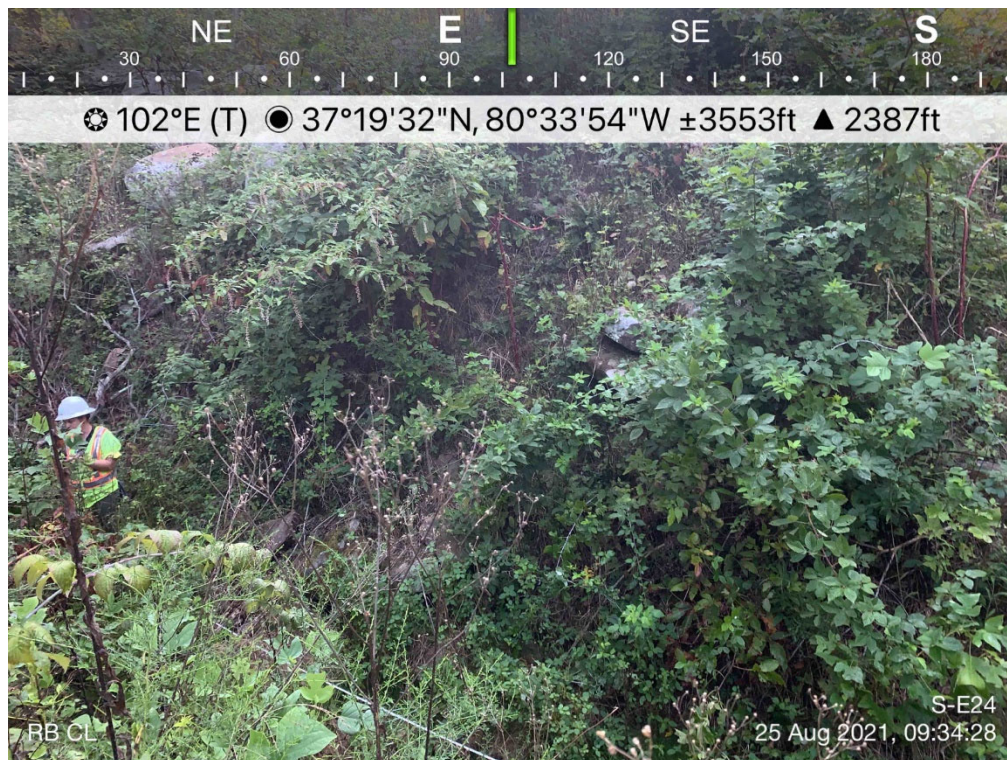
Photo Type: RB CL

Location, Orientation, Photographer Initials: On right bank at pipe centerline looking E at left streambank, TC.

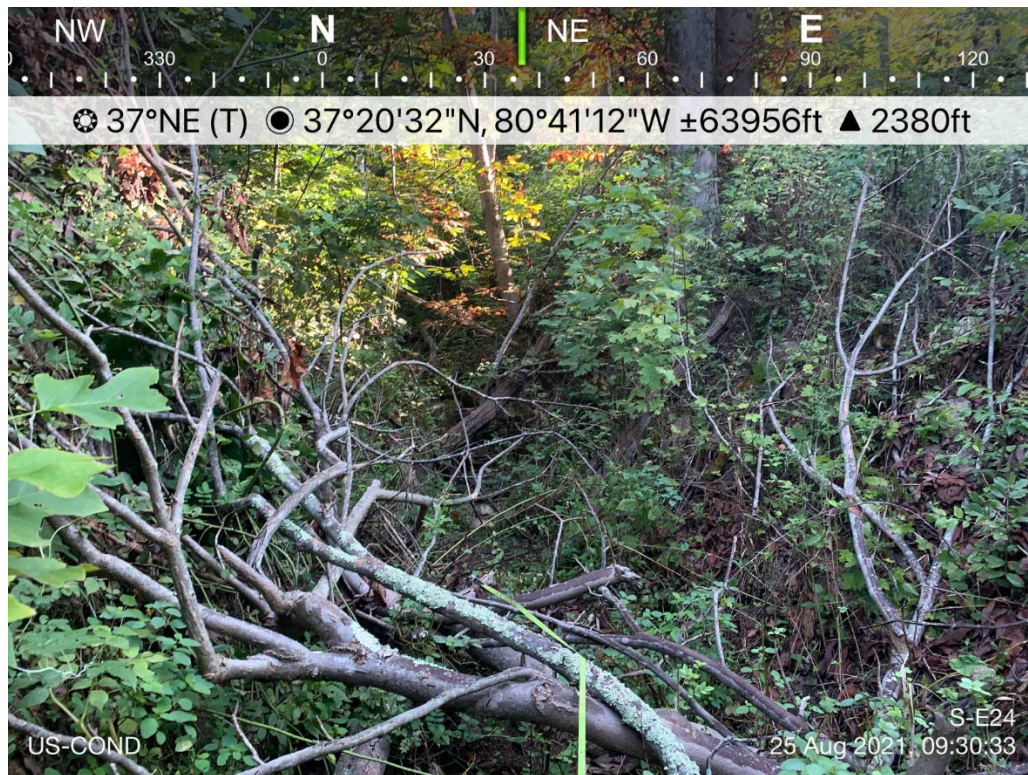
Photo Type: US COND US

Location, Orientation, Photographer Initials: Upstream at LOC looking NE upstream, TC.

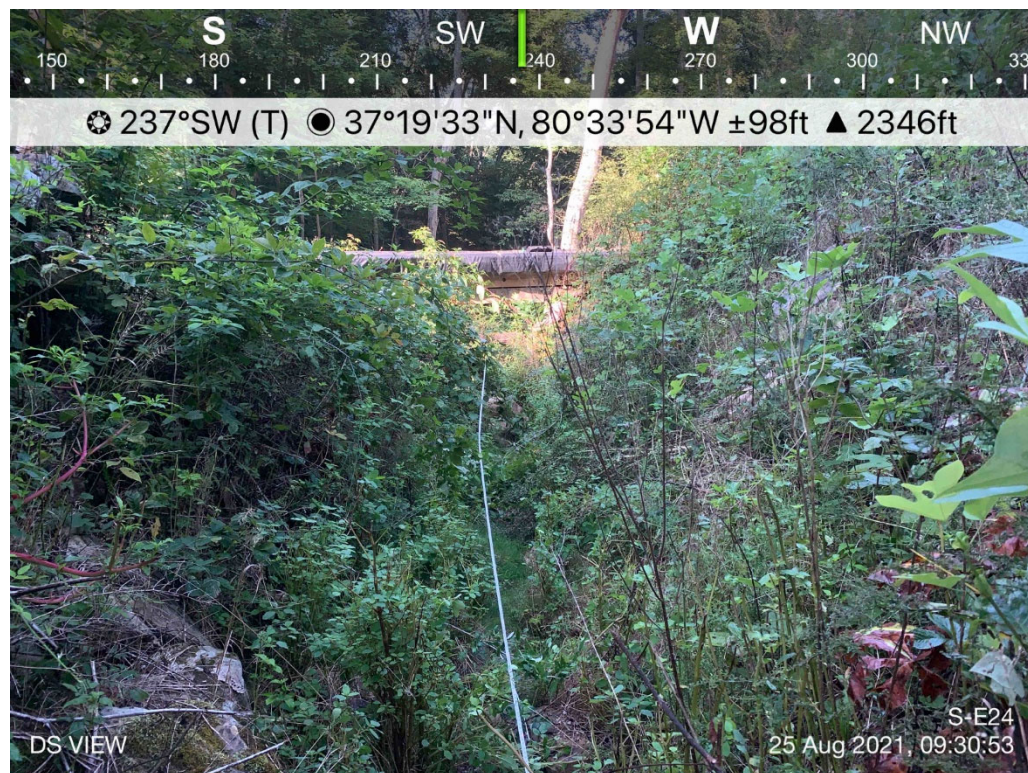
Photo Type: DS View

Location, Orientation, Photographer Initials: Upstream at LOC looking SW downstream, TC.

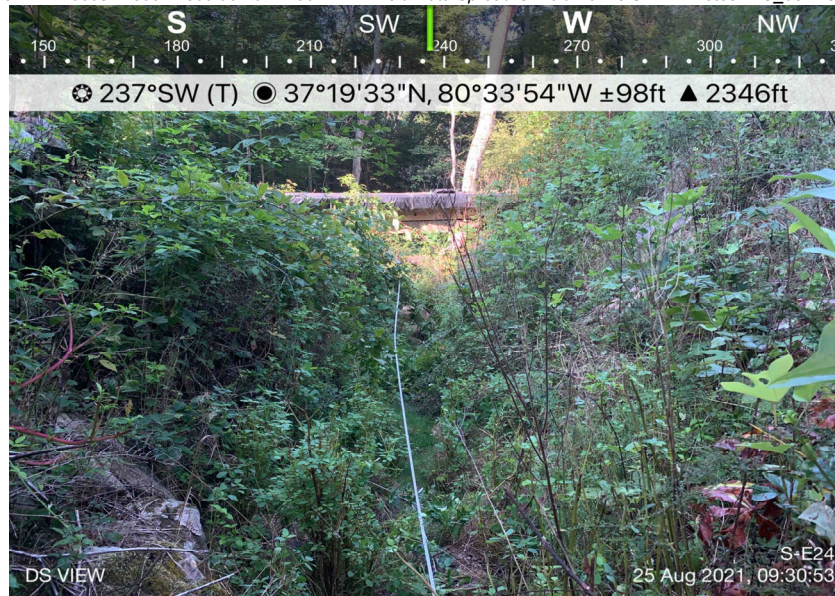
Downstream view facing SW. Assessment is limited to areas within the temporary ROW.
