Baseline Assessment - Stream Attributes

Reach S-E25-Downstream South (Timber Mat Crossing) Perennial Spread G Giles County, Virginia

Spread G Stream S-E25-Downstream 1 South (Timber Mat) Giles County

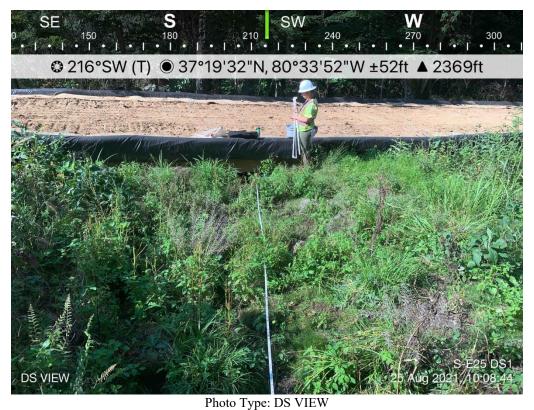
Location, Orientation, Photographer Initials: Downstream view of ROW looking SW downstream, KB

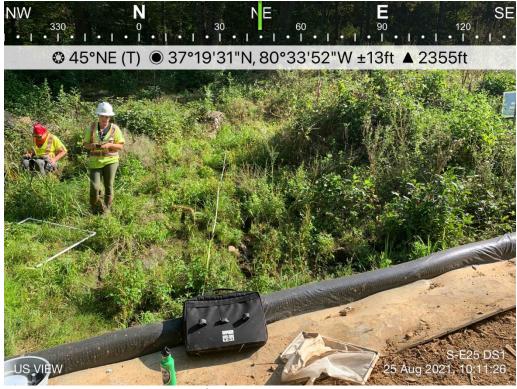
Photo Type: US VIEW
Location, Orientation, Photographer Initials: Upstream view of ROW looking NE, TC

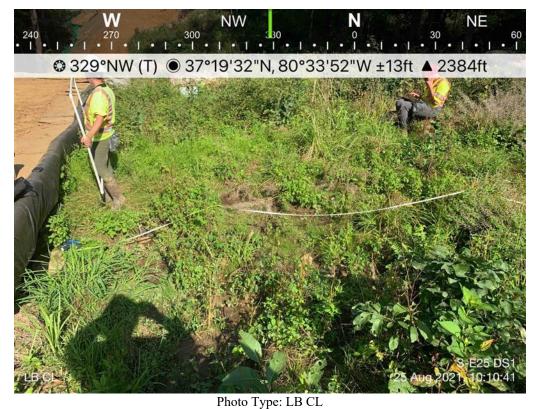
Location, Orientation, Photographer Initials: Standing on LB looking at RB along pipe centerline looking NW, TC

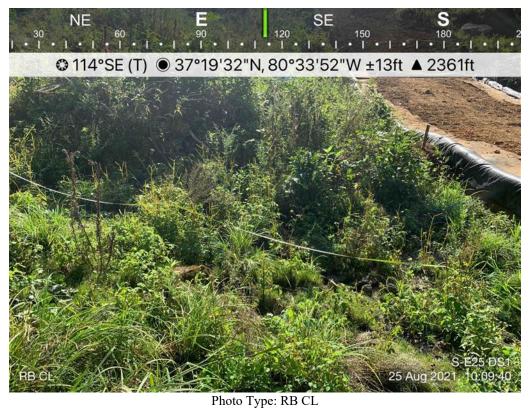
Location, Orientation, Photographer Initials: Standing on RB looking at LB along pipe centerline looking SE, TC

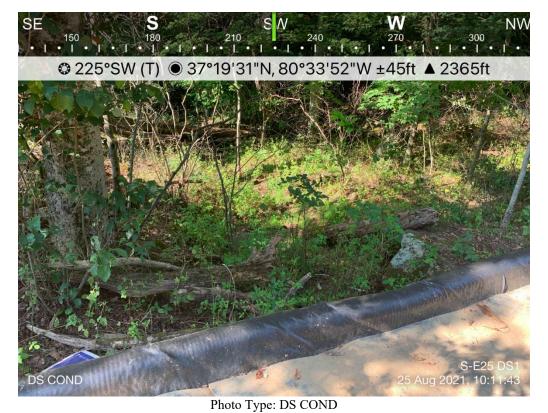
Location, Orientation, Photographer Initials: Downstream conditions outside of ROW looking SW, TC

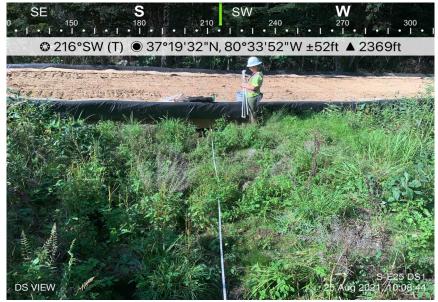
Reach S-E25-Downstream South looking downstream within ROW. Assessment is limited to areas within the temporary ROW.
