Baseline Assessment – Stream Attributes

Reach S-PP1 (Pipeline ROW)

Craig County, Virginia

Crossing S-PP1 - UNT to Sinking Creek (MP 217.4)

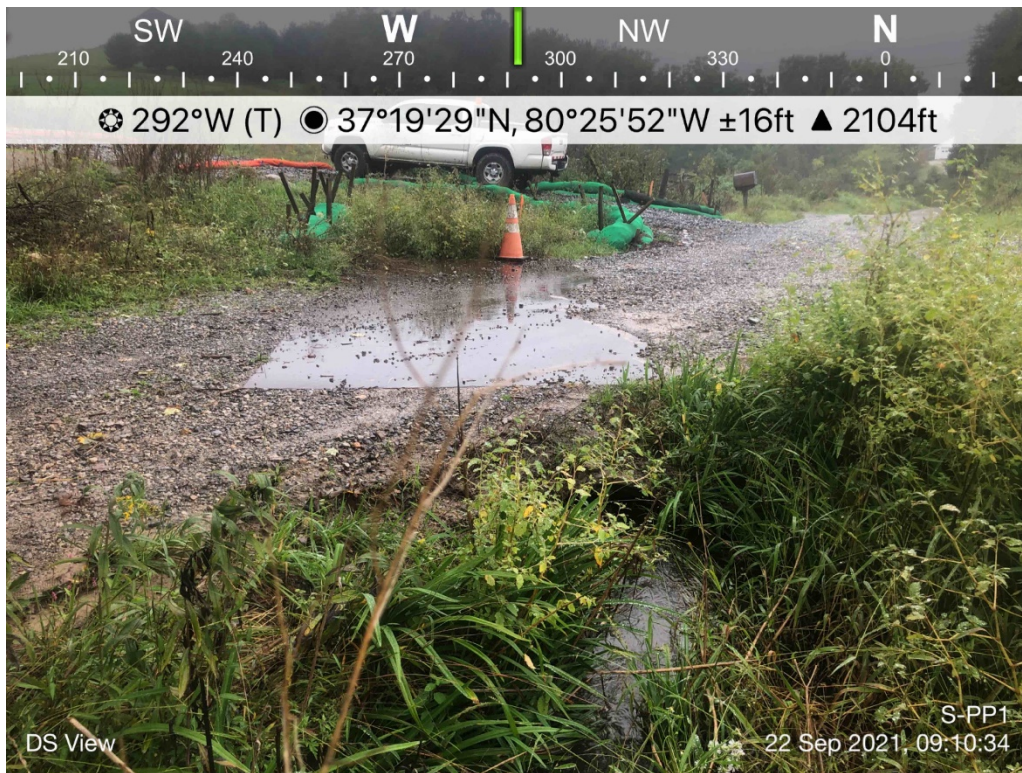
Photo Type: DS VIEW

Location, Orientation, Photographer Initials: Downstream view of ROW south of CL and east of Stevers Gap Trail looking W, KB

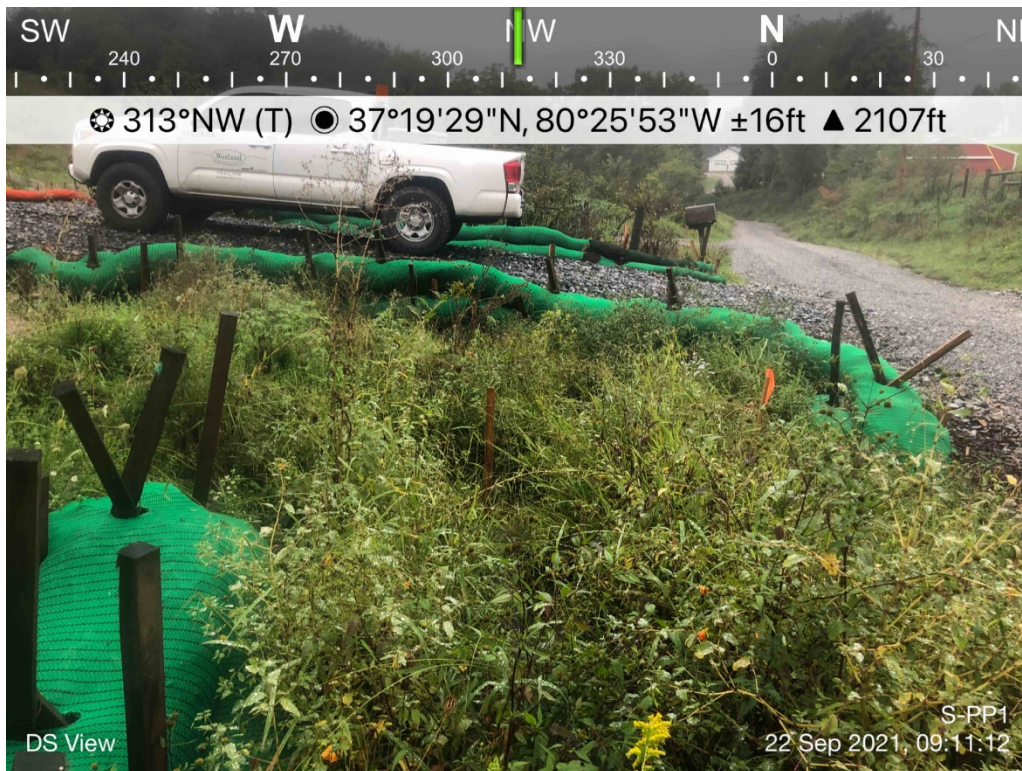
Photo Type: DS VIEW

Location, Orientation, Photographer Initials: Downstream view of ROW north of CL and west of Stevers Gap Trail looking W, KB

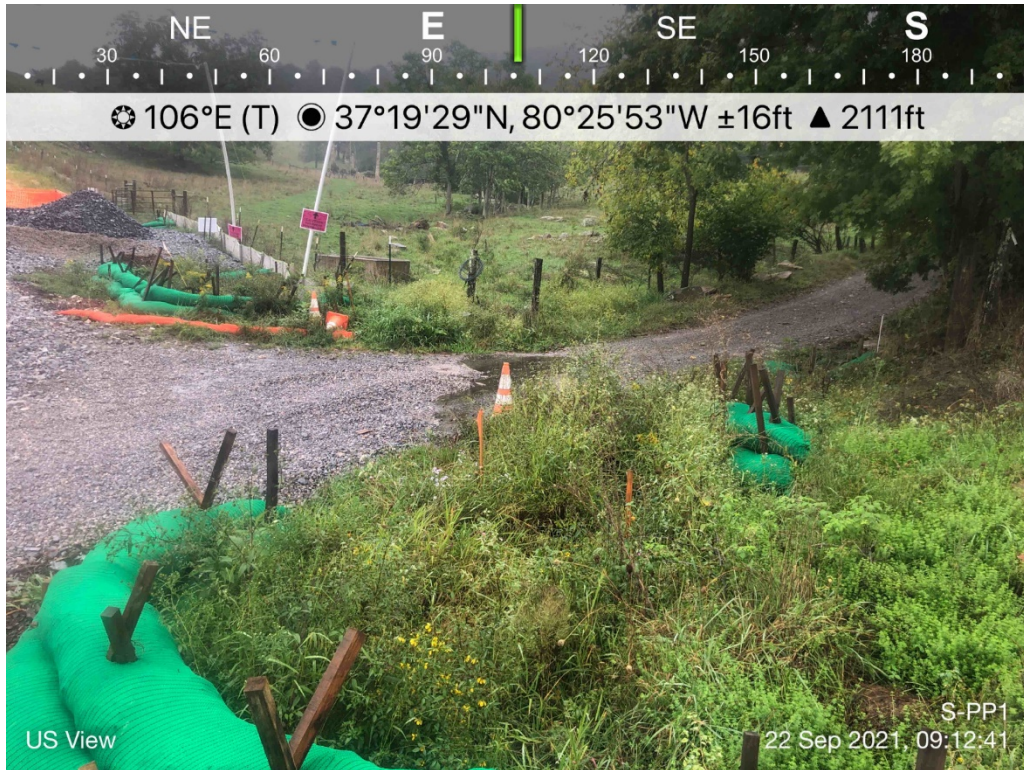
Photo Type: US VIEW

Location, Orientation, Photographer Initials: Upstream view of ROW south of CL and east of Stevers Gap Trail looking E, KB

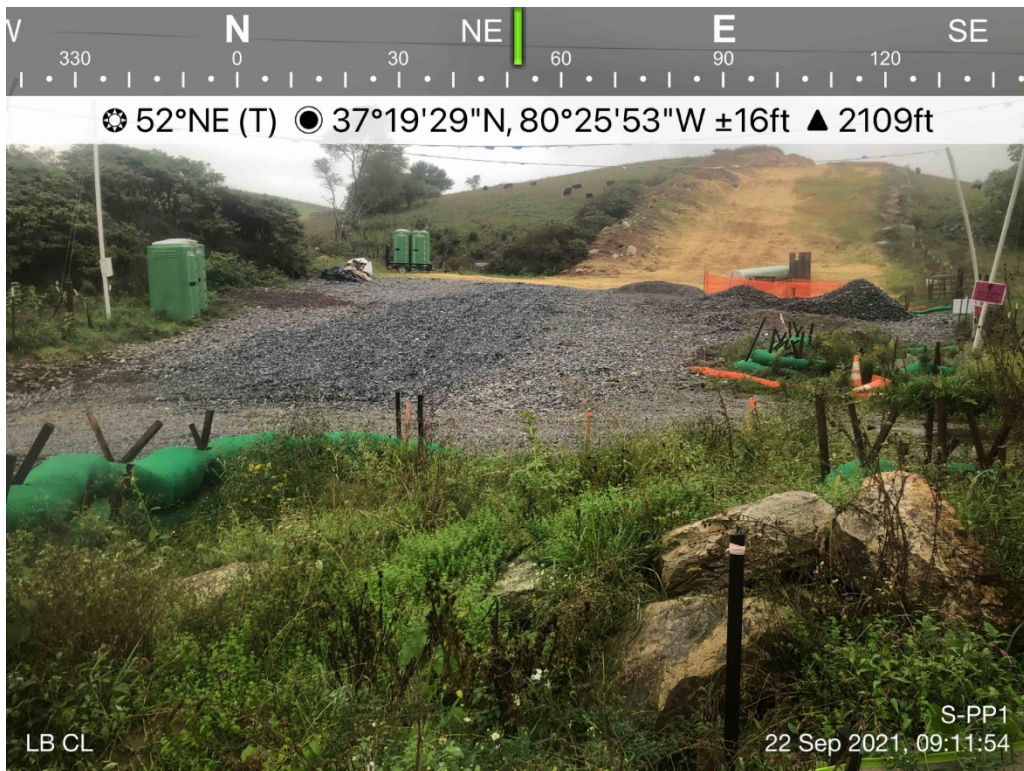
Photo Type: LB CL

Location, Orientation, Photographer Initials: Standing on LB looking at RB along pipe centerline looking NE, KB

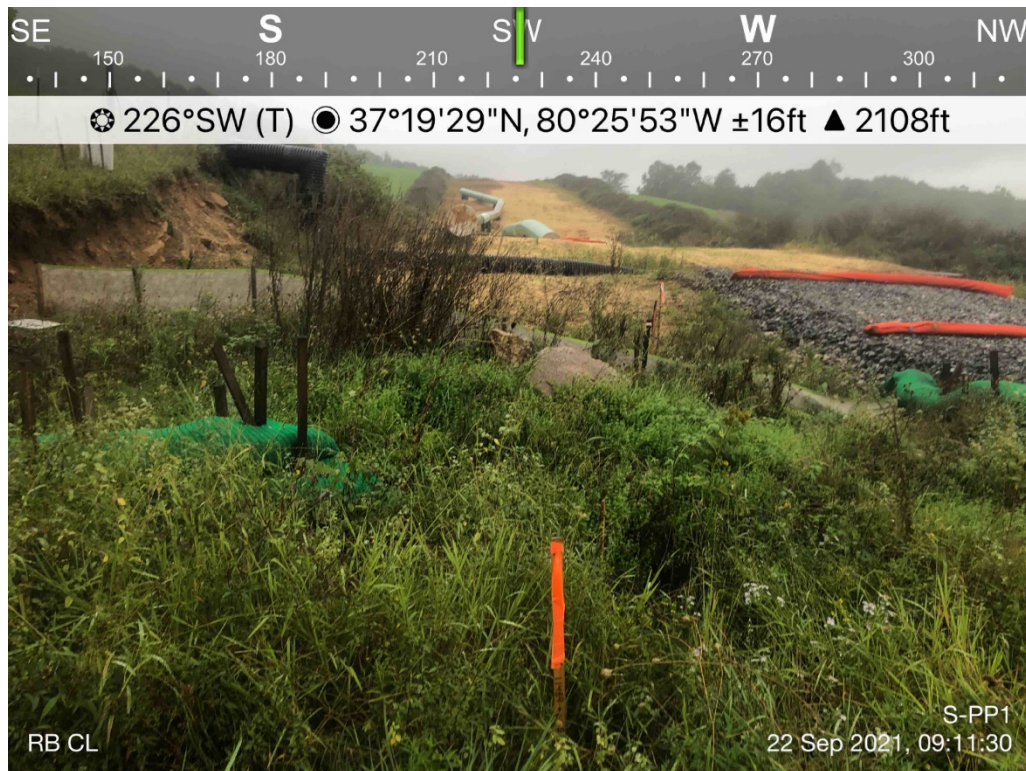
Photo Type: RB CL

Location, Orientation, Photographer Initials: Standing on RB looking at LB along pipe centerline looking SW, KB

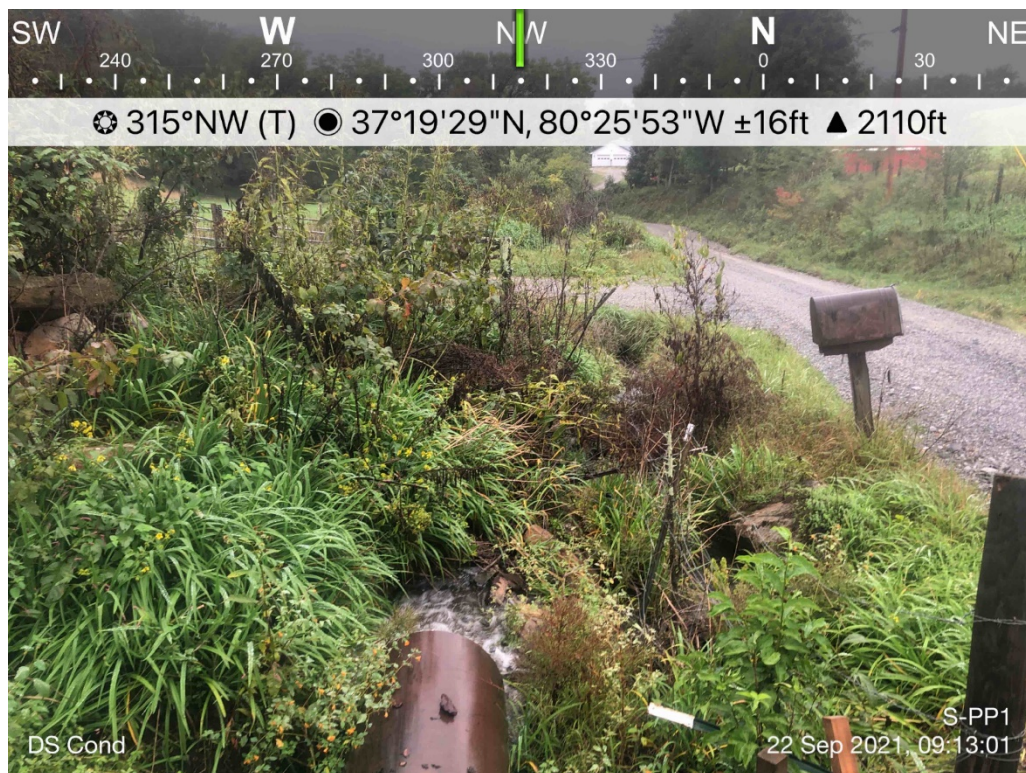
Photo Type: DS COND

Location, Orientation, Photographer Initials: Downstream conditions outside of ROW looking NW, KB

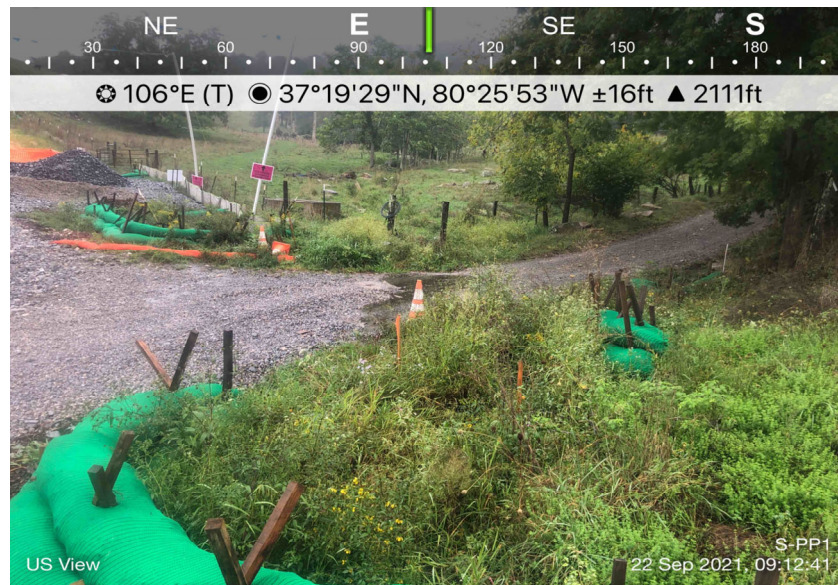
Looking upstream within the ROW. Assessment is limited to areas within the temporary ROW.

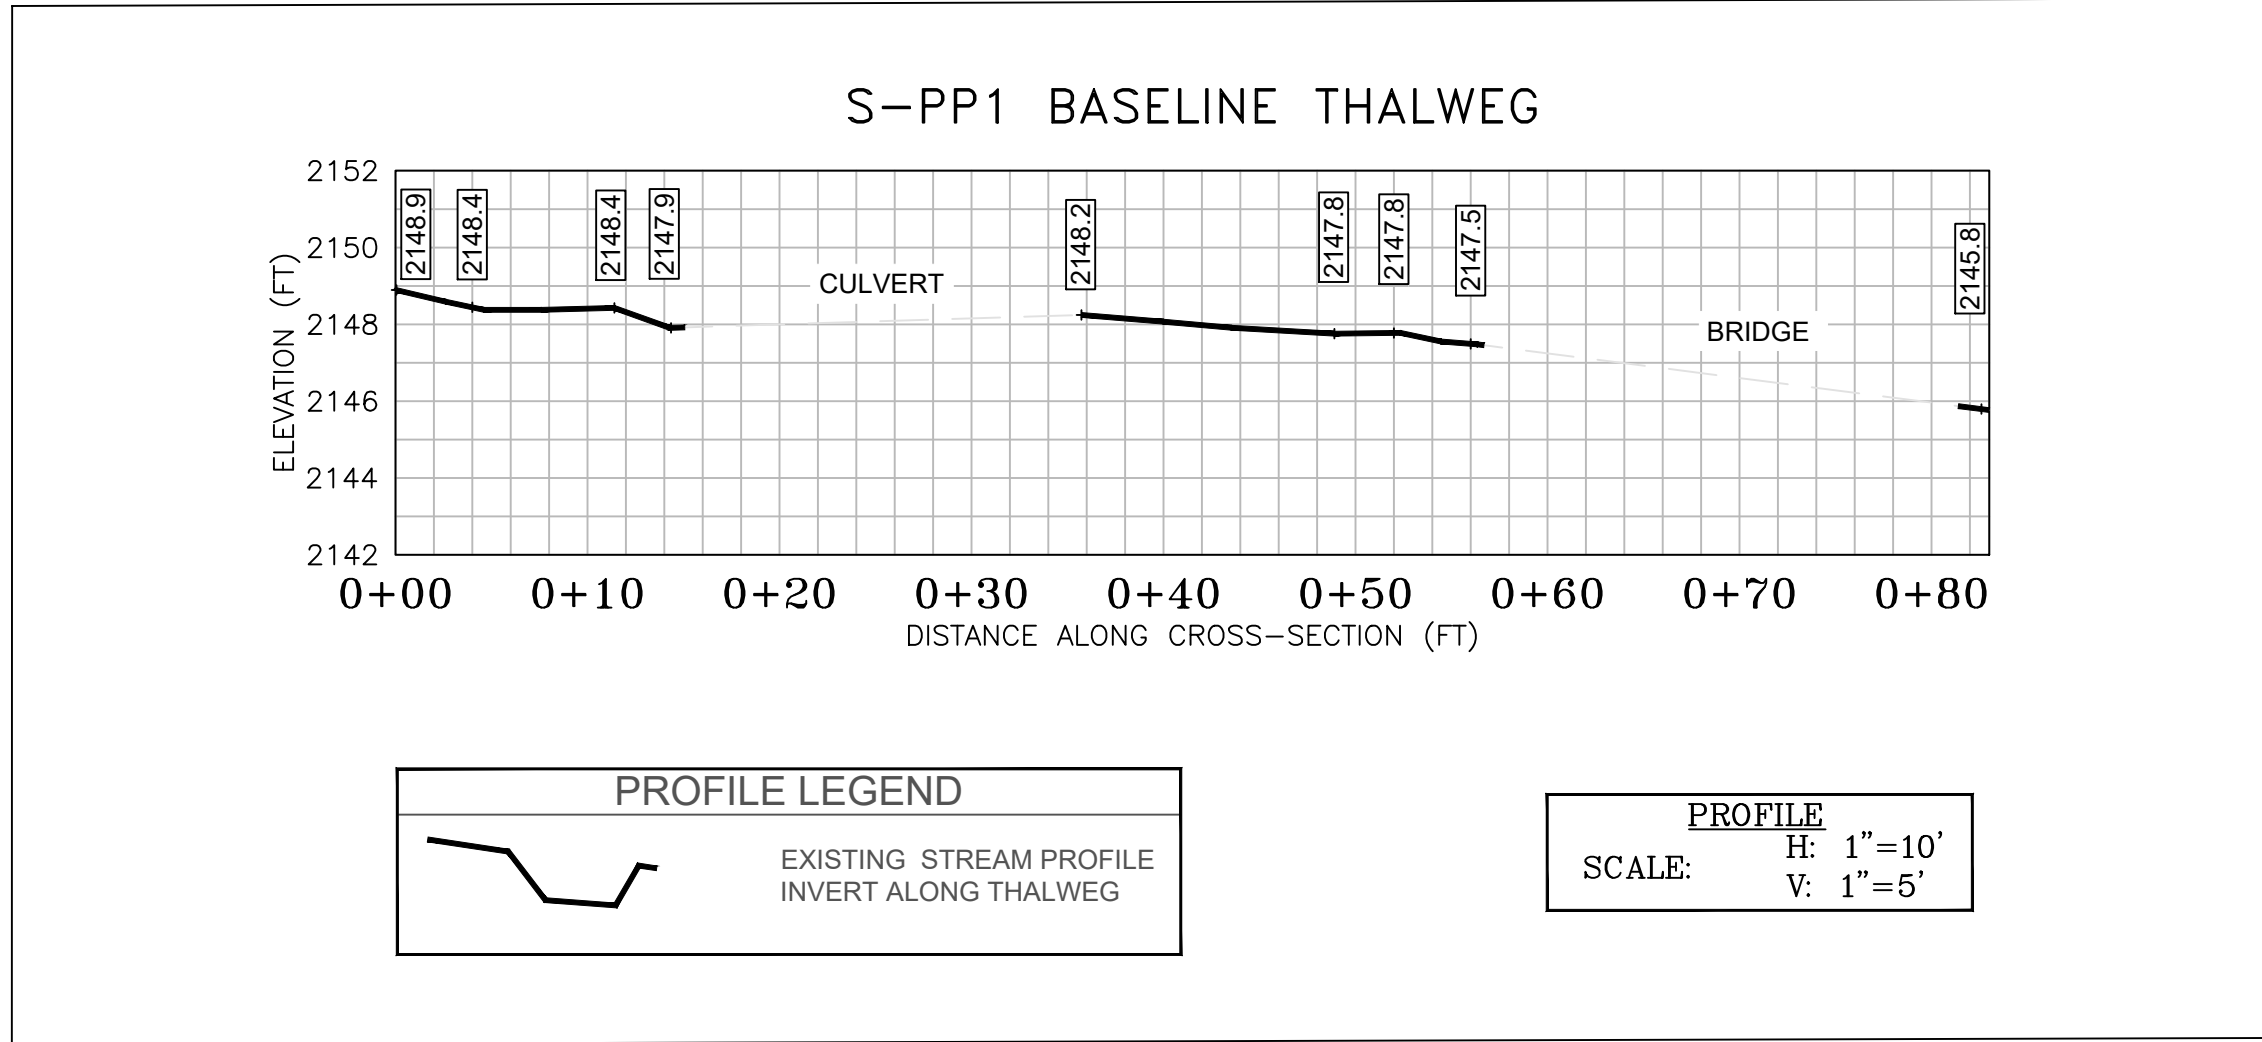
6. Cross-section B shot at location of pipe centerline (based on best professional judgement).
