Baseline Assessment – Stream Attributes

Reach S-PP3 (Pipeline ROW) Perennial Spread G Craig County, Virginia

Profile and Cross-Sections Baseline Survey

Crossing S-PP3 - UNT to Sinking Creek (MP 217.8)

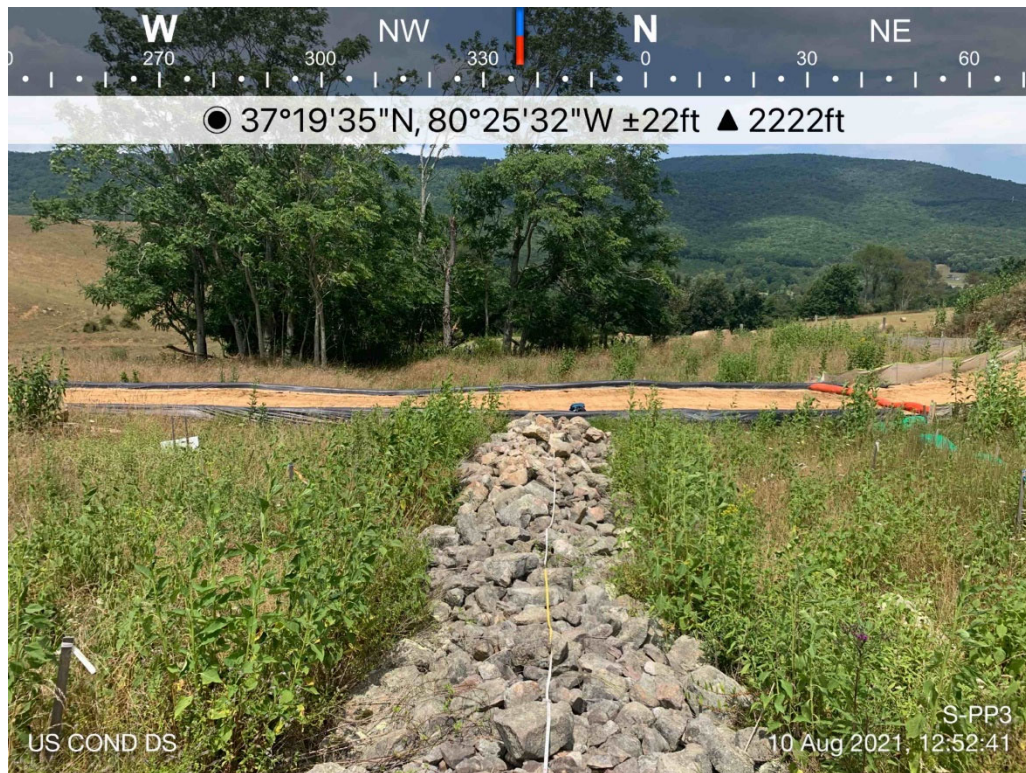
Photo Type: DS VIEW

Location, Orientation, Photographer Initials: Downstream view of ROW looking NW, SB

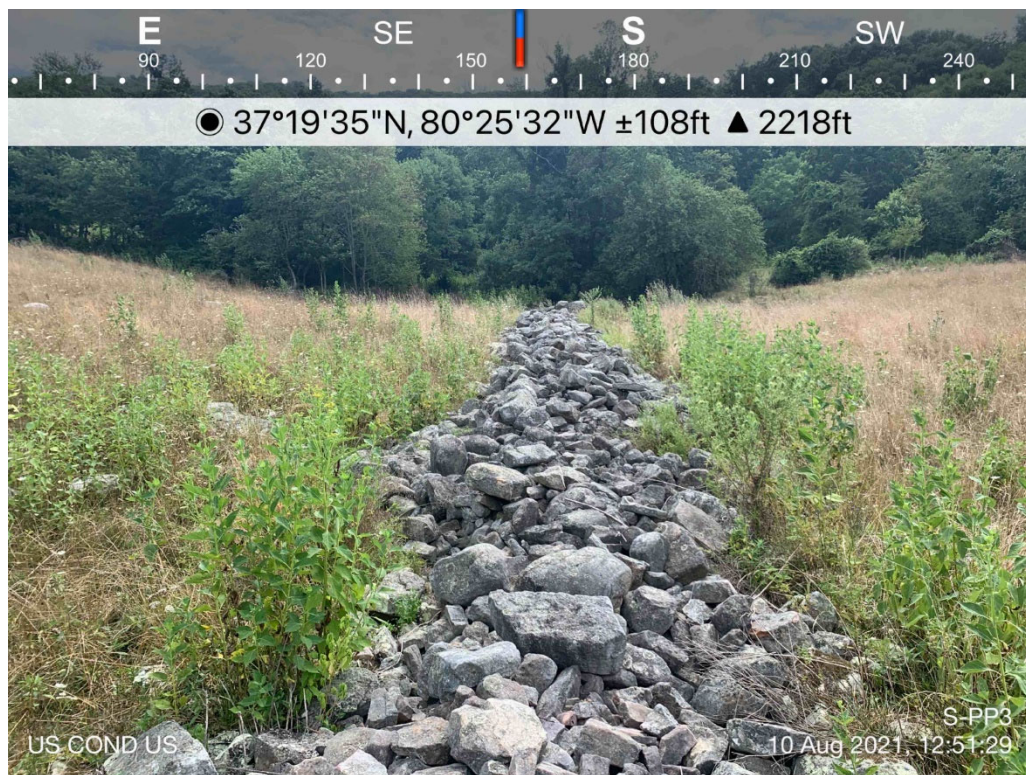
Photo Type: US VIEW

Location, Orientation, Photographer Initials: Upstream view of ROW looking SE, SB

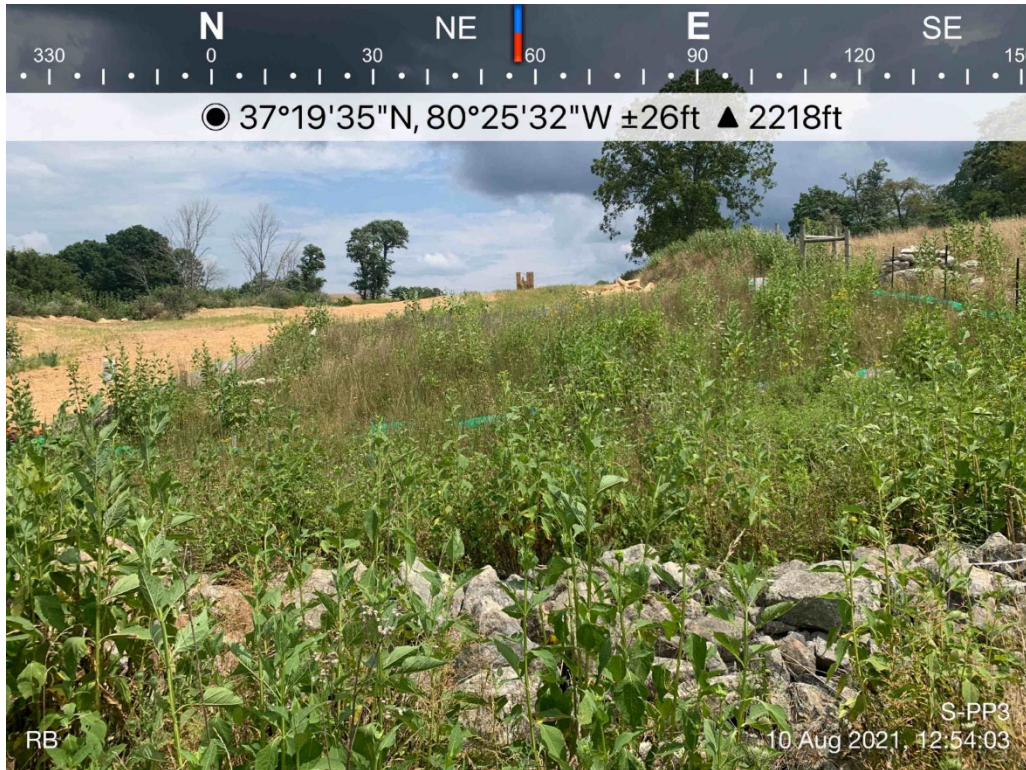
Photo Type: LB CL

Location, Orientation, Photographer Initials: Standing on LB looking at RB along pipe centerline looking NE, SB

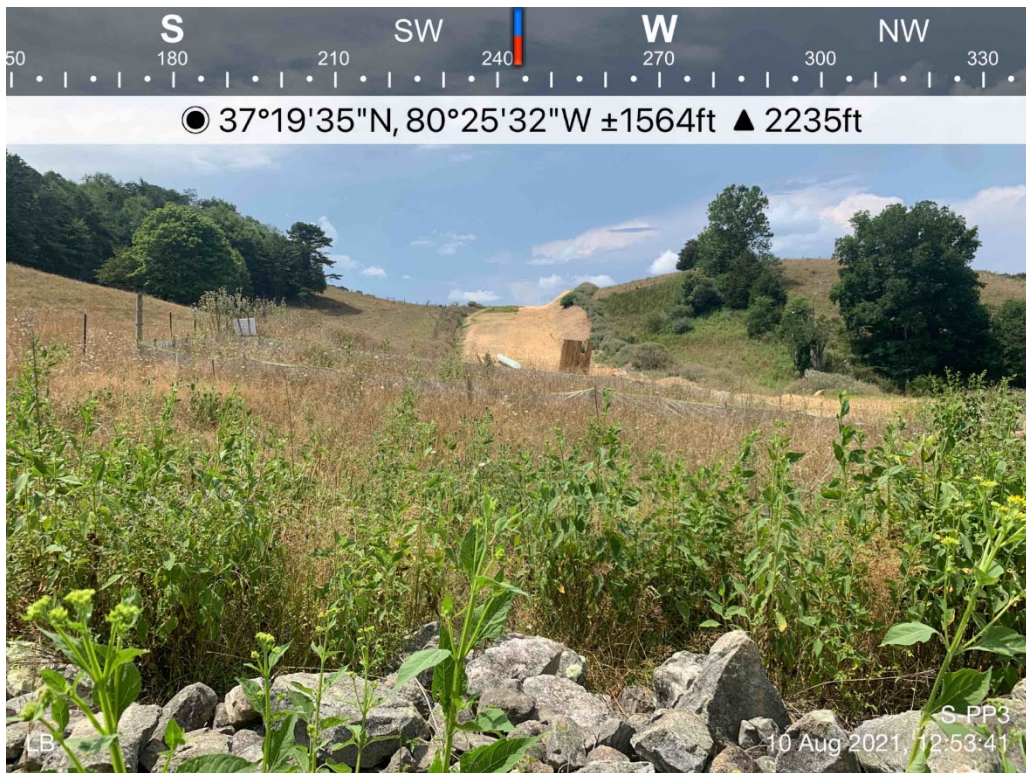
Photo Type: RB CL

Location, Orientation, Photographer Initials: Standing on RB looking at LB along pipe centerline looking SW, SB

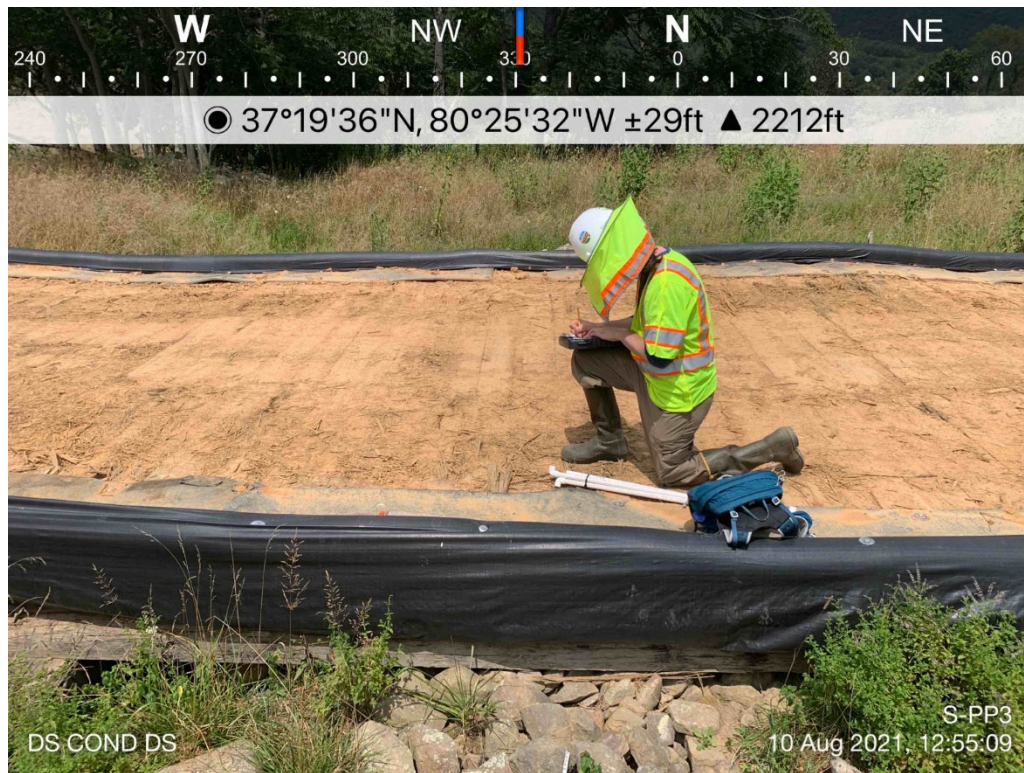
Photo Type: DS COND

Location, Orientation, Photographer Initials: Downstream conditions outside of ROW looking NW, SB

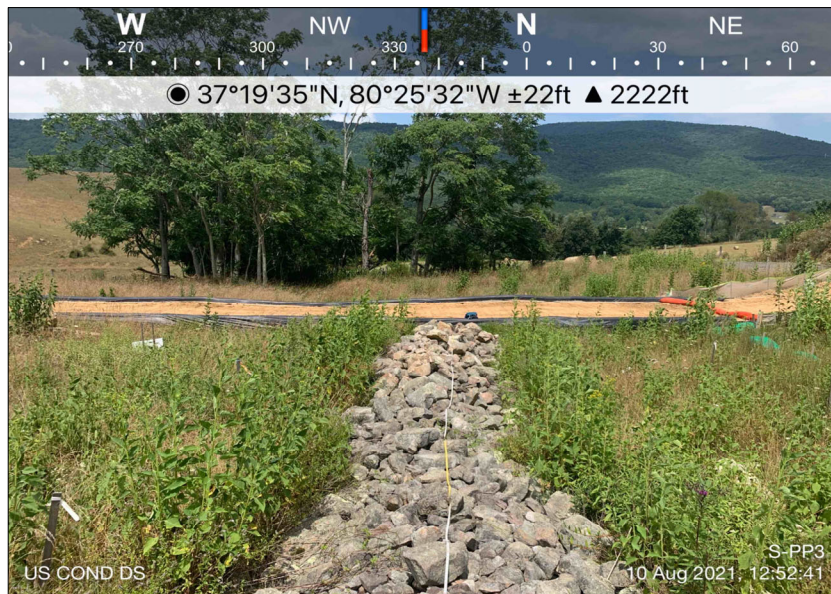
Looking downstream within the ROW. Assessment is limited to areas within the temporary ROW.
