Baseline Assessment – Stream Attributes

Reach S-A7 (Timber Mat Crossing)

Franklin County, Virginia

Crossing S-A7 - UNT to Dinner Creek (MP 280.9)
Franklin County, Virginia
Copyright © 2021 Wetland Studies and Solutions, Inc.

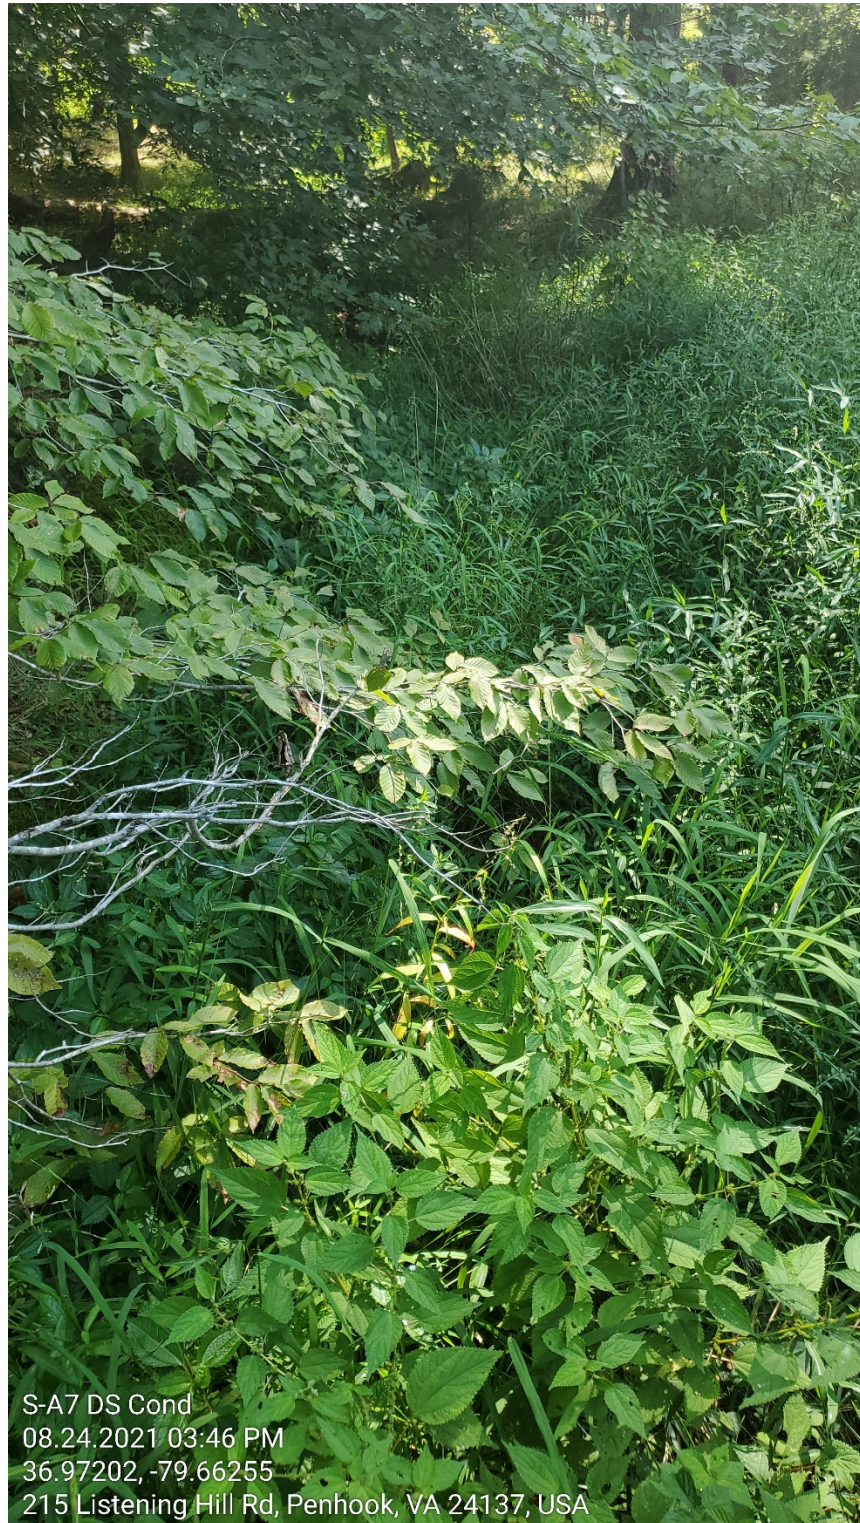
Photo Type: DS COND DS

Location, Orientation, Photographer Initials: Downstream at S-A7 looking S downstream, DW

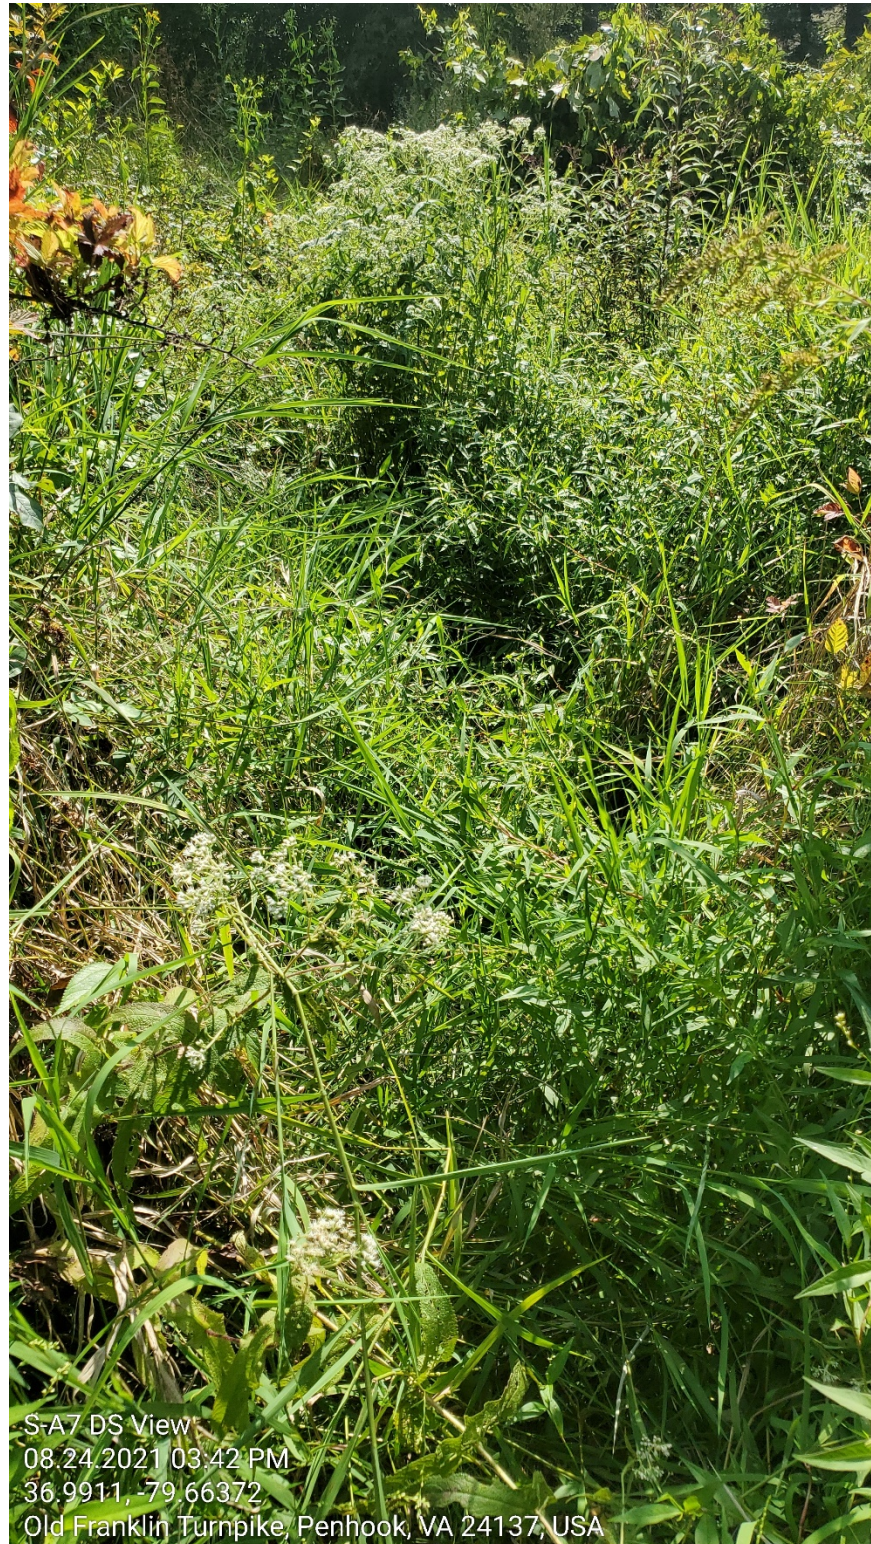
Photo Type: DS VIEW

S-A7 DS View
08.24.2021 03:42 PM
36.9911, -79.66372
Old Franklin Turnpike, Penhook, VA 24137, USA

Location, Orientation, Photographer Initials: Upstream at S-A7 looking S downstream, DW

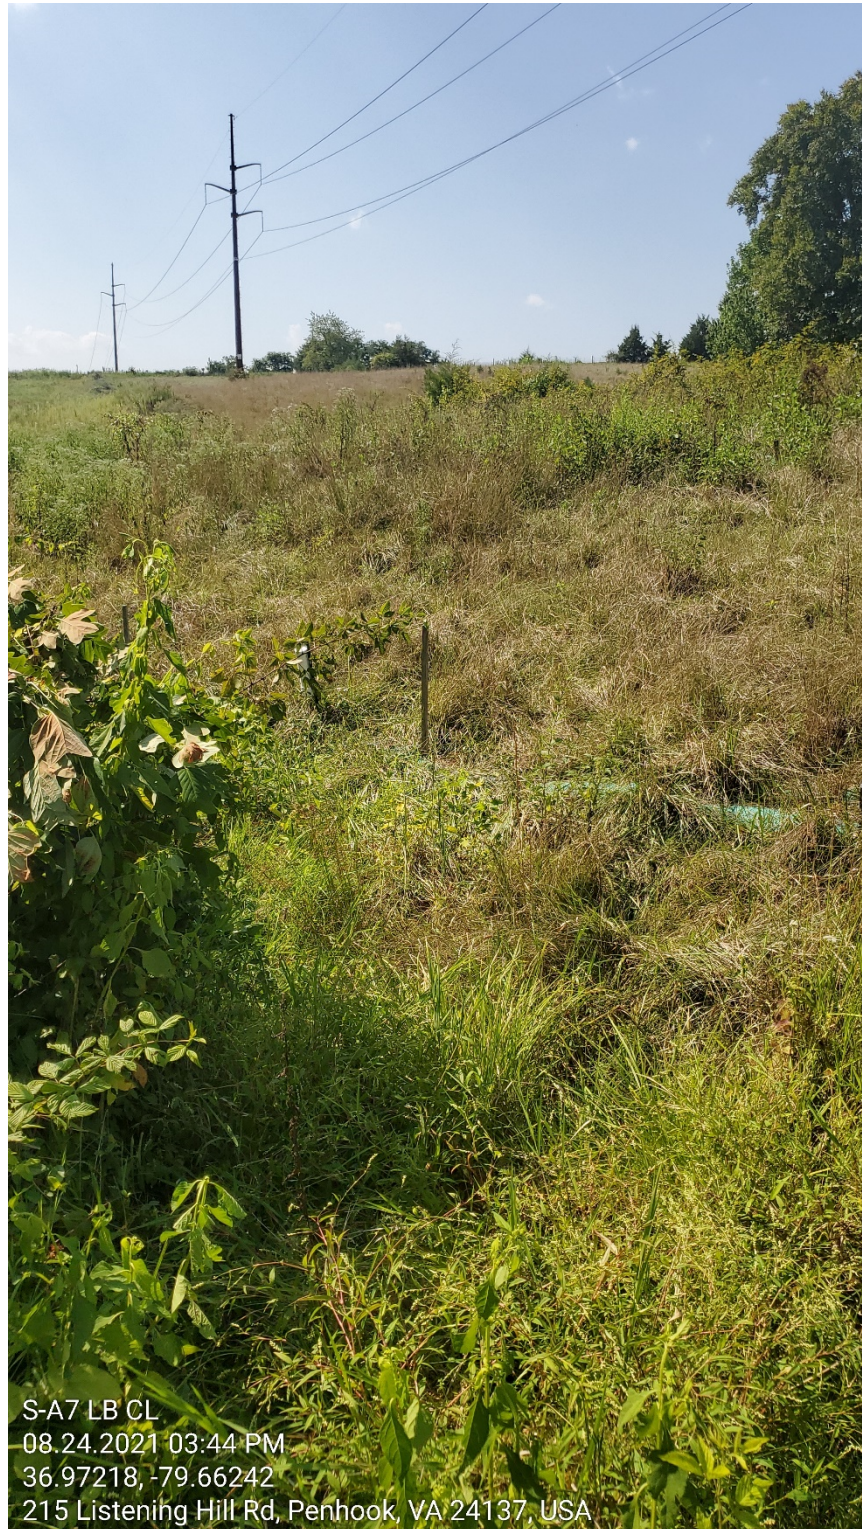
Photo Type: LB CL

S-A7 LB CL
08.24.2021 03:44 PM
36.97218, -79.66242
215 Listening Hill Rd, Penhook, VA 24137, USA

Location, Orientation, Photographer Initials: On thalweg at pipe centerline looking W at left streambank, DW

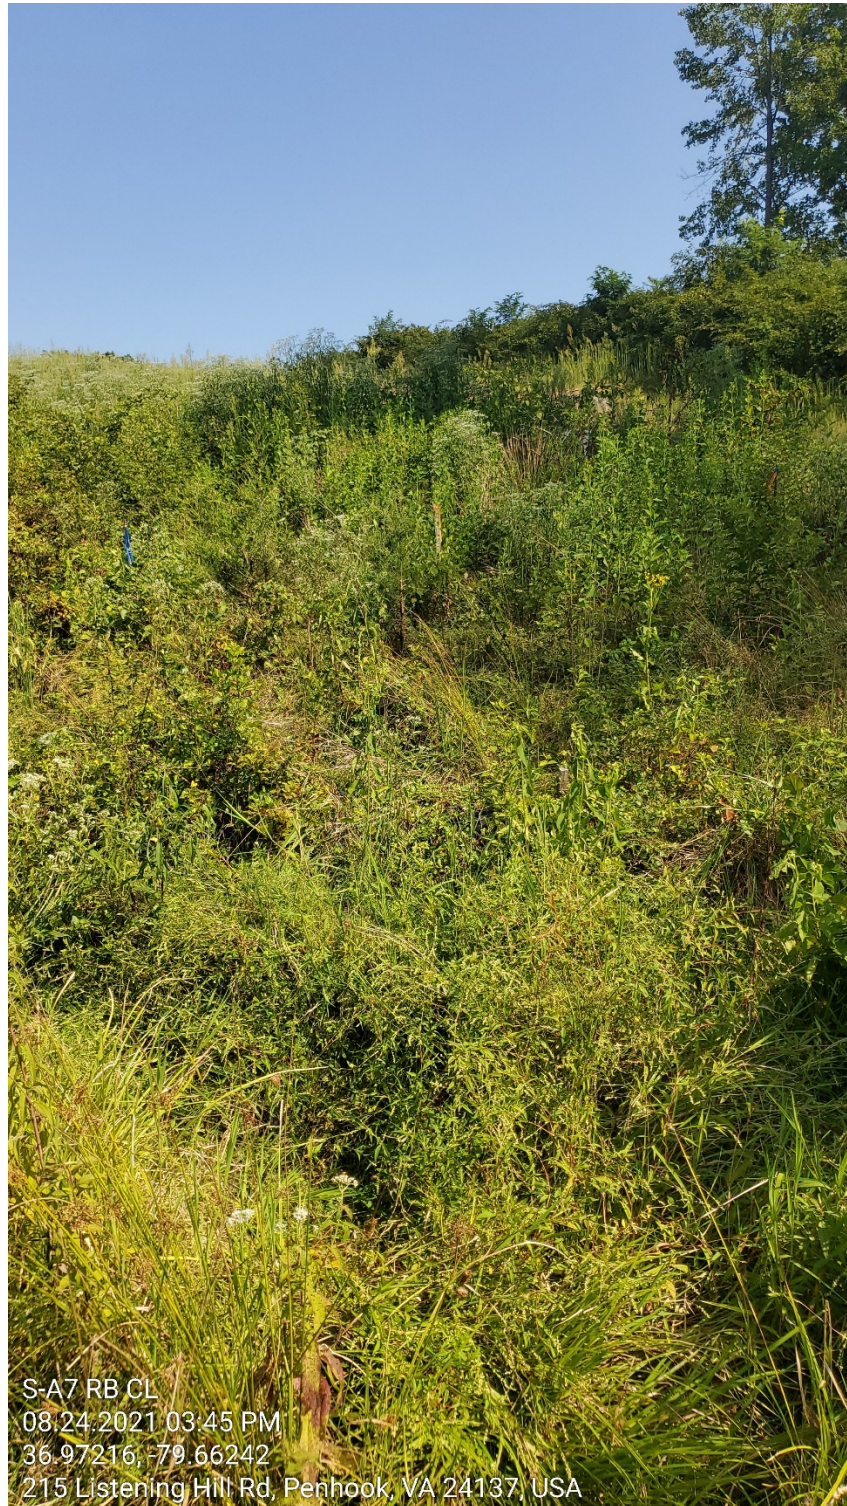
Photo Type: RB CL

Location, Orientation, Photographer Initials: On thalweg at S-A7 pipe centerline looking W at right streambank, DW

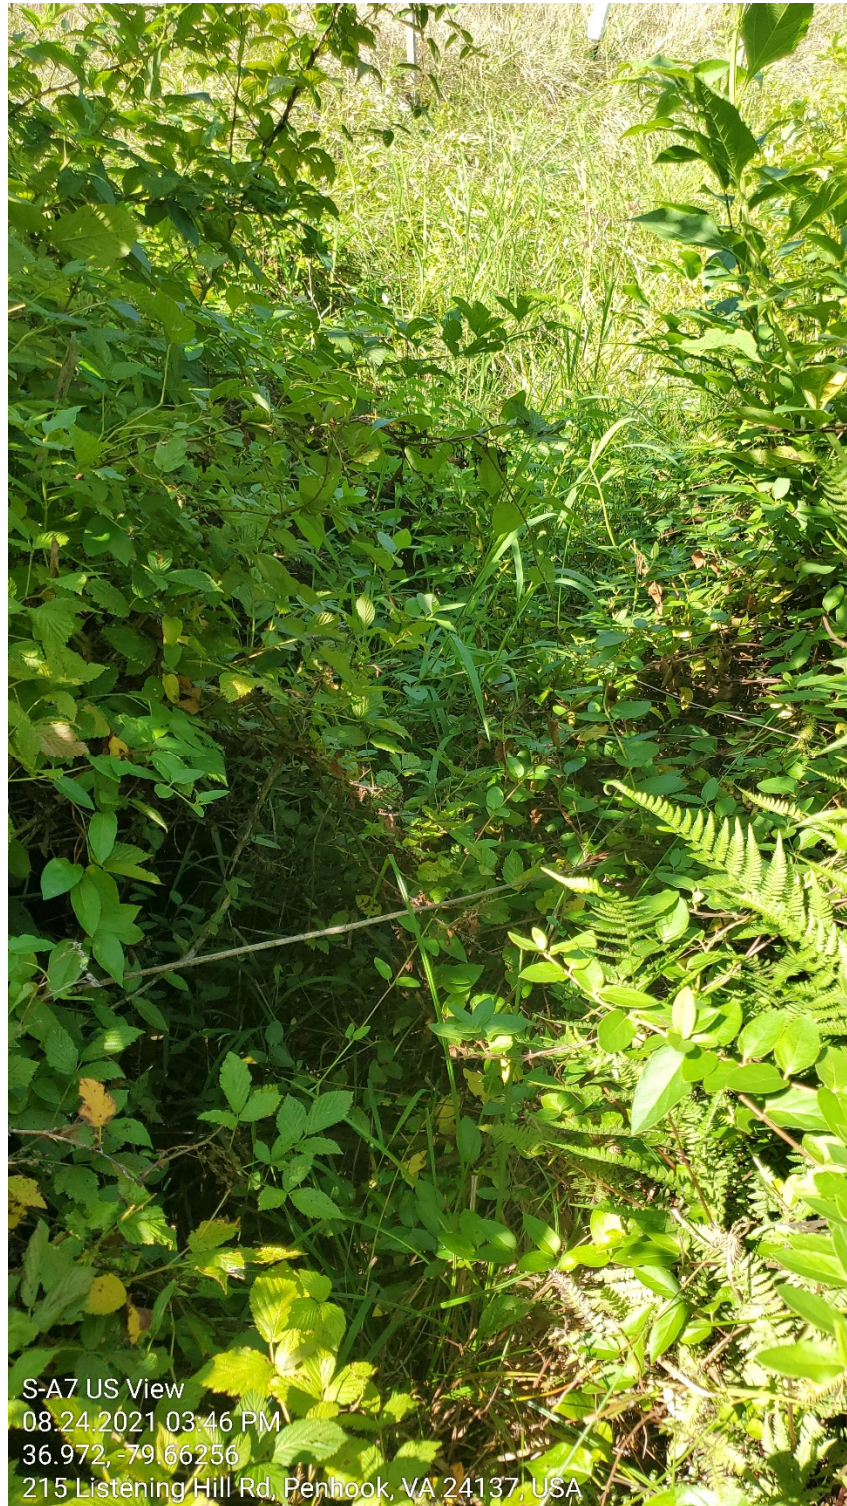
Photo Type: US VIEW

S-A7 US View
08.24.2021 03:46 PM
36.972, -79.66256
215 Listening Hill Rd, Penhook, VA 24137, USA

Location, Orientation, Photographer Initials: Downstream at S-A7 looking N upstream, DW

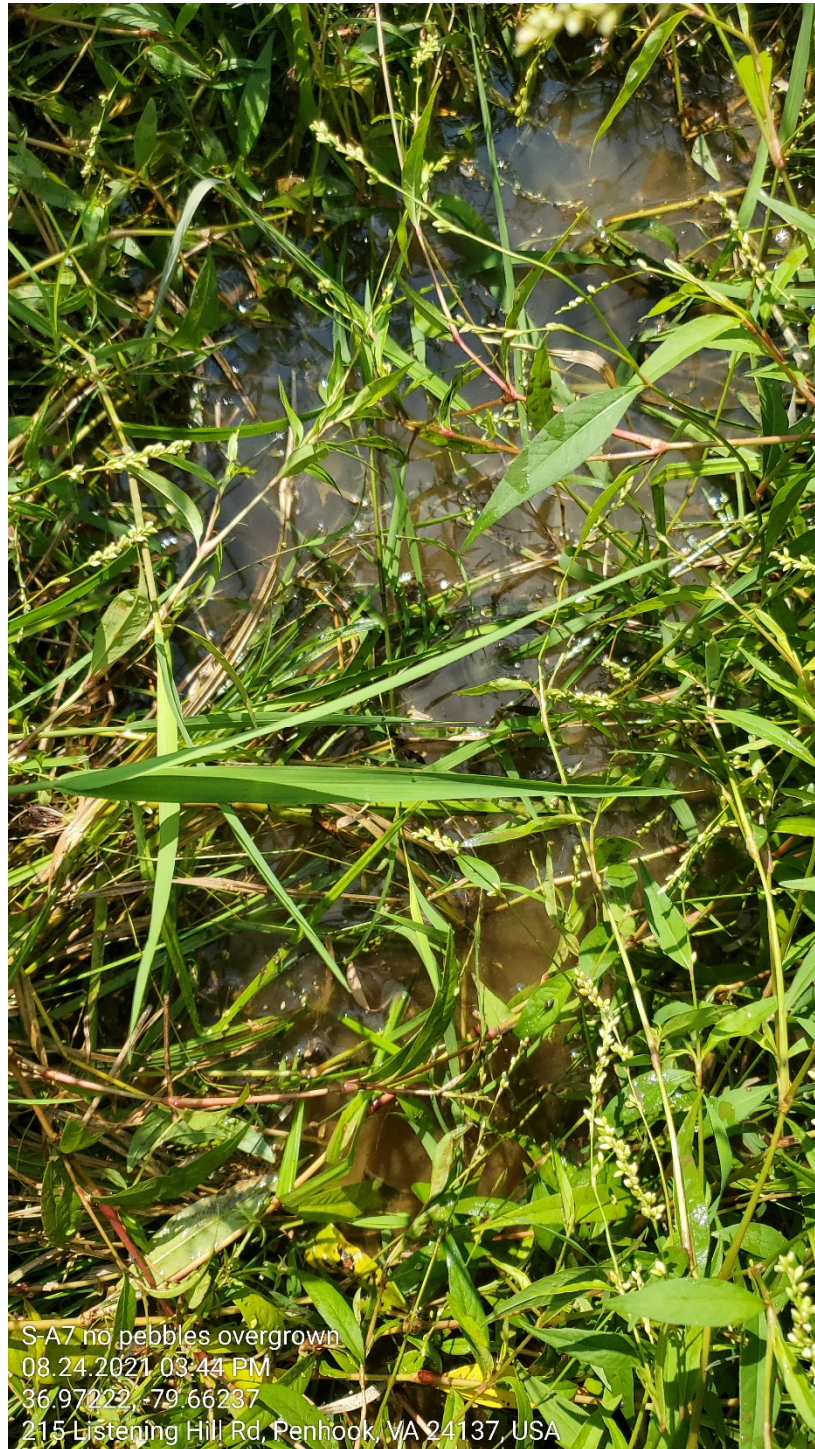
Photo Type: US VIEW

Location, Orientation, Photographer Initials: Downstream at S-A7 showing substrate, DW

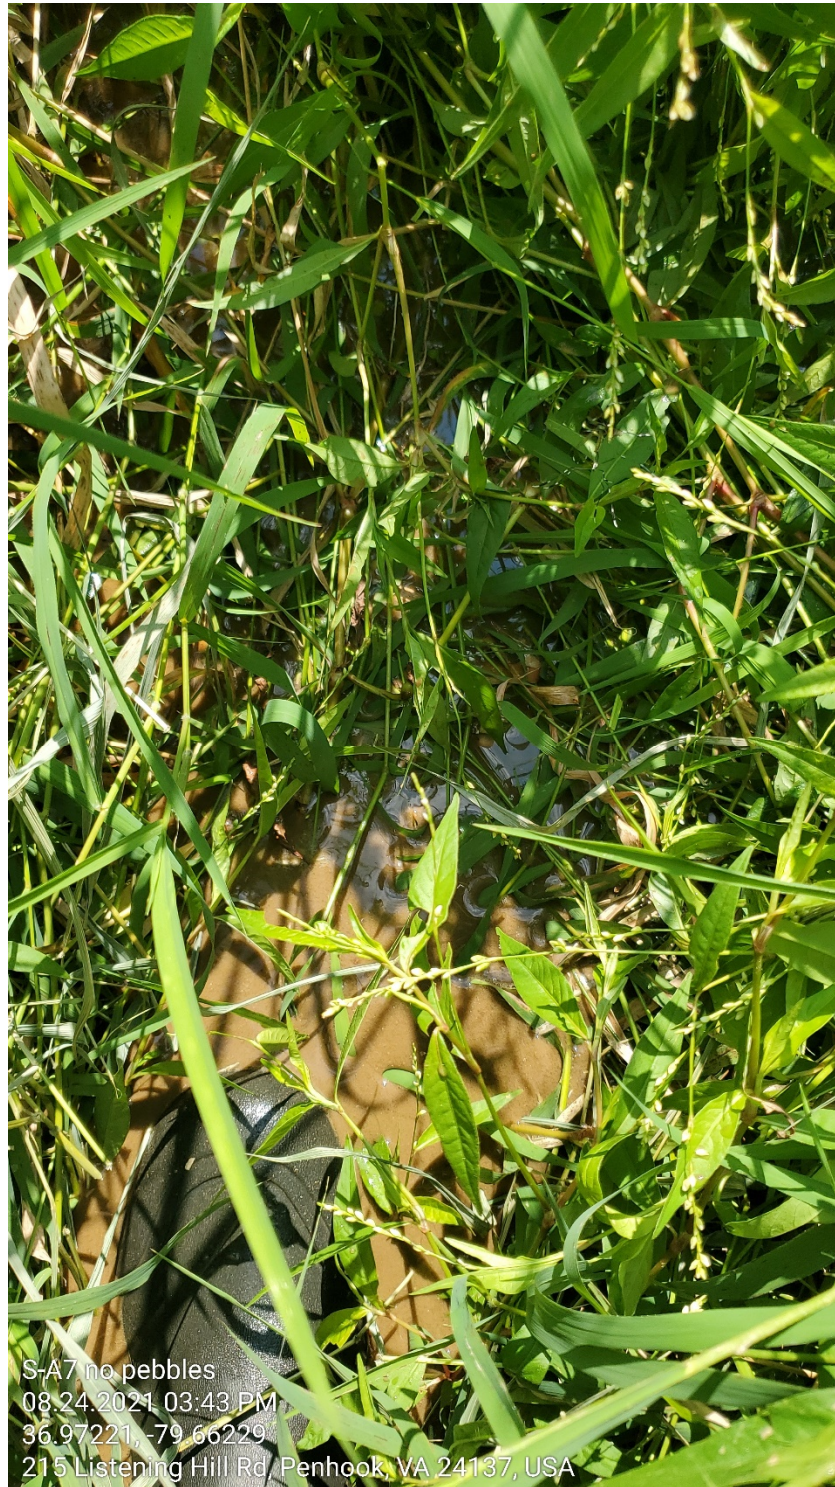
Photo Type: US VIEW

S-A7 no pebbles
08/24/2021 03:43 PM
36.97221, -79.66229
215 Listening Hill Rd, Penhook, VA 24137, USA

Location, Orientation, Photographer Initials: Downstream at S-A7 showing substrate, DW
