Baseline Assessment – Stream Attributes

Reach S-CD1 (Pipeline ROW)

Franklin County, Virginia

Crossing S-CD1 - UNT to Blackwater River (MP 263.7)

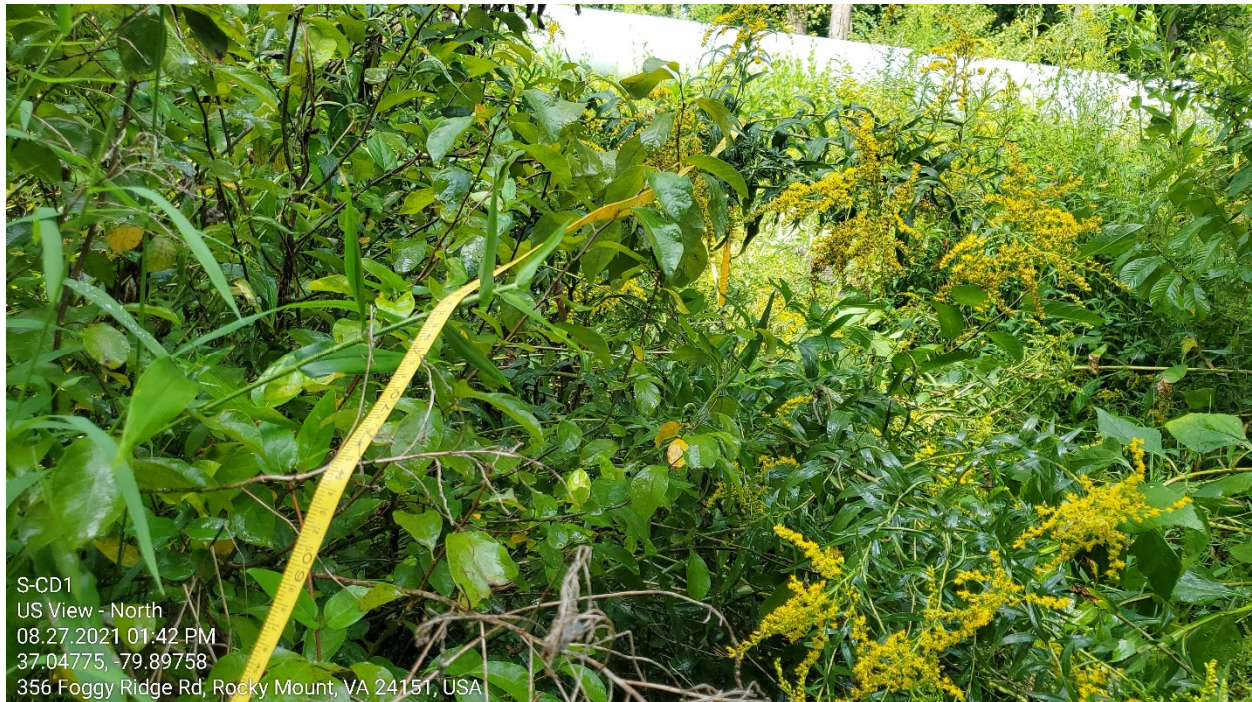
Photo Type: US VIEW

S-CD1
US View - North
08.27.2021 01:42 PM
37.04775, -79.89758
356 Foggy Ridge Rd, Rocky Mount, VA 24151, USA

Location, Orientation, Photographer Initials: Downstream at ROW/LOD looking N upstream, DW

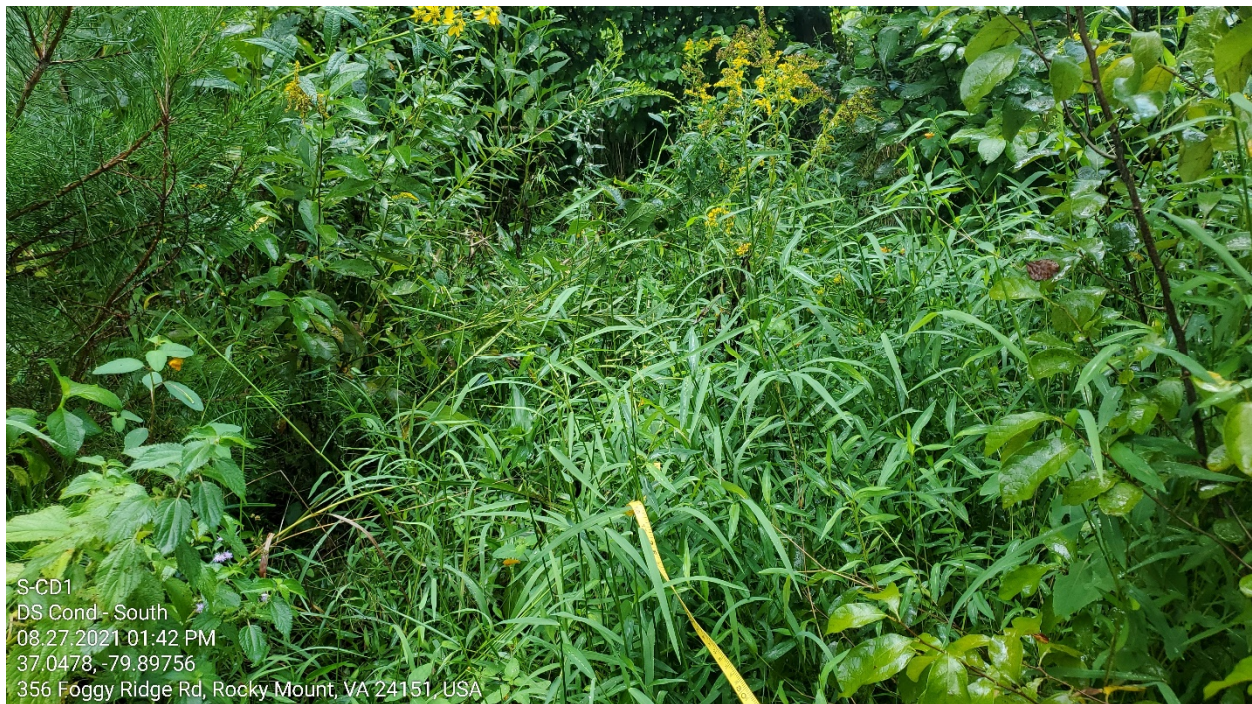
Photo Type: DS COND

S-CD1
DS Cond - South
08.27.2021 01:42 PM
37.0478, -79.89756
356 Foggy Ridge Rd, Rocky Mount, VA 24151, USA

Location, Orientation, Photographer Initials: Downstream at ROW/LOD looking S downstream, DW

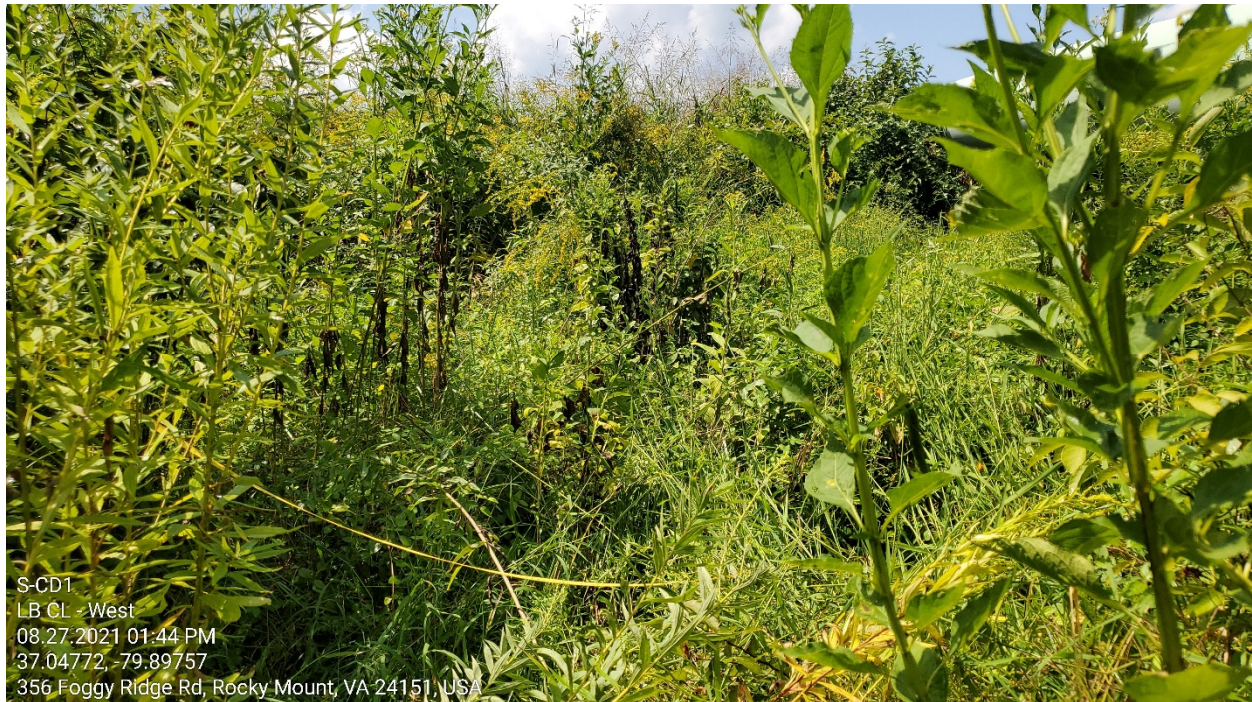
Photo Type: LB CL

Location, Orientation, Photographer Initials: On thalweg at pipe centerline looking W at right streambank, DW

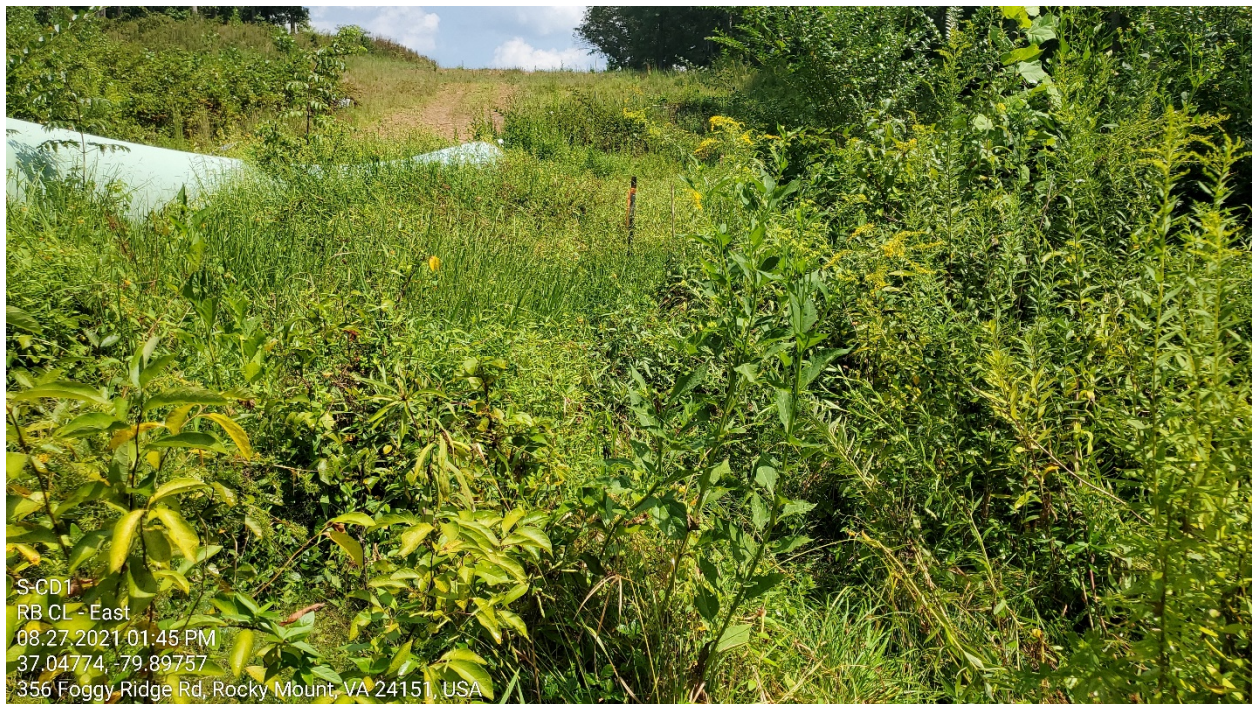
Photo Type: RB CL

Location, Orientation, Photographer Initials: On thalweg at pipe centerline looking E at left streambank, DW

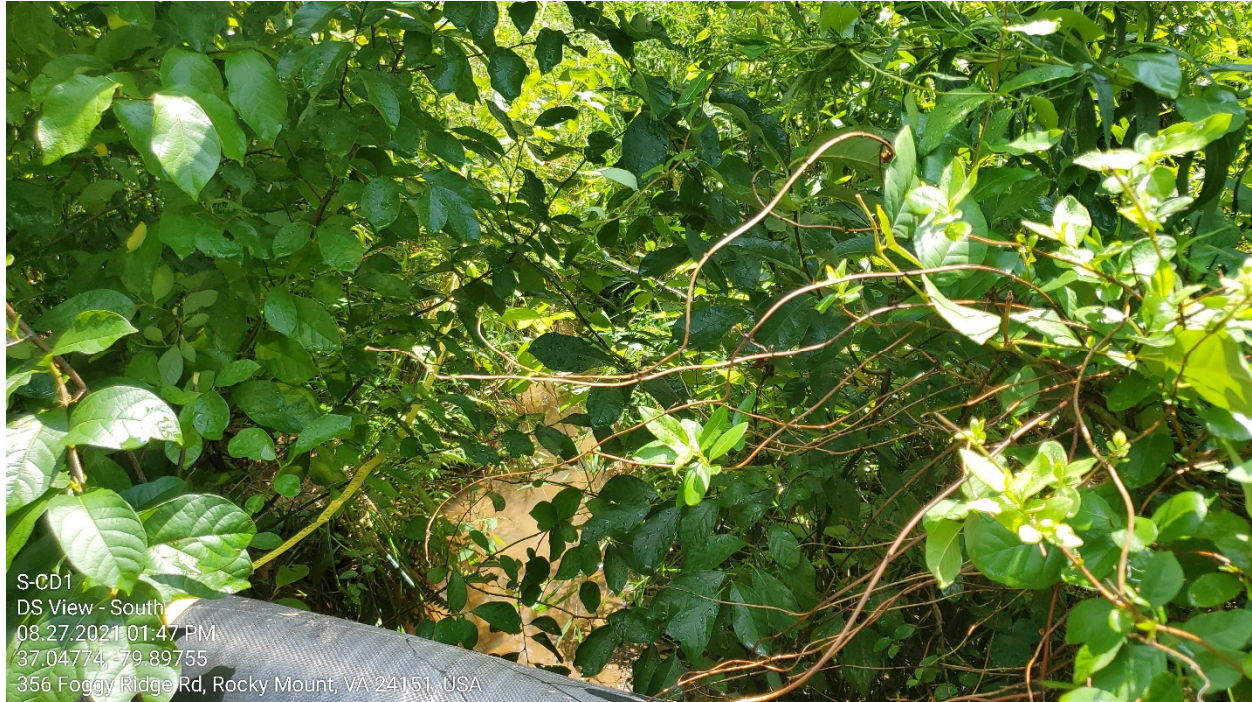
Photo Type: DS VIEW

Location, Orientation, Photographer Initials: Upstream at ROW/LOD looking S downstream, DW
