# Baseline Assessment – Stream Attributes

### Reach S-DD4 Braid 1 (Pipeline ROW) Intermittent Spread I Pittsylvania County, Virginia

# Spread I Stream S-DD4 Braid 1 ROW Pittsylvania County

# Stream Assessment Form (Form 1)

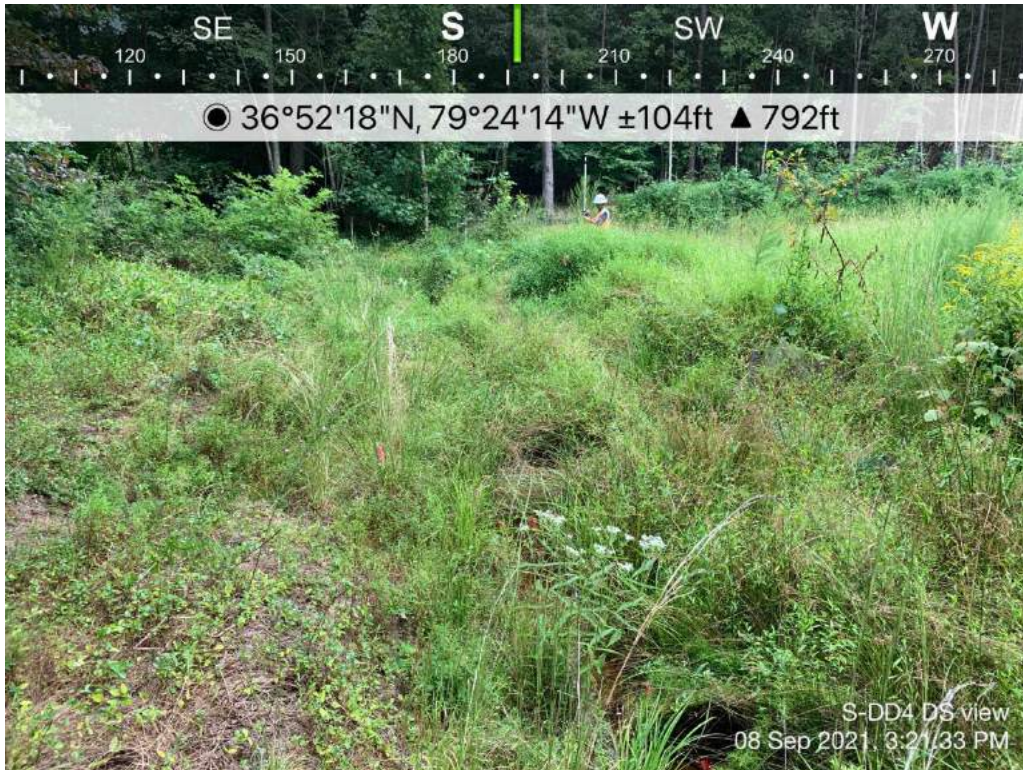
Photo Type: DS VIEW

Location, Orientation, Photographer Initials: Downstream view of ROW looking S, JMG

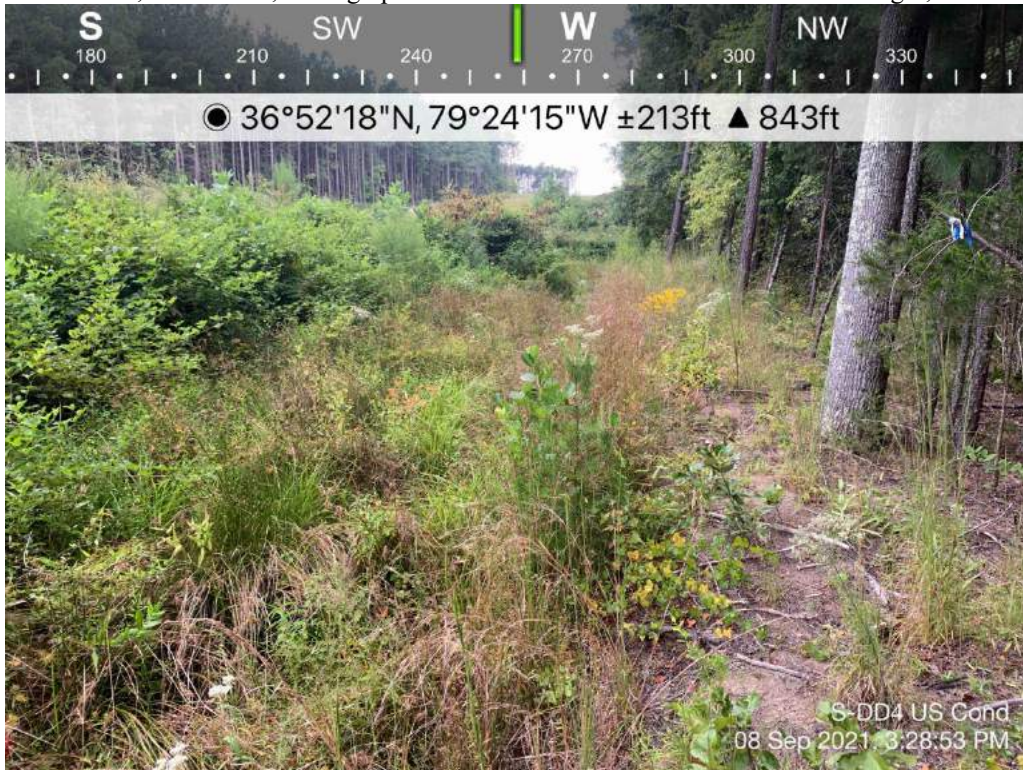
Photo Type: US VIEW

Location, Orientation, Photographer Initials: Upstream view of ROW looking W, JMG

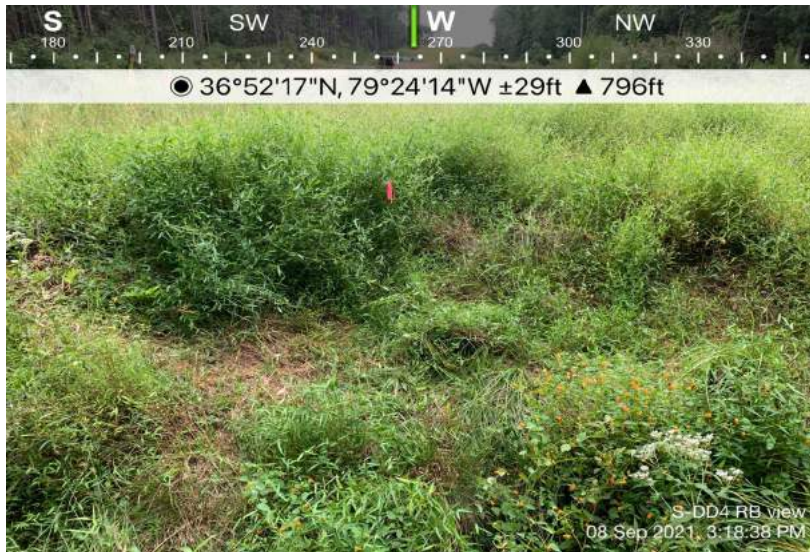
(WSSI Photo Location )

CAPTION. No bed or bank was located during field monitoring.
