#### **Baseline Assessment – Stream Attributes**

# Reach S-E28-East (Pipeline ROW) Perennial Spread I Franklin County, Virginia

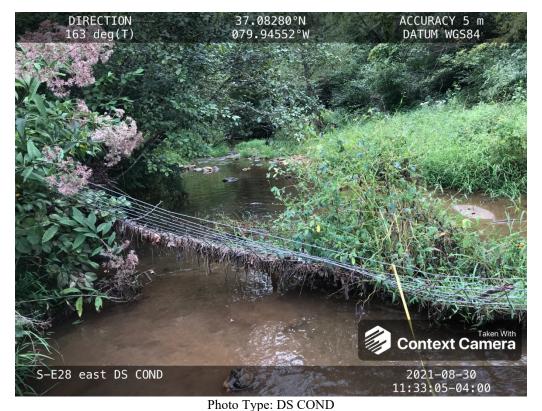
Location, Orientation, Photographer Initials: Downstream at ROW/LOD looking SE downstream, RAH

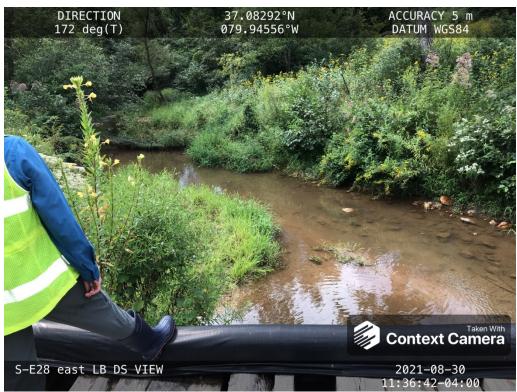
Photo Type: LB DS VIEW

Location, Orientation, Photographer Initials: Upstream at ROW/LOD on left bank looking SE downstream, RAH

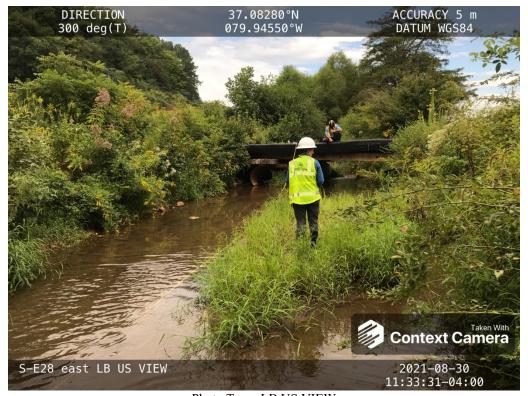
Photo Type: LB US VIEW Location, Orientation, Photographer Initials: On ROW/LOD on left bank looking NW upstream, RAH

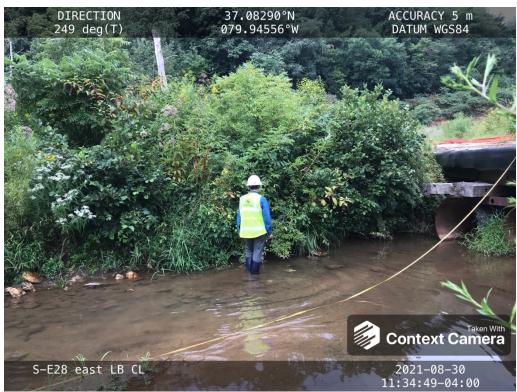
Photo Type: LB CL

Location, Orientation, Photographer Initials: On thalweg at pipe centerline looking SW at right streambank, RAH

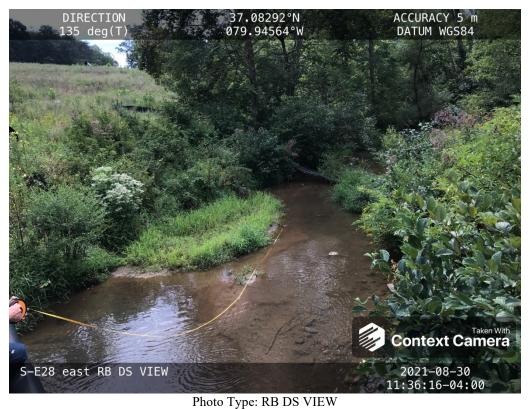
Location, Orientation, Photographer Initials: Upstream at ROW/LOD on right bank looking SE downstream, RAH

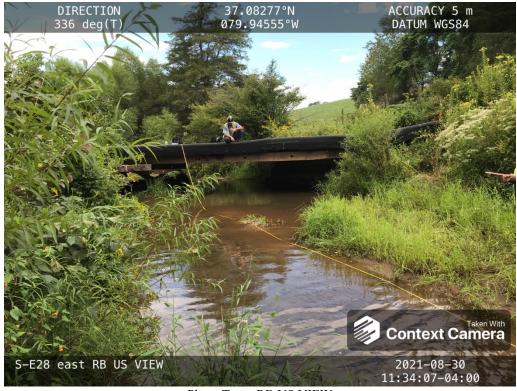
Photo Type: RB US VIEW

Location, Orientation, Photographer Initials: Downstream at ROW/LOD on right bank looking NW upstream, RAH

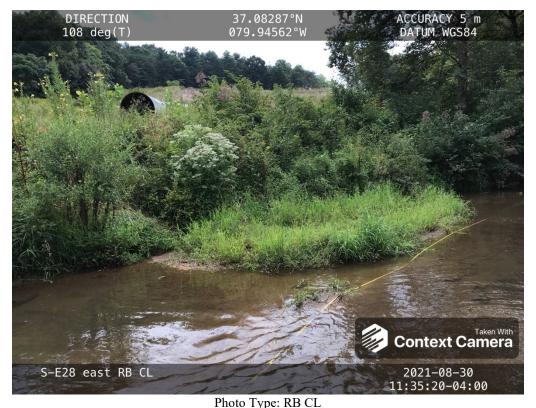
Location, Orientation, Photographer Initials: On thalweg at pipe centerline looking SE at left streambank, RAH

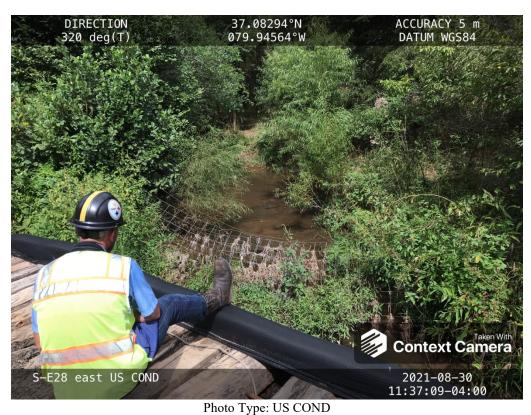
Location, Orientation, Photographer Initials: Upstream at ROW/LOD looking NW upstream, RAH
