Baseline Assessment – Stream Attributes

Reach S-G17 (Pipeline ROW) * Ephemeral Spread I Franklin County, Virginia

Ephemeral Stream Assessment Form (Form 1a)

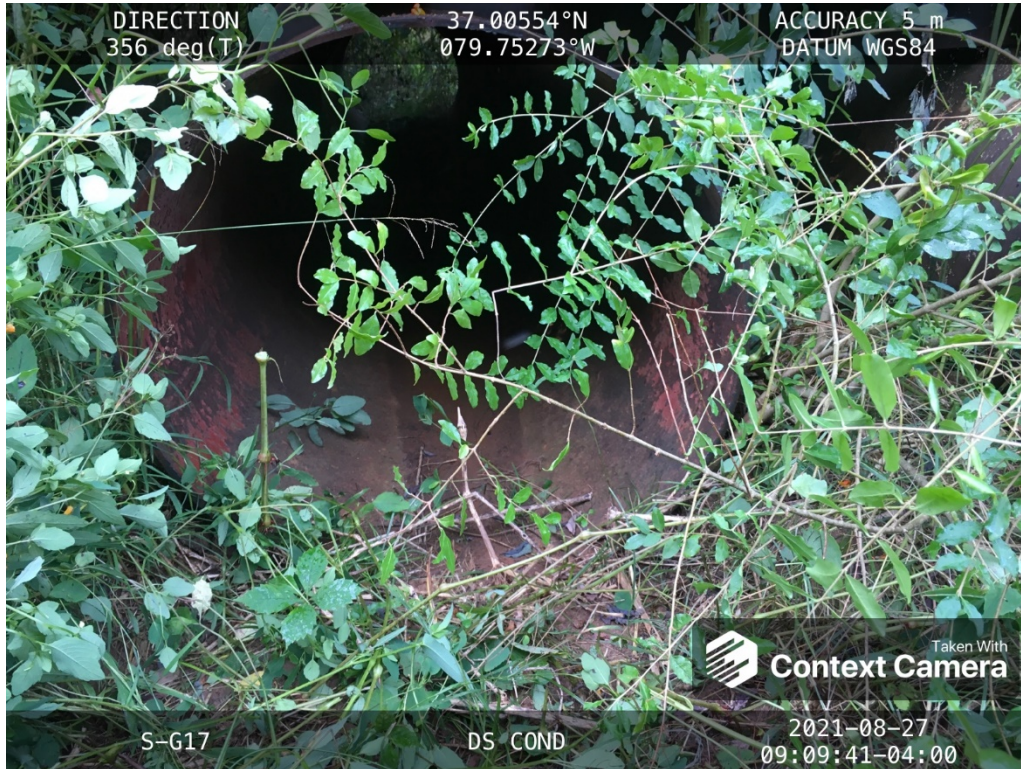
Location, Orientation, Photographer Initials: Downstream at ROW/LOD looking N downstream, BH

Photo Type: DS COND

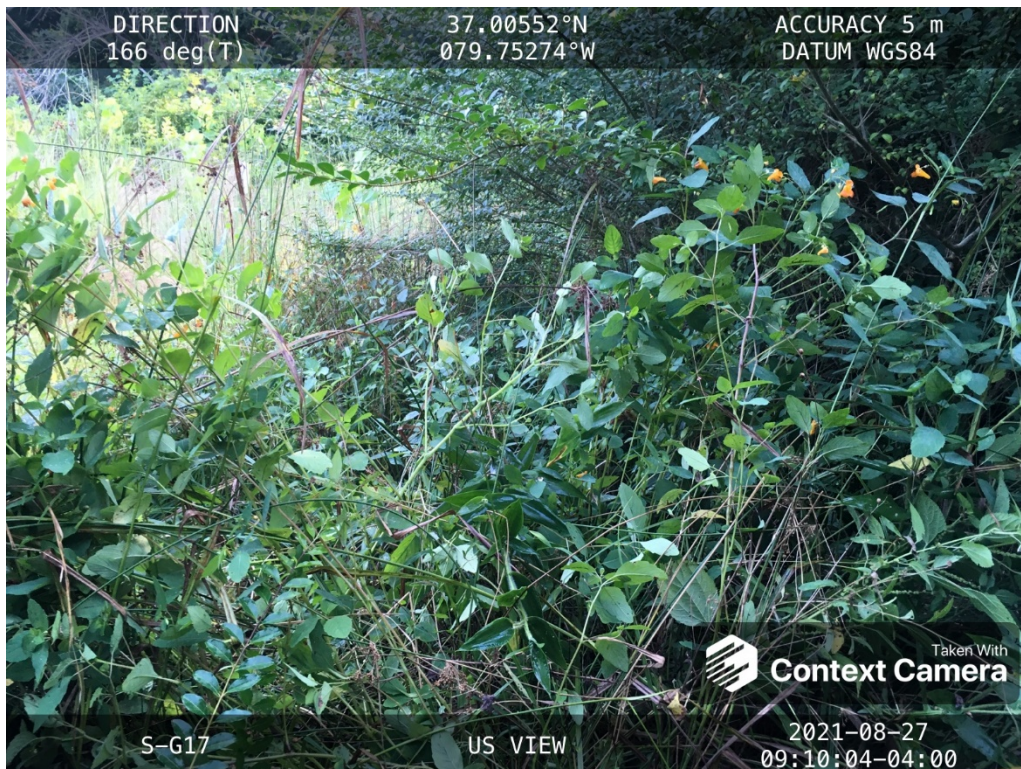
Location, Orientation, Photographer Initials: Downstream at ROW/LOD looking SE upstream, BH

Photo Type: US VIEW

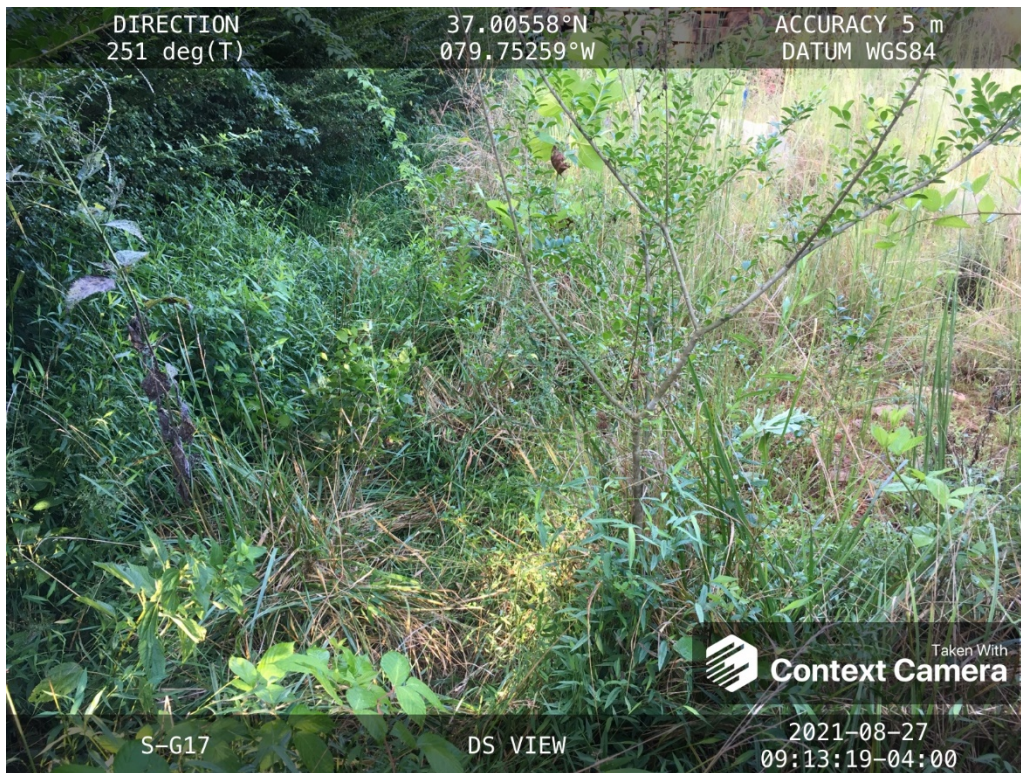
Location, Orientation, Photographer Initials: Upstream at ROW/LOD looking SW downstream, BH

Photo Type: DS VIEW

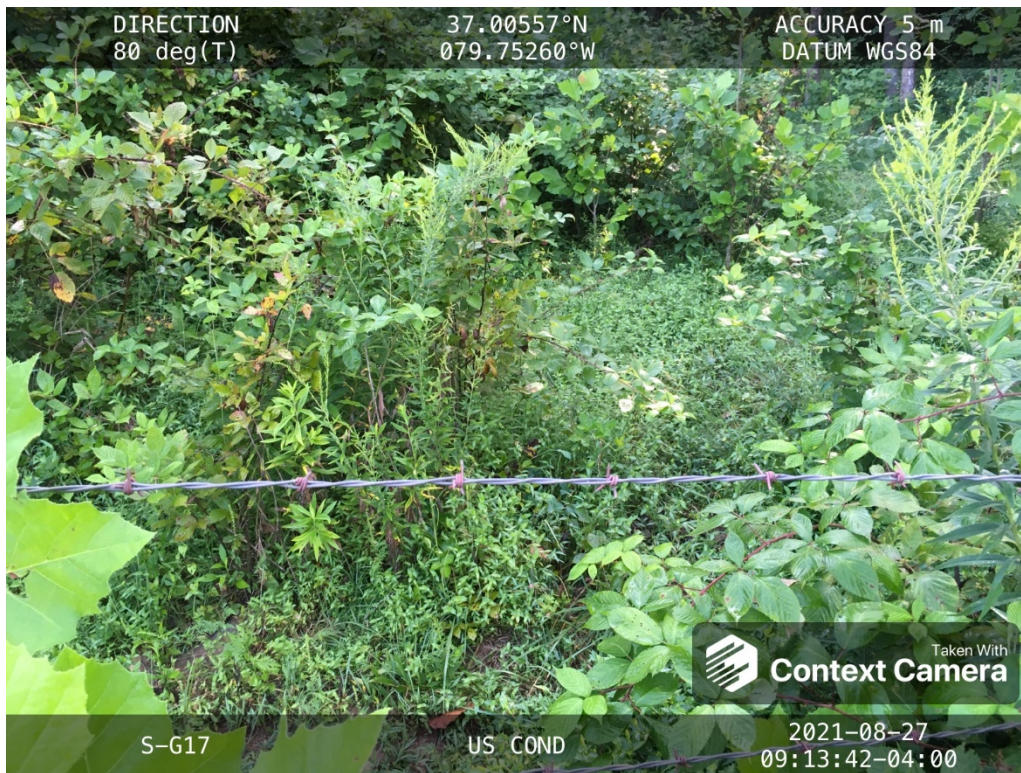
Location, Orientation, Photographer Initials: Upstream at ROW/LOD looking NE upstream, BH

Photo Type: US COND

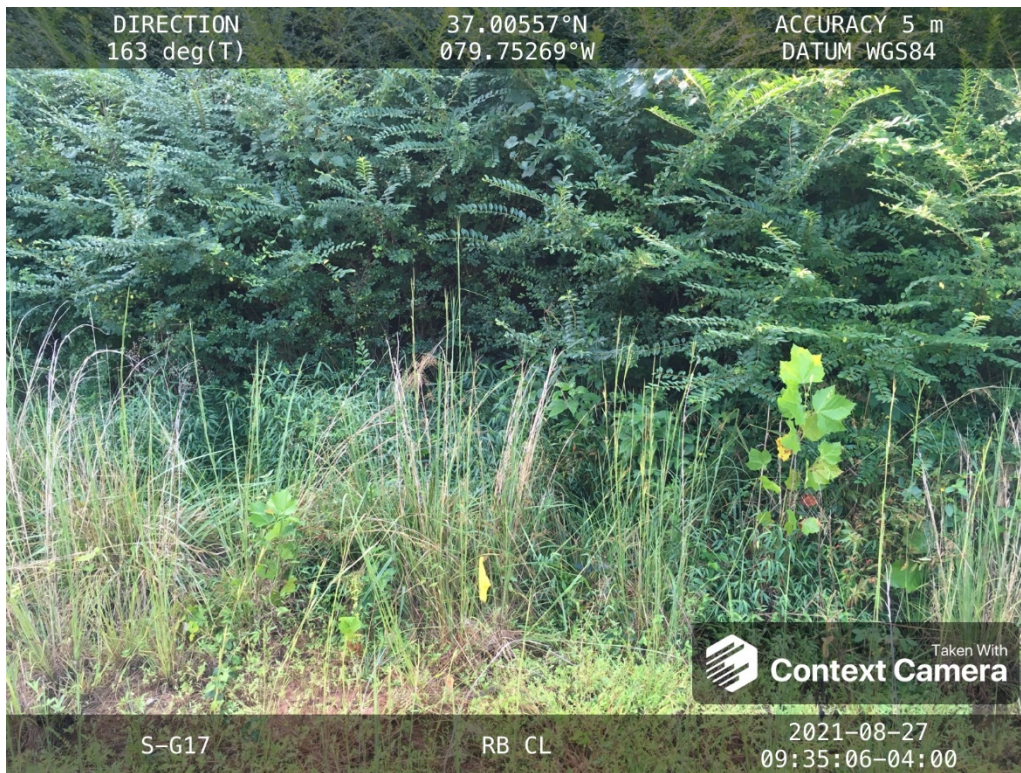
Location, Orientation, Photographer Initials: On thalweg at pipe centerline looking SE at left streambank, BH

Photo Type: RB CL

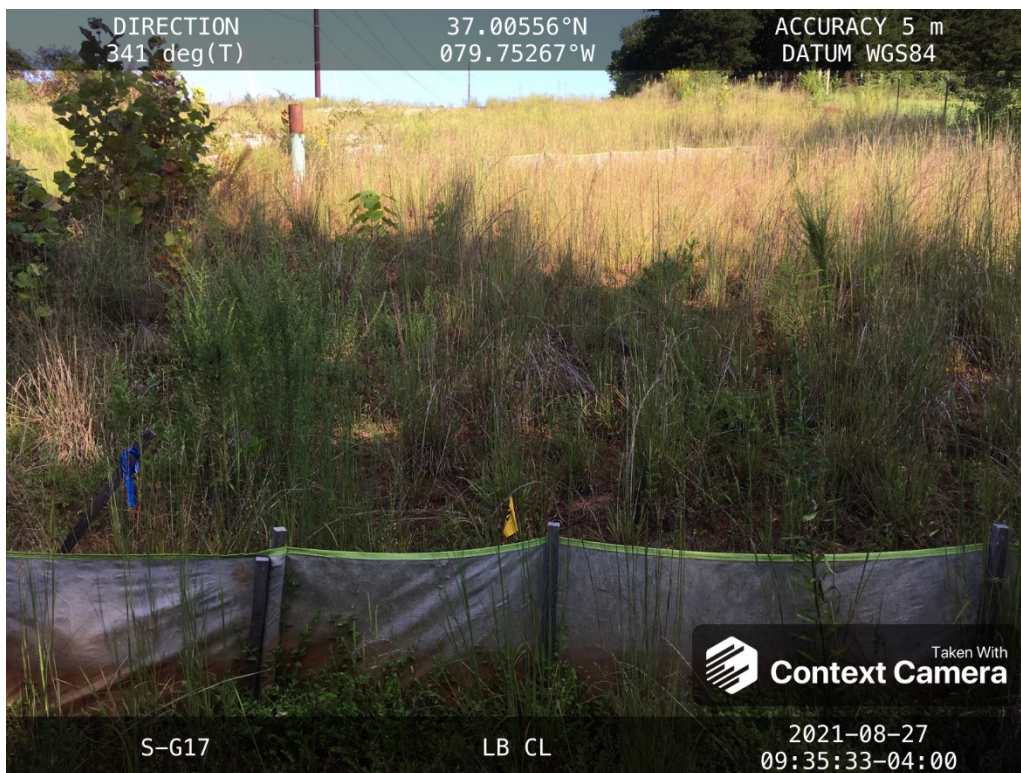
Location, Orientation, Photographer Initials: On thalweg at pipe centerline looking NW at right streambank, BH

Photo Type: LB CL

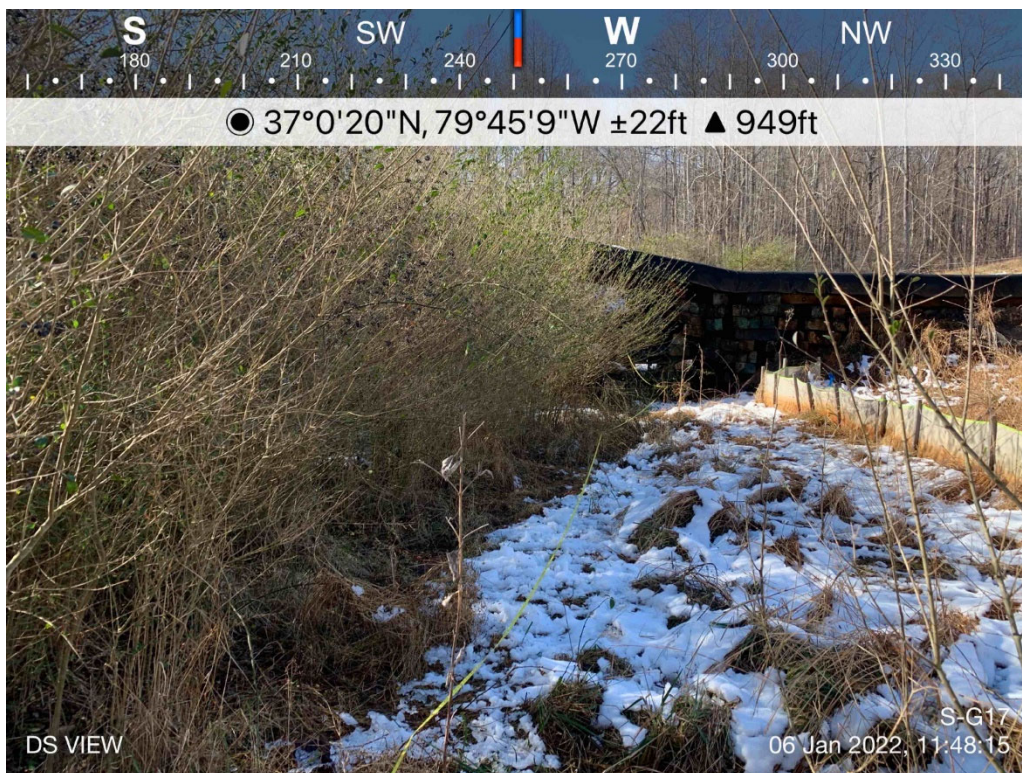
Location, Orientation, Photographer Initials: Downstream view of ROW looking W/SW, KB

Photo Type: DS VIEW

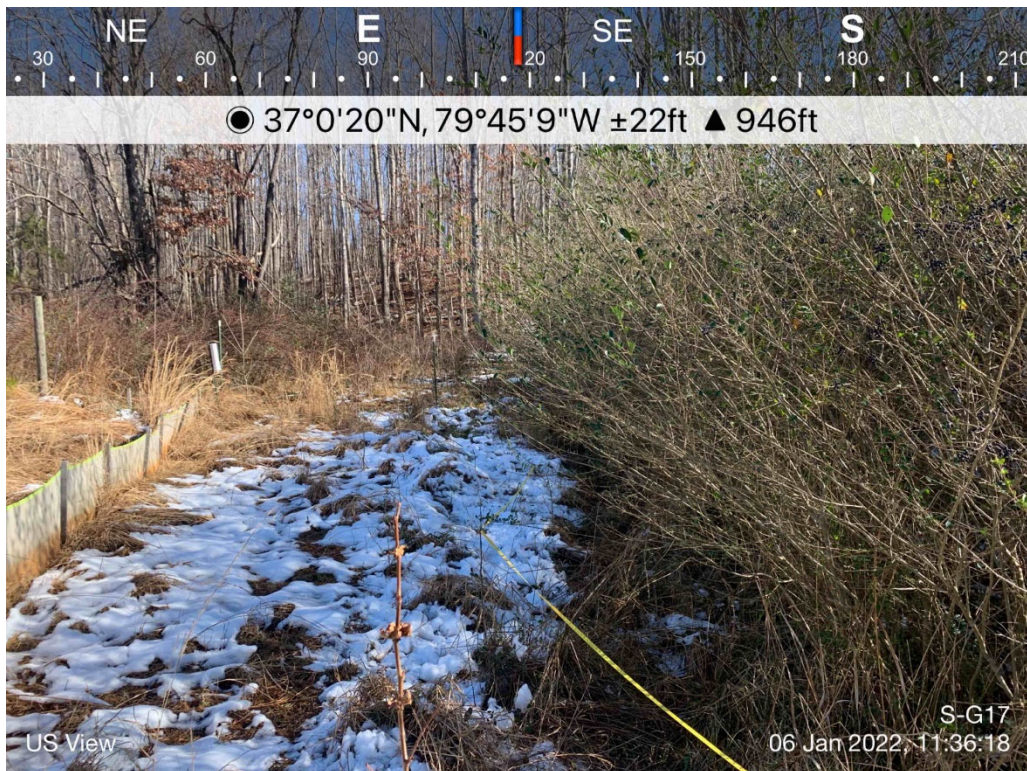
Location, Orientation, Photographer Initials: Upstream view of ROW looking E/SE, KB

Photo Type: US VIEW

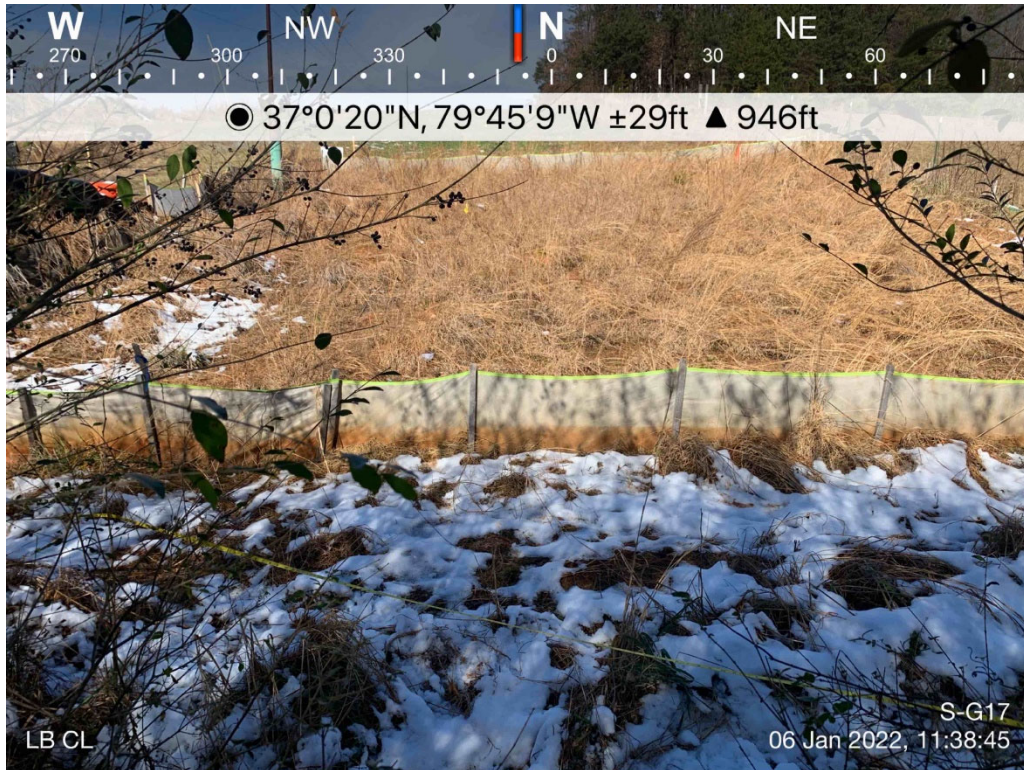
Location, Orientation, Photographer Initials: Standing on LB looking at RB along pipe centerline looking N, KB

Photo Type: LB CL

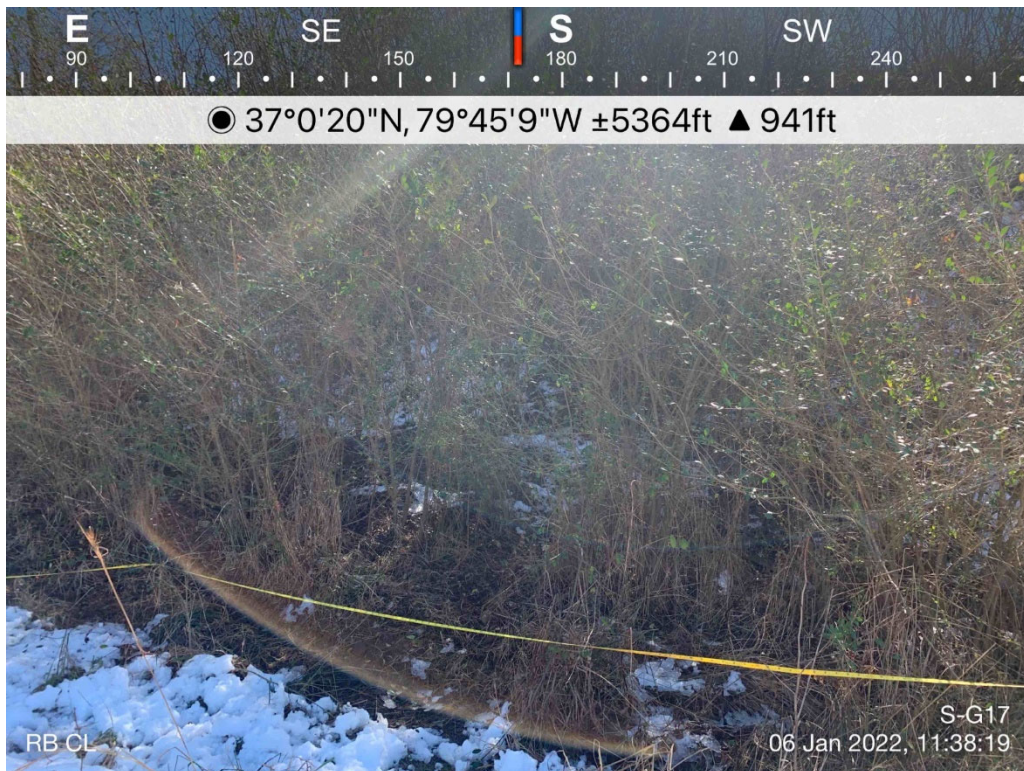
Location, Orientation, Photographer Initials: Standing on RB looking at LB along pipe centerline looking S, KB

Photo Type: RB CL

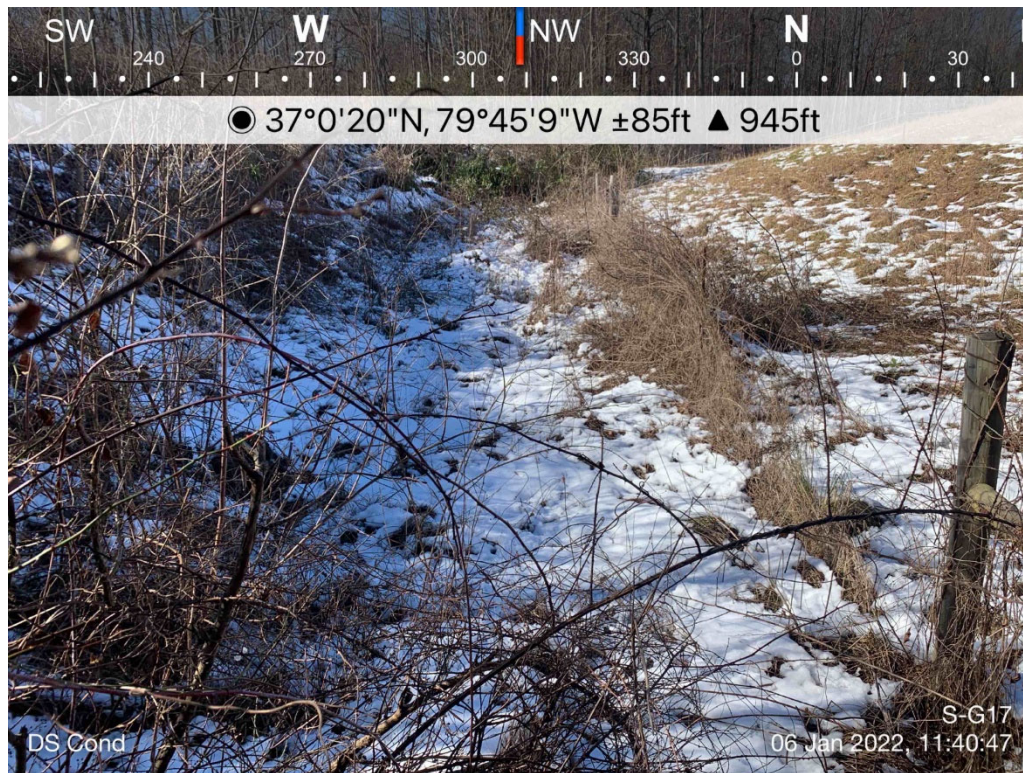
Location, Orientation, Photographer Initials: Downstream conditions outside of LOC looking NW, KB

Photo Type: DS COND
