Baseline Assessment – Stream Attributes

Reach S-H3 (Pipeline ROW) Intermittent Spread I Pittsylvania County, Virginia

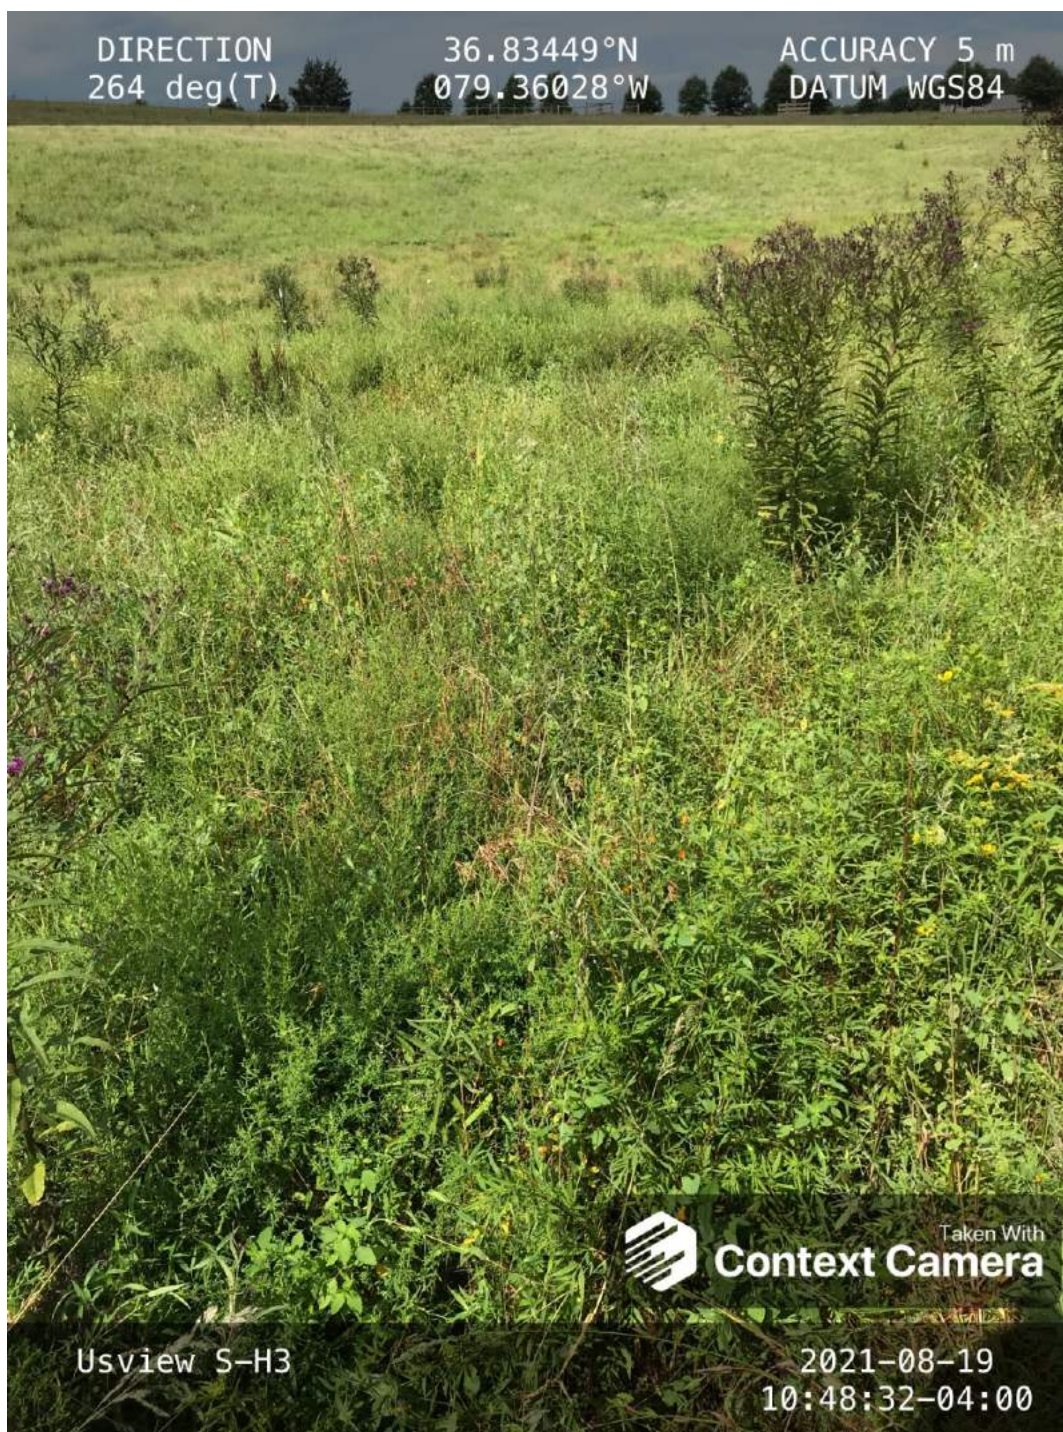
Photo Type: US VIEW

Location, Orientation, Photographer Initials: Downstream view of ROW looking SW, RH MB

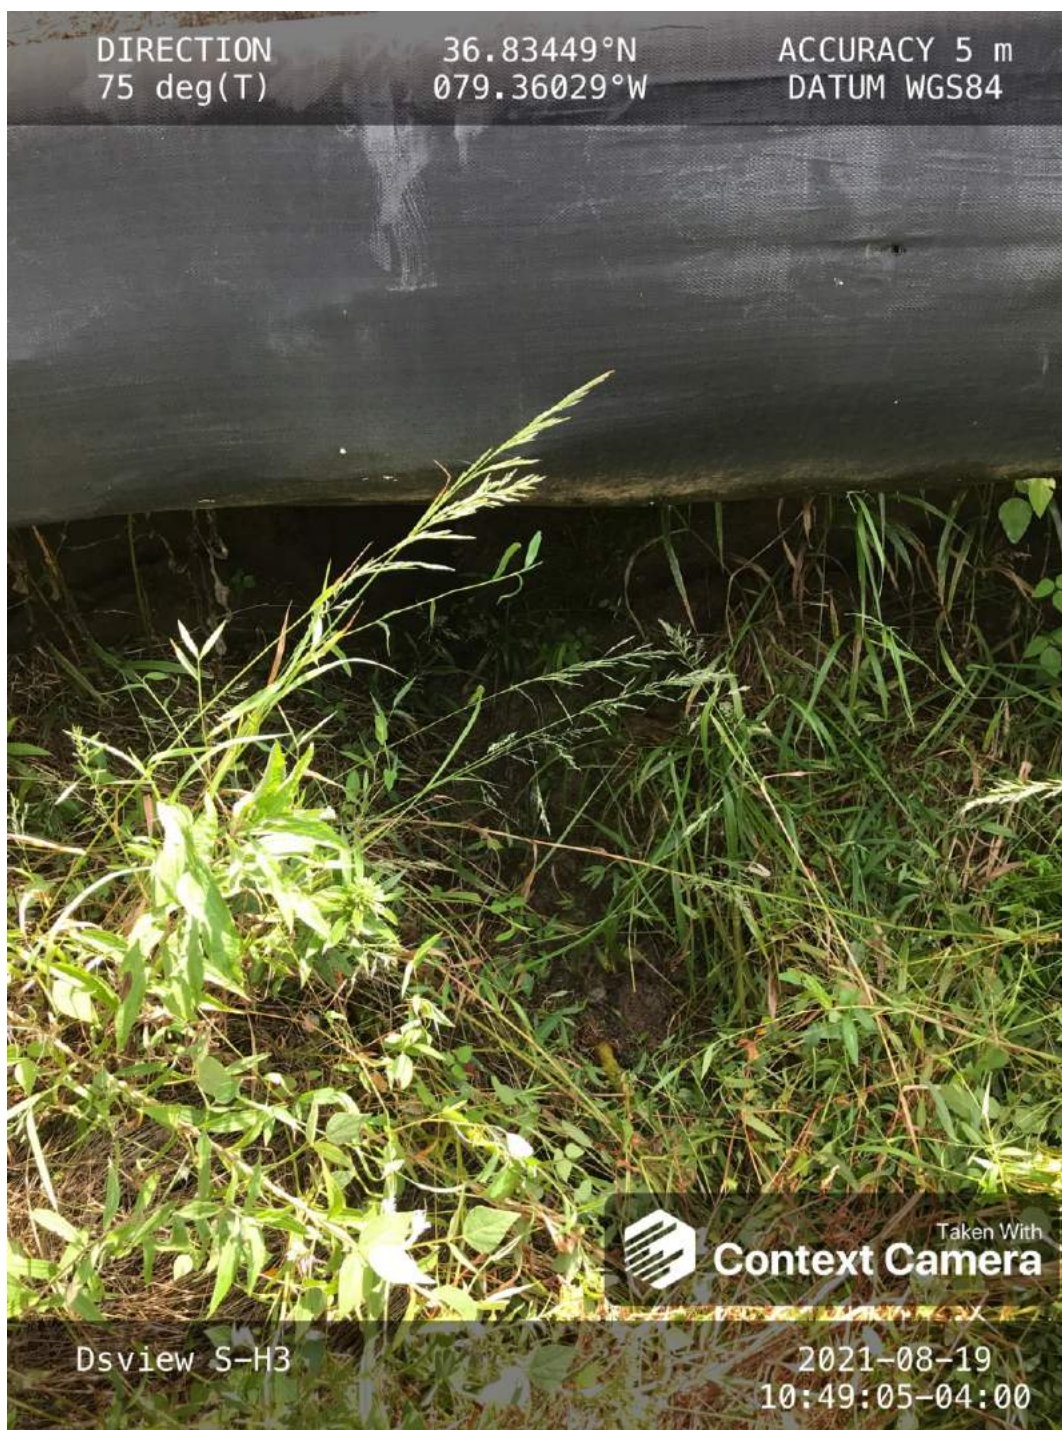
Photo Type: DS VIEW

Location, Orientation, Photographer Initials: Upstream view of ROW looking NE, RH MB

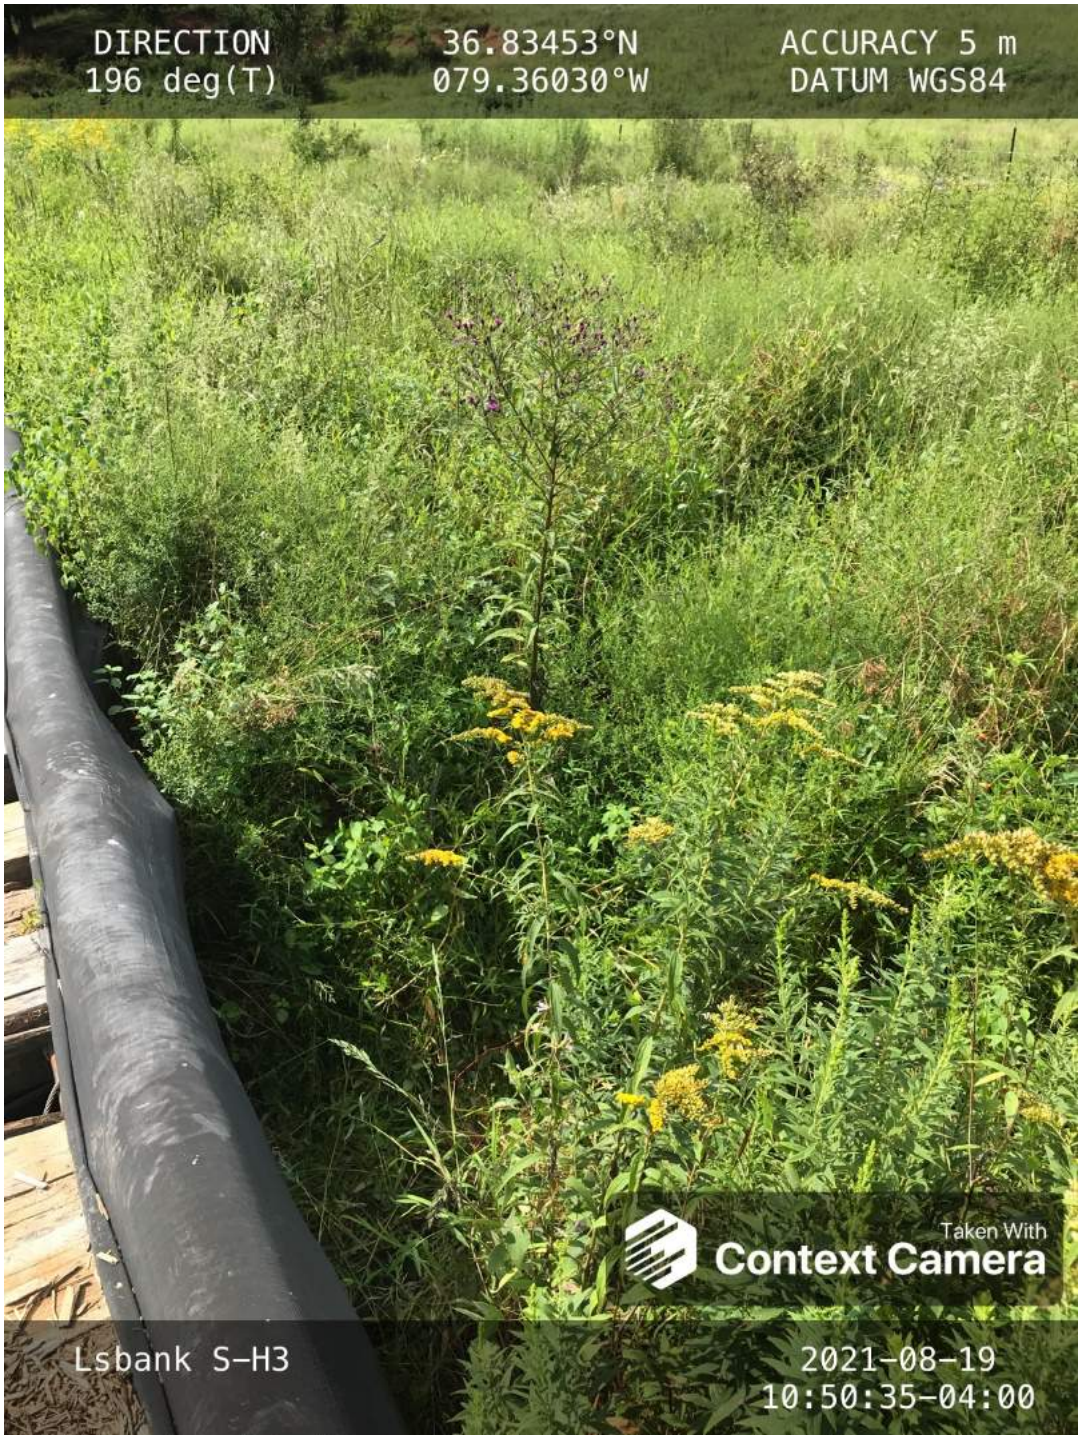
Photo Type: LB CL
Location, Orientation, Photographer Initials: Standing on LB looking at RB along pipe centerline looking N, RH MB

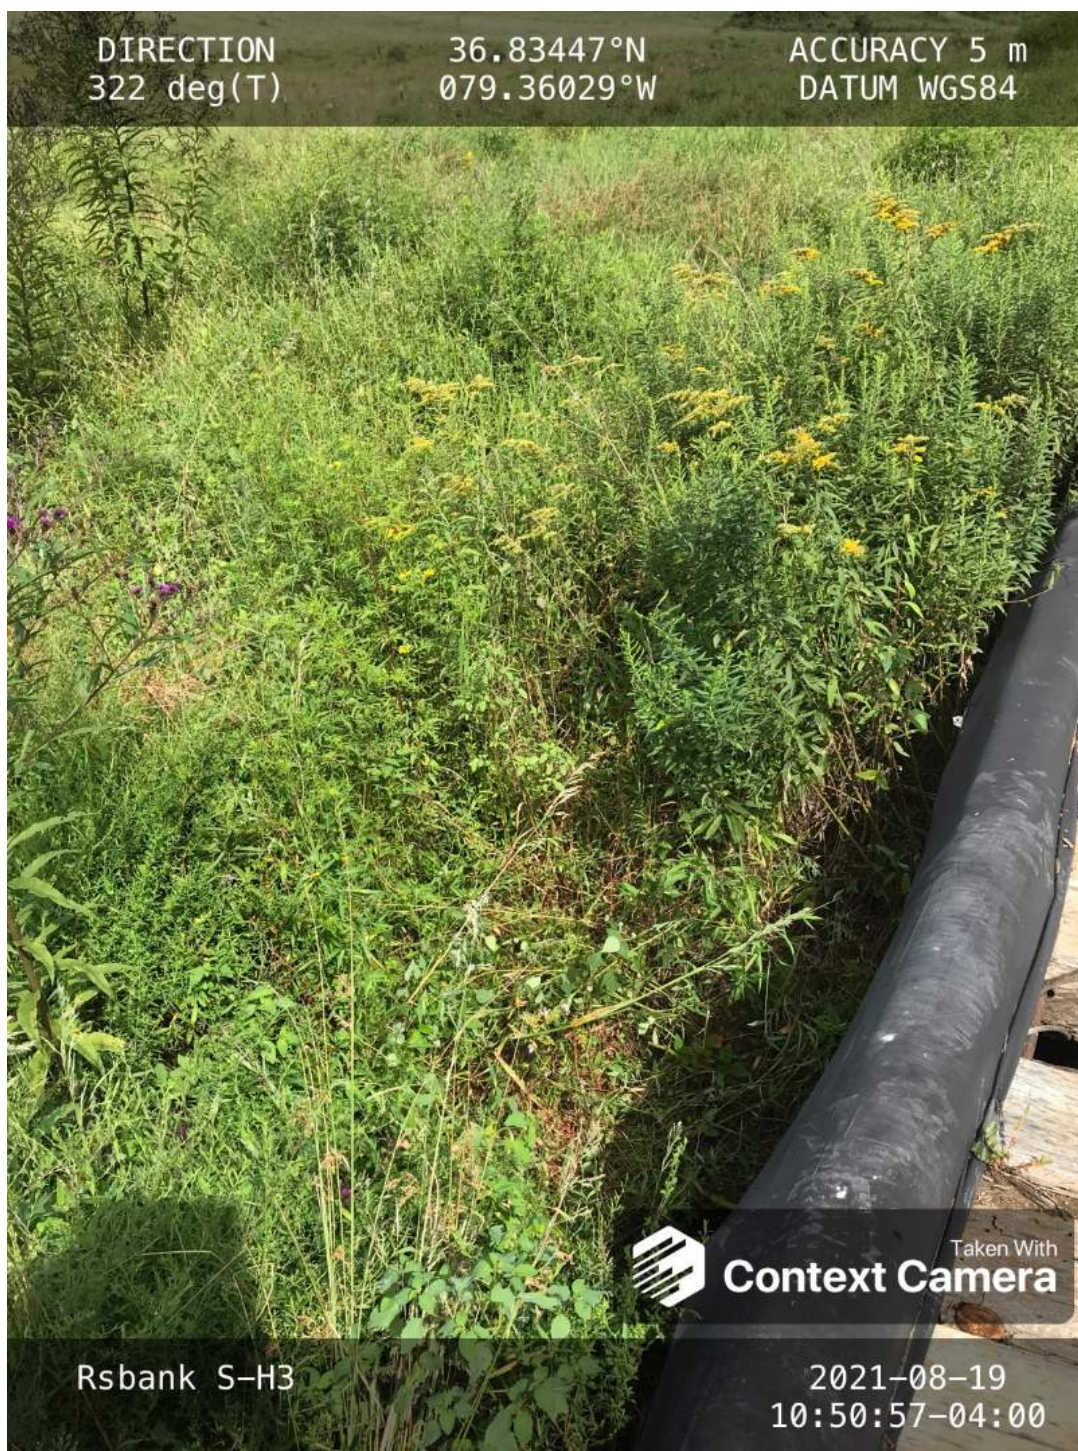
Photo Type: RB CL

Location, Orientation, Photographer Initials: Standing on RB looking at LB along pipe centerline looking N, RH MB

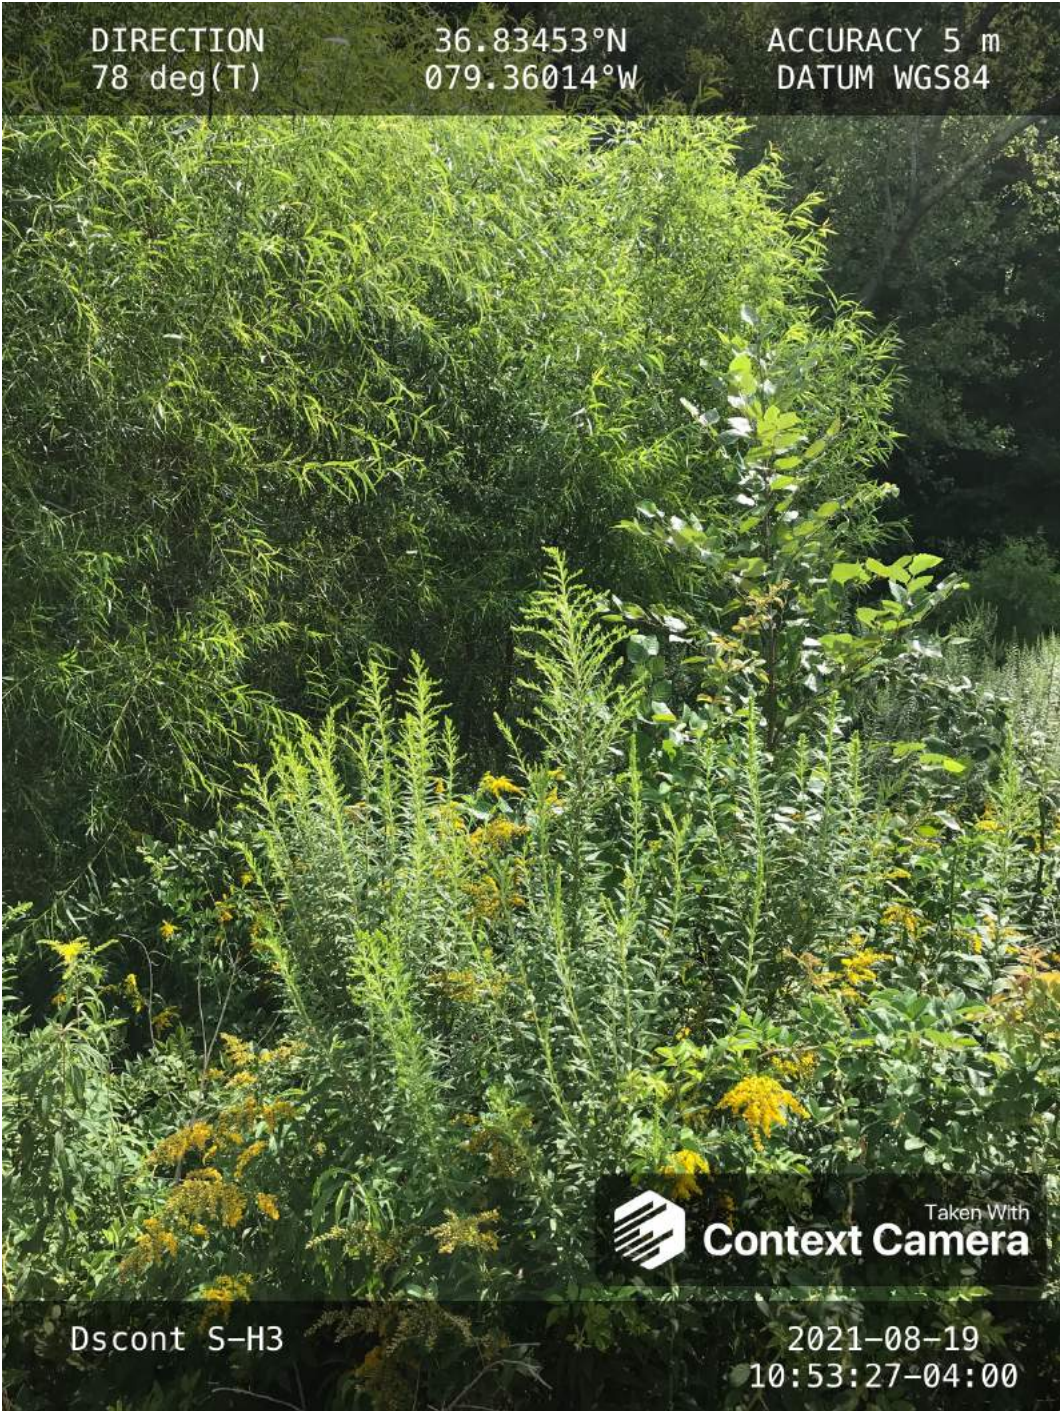
Photo Type: DS COND
Location, Orientation, Photographer Initials: Downstream conditions outside of ROW looking NE, RH MB

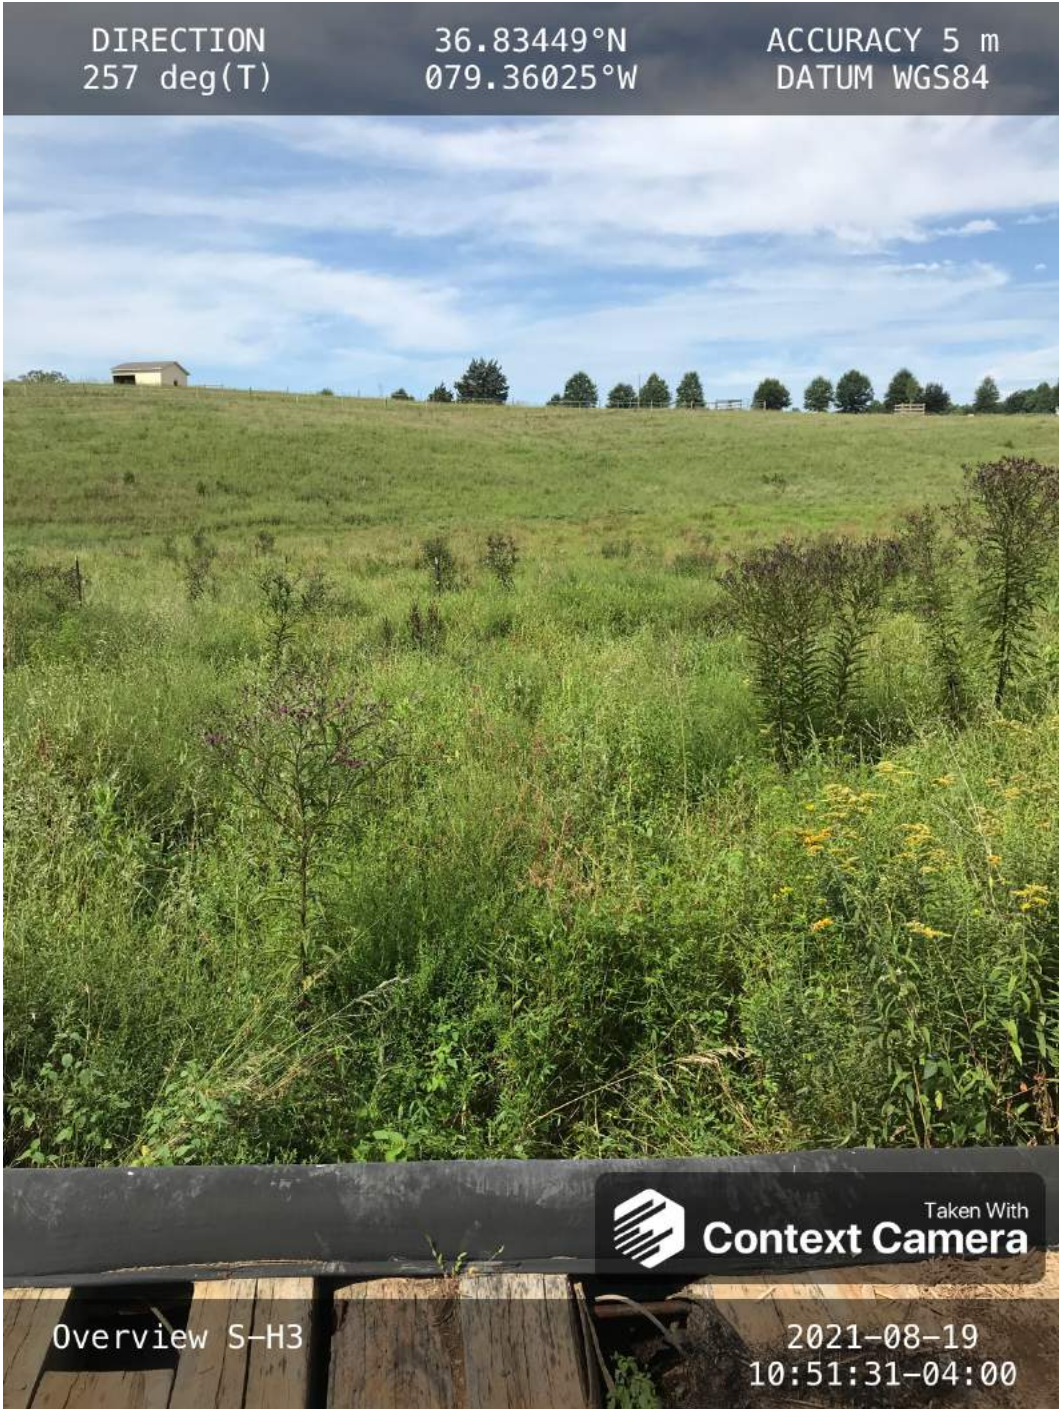
Location, Orientation, Photographer Initials: Downstream conditions outside of ROW looking SW, RH MB

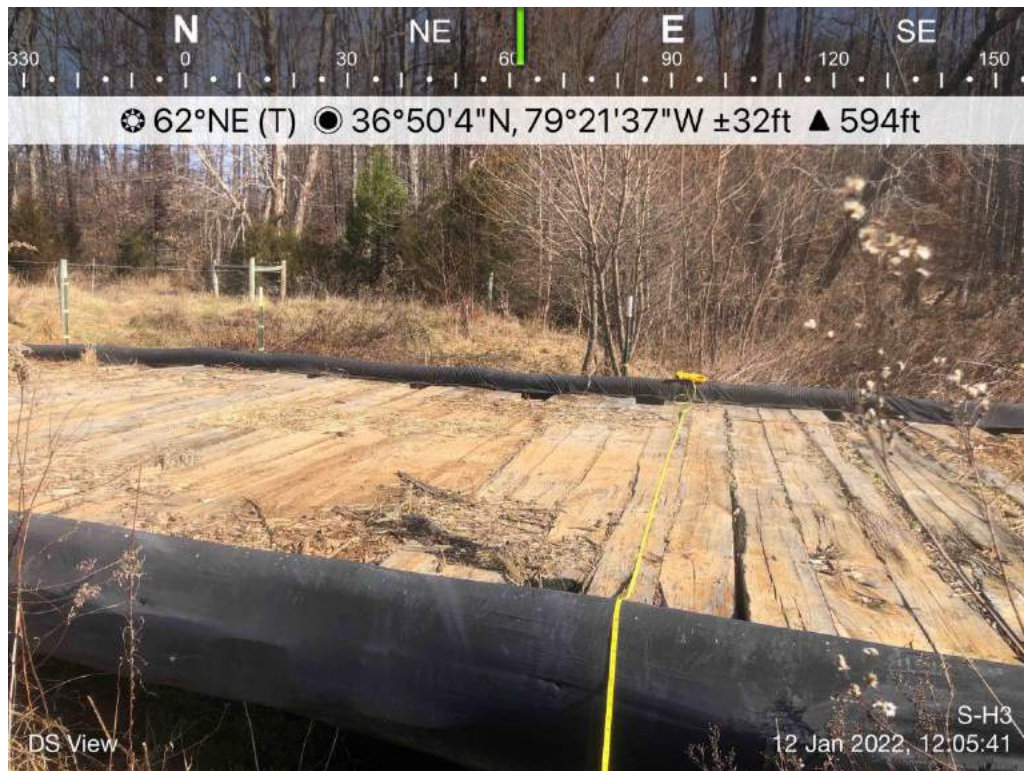
Photo Type: DS VIEW

Location, Orientation, Photographer Initials: Downstream view of LOC looking E/NE, KB
01/12/2022, 12:05 PM

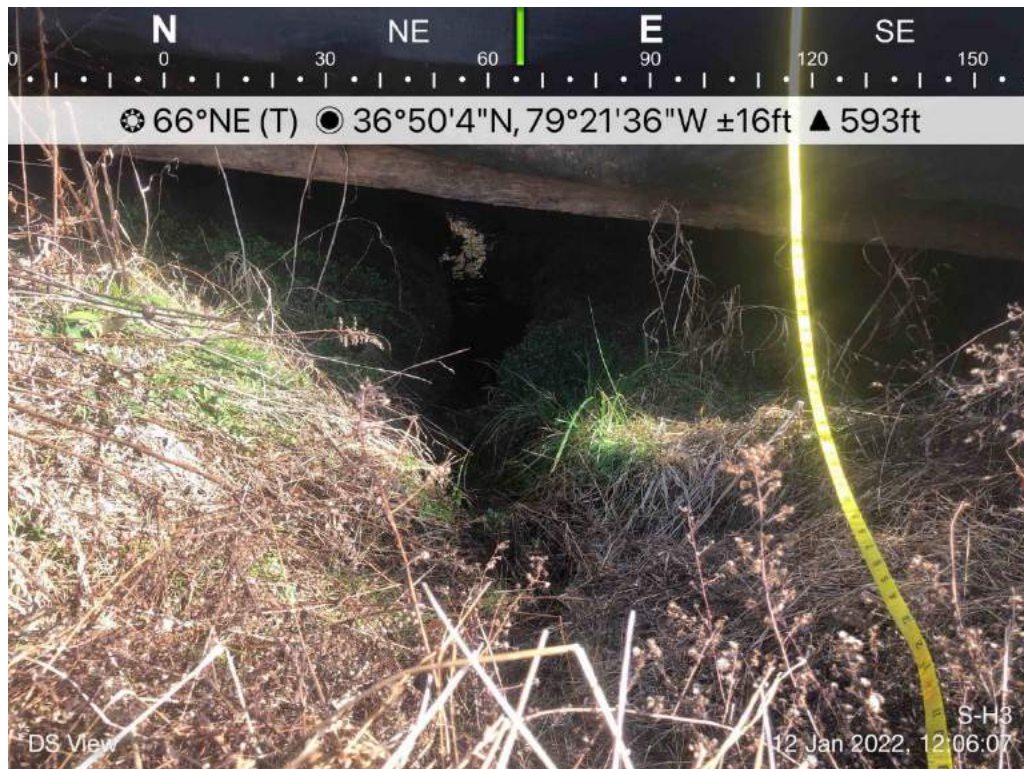
Photo Type: DS VIEW

Location, Orientation, Photographer Initials: Downstream view of LOC looking E/NE, KB
01/12/2022, 12:06 PM

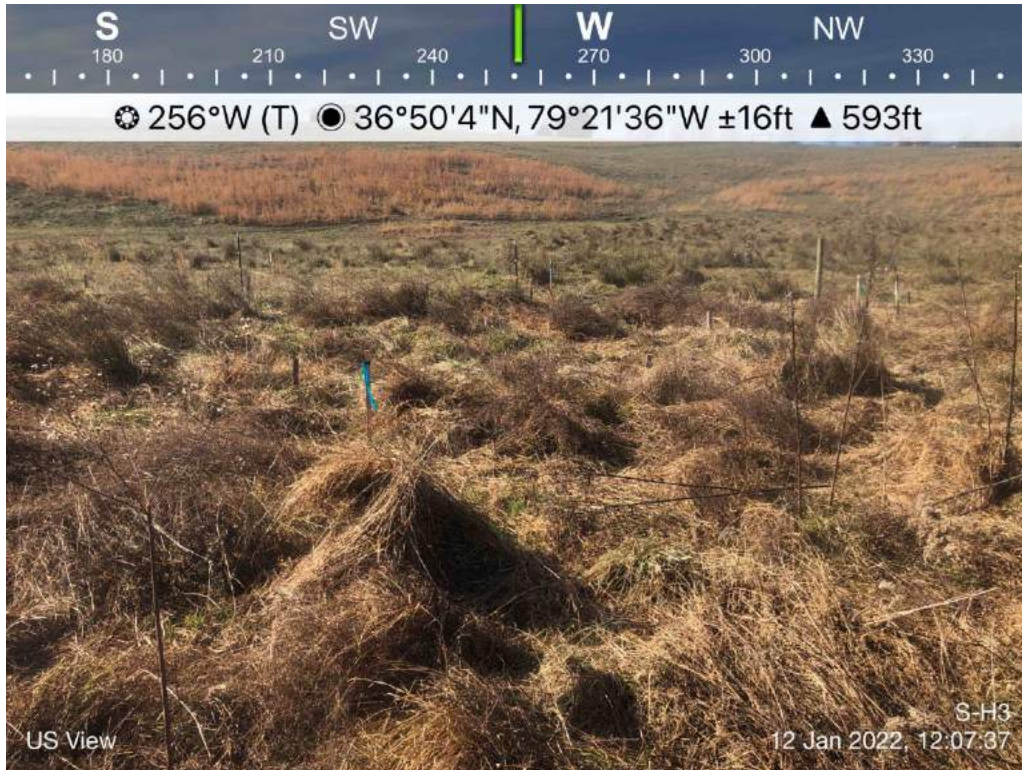
Photo Type: US View

Location, Orientation, Photographer Initials: Upstream view of LOC looking W/SW, KB
01/12/2022, 12:07 PM

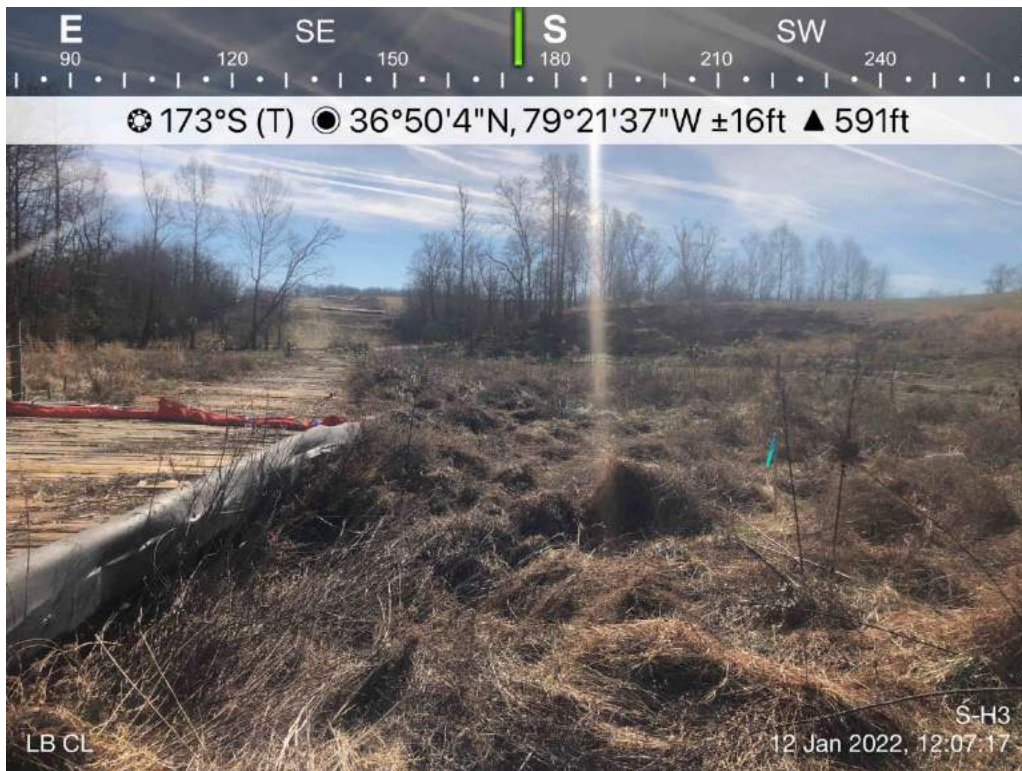
Photo Type: LB CL

Location, Orientation, Photographer Initials: Standing on LB looking at RB along pipe centerline looking S, KB
01/12/2022, 12:07 PM

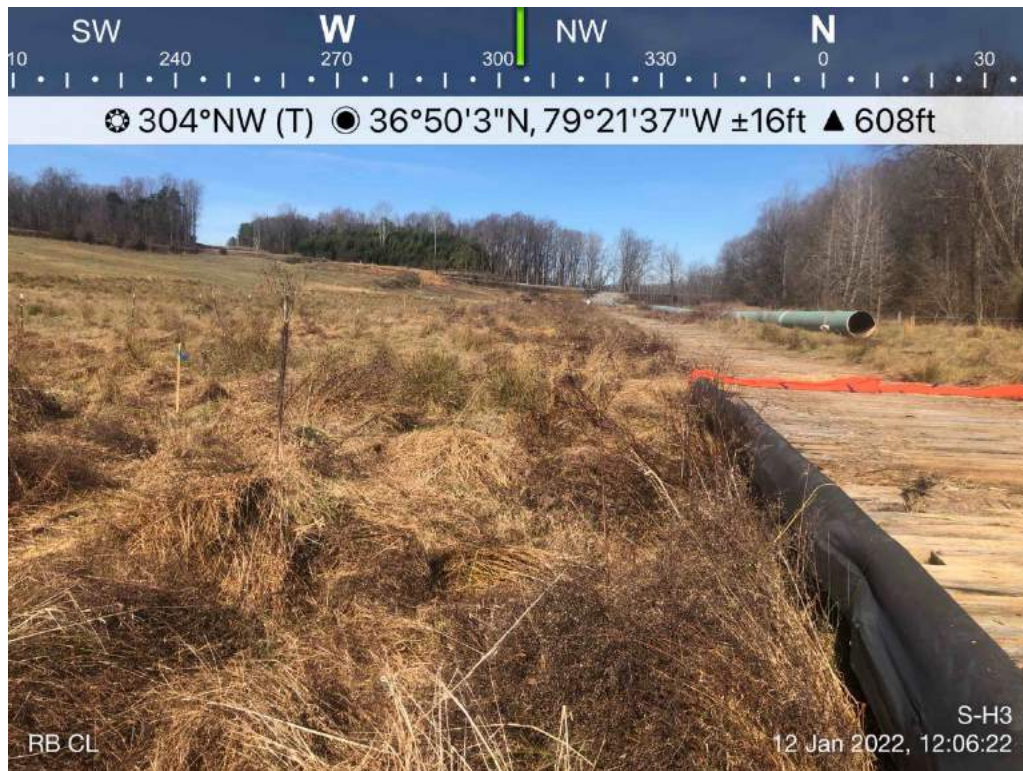
Photo Type: RB CL

Location, Orientation, Photographer Initials: Standing on RB looking at LB along pipe centerline looking NW, KB
01/12/2022, 12:06 PM

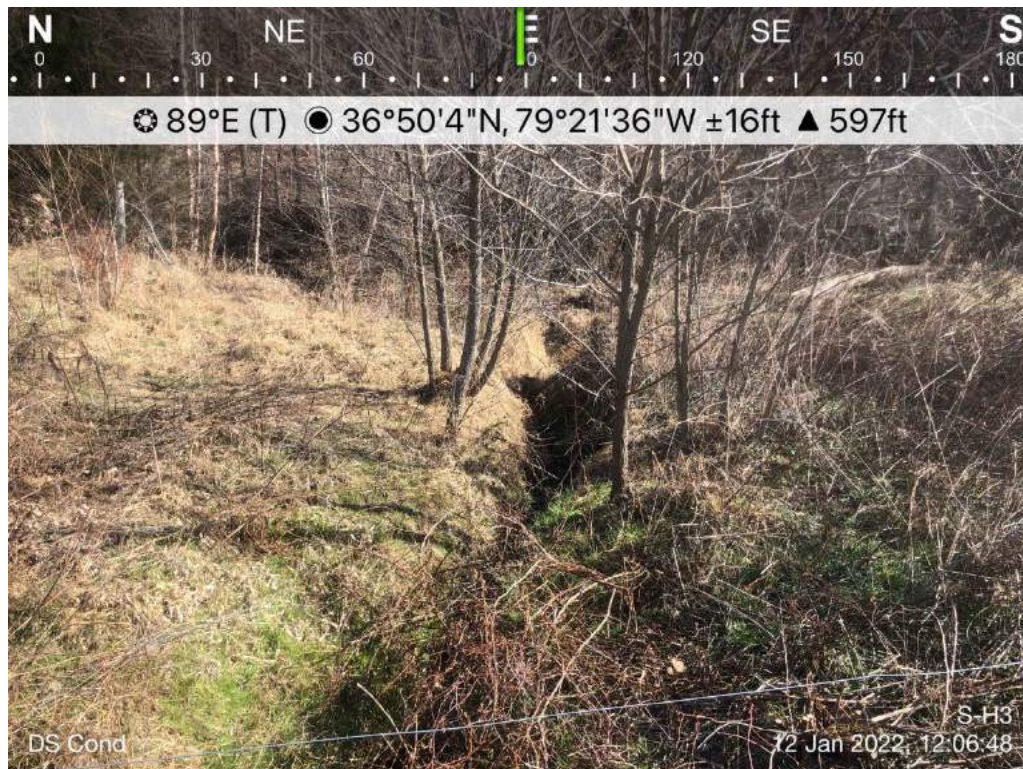
Photo Type: DS COND

Location, Orientation, Photographer Initials: Downstream conditions outside of LOC looking E, KB
01/12/2022, 12:06 PM

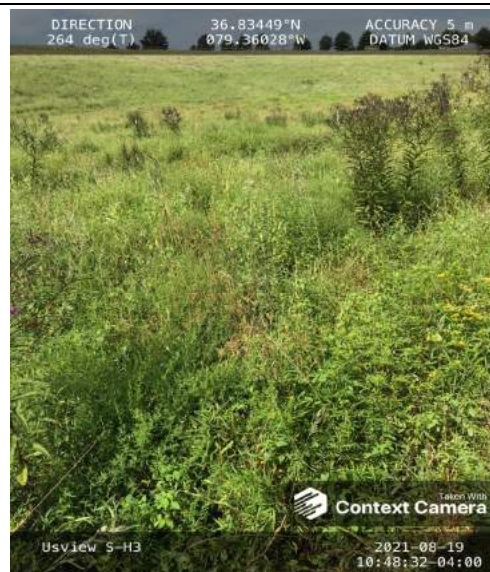
CAPTION. Assessment is limited to areas within the temporary ROW.
