Baseline Assessment – Stream Attributes

Reach S-H44 (Timber Mat Crossing)

Pittsylvania County, Virginia

Project #	Project Name (Applicant)	Locality	Cowardin Class.	HUC	Date	SAR #	Impact Length	Impact Factor
22865.06	Mountain Valley Pipeline (Mountain Valley Pipeline, LLC)	Pittslyvania	R3	03010105	09/02/21	S-H44	33	1
Name(s) of Evaluator(s)		Stream Name and Information					SAR Length	
RC, RH		UNT to Little Cherrystone Creek					116

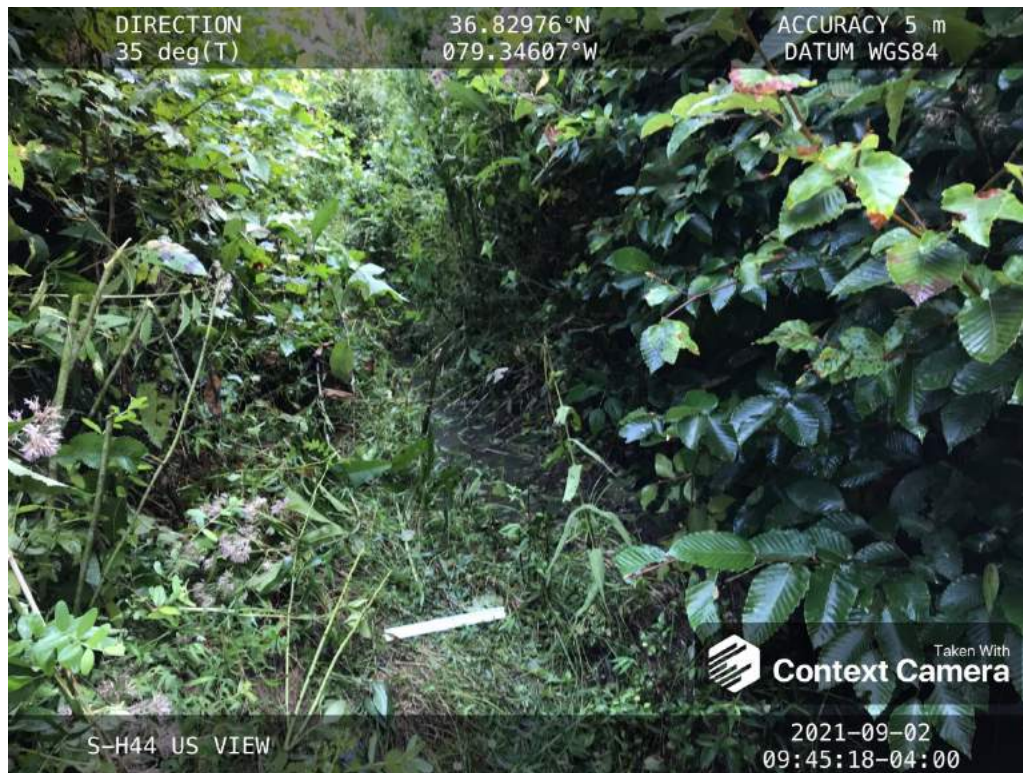
Photo Type: US VIEW

Location, Orientation, Photographer Initials: Downstream at ROW/LOD looking NE upstream, RAH

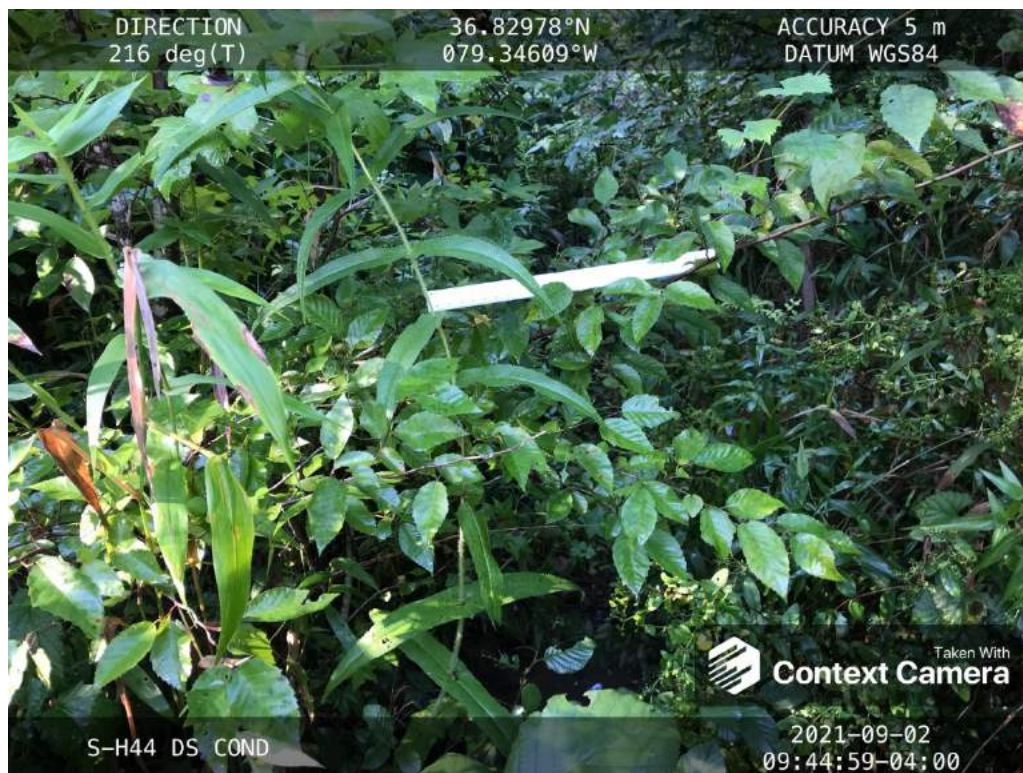
Photo Type: DS COND

Location, Orientation, Photographer Initials: Downstream at ROW/LOD looking SW downstream, RAH

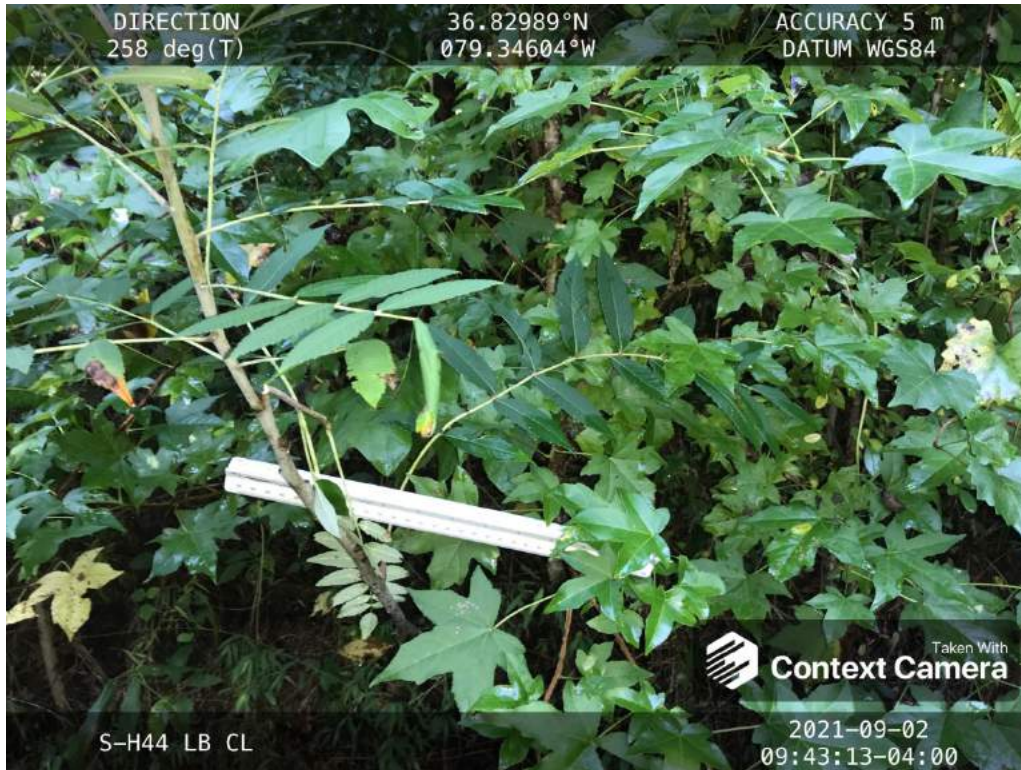
Photo Type: LB CL

Location, Orientation, Photographer Initials: On thalweg at pipe centerline looking W at right streambank, RAH

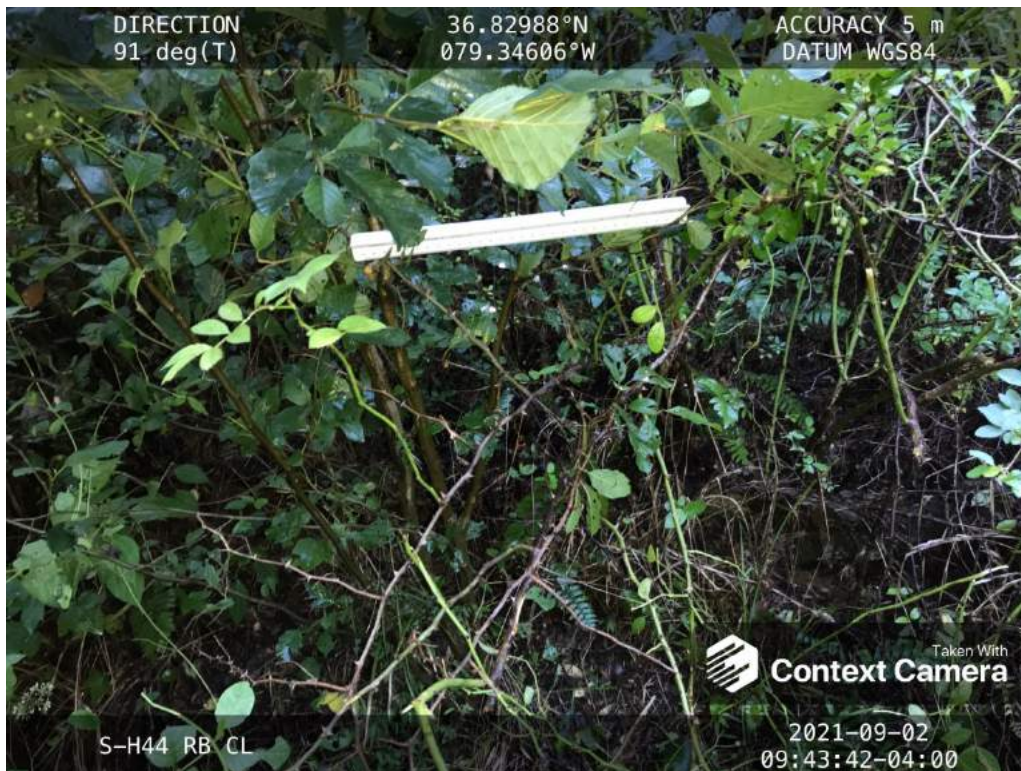
Photo Type: RB CL

Location, Orientation, Photographer Initials: On thalweg at pipe centerline looking E at left streambank, RAH

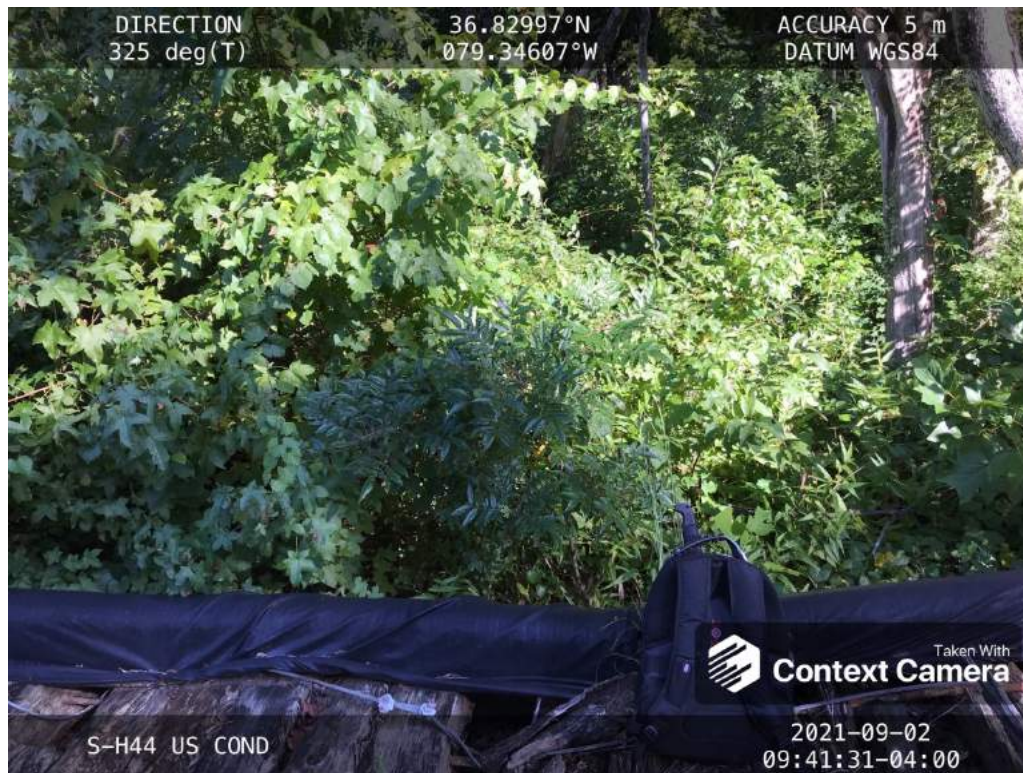
Photo Type: US COND

Location, Orientation, Photographer Initials: Upstream at ROW/LOD looking NW upstream, RAH

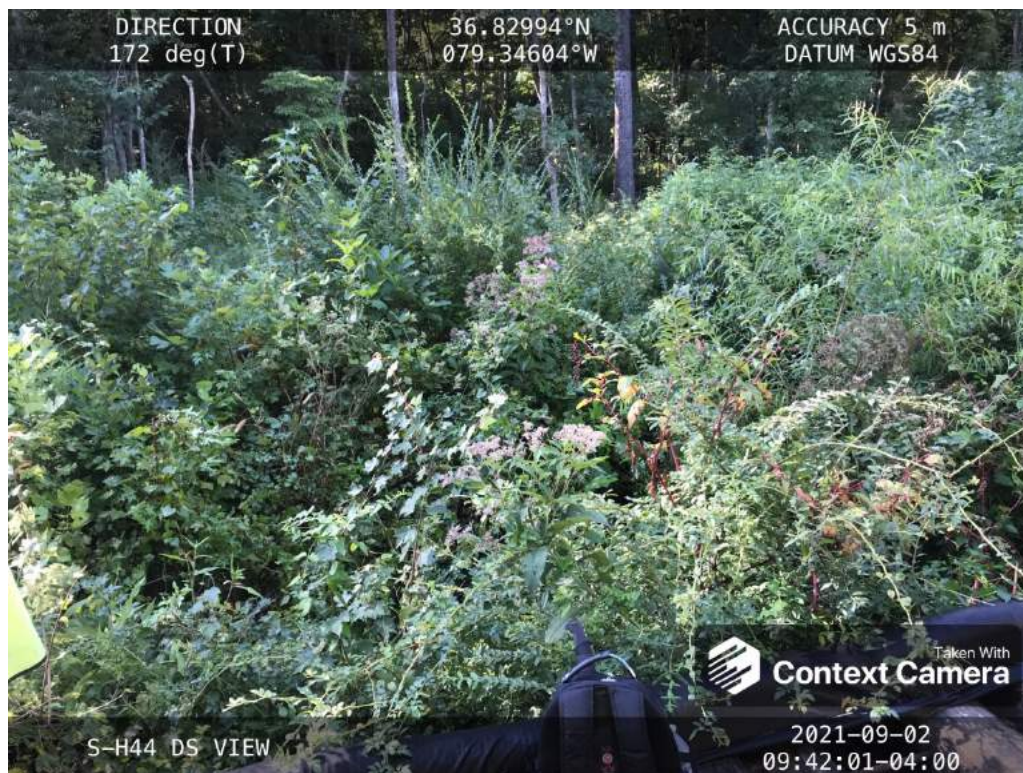
Photo Type: DS VIEW

Location, Orientation, Photographer Initials: Upstream at ROW/LOD looking SE downstream, RAH
