Baseline Assessment – Stream Attributes

Reach S-MM46 (Timber Mat Crossing) Intermittent Spread I Franklin County, Virginia

Spread I Stream S-MM46 (Timber Mat) Franklin County

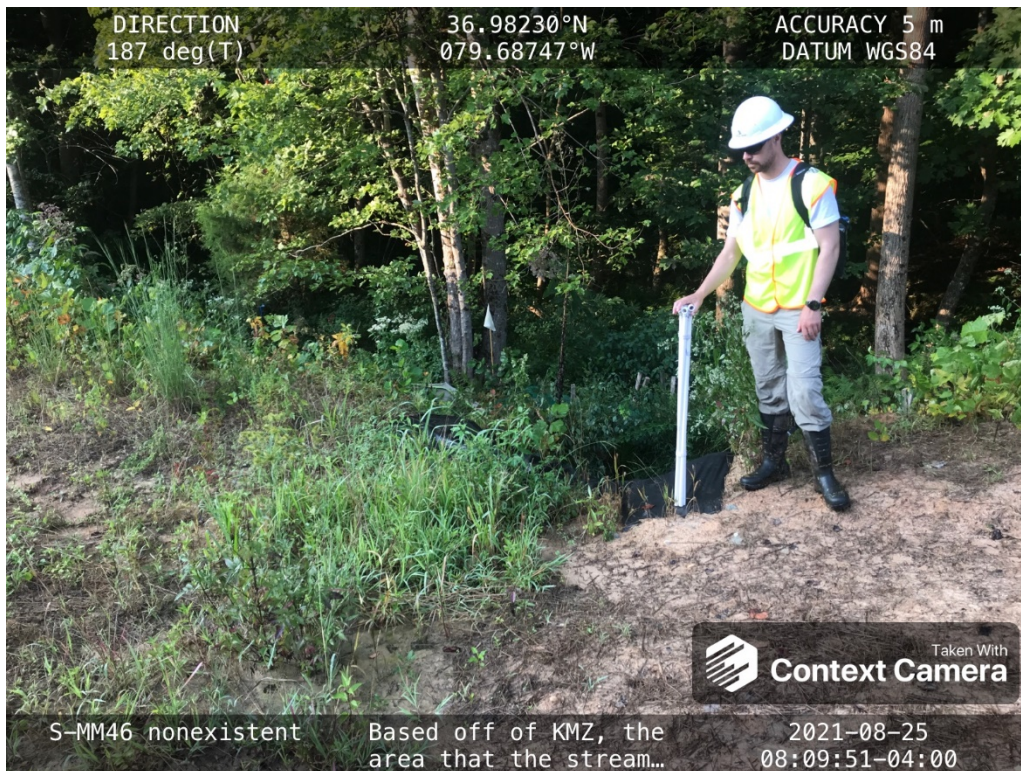
Photo Type: Stream nonexistent
Orientation, Photographer Initials: Looking S upstream, RAH

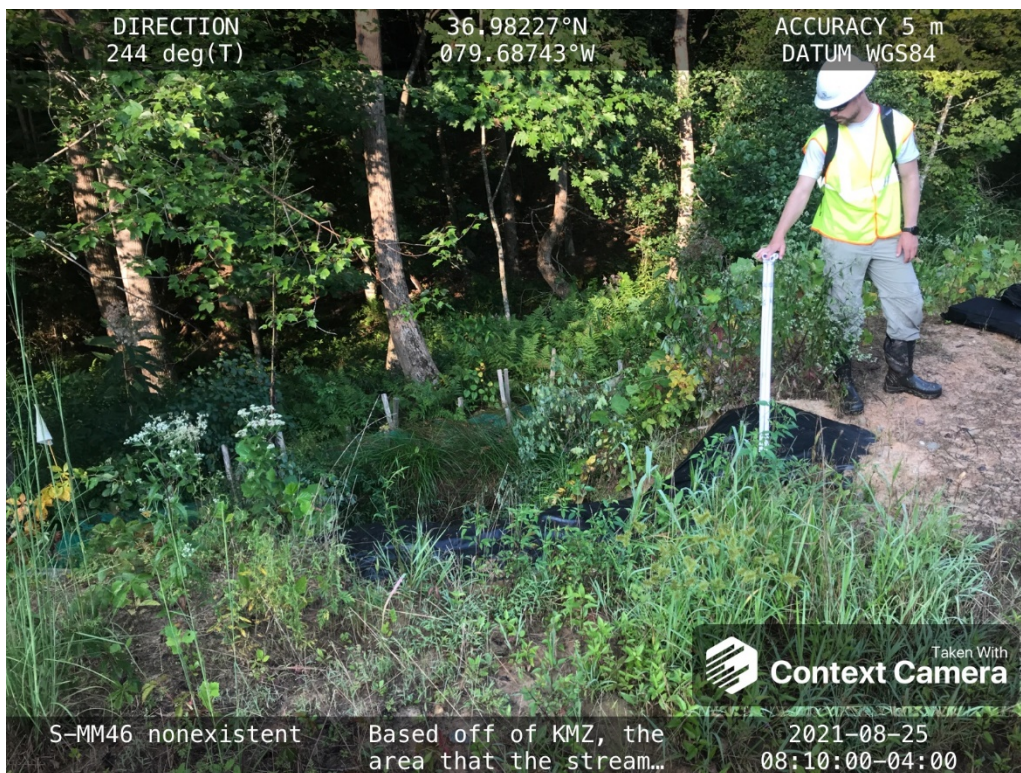
Photo Type: Stream nonexistent
Orientation, Photographer Initials: Looking SW upstream, RAH

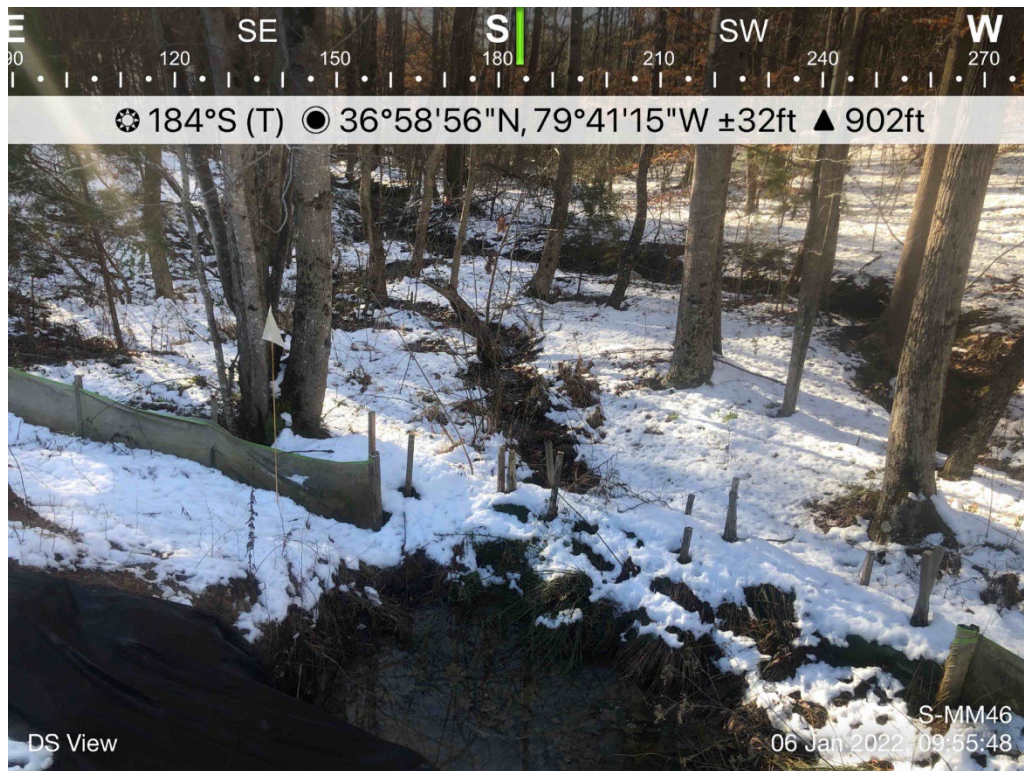
Photo Type: DS VIEW

Location, Orientation, Photographer Initials: Downstream view of ROW looking S, KB

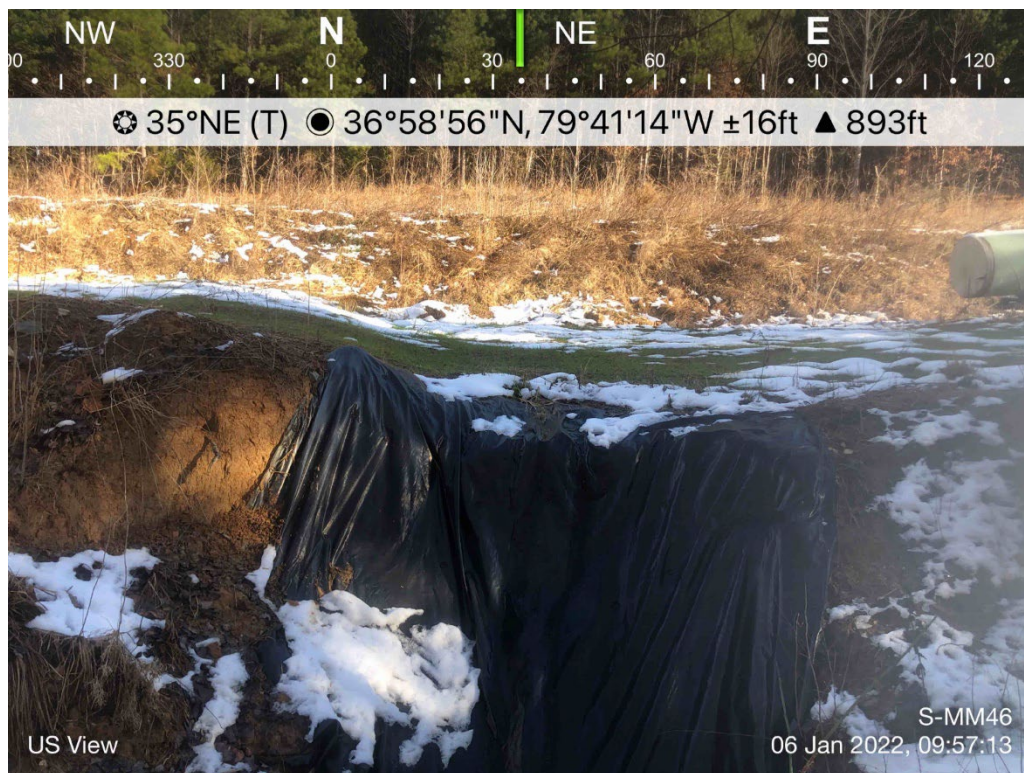
Photo Type: US VIEW

Location, Orientation, Photographer Initials: Upstream view of ROW looking NE, KB.

Note: Fabric was installed to prevent slope failure.

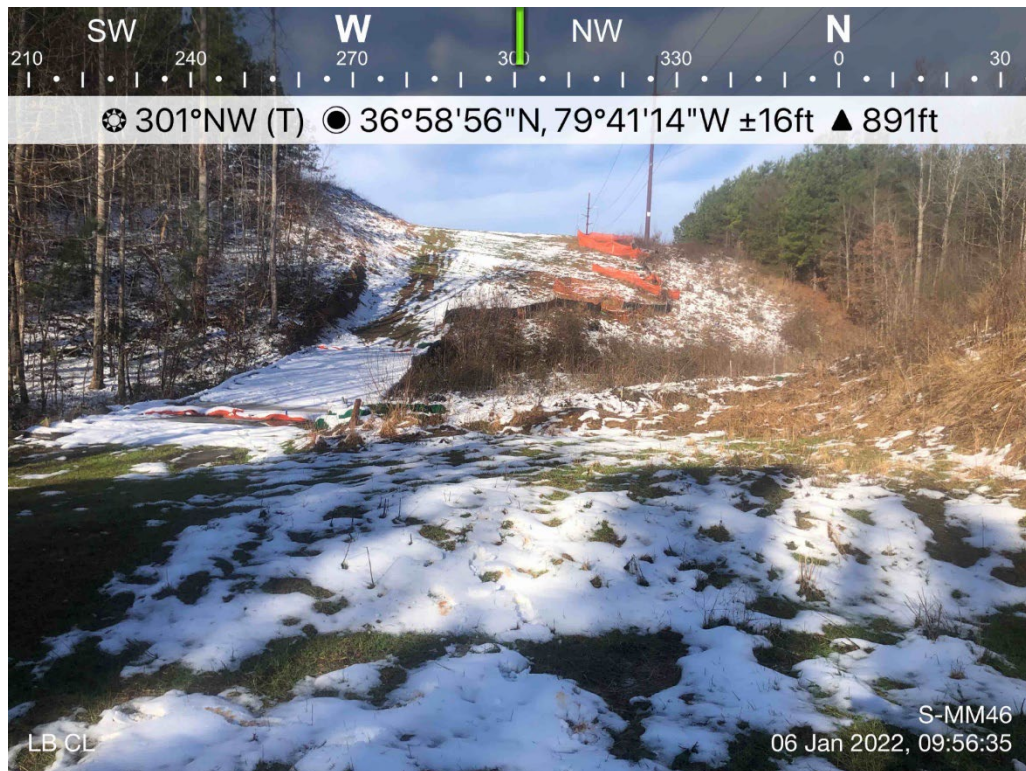
Photo Type: LB CL

Location, Orientation, Photographer Initials: Standing on LB looking at RB along pipe centerline looking N/NW, KB

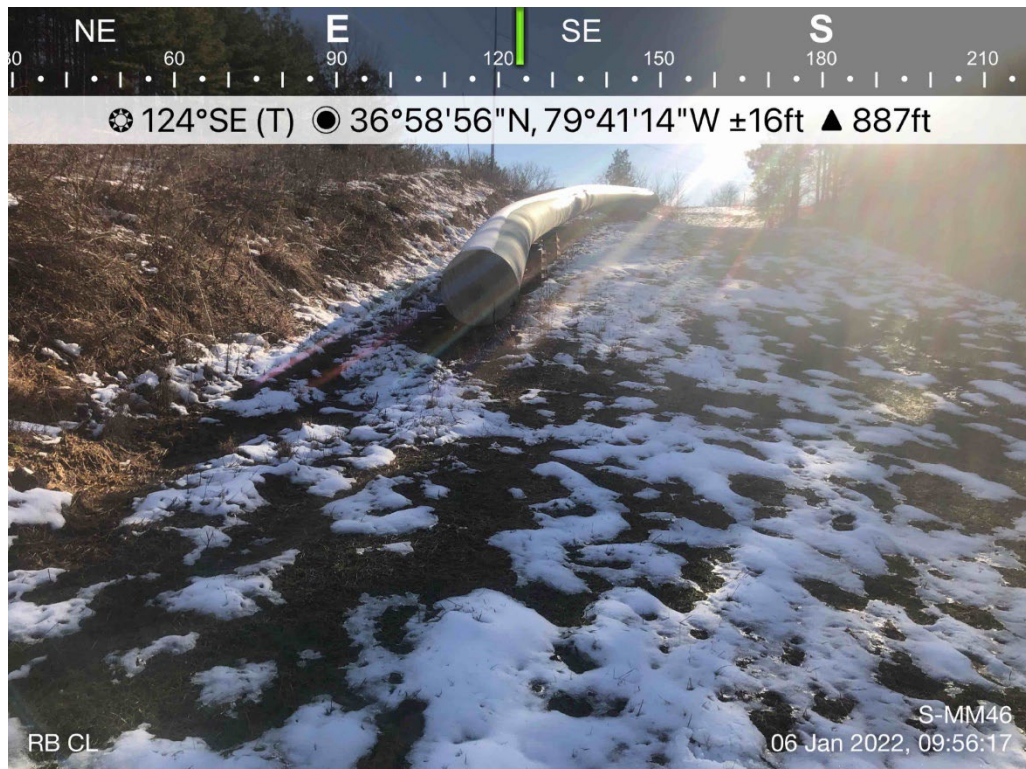
Photo Type: RB CL

Location, Orientation, Photographer Initials: Standing on RB looking at LB along pipe centerline looking SE, KB

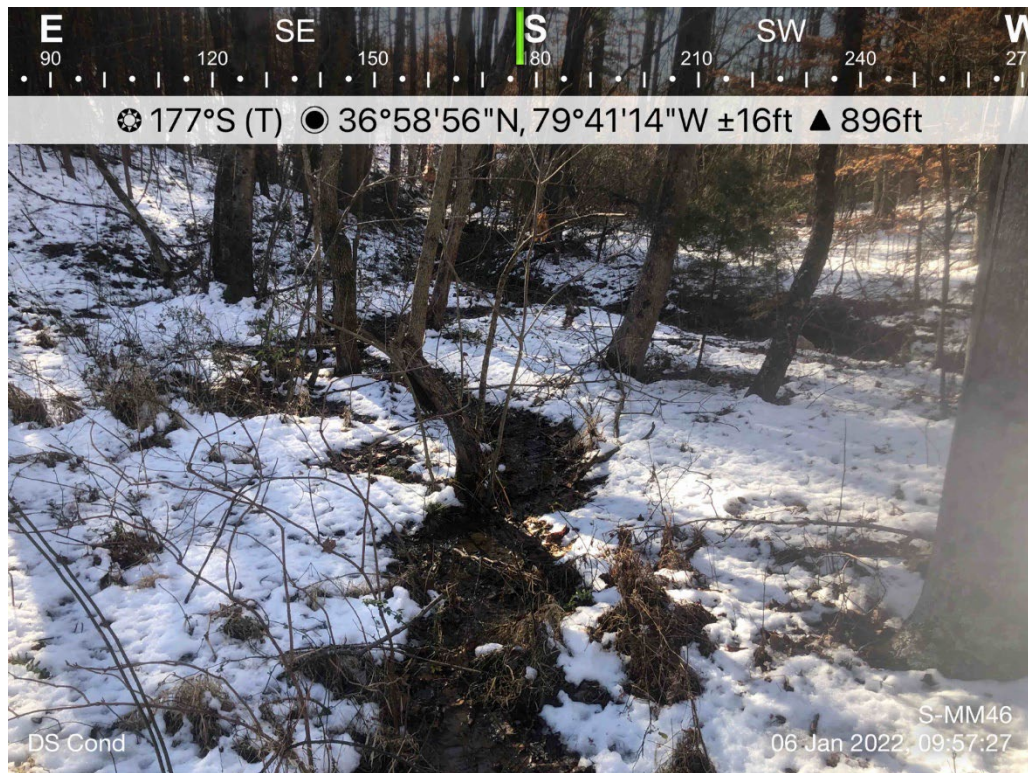
Photo Type: DS COND

Location, Orientation, Photographer Initials: Downstream conditions outside of LOC looking S, KB

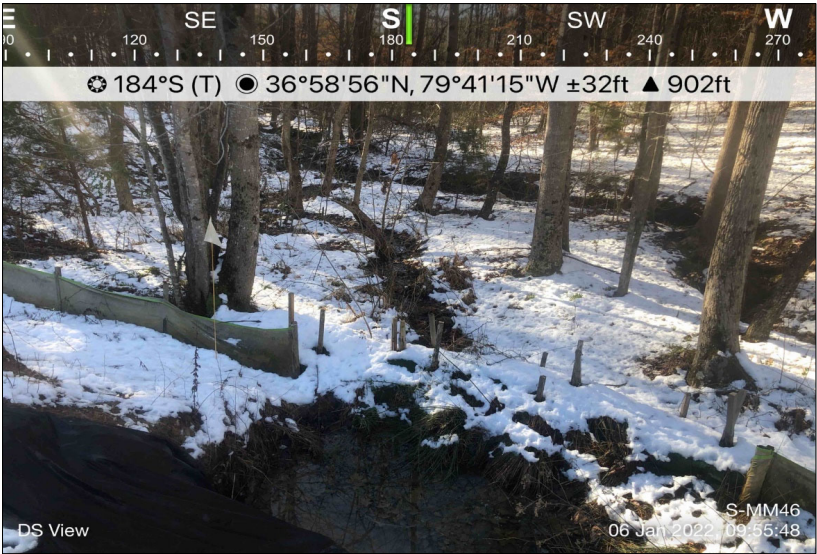
Downstream view of ROW looking S
