Baseline Assessment – Stream Attributes

Reach S-S11 (Temporary Access Road) Perennial Spread I Franklin County, Virginia

Spread I Stream S-S11 (Temporary Access Road) Franklin County

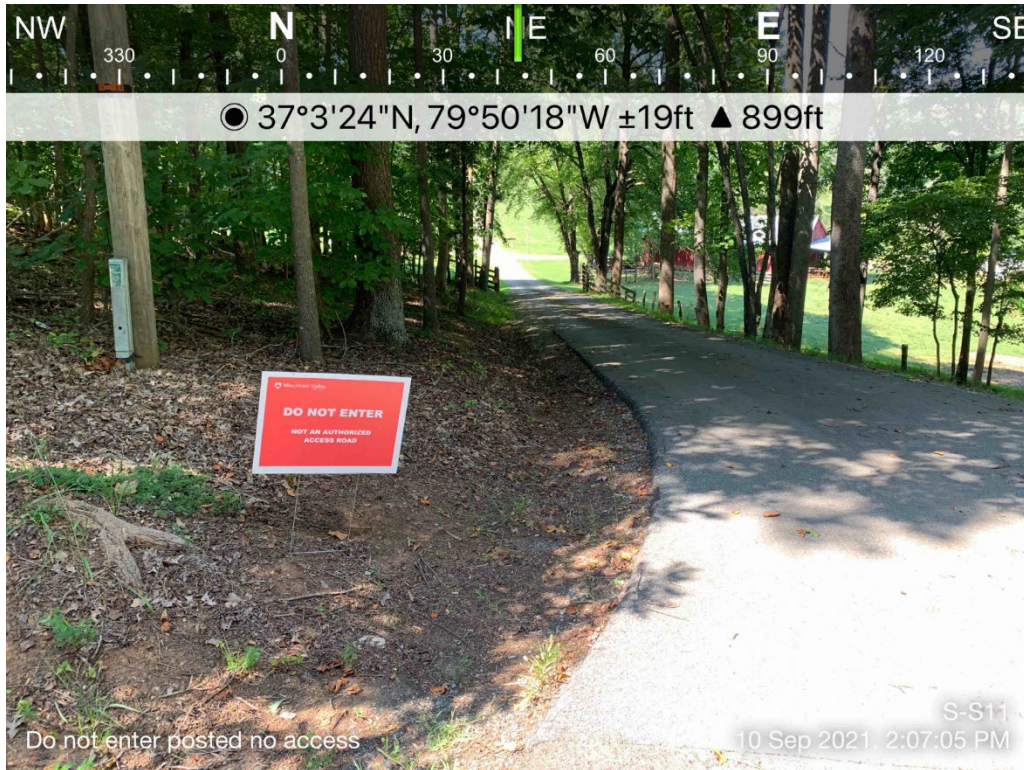
Photo Type: DS VIEW
Franklin County, looking NE at a private driveway, Photographer TT

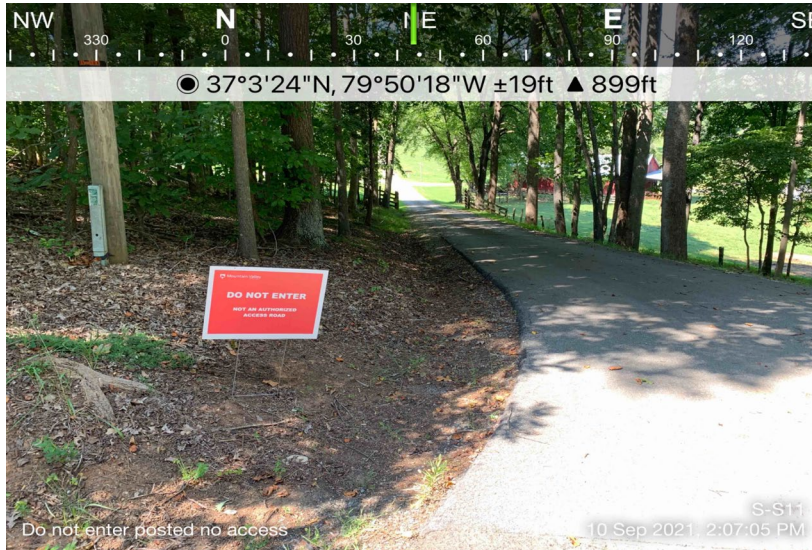
(WSSI Photo Location)

CAPTION. Assessment completed via desktop due to restricted site acces.
