Visual Site Inspection Report

Project Name H-600 Pipeline Spread G		AFE 124300137	Spread H-600 Pipeline Spread G
Contractor Precision		Report # 40506	
Inspector Patrick Shields		Date/Time 8/1/2022 3:48 PM	
Permit # TBD	Inspection Type VA SWPP	Station Begin	10929+80
State VA	Inspection Area Full	Station End	11023+80
County Giles	Ground Wet	Temperature (°F)	77.00
Municipality N/A	Weather Light Rain	Rain Gauge (in)	0.10
			Rain Accumulation Time (days) 1.00

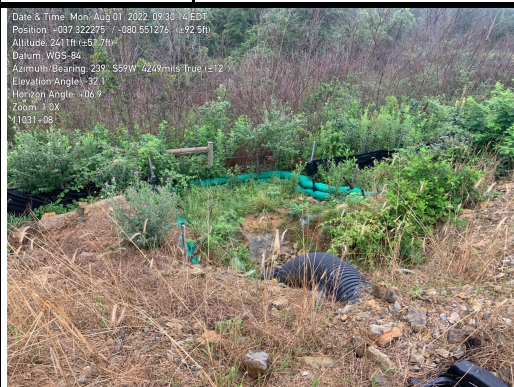
GPS Location	See photo
Field Station#	11031+08
Pic 11 Desc.	Sump pit and perimeter controls are in acceptable condition

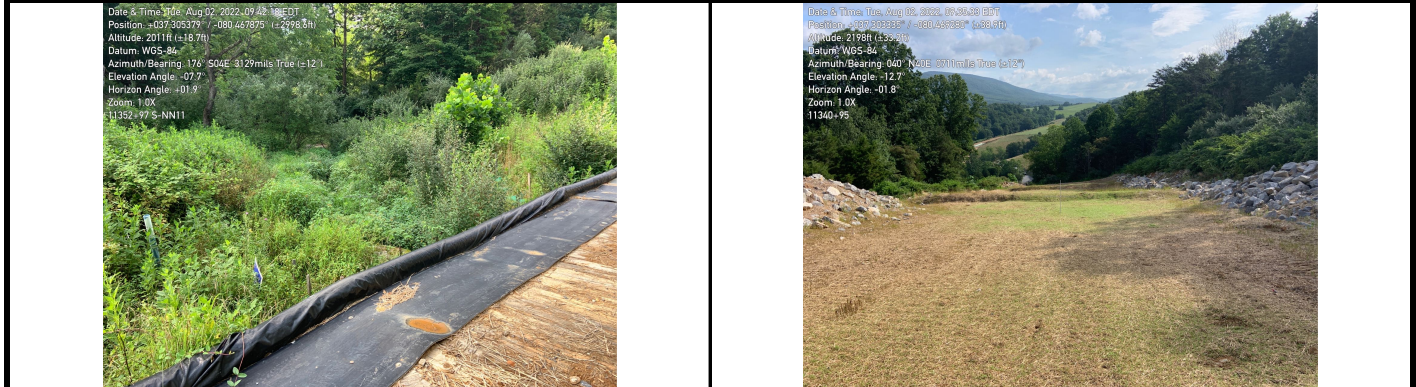
GPS Location	See photo	GPS Location	See photo
Field Station#	11352+97	Field Station#	11340+95
Pic 1 Desc.	S-NN11 looking upstream	Pic 2 Desc.	Section of Row showing conditions and controls

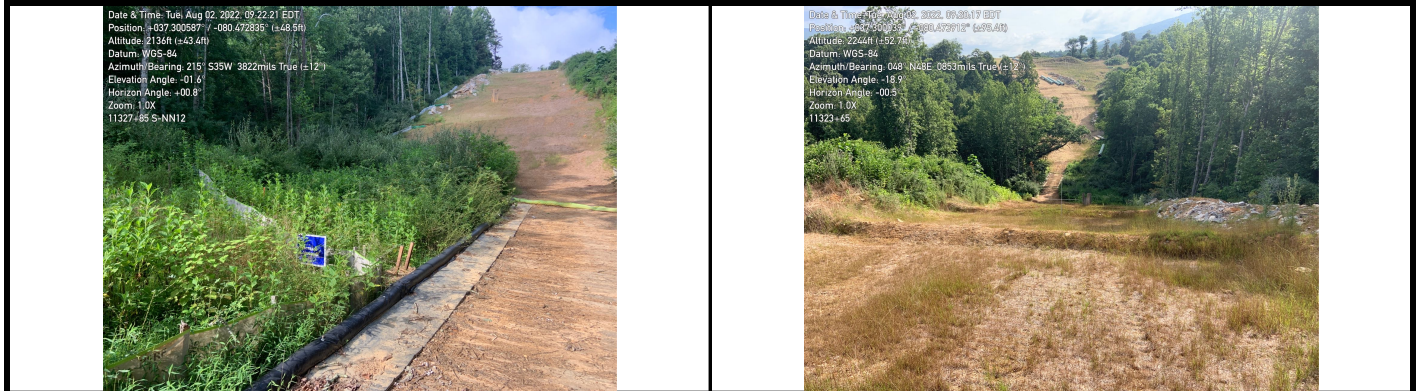
GPS Location	See photo	GPS Location	See photo
Field Station#	11327+85	Field Station#	11323+65
Pic 3 Desc.	S-NN12 looking upstream	Pic 4 Desc.	Section of Row showing conditions and controls

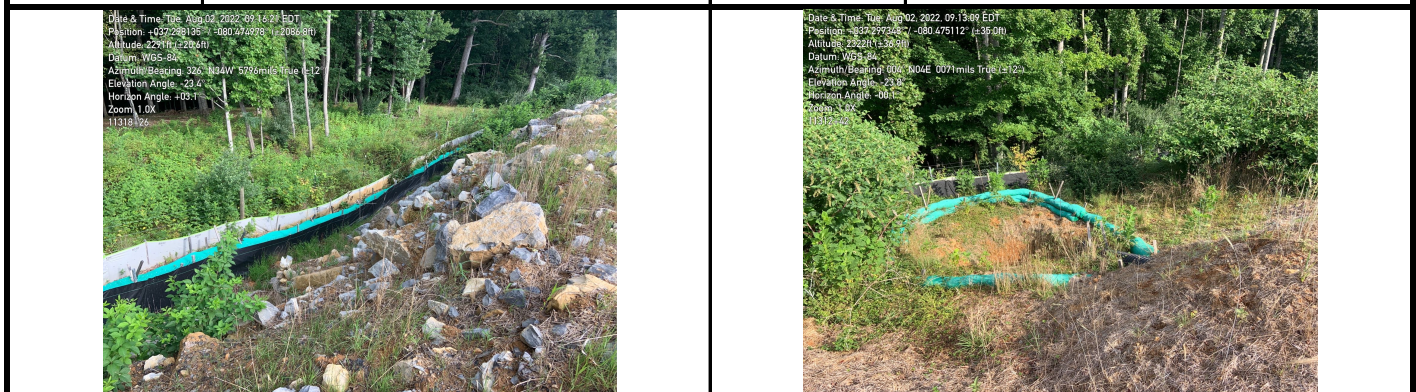
GPS Location	See photo	GPS Location	See photo
Field Station#	11318+26	Field Station#	11312+42
Pic 5 Desc.	Perimeter controls are in acceptable condition	Pic 6 Desc.	Slope drain pipe and sump pit functional

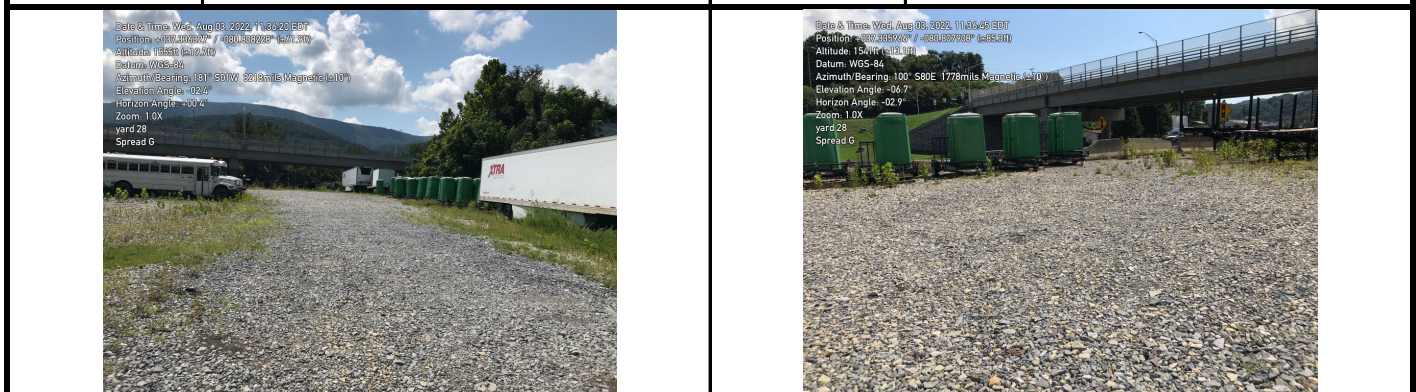
GPS Location	see photo	GPS Location	see photo
Field Station#	12005+00	Field Station#	12005+00
Pic 5 Desc.	Equipment in yard, no leaks	Pic 6 Desc.	Stacked equipment

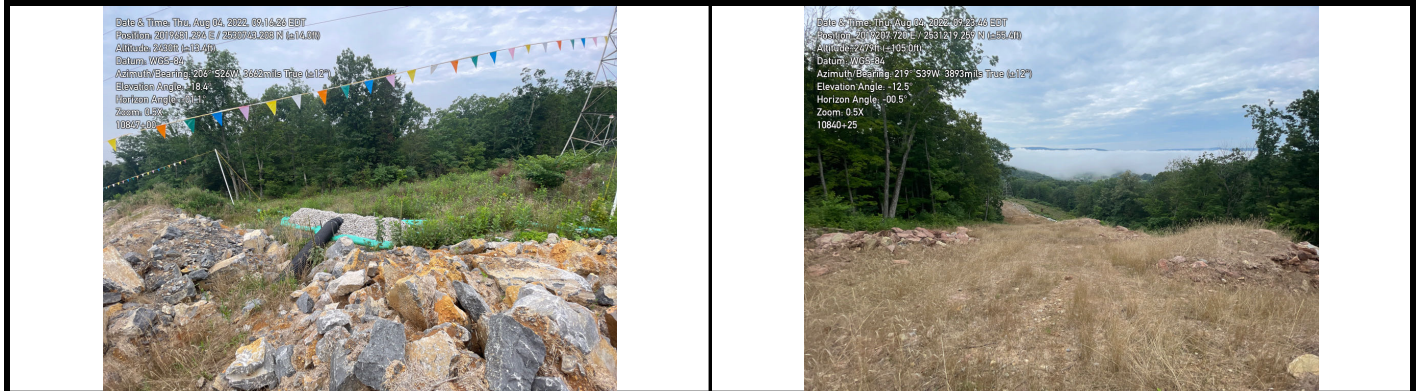
GPS Location	3	GPS Location	4
Field Station#	10847+00	Field Station#	10840+25
Pic 3 Desc.	CWDP outlet protection functional.	Pic 4 Desc.	Section of RoW showing conditions and controls.

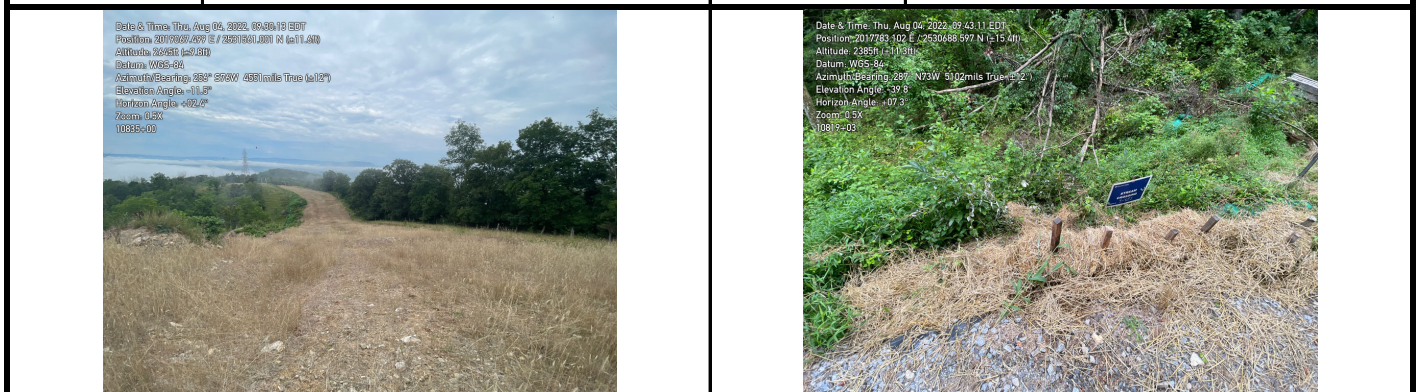
GPS Location	5	GPS Location	6
Field Station#	10835+00	Field Station#	10819+03
Pic 5 Desc.	Section of RoW showing conditions and controls.	Pic 6 Desc.	Repaired punch list item from 8/2/22.

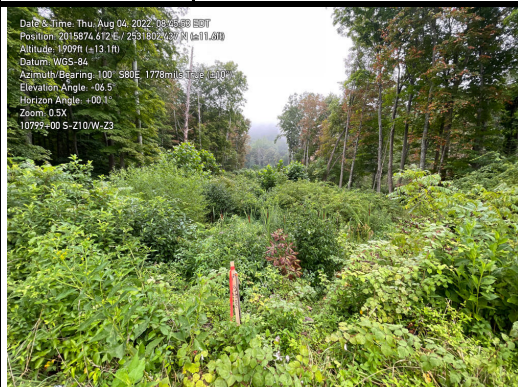
GPS Location	11	GPS Location	12		
Field Station#	10799+00	Field Station#	10819+03		
Pic 11 Desc.	S-Z10/W-Z3.		Pic 12 Desc.	Crews upgrading single 12" CFS to triple 12" CFS along AR 241.03.
