# Visual Site Inspection Report

<b>Project Name</b> H-600 Pipeline Spread G		<b>AFE</b> 124300137	<b>Spread</b> H-600 Pipeline Spread G
<b>Contractor</b> Precision		<b>Report #</b> 40994	
<b>Inspector</b> Eric Hanlon		<b>Date/Time</b> 8/15/2022 6:54 AM	
<b>Permit #</b> TBD	<b>Inspection Type</b> VA SWPP	<b>Station Begin</b> 11899+89	
<b>State</b> VA	<b>Inspection Area</b> Full	<b>Station End</b> 12005+00	
<b>County</b> Giles	<b>Ground</b> Wet	<b>Temperature (°F)</b> 65.00	
<b>Municipality</b> N/A	<b>Weather</b> Heavy Rain	<b>Rain Gauge (in)</b> 0.50	
			<b>Rain Accumulation Time (days)</b> 1.00

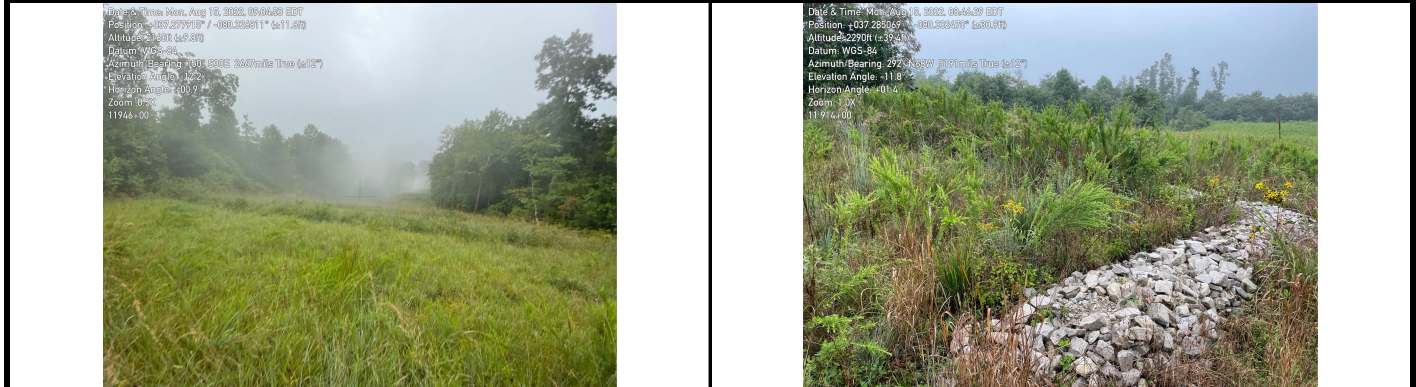
<b>GPS Location</b>	See photo	<b>GPS Location</b>	See photo
<b>Field Station#</b>	11956+00	<b>Field Station#</b>	11914+00
<b>Pic 1 Desc.</b>	Picture showing condition of row	<b>Pic 2 Desc.</b>	Permanent water bars and level spreader

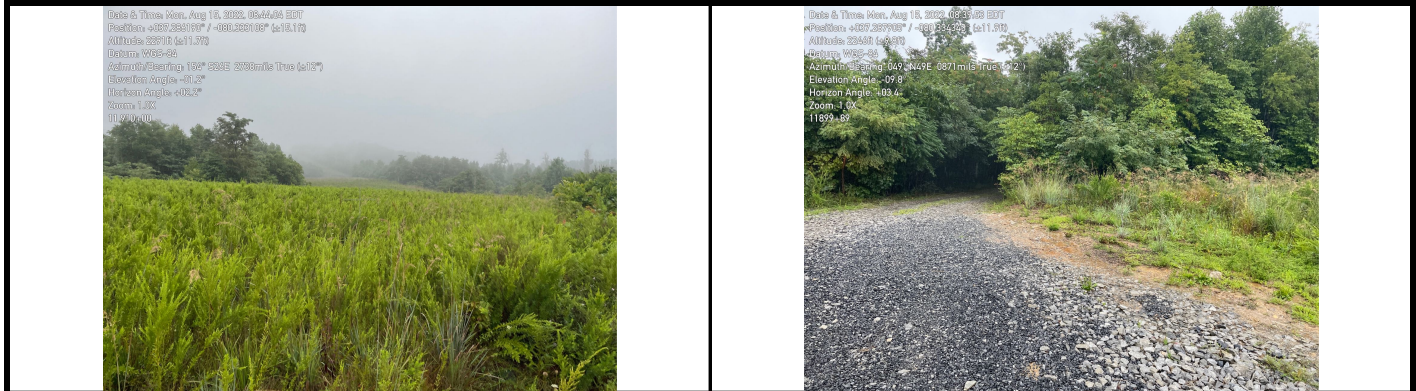
<b>GPS Location</b>	See photo	<b>GPS Location</b>	See photo
<b>Field Station#</b>	11910+00	<b>Field Station#</b>	11899+89
<b>Pic 3 Desc.</b>	Stabilization in place	<b>Pic 4 Desc.</b>	RCE functional

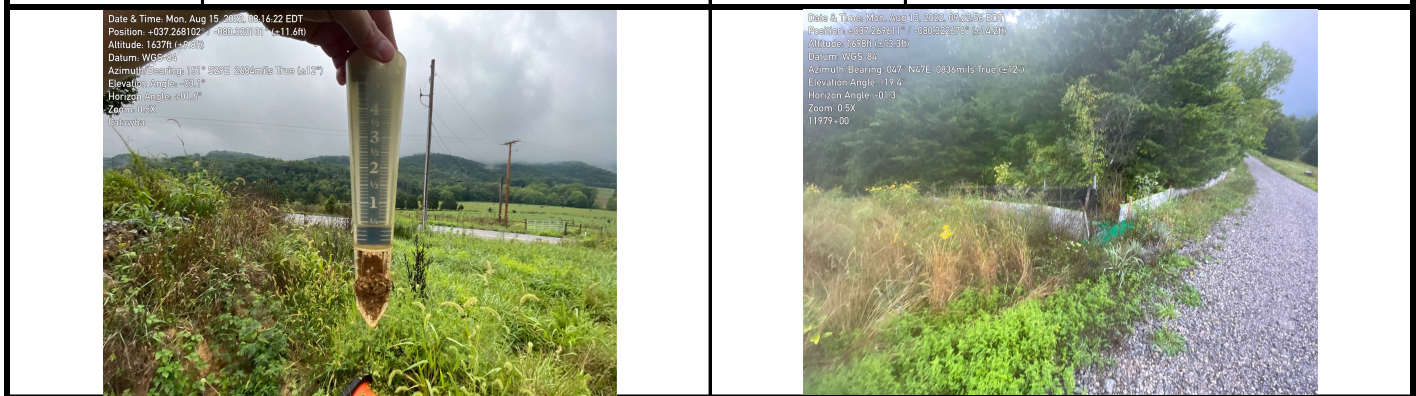
<b>GPS Location</b>	See photo	<b>GPS Location</b>	See photo
<b>Field Station#</b>	11978+54	<b>Field Station#</b>	11979+00
<b>Pic 5 Desc.</b>	Rain gauge	<b>Pic 6 Desc.</b>	Picture showing condition of row

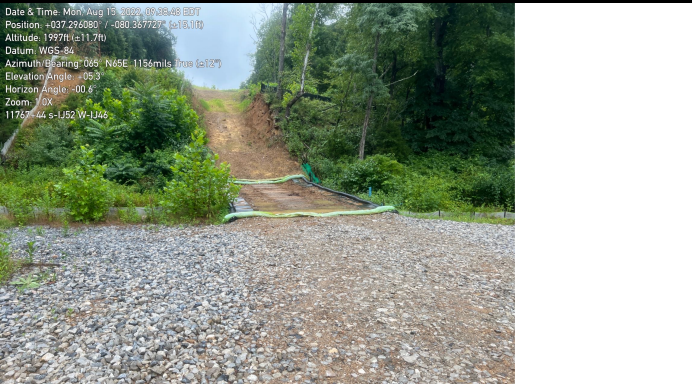
<b>GPS Location</b>	See Photo	<b>GPS Location</b>	See Photo		
<b>Field Station#</b>	11757+00	<b>Field Station#</b>	11767+44		
<b>Pic 9 Desc.</b>	Section of Row showing conditions and controls	<b>Pic 10 Desc.</b>	RCE S-IJ52 W-IJ46

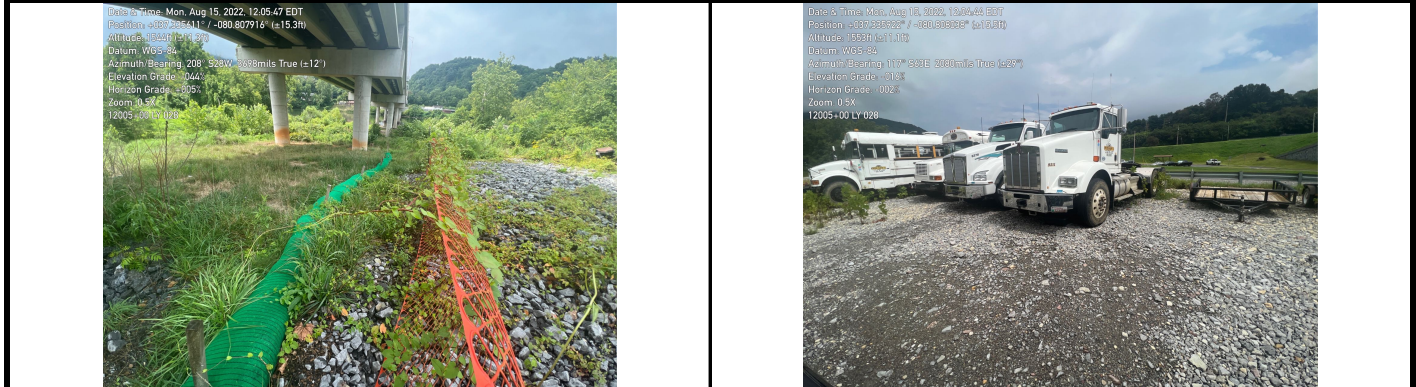
<b>GPS Location</b>	See photo	<b>GPS Location</b>	See photo
<b>Field Station#</b>	12005+00	<b>Field Station#</b>	12005+00
<b>Pic 1 Desc.</b>	Perimeter CFS and RCE condition.	<b>Pic 2 Desc.</b>	Haul trucks, Transit busses, and utility trailer found without leaks at time of inspection.

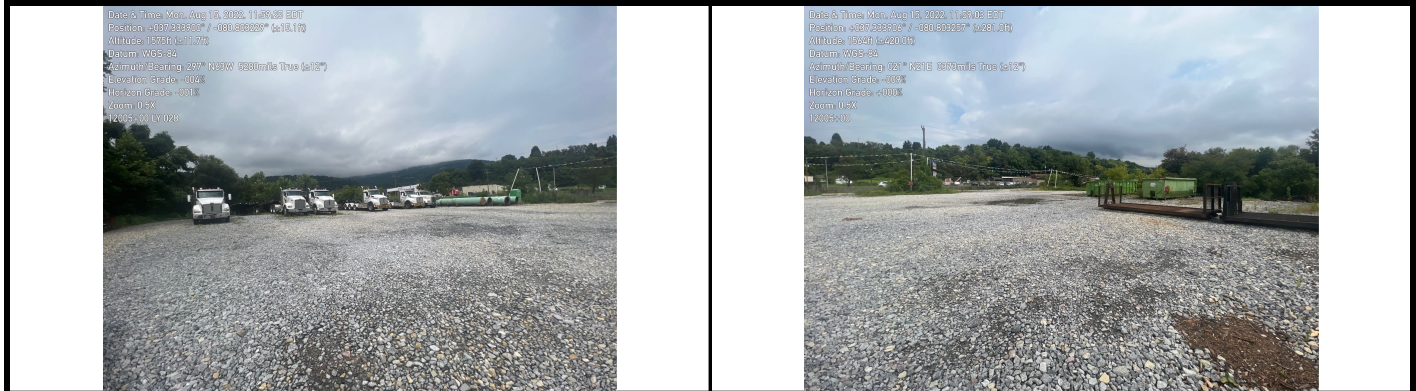
<b>GPS Location</b>	See photo	<b>GPS Location</b>	See photo
<b>Field Station#</b>	12005+00	<b>Field Station#</b>	12005+00
<b>Pic 3 Desc.</b>	Truck parking and storage area. No issues at the time of inspection	<b>Pic 4 Desc.</b>	RCE and Trash receptacle area.

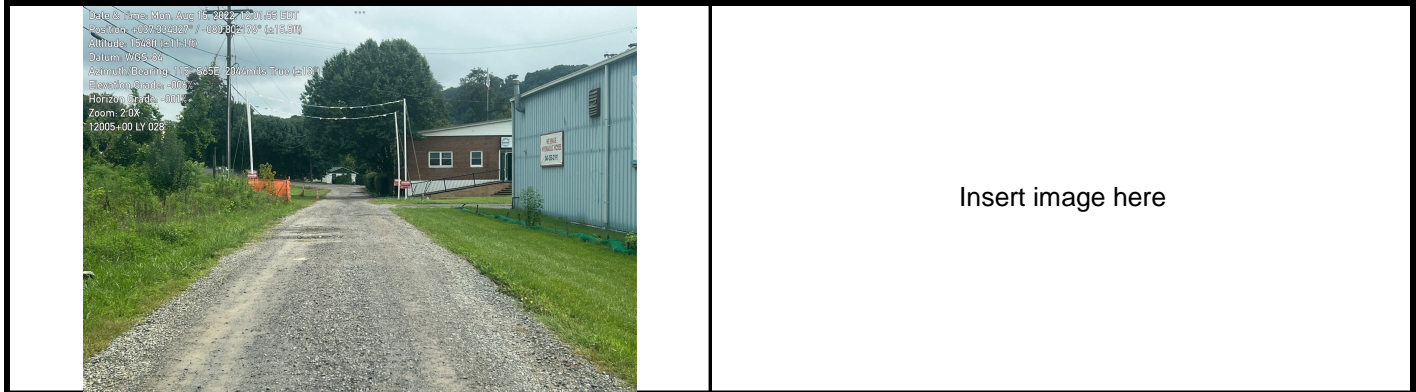
<b>GPS Location</b>	See photo	<b>GPS Location</b>	
<b>Field Station#</b>	12005+00	<b>Field Station#</b>	
<b>Pic 5 Desc.</b>	RCE to LY 28. Perimeter CFS and ECDs found functional.	<b>Pic 6 Desc.</b>

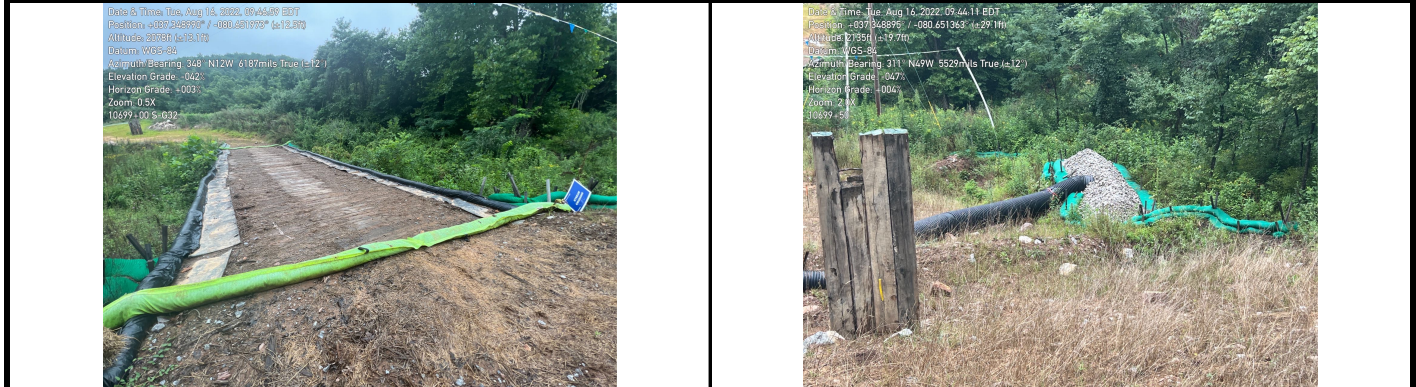
<b>GPS Location</b>	See photo	<b>GPS Location</b>	See photo
<b>Field Station#</b>	10699+00	<b>Field Station#</b>	10699+50
<b>Pic 1 Desc.</b>	S-G32 stream resource area and equipment bridge conditions. No Issues at this time.	<b>Pic 2 Desc.</b>	TLS conditions.

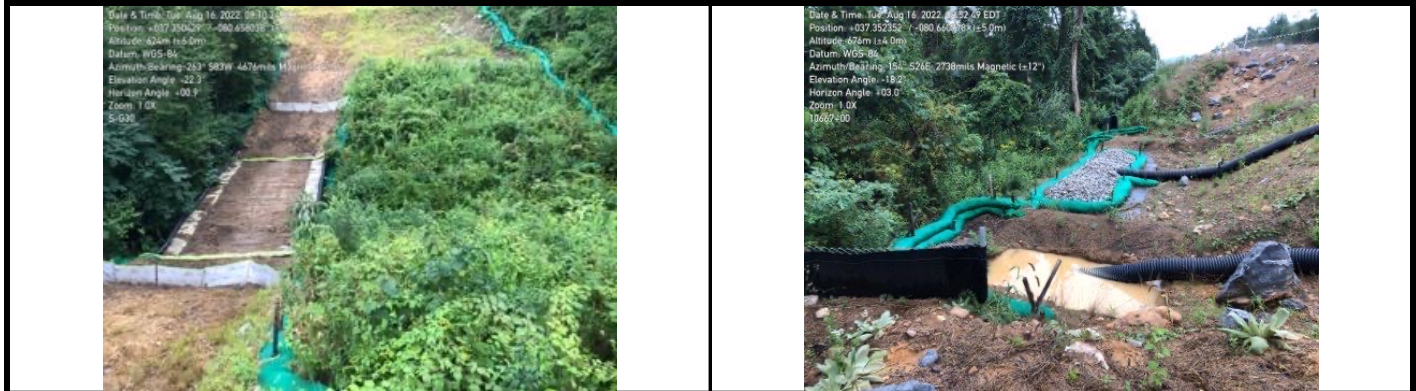
<b>GPS Location</b>	See photo	<b>GPS Location</b>	See photo
<b>Field Station#</b>	10679+36	<b>Field Station#</b>	10667+00
<b>Pic 3 Desc.</b>	Over view of well vegetated stream resource of S-G30	<b>Pic 4 Desc.</b>	TLS and storm water filled sump pits.

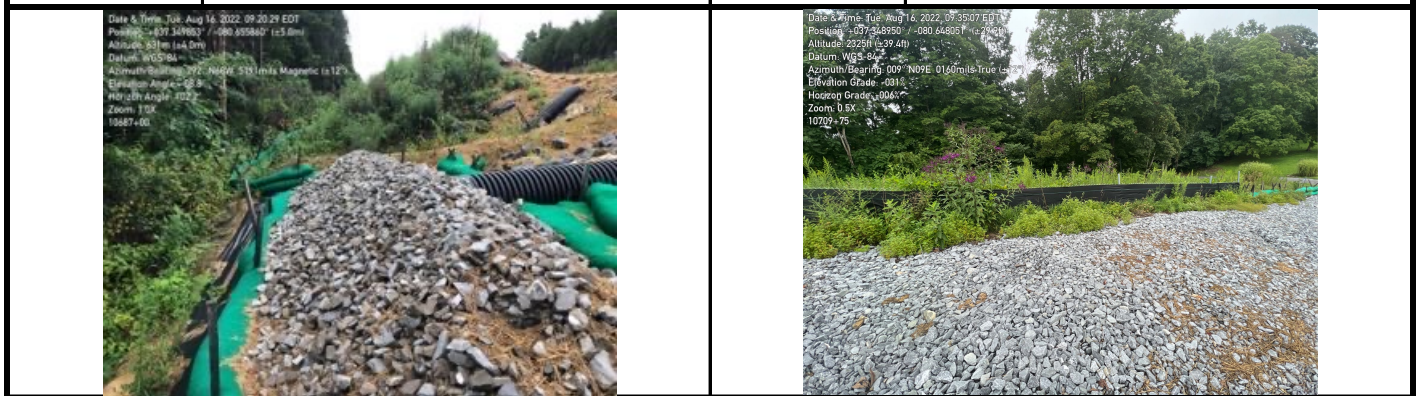
<b>GPS Location</b>	See photo	<b>GPS Location</b>	See photo
<b>Field Station#</b>	10687+00	<b>Field Station#</b>	10709+75
<b>Pic 5 Desc.</b>	TLS conditions.	<b>Pic 6 Desc.</b>	Perimeter super silt fence condition. No Issues.

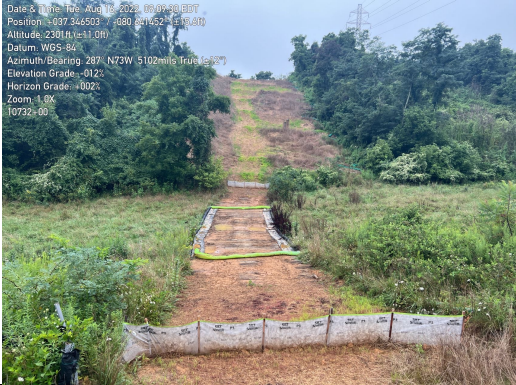
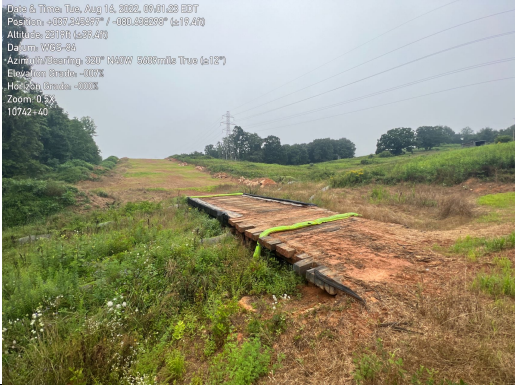
<b>GPS Location</b>	See photo	<b>GPS Location</b>	See photo		
<b>Field Station#</b>	10732+00	<b>Field Station#</b>	10742+40		
<b>Pic 13 Desc.</b>	Over view of the W-Z11 wetland conditions. No disturbances and no issues.	<b>Pic 14 Desc.</b>	View of well vegetated drainage feature.

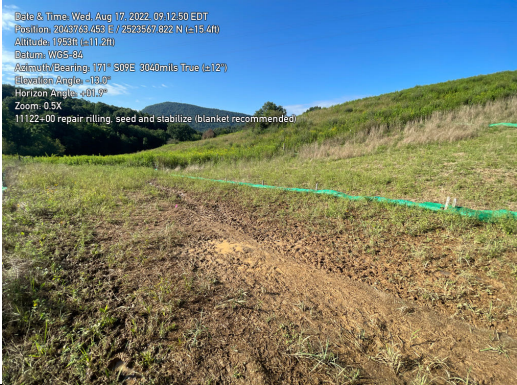
<p><small>Date &amp; Time: Wed Aug 17, 2022, 09:12:50 EDT Position: 2042373.485 E / 2523567.822 N (e15.4M) Altitude: 1939ft (e11.2M) Datum: WGS-84 Azimuth/Bearing: 171° S09E 3840mils True (e12°) Elevation Angle: -18.0° Horizon Angle: -80.0° Zoom: 0.5X 11122+00 repair rilling, seed and stabilize (blanket recommended)</small></p>

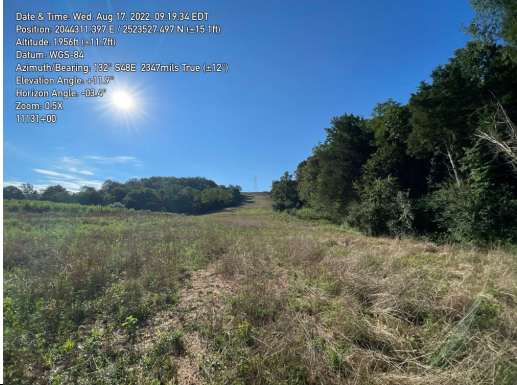
<p><small>Date &amp; Time: Wed Aug 17, 2022, 09:19:34 EDT Position: 2044211.337 E / 2523527.697 N (e15.1M) Altitude: 1934ft (e11.0M) Datum: WGS-84 Azimuth/Bearing: 132° S28E 2347mils True (e12°) Elevation Angle: -11.9° Horizon Angle: -82.6° Zoom: 0.5X 11131+00</small></p>		
<b>GPS Location</b>	7	<b>GPS Location</b>	8	<b>Field Station#</b>	11122+00
<b>Field Station#</b>	11122+00	<b>Field Station#</b>	11131+00	<b>Pic 7 Desc.</b>	Punch list item, repair rilling, seed and stabilize.
<b>Pic 7 Desc.</b>	Punch list item, repair rilling, seed and stabilize.	<b>Pic 8 Desc.</b>	Section of restored RoW showing conditions and controls.

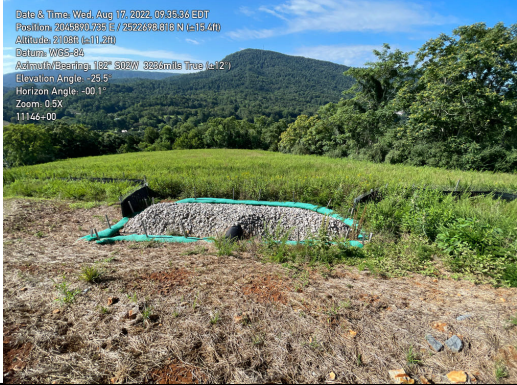
<p><small>Date &amp; Time: Wed Aug 17, 2022, 09:35:06 EDT Position: 2045530.235 E / 2523938.818 N (e15.4M) Altitude: 2108ft (e11.2M) Datum: WGS-84 Azimuth/Bearing: 132° S09W 3936mils True (e12°) Elevation Angle: -20.5° Horizon Angle: -80.1° Zoom: 0.5X 11146+00</small></p>		
<b>GPS Location</b>	9	<b>GPS Location</b>	10	<b>Field Station#</b>	11139+00
<b>Field Station#</b>	11139+00	<b>Field Station#</b>	11146+00	<b>Pic 9 Desc.</b>	Section of restored RoW showing conditions and controls.
<b>Pic 9 Desc.</b>	Section of restored RoW showing conditions and controls.	<b>Pic 10 Desc.</b>	CWDP outlet protection functional.

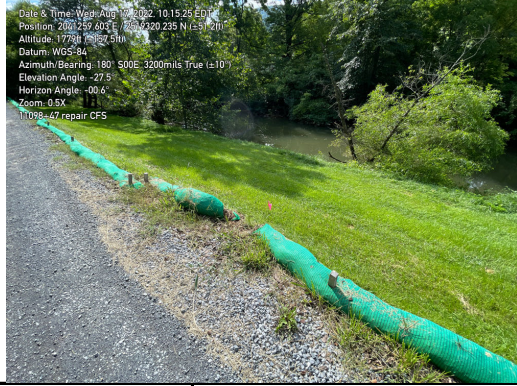
<p><small>Date &amp; Time: Wed Aug 17, 2022, 10:15:25 EDT Position: 2007257.803 E / 2521920.235 N (e15.2M) Altitude: 1773ft (e1.51M) Datum: WGS-84 Azimuth/Bearing: 180° S00E 3200mils True (e10°) Elevation Angle: -27.5° Horizon Angle: -80.6° Zoom: 0.5X 11098+47 repair CFS</small></p>

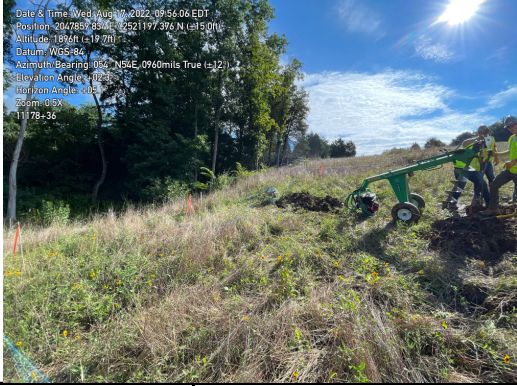
<p><small>Date &amp; Time: Wed Aug 17, 2022, 09:56:08 EDT Position: 2047837.342 E / 2521197.376 N (e15.0M) Altitude: 1934ft (e11.0M) Datum: WGS-84 Azimuth/Bearing: 052° N34E 0940mils True (e12°) Elevation Angle: -07.3° Horizon Angle: -66.6° Zoom: 0.5X 11178+36</small></p>		
<b>GPS Location</b>	11	<b>GPS Location</b>	12	<b>Field Station#</b>	11098+47
<b>Field Station#</b>	11098+47	<b>Field Station#</b>	11178+36	<b>Pic 11 Desc.</b>	Representative photo of damaged CFS along AR 245.02.
<b>Pic 11 Desc.</b>	Representative photo of damaged CFS along AR 245.02.	<b>Pic 12 Desc.</b>	Crews installing temporary anode bed.

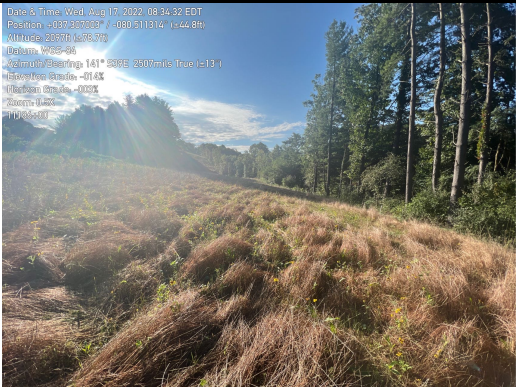
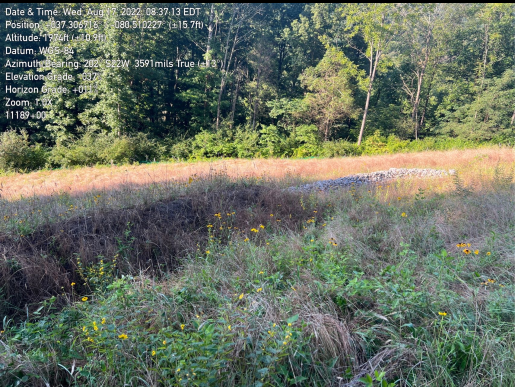
<b>GPS Location</b>	See photo	<b>GPS Location</b>	see photo		
<b>Field Station#</b>	11186+00	<b>Field Station#</b>	11189+00		
<b>Pic 1 Desc.</b>	Heavy vegetation in final restoration area.	<b>Pic 2 Desc.</b>	Heavy vegetated permanent water bar and functional level spreader. Adequate vegetation coverage of row.

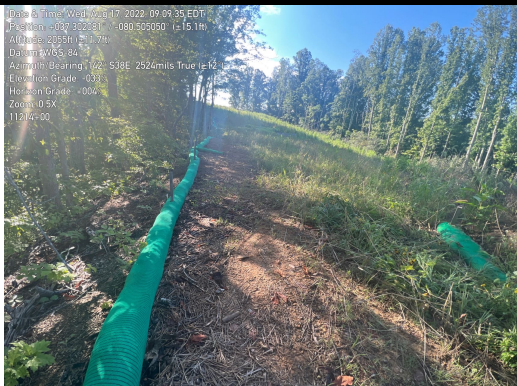
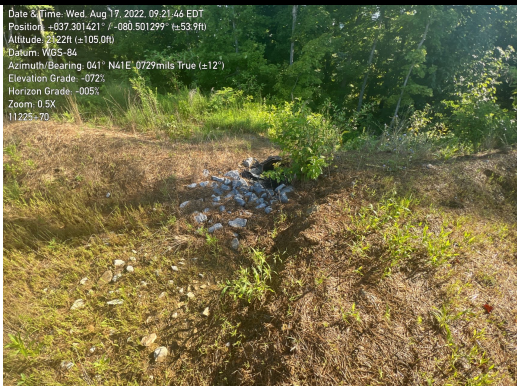
<b>GPS Location</b>	See photo	<b>GPS Location</b>	See photo
<b>Field Station#</b>	11214+00	<b>Field Station#</b>	11225+70
<b>Pic 9 Desc.</b>	Area of no permanent vegetation. This has been added to the punch list. (PL 8/17/22)	<b>Pic 10 Desc.</b>	Stone inlet protection condition in the temporary restored row.

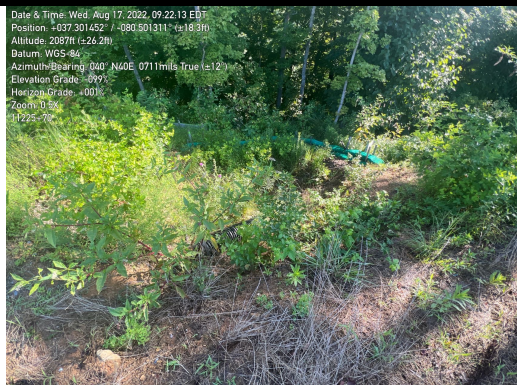
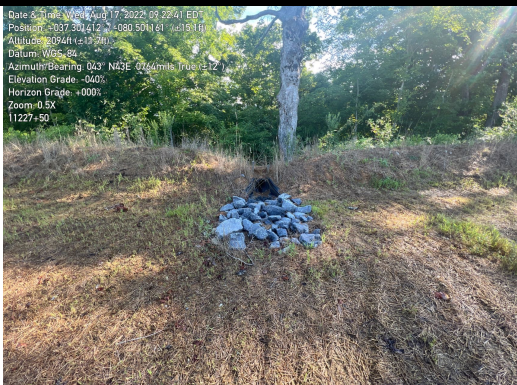
<b>GPS Location</b>	See photo	<b>GPS Location</b>	See photo
<b>Field Station#</b>	11225+70	<b>Field Station#</b>	11227+50
<b>Pic 11 Desc.</b>	Slope drain pipe leading to functional sump pit.	<b>Pic 12 Desc.</b>	Adequate Stone inlet protection.

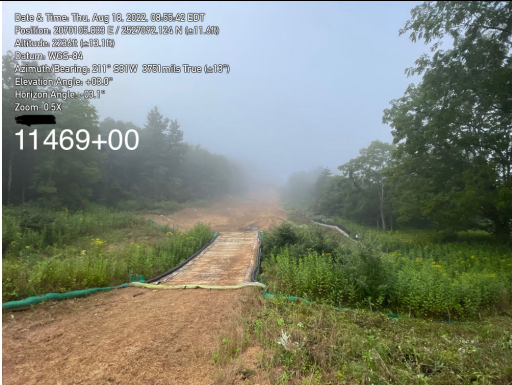
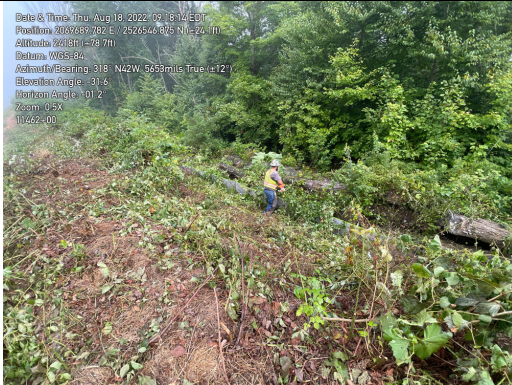
<b>GPS Location</b> 1		<b>GPS Location</b> 2			
<b>Field Station#</b> 11469+00		<b>Field Station#</b> 11462+00			
<b>Pic 1 Desc.</b> Section of RoW showing conditions and controls.		<b>Pic 2 Desc.</b> Crews performing vegetative maintenance.

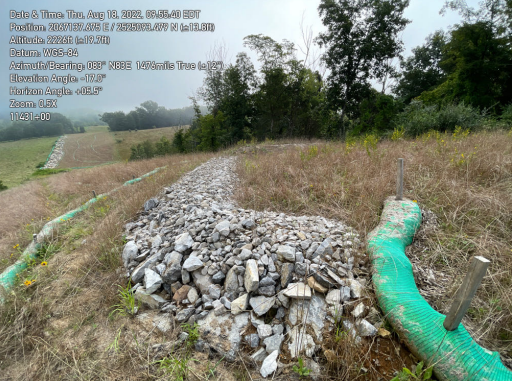
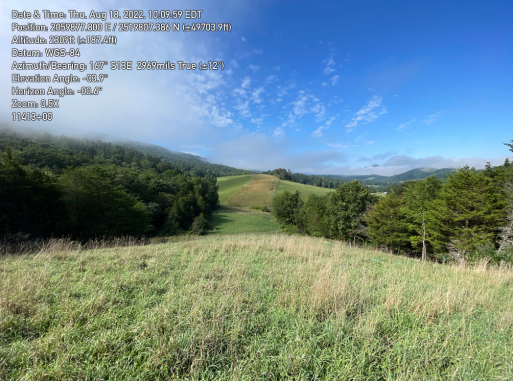
<b>GPS Location</b> 7		<b>GPS Location</b> 8			
<b>Field Station#</b> 11431+00		<b>Field Station#</b> 11413+00			
<b>Pic 7 Desc.</b> Representative photo of permanent waterbar and level spreaders installed.		<b>Pic 8 Desc.</b> Section of restored RoW showing conditions and controls.

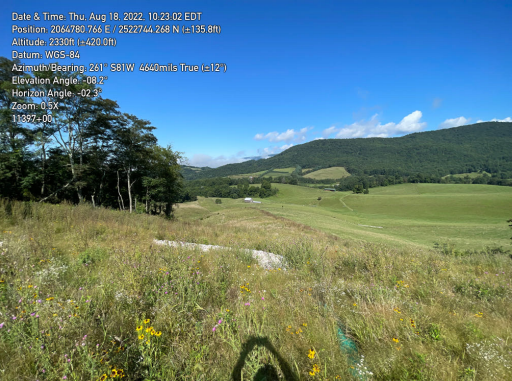
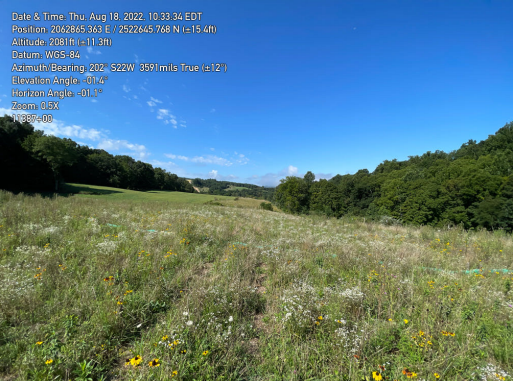
<b>GPS Location</b> 9		<b>GPS Location</b> 10			
<b>Field Station#</b> 11397+00		<b>Field Station#</b> 11387+00			
<b>Pic 9 Desc.</b> Section of restored RoW showing conditions and controls.		<b>Pic 10 Desc.</b> Section of restored RoW showing conditions and controls.

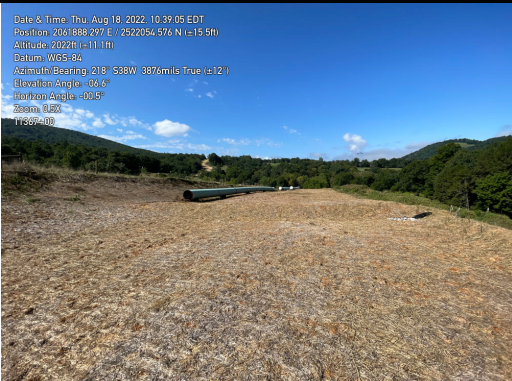
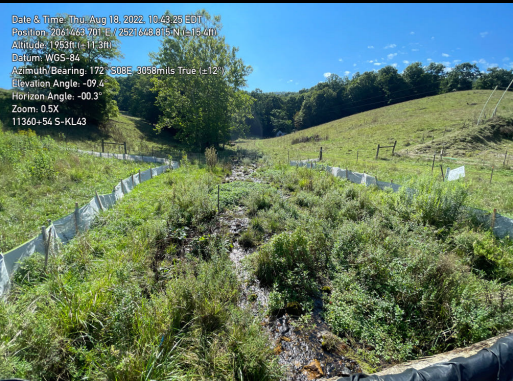
<b>GPS Location</b> 11		<b>GPS Location</b> 12			
<b>Field Station#</b> 11367+00		<b>Field Station#</b> 11360+54			
<b>Pic 11 Desc.</b> Section of RoW showing conditions and controls.		<b>Pic 12 Desc.</b> S-KL43.

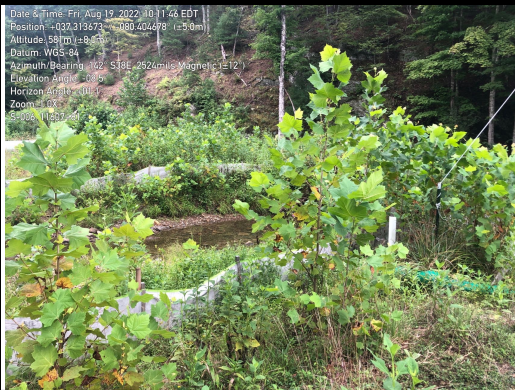
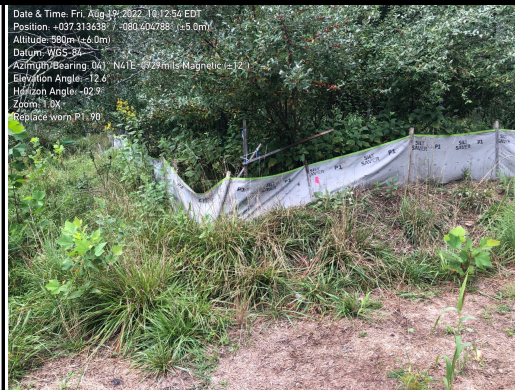
<b>GPS Location</b>	On photo
<b>Field Station#</b>	11607+81
<b>Pic 9 Desc.</b>	The S-006 crossing is stable.
