Visual Site Inspection Report

Project Name H-600 Pipeline Spread G		AFE 124300137	Spread H-600 Pipeline Spread G
Contractor Precision		Report # 40724	
Inspector Joe Sweeden		Date/Time 8/8/2022 6:53 AM	
Permit # TBD	Inspection Type VA SWPP	Station Begin 11254+99	
State VA	Inspection Area Partial	Station End 11353+67	
County Giles	Ground Wet	Temperature (°F) 80.00	
Municipality N/A	Weather Cloudy	Rain Gauge (in) 0.40	
			Rain Accumulation Time (days) 1.00

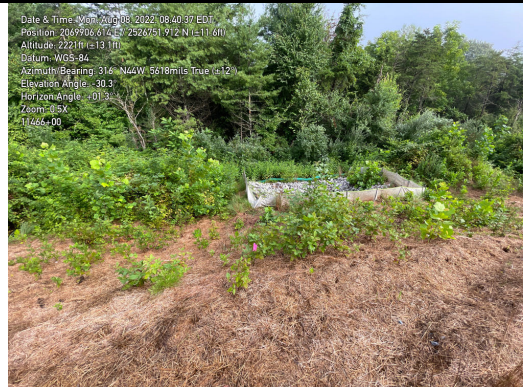
GPS Location	1		GPS Location	2	
Field Station#	11469+00		Field Station#	11466+00	
Pic 1 Desc.	Section of RoW showing conditions and controls.		Pic 2 Desc.	Repair P-1.

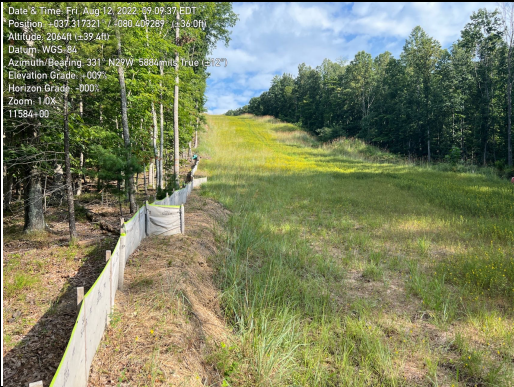
GPS Location	See photo
Field Station#	11584+00
Pic 7 Desc.	Perimeter P1 silt fencing condition. Temporary stabilization of row condition.

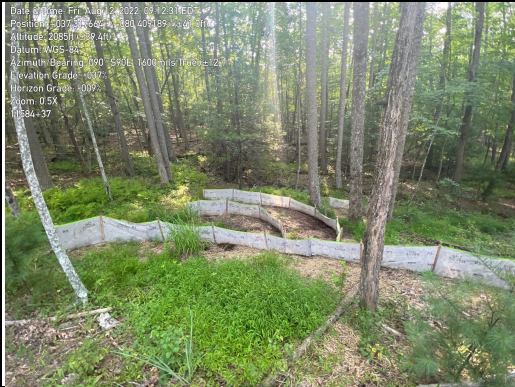
GPS Location	See photo
Field Station#	11584+37
Pic 8 Desc.	P1 silt fencing condition.

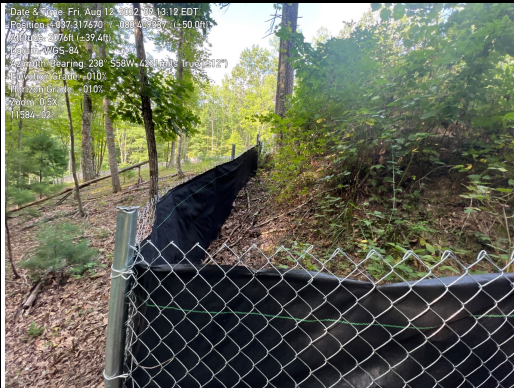
GPS Location	See photo
Field Station#	11584+02
Pic 9 Desc.	(Reinforced) Super silt fence condition.

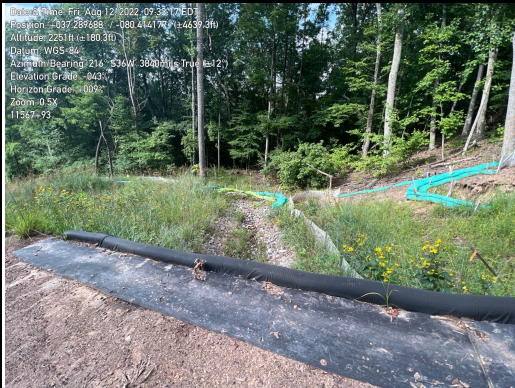
GPS Location	See photo
Field Station#	11567+93
Pic 10 Desc.	S-PP22 Stream bed flow path. Vegetated buffer zones adequately protected with functional ECDs.

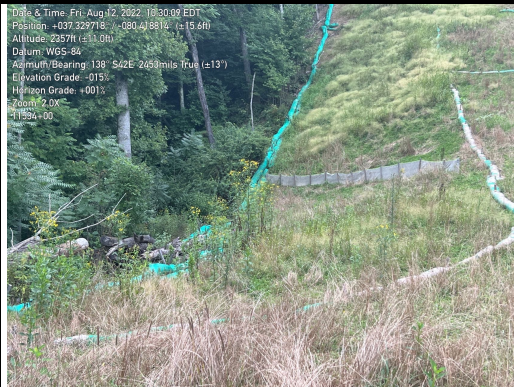
GPS Location	See photo
Field Station#	11534+00
Pic 11 Desc.	Perimeter CFS and P1 silt fencing found functional.

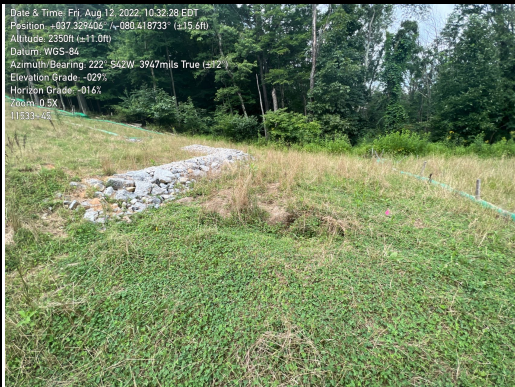
GPS Location	See photo
Field Station#	11533+45
Pic 12 Desc.	Small subsidence area below permanent level spreader over ditch line. Approximate area 3'x3'x1'.
