# Visual Site Inspection Report

<b>Project Name</b> H-600 Pipeline Spread H		<b>AFE</b> 124300138	<b>Spread</b> H-600 Pipeline Spread H
<b>Contractor</b> Precision		<b>Report #</b> 40516	
<b>Inspector</b> Jonathan Altizer		<b>Date/Time</b> 8/1/2022 3:21 PM	
<b>Permit #</b> TBD	<b>Inspection Type</b> VA SWPP	<b>Station Begin</b>	12600+00
<b>State</b> VA	<b>Inspection Area</b> Partial	<b>Station End</b>	12725+00
<b>County</b> Roanoke	<b>Ground</b> Wet	<b>Temperature (°F)</b>	80.00
<b>Municipality</b> N/A	<b>Weather</b> Cloudy	<b>Rain Gauge (in)</b>	0.30
			<b>Rain Accumulation Time (days)</b> 1.00

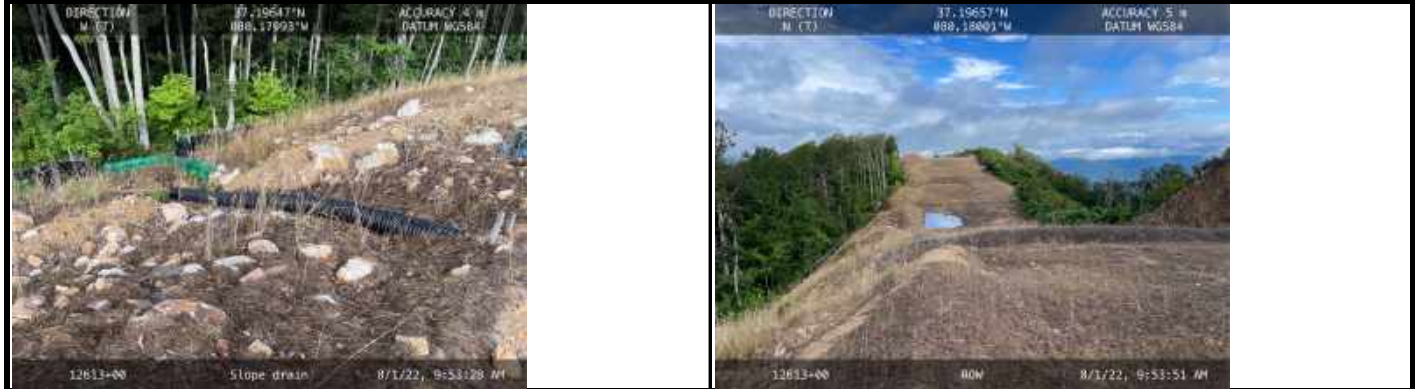
<b>GPS Location</b>	See photo	<b>GPS Location</b>	See photo
<b>Field Station#</b>	12613+00	<b>Field Station#</b>	12613+00
<b>Pic 7 Desc.</b>	Slope drain is functional	<b>Pic 8 Desc.</b>	Current ROW conditions. ROW is stable and ECDs are functional.

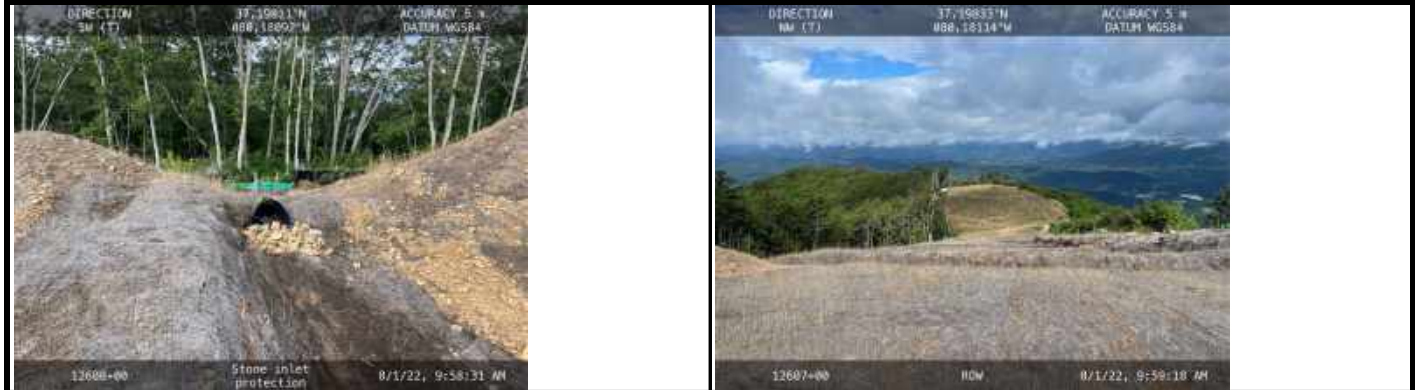
<b>GPS Location</b>	See photo	<b>GPS Location</b>	See photo
<b>Field Station#</b>	12608+00	<b>Field Station#</b>	12607+00
<b>Pic 9 Desc.</b>	Stone inlet protection is functional	<b>Pic 10 Desc.</b>	Current ROW conditions. ROW is stable and ECDs are functional.

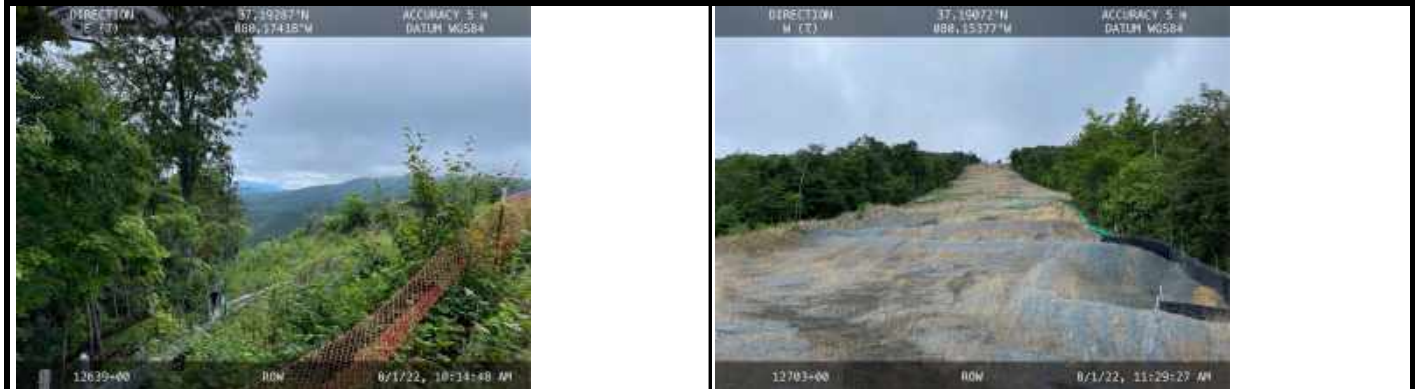
<b>GPS Location</b>	See photo	<b>GPS Location</b>	See photo
<b>Field Station#</b>	12639+00	<b>Field Station#</b>	12703+00
<b>Pic 11 Desc.</b>	Current ROW conditions. ROW is stable and ECDs are functional.	<b>Pic 12 Desc.</b>	Current ROW conditions. ROW is stable and ECDs are functional.

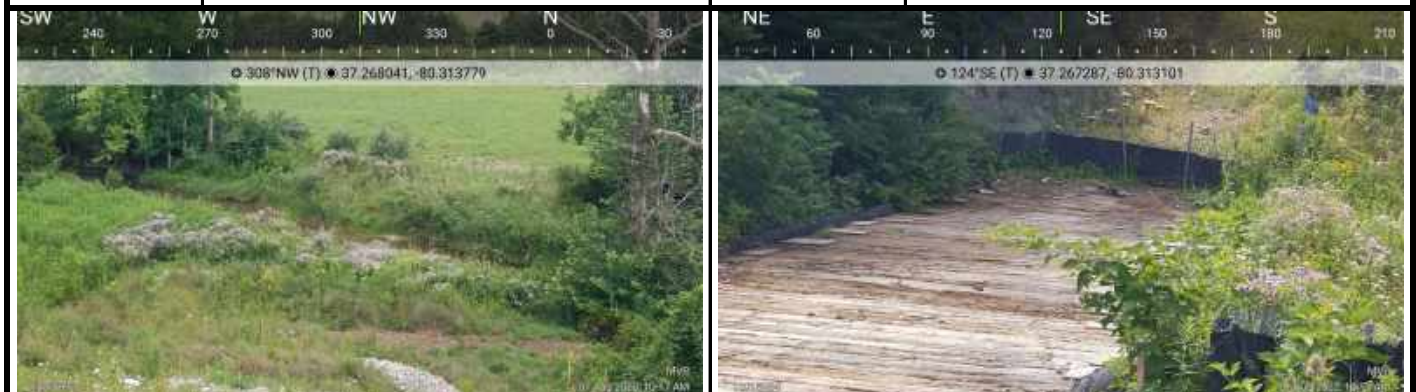
<b>Pic 1 Desc.</b>	Photo shows current stabilized ROW conditions along with stabilized topsoil pile on the perimeter of the ROW.	<b>Pic 2 Desc.</b>	Photo shows stabilized ROW conditions along with P1 silt fence installed around a segregated topsoil pile.
--------------------	---	--------------------	--

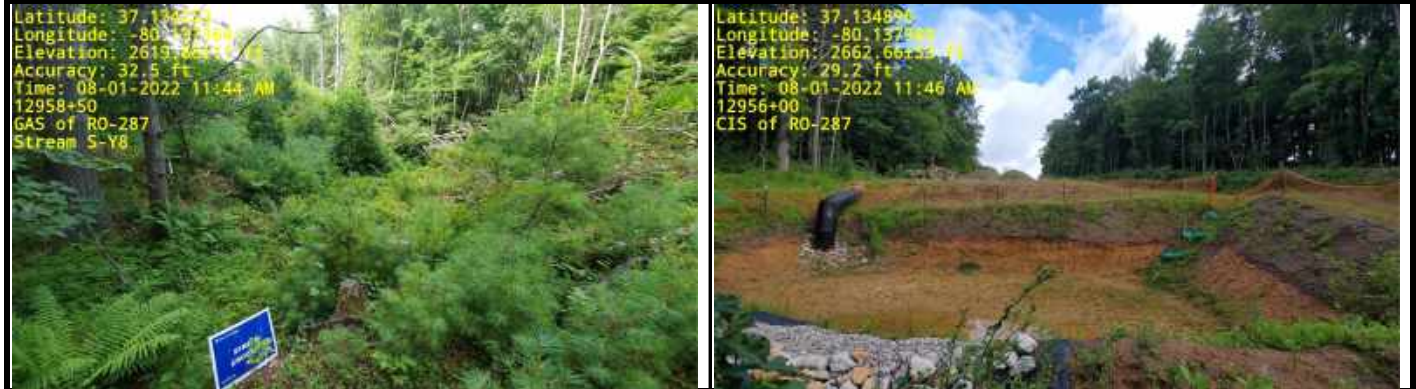
<b>GPS Location</b>	See pic.	<b>GPS Location</b>	See pic.
<b>Field Station#</b>	12958+50	<b>Field Station#</b>	12956+00
<b>Pic 13 Desc.</b>	Downstream side of stream S-Y8.	<b>Pic 14 Desc.</b>	Current ROW conditions.

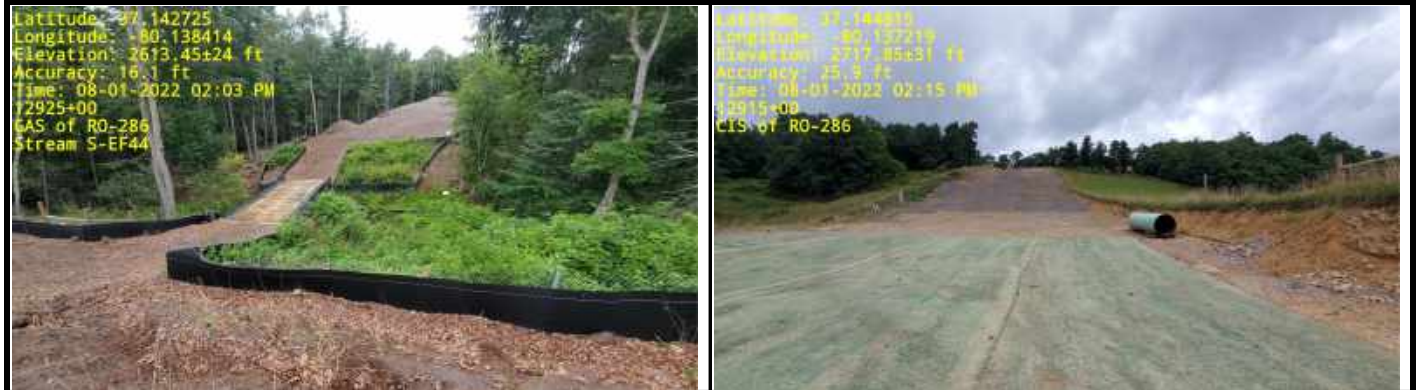
<b>GPS Location</b>	See pic.	<b>GPS Location</b>	See pic.
<b>Field Station#</b>	12925+00	<b>Field Station#</b>	12915+00
<b>Pic 15 Desc.</b>	Stream crossing S-EF44 from the GAS.	<b>Pic 16 Desc.</b>	Current ROW conditions.

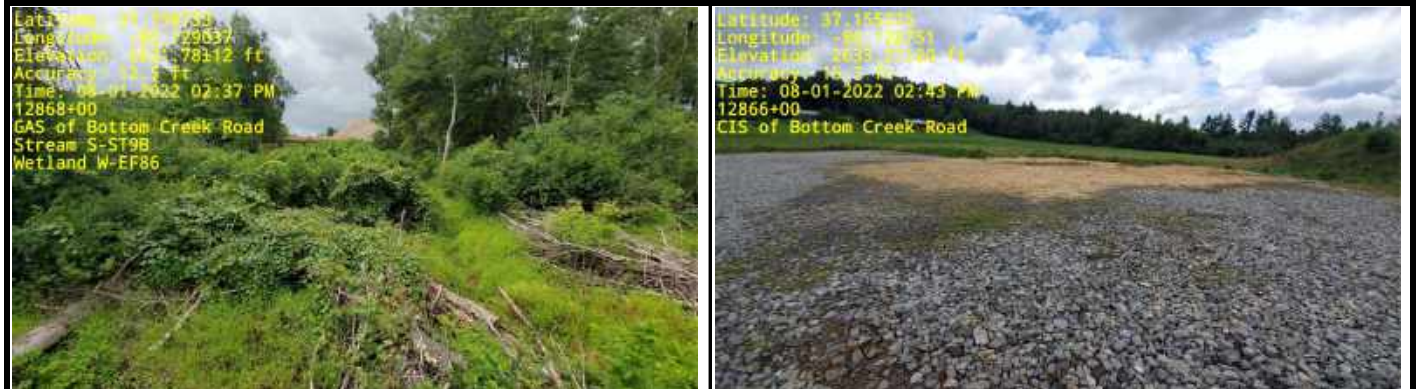
<b>GPS Location</b>	See pic.	<b>GPS Location</b>	See pic.
<b>Field Station#</b>	12868+00	<b>Field Station#</b>	12866+00
<b>Pic 17 Desc.</b>	Stream S-ST9B and wetland W-EF86 from the CIS.	<b>Pic 18 Desc.</b>	Bare soils left after mats were removed was stabilized immediately last week.

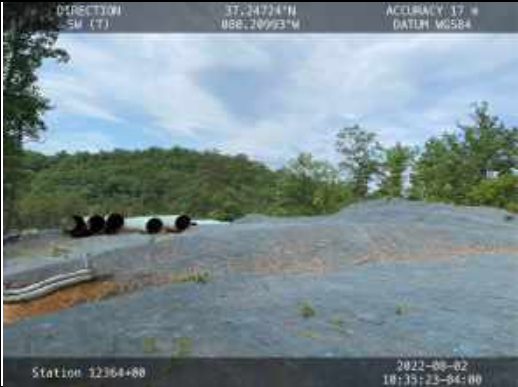
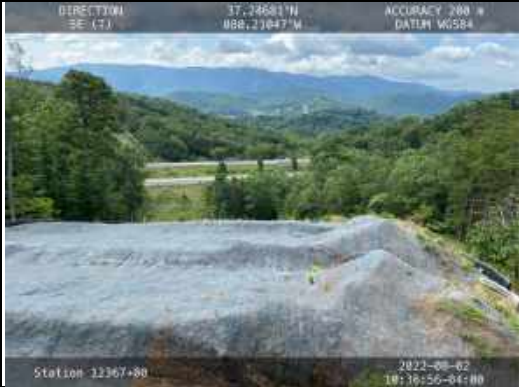
<b>GPS Location</b>	Please see photo for details.		<b>GPS Location</b>	Please see photo for details.	
<b>Field Station#</b>	22364+00		<b>Field Station#</b>	12367+00	
<b>Pic 7 Desc.</b>	Photo shows the stabilized ROW conditions with water bars and that all ECDs are installed and are functioning as designed.		<b>Pic 8 Desc.</b>	Photo shows the stabilized ROW conditions with water bars and that all ECDs are installed and are functioning as designed.

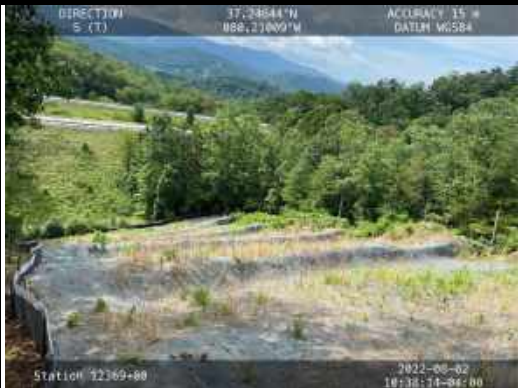
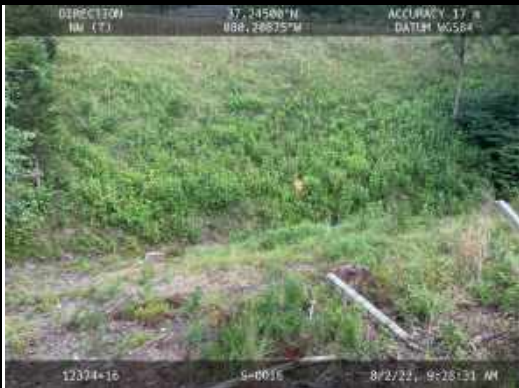
<b>GPS Location</b>	Please see photo for details.		<b>GPS Location</b>	Please see photo for details.	
<b>Field Station#</b>	12369+00		<b>Field Station#</b>	12374+16	
<b>Pic 9 Desc.</b>	Photo shows the stabilized ROW conditions with water bars and that all ECDs are installed and are functioning as designed.		<b>Pic 10 Desc.</b>	Photo shows overview of Stream S-0016 from the coming in side.

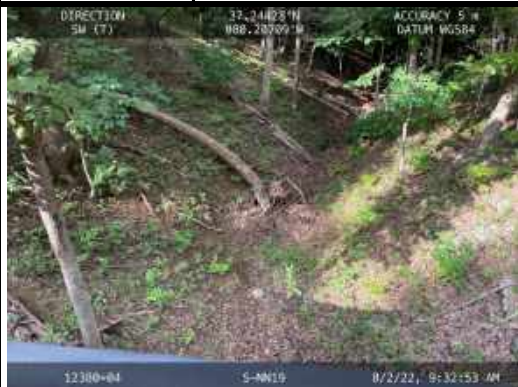
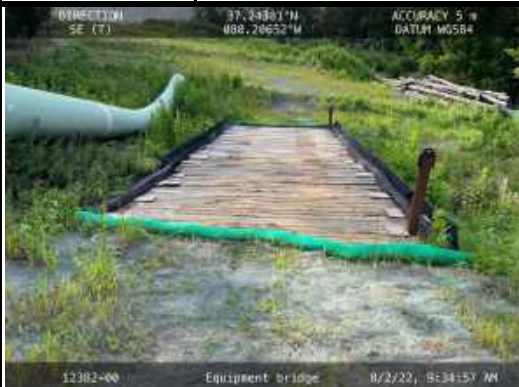
<b>GPS Location</b>	Please see photo for details.		<b>GPS Location</b>	Please see photo for details.	
<b>Field Station#</b>	12380+04		<b>Field Station#</b>	12382+00	
<b>Pic 11 Desc.</b>	Photo shows downstream view of Stream S-NN19 from the equipment bridge spanning the stream channel.		<b>Pic 12 Desc.</b>	Photo shows equipment bridge spanning low lying clean water drainage feature.

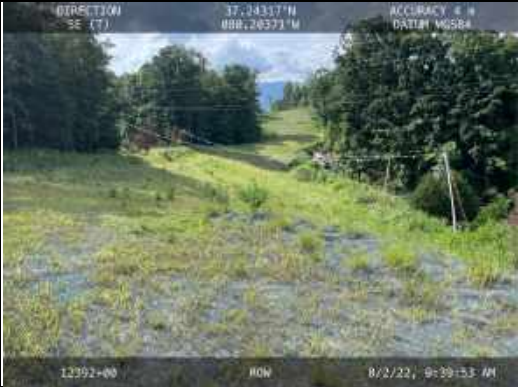
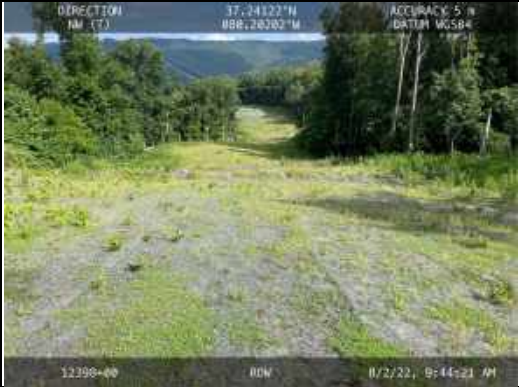
<b>GPS Location</b>	Please see photo for details.		<b>GPS Location</b>	Please see photo for details.	
<b>Field Station#</b>	12392+00		<b>Field Station#</b>	12398+00	
<b>Pic 13 Desc.</b>	Photo shows the stabilized ROW conditions with water bars and that all ECDs are installed and are functioning as designed.		<b>Pic 14 Desc.</b>	Photo shows the stabilized ROW conditions with water bars and that all ECDs are installed and are functioning as designed.

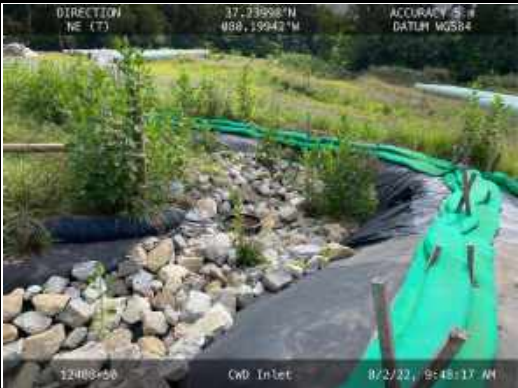
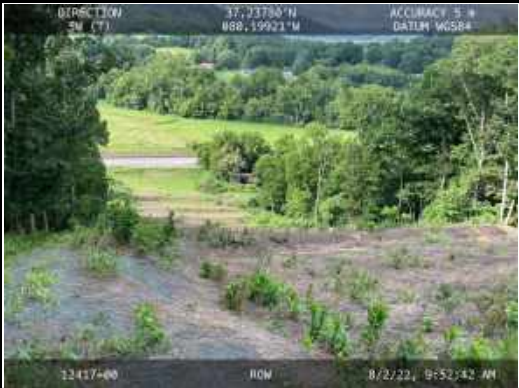
<b>GPS Location</b>	Please see photo for details.		<b>GPS Location</b>	Please see photo for details.	
<b>Field Station#</b>	12408+50		<b>Field Station#</b>	12417+00	
<b>Pic 15 Desc.</b>	Photo shows clean water diversion inlet equipped with stone inlet protection.		<b>Pic 16 Desc.</b>	Photo shows the stabilized ROW conditions with water bars and that all ECDs are installed and are functioning as designed.

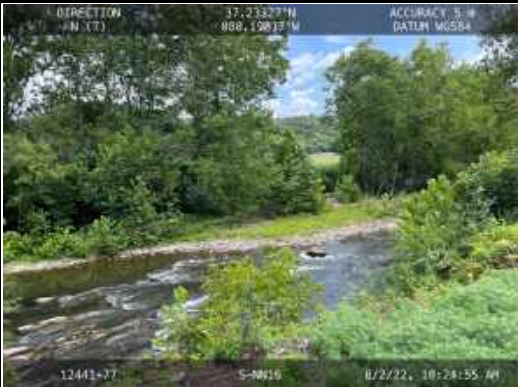
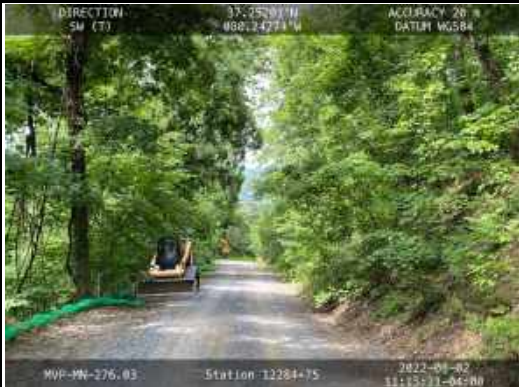
<b>GPS Location</b>	Please see photo for details.		<b>GPS Location</b>	Please see photo for details.	
<b>Field Station#</b>	12435+50		<b>Field Station#</b>	12284+75	
<b>Pic 17 Desc.</b>	Photo shows overview of Stream S-NN16 from the going away side.		<b>Pic 18 Desc.</b>	Photo shows environmental crew maintaining MVP-MN-276.03 along with the ECDs installed on the perimeter.

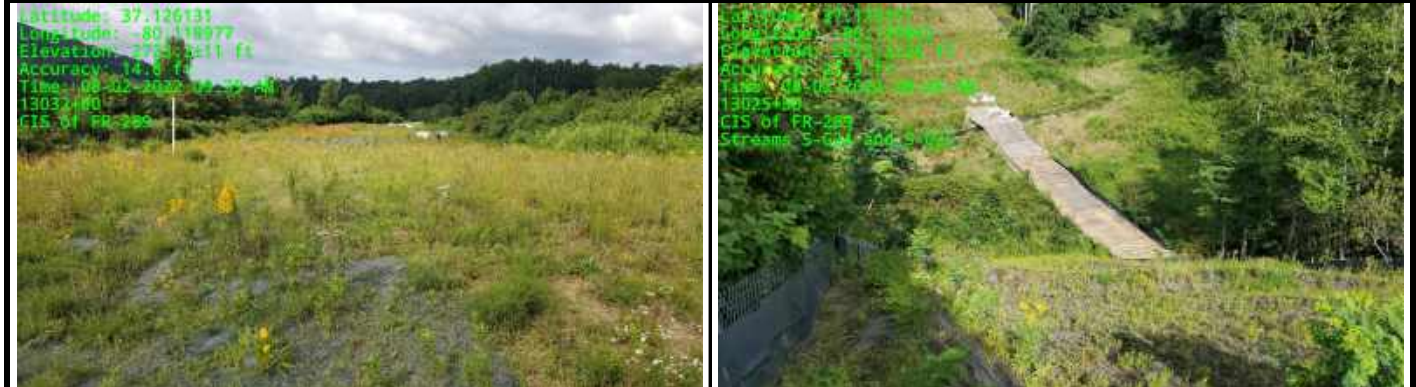
<b>GPS Location</b>	See pic.	<b>GPS Location</b>	See pic.
<b>Field Station#</b>	13032+00	<b>Field Station#</b>	13025+50
<b>Pic 1 Desc.</b>	Current ROW conditions.	<b>Pic 2 Desc.</b>	Streams S-G24 and S-G25 from the GAS.

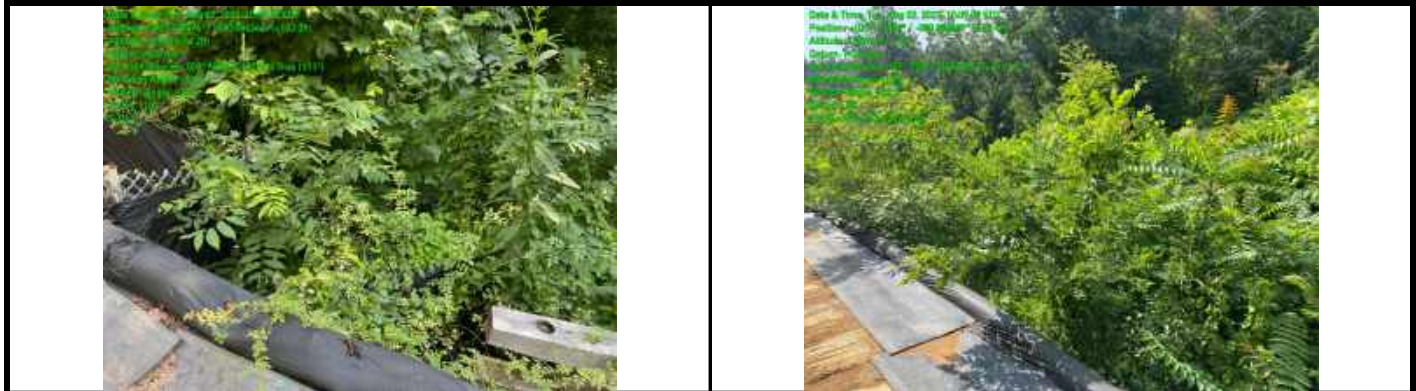
<b>GPS Location</b>	See pic.	<b>GPS Location</b>	See pic.
<b>Field Station#</b>	13141+53	<b>Field Station#</b>	13137+78
<b>Pic 3 Desc.</b>	Downstream side of stream S_D17/14 at access road FR-292.	<b>Pic 4 Desc.</b>	Downstream side of stream S_D17/14.

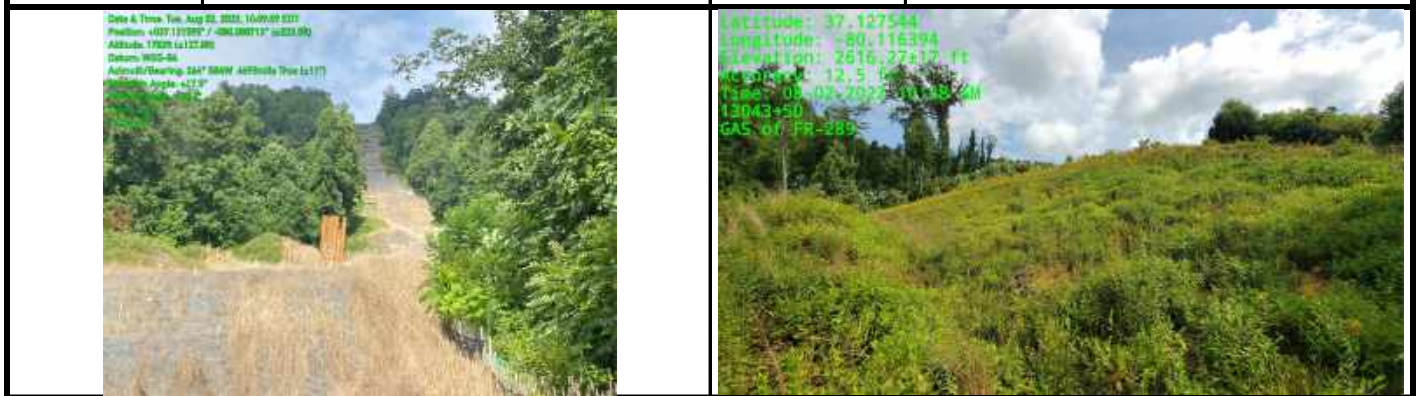
<b>GPS Location</b>	See pic.	<b>GPS Location</b>	See pic.
<b>Field Station#</b>	13136+00	<b>Field Station#</b>	13043+50
<b>Pic 5 Desc.</b>	Current ROW conditions.	<b>Pic 6 Desc.</b>	Current ROW conditions.

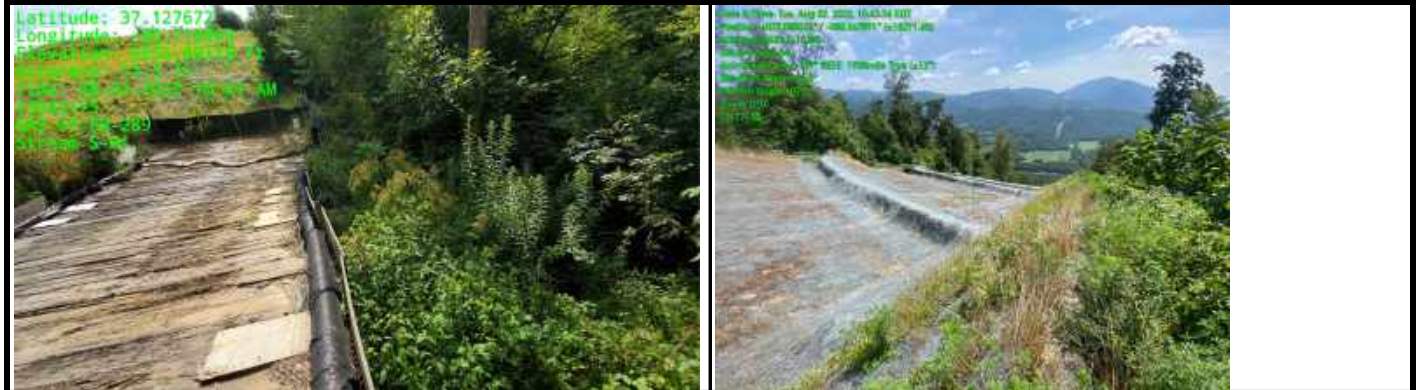
<b>GPS Location</b>	See pic.	<b>GPS Location</b>	See pic.
<b>Field Station#</b>	13042+75	<b>Field Station#</b>	13117+00
<b>Pic 9 Desc.</b>	Downstream side of stream S-H1.	<b>Pic 10 Desc.</b>	Current ROW conditions.

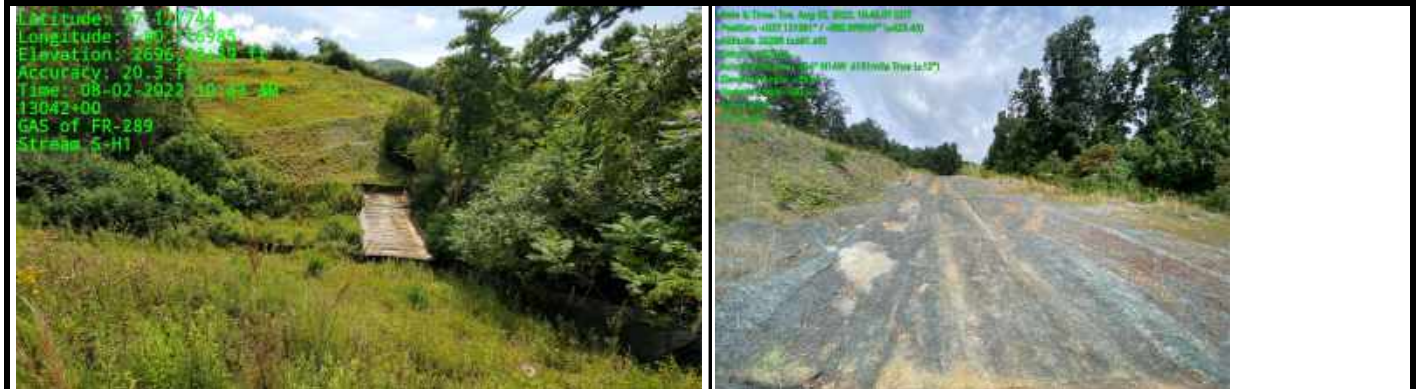
<b>GPS Location</b>	See pic.	<b>GPS Location</b>	See pic.
<b>Field Station#</b>	13042+00	<b>Field Station#</b>	13115+00
<b>Pic 11 Desc.</b>	Stream S-H1 from the CIS.	<b>Pic 12 Desc.</b>	Current ROW conditions.

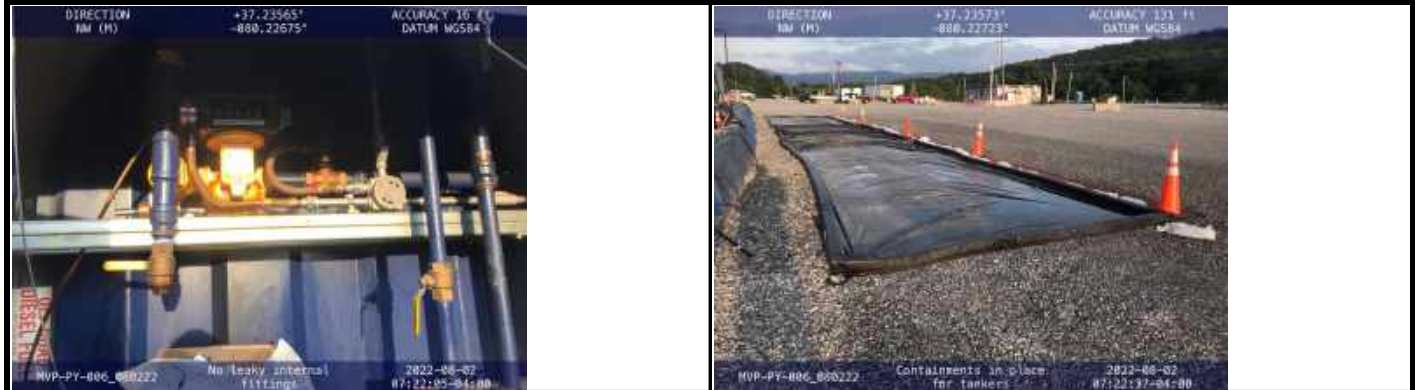
<b>GPS Location</b>	MVP-PY-006 See photo for gps data	<b>GPS Location</b>	MVP-PY-006 See photo for gps data
<b>Field Station#</b>	+0	<b>Field Station#</b>	+0
<b>Pic 15 Desc.</b>	Blue Bulk Fuel tanks no leaky internal fittings. Looking NW.	<b>Pic 16 Desc.</b>	Blue Bulk Fuel tanks secondary containments in place for tankers offloading fuel. Looking NW.

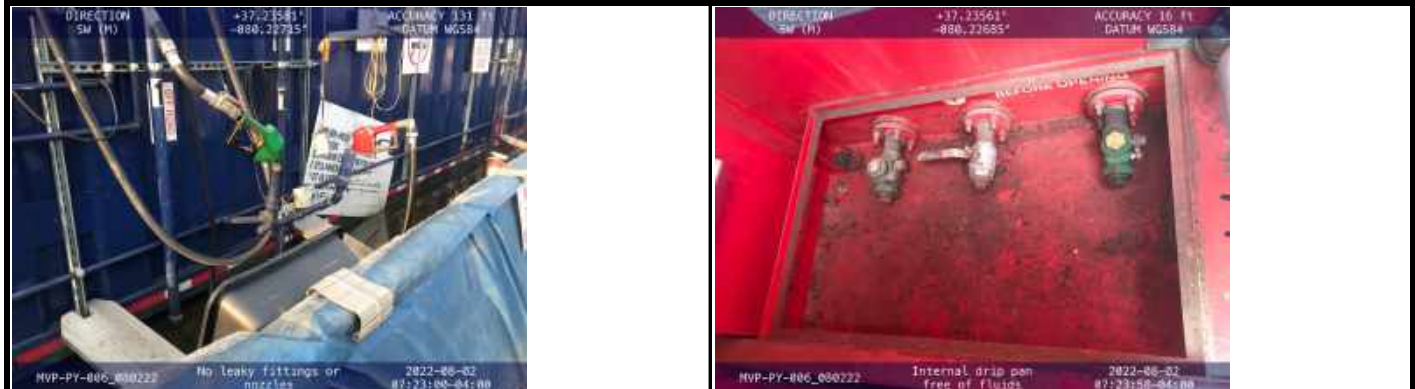
<b>GPS Location</b>	MVP-PY-006 See photo for gps data	<b>GPS Location</b>	MVP-PY-006 See photo for gps data
<b>Field Station#</b>	+0	<b>Field Station#</b>	+0
<b>Pic 17 Desc.</b>	Blue Bulk Fuel tanks no leaky fittings or nozzles. Catch pans on site.. looking SW.	<b>Pic 18 Desc.</b>	Off Road Fuel unit no leaky internal fittings and internal drip pan free of fluids. Looking SW.

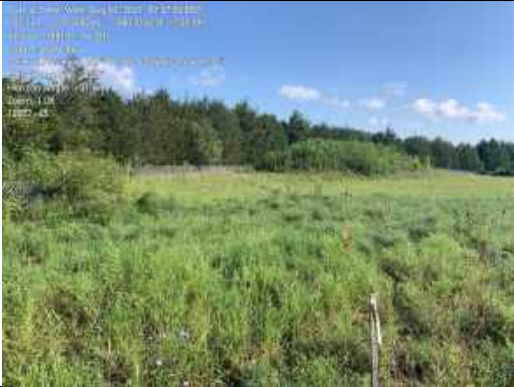
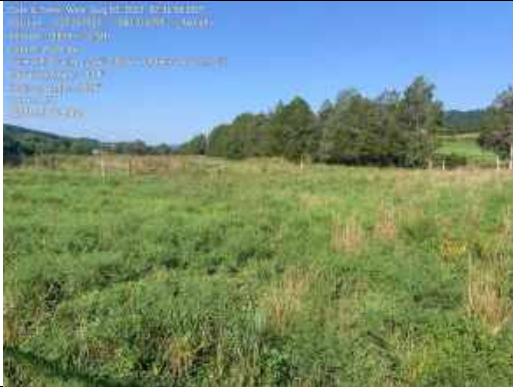
<b>GPS Location</b>	See photo		<b>GPS Location</b>	See photo	
<b>Field Station#</b>	12002+45		<b>Field Station#</b>	12001+50	
<b>Pic 1 Desc.</b>	Section of Row showing conditions and controls		<b>Pic 2 Desc.</b>	W-NN6

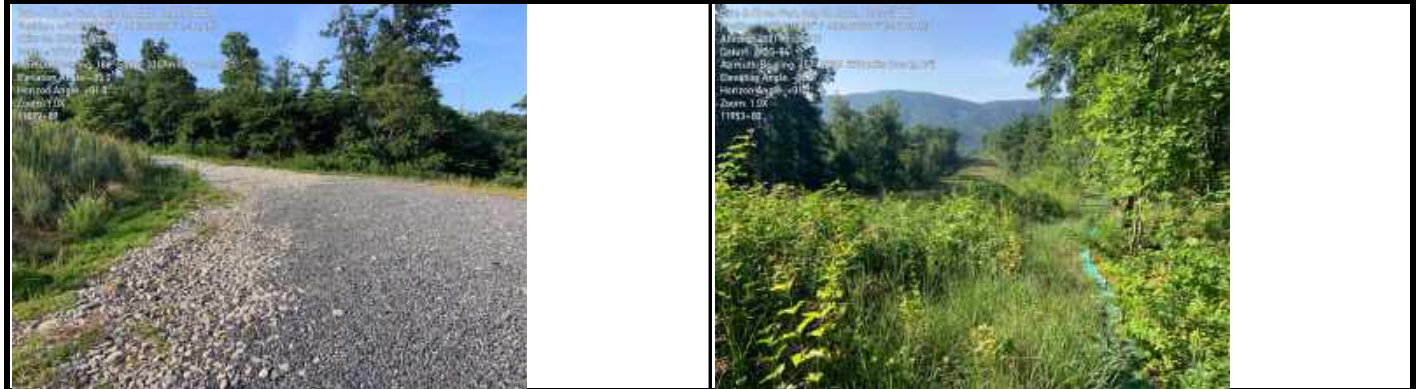
<b>GPS Location</b>	See photo	<b>GPS Location</b>	See photo
<b>Field Station#</b>	11899+89	<b>Field Station#</b>	11953+00
<b>Pic 7 Desc.</b>	AR266.03	<b>Pic 8 Desc.</b>	Section of Row showing conditions and controls

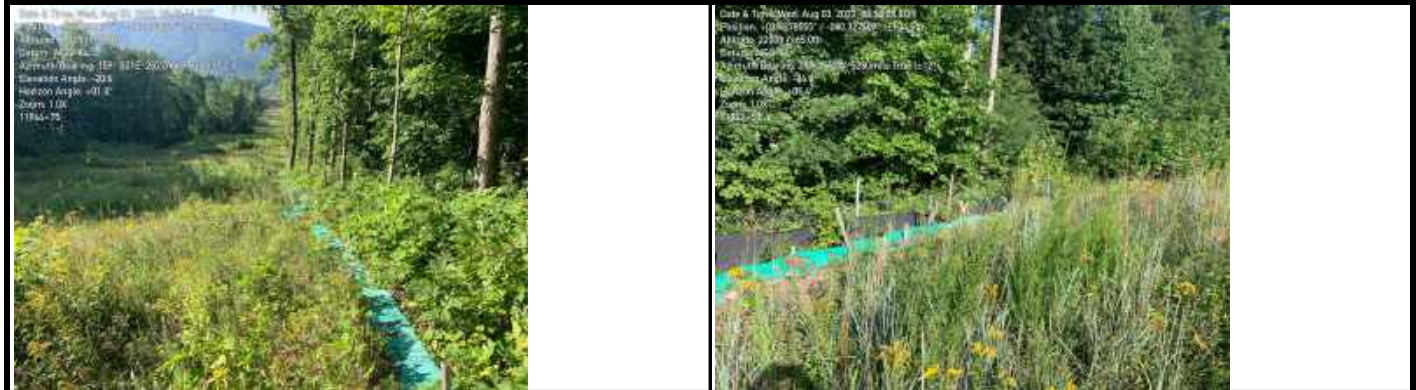
<b>GPS Location</b>	See photo	<b>GPS Location</b>	See photo
<b>Field Station#</b>	11944+75	<b>Field Station#</b>	11942+50
<b>Pic 9 Desc.</b>	Section of Row showing conditions and controls	<b>Pic 10 Desc.</b>	Perimeter controls are in place

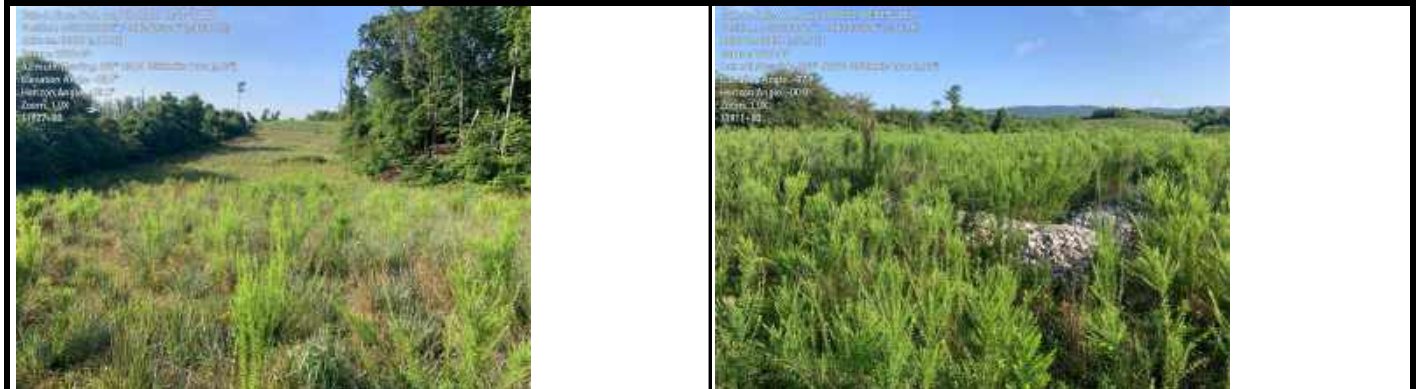
<b>GPS Location</b>	See photo	<b>GPS Location</b>	See photo
<b>Field Station#</b>	11927+20	<b>Field Station#</b>	11911+00
<b>Pic 11 Desc.</b>	Section of Row showing conditions and controls	<b>Pic 12 Desc.</b>	Representational photo of water bar and level spreader

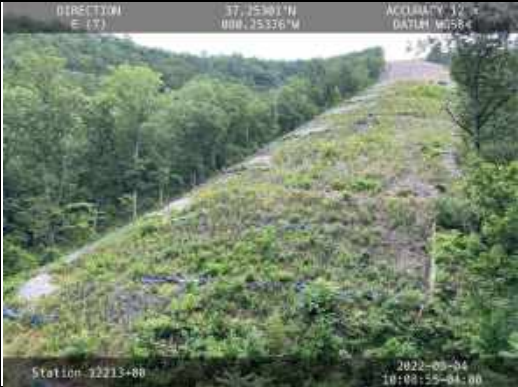
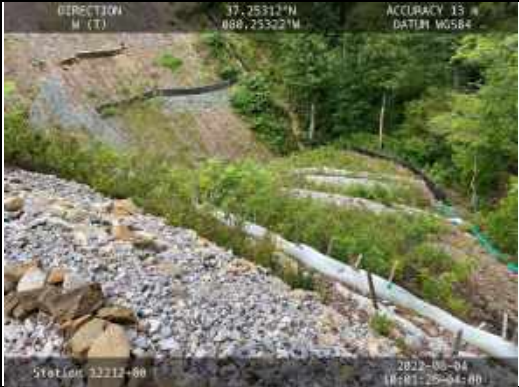
<b>GPS Location</b>	Please see photo for details.		<b>GPS Location</b>	Please see photo for details.	
<b>Field Station#</b>	12213+00		<b>Field Station#</b>	12212+00	
<b>Pic 13 Desc.</b>	Photo shows stabilized ROW conditions in permanent restoration area with permanent waterbars equipped with level spreaders.		<b>Pic 14 Desc.</b>	Photo shows stabilized ROW conditions in permanent restoration area with permanent waterbars equipped with level spreaders.

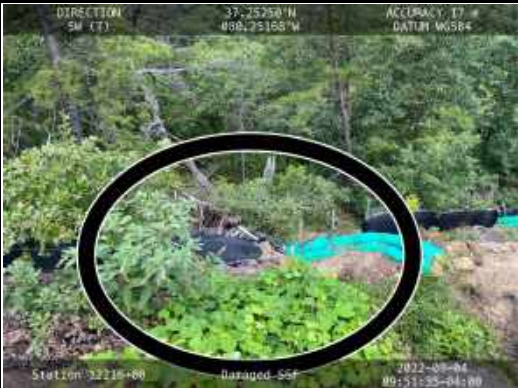
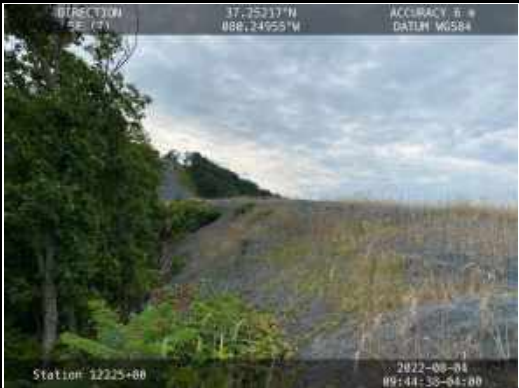
<b>GPS Location</b>	Please see photo for details.		<b>GPS Location</b>	Please see photo for details.	
<b>Field Station#</b>	12216+00		<b>Field Station#</b>	12225+00	
<b>Pic 15 Desc.</b>	Photo shows punch list item from today of damaged SSF that was resolved. (08/04/2022).		<b>Pic 16 Desc.</b>	Photo shows the stabilized ROW conditions with water bars and that all ECDs are installed and are functioning as designed.

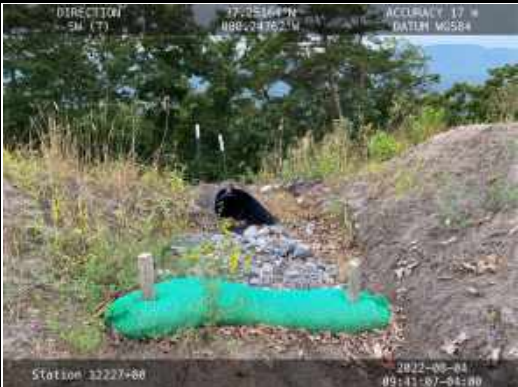
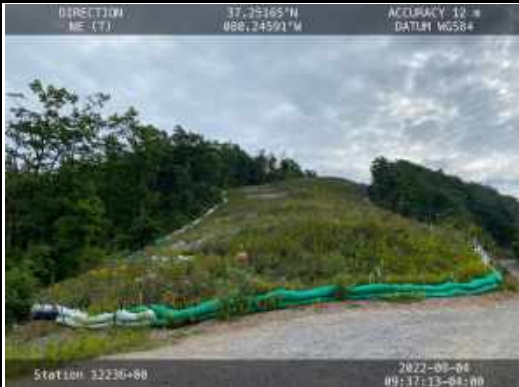
<b>GPS Location</b>	Please see photo for details.		<b>GPS Location</b>	Please see photo for details.	
<b>Field Station#</b>	12227+00		<b>Field Station#</b>	12236+00	
<b>Pic 17 Desc.</b>	Photo shows stone inlet protection for slope drain pipe as well as a CFS check.		<b>Pic 18 Desc.</b>	Photo shows stabilized ROW conditions in permanent restoration area with permanent waterbars equipped with level spreaders.

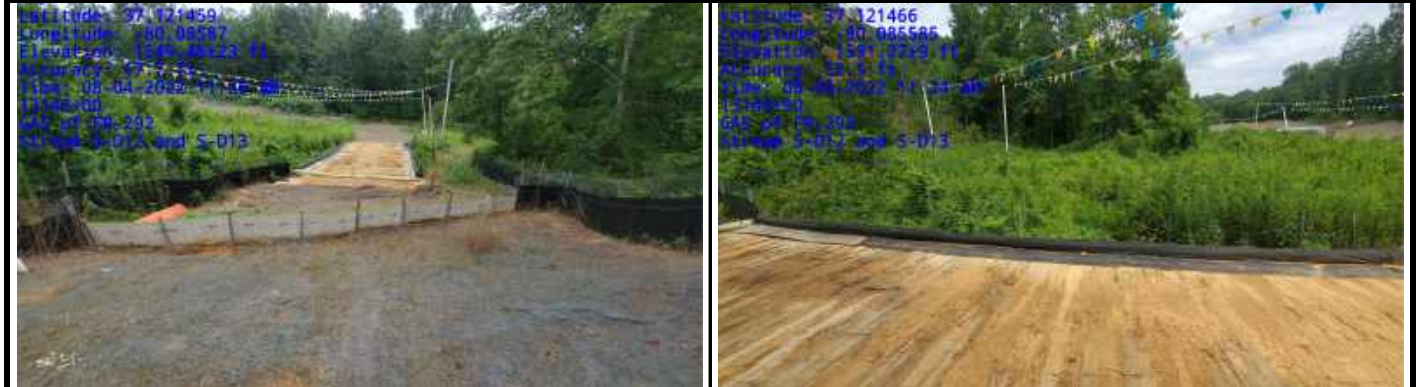
<b>GPS Location</b>	See photo for coordinates.	<b>GPS Location</b>	See photo for coordinates.
<b>Field Station#</b>	13146+00	<b>Field Station#</b>	131465013148+00
<b>Pic 1 Desc.</b>	Perimeter controls in acceptable condition along S-D12 and S-D13 stream crossings.	<b>Pic 2 Desc.</b>	S-D12 and S-D13, upstream, no impacts noted.

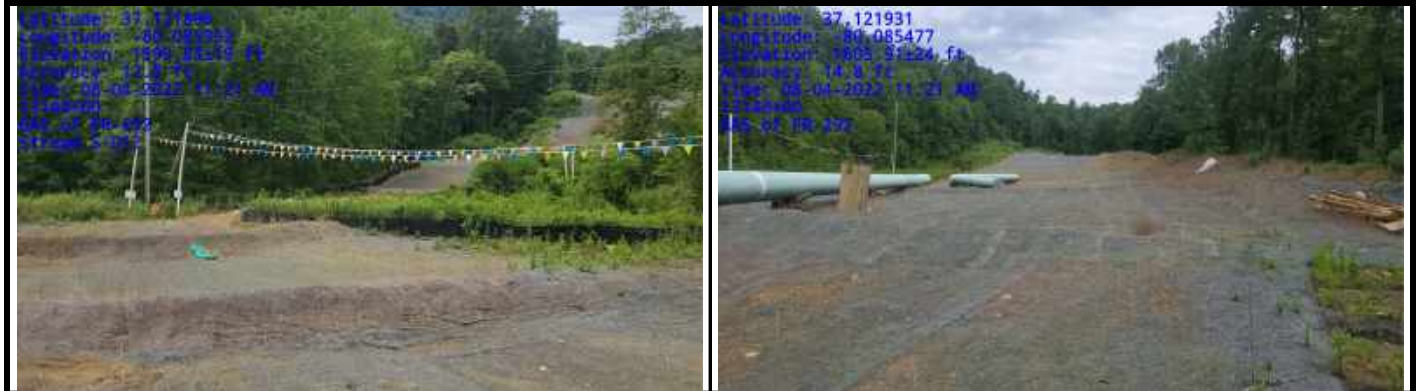
<b>GPS Location</b>	See photo for coordinates.	<b>GPS Location</b>	See photo for coordinates.
<b>Field Station#</b>	13148+00	<b>Field Station#</b>	13148+00
<b>Pic 3 Desc.</b>	ROW stabilized, no deficiencies noted.	<b>Pic 4 Desc.</b>	ROW stabilized.

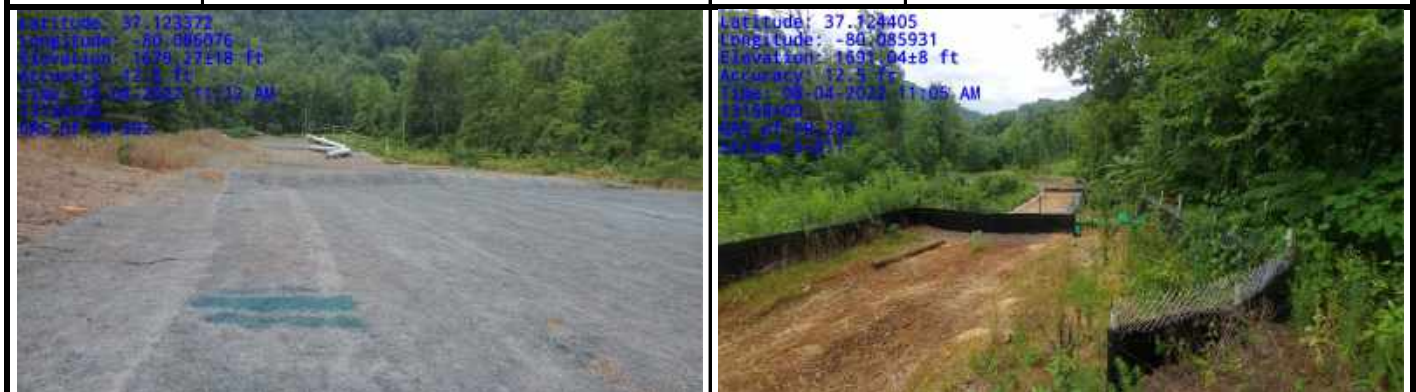
<b>GPS Location</b>	See photo for coordinates.	<b>GPS Location</b>	See photo for coordinates.
<b>Field Station#</b>	13154+00	<b>Field Station#</b>	13158+00
<b>Pic 5 Desc.</b>	ROW stabilized.	<b>Pic 6 Desc.</b>	Perimeter controls in acceptable condition at S-D11 stream crossing.

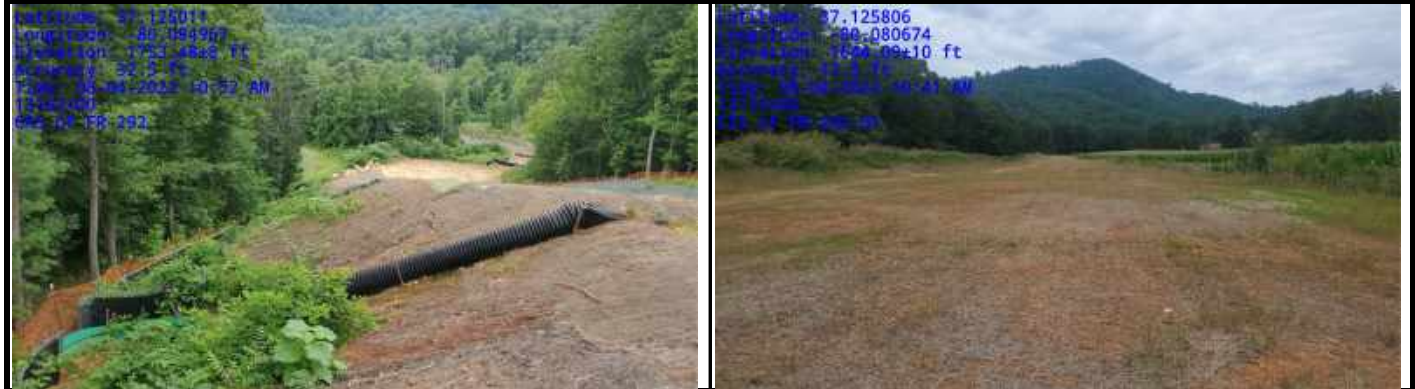
<b>GPS Location</b>	See photo for coordinates.	<b>GPS Location</b>	See photo for coordinates.
<b>Field Station#</b>	13162+00	<b>Field Station#</b>	13175+00
<b>Pic 7 Desc.</b>	Fill slope stable, slope drains and end treatments in acceptably condition.	<b>Pic 8 Desc.</b>	ROW stabilized.

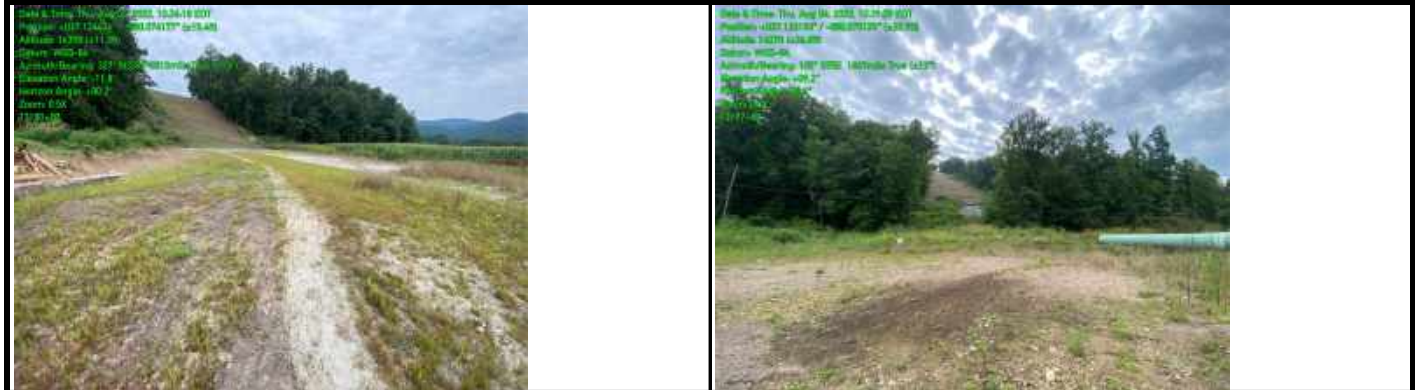
<b>GPS Location</b>	See photo for coordinates.	<b>GPS Location</b>	See photo for coordinates.
<b>Field Station#</b>	13190+00	<b>Field Station#</b>	13197+00
<b>Pic 9 Desc.</b>	ROW stabilized.	<b>Pic 10 Desc.</b>	ROW stabilized.

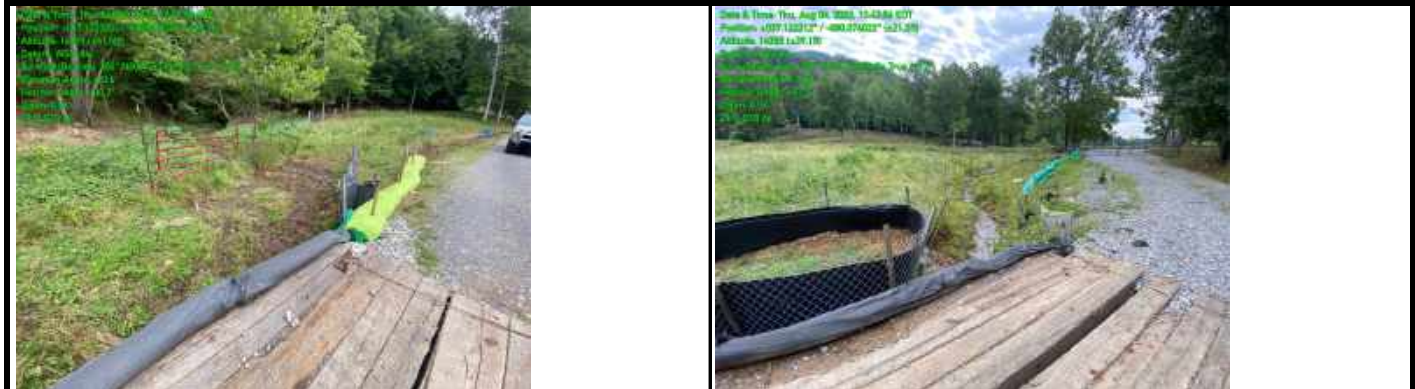
<b>GPS Location</b>	See photo for coordinates.	<b>GPS Location</b>	See photo for coordinates.
<b>Field Station#</b>	13196+31	<b>Field Station#</b>	13196+31
<b>Pic 11 Desc.</b>	S-D10, upstream, cattle disturbance noted in stream and along stream banks.	<b>Pic 12 Desc.</b>	S-D10, downstream, no impacts noted.

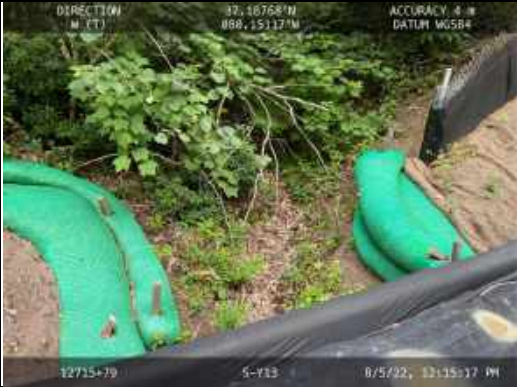
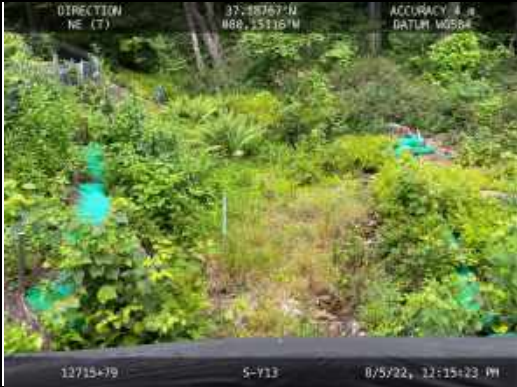
<b>GPS Location</b>	See photo		<b>GPS Location</b>	See photo
<b>Field Station#</b>	12715+79		<b>Field Station#</b>	12715+79
<b>Pic 13 Desc.</b>	Upstream of crossing at Stream S-Y13		<b>Pic 14 Desc.</b>	Downstream of crossing at Stream S-Y13

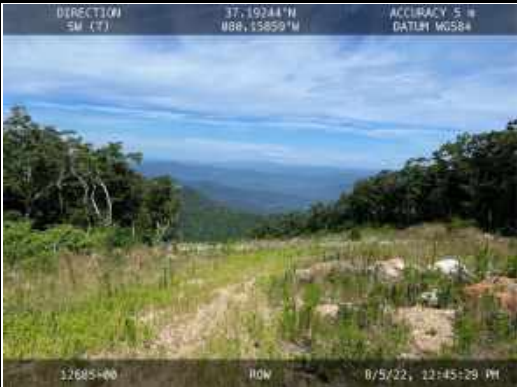
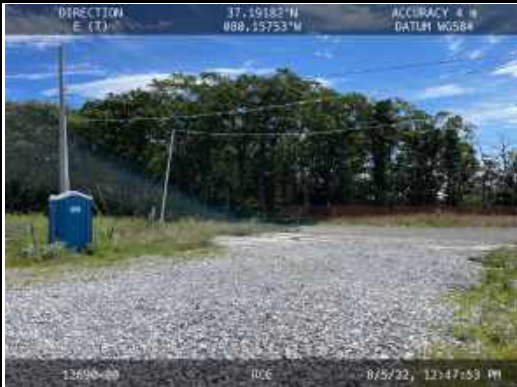
<b>GPS Location</b>	See photo		<b>GPS Location</b>	See photo
<b>Field Station#</b>	12685+00		<b>Field Station#</b>	12690+00
<b>Pic 17 Desc.</b>	Current ROW conditions. ROW is stable and ECDs are functional		<b>Pic 18 Desc.</b>	RCE is well maintained and functional

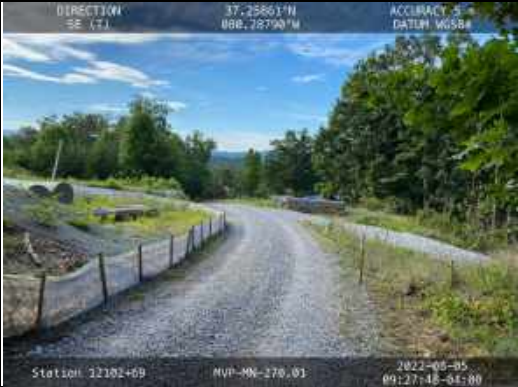
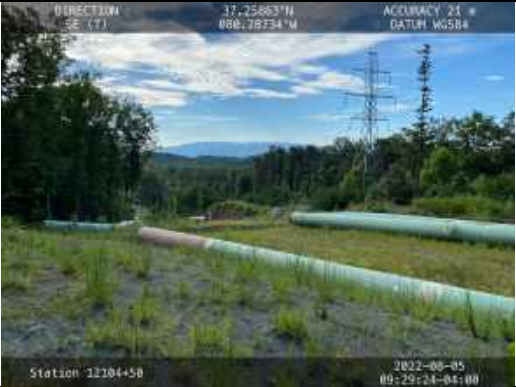
<b>GPS Location</b>	See Above	<b>GPS Location</b>	See Above
<b>Field Station#</b>	12102+69	<b>Field Station#</b>	12104+50
<b>Pic 13 Desc.</b>	ROW Overview (Acc Rd 270.01/Half Acre of Rocks Rd). ECDs functional and in good condition and ROW is stable.	<b>Pic 14 Desc.</b>	ROW Overview. ECDs are functional and ROW is stable.

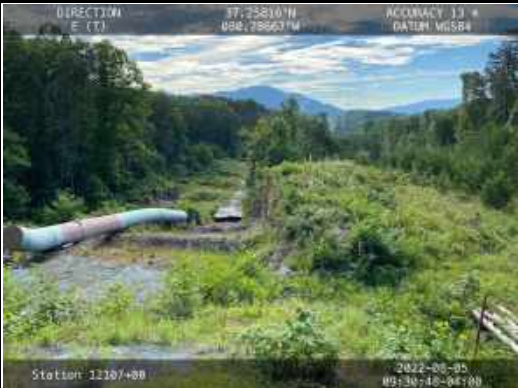
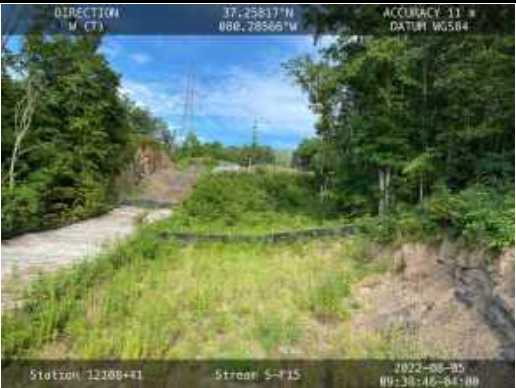
<b>GPS Location</b>	See Above	<b>GPS Location</b>	See Above
<b>Field Station#</b>	12107+00	<b>Field Station#</b>	12108+41
<b>Pic 15 Desc.</b>	ROW Overview. ECDs are functional and ROW is stable.	<b>Pic 16 Desc.</b>	Overview of Waterbody S-F15. ECDs are functional and ROW is stable.

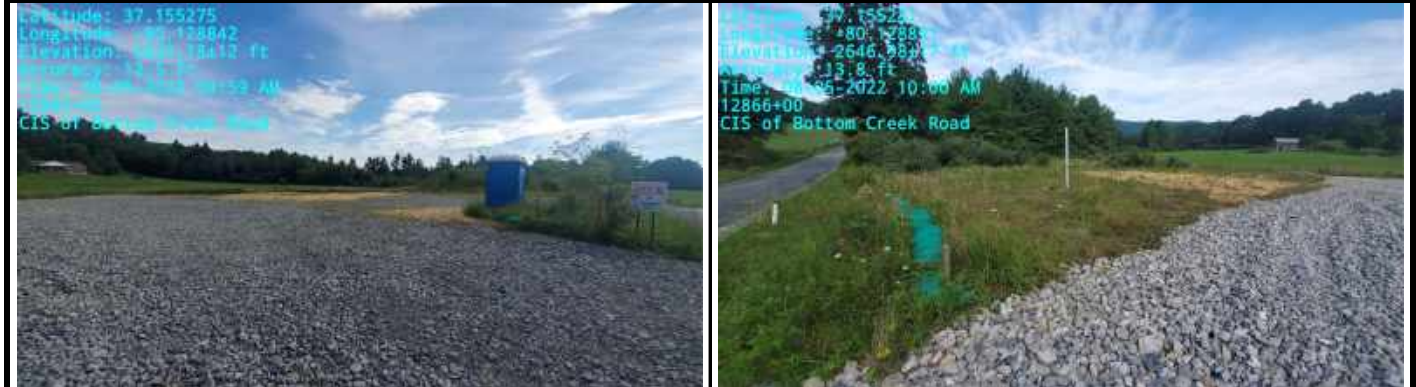
<b>GPS Location</b>	See pic.	<b>GPS Location</b>	See pic.
<b>Field Station#</b>	12866+00	<b>Field Station#</b>	12866+00
<b>Pic 1 Desc.</b>	Current ROW conditions.	<b>Pic 2 Desc.</b>	Current ROW conditions.

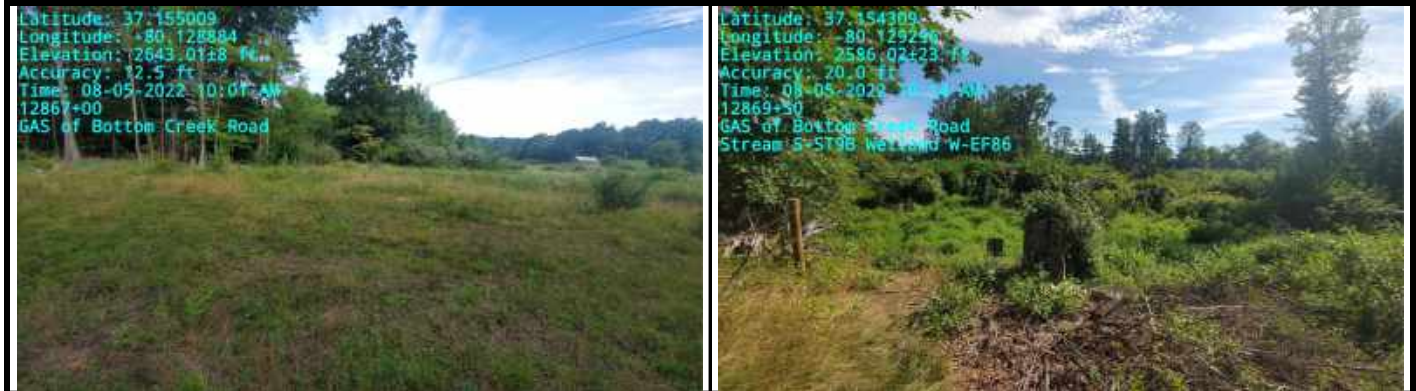
<b>GPS Location</b>	See pic.	<b>GPS Location</b>	See pic.
<b>Field Station#</b>	12867+00	<b>Field Station#</b>	12869+50
<b>Pic 3 Desc.</b>	Current ROW conditions.	<b>Pic 4 Desc.</b>	Stream crossing S-ST9B from the GAS.
