# Visual Site Inspection Report

<b>Project Name</b> H-600 Pipeline Spread H		<b>AFE</b> 124300138	<b>Spread</b> H-600 Pipeline Spread H
<b>Contractor</b> Precision		<b>Report #</b> 40516	
<b>Inspector</b> Jonathan Altizer		<b>Date/Time</b> 8/1/2022 3:21 PM	
<b>Permit #</b> TBD	<b>Inspection Type</b> VA SWPP	<b>Station Begin</b>	12600+00
<b>State</b> VA	<b>Inspection Area</b> Partial	<b>Station End</b>	12725+00
<b>County</b> Roanoke	<b>Ground</b> Wet	<b>Temperature (°F)</b>	80.00
<b>Municipality</b> N/A	<b>Weather</b> Cloudy	<b>Rain Gauge (in)</b>	0.30
			<b>Rain Accumulation Time (days)</b> 1.00

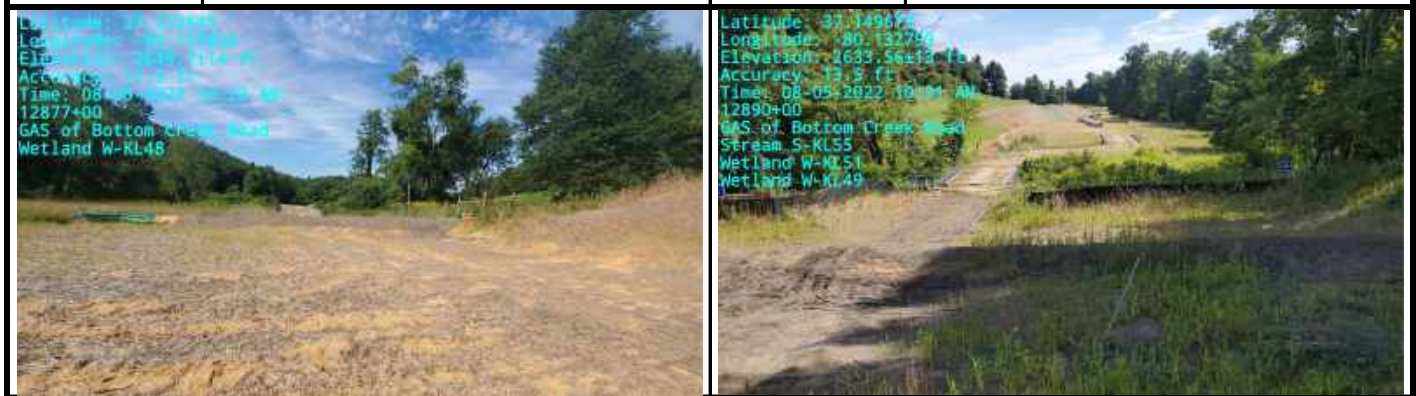
<b>GPS Location</b>	See pic.	<b>GPS Location</b>	See pic.
<b>Field Station#</b>	12877+00	<b>Field Station#</b>	12890+00
<b>Pic 5 Desc.</b>	Wetland W-KL48 from the CIS.	<b>Pic 6 Desc.</b>	Stream S-KL55 from the GAS.

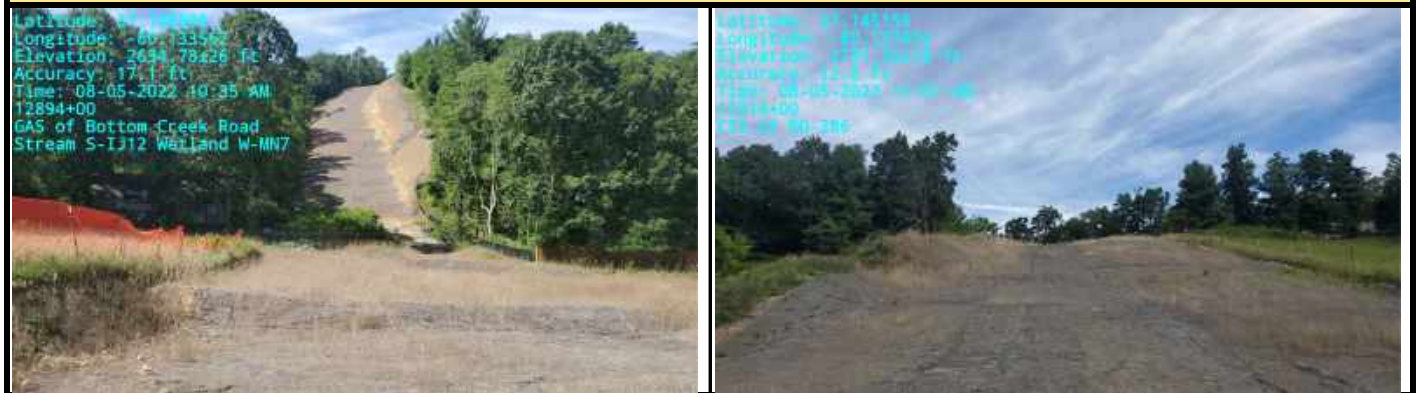
<b>GPS Location</b>	See pic.	<b>GPS Location</b>	See pic.
<b>Field Station#</b>	12894+00	<b>Field Station#</b>	12914+00
<b>Pic 7 Desc.</b>	Stream crossing S-IJ12 from the CIS.	<b>Pic 8 Desc.</b>	Current ROW conditions.

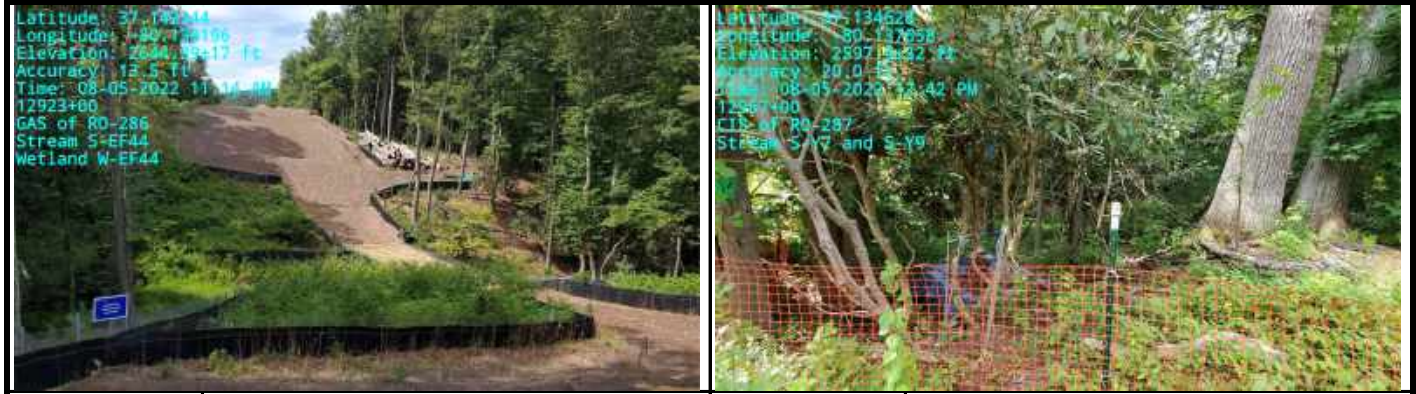
<b>GPS Location</b>	See pic.	<b>GPS Location</b>	See pic.
<b>Field Station#</b>	12923+00	<b>Field Station#</b>	12957+00
<b>Pic 9 Desc.</b>	Stream crossing S-EF44 from the CIS.	<b>Pic 10 Desc.</b>	Upstream side of streams S-Y7 and S-Y9.
