# Visual Site Inspection Report

<b>Project Name</b> H-600 Pipeline Spread H		<b>AFE</b> 124300138	<b>Spread</b> H-600 Pipeline Spread H
<b>Contractor</b> Precision		<b>Report #</b> 41019	
<b>Inspector</b> Dustin Lyons		<b>Date/Time</b> 8/15/2022 4:20 PM	
<b>Permit #</b> TBD	<b>Inspection Type</b> VA SWPP	<b>Station Begin</b> 12443+75	
<b>State</b> VA	<b>Inspection Area</b> Partial	<b>Station End</b> 12544+06	
<b>County</b> Montgomery	<b>Ground</b> Wet	<b>Temperature (°F)</b> 75.00	
<b>Municipality</b> N/A	<b>Weather</b> Cloudy	<b>Rain Gauge (in)</b> 0.50	
<b>Rain Accumulation Time (days)</b>			3.00

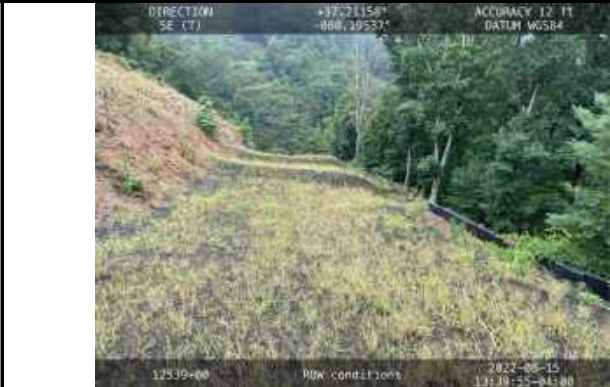
<p>DIRECTION: SE (77) +37.21158° -860.19537° ACCURACY 12 FT DATUM WGS84 12539+00 ROW conditions 2022-08-15 13:19:45-04:00</p>		
<b>GPS Location</b>	See photo for gps location data.		<b>GPS Location</b>	See photo for gps location data.	
<b>Field Station#</b>	12544+06		<b>Field Station#</b>	12539+00	
<b>Pic 1 Desc.</b>	Photo shows the ECDs along Yellowfinch Lane.		<b>Pic 2 Desc.</b>	Photo shows the ROW conditions. ECDs are installed and functioning as designed.

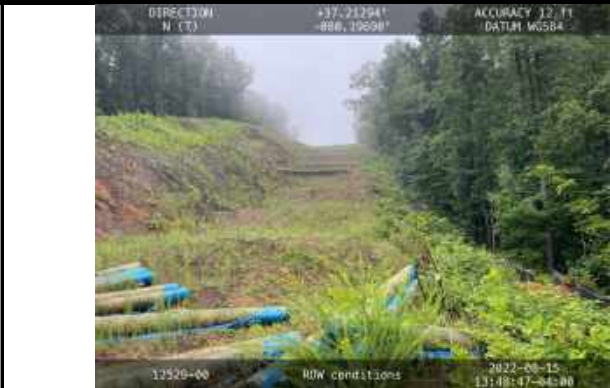
<p>DIRECTION: N (77) +37.21294° -860.19630° ACCURACY 12 FT DATUM WGS84 12529+00 ROW conditions 2022-08-15 13:49:47-04:00</p>		
<b>GPS Location</b>	See photo for gps location data.		<b>GPS Location</b>	See photo for gps location data.	
<b>Field Station#</b>	12532+00		<b>Field Station#</b>	12529+00	
<b>Pic 5 Desc.</b>	Photo shows the ROW conditions. ECDs are installed and functioning as designed.		<b>Pic 6 Desc.</b>	Photo shows the ROW conditions. ECDs are installed and functioning as designed.

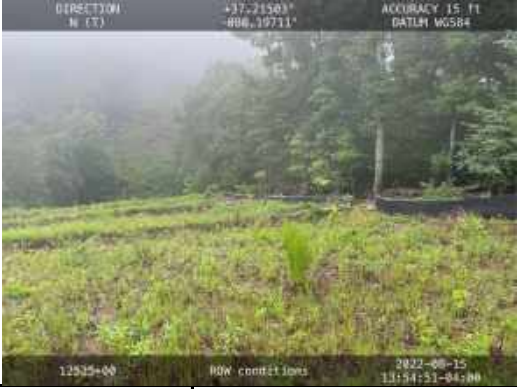
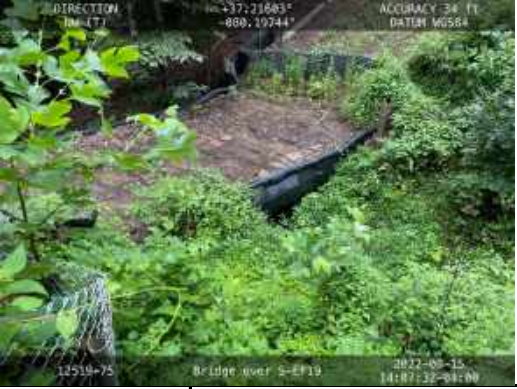
<b>GPS Location</b>	See photo for gps location data.	<b>GPS Location</b>	See photo for gps location data.
<b>Field Station#</b>	12525+00	<b>Field Station#</b>	12519+75
<b>Pic 7 Desc.</b>	Photo shows the ROW conditions. ECDs are installed and functioning as designed.	<b>Pic 8 Desc.</b>	Photo shows the bridge over stream S-EF19.

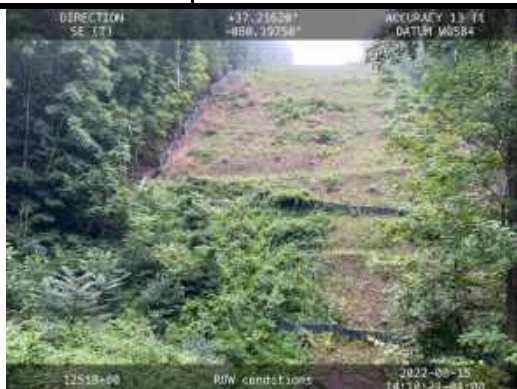
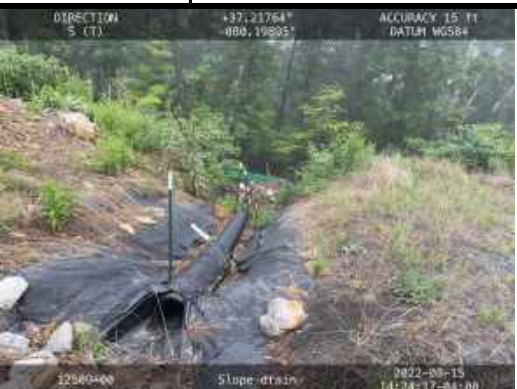
<b>GPS Location</b>	See photo for gps location data.	<b>GPS Location</b>	See photo for gps location data.
<b>Field Station#</b>	12518+00	<b>Field Station#</b>	12509+00
<b>Pic 11 Desc.</b>	Photo shows the ROW conditions. ECDs are installed and functioning as designed.	<b>Pic 12 Desc.</b>	Photo shows the slope drain.

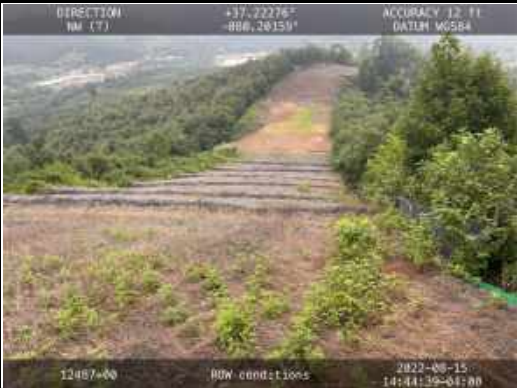
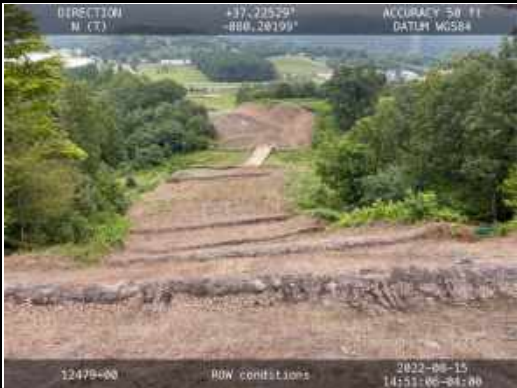
<b>GPS Location</b>	See photo for gps location data.	<b>GPS Location</b>	See photo for gps location data.
<b>Field Station#</b>	12487+00	<b>Field Station#</b>	12479+00
<b>Pic 15 Desc.</b>	Photo shows the ROW conditions. ECDs are installed and functioning as designed.	<b>Pic 16 Desc.</b>	Photo shows the ROW conditions. ECDs are installed and functioning as designed.

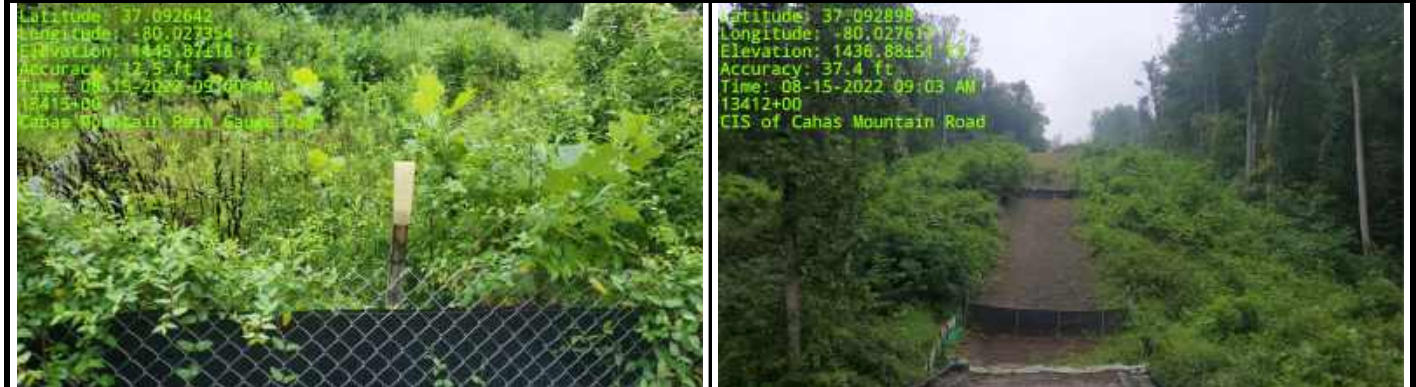
<b>GPS Location</b>	See pic.	<b>GPS Location</b>	See pic.
<b>Field Station#</b>	13415+00	<b>Field Station#</b>	13412+00
<b>Pic 1 Desc.</b>	0.3" total precipitation.	<b>Pic 2 Desc.</b>	Current ROW conditions.

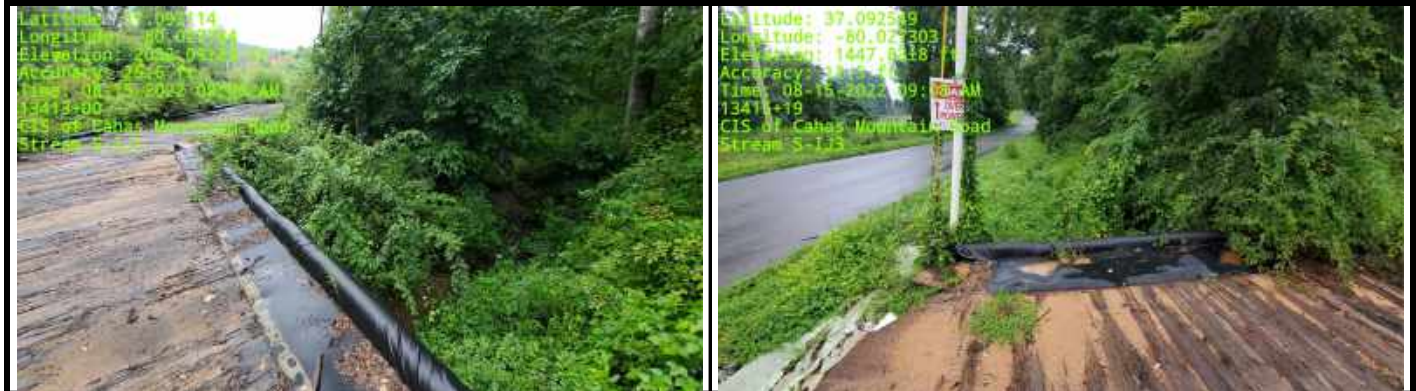
<b>GPS Location</b>	See pic.	<b>GPS Location</b>	See pic.
<b>Field Station#</b>	13413+00	<b>Field Station#</b>	13415+19
<b>Pic 3 Desc.</b>	Downstream side of stream crossing.	<b>Pic 4 Desc.</b>	Downstream side of stream crossing.

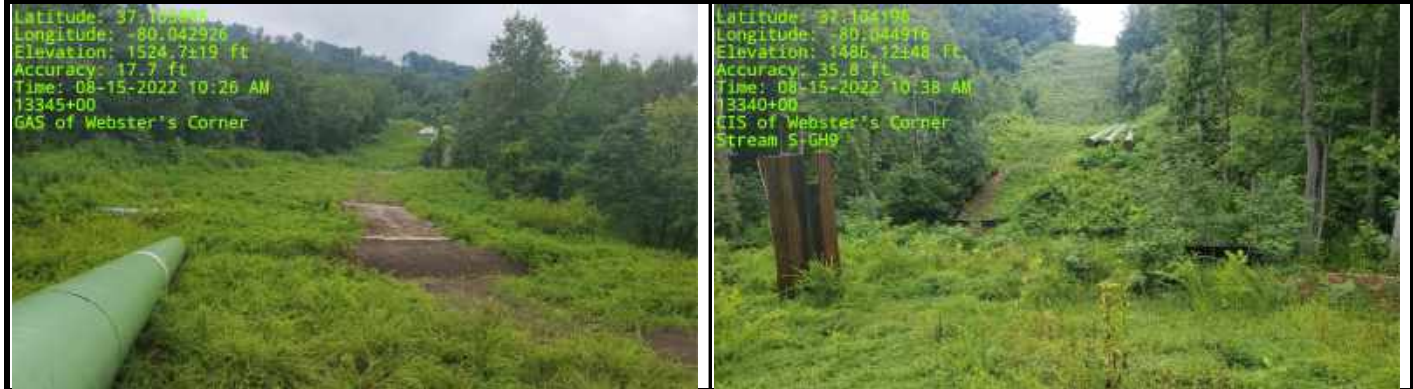
<b>GPS Location</b>	See pic.	<b>GPS Location</b>	See pic.
<b>Field Station#</b>	13345+00	<b>Field Station#</b>	13340+00
<b>Pic 13 Desc.</b>	Current ROW conditions.	<b>Pic 14 Desc.</b>	Current ROW conditions.

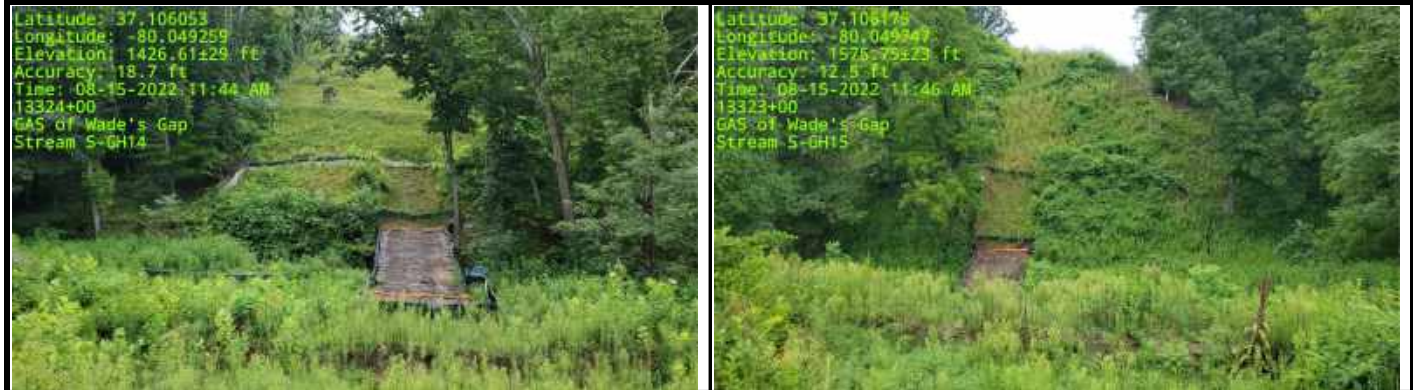
<b>GPS Location</b>	See pic.	<b>GPS Location</b>	See pic.
<b>Field Station#</b>	13324+00	<b>Field Station#</b>	13323+00
<b>Pic 15 Desc.</b>	Stream crossing from the CIS.	<b>Pic 16 Desc.</b>	Stream crossing from the GAS.

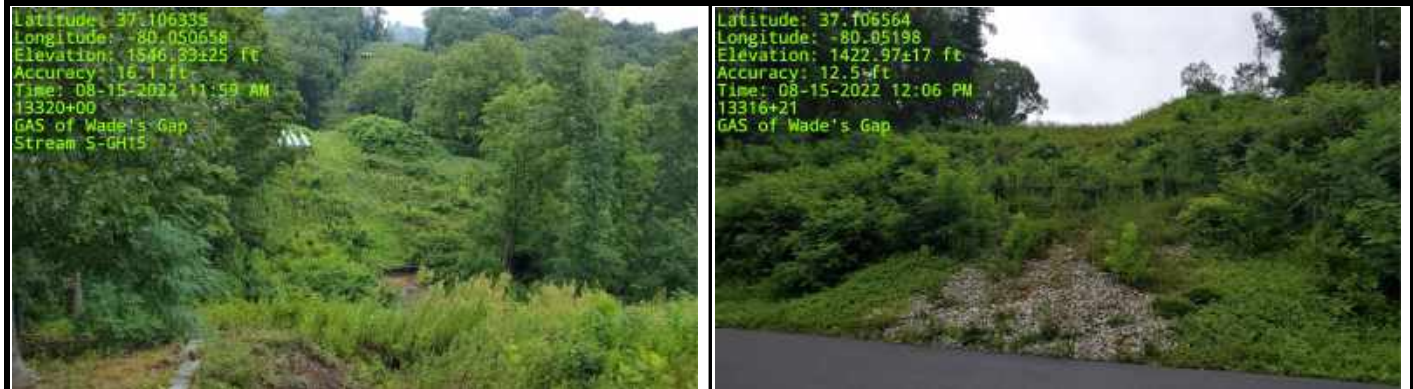
<b>GPS Location</b>	See pic.	<b>GPS Location</b>	See pic.
<b>Field Station#</b>	13320+00	<b>Field Station#</b>	13316+21
<b>Pic 17 Desc.</b>	Current ROW conditions.	<b>Pic 18 Desc.</b>	Current ROW conditions.

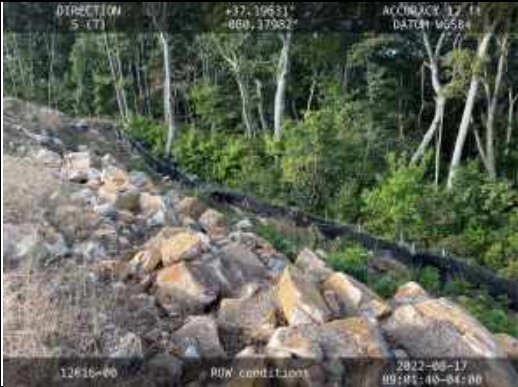
<b>GPS Location</b>	See photo for gps location data.	<b>GPS Location</b>	See photo for gps location data.	
<b>Field Station#</b>	12616+00	<b>Field Station#</b>	12614+00	
<b>Pic 7 Desc.</b>	Photo shows the ROW condition. ECDs are installed and functioning as designed.	<b>Pic 8 Desc.</b>	Photo shows the slope drain.

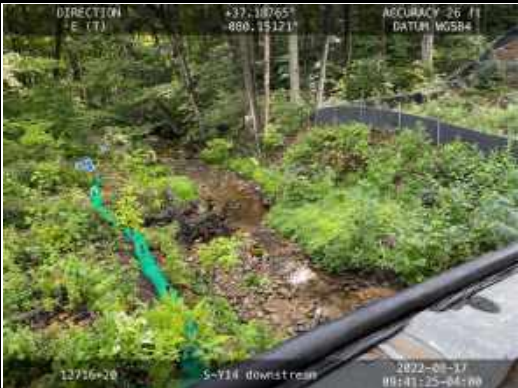
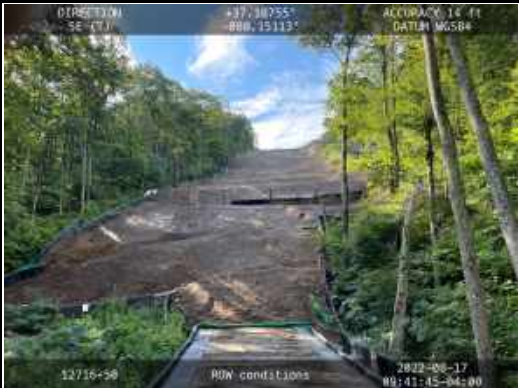
<b>GPS Location</b>	See photo for gps location data.		<b>GPS Location</b>	See photo for gps location data.	
<b>Field Station#</b>	12716+20		<b>Field Station#</b>	12716+50	
<b>Pic 15 Desc.</b>	Photo shows S-Y14 downstream from the bridge.		<b>Pic 16 Desc.</b>	Photo shows the ROW condition. ECDs are installed and functioning as designed.

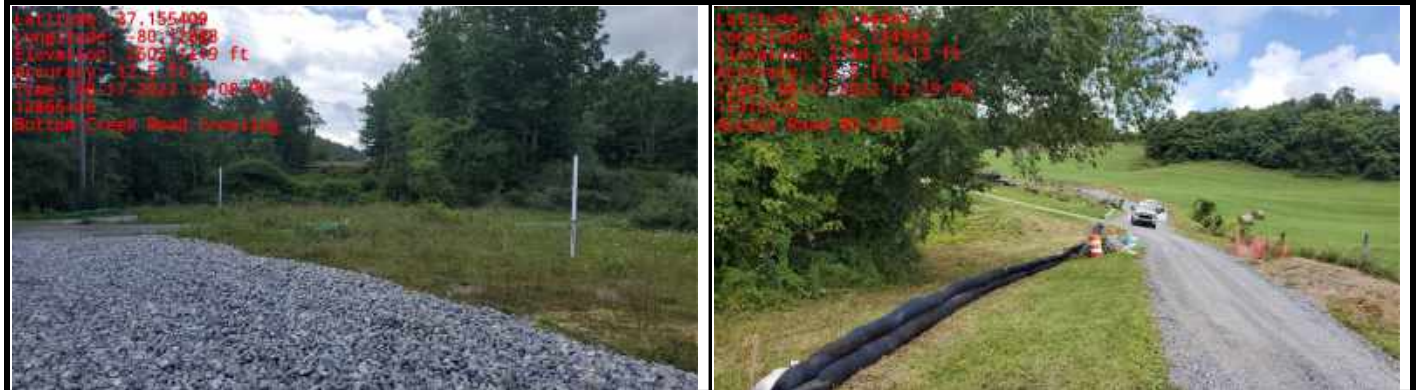
<b>GPS Location</b>	See pic.	<b>GPS Location</b>	See pic.
<b>Field Station#</b>	12866+26	<b>Field Station#</b>	12915+20
<b>Pic 15 Desc.</b>	Current ROW condition.	<b>Pic 16 Desc.</b>	Triple stacked 12" CFS replaced after being removed to allow mowing by the landowner.

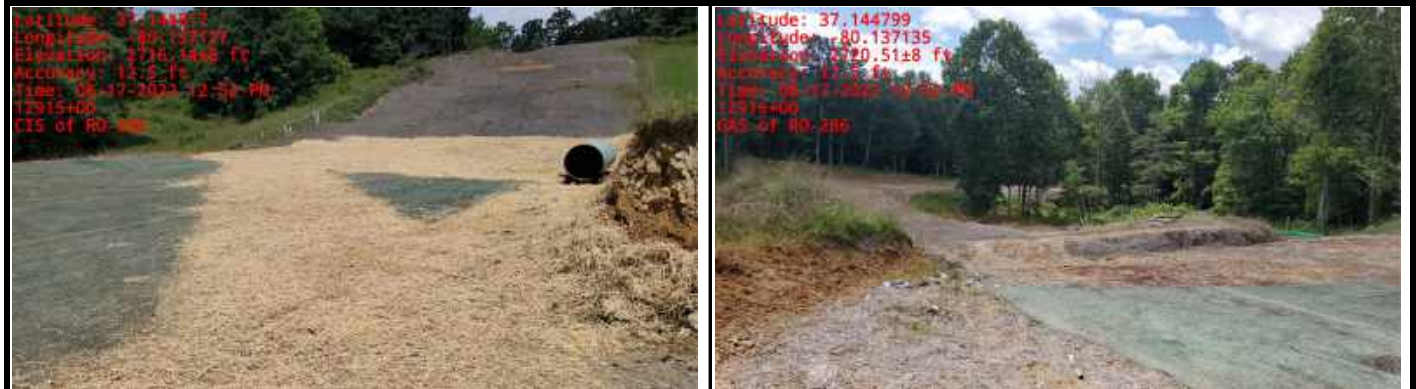
<b>GPS Location</b>	See pic.	<b>GPS Location</b>	See pic.
<b>Field Station#</b>	12915+00	<b>Field Station#</b>	12916+00
<b>Pic 17 Desc.</b>	Bare soils stabilized with grass seed and straw mulch.	<b>Pic 18 Desc.</b>	Current ROW condition.

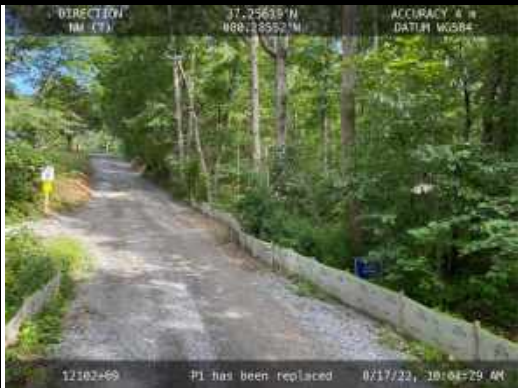
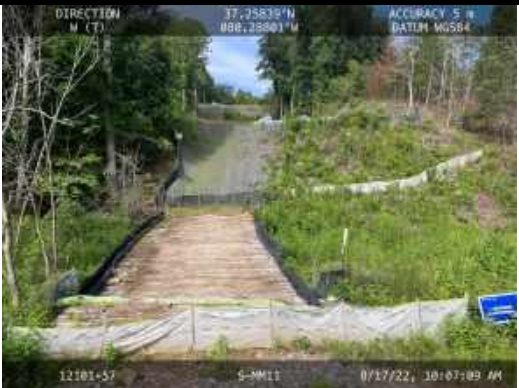
<b>GPS Location</b>	See photo	<b>GPS Location</b>	See photo
<b>Field Station#</b>	12102+69	<b>Field Station#</b>	12101+57
<b>Pic 9 Desc.</b>	P1 Silt Fence has been replaced	<b>Pic 10 Desc.</b>	Overview of Stream S-MM11

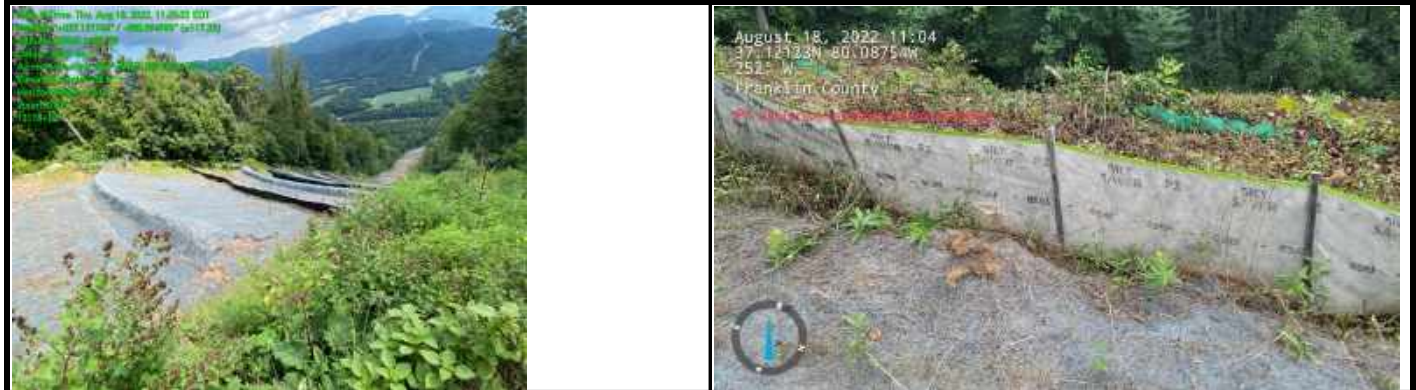
<b>GPS Location</b>	See pic.	<b>GPS Location</b>	See pic.
<b>Field Station#</b>	13118+00	<b>Field Station#</b>	13140+00
<b>Pic 15 Desc.</b>	Current ROW conditions.	<b>Pic 16 Desc.</b>	P1 silt fence repaired immediately after reporting.

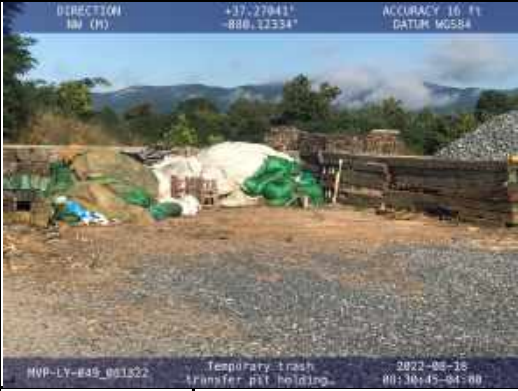
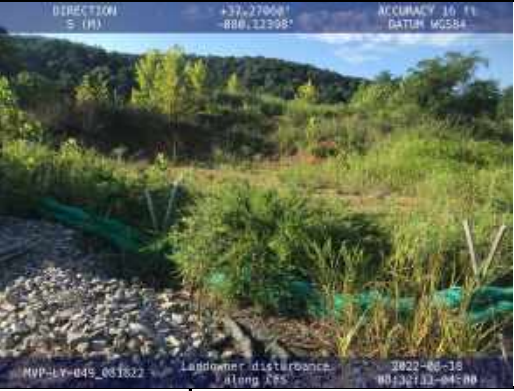
<b>GPS Location</b>	MVP-LY-049 See photo for gps data		<b>GPS Location</b>	MVP-LY-049 See photo for gps data
<b>Field Station#</b>	+0		<b>Field Station#</b>	+0
<b>Pic 13 Desc.</b>	Temporary trash transfer pit holding debris. Looking NW.		<b>Pic 14 Desc.</b>	Landowner soil disturbance along triple stack compost filter sock. No new damage to installed ECD's. Looking S.

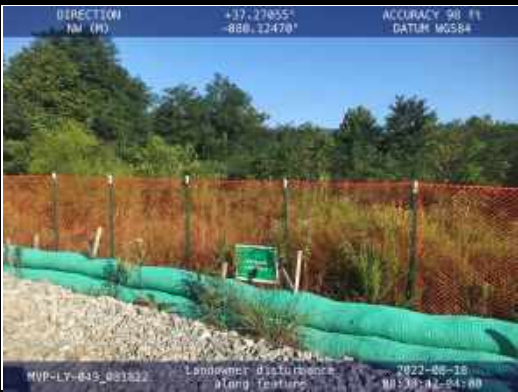
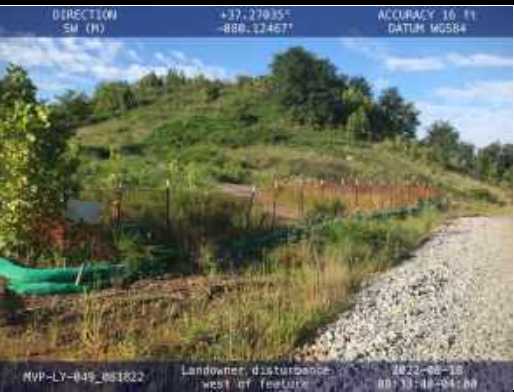
<b>GPS Location</b>	MVP-LY-049 See photo for gps data		<b>GPS Location</b>	MVP-LY-049 See photo for gps data
<b>Field Station#</b>	+0		<b>Field Station#</b>	+0
<b>Pic 15 Desc.</b>	Landowner soil disturbance along feature W-CV21A. Area not stabilized. Looking NW.		<b>Pic 16 Desc.</b>	Landowner soil disturbance west of feature W-CV21B. Areas not stabilized. Looking SW.

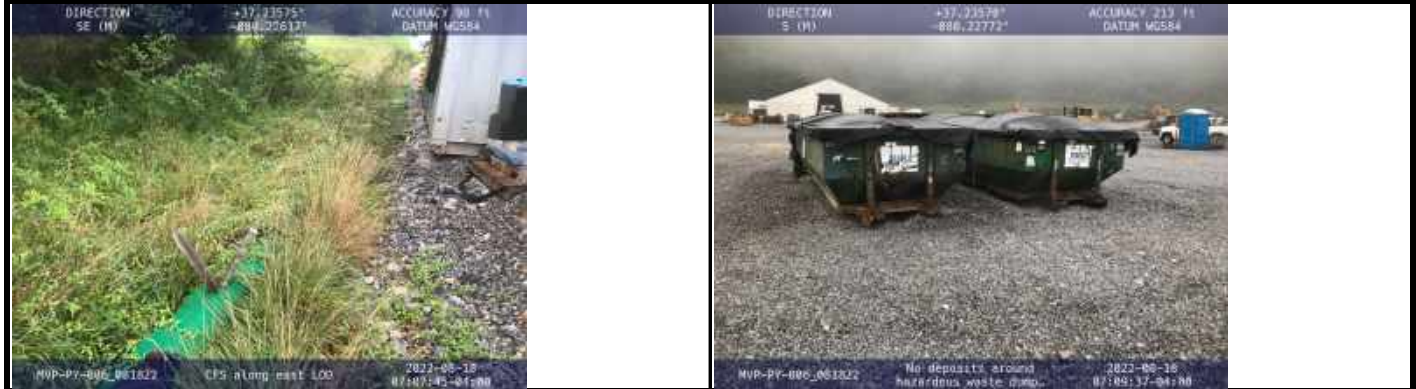
<b>GPS Location</b>	MVP-PY-006 See photo for gps data	<b>GPS Location</b>	MVP-PY-006 See photo for gps data
<b>Field Station#</b>	+0	<b>Field Station#</b>	+0
<b>Pic 13 Desc.</b>	Triple stack compost filter sock along east LOD. Overgrown with vegetation. Looking SE.	<b>Pic 14 Desc.</b>	No deposits or fluids around hazardous waste dumpsters. Looking S.

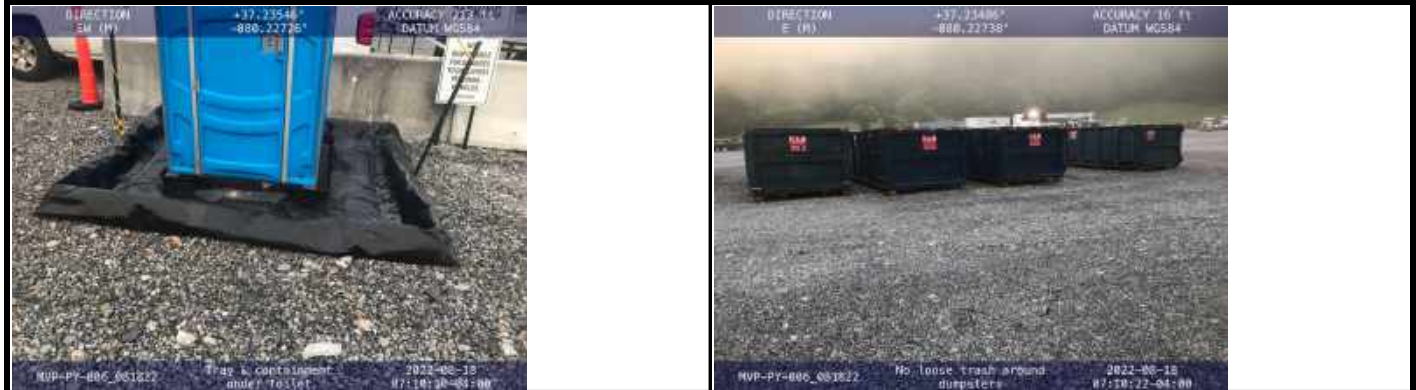
<b>GPS Location</b>	MVP-PY-006 See photo for gps data	<b>GPS Location</b>	MVP-PY-006 See photo for gps data
<b>Field Station#</b>	+0	<b>Field Station#</b>	+0
<b>Pic 15 Desc.</b>	Tray and containment under toilet. Tray holding fluids. Looking SW.	<b>Pic 16 Desc.</b>	No loose trash around dumpsters or in the yard. Looking E.

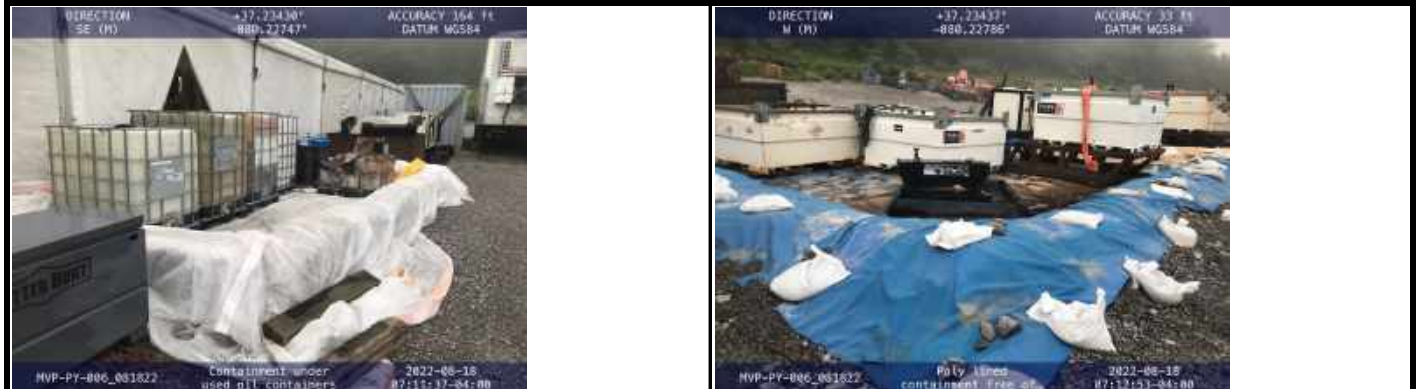
<b>GPS Location</b>	MVP-PY-006 See photo for gps data	<b>GPS Location</b>	MVP-PY-006 See photo for gps data
<b>Field Station#</b>	+0	<b>Field Station#</b>	+0
<b>Pic 17 Desc.</b>	Secondary containment under used oil containers secured and free of fluids. Looking SE.	<b>Pic 18 Desc.</b>	Poly lined rock berm containments free of stormwater. Looking W.
