Visual Site Inspection Report

Project Name H-600 Pipeline Spread H		AFE 124300138	Spread H-600 Pipeline Spread H
Contractor Precision		Report # 41503	
Inspector Dustin Lyons		Date/Time 8/29/2022 4:18 PM	
Permit # TBD	Inspection Type VA SWPP	Station Begin	12600+00
State VA	Inspection Area Partial	Station End	12725+00
County Roanoke	Ground Damp	Temperature (°F)	73.00
Municipality N/A	Weather Sunny	Rain Gauge (in)	0.50
Rain Accumulation Time (days)			3.00

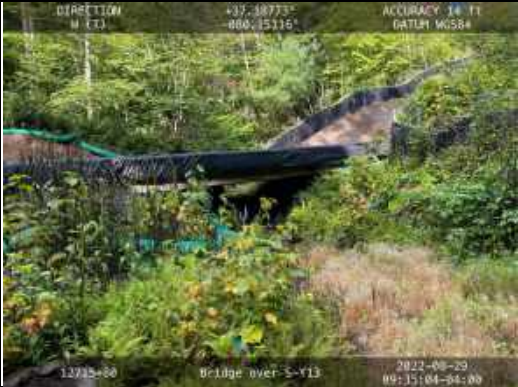
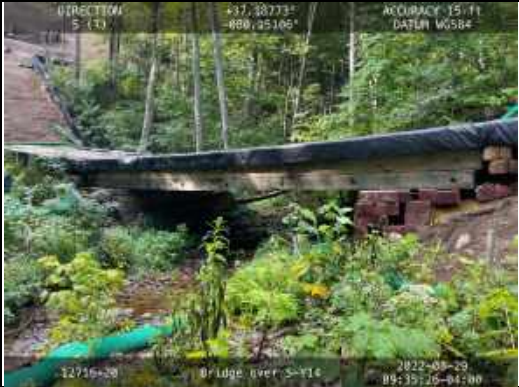
GPS Location	See photo for gps location data.		GPS Location	See photo for gps location data.	
Field Station#	12715+80		Field Station#	12716+20	
Pic 13 Desc.	Photo shows the bridge over stream S-Y13.		Pic 14 Desc.	Photo shows the bridge over stream S-Y14.

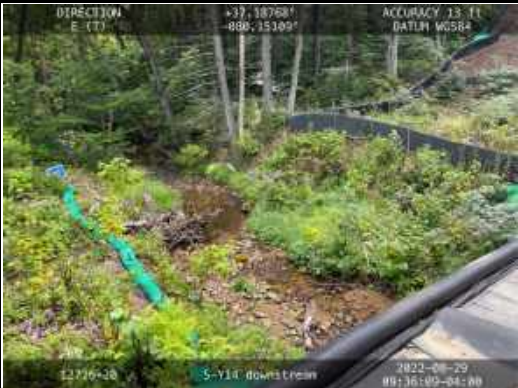
GPS Location	See photo for gps location data.		GPS Location	See photo for gps location data.	
Field Station#	12716+20		Field Station#	12716+50	
Pic 15 Desc.	Photo shows S-Y14 downstream from the bridge.		Pic 16 Desc.	Photo shows the ROW condition. ECDs are installed and functioning as designed.

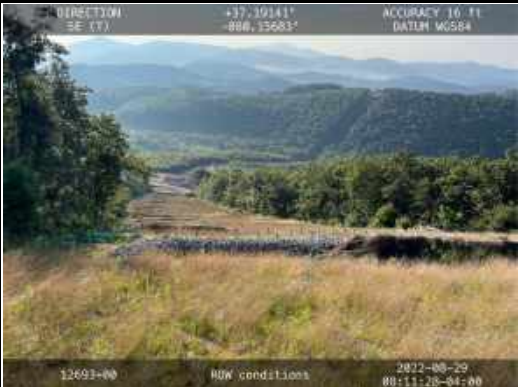
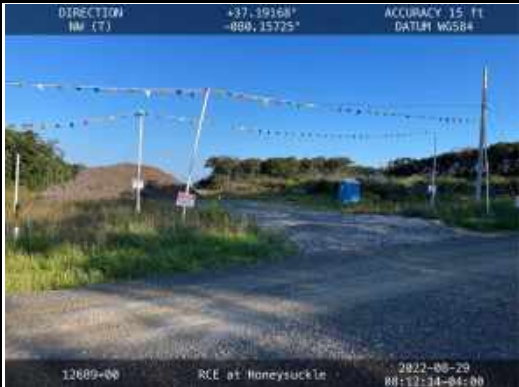
GPS Location	See photo for gps location data.		GPS Location	See photo for gps location data.	
Field Station#	12693+00		Field Station#	12689+00	
Pic 17 Desc.	Photo shows the ROW condition. ECDs are installed and functioning as designed.		Pic 18 Desc.	Photo shows the RCE at Honeysuckle Road.

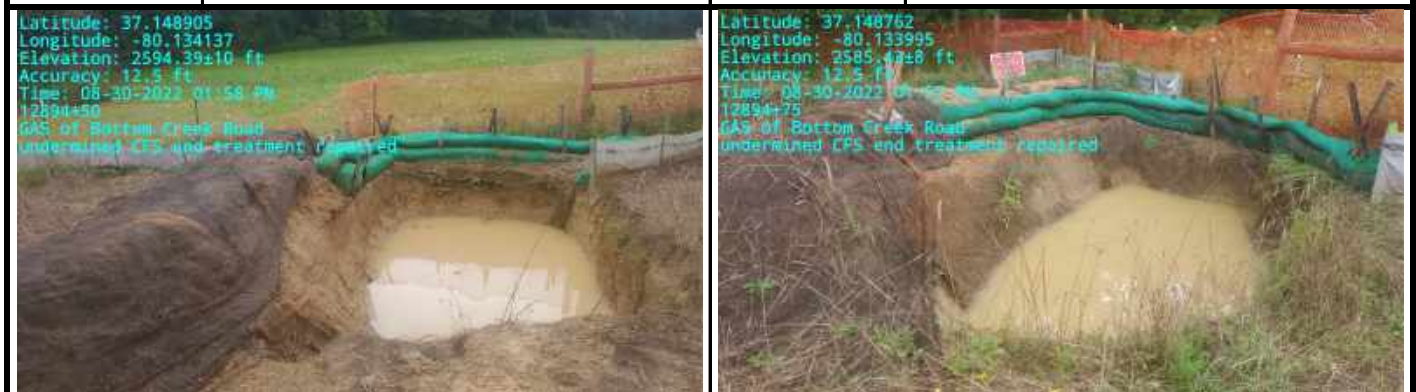
GPS Location	See pic.	GPS Location	See pic.
Field Station#	12894+50	Field Station#	12894+75
Pic 5 Desc.	CFS undermined at sump. Added to the punch list to be addressed by the contractor. Repaired 8/30	Pic 6 Desc.	CFS undermined at sump. Added to the punch list to be addressed by the contractor. Repaired 8/30

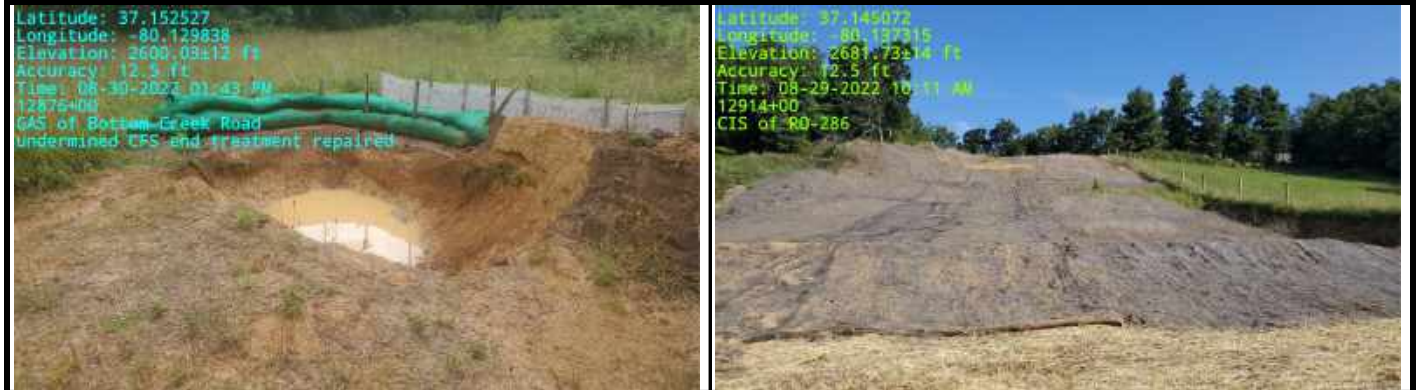
GPS Location	See pic.	GPS Location	See pic.
Field Station#	12876+00	Field Station#	12914+00
Pic 9 Desc.	CFS undermined at sump. Added to the punch list to be addressed by the contractor. Repaired 8/30	Pic 10 Desc.	Current ROW conditions.

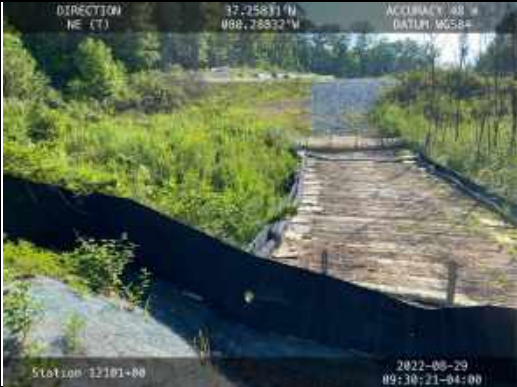
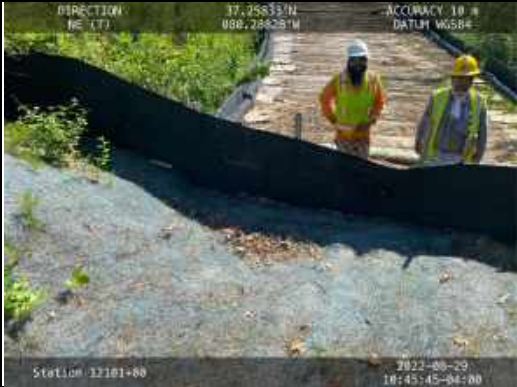
GPS Location	Please see photo for details.		GPS Location	Please see photo for details.	
Field Station#	12101+00		Field Station#	12101+00	
Pic 13 Desc.	Photo shows punch list item of hole in SSF fabric.		Pic 14 Desc.	Photo shows punch list item completed.

* One punch list item was found during todays VA DEQ SWPPP inspection and consisted of repairing hole in SSF @ 12101+00.

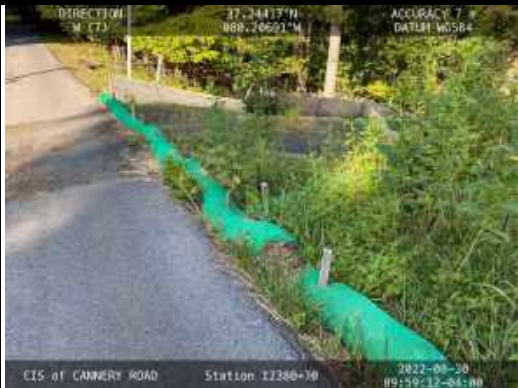
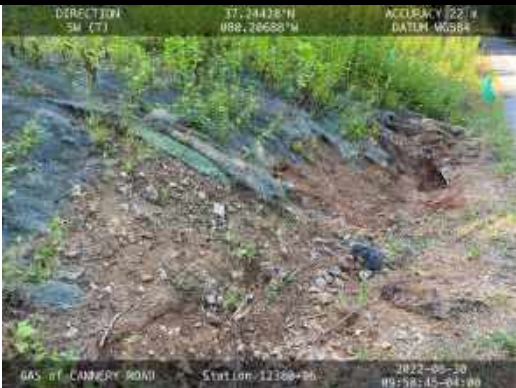
GPS Location	Please see photo for details.		GPS Location	Please see photo for details.	
Field Station#	12380+70		Field Station#	12380+86	
Pic 9 Desc.	Photo shows punch list item from today of damaged CFS in need of repair.		Pic 10 Desc.	Photo shows punch list item from today of third party damaged ECB in need of replacing.

* Three total punch list items were found during todays VA DEQ SWPPP inspection and they are as follows: (1) Repair damaged CFS at station 12380+70 (Resolved 8/30/22) (2) Repair third party damaged ECB at station 12380+86 (Resolved 8/30/22) (3) Replace damaged triangle silt dike at station 12425+00.

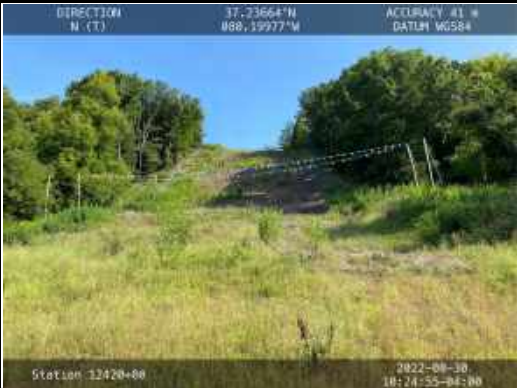
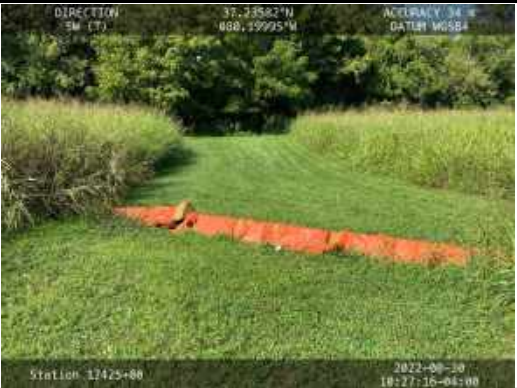
GPS Location	Please see photo for details.		GPS Location	Please see photo for details.	
Field Station#	12420+00		Field Station#	12425+00	
Pic 15 Desc.	Photo shows the stabilized ROW conditions with water bars and that all ECDs are installed and are functioning as designed.		Pic 16 Desc.	Photo shows today's punch list item of a damaged triangle silt dike in need of placing.

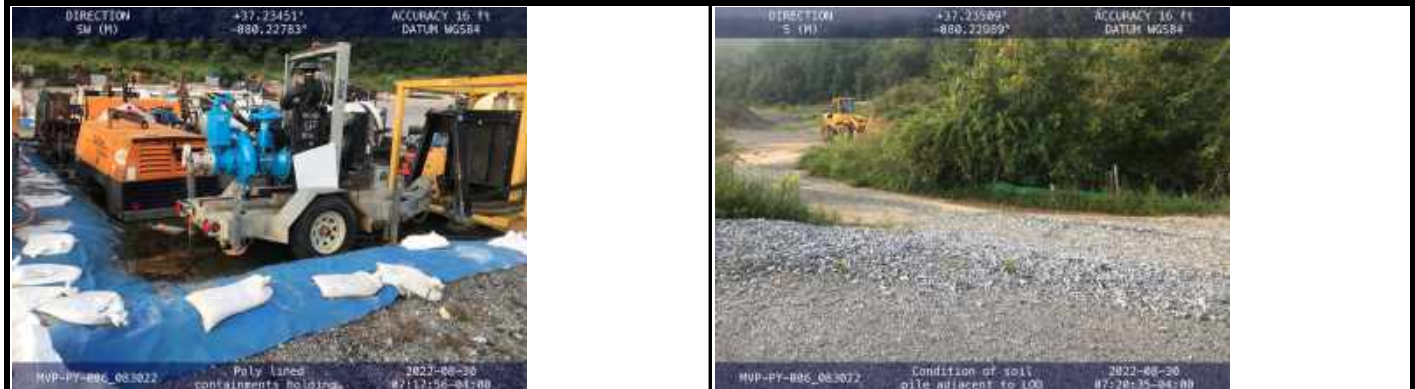
GPS Location	MVP-PY-006 See photo for gps data	GPS Location	MVP-PY-006 See photo for gps data
Field Station#	+0	Field Station#	+0
Pic 17 Desc.	Poly lined rock berm containments holding stormwater. Looking SW.	Pic 18 Desc.	Soil pile not stabilized adjacent to LOD on VDOT property. Looking S.

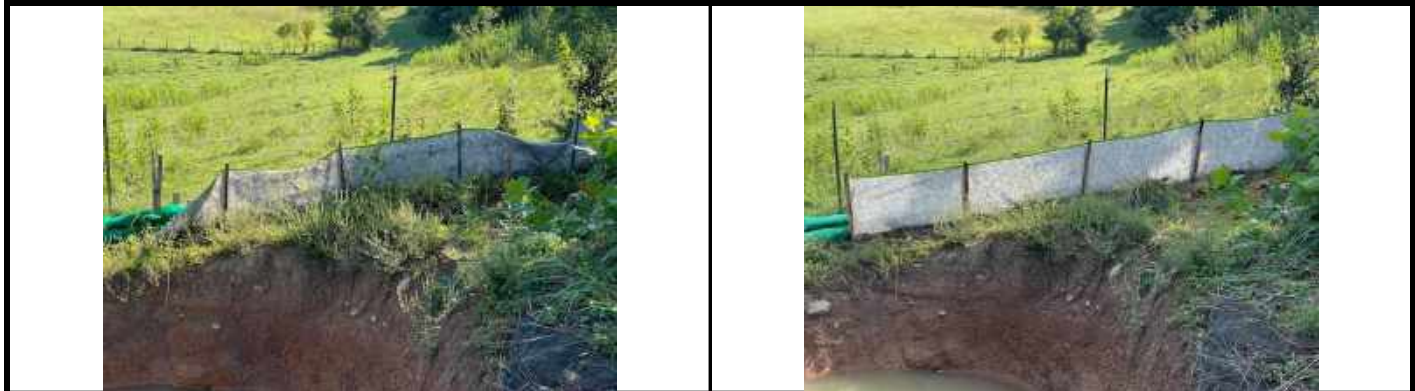
GPS Location	See Above	GPS Location	See Above
Field Station#	12470+00	Field Station#	12470+00
Pic 3 Desc.	Punchlist Item: Repair P1 Silt Fence.	Pic 4 Desc.	Punchlist Item Completed: Repair P1 Silt Fence.

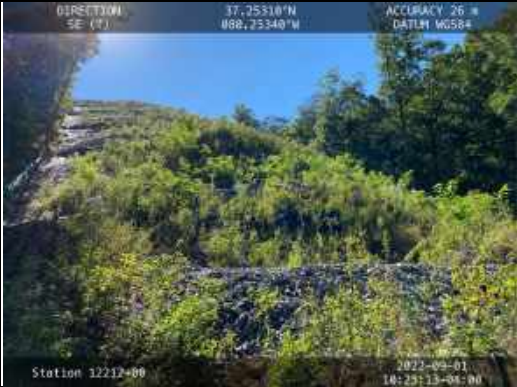
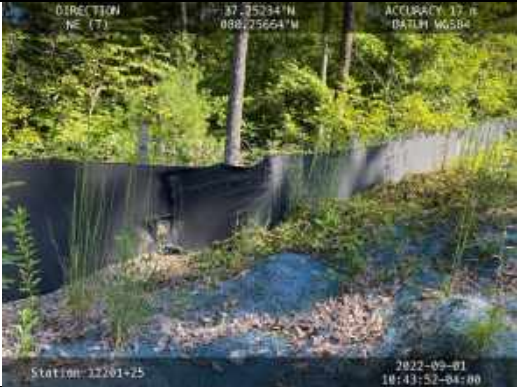
GPS Location	Please see photo for details.		GPS Location	Please see photo for details.	
Field Station#	12212+00		Field Station#	12201+25	
Pic 7 Desc.	Photo shows the stabilized ROW conditions with water bars and that all ECDs are installed and are functioning as designed.		Pic 8 Desc.	Photo shows todays punch list item of holes in SSF fabric.

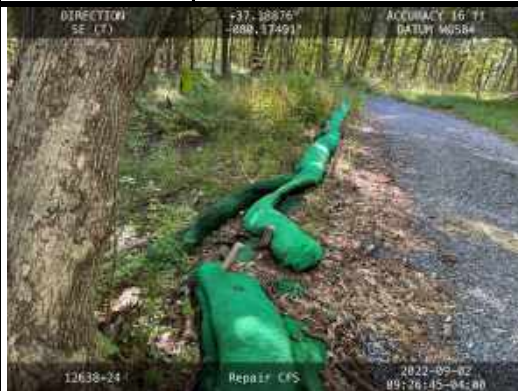
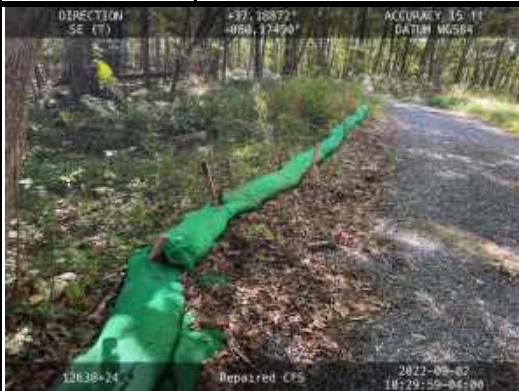
GPS Location	See photo for gps location data.		GPS Location	See photo for gps location data.
Field Station#	12638+24		Field Station#	12638+24
Pic 11 Desc.	Photo shows the displaced CFS along RO-279.01.		Pic 12 Desc.	Photo shows the repaired CFS along RO-279.01.
