Visual Site Inspection Report

Project Name H-600 Pipeline Spread I		AFE 124300139	Spread H-600 Pipeline Spread I
Contractor Precision		Report # 40496	
Inspector Ben Farmer		Date/Time 8/1/2022 12:54 PM	
Permit # TBD	Inspection Type VA SWPP	Station Begin 13853+45	
State VA	Inspection Area Partial	Station End 13958+31	
County Franklin	Ground Wet	Temperature (°F) 72.00	
Municipality N/A	Weather Cloudy	Rain Gauge (in) 1.50	
Rain Accumulation Time (days)			0.00

SWPPP Inspection (Cloudy, 72F)
 Rain Gauge= 1.5"
 13853+45-13958+31

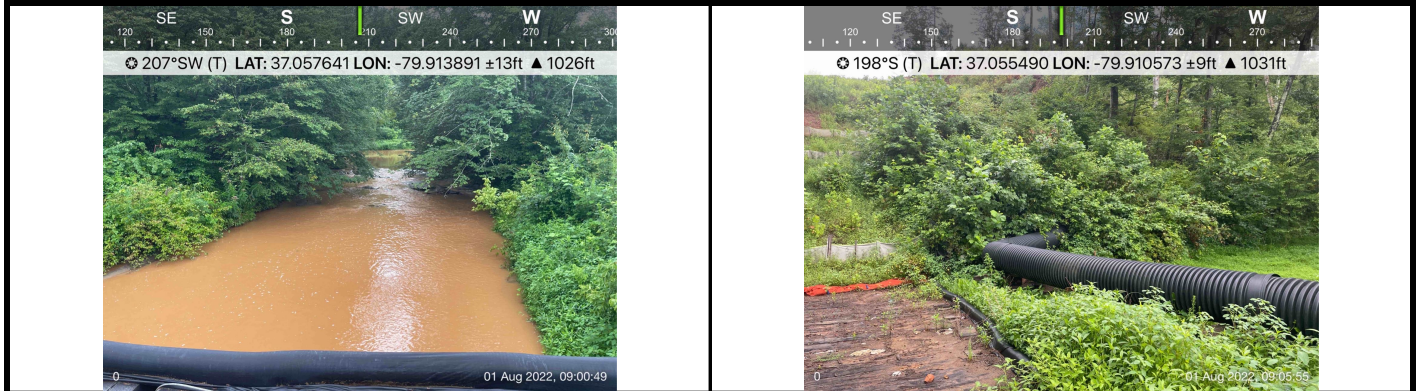
Pic 1 Desc.	Resource buffers remain well vegetated	Pic 2 Desc.	Equipment bridge ECDs are in good condition
--------------------	--	--------------------	---

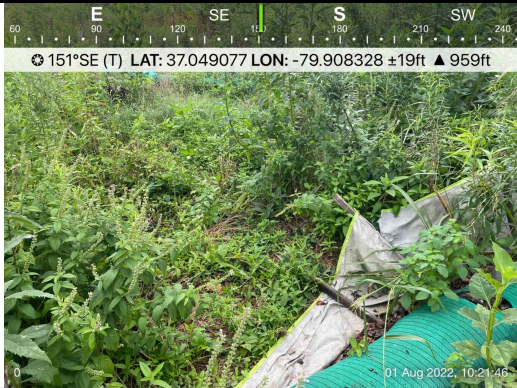
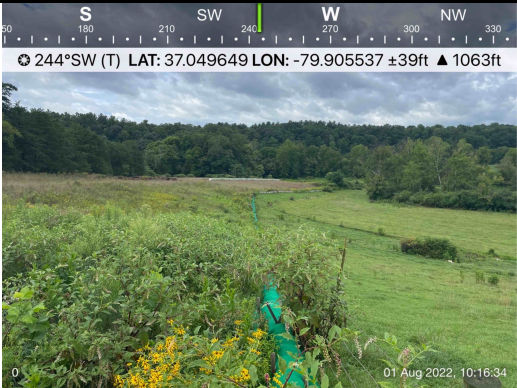
GPS Location	See photo	GPS Location	See photo
Field Station#	13916+30	Field Station#	13925+00
Pic 9 Desc.	P1 has been damaged and needs to be replaced	Pic 10 Desc.	CFS is in good condition throughout this section

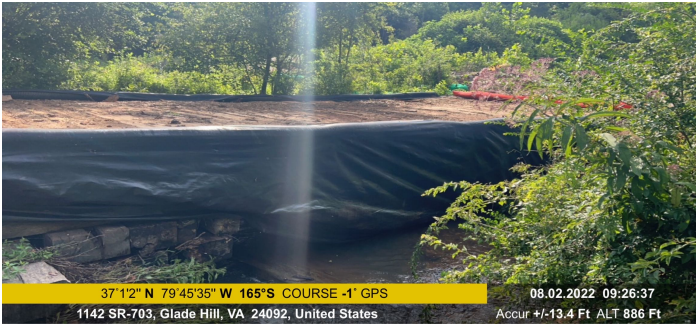
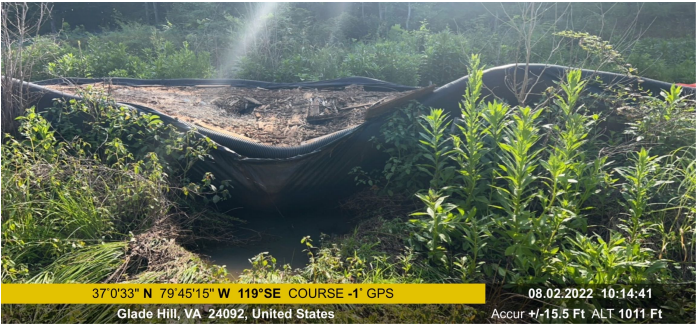
GPS Location	3	GPS Location	4		
Field Station#	14496+58	Field Station#	14531+58		
Pic 3 Desc.	Routine maintenance. Bridge maintenance required at S-G20.	Pic 4 Desc.	Routine maintenance. Bridge maintenance required at S-G18.

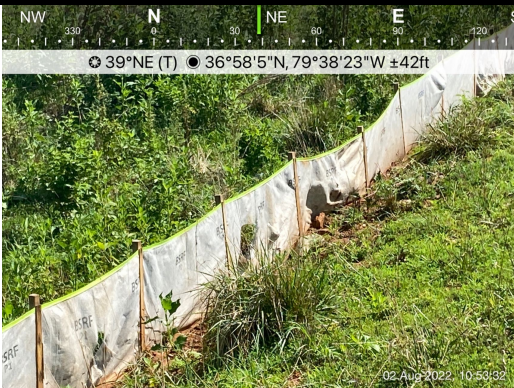
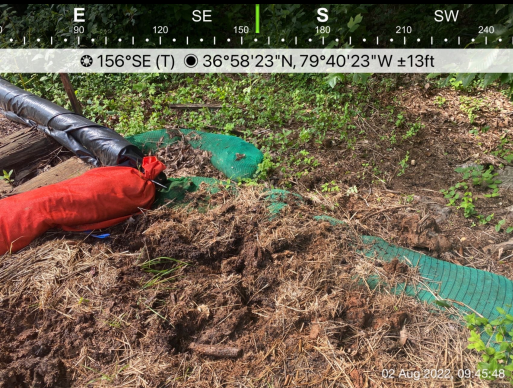
GPS Location 0		GPS Location 0			
Field Station# 14923+00		Field Station# 14823+40			
Pic 5 Desc. Approximately 14923+00. P-1 along drainage feature requires maintenance. Damaged by livestock.		Pic 6 Desc. Approximately 14823+40. CFS requires maintenance. Livestock damage. Remove soil buildup from CFS.

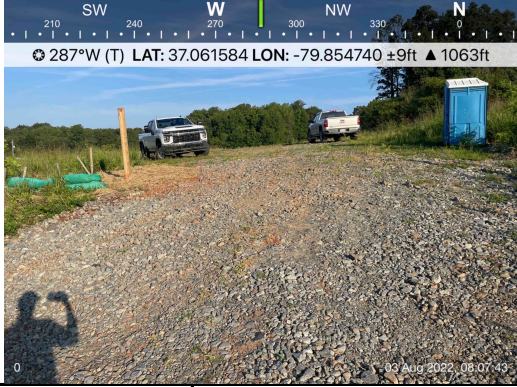
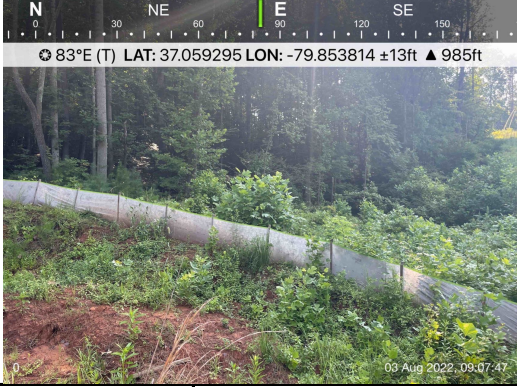
GPS Location	See photo	GPS Location	See photo
Field Station#	14131+00	Field Station#	14141+00
Pic 9 Desc.	RCE needs additional stone.	Pic 10 Desc.	P1 is in good condition at all stream and wetland buffers

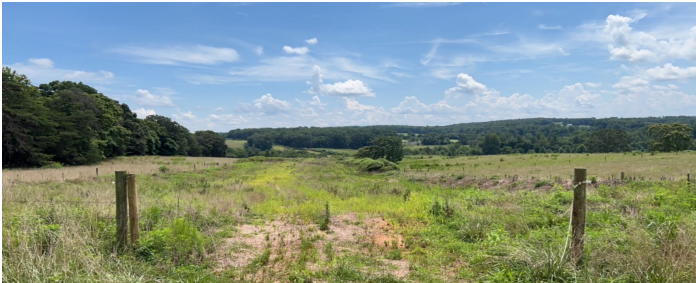
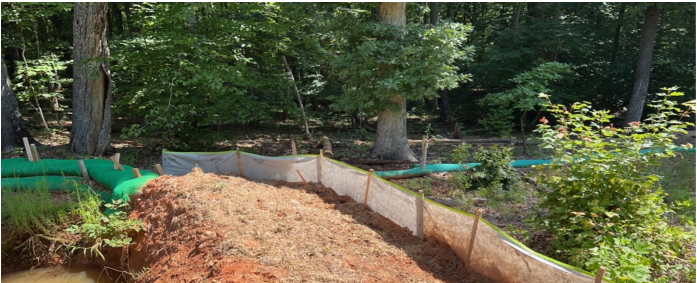
Field Station#	14371+00		Field Station#	14433+00	
Pic 3 Desc.	ROW stabilized and vegetated in temporary area.		Pic 4 Desc.	Contractor replaced P1 silt fence per punch list item.
