Visual Site Inspection Report

Project Name H-602 Pipeline Spread I		AFE 124300139	Spread H-602 Pipeline Spread I
Contractor Precision		Report # 41263	
Inspector John White		Date/Time 8/22/2022 10:18 AM	
Permit # TBD	Inspection Type VA SWPP	Station Begin	00+00
State VA	Inspection Area Full	Station End	19+25
County Pittsylvania	Ground Wet	Temperature (°F)	74.00
Municipality Chatham	Weather Cloudy	Rain Gauge (in)	0.60
			Rain Accumulation Time (days) 6.00

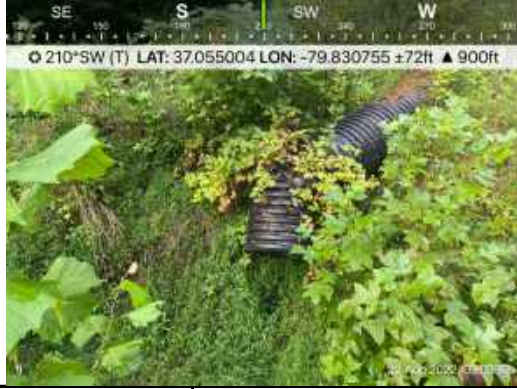
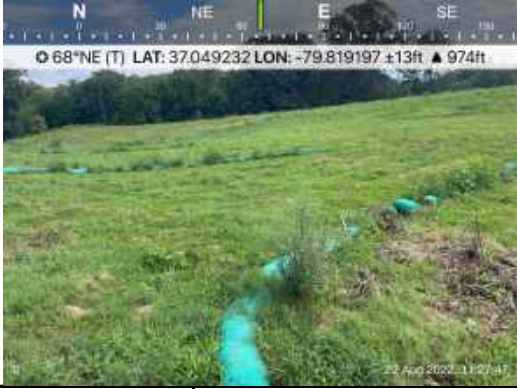
GPS Location	See photo	GPS Location	See photo
Field Station#	14224+00	Field Station#	14230+00
Pic 9 Desc.	Perimeter P1 has been damaged and needs to be replaced	Pic 10 Desc.	Perimeter P1 has been damaged and needs to be replaced

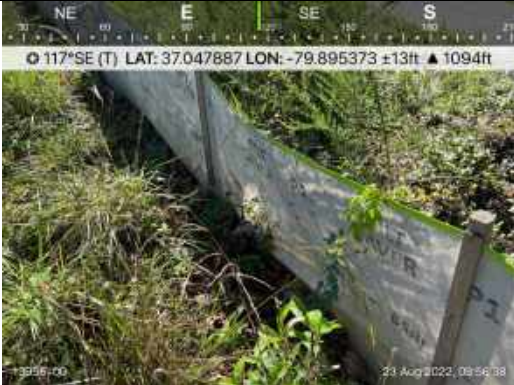
GPS Location See photo		GPS Location See photo			
Field Station# 13955+00		Field Station# 13954+00			
Pic 1 Desc. P1 has been damaged and needs to be replaced		Pic 2 Desc. Slope drain outlet is in good condition and functioning

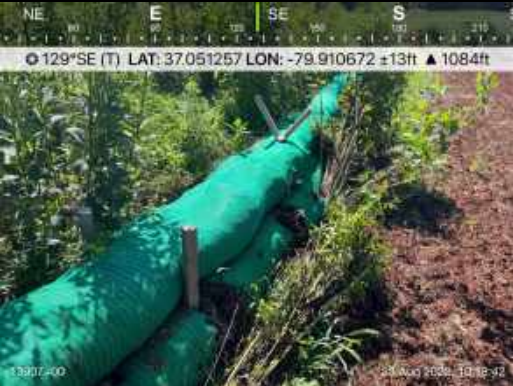
GPS Location See photo		GPS Location See photo			
Field Station# 13942+00		Field Station# 13907+00			
Pic 5 Desc. CWDs are functioning as intended		Pic 6 Desc. CFS has been damaged by 3rd party and needs to be repaired

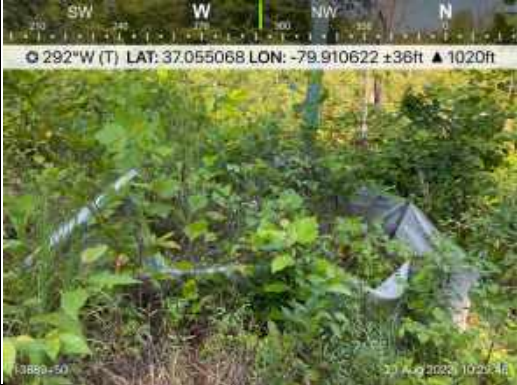
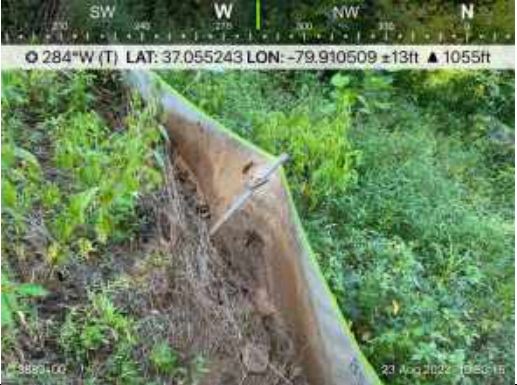
GPS Location	See photo	GPS Location	See photo
Field Station#	13889+50	Field Station#	13889+00
Pic 13 Desc.	P1 has been damaged and needs to be replaced	Pic 14 Desc.	P1 has been damaged and needs to be replaced

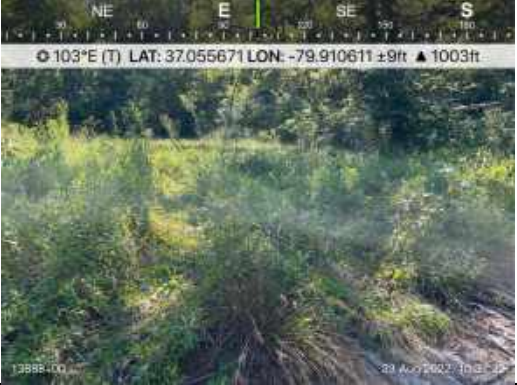
GPS Location	See photo	GPS Location	See photo
Field Station#	13888+50	Field Station#	13888+00
Pic 15 Desc.	Slope drain is functioning as intended	Pic 16 Desc.	P1 has been damaged by 3rd party and needs to be replaced
