Visual Site Inspection Report

Project Name H-600 Pipeline Spread I		AFE 124300139	Spread H-600 Pipeline Spread I
Contractor Precision		Report # 41511	
Inspector Justin Burch		Date/Time 8/29/2022 12:12 PM	
Permit # TBD	Inspection Type VA SWPP	Station Begin	15142+66
State VA	Inspection Area Full	Station End	15260+00
County Pittsylvania	Ground Dry	Temperature (°F)	90.00
Municipality Chatham	Weather Sunny	Rain Gauge (in)	0.00
Rain Accumulation Time (days)			6.00

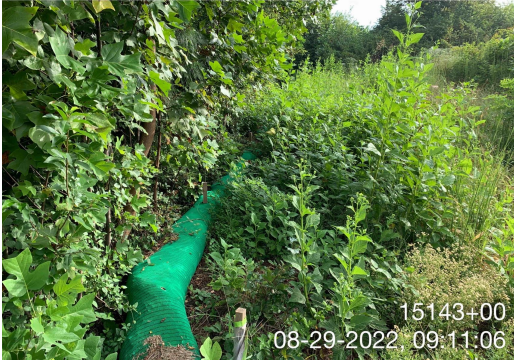
<p>15144+00 08-29-2022 09:11:39</p>	
GPS Location	0	GPS Location	0
Field Station#	15143+00	Field Station#	15144+00
Pic 1 Desc.	Perimeter CFS in acceptable condition	Pic 2 Desc.	Permanent vegetative stabilization in acceptable condition
<p>239°SW (T) 36.945832°, -79.575629° ±13ft ▲ 823ft</p>

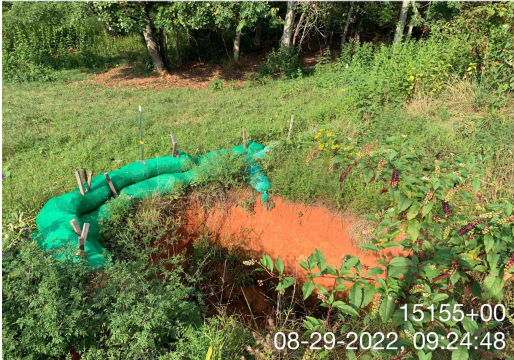
<p>15200+00 08-29-2022 10:53:05</p>	
GPS Location	0	GPS Location	0
Field Station#	15155+00	Field Station#	15200+00
Pic 3 Desc.	Waterbar end treatment in acceptable condition	Pic 4 Desc.	Permanent vegetative stabilization in acceptable condition
<p>220°SW (T) 36.943923°, -79.571599° ±4169ft ▲ 722ft</p>

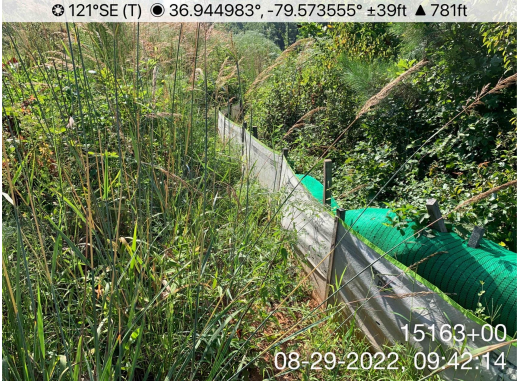
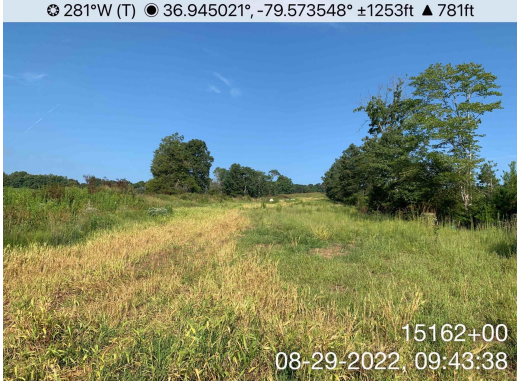
GPS Location	0	GPS Location	0	GPS Location	0
Field Station#	15163+00	Field Station#	15162+00	Field Station#	15162+00
Pic 7 Desc.	P1 silt fence in acceptable condition		Pic 8 Desc.	Temporary vegetative stabilization in acceptable condition

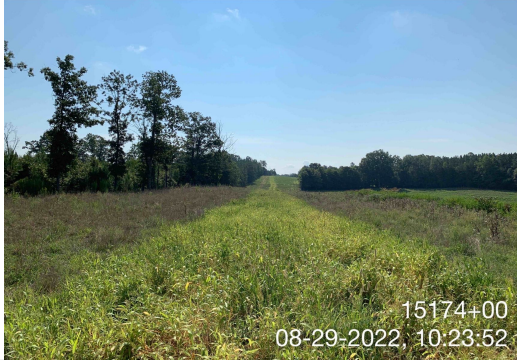
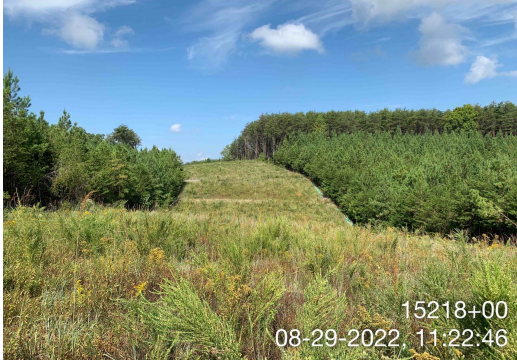
GPS Location	0	GPS Location	0	GPS Location	0
Field Station#	15174+00	Field Station#	15218+00	Field Station#	15218+00
Pic 9 Desc.	Permanent vegetative stabilization in acceptable condition		Pic 10 Desc.	Permanent vegetative stabilization in acceptable condition	
Insert image here			Insert image here		
GPS Location		GPS Location		GPS Location	
Field Station#		Field Station#		Field Station#	
Pic 11 Desc.		Pic 12 Desc.		Pic 12 Desc.

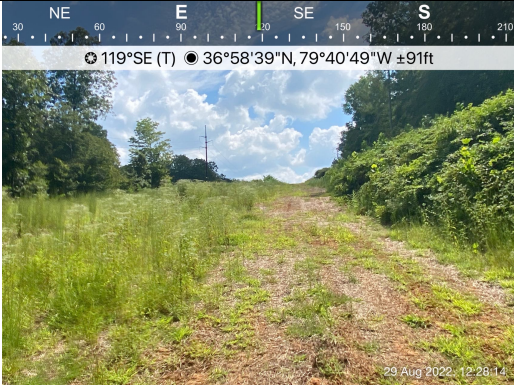
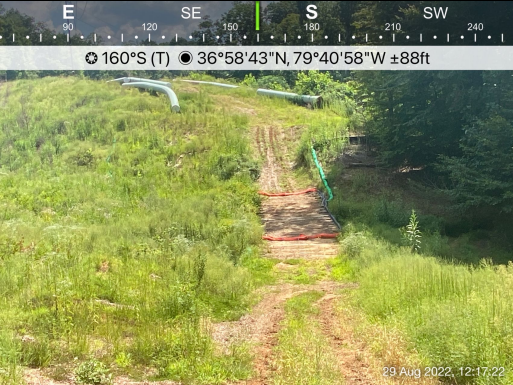
GPS Location	0	GPS Location	0
Field Station#	14799+00	Field Station#	14788+77
Pic 1 Desc.	Approximately 14799+00. Overview of ROW.	Pic 2 Desc.	Approximately 14788+77. Overview of stream crossing, equipment bridge and ECDs at stream S-H25.

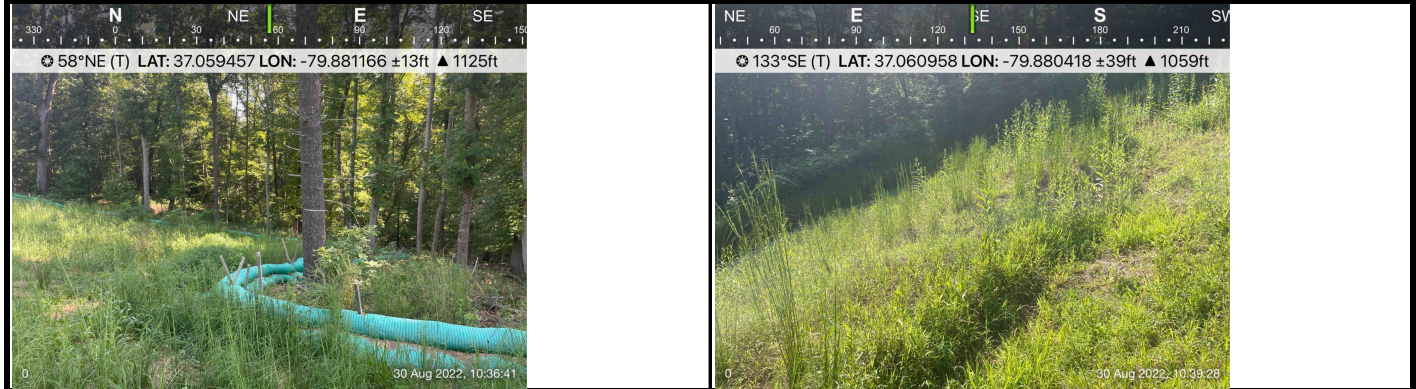
GPS Location	See photo	GPS Location	See photo
Field Station#	14027+00	Field Station#	14033+00
Pic 7 Desc.	CFS is in good condition throughout this section.	Pic 8 Desc.	Waterbars are functioning as intended

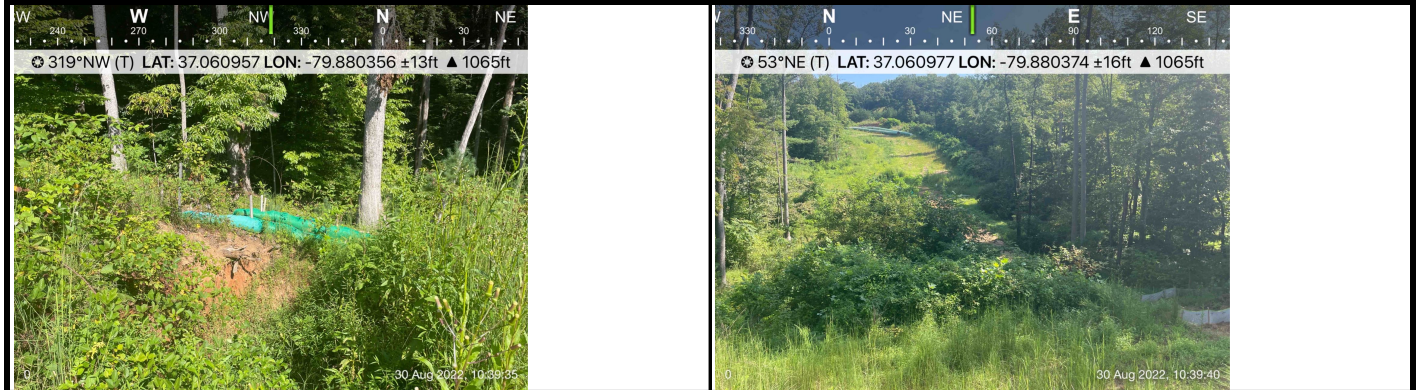
GPS Location	See photo	GPS Location	See photo
Field Station#	14033+00	Field Station#	14035+00
Pic 9 Desc.	End treatments are functioning as intended	Pic 10 Desc.	Resource buffers remain well vegetated

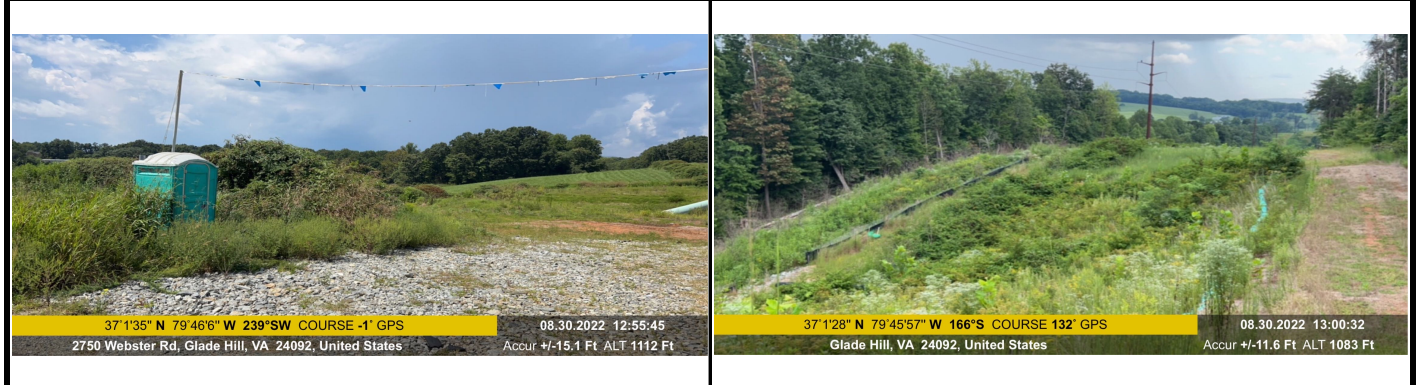
GPS Location	1	GPS Location	2
Field Station#	14454+22	Field Station#	14461+00
Pic 1 Desc.	RCE in good condition; portajon properly contained in secondary containment at road crossing.	Pic 2 Desc.	Perimeter SSF and CFS in good condition.

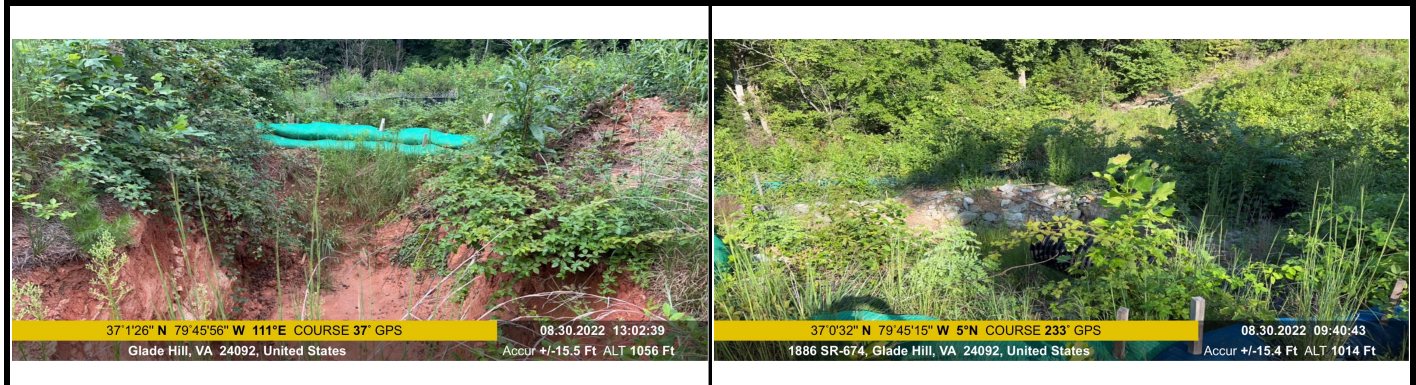
GPS Location	3	GPS Location	4
Field Station#	14479+00	Field Station#	14532+50
Pic 3 Desc.	Sump pit and CFS end treatment performing intended functions.	Pic 4 Desc.	Plunge pool performing intended function.

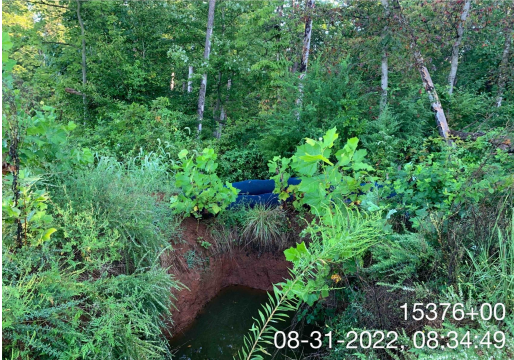
GPS Location		0		GPS Location		0	
Field Station#		15376+00		Field Station#		15381+00	
Pic 1 Desc.		Waterbar end treatment in acceptable condition		Pic 2 Desc.		CFS in acceptable condition

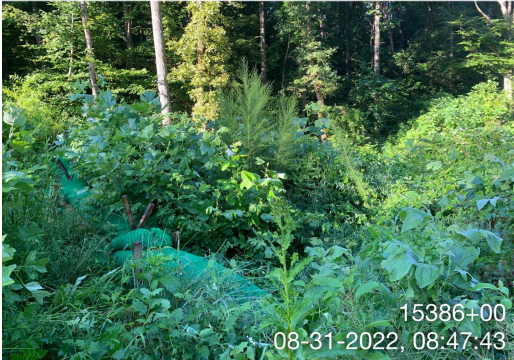
GPS Location		0		GPS Location		0	
Field Station#		15386+00		Field Station#		15394+00	
Pic 3 Desc.		CFS and sensitive resource buffer in acceptable conditions		Pic 4 Desc.		P1 silt fence in acceptable condition

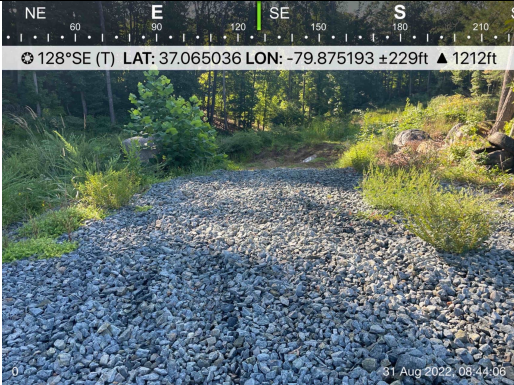
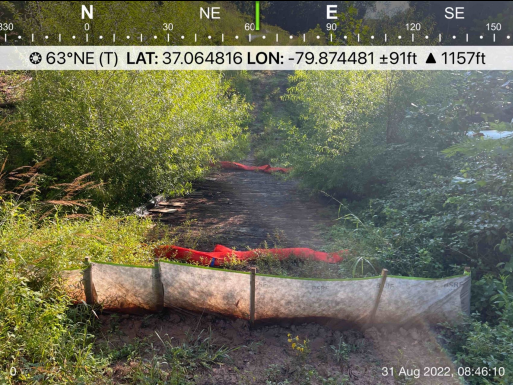
GPS Location	See photo	GPS Location	See photo
Field Station#	14062+17	Field Station#	14066+77
Pic 1 Desc.	RCEs are in good condition at all road crossings	Pic 2 Desc.	Equipment bridge ECDs are functioning as intended

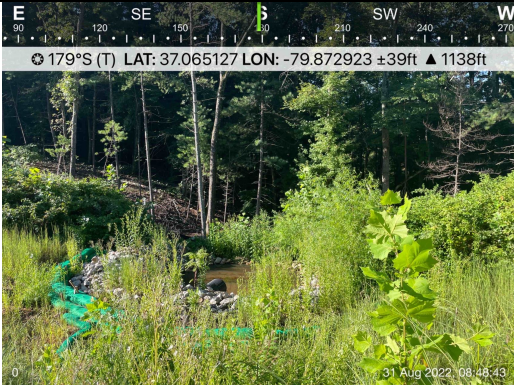
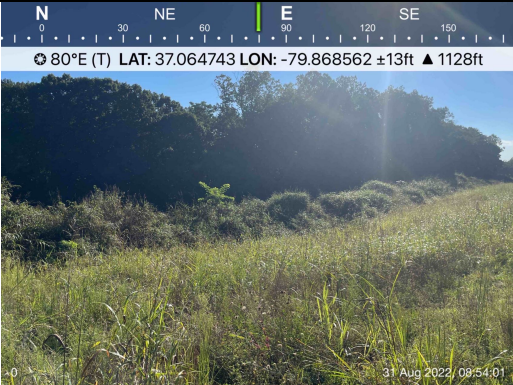
GPS Location	See photo	GPS Location	See photo
Field Station#	14070+00	Field Station#	14085+00
Pic 3 Desc.	CWDs are functioning as intended	Pic 4 Desc.	Topsoil berms remain stabilized

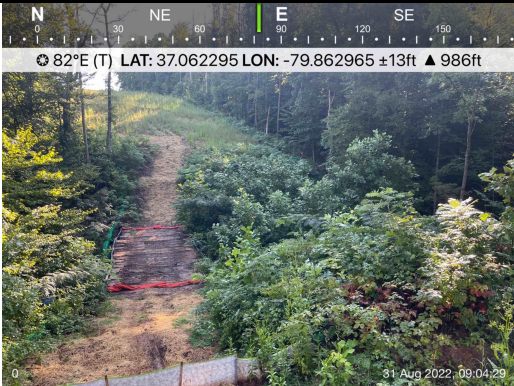
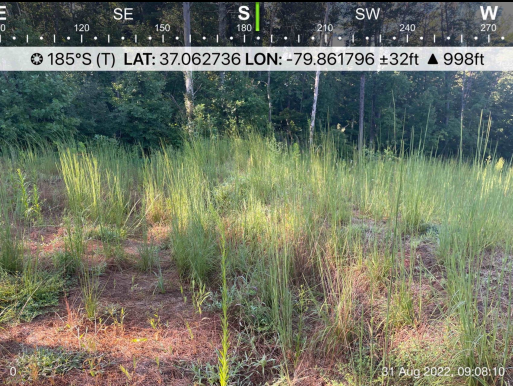
GPS Location	See photo	GPS Location	See photo
Field Station#	14105+20	Field Station#	14110+00
Pic 5 Desc.	Resource buffers remain well vegetated	Pic 6 Desc.	Waterbars are in good condition

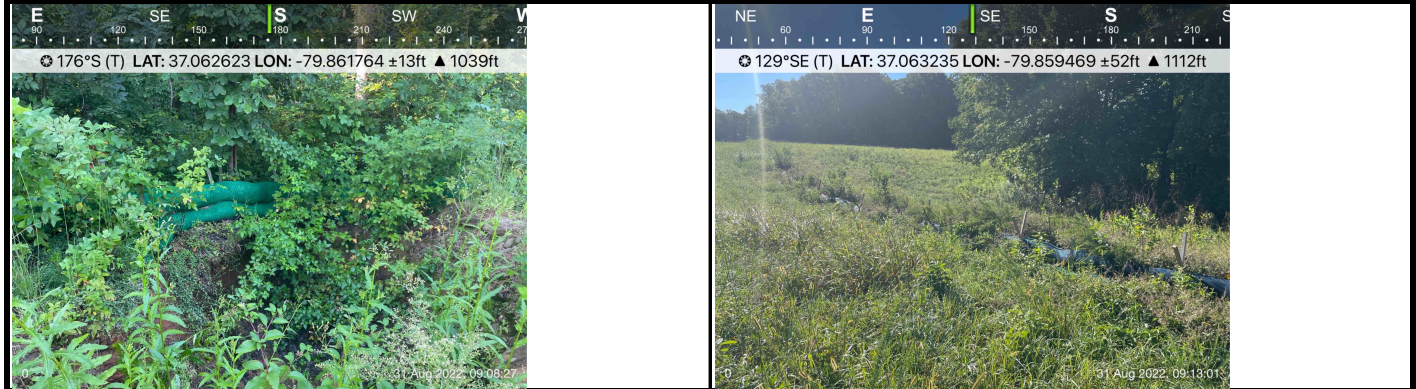
GPS Location	See photo	GPS Location	See photo
Field Station#	14110+00	Field Station#	14120+00
Pic 7 Desc.	End treatments are functioning as intended	Pic 8 Desc.	CFS is in good condition throughout this section

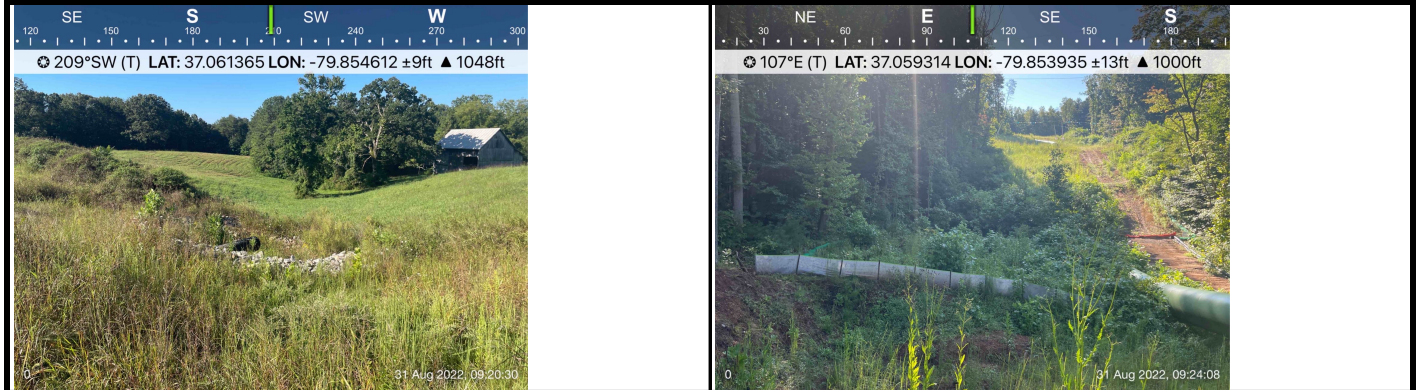
GPS Location	See photo	GPS Location	See photo
Field Station#	14132+00	Field Station#	14141+00
Pic 9 Desc.	CWD is functioning as intended	Pic 10 Desc.	P1 is in good condition at all stream and wetland buffers

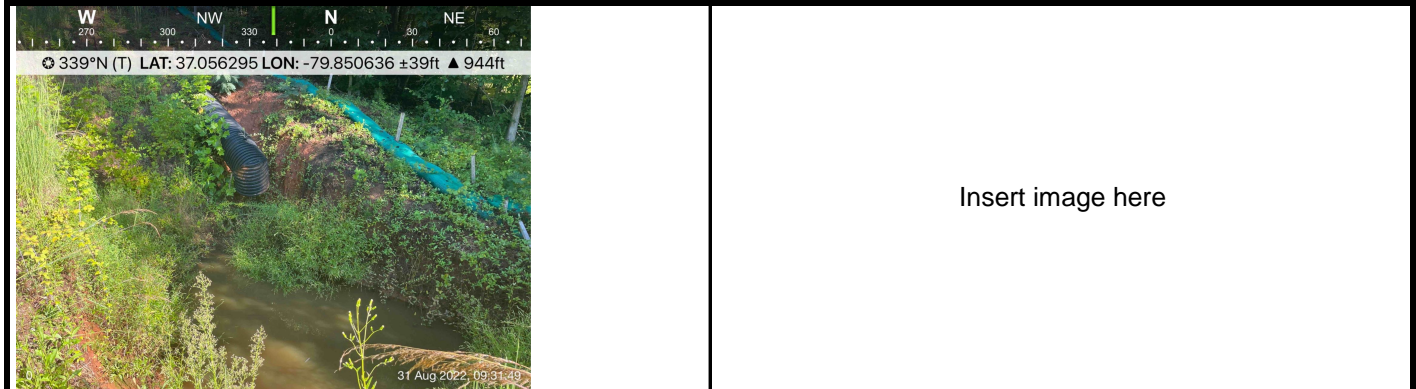
GPS Location	See photo	GPS Location	
Field Station#	14156+00	Field Station#	
Pic 11 Desc.	Slope drain is in good condition and functioning	Pic 12 Desc.

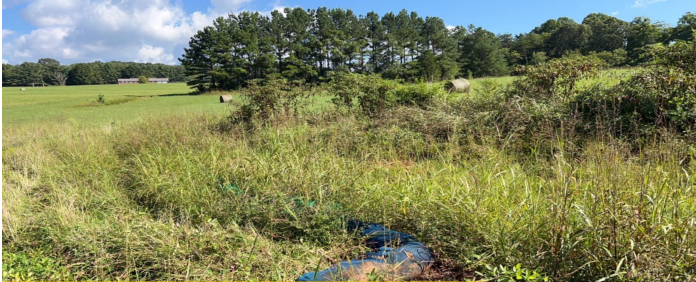
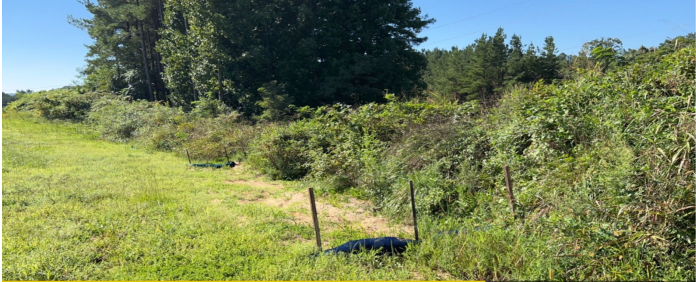
<small>37°07' N 79°44'57" W 171°S COURSE 357° GPS 08.31.2022 10:17:37 Sorry no results found Accur +/-11.6 Ft ALT 903 Ft</small>		<small>37°0'10" N 79°45'2" W 182°S COURSE 196° GPS 08.31.2022 10:14:13 Sorry no results found Accur +/-15.4 Ft ALT 910 Ft</small>	
GPS Location	1	GPS Location	2
Field Station#	14565+00	Field Station#	14558+00
Pic 1 Desc.	Routine maintenance. Repair damaged CFS in natural drainage area from landowner or animal damage.	Pic 2 Desc.	CFS check dams performing intended function.

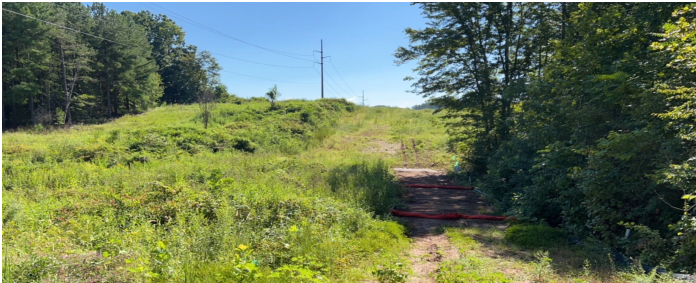
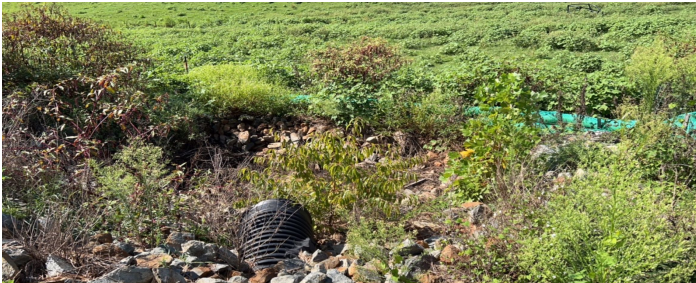
Pic 3 Desc.	Equipment bridge and surrounding ECDs in place and functional at stream crossing and resource buffer.	Pic 4 Desc.	Plunge pool performing intended function.

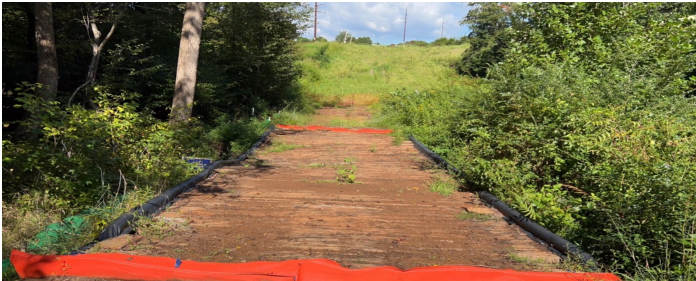
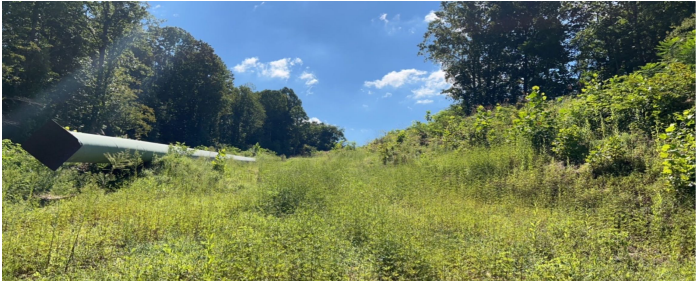
<small>36°59'44" N 79°44'5" W 334°NW COURSE -1° GPS 08.31.2022 10:39:04 Union Hall, VA 24176, United States Accur +/-155.4 Ft ALT 931 Ft</small>		<small>36°59'44" N 79°44'6" W 150°SE COURSE 79° GPS 08.31.2022 10:42:16 Union Hall, VA 24176, United States Accur +/-173.4 Ft ALT 855 Ft</small>	
GPS Location	5	GPS Location	6
Field Station#	14611+17	Field Station#	14614+50
Pic 5 Desc.	Equipment bridge and surrounding ECDs in place and functional at stream crossing and resource buffer.	Pic 6 Desc.	ROW stabilized and vegetated in temporary area.

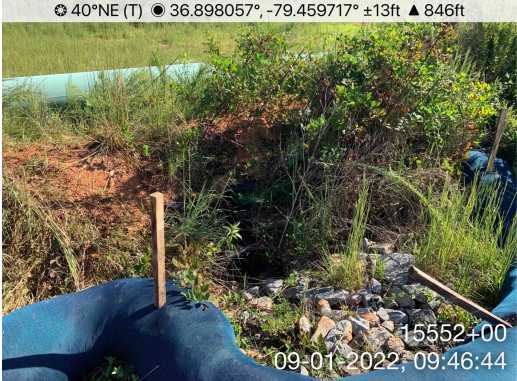
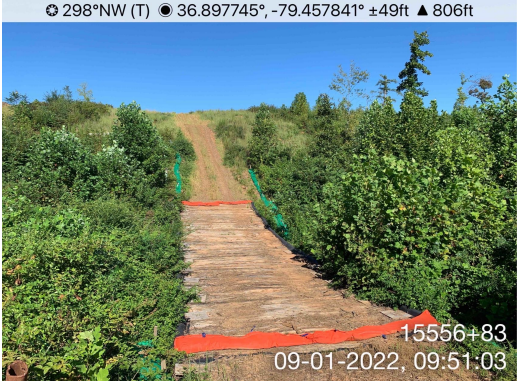
GPS Location 0		GPS Location 0			
Field Station# 15552+00		Field Station# 15556+83			
Pic 7 Desc. Clean water diversion pipe in acceptable condition		Pic 8 Desc. Equipment bridge in acceptable condition

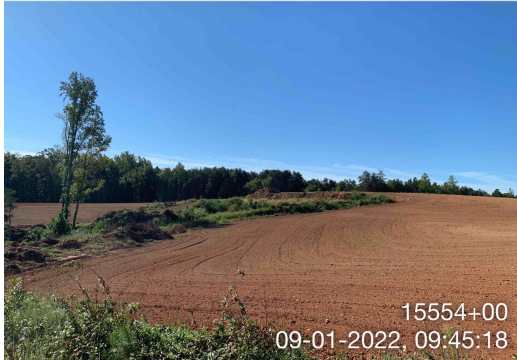
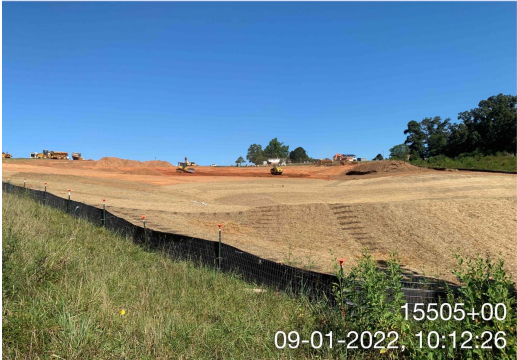
GPS Location 0		GPS Location 0			
Field Station# 15554+00		Field Station# 15505+00			
Pic 9 Desc. Land that was recently cleared of stumps and rocks with no stabilization		Pic 10 Desc. Solar farm grading operation

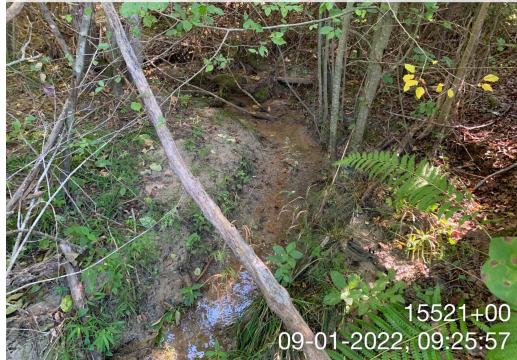
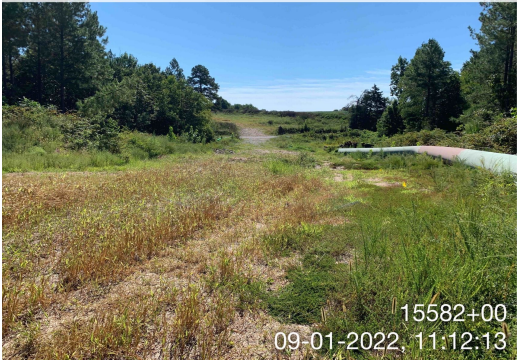
GPS Location 0		GPS Location 0			
Field Station# 15521+00		Field Station# 15582+00			
Pic 11 Desc. Stream S-MM8 is running clear		Pic 12 Desc. Temporary vegetative stabilization in acceptable condition

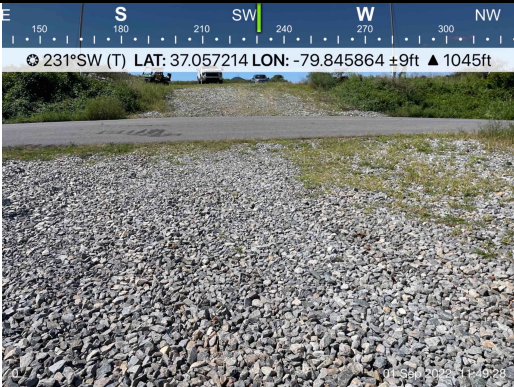
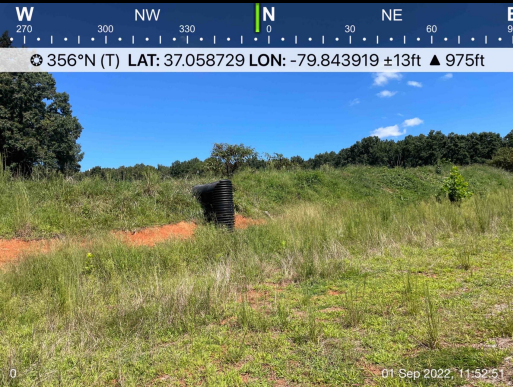
GPS Location	See photo	GPS Location	See photo
Field Station#	14171+36	Field Station#	14180+00
Pic 1 Desc.	RCEs are in good condition at all road crossings	Pic 2 Desc.	CWDs are functioning as intended

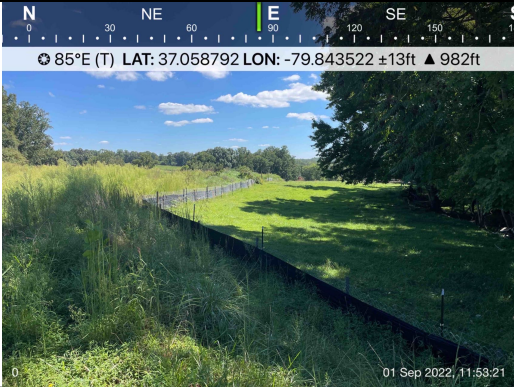
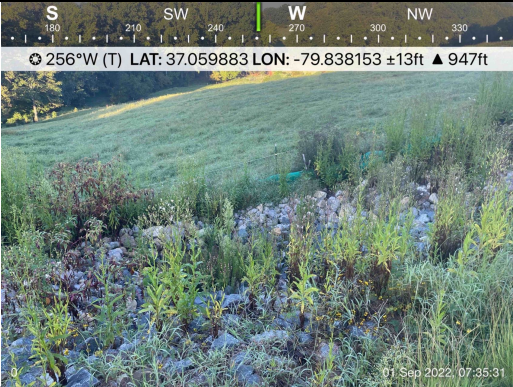
GPS Location	See photo	GPS Location	See photo
Field Station#	14182+00	Field Station#	14200+00
Pic 3 Desc.	SSF is in good condition	Pic 4 Desc.	CWD is functioning as intended

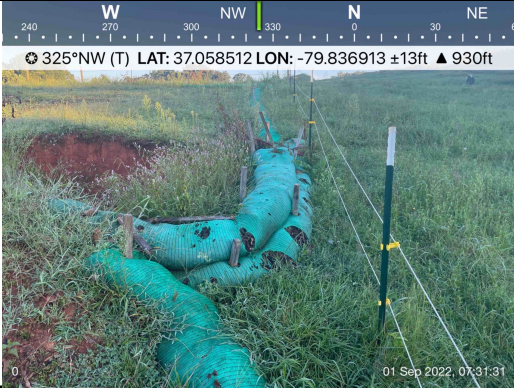
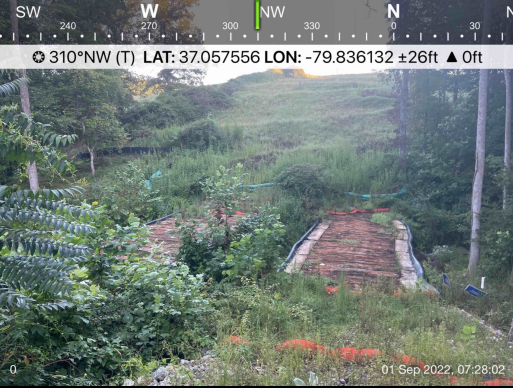
GPS Location	See photo	GPS Location	See photo
Field Station#	14205+00	Field Station#	14208+69
Pic 5 Desc.	CFS end treatments have been damaged by livestock and needs to be replaced 14205+00-14207+00	Pic 6 Desc.	Equipment bridge ECDs are in good condition and functioning

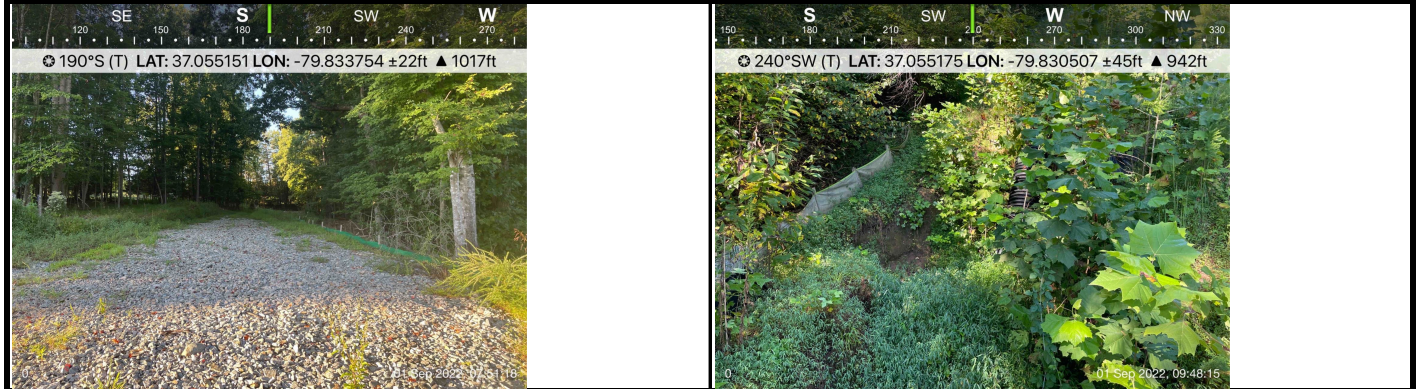
GPS Location	See photo	GPS Location	See photo
Field Station#	14223+41	Field Station#	14232+00
Pic 7 Desc.	MVP-FR-311 is in good condition with controls in place.	Pic 8 Desc.	Slope drain is in good condition and functioning

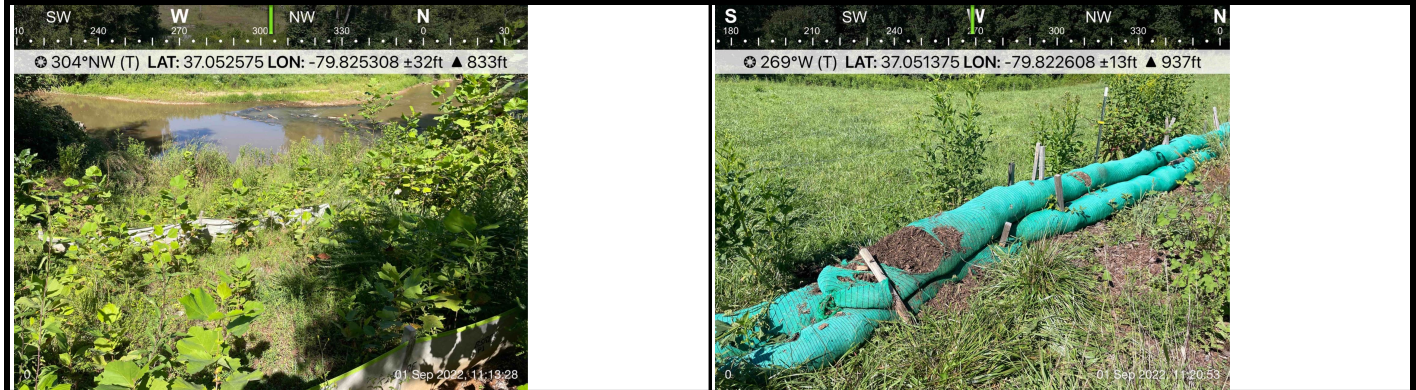
GPS Location	See photo	GPS Location	See photo
Field Station#	14252+00	Field Station#	14260+00
Pic 9 Desc.	Slope remains stabilized with controls in place	Pic 10 Desc.	Perimeter CFS has been damaged by livestock and needs to be replaced

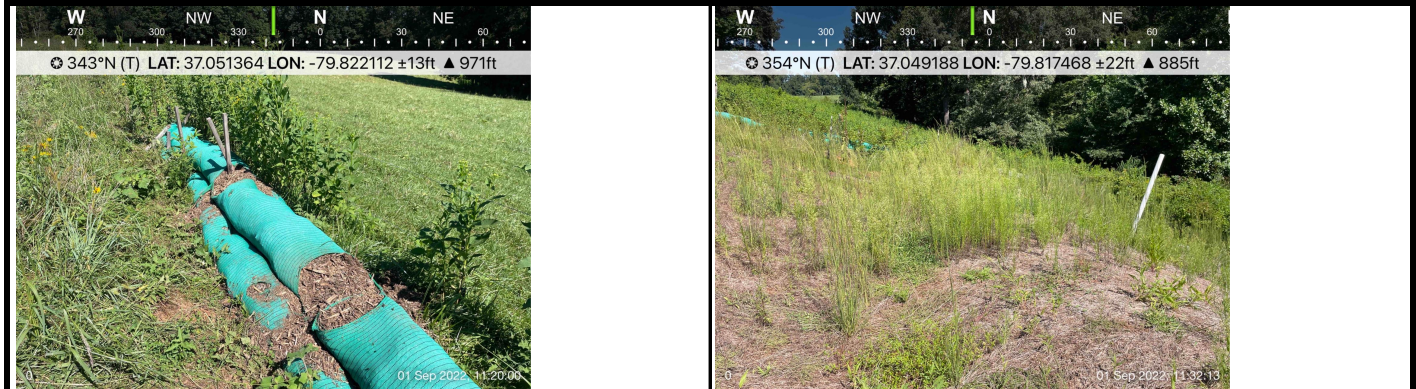
GPS Location	See photo	GPS Location	See photo
Field Station#	14263+00	Field Station#	14277+00
Pic 11 Desc.	Perimeter CFS has been damaged by livestock and needs to be replaced	Pic 12 Desc.	Waterbars are in good condition

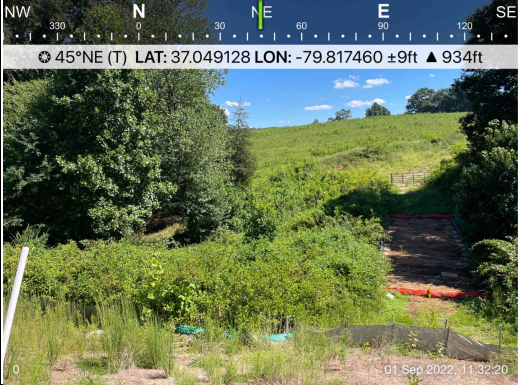
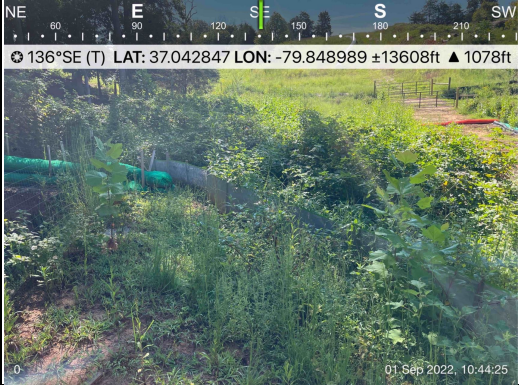
GPS Location	See photo	GPS Location	See photo		
Field Station#	14278+93	Field Station#	14294+00		
Pic 13 Desc.	Resource buffers remain well vegetated	Pic 14 Desc.	P1 is in good condition at all stream and wetland buffers

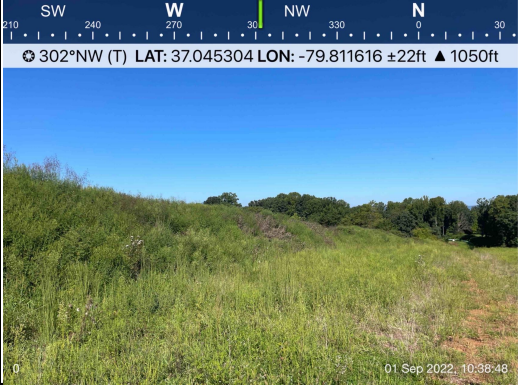
Insert image here			
GPS Location	See photo	GPS Location			
Field Station#	14300+00	Field Station#			
Pic 15 Desc.	Topsoil berms remain stabilized	Pic 16 Desc.			
Insert image here			Insert image here		
GPS Location		GPS Location			
Field Station#		Field Station#			
Pic 17 Desc.		Pic 18 Desc.

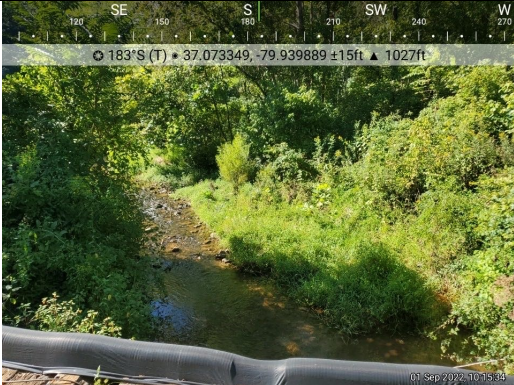
GPS Location	0	GPS Location	0		
Field Station#	13755+60	Field Station#	13757+00		
Pic 1 Desc.	S-EF12 Channel and banks	Pic 2 Desc.	Third party rutting in ROW

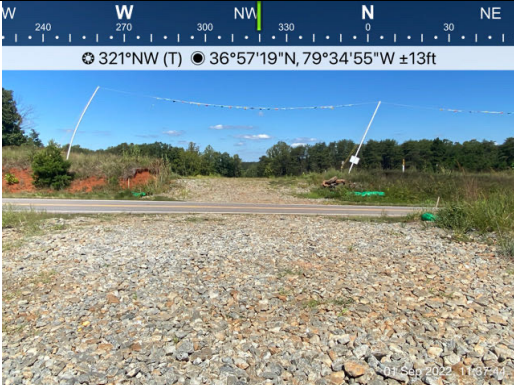
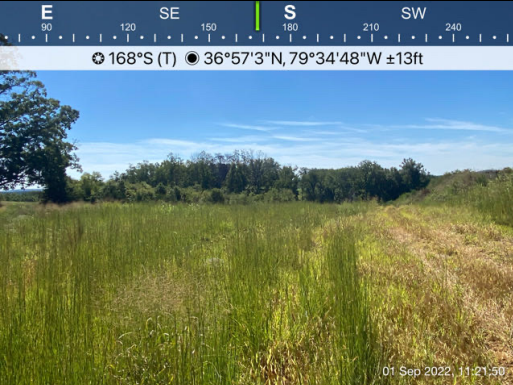
GPS Location	0	GPS Location	0
Field Station#	15113+00	Field Station#	15132+00
Pic 1 Desc.	Approximately 15113+00. Overview of road crossing and RCEs.	Pic 2 Desc.	Approximately 15132+00. Overview of ROW.

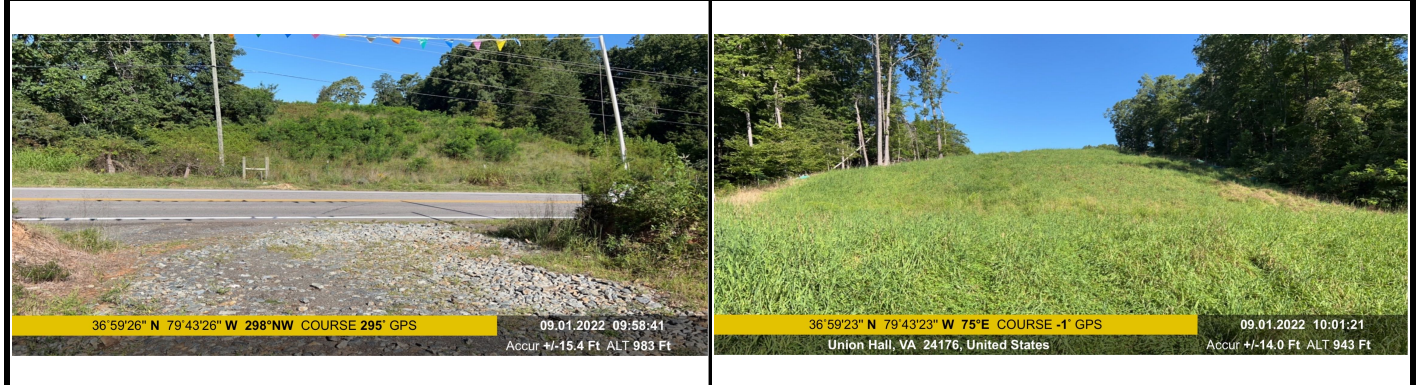
GPS Location	1	GPS Location	2
Field Station#	14649+67	Field Station#	14651+25
Pic 1 Desc.	RCE at Hwy 40 crossing in good condition.	Pic 2 Desc.	ROW stabilized and vegetated in final cleanup area.

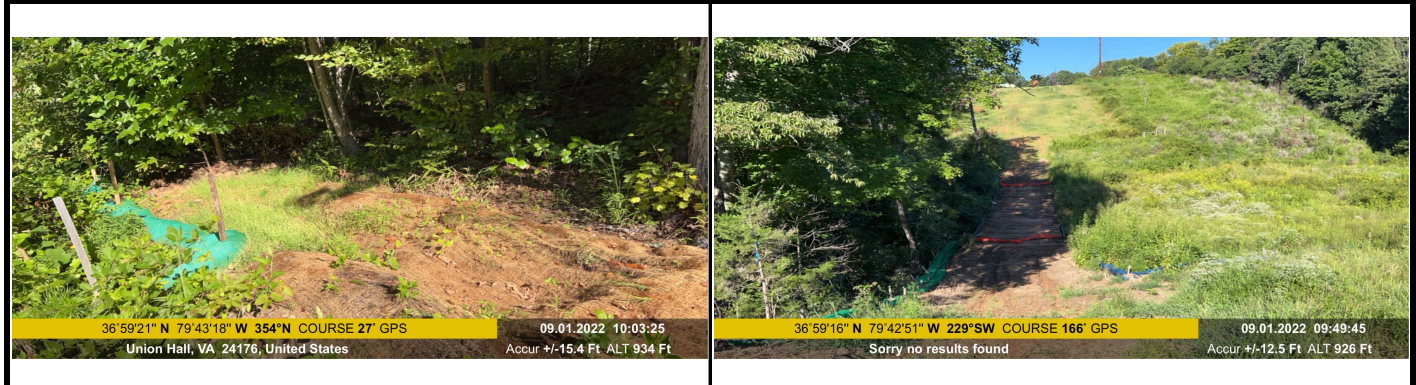
GPS Location	3	GPS Location	4
Field Station#	14657+75	Field Station#	14680+37
Pic 3 Desc.	Erosion control blanket and perimeter CFS performing intended functions.	Pic 4 Desc.	Equipment bridge and surrounding ECDs in place and functional at stream crossing and resource buffer.

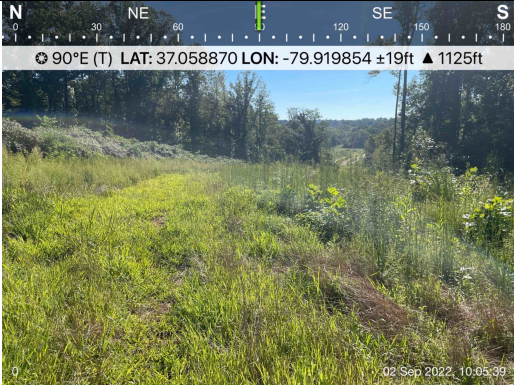
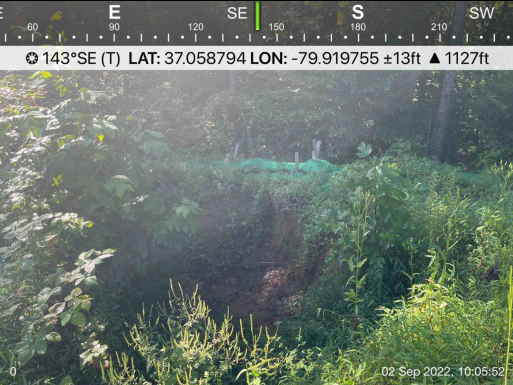
GPS Location See photo		GPS Location See photo			
Field Station# 13857+00		Field Station# 13857+00			
Pic 1 Desc. Waterbars are in good condition		Pic 2 Desc. End treatments are functioning as intended

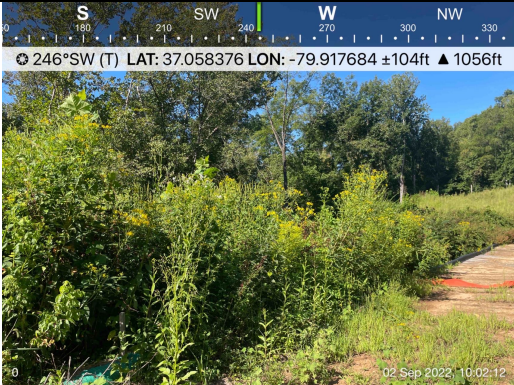
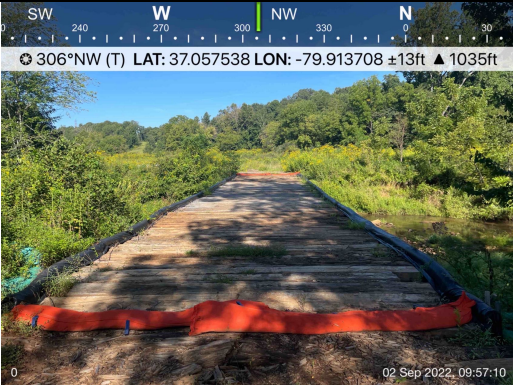
GPS Location See photo		GPS Location See photo			
Field Station# 13863+00		Field Station# 13875+50			
Pic 3 Desc. Resource buffers remain well vegetated		Pic 4 Desc. Equipment bridge ECDs are in good condition and functioning

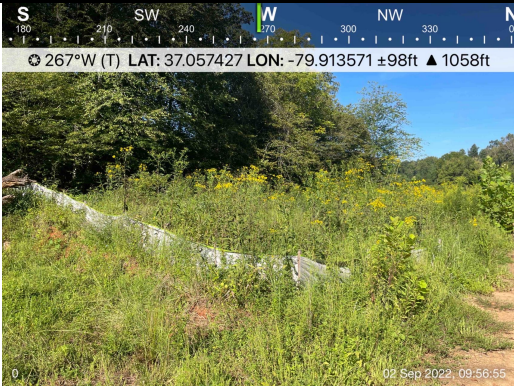
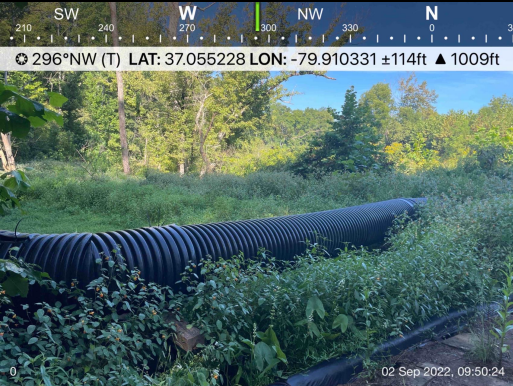
GPS Location See photo		GPS Location See photo			
Field Station# 13875+00		Field Station# 13888+50			
Pic 5 Desc. P1 is in good condition at all stream and wetland buffers		Pic 6 Desc. Slope drain is in good condition and functioning

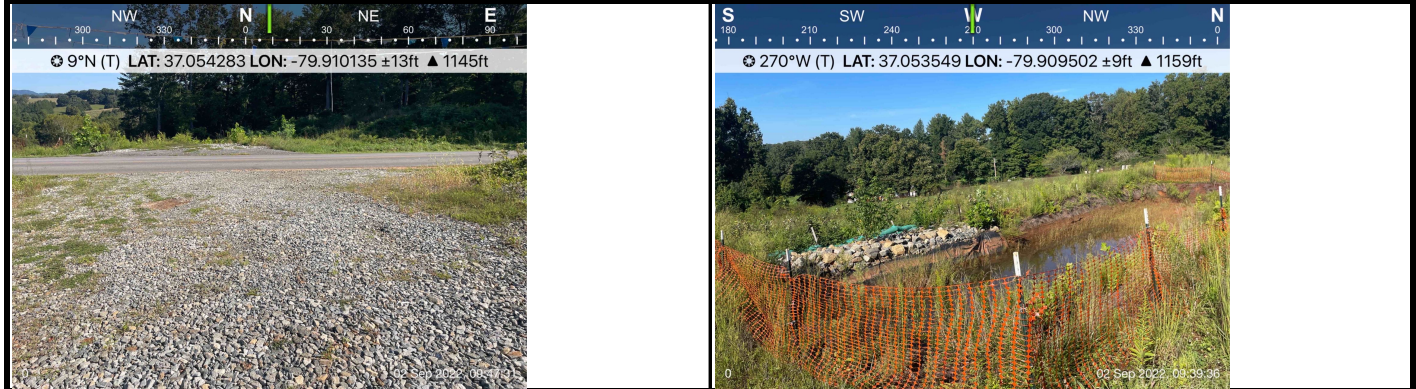
GPS Location	See photo	GPS Location	See photo
Field Station#	13892+45	Field Station#	13897+00
Pic 7 Desc.	RCEs are in good condition at all road crossings	Pic 8 Desc.	Sediment trap is functioning as intended

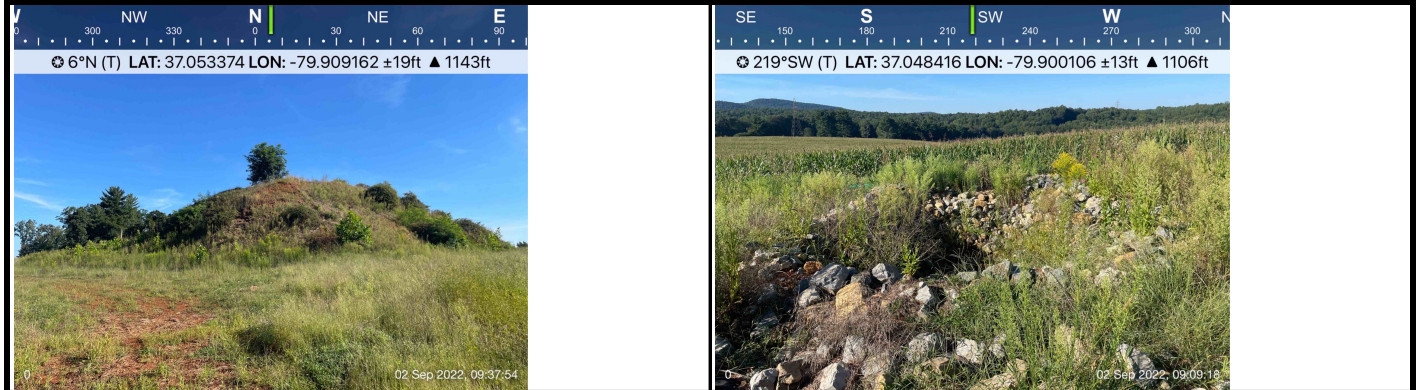
GPS Location	See photo	GPS Location	See photo
Field Station#	13897+00	Field Station#	13942+00
Pic 9 Desc.	Topsoil pile remains stabilized	Pic 10 Desc.	CWDs are functioning as intended throughout this section

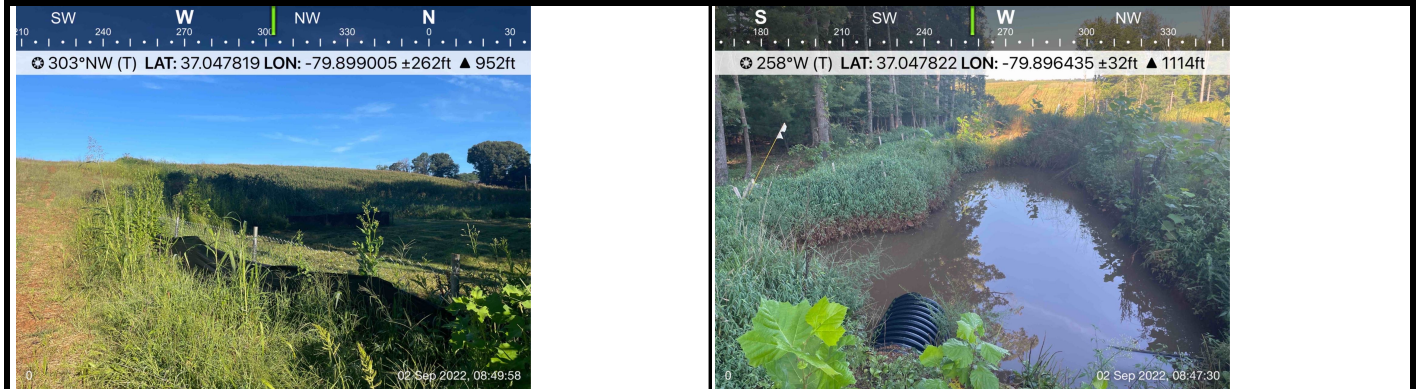
GPS Location	See photo	GPS Location	See photo
Field Station#	13949+00	Field Station#	13954+00
Pic 11 Desc.	SSF is in good condition	Pic 12 Desc.	Slope drain outlet is in good condition

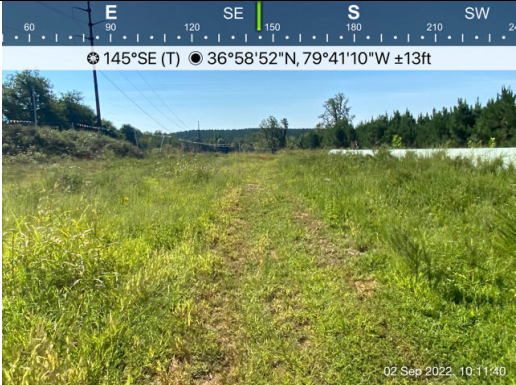
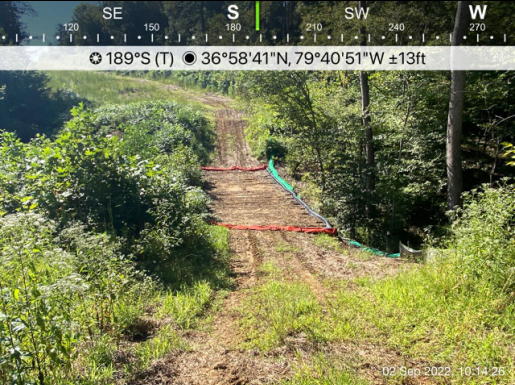
GPS Location 0		GPS Location 0			
Field Station# 14765+00		Field Station# 14794+00			
Pic 1 Desc. Approximately 13765+00. Overview of ROW.		Pic 2 Desc. Approximately 14794+00. Overview of stream crossing, equipment bridge and ECDs at stream S-H24.
