Visual Site Inspection Report

Project Name H-600 Pipeline Spread I		AFE 124300139	Spread H-600 Pipeline Spread I
Contractor Precision		Report # 40732	
Inspector Justin Burch		Date/Time 8/8/2022 9:17 AM	
Permit # TBD	Inspection Type VA SWPP	Station Begin	15260+00
State VA	Inspection Area Full	Station End	15370+62
County Pittsylvania	Ground Wet	Temperature (°F)	90.00
Municipality Chatham	Weather Sunny	Rain Gauge (in)	1.20
			Rain Accumulation Time (days) 6.00

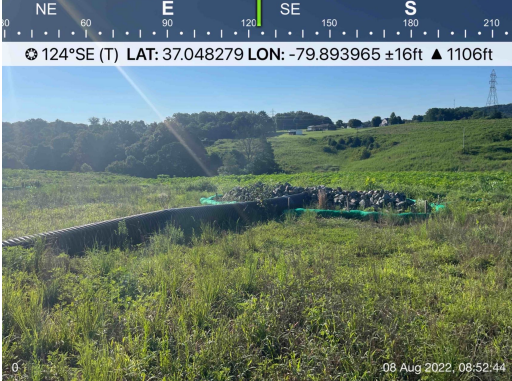
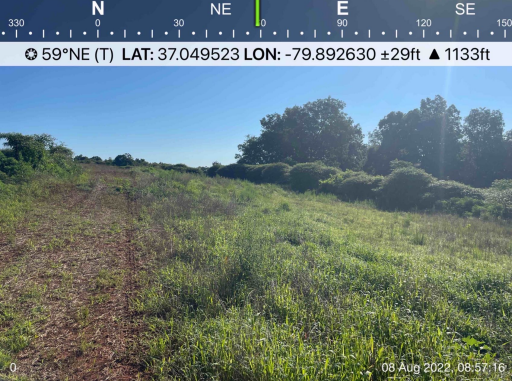
GPS Location See photo		GPS Location See photo			
Field Station# 13960+00		Field Station# 13970+00			
Pic 1 Desc. CWDs are functioning as intended		Pic 2 Desc. Vegetation continues to fill in throughout this section

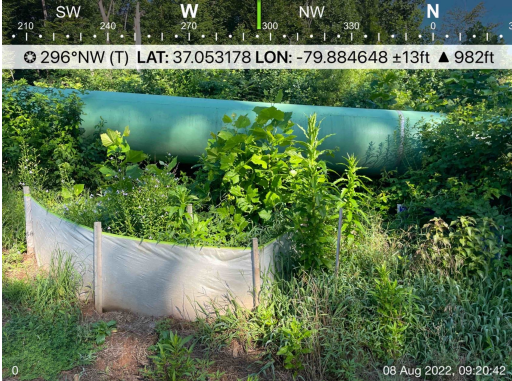
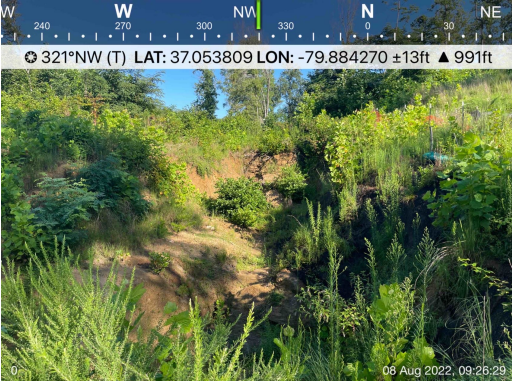
GPS Location See photo		GPS Location See photo			
Field Station# 13997+50		Field Station# 14000+00			
Pic 3 Desc. P1 is in good condition at all stream and wetland buffers		Pic 4 Desc. No evidence of 3rd party pond discharging onto ROW.

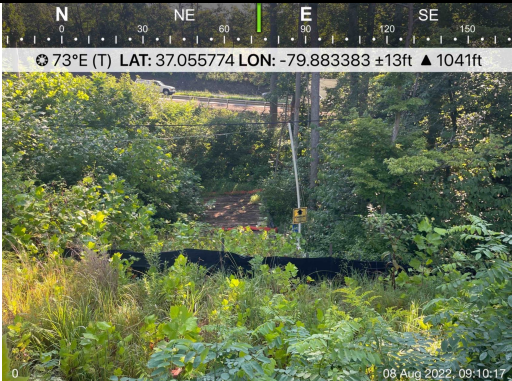
GPS Location See photo		GPS Location See photo			
Field Station# 14009+11		Field Station# 14018+47			
Pic 5 Desc. SSF is in good condition		Pic 6 Desc. RCEs are in good condition at all stream and wetland buffers

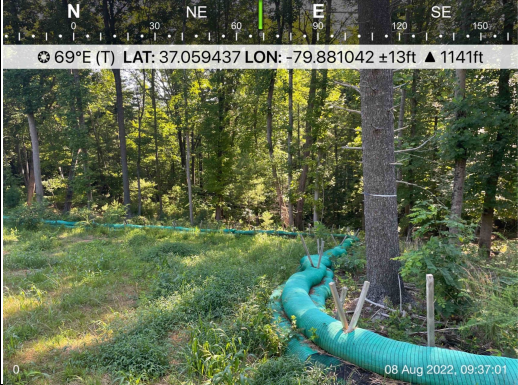
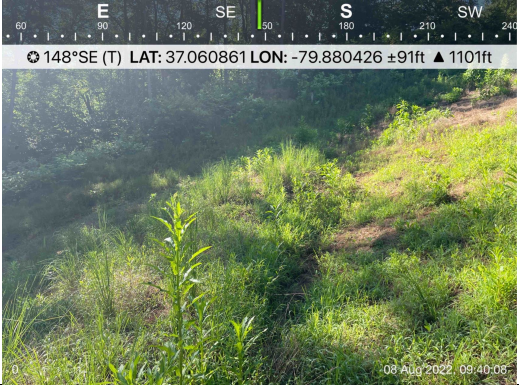
GPS Location	See photo	GPS Location	See photo
Field Station#	14027+00	Field Station#	14033+00
Pic 7 Desc.	CFS is in good condition throughout this section	Pic 8 Desc.	Waterbars are in good condition

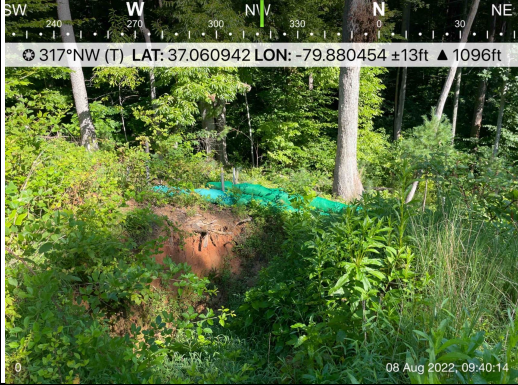
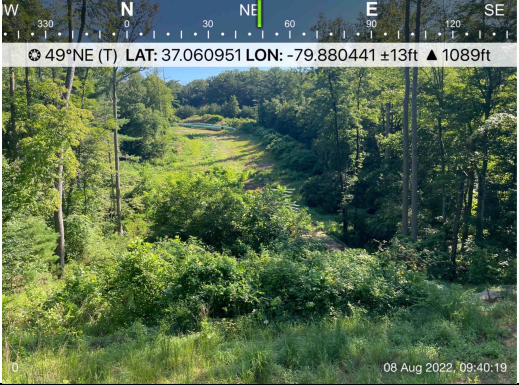
GPS Location	See photo	GPS Location	See photo
Field Station#	14033+00	Field Station#	14035+00
Pic 9 Desc.	End treatments are functioning as intended	Pic 10 Desc.	Resource buffers remain well vegetated

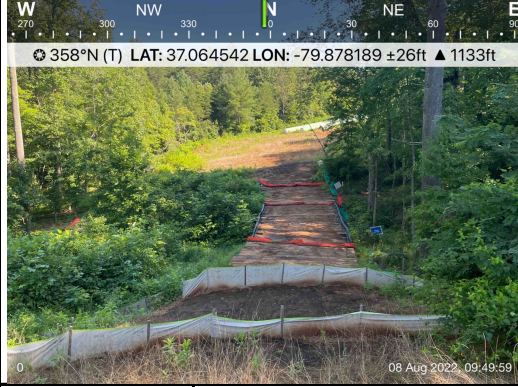
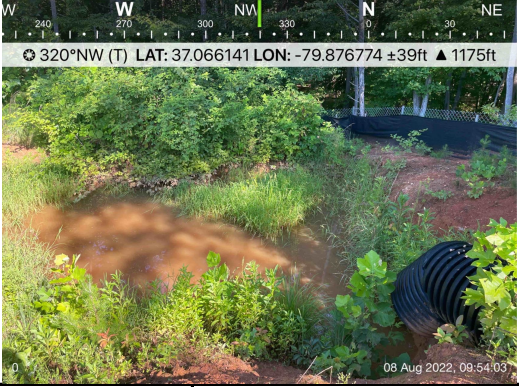
GPS Location	See photo	GPS Location	See photo
Field Station#	14050+00	Field Station#	14057+00
Pic 11 Desc.	Equipment bridge ECDs are functioning as intended	Pic 12 Desc.	Slope drain is in good condition and functioning

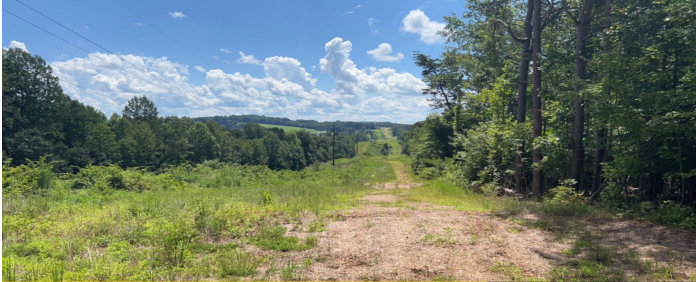
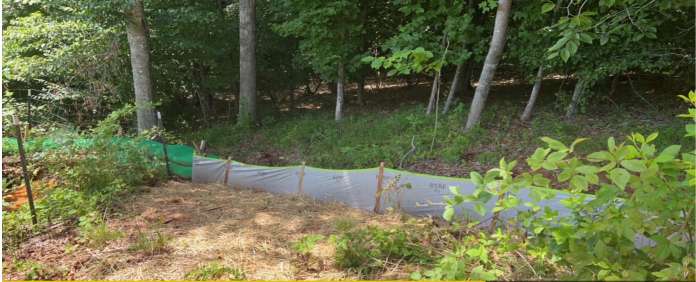
<small>37°1'24" N 79°45'54" W 169°S COURSE 144° GPS 08.08.2022 12:10:42 Glade Hill, VA 24092, United States Accur +/-12.2 Ft ALT 1056 Ft</small>			<small>37°1'11" N 79°45'44" W 175°S COURSE 228° GPS 08.08.2022 12:17:25 Glade Hill, VA 24092, United States Accur +/-15.5 Ft ALT 922 Ft</small>		
GPS Location	1		GPS Location	2	
Field Station#	14470+95		Field Station#	14485+00	
Pic 1 Desc.	ROW stabilized and vegetated in temporary area.		Pic 2 Desc.	Contractor repaired erosion and replaced perimeter P1 silt fence per punch list item.

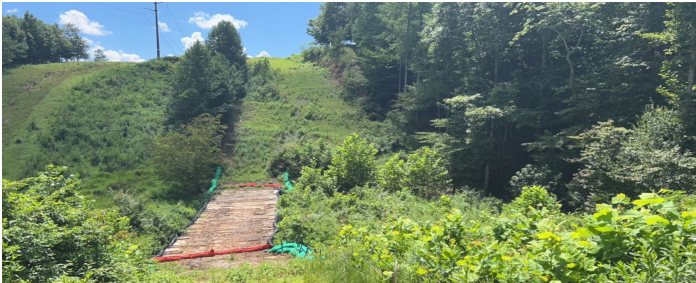
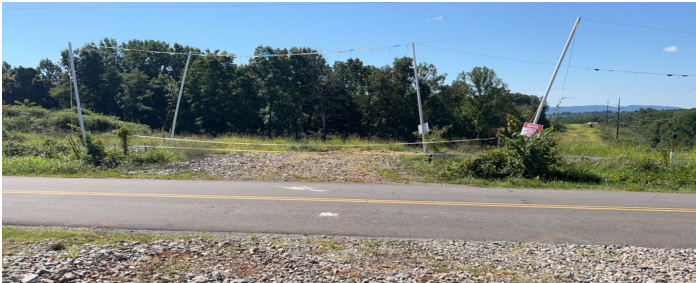
GPS Location	3		GPS Location	4	
Field Station#	14486+68		Field Station#	14524+76	
Pic 3 Desc.	Equipment bridge and surrounding ECDs in place and functional at stream crossing and resource buffer.		Pic 4 Desc.	RCE at Timber Ridge Rd in good condition.

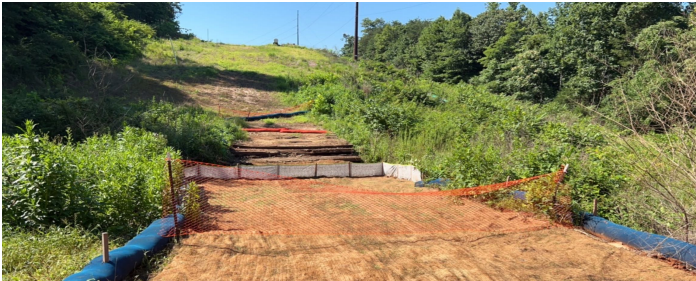
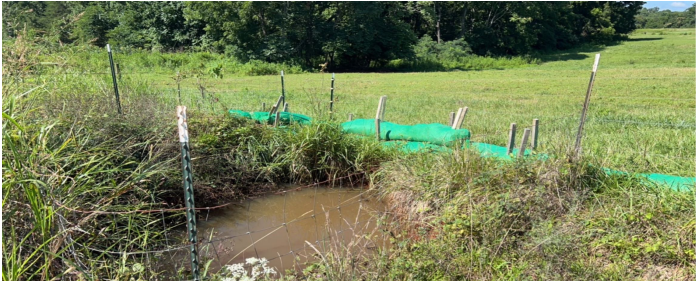
<small>37°0'33" N 79°45'15" W 262°W COURSE 165° GPS 08.08.2022 10:45:58 1694 SR-674, Glade Hill, VA 24092, United States Accur +/-15.4 Ft ALT 1000 Ft</small>			<small>37°0'37" N 79°45'16" W 179°S COURSE 254° GPS 08.08.2022 10:44:02 1694 SR-674, Glade Hill, VA 24092, United States Accur +/-15.5 Ft ALT 1038 Ft</small>		
GPS Location	5		GPS Location	6	
Field Station#	14531+58		Field Station#	14542+00	
Pic 5 Desc.	Contractor removed damaged equipment bridge at stream crossing and installed new ECDs in resource buffer.		Pic 6 Desc.	Sump pit and CFS end treatment performing intended functions.

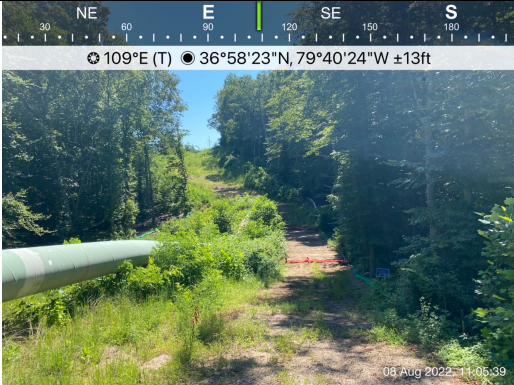
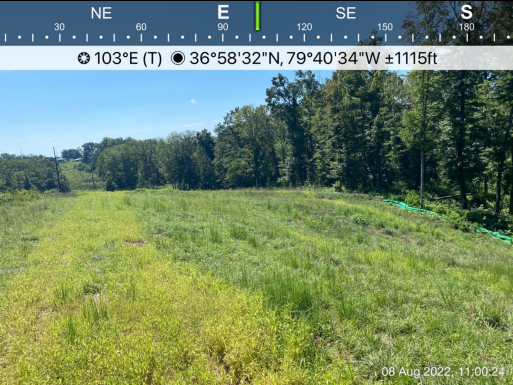
GPS Location	0	GPS Location	0
Field Station#	14823+54	Field Station#	14813+00
Pic 1 Desc.	Approximately 14823+54. Overview of stream crossing, equipment bridge and ECDs at stream S-A13.	Pic 2 Desc.	Approximately 14813+00. Overview of ROW. Permanent vegetation.

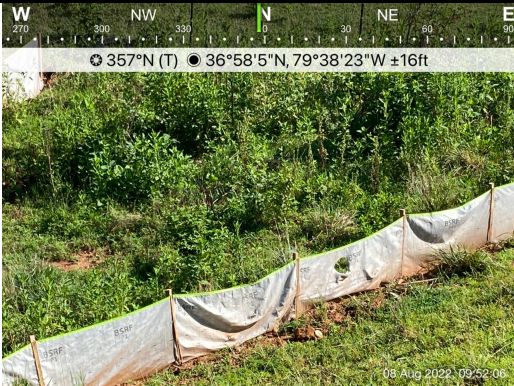
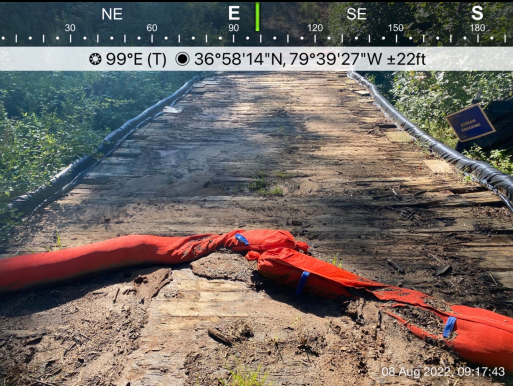
GPS Location	0	GPS Location	0
Field Station#	14923+00	Field Station#	14870+00
Pic 5 Desc.	Approximately 14923+00. P-1 requires maintenance along drainage feature. Damaged by livestock.	Pic 6 Desc.	Approximately 14870+00. Equipment bridge requires maintenance. Remove sediment.

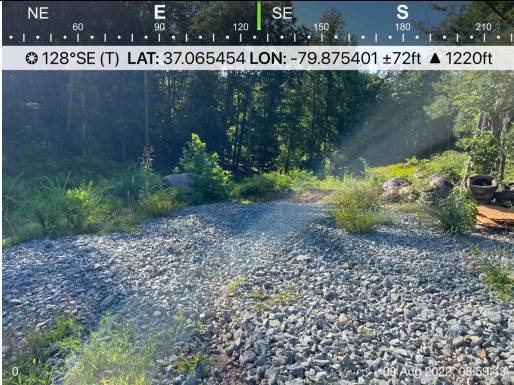
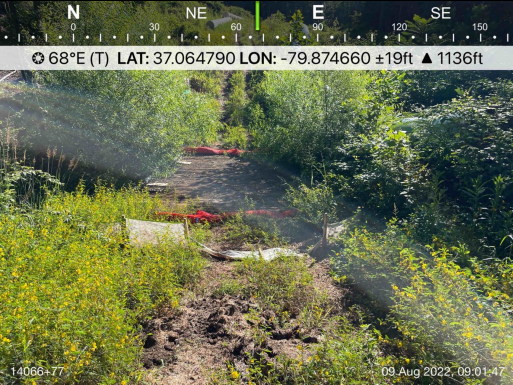
GPS Location See photo		GPS Location See photo			
Field Station# 14062+17		Field Station# 14066+77			
Pic 1 Desc. RCEs are in good condition at all road crossings		Pic 2 Desc. P1 has been damaged by 3rd party and needs to be replaced

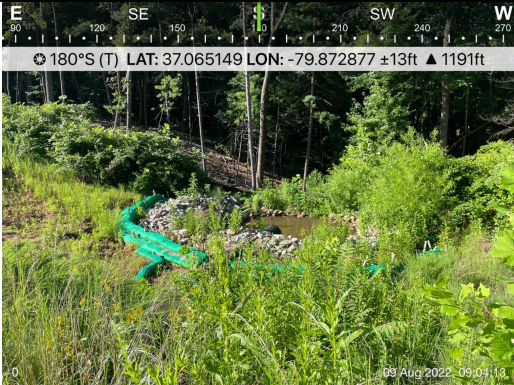
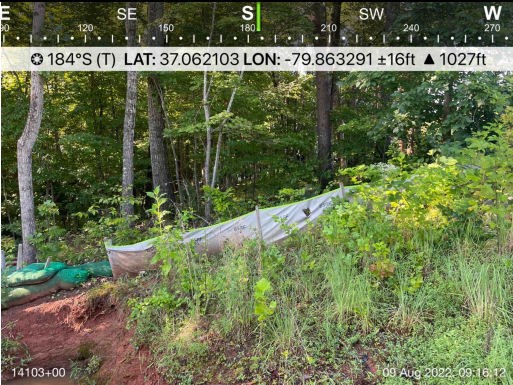
GPS Location See photo		GPS Location See photo			
Field Station# 14070+00		Field Station# 14103+00			
Pic 3 Desc. CWDs are functioning as intended		Pic 4 Desc. P1 has been damaged and needs to be replaced

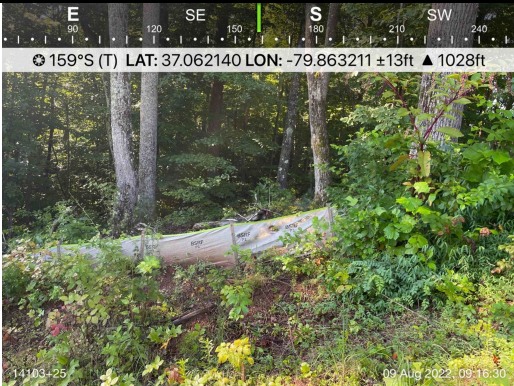
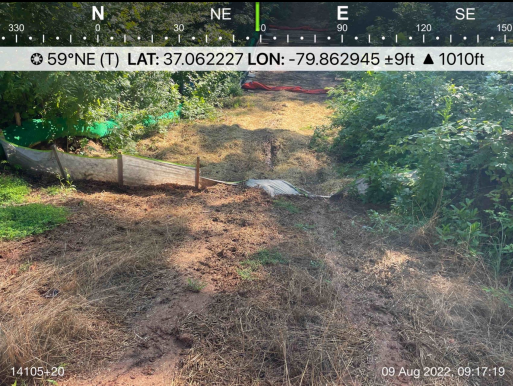
GPS Location See photo		GPS Location See photo			
Field Station# 14103+25		Field Station# 14105+20			
Pic 5 Desc. P1 has been damaged and needs to be replaced		Pic 6 Desc. P1 has been damaged by 3rd party and needs to be replaced

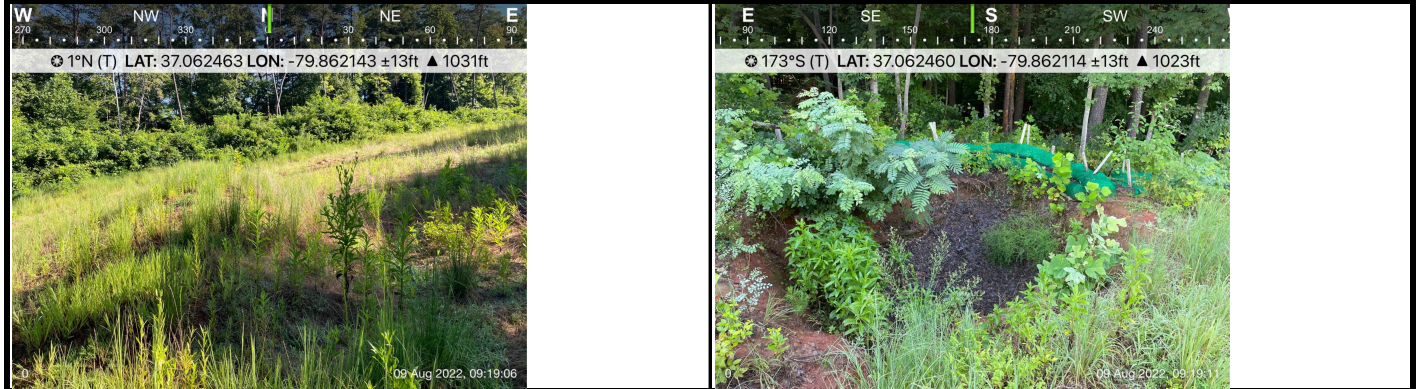
GPS Location	See photo	GPS Location	See photo
Field Station#	14109+00	Field Station#	14109+00
Pic 7 Desc.	Waterbars are in good condition	Pic 8 Desc.	End treatments are functioning as intended

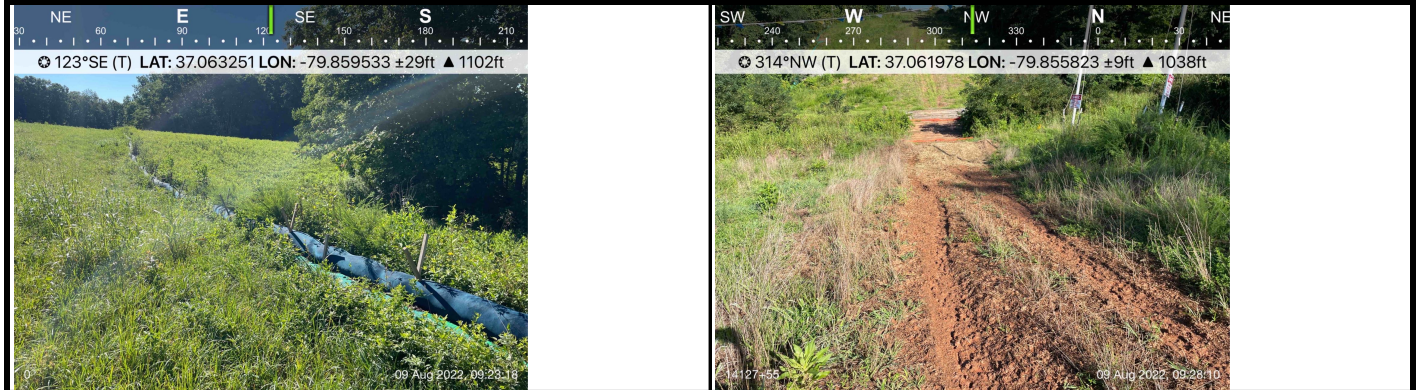
GPS Location	See photo	GPS Location	See photo
Field Station#	14120+00	Field Station#	14127+55
Pic 9 Desc.	CFS is in good condition throughout this section	Pic 10 Desc.	ROW has been damaged by 3rd party and needs to be replaced

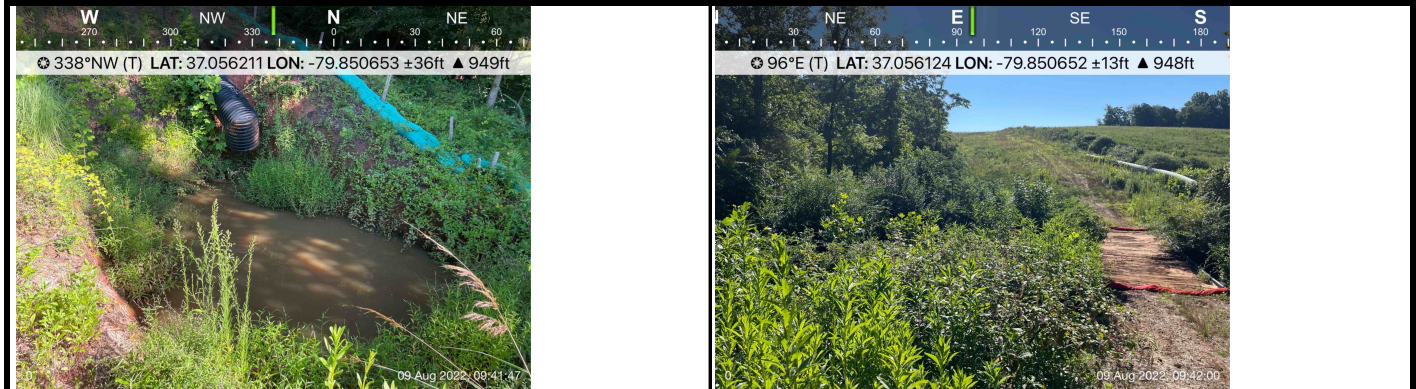
GPS Location	See photo	GPS Location	See photo
Field Station#	14156+00	Field Station#	14157+55
Pic 11 Desc.	Slope drain is in good condition and functioning	Pic 12 Desc.	Resource buffers remain well vegetated

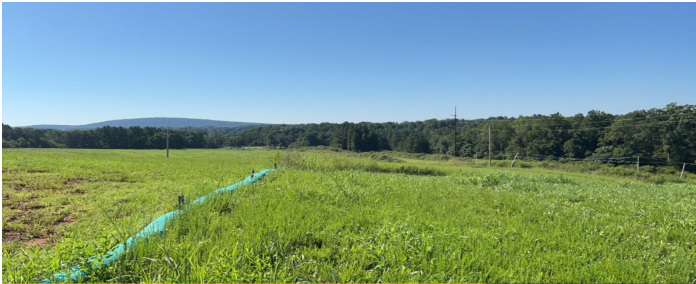
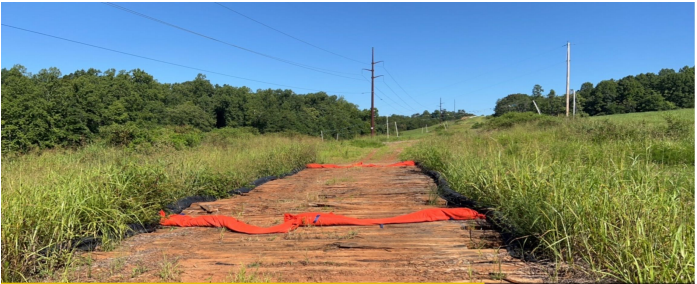
<small>37°0'18" N 79°45'6" W 154°SE COURSE 116' GPS 08.09.2022 10:19:41 594 Tobacco Rd, Glade Hill, VA 24092, United States Accur +/-15.5 Ft ALT 964 Ft</small>			<small>37°0'13" N 79°45'4" W 341°N COURSE 164' GPS 08.09.2022 10:22:15 594 Tobacco Rd, Glade Hill, VA 24092, United States Accur +/-42.2 Ft ALT 965 Ft</small>		
GPS Location	1		GPS Location	2	
Field Station#	14548+00		Field Station#	14552+00	
Pic 1 Desc.	Perimeter CFS in good condition and ROW stabilized and vegetated in temporary extra workspace.		Pic 2 Desc.	Equipment bridge over natural drainage area performing intended function.

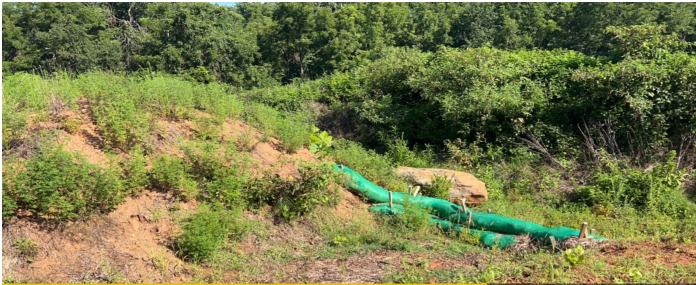
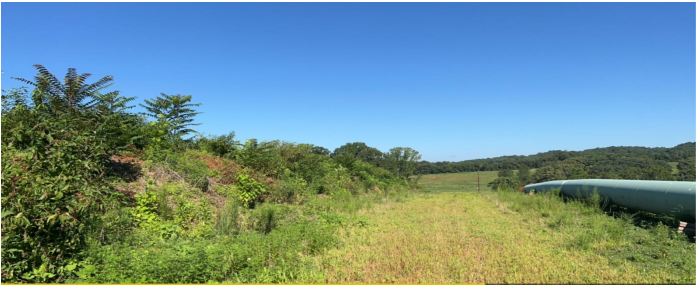
GPS Location	3		GPS Location	4	
Field Station#	14584+96		Field Station#	14593+00	
Pic 3 Desc.	CFS triple stack in place and functional.		Pic 4 Desc.	Temporary diversion berm stabilized and vegetated.

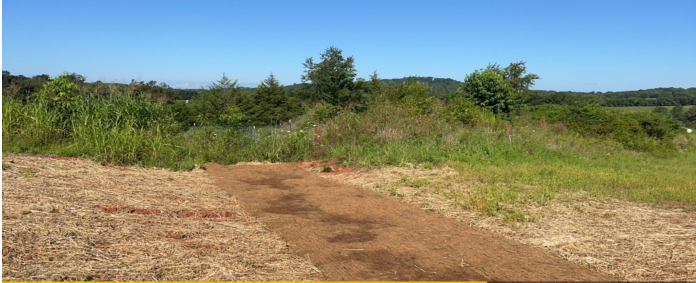
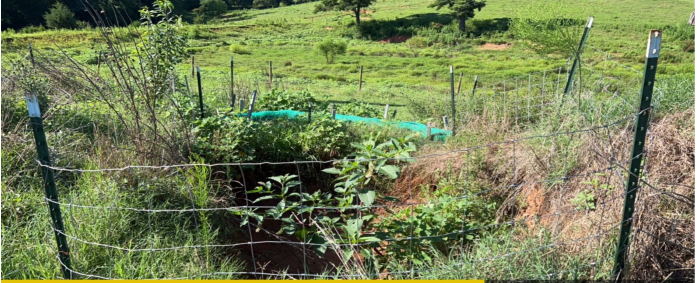
<small>36°59'54" N 79°44'21" W 317°NW COURSE 336' GPS 08.09.2022 10:00:19 753 Simmons Creek Rd, Union Hall, VA 24176, United States Accur +/-15.1 Ft ALT 952 Ft</small>			<small>36°59'47" N 79°44'11" W 224°SW COURSE 201' GPS 08.09.2022 09:52:38 Sorry no results found Accur +/-15.5 Ft ALT 907 Ft</small>		
GPS Location	5		GPS Location	6	
Field Station#	14595+00		Field Station#	14608+00	
Pic 5 Desc.	Erosion control blanket in throat of water bar performing intended function.		Pic 6 Desc.	Sump pit and CFS end treatment in good condition.

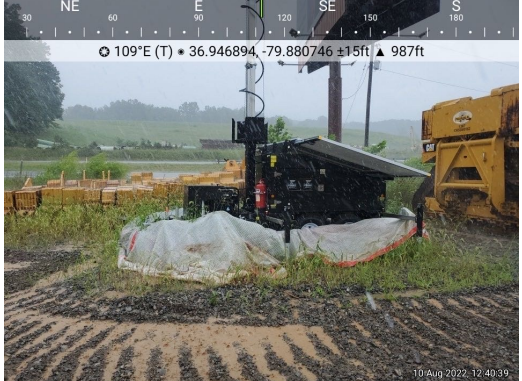
GPS Location	0		GPS Location	0	
Field Station#	0+00		Field Station#	0+00	
Pic 1 Desc.	LY-032 Rock construction entrance during shower		Pic 2 Desc.	LY-032 Secondary containment

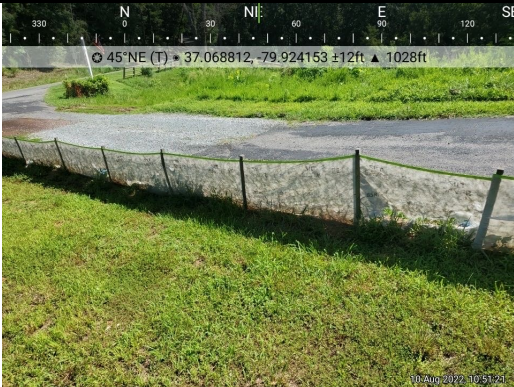
GPS Location	0		GPS Location	0	
Field Station#	13812+10		Field Station#	13811+90	
Pic 1 Desc.	Replace damaged silt fence and CFS between Brick Church Rd and private driveway.		Pic 2 Desc.	Remove damaged CFS in borrow ditch

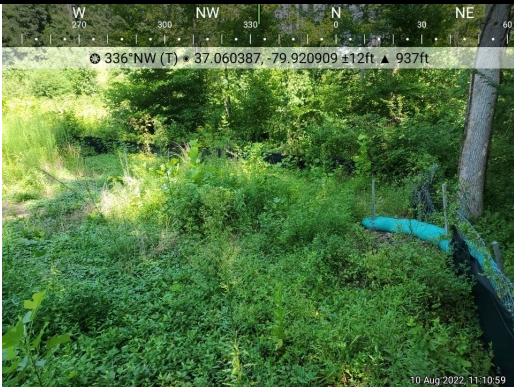
GPS Location	0		GPS Location	0	
Field Station#	13848+00		Field Station#	13840+00	
Pic 3 Desc.	GAS S-C16 Buffer zone Super Silt fence		Pic 4 Desc.	Perimeter Super Silt fence

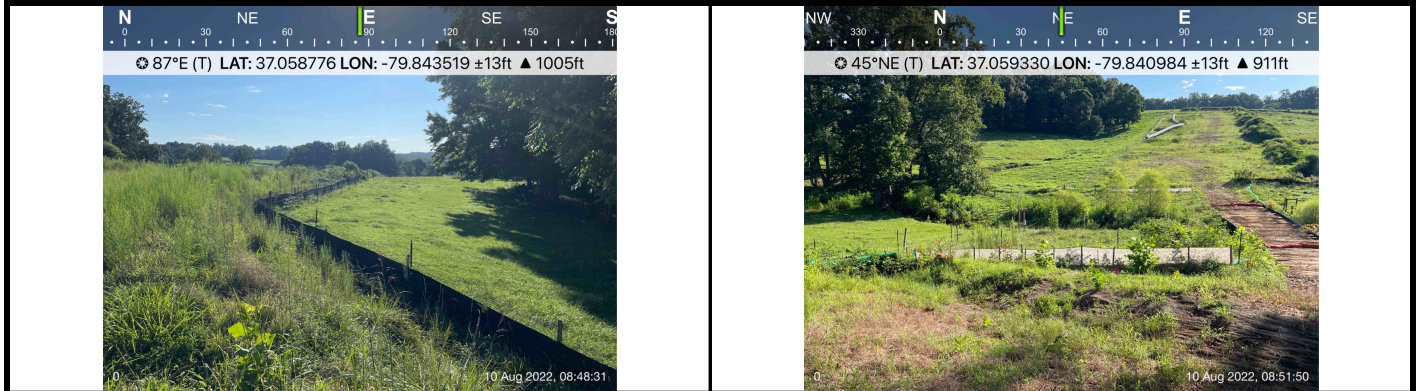
Pic 1 Desc.	RCEs are in good condition at all road crossings	Pic 2 Desc.	CWDs are functioning as intended
--------------------	--	--------------------	----------------------------------

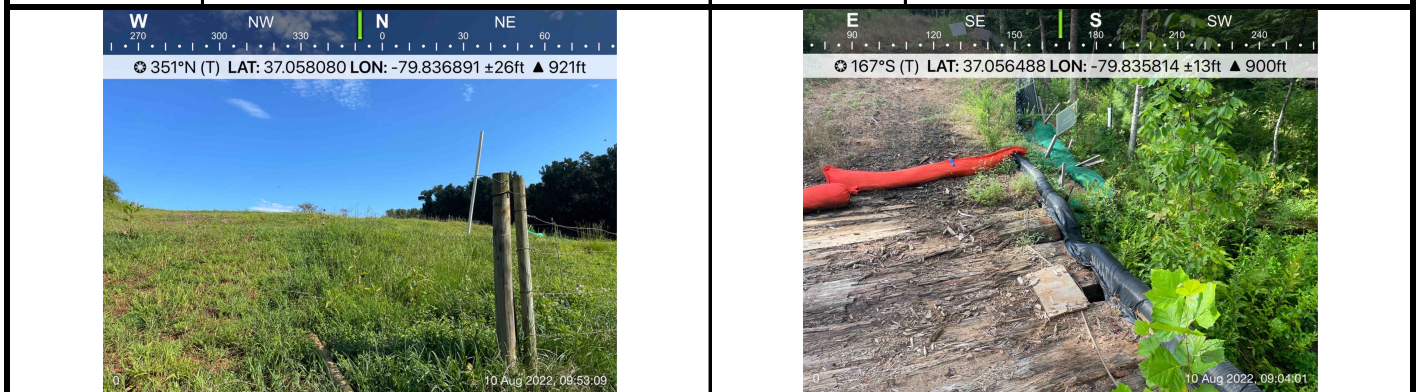
Pic 3 Desc.	SSF is in good condition	Pic 4 Desc.	P1 is in good condition at all stream and wetland buffers
--------------------	--------------------------	--------------------	---

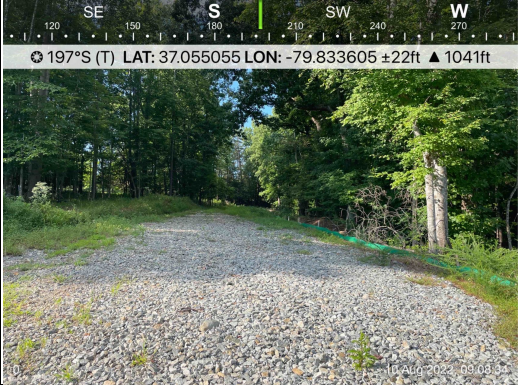
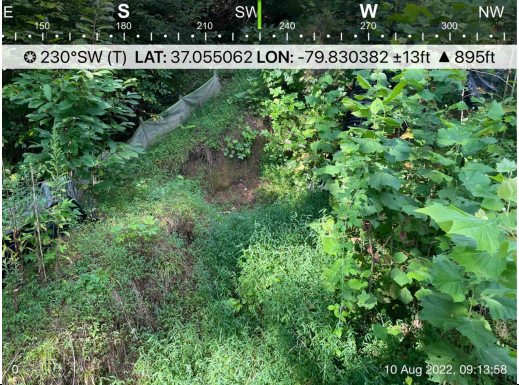
GPS Location	See photo		GPS Location	See photo	
Field Station#	14223+41		Field Station#	14232+00	
Pic 7 Desc.	MVP-FR-311 is in good condition with controls in place		Pic 8 Desc.	Slope drain is in good condition and functioning

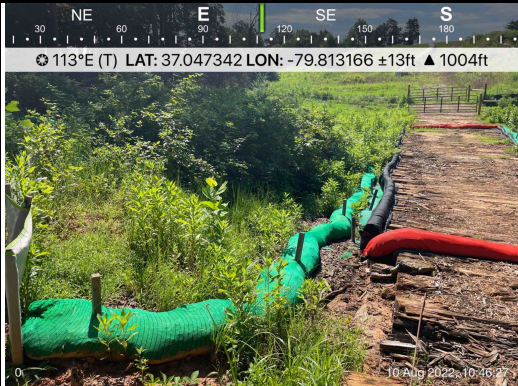
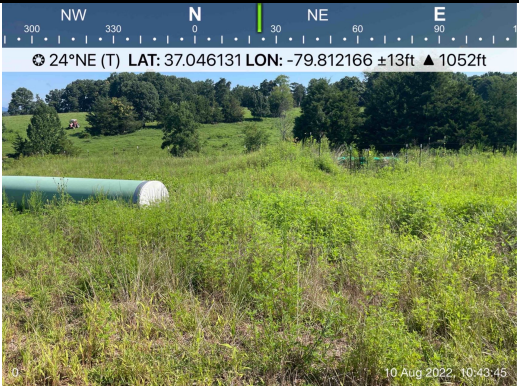
GPS Location	See photo		GPS Location	See photo	
Field Station#	14294+00		Field Station#	14300+00	
Pic 9 Desc.	CFS is in good condition		Pic 10 Desc.	Waterbars are in good condition

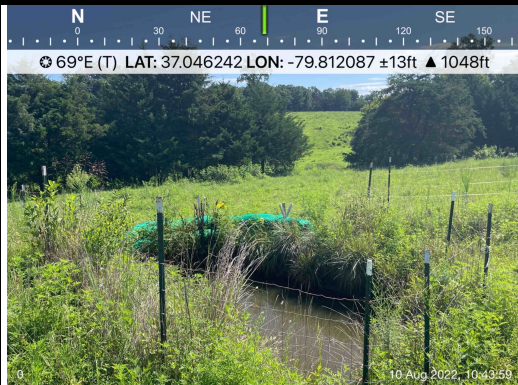
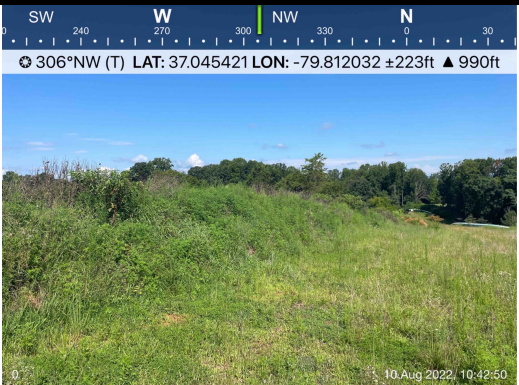
GPS Location	See photo		GPS Location	See photo	
Field Station#	14300+00		Field Station#	14305+00	
Pic 11 Desc.	End treatments are functioning as intended		Pic 12 Desc.	Topsoil berms remain stabilized

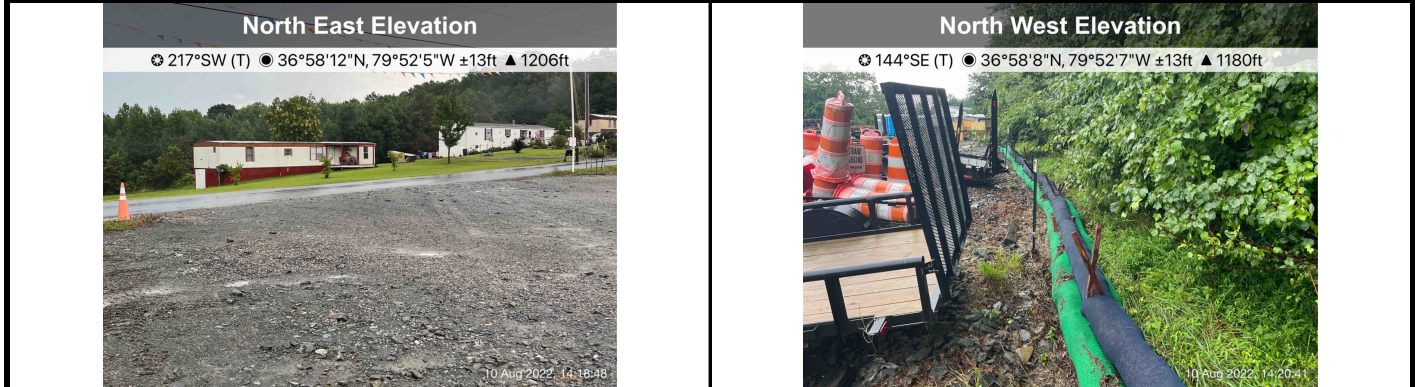
GPS Location	See picture	GPS Location	See picture
Field Station#	0000+00	Field Station#	0000+00
Pic 1 Desc.	RCE at LY-045 in good condition.	Pic 2 Desc.	Perimeter ECD's on west side of LY-045 near employee parking area.

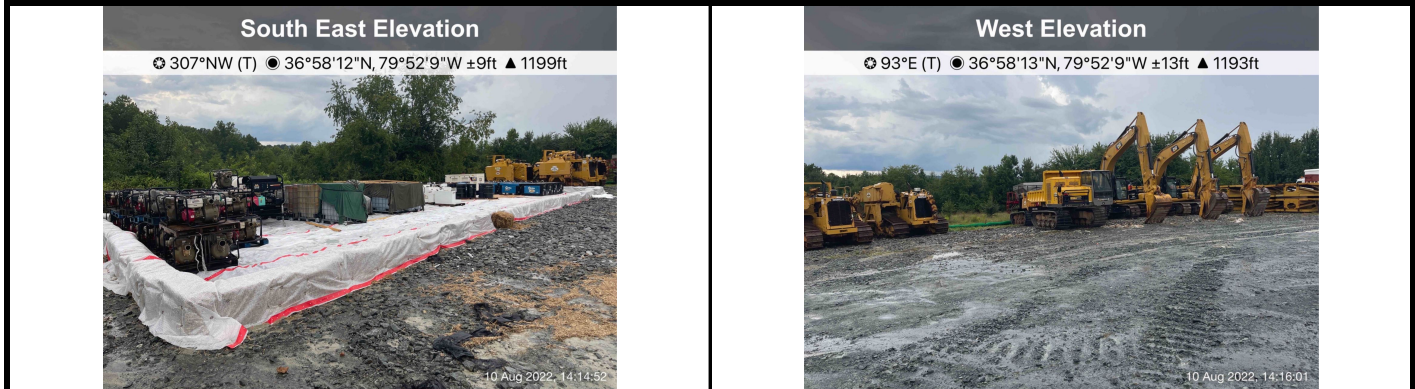
GPS Location	See picture	GPS Location	See picture
Field Station#	0000+00	Field Station#	0000+00
Pic 3 Desc.	Secondary containment structure on north end of LY-045 in good condition.	Pic 4 Desc.	Equipment inspected at LY-045 no leaks observed during inspection.

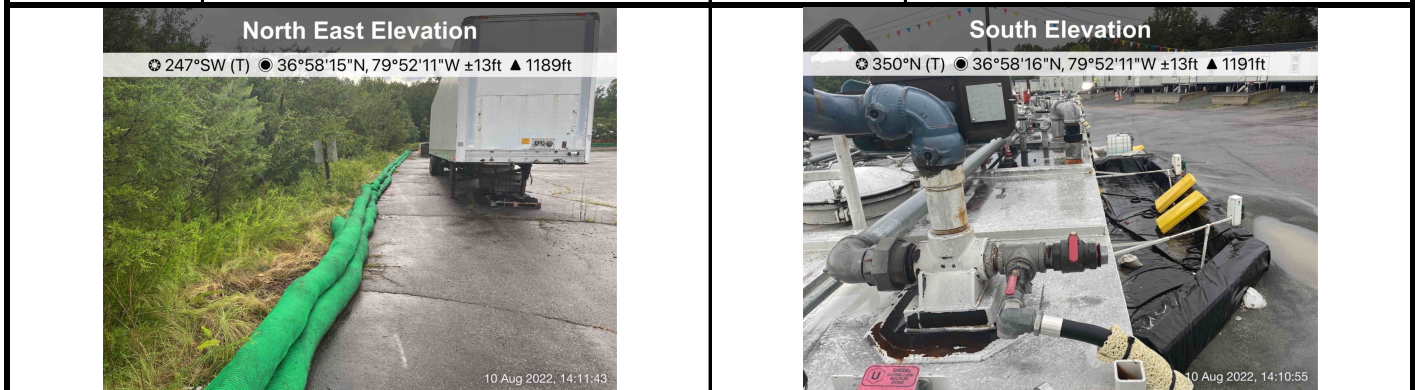
GPS Location	See picture	GPS Location	See picture
Field Station#	0000+00	Field Station#	0000+00
Pic 5 Desc.	Perimeter ECD's on south end of LY-046 in good condition.	Pic 6 Desc.	Secondary containment structure for fuel cell at LY-046 in good condition.

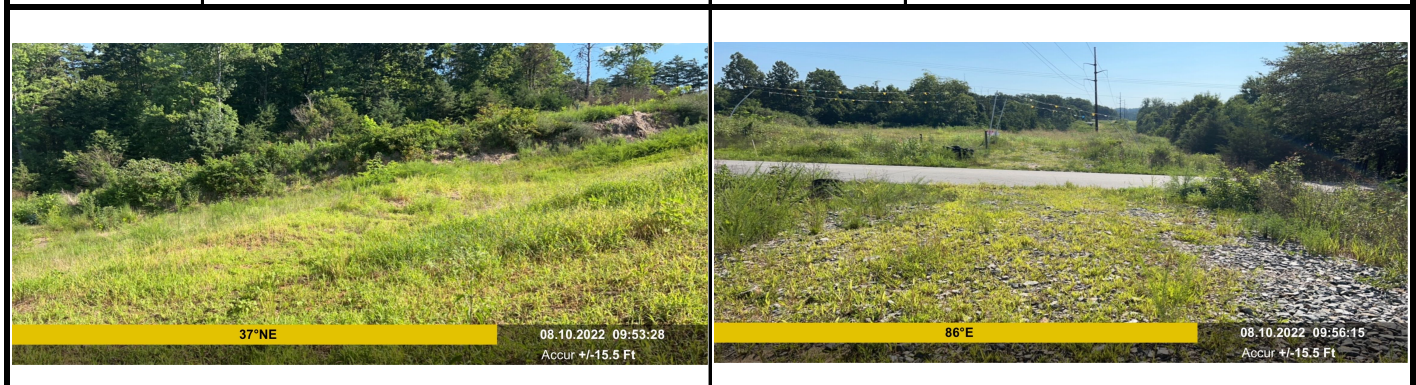
GPS Location	5	GPS Location	6
Field Station#	14692+00	Field Station#	14694+77
Pic 5 Desc.	Water bars performing intended functions.	Pic 6 Desc.	RCE at Jacks Creek Rd in good condition.

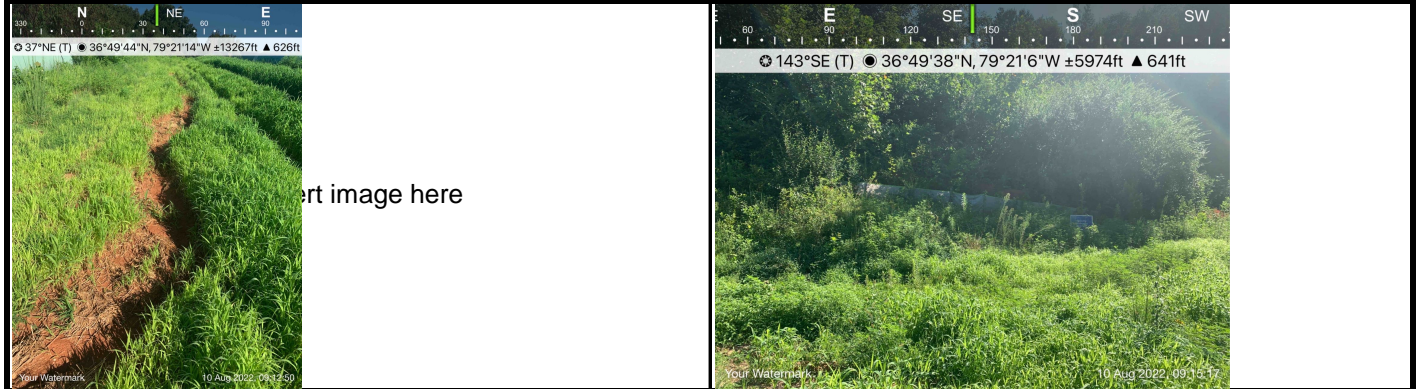
GPS Location	O	GPS Location	O
Field Station#	15995+00	Field Station#	15999+80
Pic 7 Desc.	Observing erosion that needs to be repaired and stabilized	Pic 8 Desc.	Observing temporary stabilization, signage, buffer and ECD's

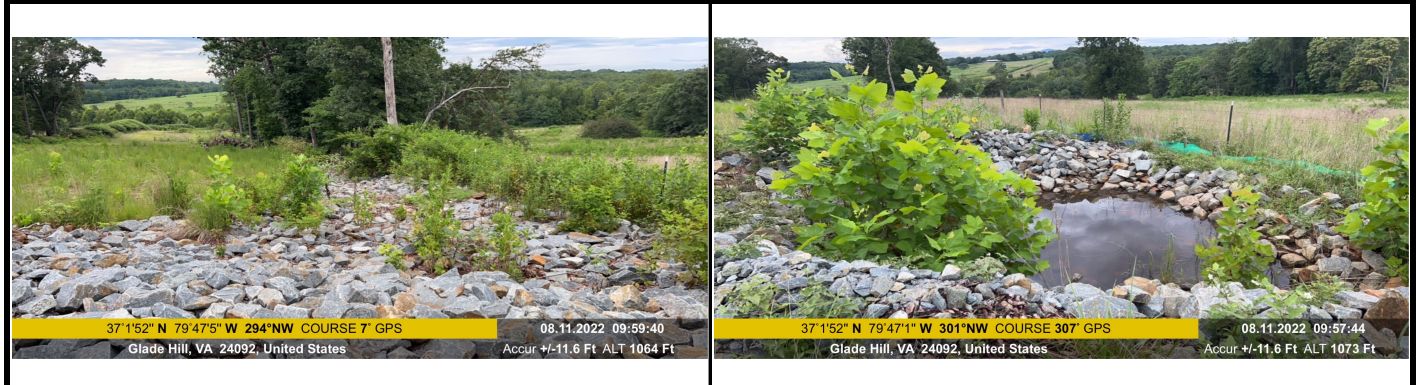
GPS Location 3	GPS Location 4
Field Station# 14401+00	Field Station# 14410+00
Pic 3 Desc. Rock lined channel in good condition.	Pic 4 Desc. Plunge pool performing intended function.

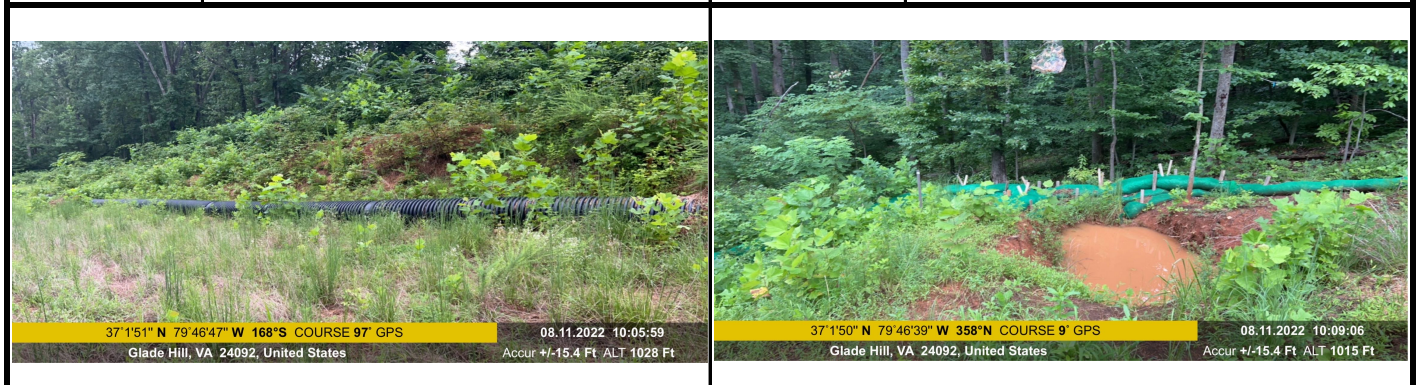
GPS Location 5	GPS Location 6
Field Station# 14417+00	Field Station# 14426+00
Pic 5 Desc. Slope drain pipe performing intended function.	Pic 6 Desc. Sump pit and CFS end treatment performing intended functions.

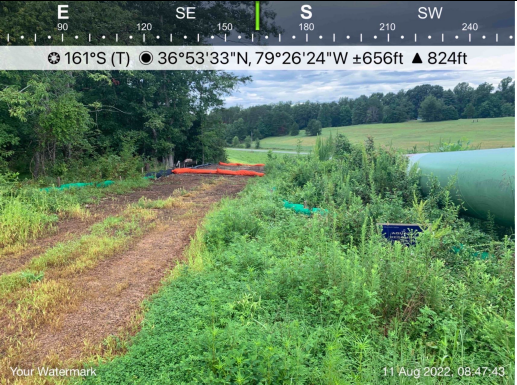
GPS Location	O	GPS Location	O		
Field Station#	15616+00	Field Station#	15614+94		
Pic 1 Desc.	Observing temporary stabilization, sump and end treatment	Pic 2 Desc.	Observing temporary stabilization, signage, buffer, equipment crossing and ECD's

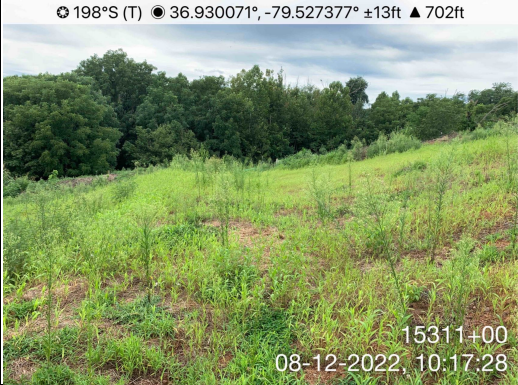
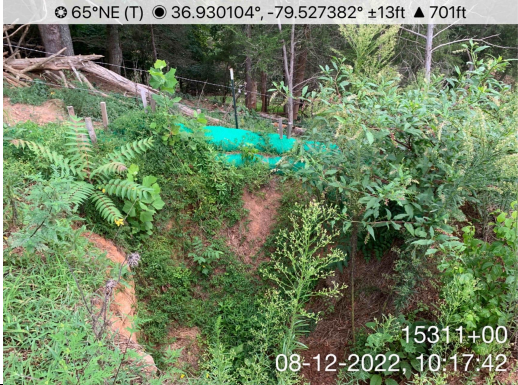
GPS Location 0		GPS Location 0			
Field Station# 15311+00		Field Station# 15311+00			
Pic 7 Desc. Waterbar in acceptable condition		Pic 8 Desc. Waterbar end treatment in acceptable condition

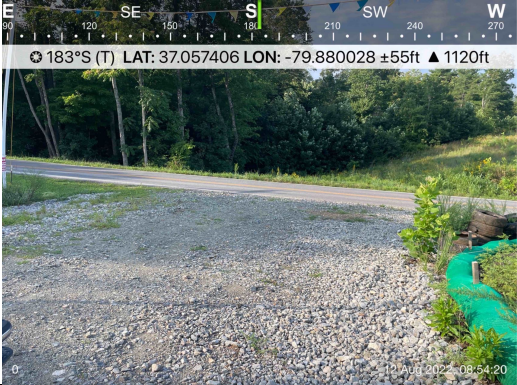
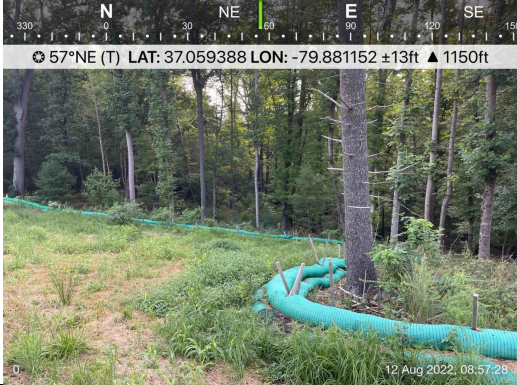
GPS Location	See photo	GPS Location	See photo		
Field Station#	14018+47	Field Station#	14027+00		
Pic 7 Desc.	RCEs are in good condition at all road crossings	Pic 8 Desc.	CFS is in good condition throughout this section

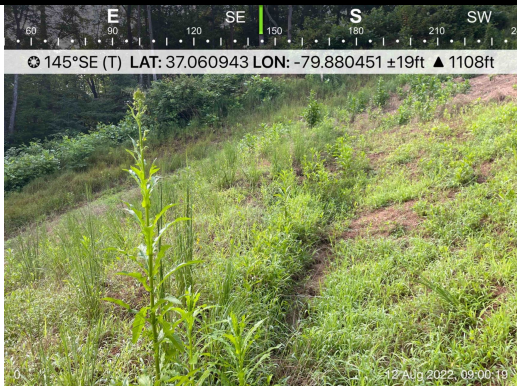
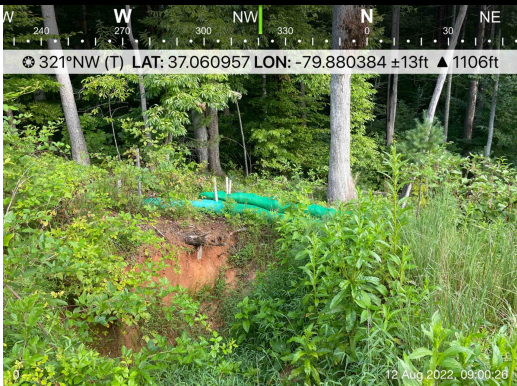
GPS Location	See photo	GPS Location	See photo		
Field Station#	14033+00	Field Station#	14033+00		
Pic 9 Desc.	Waterbars are in good condition	Pic 10 Desc.	End treatments are functioning as intended

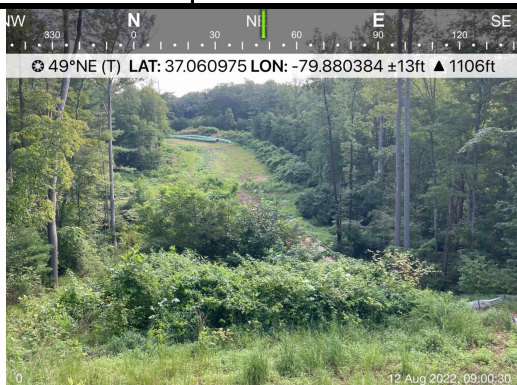
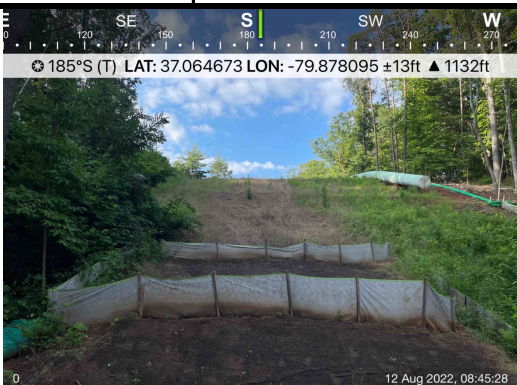
GPS Location	See photo	GPS Location	See photo		
Field Station#	14035+00	Field Station#	14050+00		
Pic 11 Desc.	Resource buffers remain well vegetated	Pic 12 Desc.	Slope remains stabilized with controls in place

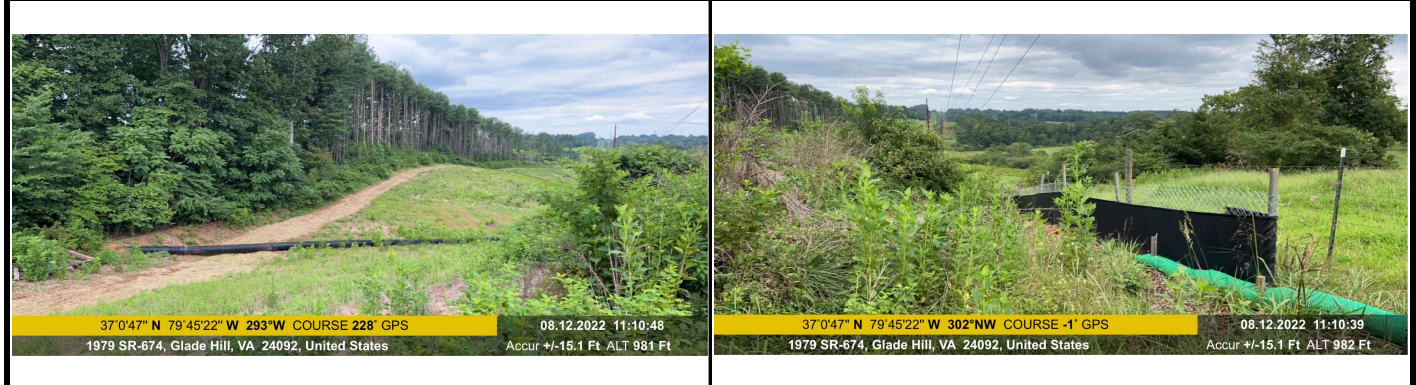
GPS Location	1	GPS Location	2
Field Station#	14506+00	Field Station#	14517+00
Pic 1 Desc.	CWD pipe in good condition.	Pic 2 Desc.	Perimeter SSF in place and functional.

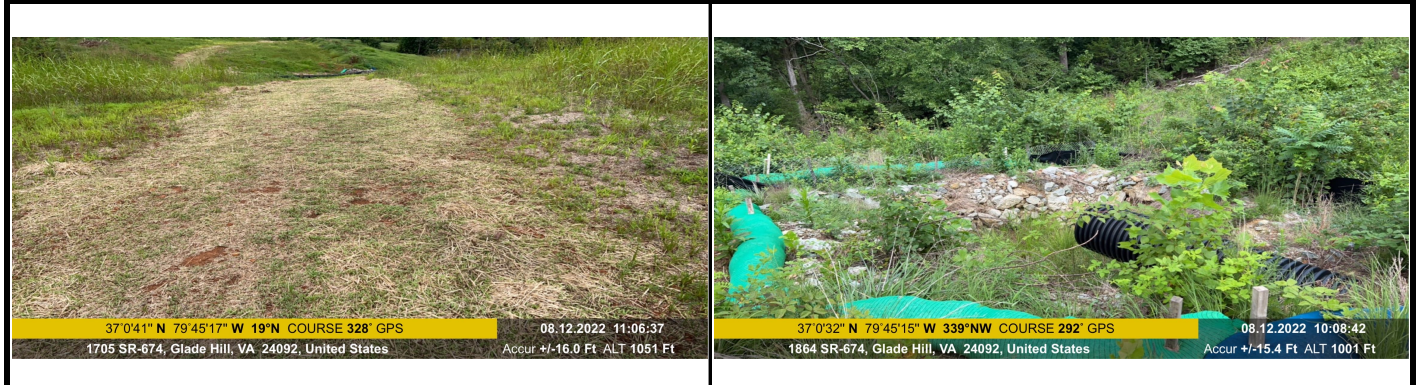
GPS Location	3	GPS Location	4
Field Station#	14521+00	Field Station#	14533+00
Pic 3 Desc.	Travel lane recently seeded and stabilized.	Pic 4 Desc.	Plunge pool performing intended function.

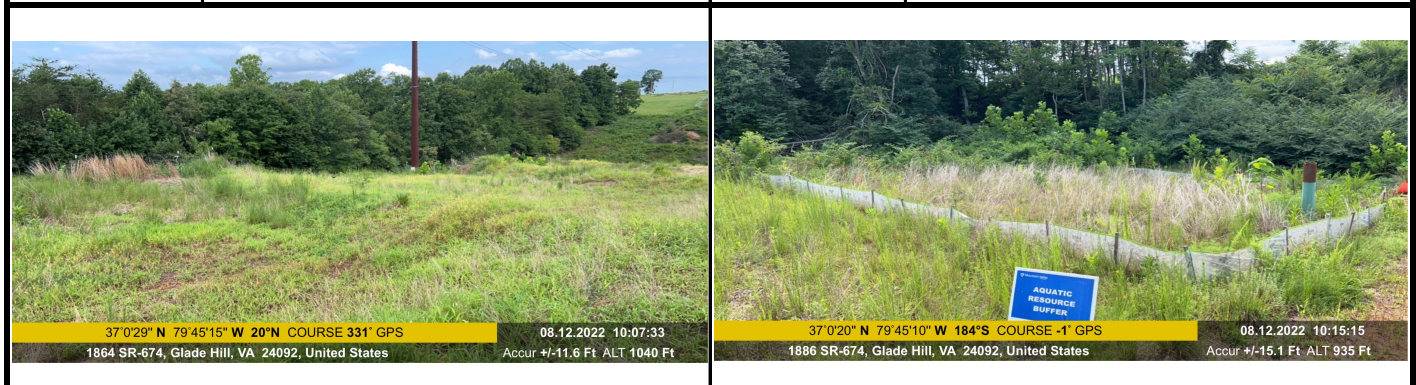
GPS Location	5	GPS Location	6
Field Station#	14534+00	Field Station#	14545+83
Pic 5 Desc.	Water bar performing intended function; ROW stabilized and vegetated in temporary area.	Pic 6 Desc.	Sensitive resource buffer and signage visible and intact. P1 silt fence in good condition.
