Stream Biological Conditions EA Report

Project Name	H-600 Pipeline Spread A	AFE	124300129	Spread	H-600 Pipeline Spread A
Contractor	Precision	Report #	9		
Environmental Auditor	Samantha Felix	Date/Time	7/16/2023 7:49 AM		
Stream ID	S-A118	Crossing Start Date	7/7/2023	Crossing Completion Date	7/13/2023
Milepost	5.53	Pre-Con Assessment Date	7/6/2023	Post-Con Assessment Date	7/14/2023
Station	291+98	Bankfull Width (ft.)	1.0	Riffle:Pool Complexes Present?	No
State	WV	Stream Classification	Intermittent		
County	Wetzel	303(d) Impairment Listing	Not impaired

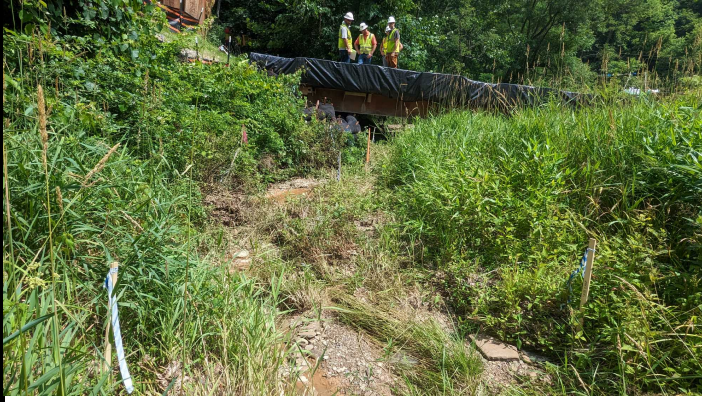
GPS Location 39.502294, -80.523569		GPS Location 39.502494, -80.523490			
Description Downstream view of permitted impact area during pre-construction assessment.		Description Downstream view of unimpacted area during pre-construction assessment.

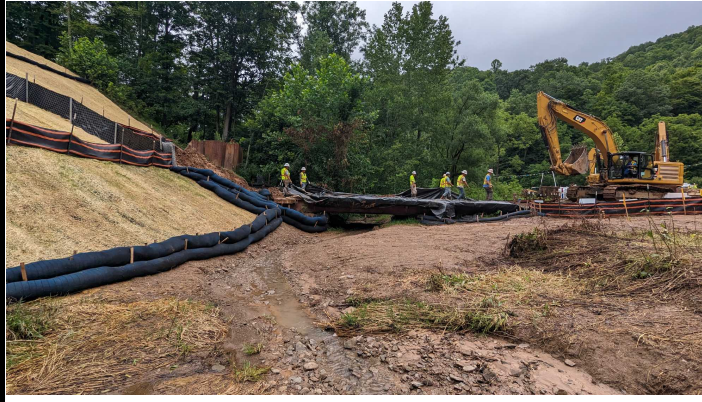
GPS Location 39.502324, -80.523568		GPS Location 39.502494, -80.523482			
Description Downstream view of permitted impact area during post-construction assessment.		Description Downstream view of unimpacted area during post-construction assessment.			
Insert image here		Insert image here			
GPS Location		GPS Location			
Description		Description
