STREAM BIOLOGICAL CONDITIONS ENVIRONMENTAL AUDITOR REPORT

Stream ID: S-C29	Crossing Start Date: 07/10/2023	Crossing Completion Date: 07/13/2023
Milepost: 229.6	Pre-Con Assessment Date: 07/08/2023	Post-Con Assessment Date: 07/14/2023
Station: 12132+73	Stream Classification: Ephemeral	Bankfull Width (ft.): 1.2
County: Montgomery	303(d) Impairment Listing: Not Impaired	Riffle:Pool Complexes Present? No

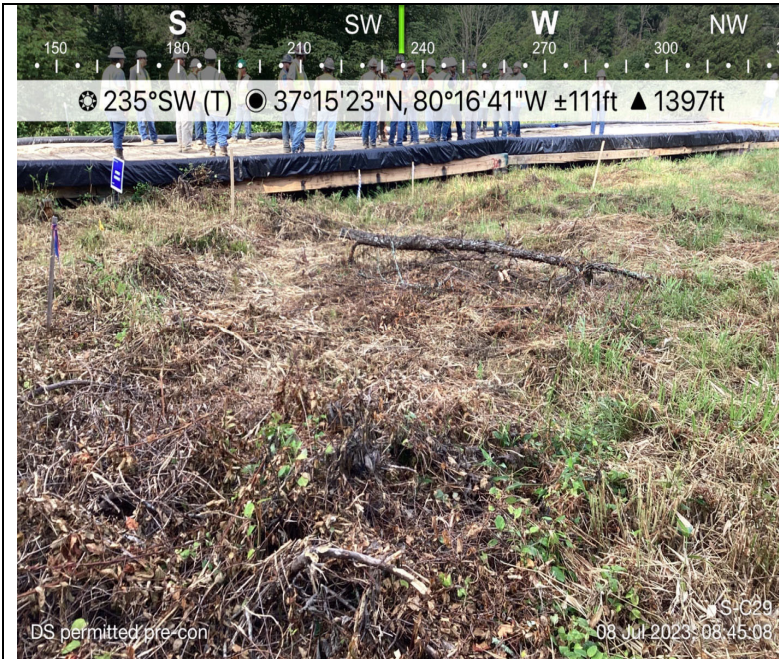
Photo Description: Downstream view of permitted impact area during pre-construction assessment.

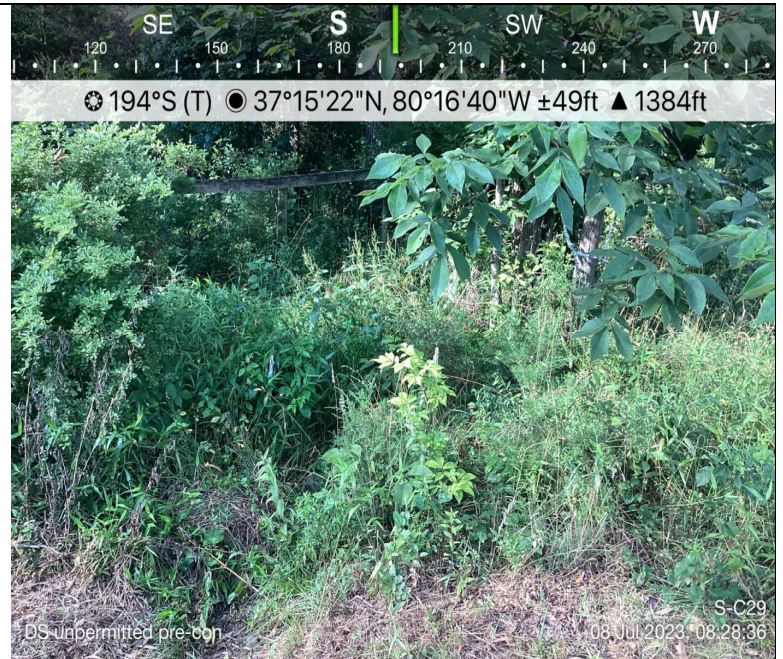
Photo Description: Downstream view of conditions outside the right-of-way during pre-construction assessment.

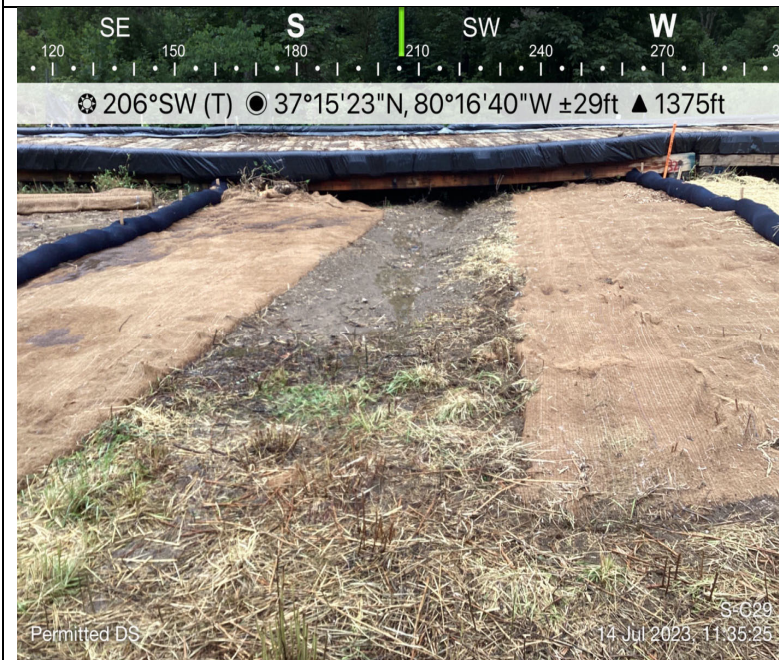
7/14/23: Stream has a small amount of stormwater flowing with minimal erosion. – T. Cullop

Photo Description: Downstream view of permitted impact area during post-construction assessment.

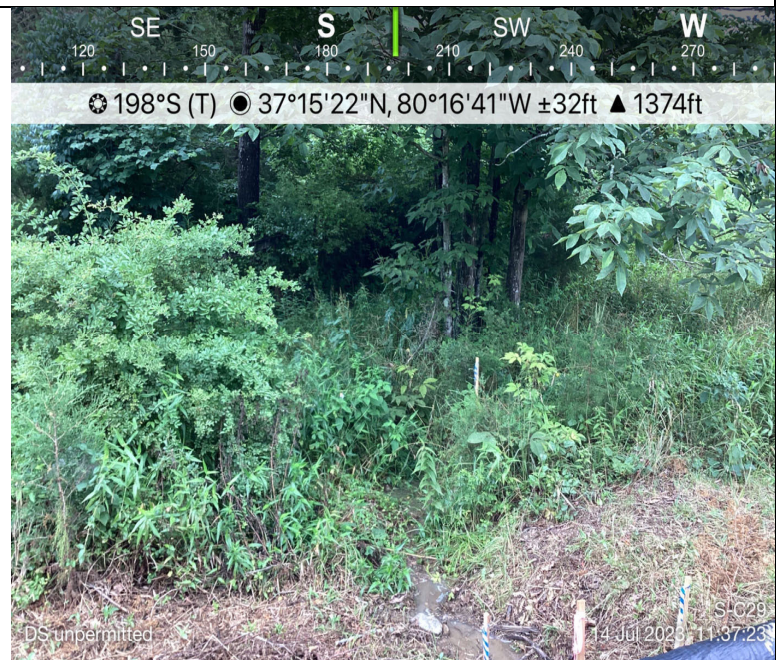
7/14/23: Downstream biological conditions appear unimpacted from construction activities. – T. Cullop

Photo Description: Downstream view of conditions outside the right-of-way during post-construction assessment.

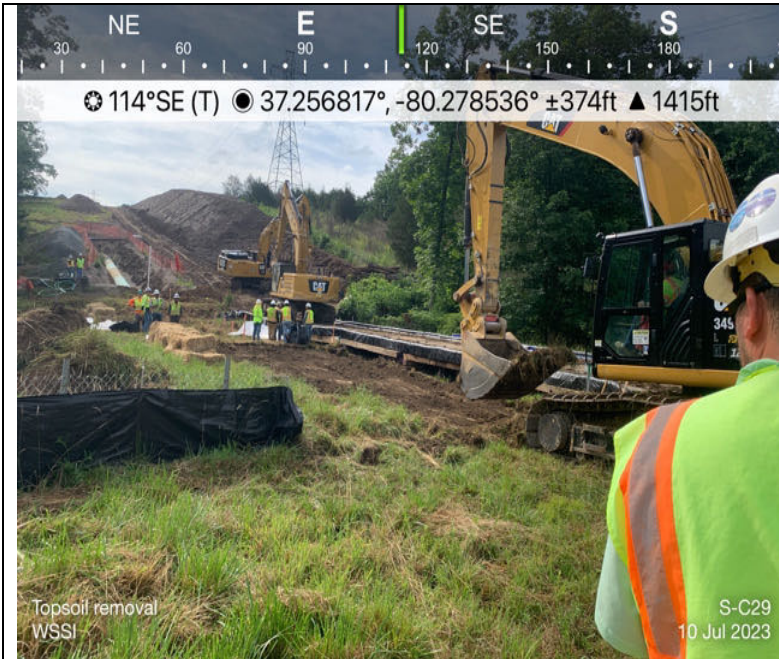
Photo Description: Topsoil removal.

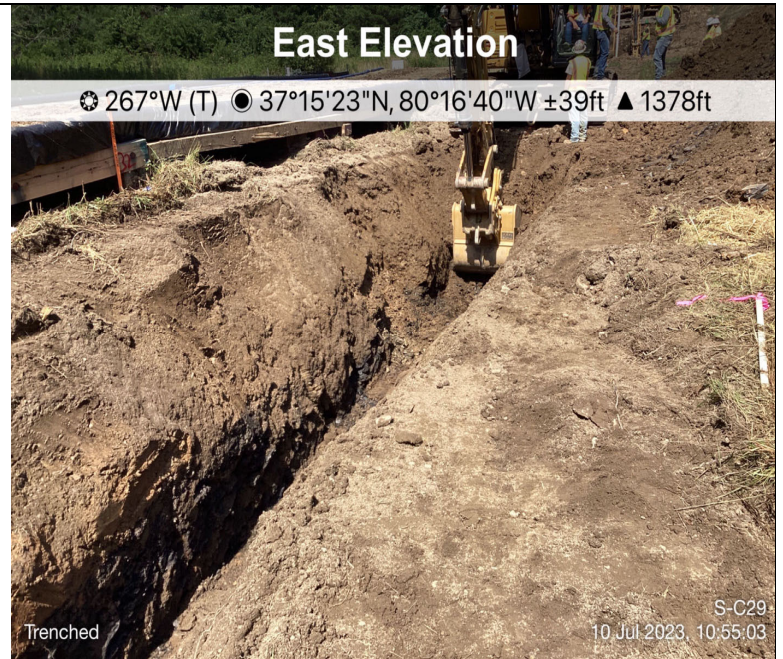
Photo Description: Trenching.

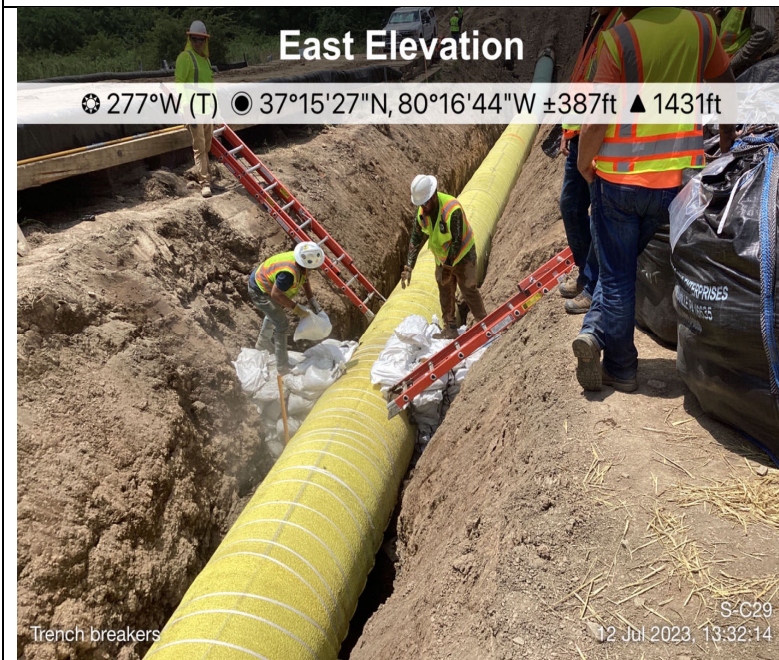
7/12/23: Trench breakers were installed, and backfilling has begun. – T. Cullop

Photo Description: Trench breakers being installed.

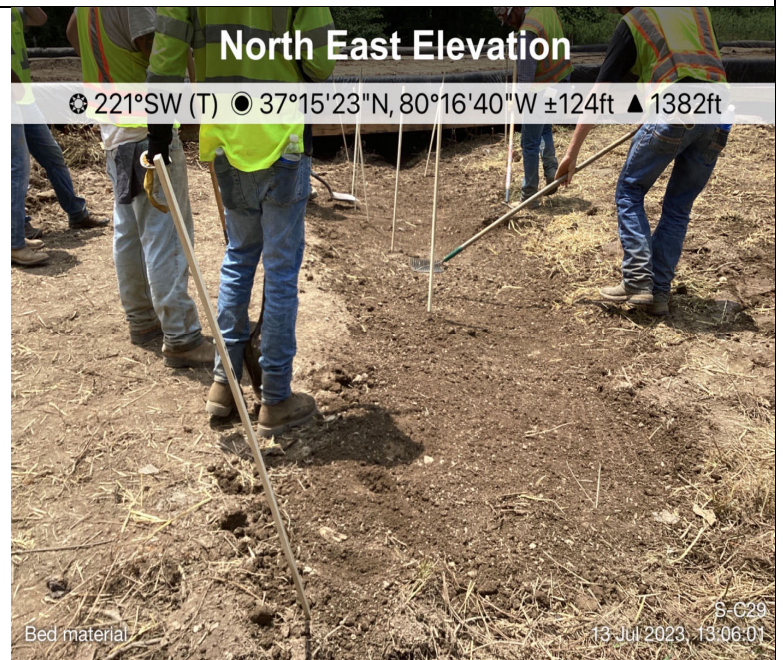
Photo Description: Stream material returned to the stream bed and fine grading.
