Wetland Biological Conditions EA Report

Project Name	H-600 Pipeline Spread A	AFE	124300129	Spread	H-600 Pipeline Spread A
Contractor	Precision	Report #	3		
Environmental Auditor	Samantha Felix			Date/Time	7/5/2023 5:47 PM
Wetland ID	W-A27 PEM	Crossing Start Date	7/7/2023	Crossing Completion Date	7/13/2023
Milepost	5.53	Pre-Con Assessment Date	7/6/2023	Post-Con Assessment Date	7/14/2023
Station	291+98	Cowardin Classification	PEM	Wetland Impact Area(acres)	0.0497
State	WV				
County	Wetzel

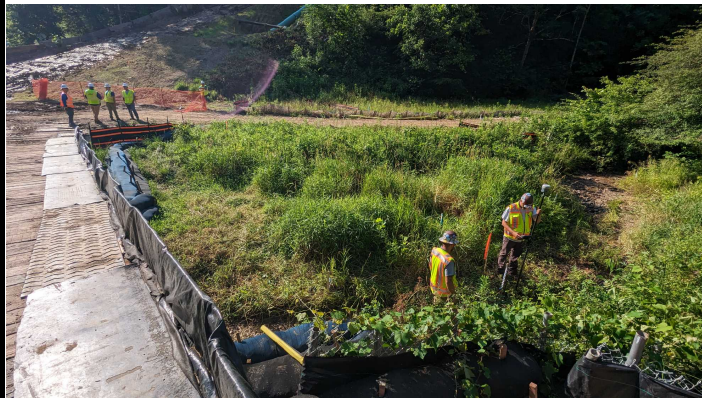
GPS Location 39.502414, -80.523324

Heavily vegetated emergent wetland bordering the south side of stream S-A118. A timber matted access road unaffiliated with Mountain Valley Pipeline runs through W-A27 PEM going north to south. Wetland W-A27 PEM did not appear to have any large rocks or woody debris present. No standing water was observed in the wetland. The timber mat temporary equipment crossing installed for the project runs along the north side of the wetland W-A27 PEM going east to west.

Description View of permitted resource impact area during pre-construction assessment.

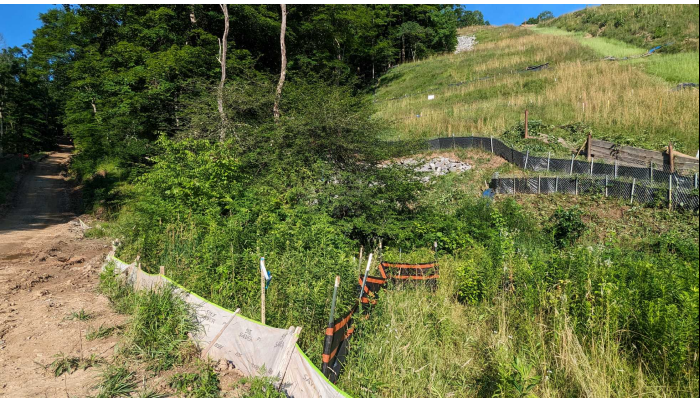
GPS Location 39.502333, -80.523209

Description At edge of LOD, view of unimpacted resource area conditions during pre-construction assessment.

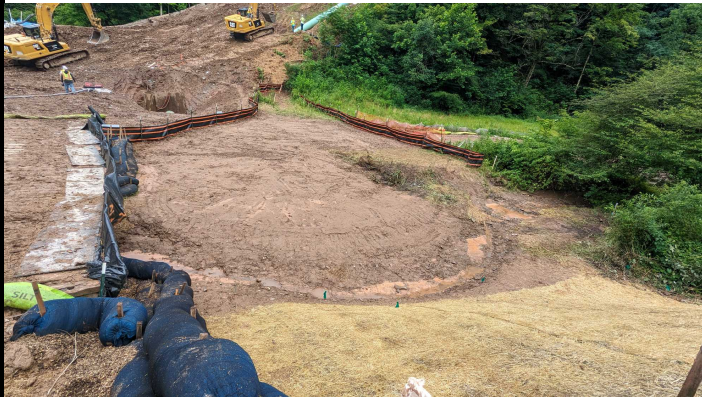
GPS Location 39.502414, -80.523324

Conditions 18 and 19 were given a rating of 4 during the post construction inspection due to the lack of vegetation in the disturbed permitted impact area following completion of the crossing and restoration efforts. The W-A27 PEM wetland topsoils have been properly stabilized and the disturbed area has been seeded with the appropriate permanent seed mix in accordance with Appendix B: Restoration Work Plan of the Mountain Valley Pipeline Comprehensive Stream and Wetland Monitoring, Restoration and Mitigation Framework.

Description View of permitted resource impact area during post-construction assessment.

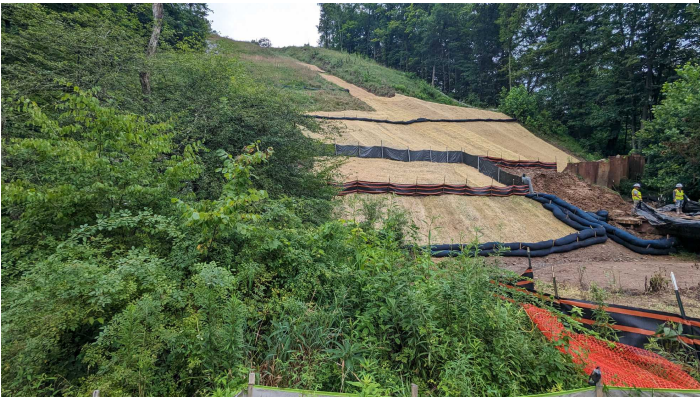
GPS Location 39.502333, -80.523209

Description At edge of LOD, view of unimpacted resource area conditions during post-construction assessment.
